**Tampa Electric Company  
(TECO)  
Coal Yard Mechanical,  
Electrical and Structural  
Assessment**

Results from field review of the  
coal unloading equipment,  
structures and conveyors.

June 21, 2010

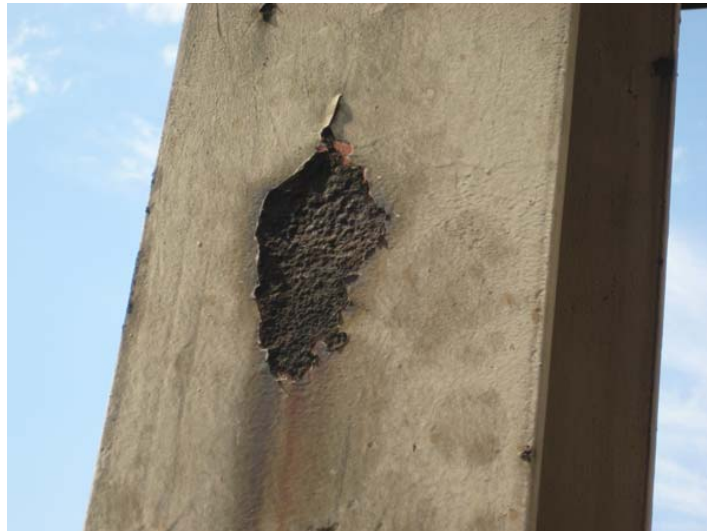
PICTURE CONV-L1-AH

- C-4 In Pictures CONV-L1-AH and CONV-L1-AJ, some corrosion was observed at about 8 feet above grade at the southwest leg. Cleaning and painting is necessary and possibly repairs if rust removal reveals excessive loss of section.

It is recommended the entire tower be inspected for its full height to determine if there are areas of corrosion not visible from grade or the conveyor level with cleaning and painting and repairing if necessary. Additionally, the horizontal X-bracing should also be inspected along the full height of the tower to see if any other areas exhibit the deterioration noted in M-11 above and previously in Pictures CONV-L1-Z and CONV-L1-AA, including the end connections.
