POST STORM FORENSICS ANALYSIS

# Forensics Analysis of Hurricane Irma Data

Tampa Electric

**Date:** February 2, 2018

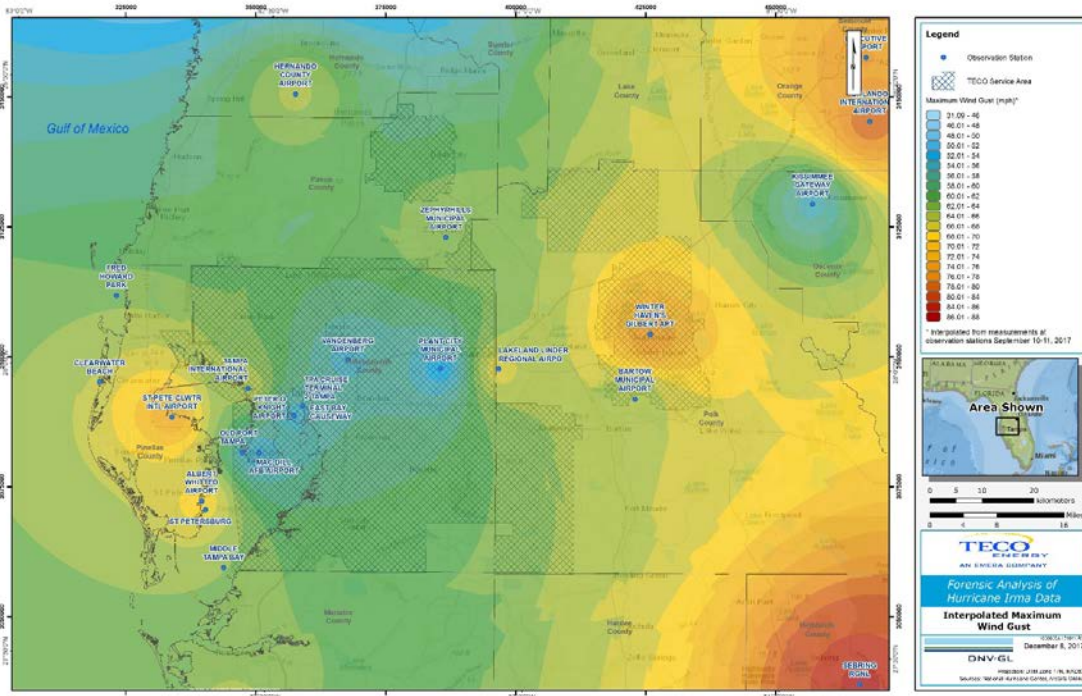
Figure 3-4 Interpolated Wind Gust

What DNV GL did to estimate wind speeds was to interpolate. To produce the interpolated maps for this report (Figures 3-4, 3-8 and 3-9), the maximum wind speed and maximum wind gust at each of the 94 observation stations over September 10-11, 2017 was used. This data was provided by TECO. The interpolation for each variable was conducted using inverse distance weighting (IDW) to predict the values between multiple sets of points. In this technique, the measured values closest to the prediction location have more influence on the predicted value than those farther away. IDW assumes that each measured point has a local influence that diminished with distance. It gives greater weights to points closest to the prediction location, and the weights diminish as a function of distance. This technique does have limitations as it only considers distance to the measured location and does not consider local topography which can greatly influence wind speeds.

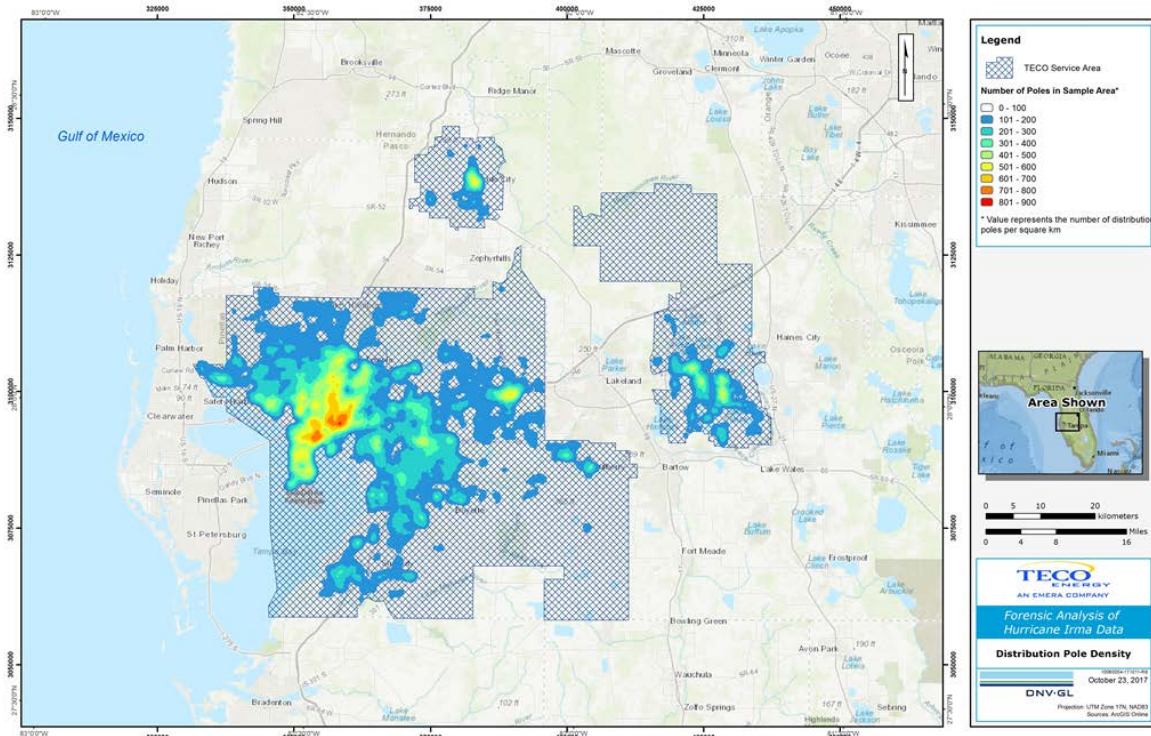
Figure 3-6 Distribution Pole Density

DNV GL defined the survey areas for field data collection based on TECO service areas (Figure 3-2), interpolated maximum wind speed (Figure 3-3), interpolated wind gusts (Figure 3-4), outage information (Figure 3-5) and pole density data (Figure 3-6). TECO determined that the Winter Haven service area reportedly experienced Category 1 severity and was a priority survey area. The other service areas sustained tropical storm wind intensity. The survey had to be performed in a timely manner before significant restoration activities began. Only above ground assets were surveyed and no survey was conducted on substations or underground facilities.

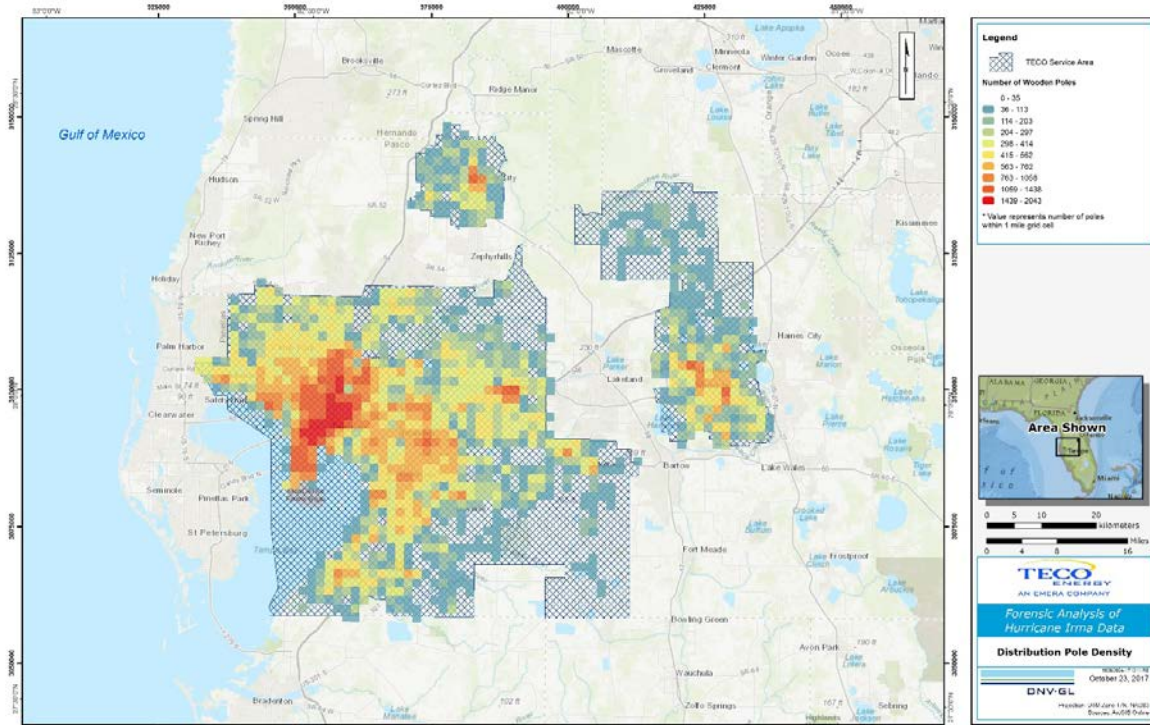
**Figure 4-2 Total TECO Distribution Pole Density Map**

These poles are distributed mostly in the Tampa area, but the TECO service area includes areas outside of the immediate Tampa location, such as Winter Haven, as illustrated by Figure 4-2. This figure shows pole density throughout the area of TECO. The scale indicates the number of poles present in a specific area.

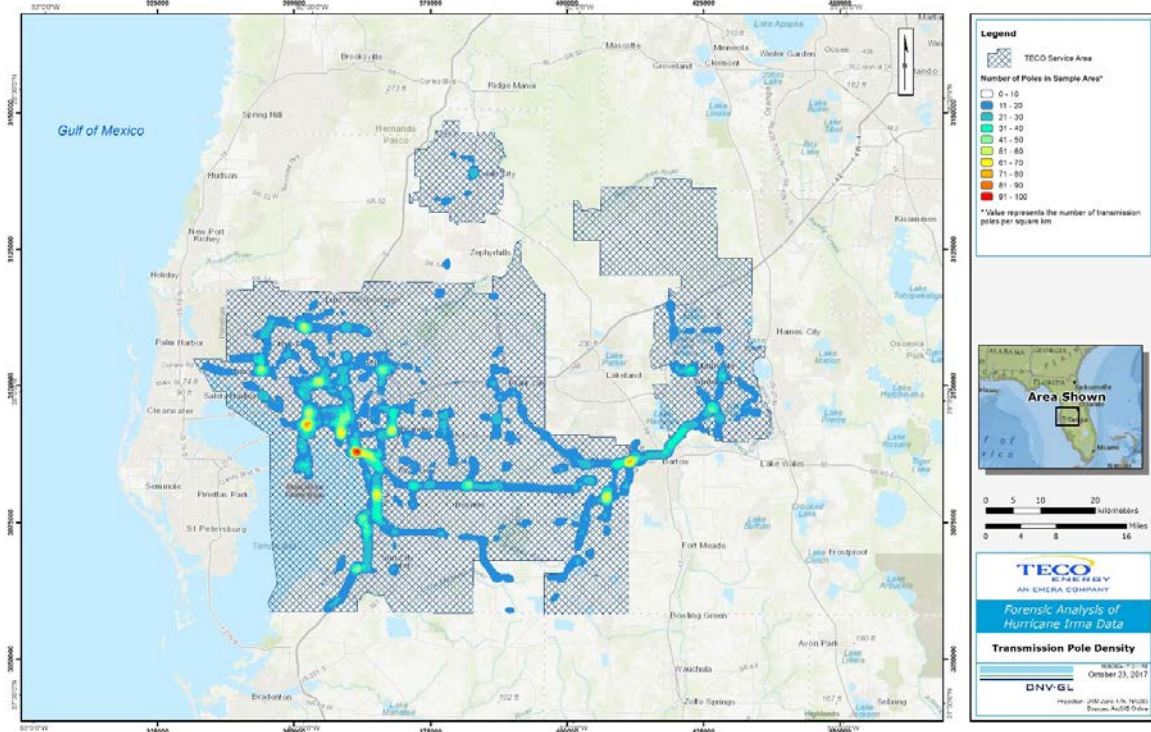
Figure 4-3 Transmission Structure Density

Transmission structure density for the TECO service area is shown in Figure 4-3.
