Power Delivery Performance

Hurricane Matthew

Report Date: November 17, 2017

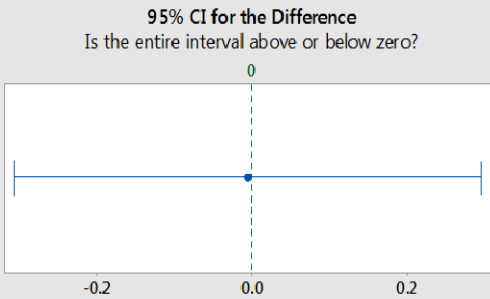
- Test: There is not enough evidence to conclude that the % defectives differ at the 0.05 level of significance.
- CI: Quantifies the uncertainty associated with estimating the difference from sample data. You can be 95% confident that the true difference is between -0.31% and 0.29%.
