DOCUMENTS: Panel deposition of Jeffrey Swartz, Anthony Salvarezza and C. Wayne Toms, August 30, 2019.

CONFIDENTIAL**Bartow 4S Root Cause Analysis – Evaluation of Contributing Factors**

Duke and Mitsubishi Hitachi Power Systems (MHPS) have worked both independently and together over the past 12 months to determine what has caused the Bartow Unit 4S L-0 blades to crack and break during operation. During a presentation given at Bartow Station on 15 March 2017, MHPS suggested the sole root cause for Period 3 (Dec 2014-Mar 2016) was “operation in the avoidance zone”. While Duke Engineering would agree that operation in the “avoidance zone” is certainly a *contributing factor* to the shroud chipping experienced in Period 3, it is not the only driving mechanism that should be considered when trying to determine root cause for the Period 3 Bartow Unit 4S event, or any of the previous/subsequent events for that matter.

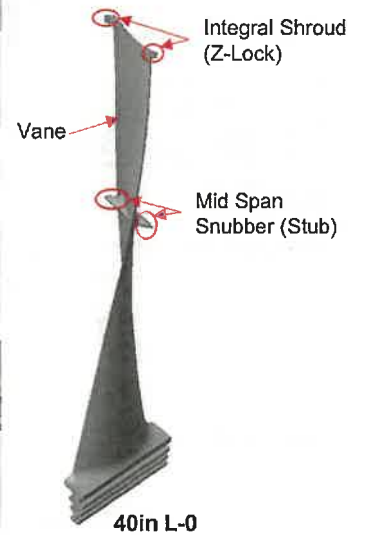
Period	Operating Time	Blade Type	Major Damage
Period 1	2009 - 2012	Type 1	Mid Span Snubber Only

Period 2	2012 - 2014	Type1	No Significant Damage  
Period 3	Dec 2014 – Apr 2016	HVOF Stellite Mid Span Type 3	Shroud Only  
Period 4	Jun 2016 – Oct 2016	HVOF Stellite Mid Span + HVOF Stellite Shroud Type 3	Vane + Snubber (Note 1)

Period 5	Dec 2016 – Feb 2017	Type 1	Mid Span Snubber Only

Note 1 – Period 4 did not show shroud fretting fatigue / contact wear damage.

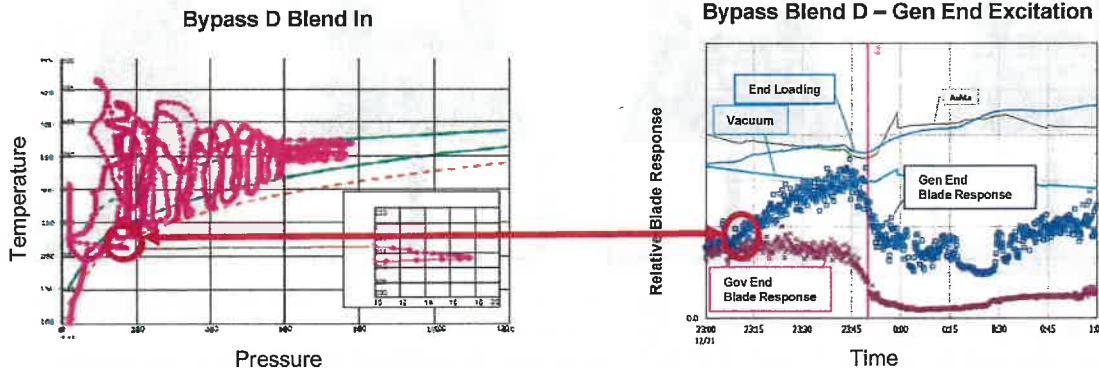
Bypass Operation - Does hitting the saturation line during bypass blending produce a forced response on the blade ?

During the telemetry test 2 blend in event were captured, but pipe accelerometers were not installed until Mid 2015. Based on Duke's evaluation of blends after installation of the accelerometers, dropping below the saturation line potentially produces a shock wave which excites the blades.

- Based on the telemetry test data available for blade response during bypass operation, dropping below the saturation temperature line did not show a blade response

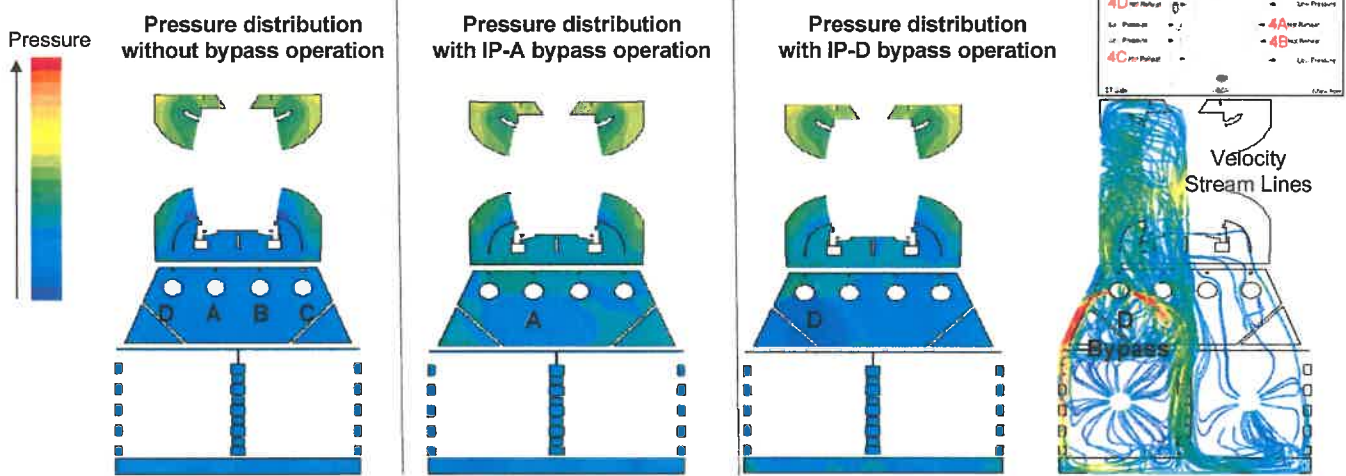
Does Bypass Operation Provide Stimulus to the blades?

- Increased blade response (1.5X Increase from C or D Bypass) was quantified through Telemetry Testing (Blade response was recorded and shown to be Non-Synchronous Self Excited Vibration (Flutter))
- A and B Bypass operation do not show increased blade response which is consistent with other 2on1 bypass configuration telemetry Tests.
- Bypass configuration within the condenser is unique to Bartow with C and D bypasses located close to the exhaust.
- Condenser heat load at 420MW is at the limit of the condenser specification. High velocities during 3 to 4 GT Bypass Operation

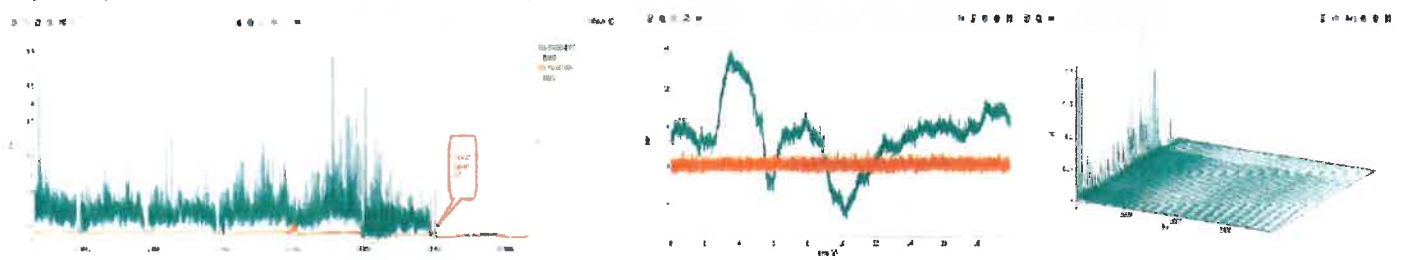
Dynamic pressure identified associated with Hood Sprays :

Pressure fluctuations did not have high frequency content, and identified pressure rising from 2.5" Hg to atmospheric pressure. No corresponding blade response identified during telemetry test.

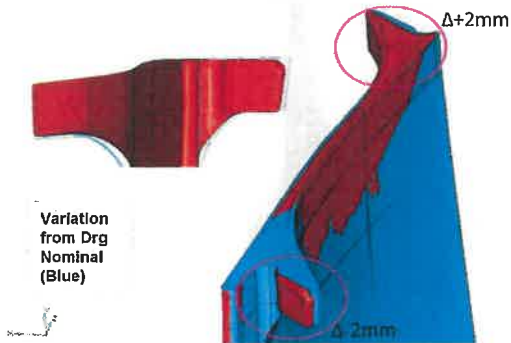
Geometry Evaluation – Type 3

- The blade response analysis has captured the worst case geometry variation. The baseline geometry for the blade response in the telemetry test was the Type 3 blade which shows the greatest geometry variation.
- Type 1 blade shows less distortion than the Type 3 Blades.

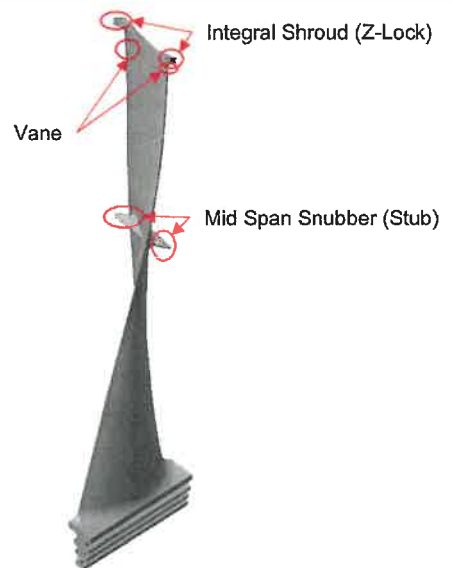
- Stress comes from Dynamic Loads superimposed on the steady state loads (Centrifugal + Steam Bending Loads).
- Limiting stress locations for 40" L-0 Blade :
 - 1) Mid Span Snubber
 - 2) Integral Shroud
 - 3) Vane HCF
- Dynamic Stresses are controlled by avoiding resonant operating conditions where the blade response frequency matches frequency of the stimulus, and ensuring adequate damping.

Root Cause Analysis has identified all blade damage from Period 1 thru Period 5 has been identified as Dynamic Loads from Non-Synchronous Self Excited Vibration (Flutter)

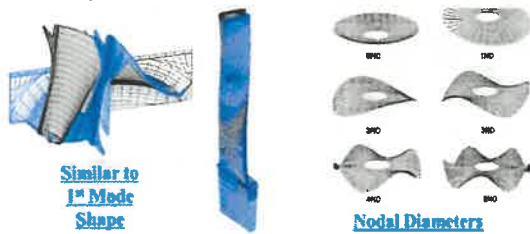
- Blade response is measured during Telemetry Testing and analytically predicted at around 16th Nodal Diameter of the first mode (approx. 200Hz).
- The Notable Non-synchronous Vibration is caused by aero-dynamic flow and observed as the Multiple Modes Response (180Hz-230Hz).

- Cycles accumulate at 12,000 cycles per minute at 200 Hz

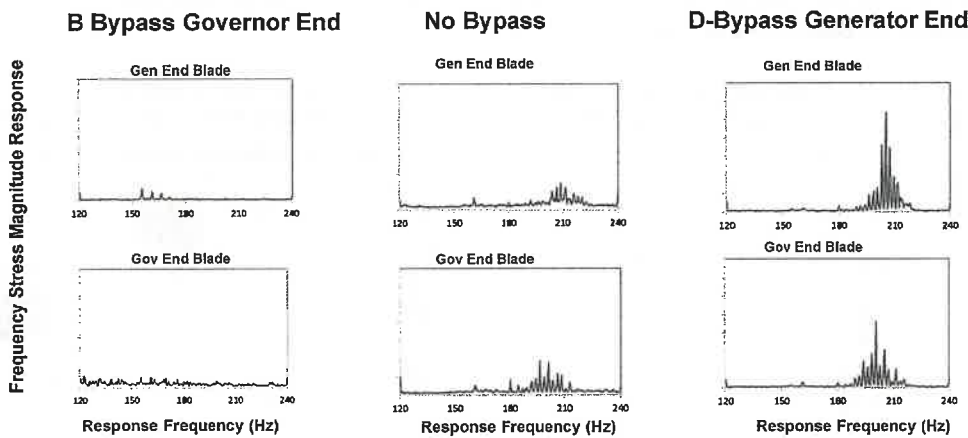
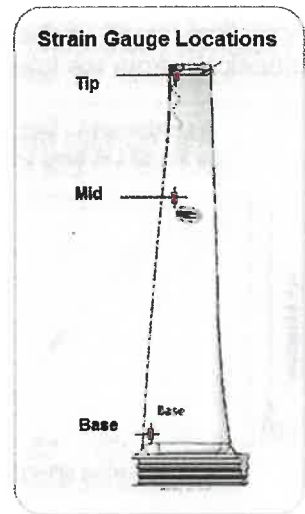
Frequency Response from Telemetry Test :

- Peaks at 120, 180, 240Hz are per Rev Responses
- Peaks between 180 to 230Hz are High Nodal Diameter responses of the First Cantilever Mode. These frequencies are associated with Non-Synchronous Self Excited Vibration

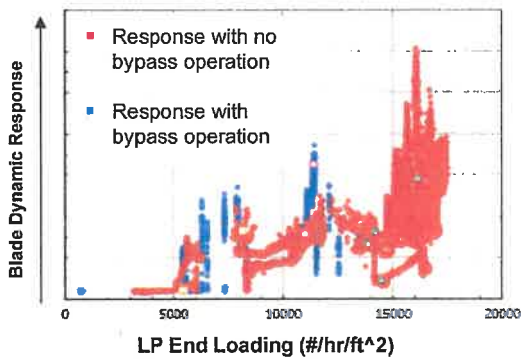
Blade Response vs LP End Loading

- Outside of the originally developed design space, blade response becomes sensitive to operating conditions.
Example : At 16,500 #/hr/ft² there is a 10X change in blade response based on condenser pressure

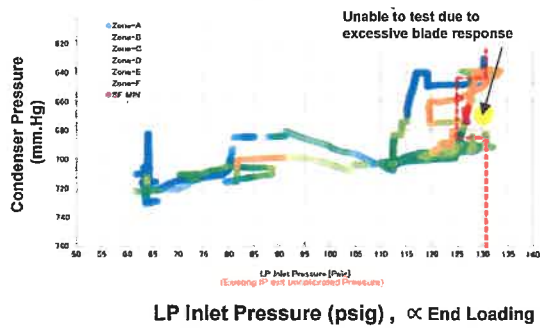
Blade Response – Design Margin (Red High / Blue Low)
Example : Shroud Fretting Fatigue

- The avoidance zone established in 2015 was developed to prevent operation in the region which measured high blade response.

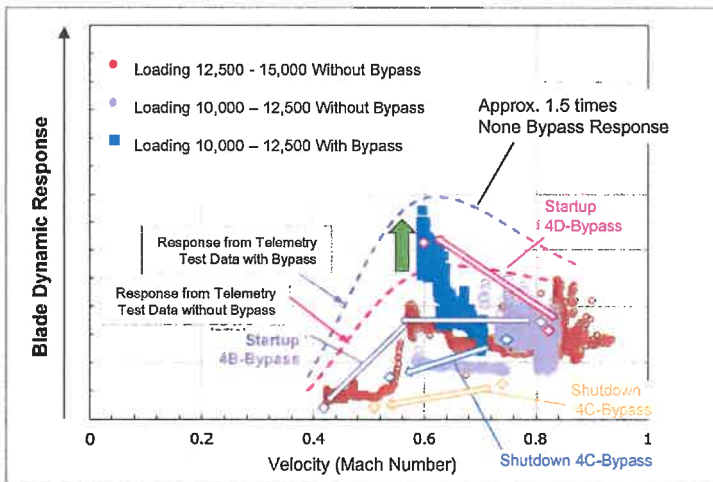
Blade Response as a Function of Bypass Operation

- Bypass C Operation increases response on Governor End Blades
- Bypass D Operation increases response on Generator End Blades

- Operation with Bypass D and C Produce a 1.5X Increase in blade response on the blades closest to the bypass
- Operation with Bypass A and B did not show an increase in blade response over none Bypass Operation
- Limited Blade Response data during Bypass is available with the operation before and after Dec 2014 Telemetry Testing being assumed to have remained the same change in response.

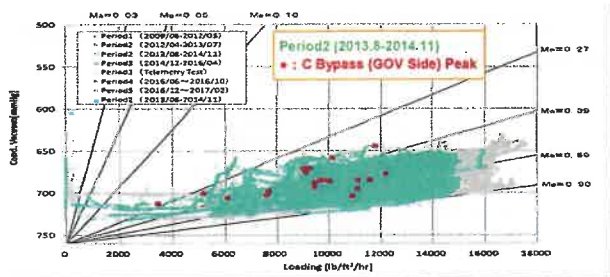
Period 2 Gov End - Type 1 Blade

Period 2 – C Bypass Accumulation – No Stub Damage (Gov)

Period 2 – D Bypass Accumulation – No Stub Damage (Gen) + Period 1 but no minute data available

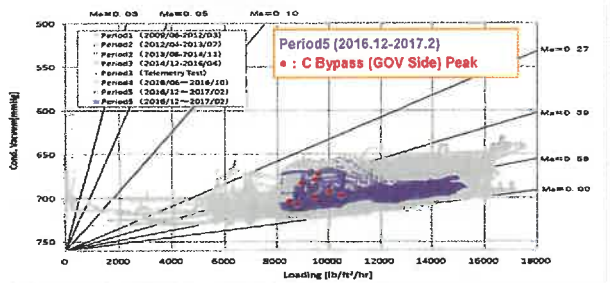
Period 5 Gov End - Type 1 Blade

Period 5 – C Bypass Accumulated Time – No Stub Damage (Gov)

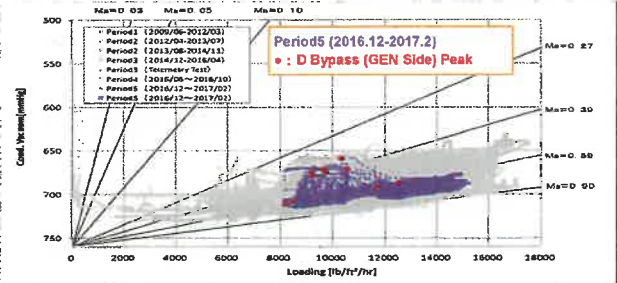
Period 5 Gen End - Type 1 Blade

Period 5 – D Bypass Accumulated Time – Stub Damage (Gen)

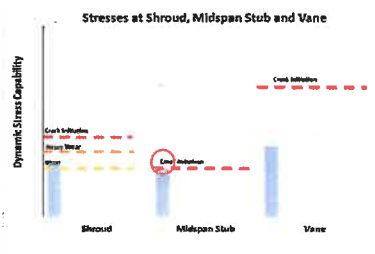
Dynamic Stress from Damage

Period 1 – Stub Cracking

Operation at higher loads than Period 3, but Type 1 Blade has improved damping over Type 3 in Telemetry Test

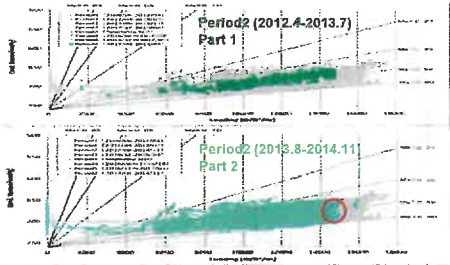
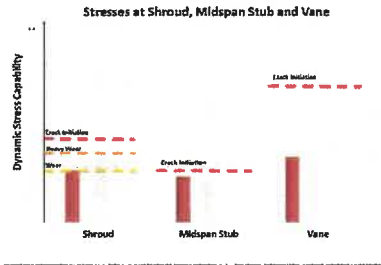
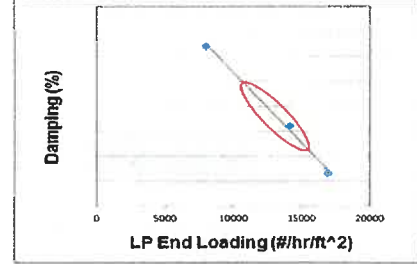
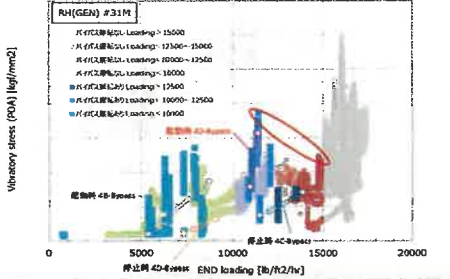
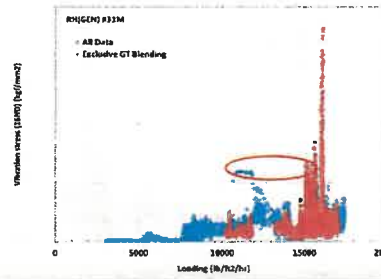
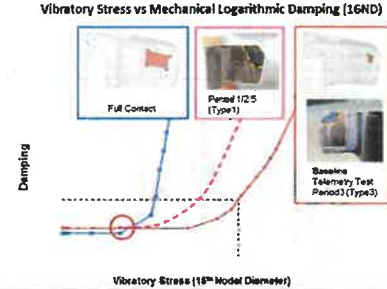
Period 2 – No Major Damage, Minor Shroud Chipping

Reduced LP Loading over Period 1, reduced bypass operation loading over period 5, light wear observed on shroud

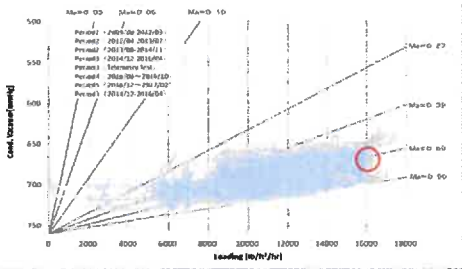
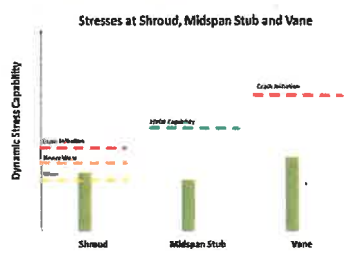
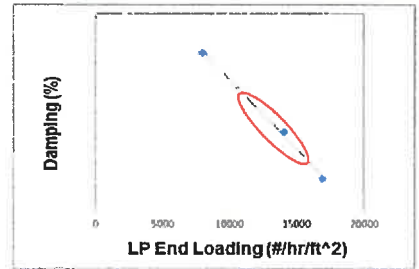
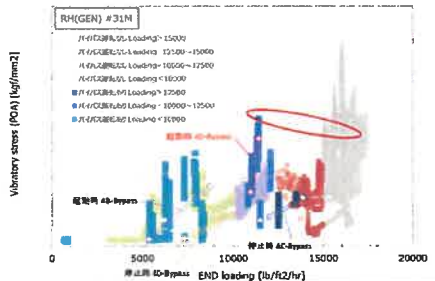
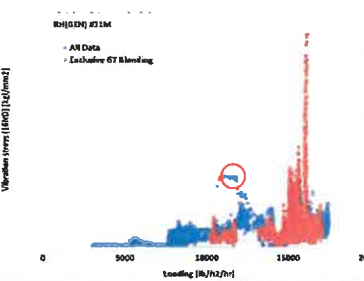
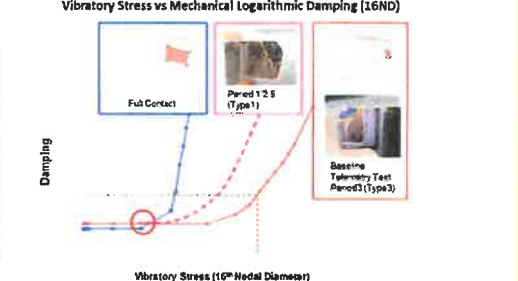
Period 3 – Shroud Cracking - Outside Avoidance Zone

Outside of avoidance zone, bypass operation becomes most limiting. With HVOF on Mid Span Stub no cracking is predicted.

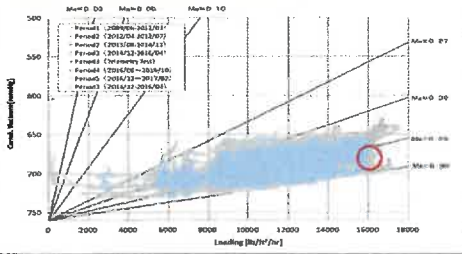
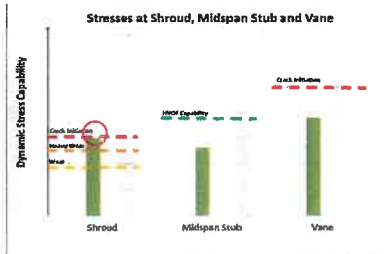
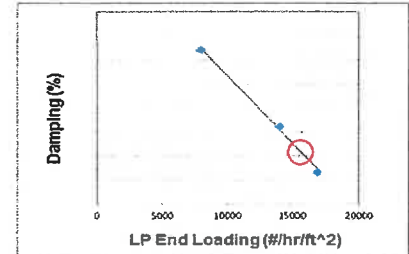
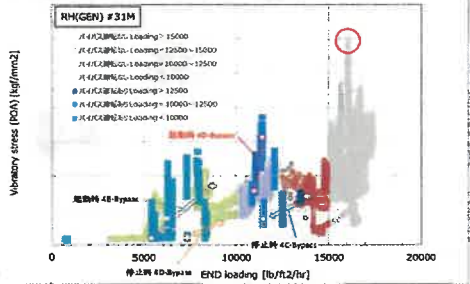
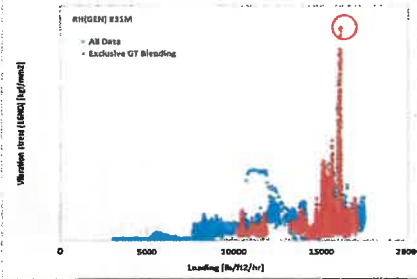
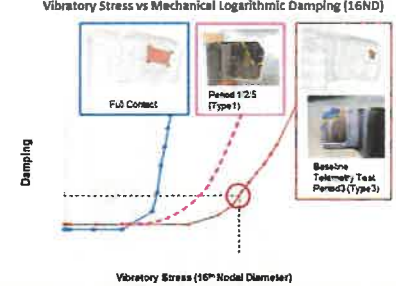
Period 3 – Shroud Cracking– Inside avoidance zone

High blade response established in Telemetry Test. Mid Span Stub protected by HVOF. Shroud become limiting location.

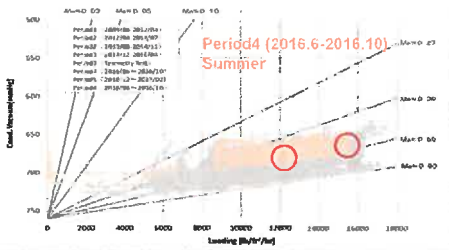
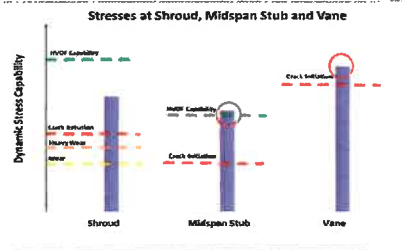
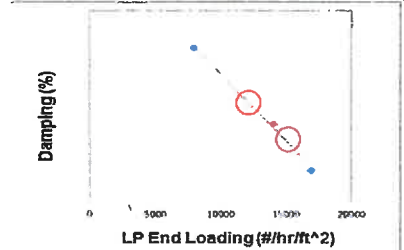
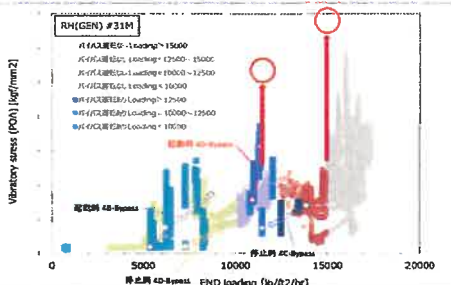
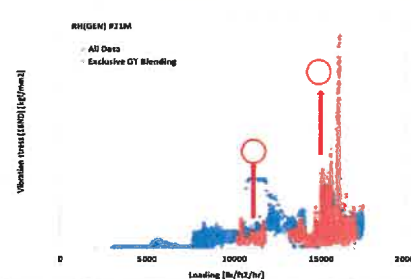
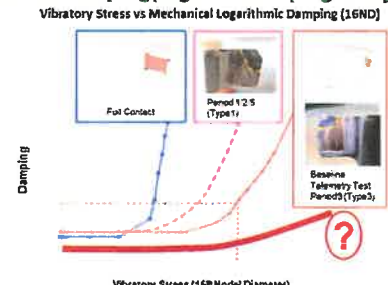
Period 4 – Vane + Stub Cracking

Reduced LP Loading. Application of HVOF reduces mechanical damping increasing amplitude of response. With HVOF protecting the Shroud and Stub, the limiting location becomes the Vane

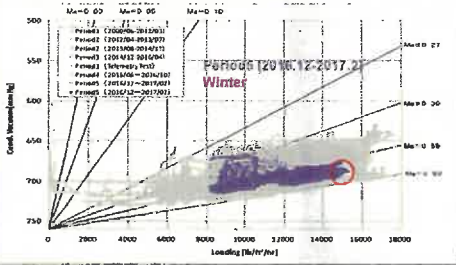
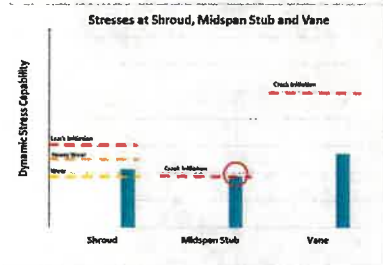
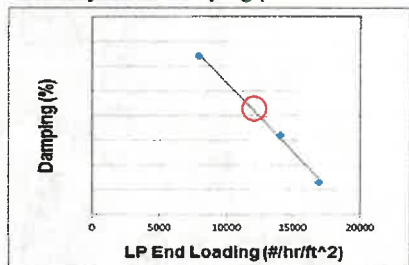
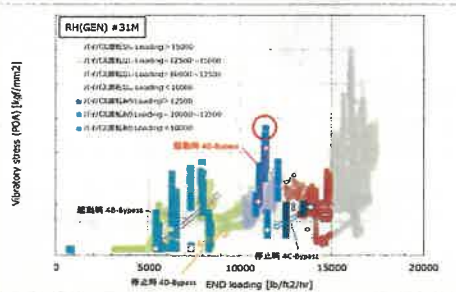
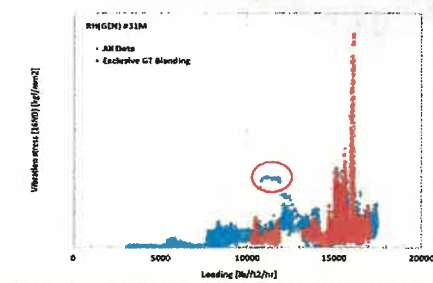
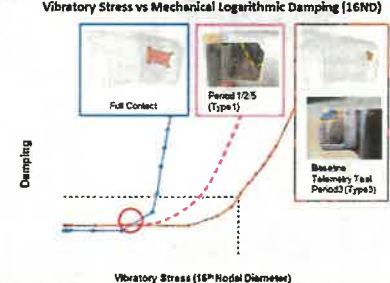
Period 5 – Stub Cracking

Reduced LP Loading over Period 2 with longer periods of bypass operation at High Mach Number. No HVOF Protection.

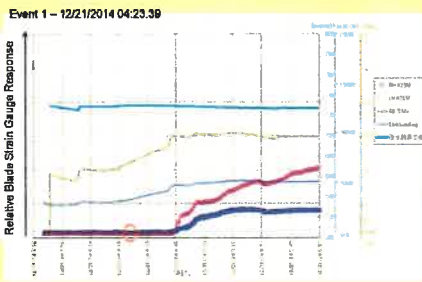
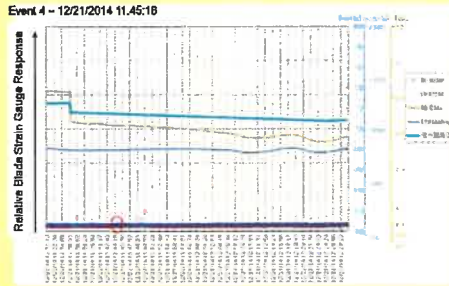
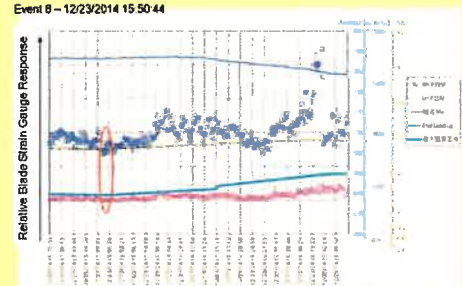
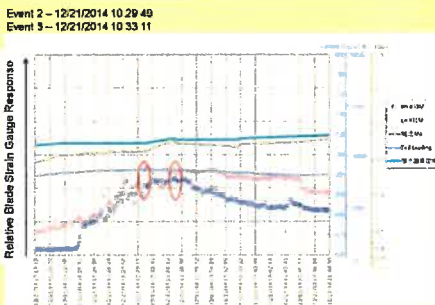
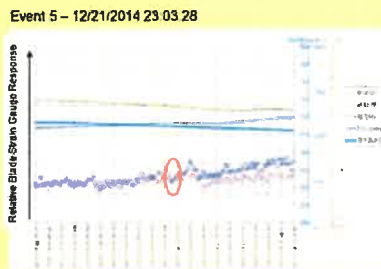
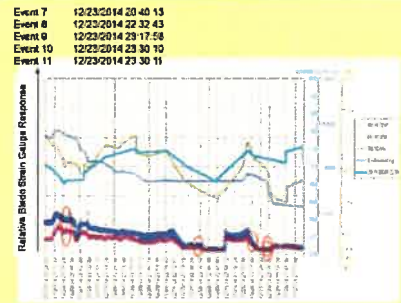
The action was taken on 9/22/17 to evaluate the telemetry test data to confirm whether high rate of change events of superheat showed any blade response.

Evaluation of the 11 thermal event during the 2014 telemetry test did not show any corresponding increase in blade response.

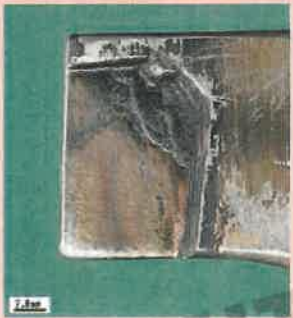
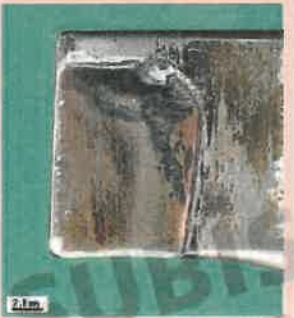
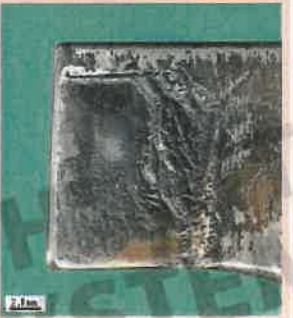
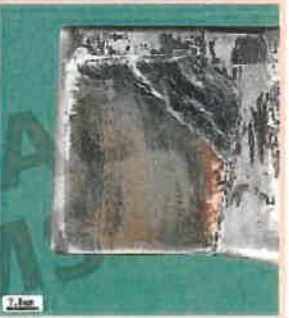
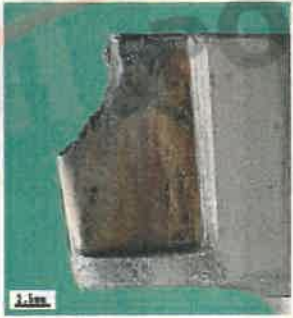
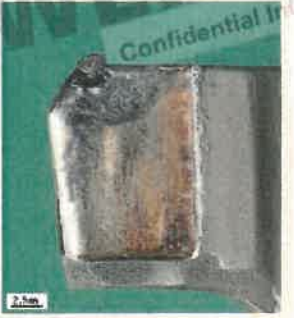
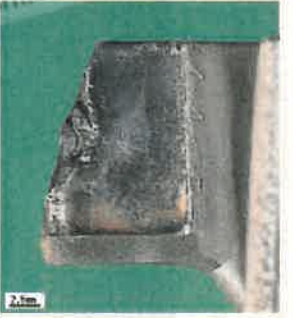
#42 outlet #43 inlet	#43 outlet #44 inlet	#44 outlet #45 inlet	#45 outlet -----
Outlet side contact surface

Shroud Chipping is starting at same location for all blades

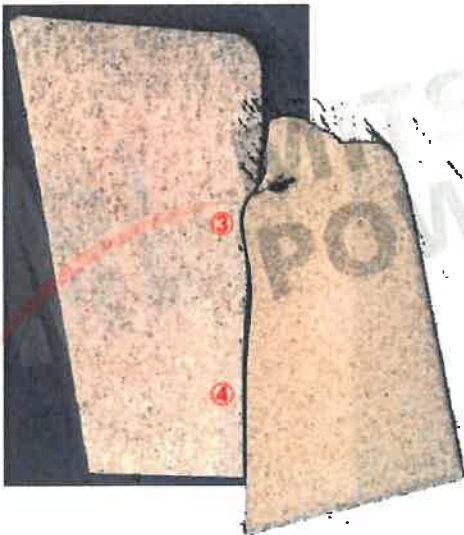
#44 inlet side

Microscopic observation was performed on the same sections in contact condition for each of outlet side of #43 blade and inlet side of #44 blade.

- ③: Oxide scale was found on black surface of local deformation area.
- ④: Dark brown surface of worn and thinned part is free of oxide scale and smoother than non-contact surface of ⑤.

Oxide scale with local deformation observed on black surface

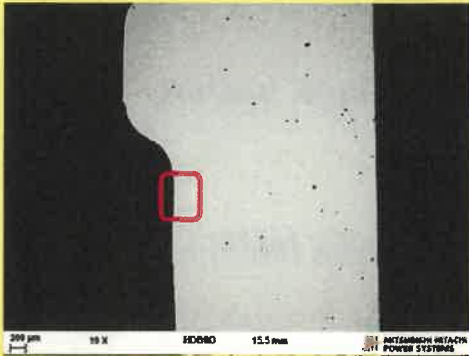
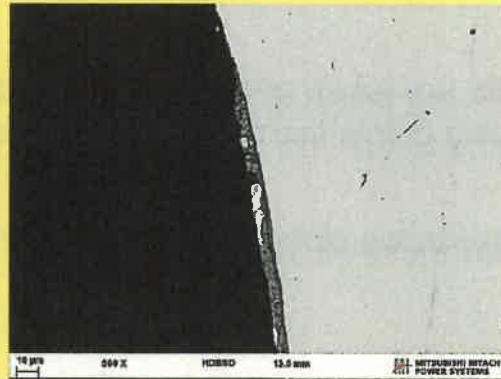
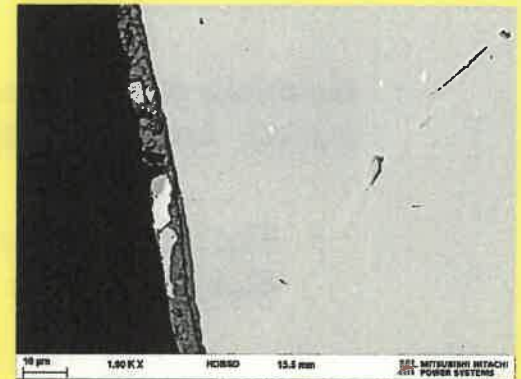
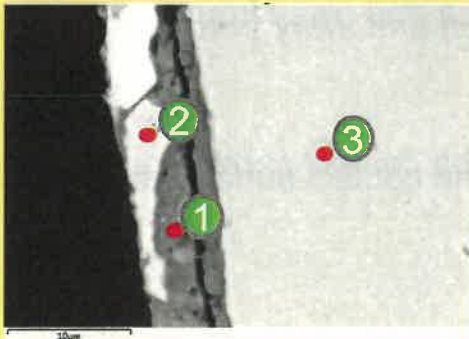
Location	Semi-Qualitative EDS analysis of elements detected (wt%)							
	O	Si	Cr	Mn	Fe	Ni	Cu	Nb
1	25.97	0.44	7.67	0.41	61.59	1.84	1.18	0.00
2	0	0.35	18.15	0.95	70.12	9.35	0.08	1.00
3	0	0.33	15.86	0.54	73.65	4.91	3.58	1.14

- Oxidation/corrosion was observed on the trailing edge contact surface of the tip shroud.
- Material removal from wear is from abrasion.

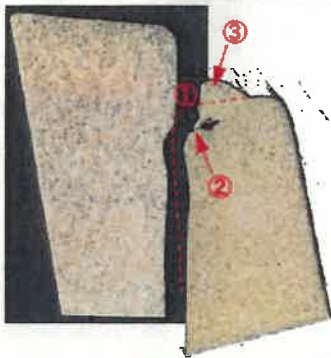
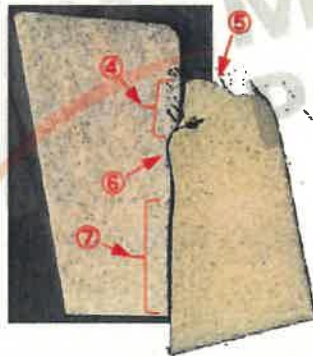
Images of initial contact conditions

① Partial local contact at the top and tip of blade

② Fretting fatigue crack generated in local area

③ Local deformation is generated along with the crack

⑤ HCF crack is generated.

⑥ Local wear generated by high surface pressure & excessive sliding. Oxide scale developed by heat generation (black surface).

⑦ Worn by wear debris

⑧ Partial defect was caused by fretting fatigue crack which was generated and propagated in high surface pressure and sliding area (black surface).

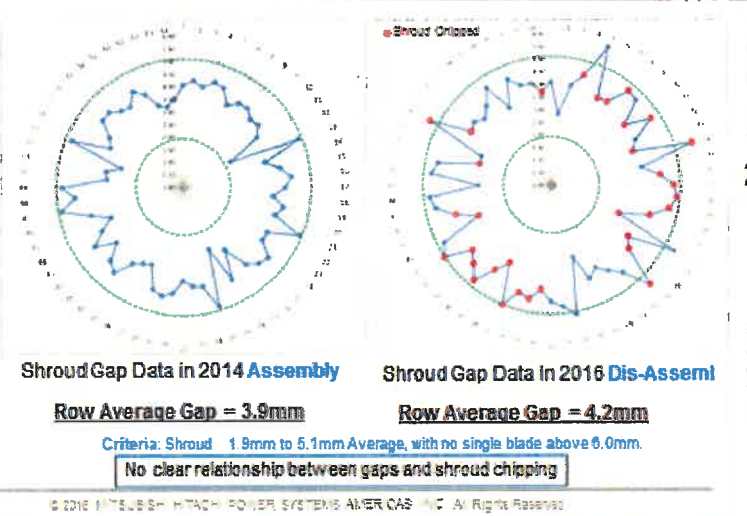
2014 Blade LH (Gov. End) Shroud Gap Data

**LH and RH shroud average gaps are nearly same
No clear relationship between gap and shroud chipping**

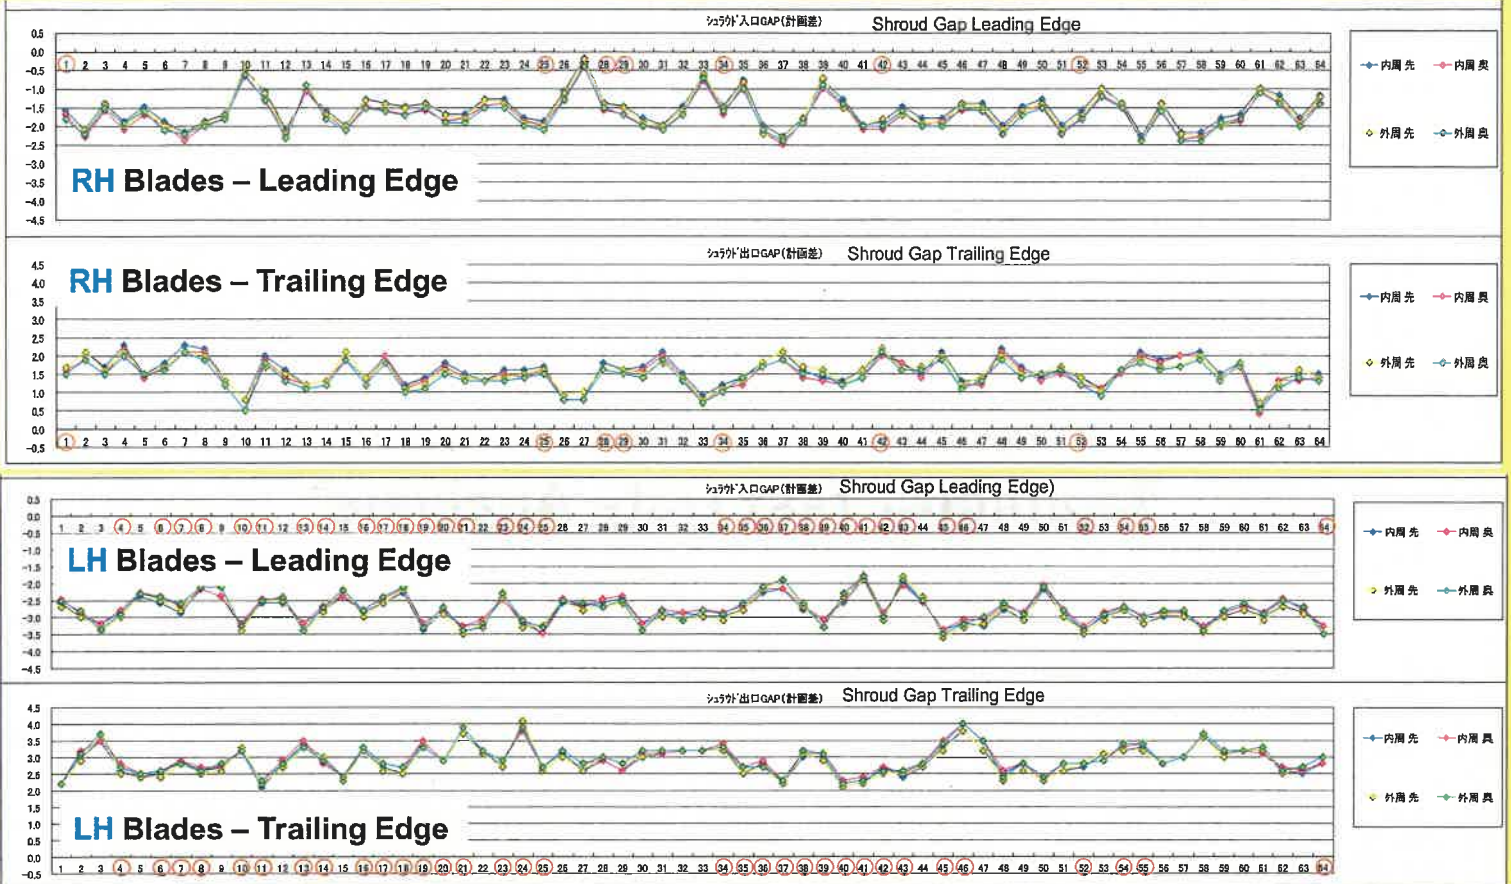
Blade manufacturing data show variation within criteria

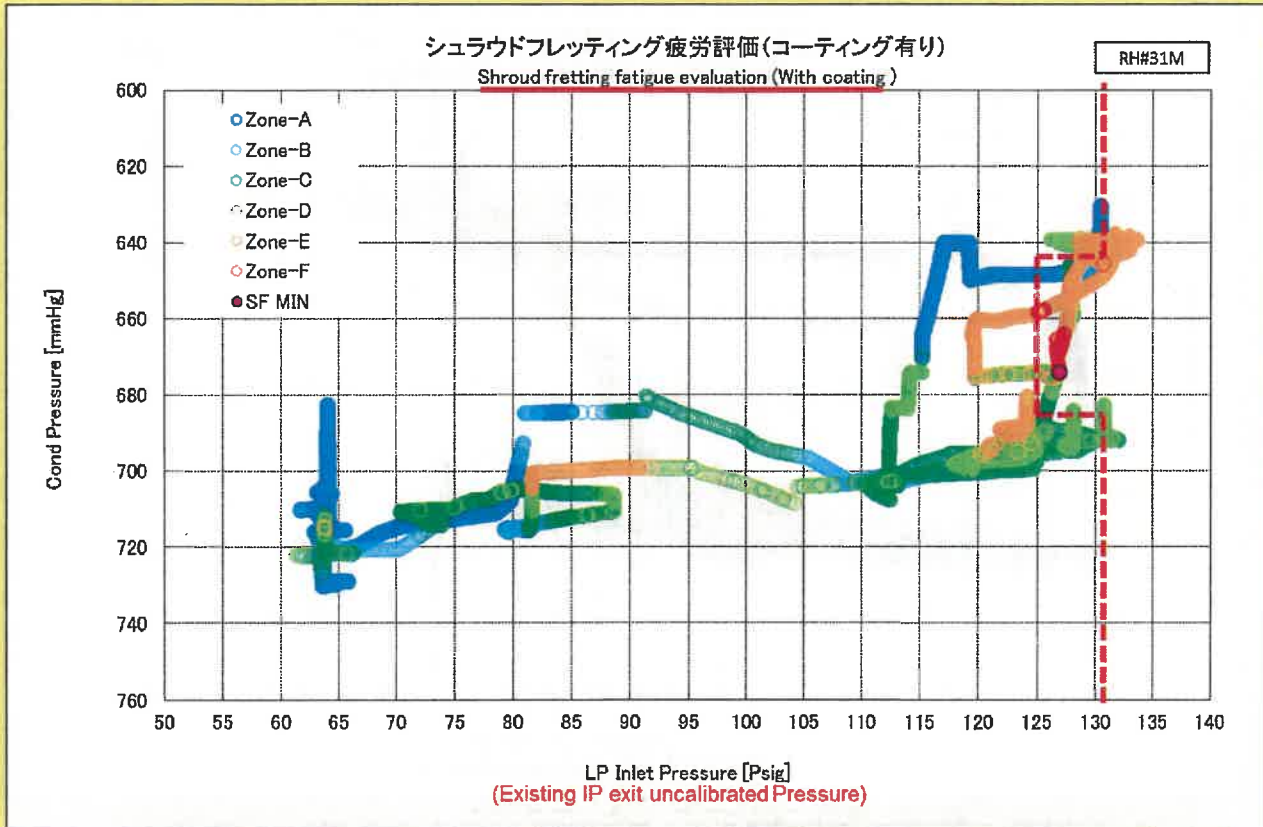
Telemetry Test Results – Shroud Fretting

Fretting fatigue calculations for shroud with coating show acceptable margins outside avoidance zone

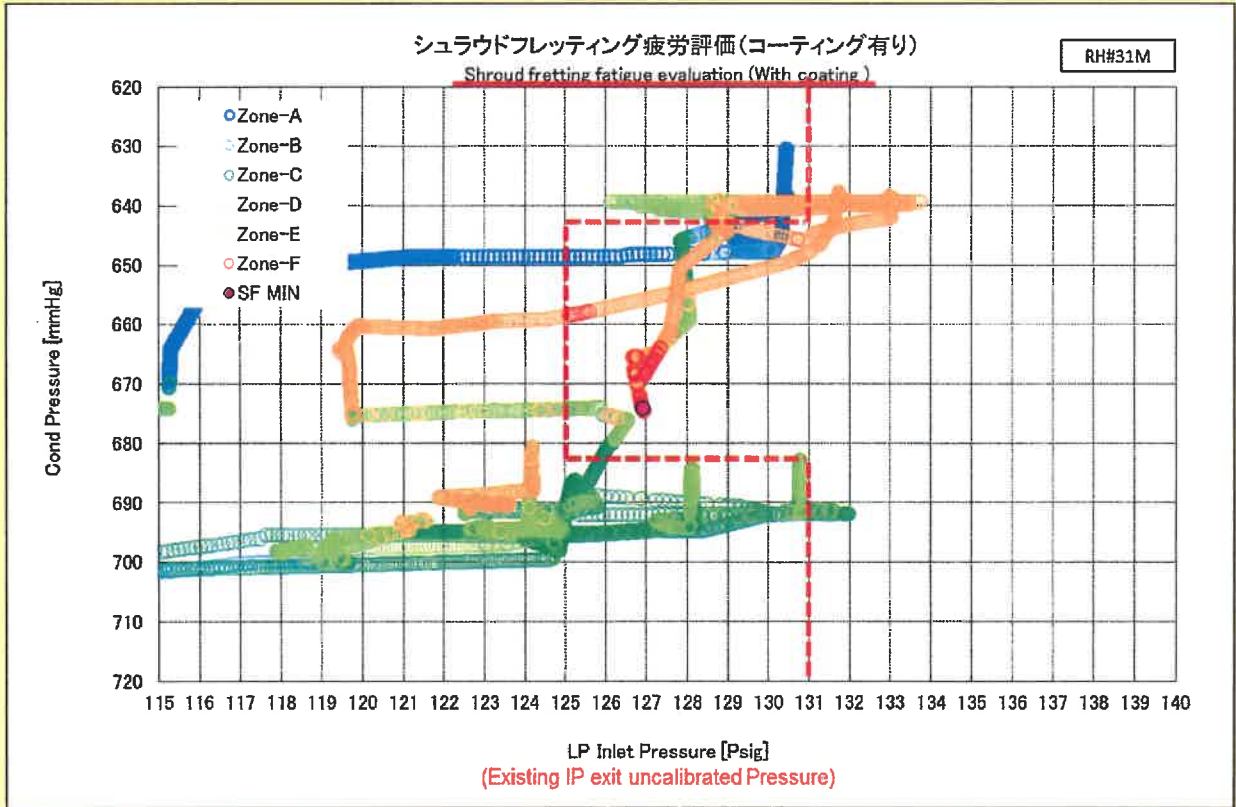
Telemetry Test Data – Shroud Fretting

Fretting fatigue calculations for shroud with coating show acceptable margins outside avoidance zone

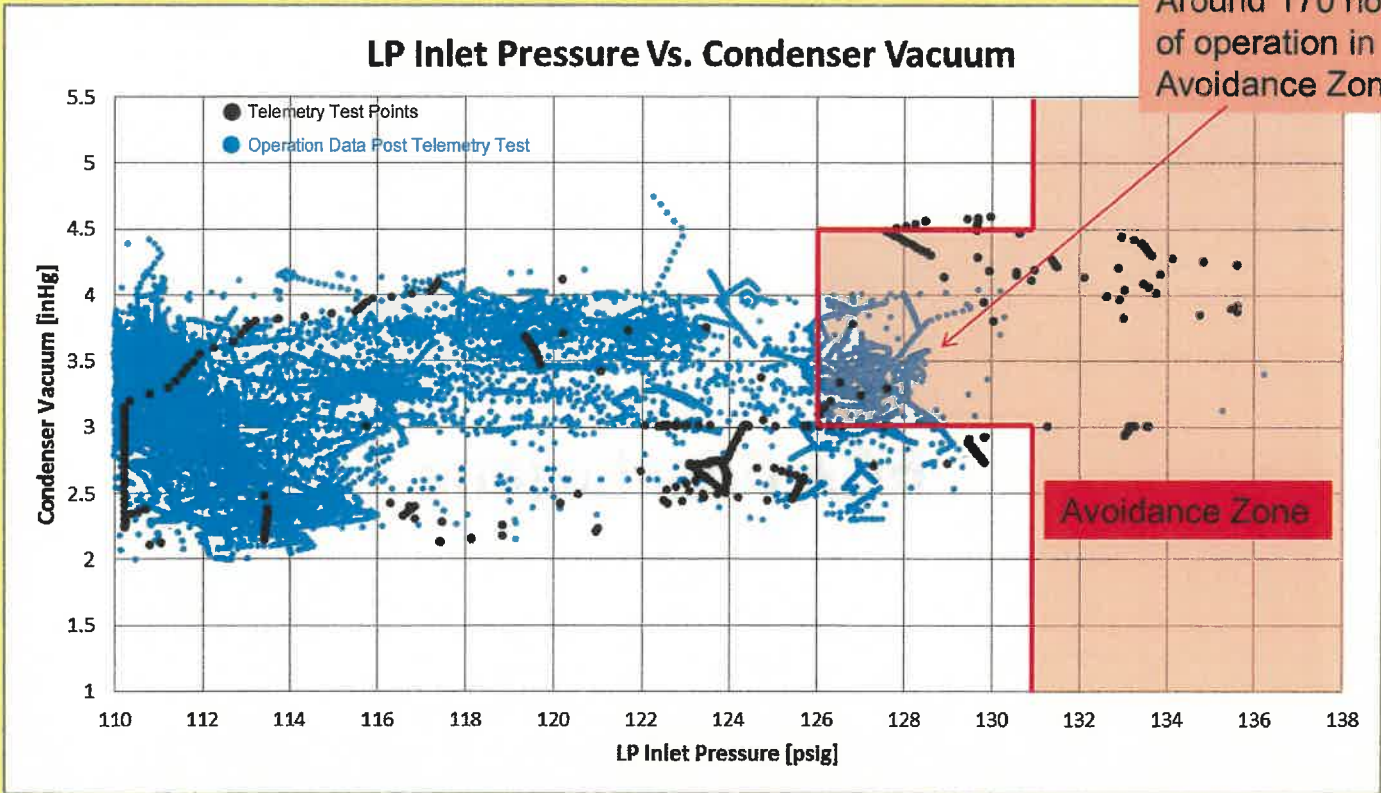
Operation Data Review **CONFIDENTIAL**

170+ hours of operation in avoidance zone with a response frequency $\sim 200\text{Hz} = 1.2\text{E}8$ Cycles

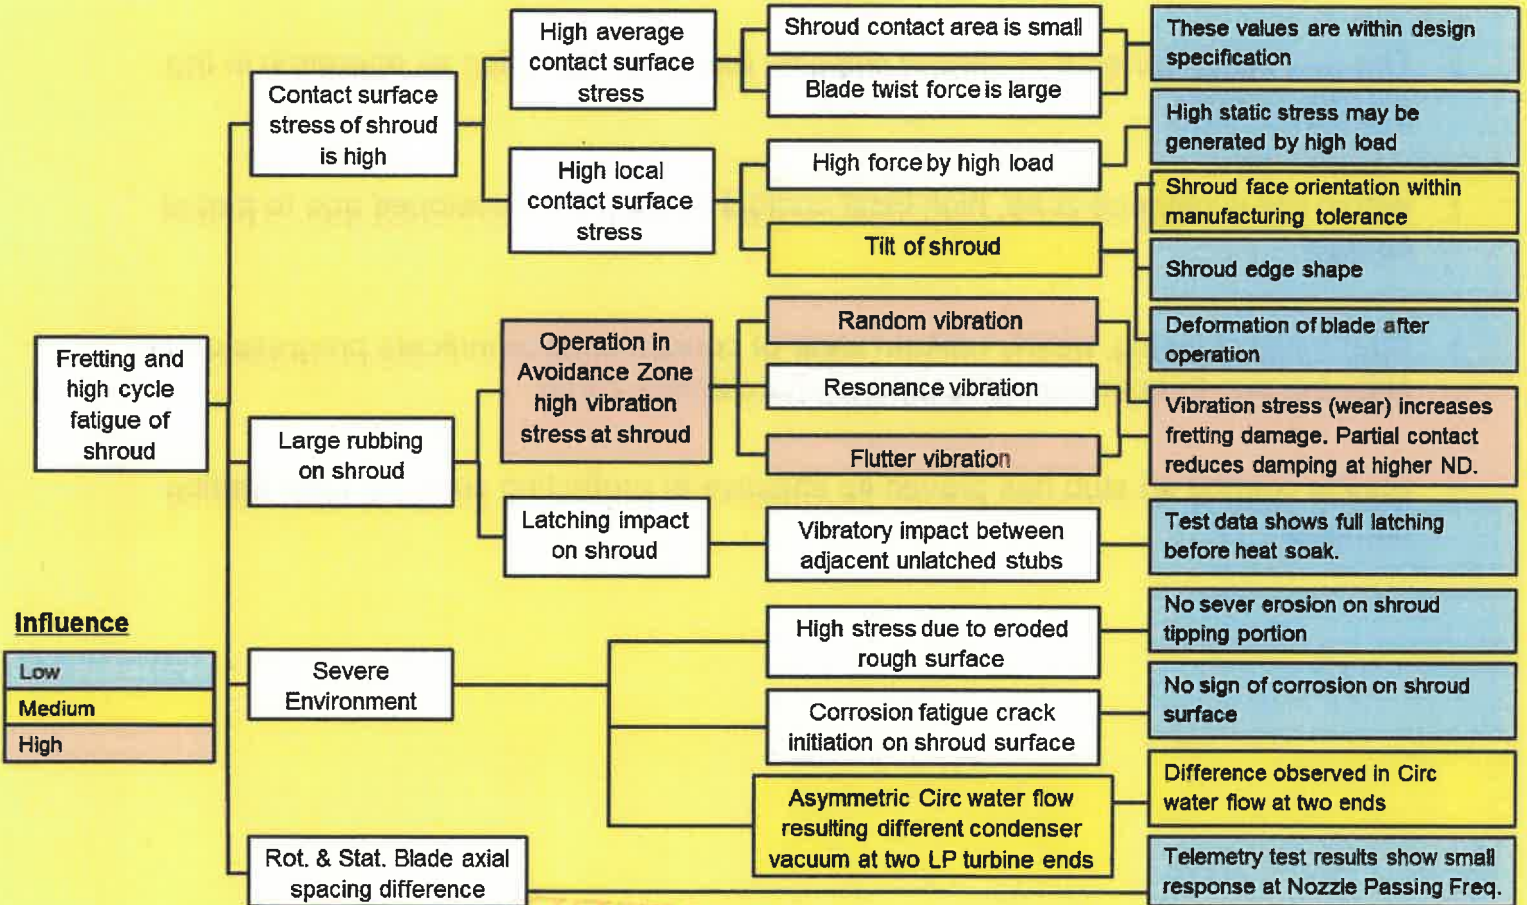
Blade Shroud Cause and Effect Diagram

- The root cause for start of shroud chipping has been identified as operation in the avoidance zone.
- Within the avoidance zone, high local contact pressure is developed due to partial contact.
- After initial chipping, nearly uniform wear of contact surface indicate progression of chipping due to operation at resonance (avoidance zone).
- Stellite coating on stub has proven its effective at protecting surfaces from fretting damage.

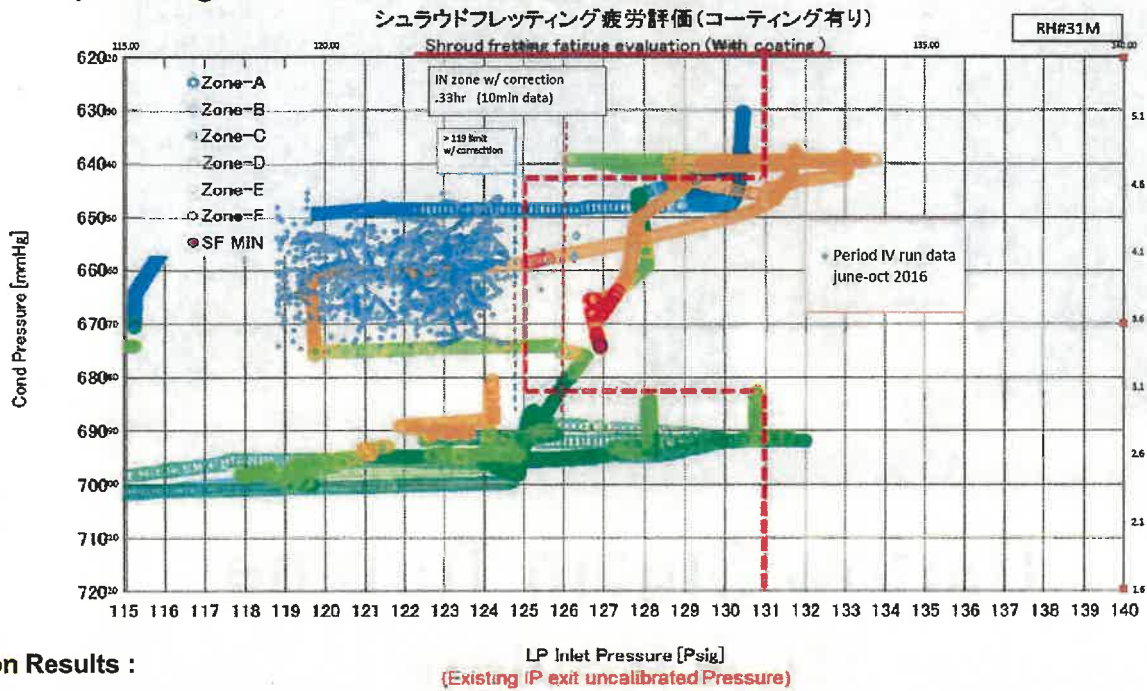
1.4) Operating Time 4 : Jun 2016 to Oct 2016

Location	Blades	Service	Mid Span Snubber	Shroud	Disposition
Gen End	Type 3 + HVOF++	4 Months	1 Liberation	3 Shroud Liberations	Replace Row
Gov End	Type 3 + HVOF++	4 Months	No significant damage	1 Shroud Liberation	Replace Row

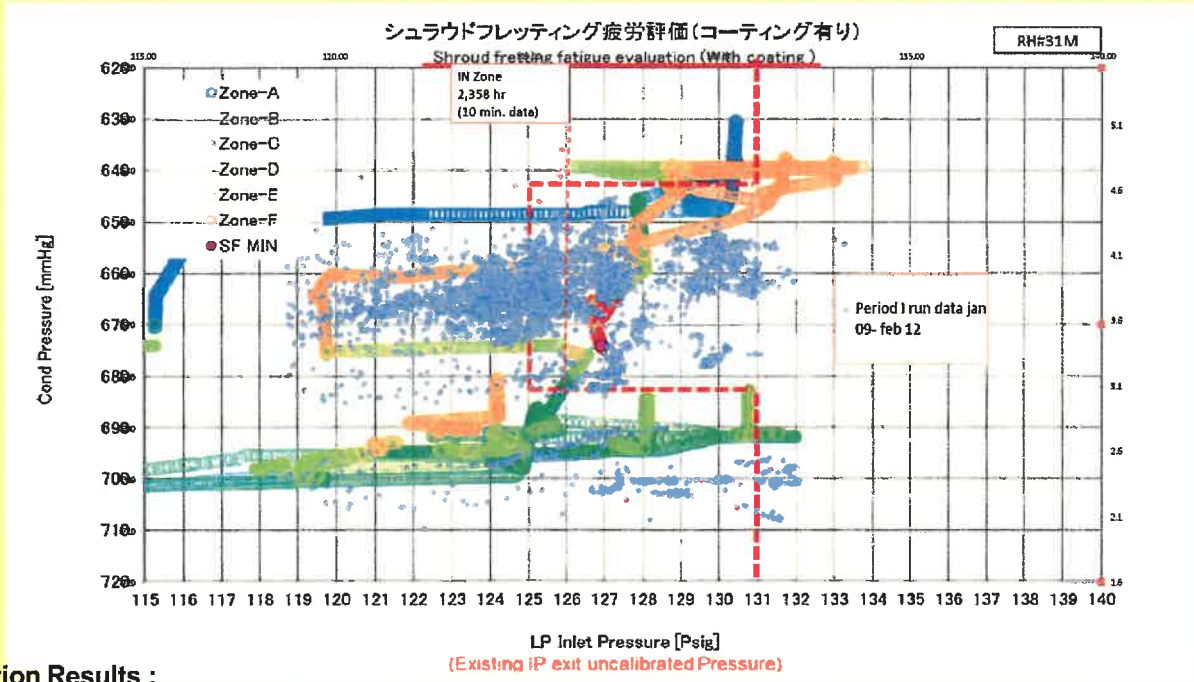
Location	Blades	Service	Mid Span Snubber	Shroud	Disposition
Gen End	Type 1	3 yrs	No significant damage	No significant damage	Continue operation until 2014 planned replacement
Gov End	Type 1	3 yrs	5 Major Chip	3 minor chips	Replace blades as continues midspan chipping could results in a free standing blade

1.1) Operating Time 1 : Jan 2009 to Feb 2012
Significant operation in the avoidance zone.
Significant damage observed on the blades.

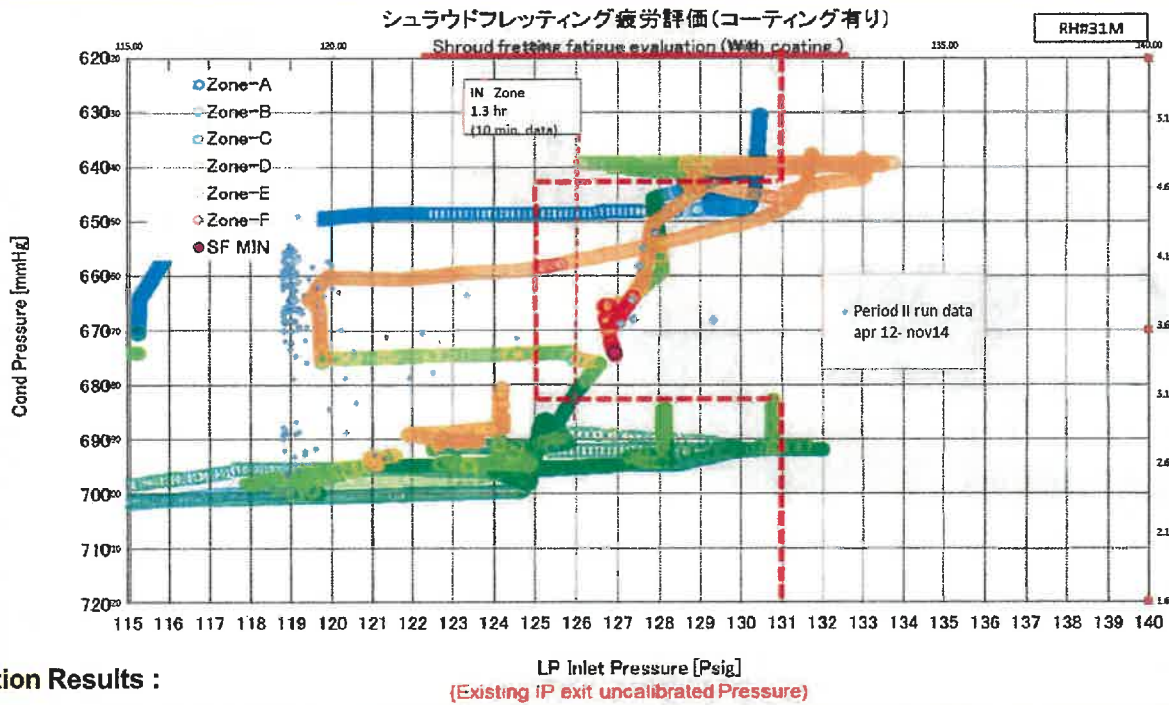
Location	Blades	Service	Mid Span Snubber	Shroud	Disposition
Gen End	Type 1	5 yrs	No significant damage	12 minor chips	Scheduled change out to blades with midspan HVOF
Gov End	Type 1	2 yrs	No significant damage	3 minor chips	Scheduled change out to blades with midspan HVOF

1.2) Operating Time 2 : Apr 2012 to Nov 2014
Minimal operation in the avoidance zone.
Minor chipping observed.

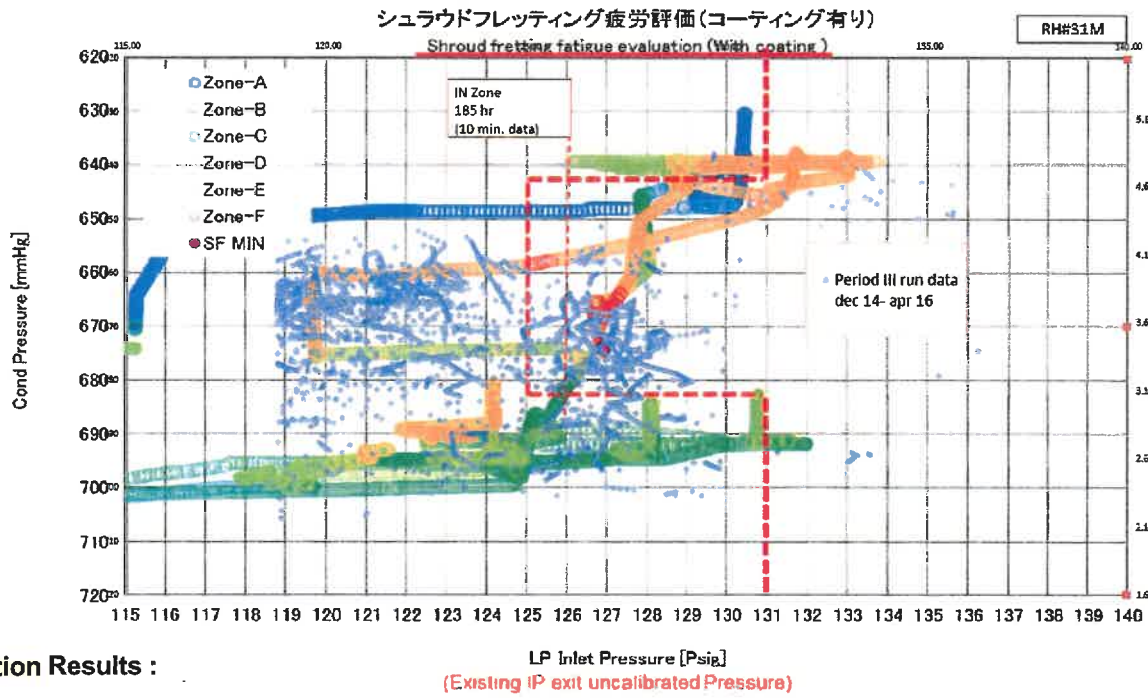
Location	Blades	Service	Mid Span Snubber	Shroud	Disposition
Gen End	Type 3 + HVOF	15 Months	No significant damage	7 minor chips	Fit for continued operation. Shroud contact on all blades.
Gov End	Type 3 + HVOF	15 Months	No significant damage	33 chips including significant damage	Replace row as free shroud contact has been lost on 1 blade.

1.3) Operating Time 3 : Dec 2014 to Apr 2016
Significant operation in the avoidance zone.
Significant damage observed on the blades.
