DOCUMENTS: Panel deposition of Jeffrey Swartz, Anthony Salvarezza and C. Wayne Toms, August 30, 2019.

CONFIDENTIAL**Bartow 4S Root Cause Analysis – Evaluation of Contributing Factors**

Duke and Mitsubishi Hitachi Power Systems (MHPS) have worked both independently and together over the past 12 months to determine what has caused the Bartow Unit 4S L-0 blades to crack and break during operation. During a presentation given at Bartow Station on 15 March 2017, MHPS suggested the sole root cause for Period 3 (Dec 2014-Mar 2016) was “operation in the avoidance zone”. While Duke Engineering would agree that operation in the “avoidance zone” is certainly a *contributing factor* to the shroud chipping experienced in Period 3, it is not the only driving mechanism that should be considered when trying to determine root cause for the Period 3 Bartow Unit 4S event, or any of the previous/subsequent events for that matter.

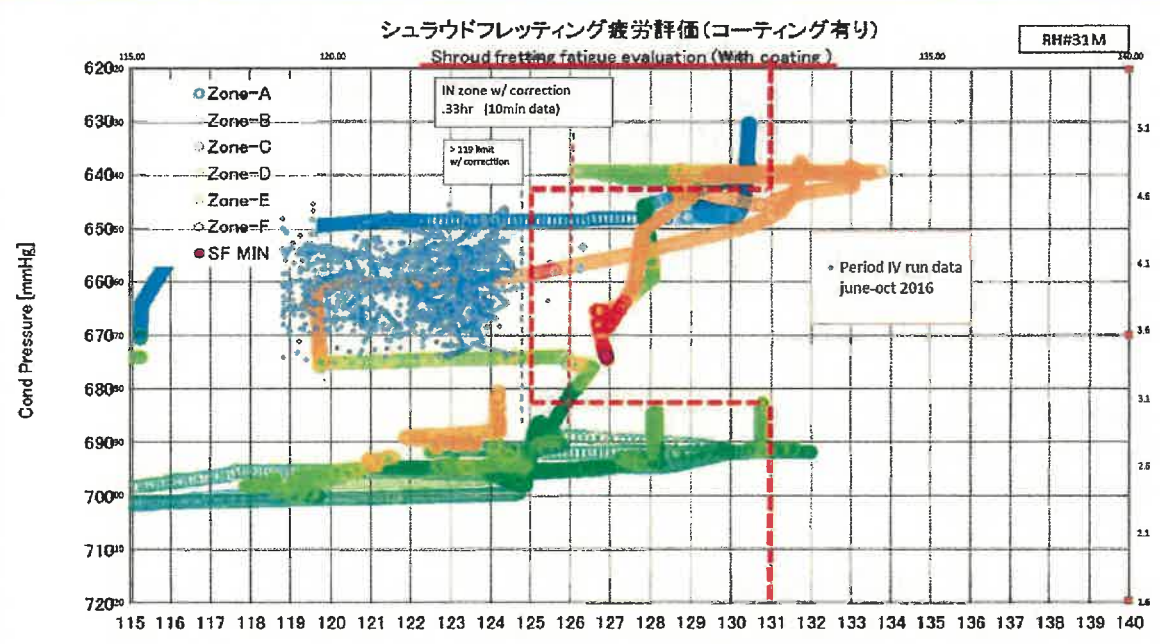
1.4) Operating Time 4 : Jun 2016 to Oct 2016

Location	Blades	Service	Mid Span Snubber	Shroud	Disposition
Gen End	Type 3 + HVOF++	4 Months	No significant damage	7 minor chips	Fit for continued operation. Shroud contact on all blades.
Gov End	Type 3 + HVOF++	4 Months	No significant damage	33 significant damage	Replace row as free shroud contact has been lost on 1 blade.

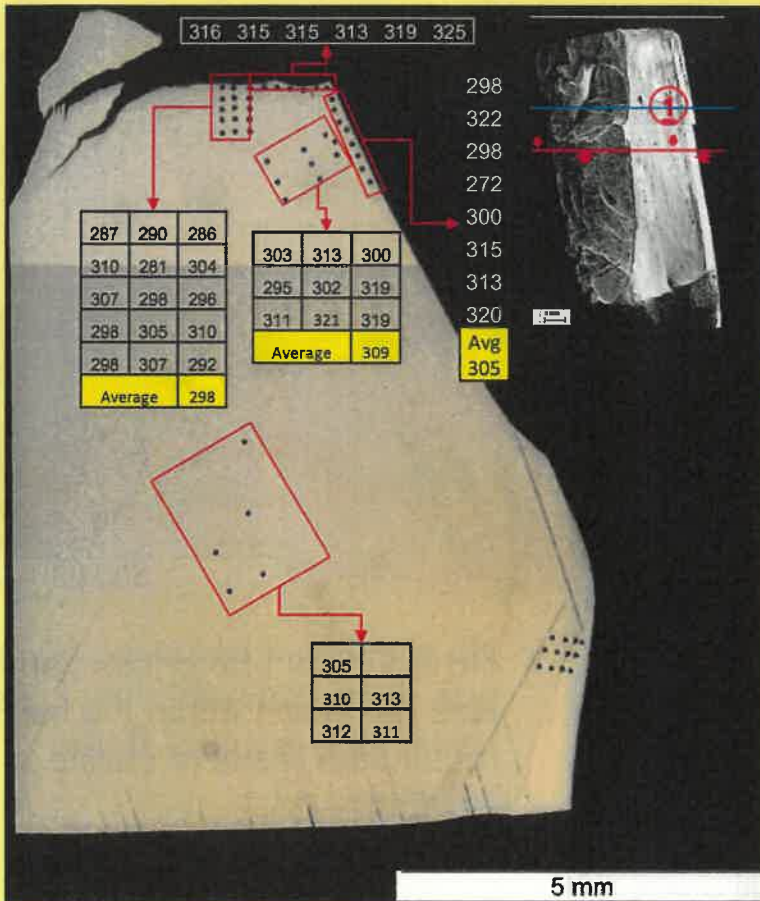
2 - Hardness Variation – Presented

- From hardness observation no significant decrease was observed where the crack initiated.
- A decrease in hardness was observed on the contact surface.

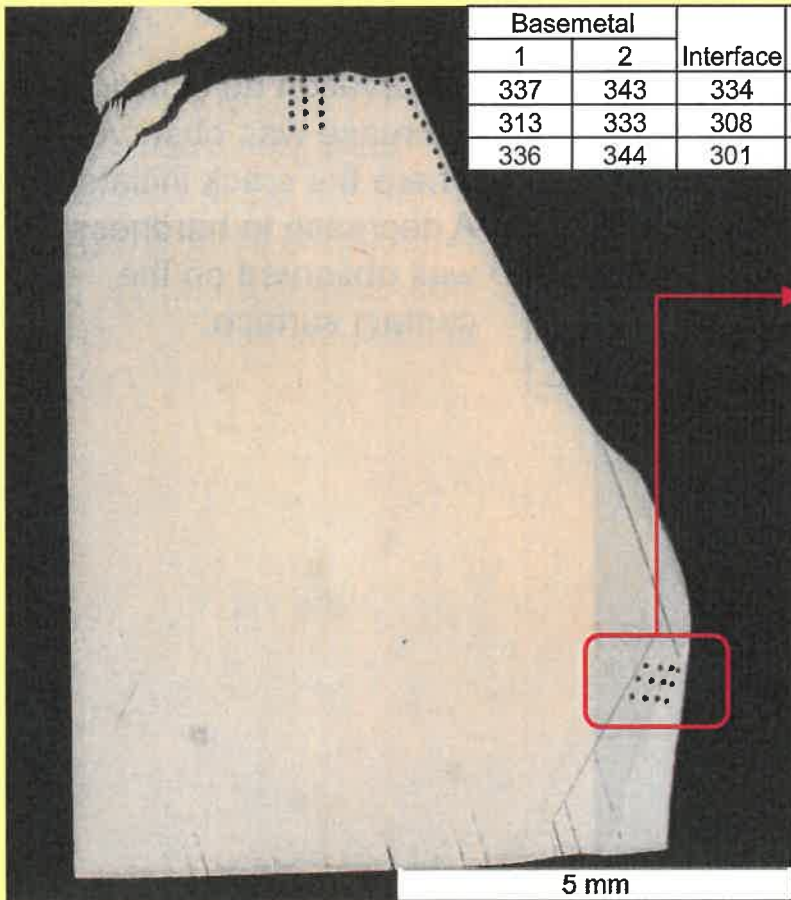
2- Hardness Variation basemetal, Interface and Stellite Coating

- No significant hardness variation was observed within the base metal as a result of stellite welding.

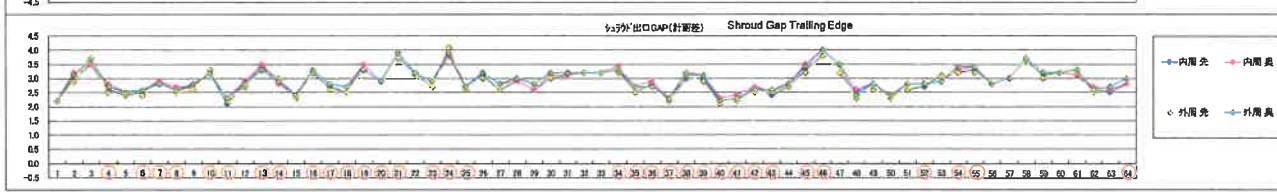
Shroud GAP ○: Shrouds with Damage

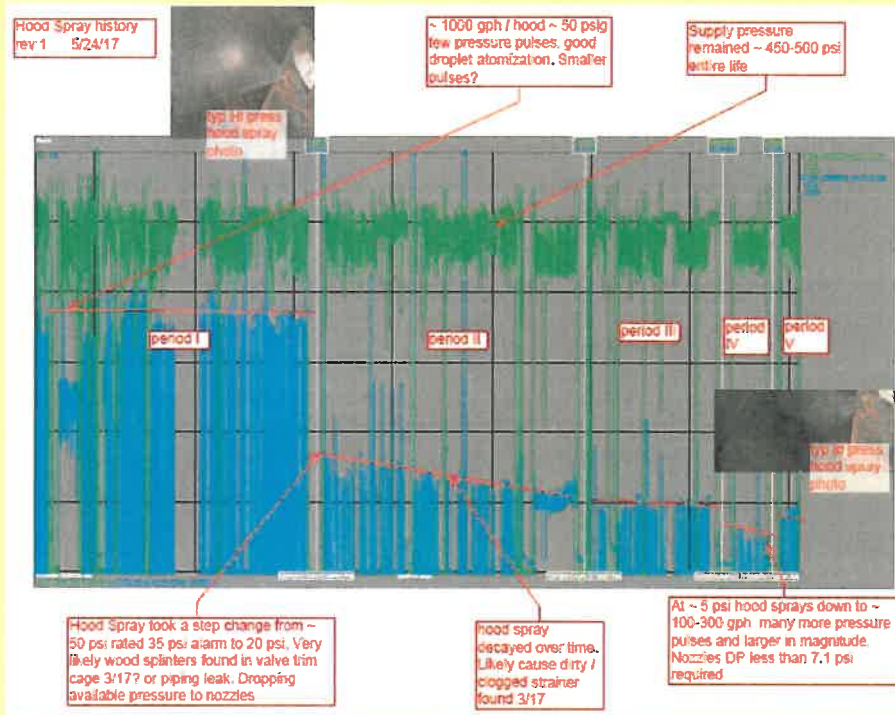
Careful attention was also paid to the hood spray pressure over time. This was found to steadily decrease over successive Periods. Maintenance of the valve in Spring 2017 revealed debris in the valve passageways. Review of historical records also indicate the strainer ahead of the valve had filled with debris in prior years.

The chart below demonstrates what happened to hood spray pressure over time. The decay in water pressure at the hood spray nozzles will yield reduced atomization as these style of nozzle rely on pressure drop to create a vortex inside the nozzle that causes atomization thru centripetal force. The effect of reduced atomization was verified during a test just prior to unit restart in April 2017. A key concern of poor atomization is the effect it might have on generating dynamic pressures which the L-0 blades might see as large water droplets evaporate in the exhaust stream.

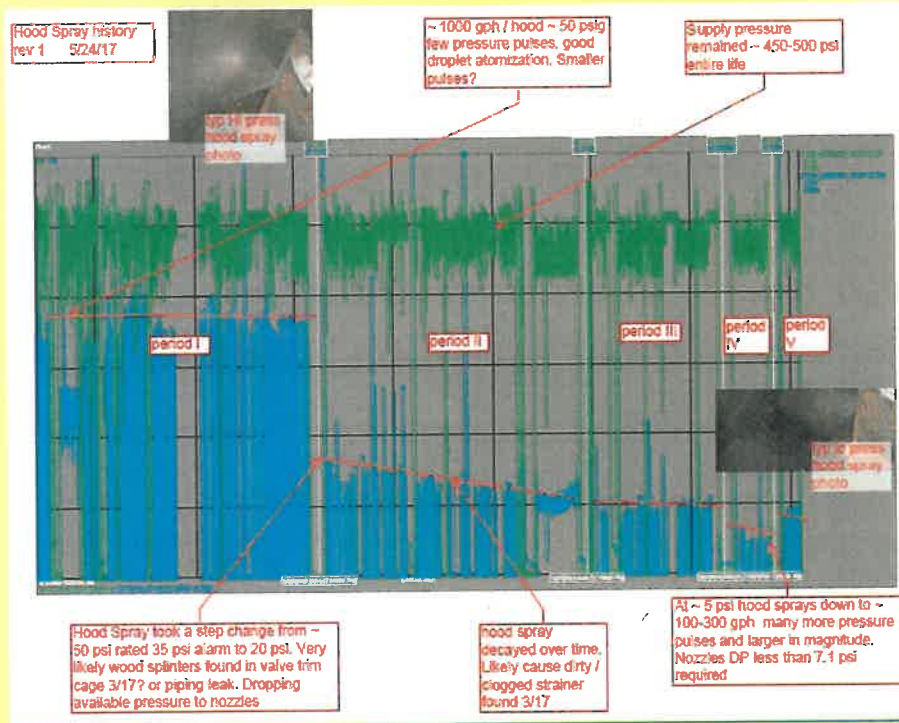
Careful attention was also paid to the hood spray pressure over time. This was found to steadily decrease over successive Periods. Maintenance of the valve in spring 2017 revealed debris in the valve passageways. Review of historical records also indicate the strainer ahead of the valve had filled with debris in prior years.

The chart below shows what happened to hood spray pressure over time. The decay in water pressure at the hood spray nozzles will have reduced atomization as these style of nozzle rely on pressure drop to create a vortex inside the nozzle that causes atomization thru centripetal force. The effect of reduced atomization was verified during a test just prior to unit restart in April 2017. A key concern of poor atomization is the effect it might have on generating dynamic pressures which the L-0 blades might see as large water droplets evaporate in the exhaust stream.

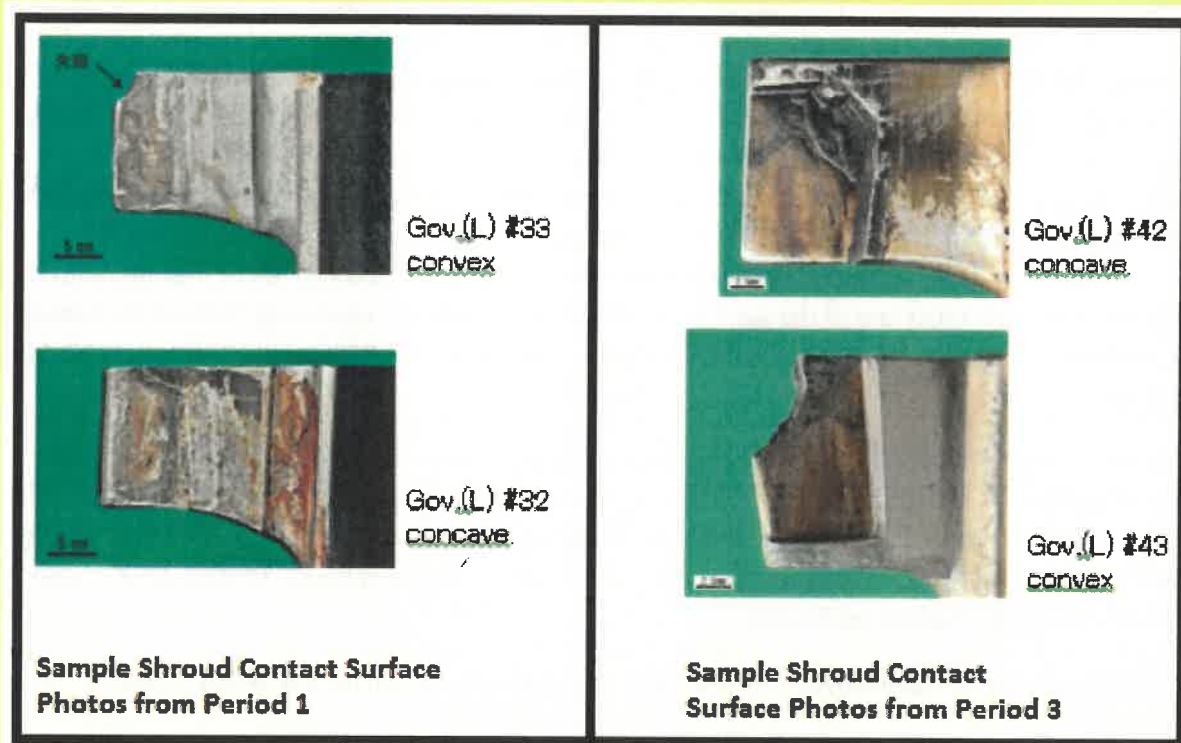
Figure 1 –Photos of Shroud Contact Surface Wear for Periods 1 and 3

Based on comparative run times and damage, it is difficult to conclude that the L-0 blade damage in each Period or any particular Period is due to unit operation in the avoidance zone.⁶

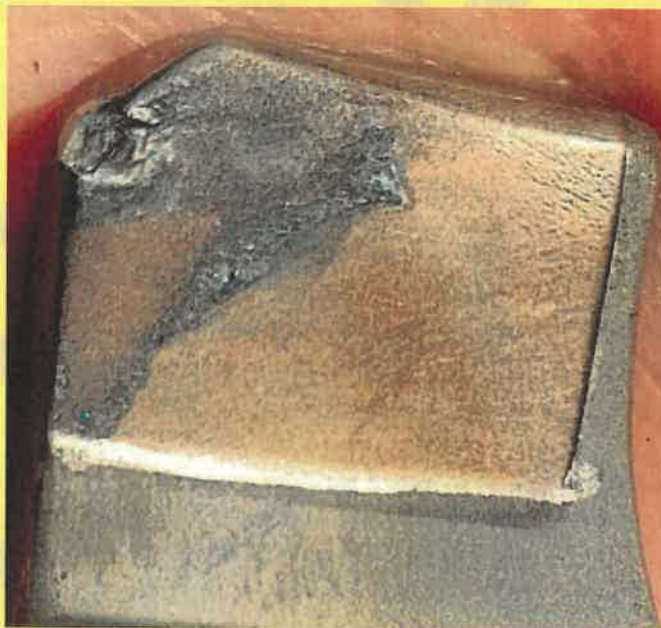
Figure 4 – Photo of an L-0 blade Z-Lock from Period 5 Showing Contact Surface Wear

While the findings are not completely conclusive, there is good reason to believe that MHPS' design may be susceptible to damage when run in these zones. All Periods had hours in Zone F1 and F2. In addition, both on a percentage and absolute basis, Period 5 had a significant number of operating hours in this higher dynamic stress zone. Because each Period included run times in one or more zones and because each Period resulted in differing degrees of damage without direct correlation to the run times in those zones, it is difficult to conclude that operation within the zones is the cause of the L-0 blade failures. However, if the design margin on the blades is small, the blades may be susceptible to cracking, excessive wear, etc., when the unit either runs in or passes through these zones.

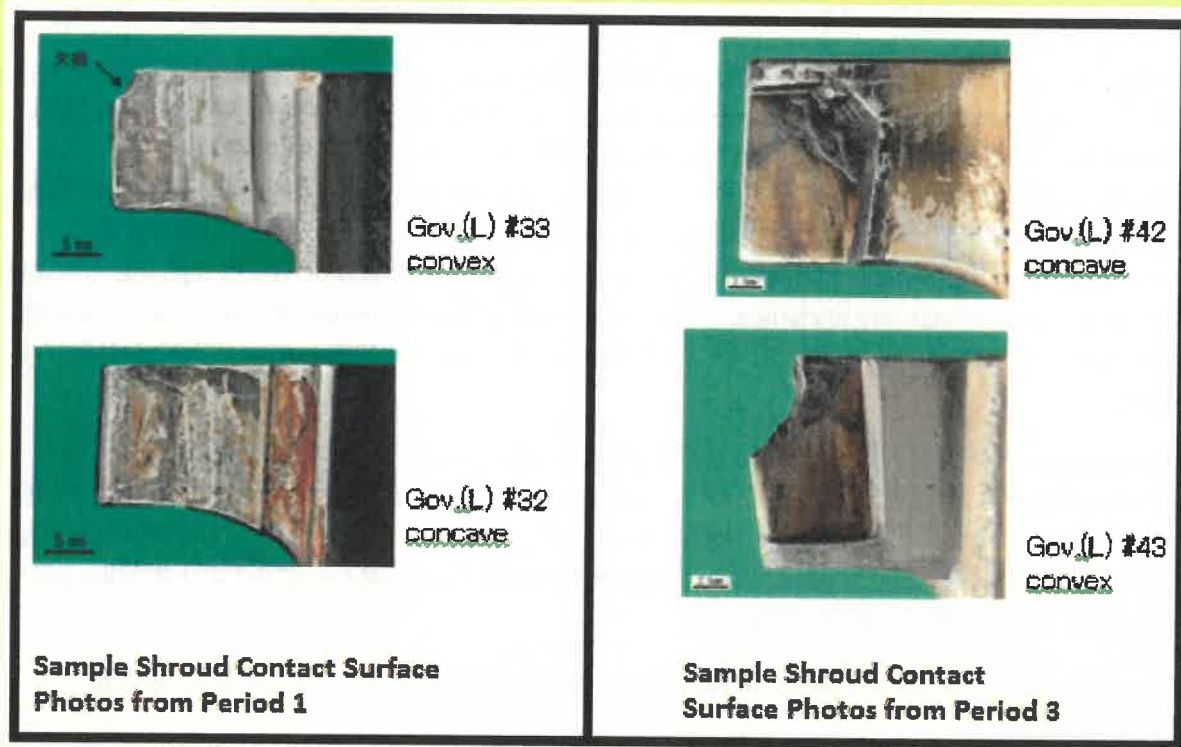
Figure 1 –Photos of Shroud Contact Surface Wear for Periods 1 and 3

Based on comparative run times and damage, it is difficult to conclude that the L-0 blade damage in each Period or any particular Period is due to unit operation in the avoidance zone.⁶

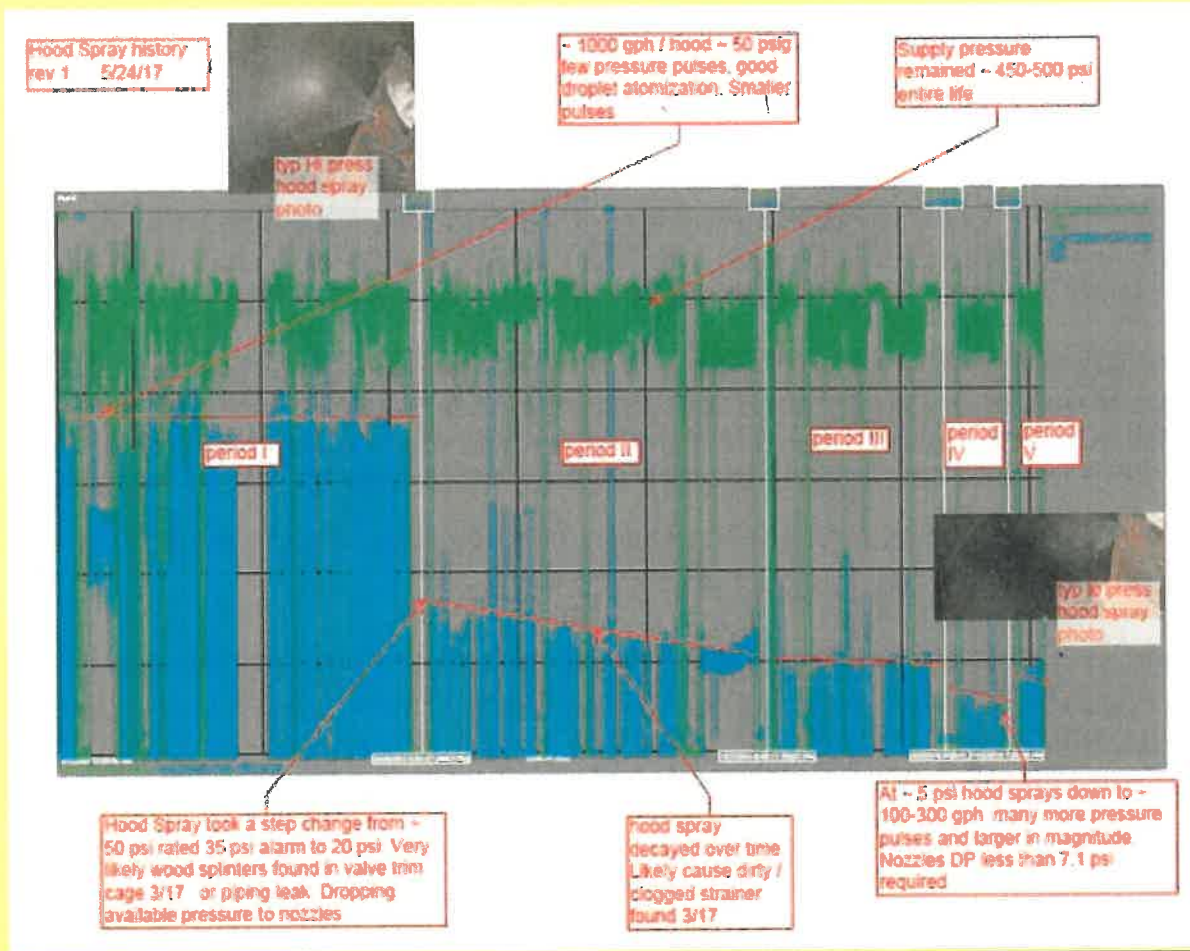
Figure 2 – Hood Spray Pressure Degradation Over Periods 1-5

At the kind of hood spray pressures shown in Figure 2, the atomization of the hood sprays would have been poor. Larger water droplets will cause pressure pulses as evaporation occurs, during times when the LP exhaust steam temperatures are elevated during blending.

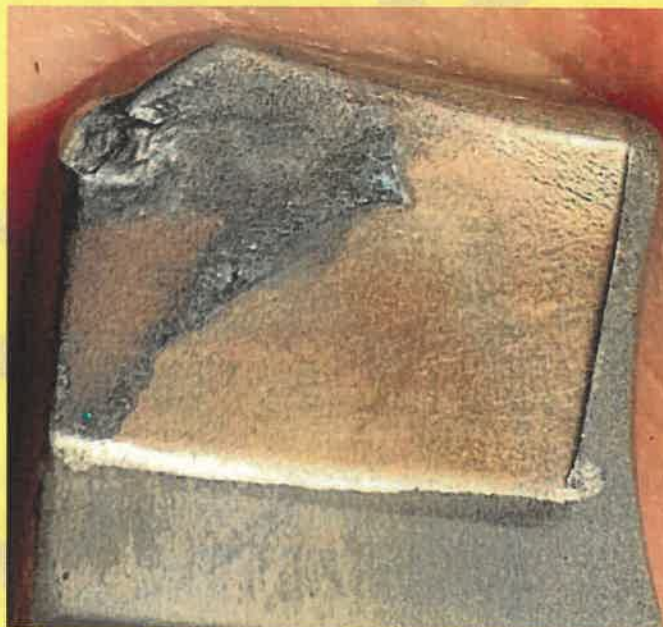
Figure 4 – Photo of an L-0 blade Z-Lock from Period 5 Showing Contact Surface Wear

While the findings are not completely conclusive, there is good reason to believe that MHPS' design may be susceptible to damage when run in these zones. All Periods had hours in Zone F1 and F2. In addition, both on a percentage and absolute basis, Period 5 had a significant number of operating hours in this higher dynamic stress zone. Because each Period included run times in one or more zones and because each Period resulted in differing degrees of damage without direct correlation to the run times in those zones, it is difficult to conclude that operation within the zones is the cause of the L-0 blade failures. However, if the design margin on the blades is small, the blades may be susceptible to cracking, excessive wear, etc., when the unit either runs in or passes through these zones.

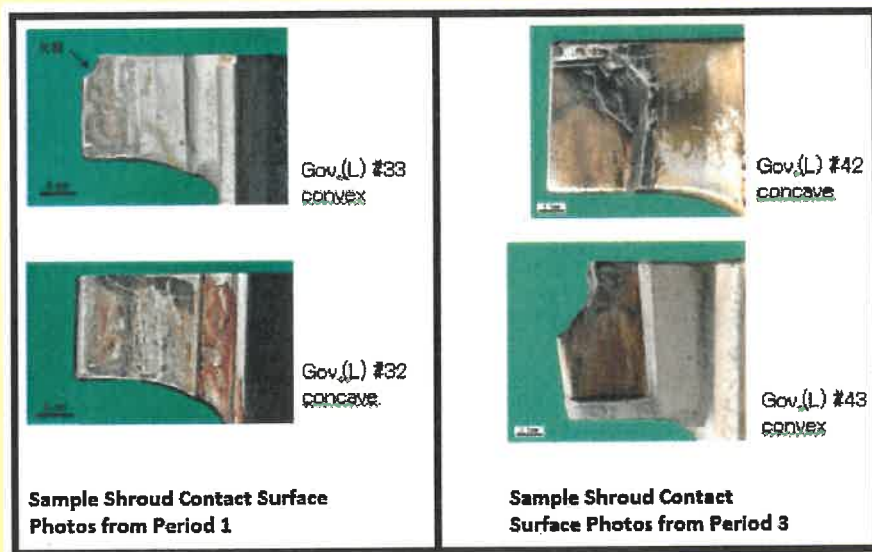
Figure 1 -- Comparative Photos of Shroud Contact Surface Wear for Periods 1 and 3

Conversely, during Period 3, there were only 240 hours (out of 10,286 total hours) of operation in the "avoidance zone", approx. 11 hours of which occurred during the instrumented blade telemetry test performed by MHPS in December 2014. Even with a significantly fewer number of "avoidance zone" hours for Period 3 relative to Period 1 – a factor of 10 fewer hours for Period 3 – there was significantly greater amounts of blade damage and fretting on both ends of the machine. While the amount of Z-Lock wear is not quantified for Periods 1 and 3, photographic evidence suggests that the amount of wear is much greater for Period 3, as shown below in Figure 1. It is therefore difficult to conclude that damage to the L-0 blades in Period 3 is solely due to unit operation above the exhaust flow limit.

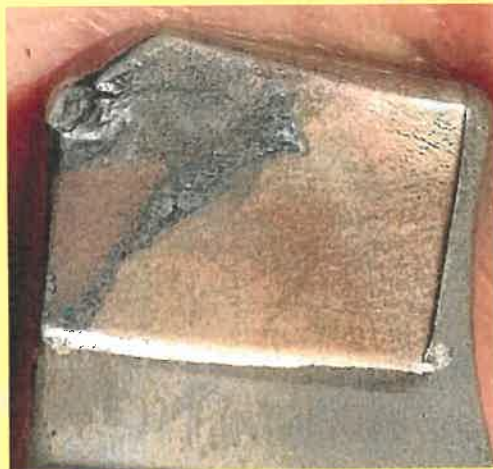
Figure 4 -- Photo of an L-0 blade Z-Lock from Period 5 Showing Contact Surface Wear

The main reason for conducting this analysis stems from the observed amount of wear seen on the contact surfaces for Period 5. Period 5 did not have any operation time in the exclusion zone and the amount of wear for the amount of operation time seems excessive. A photo showing the amount of wear seen is shown in Figure 4. There was a varying degree of wear seen on the Period 5 Z-notches, however, the wear is higher than what one would expect given the relatively low operating hours.

Period 5 did have its share of higher energy blends as detected by the blend energy method. However, in terms of operating hours in blend mode, Period 5 is not excessive in terms of percentage time blending. The total of 20 hours of blend time does not appear to justify the wear seen.

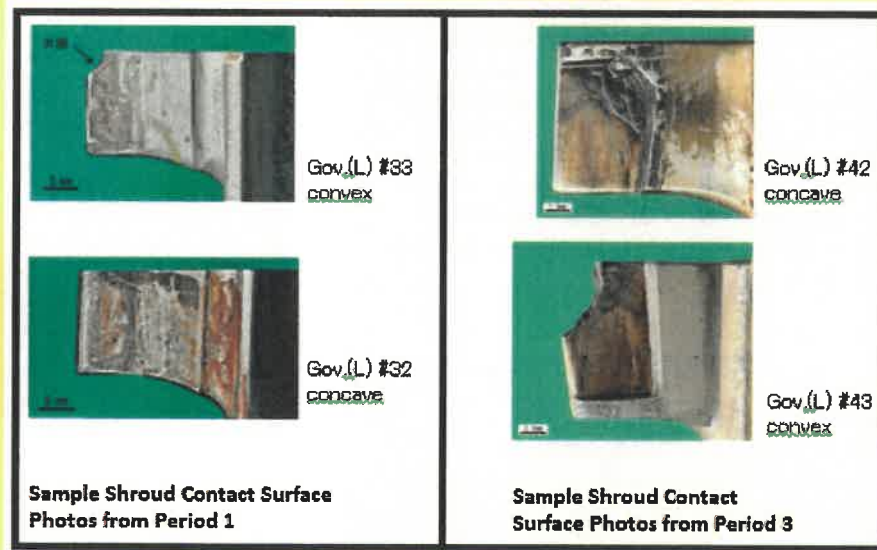
Figure 1 -- Comparative Photos of Shroud Contact Surface Wear for Periods 1 and 3

Conversely, during Period 3, there were only 240 hours (out of 10,286 total hours) of operation in the "avoidance zone", approx. 11 hours of which occurred during the instrumented blade telemetry test performed by MHPS in December 2014. Even with a significantly fewer number of "avoidance zone" hours for Period 3 relative to Period 1 – a factor of 10 fewer hours for Period 3 – there was significantly greater amounts of blade damage and fretting on both ends of the machine. While the amount of Z-Lock wear is not quantified for Periods 1 and 3, photographic evidence suggests that the amount of wear is much greater for Period 3, as shown below in Figure 1. It is therefore difficult to conclude that damage to the L-0 blades in Period 3 is solely due to unit operation above the exhaust flow limit.

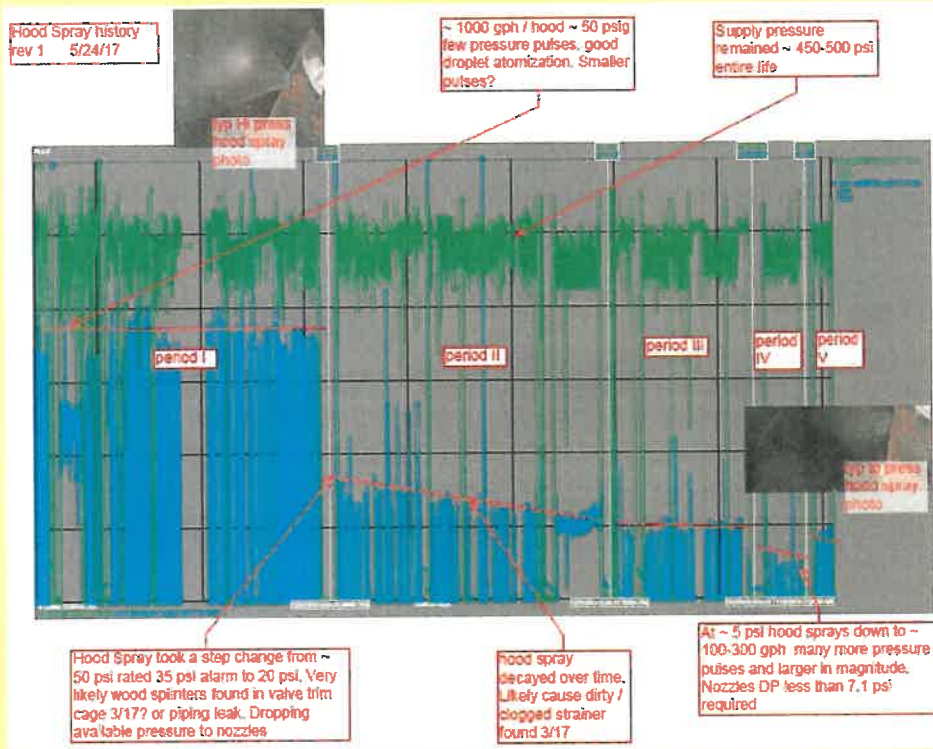
Figure 2 -- Hood Spray Pressure Degradation Over Periods 1-5

Figure 2, below, demonstrates what happened to hood spray pressure over time. The decay in water pressure at the hood spray nozzles will yield reduced atomization as these style of nozzle rely on pressure drop to create a vortex inside the nozzle that causes atomization thru centripetal force. The effect of reduced atomization was verified during a test just prior to unit restart in April 2017. A key concern of poor atomization is the effect it might have on generating dynamic pressures which the L-0 blades might see as large water droplets evaporate in the exhaust stream.

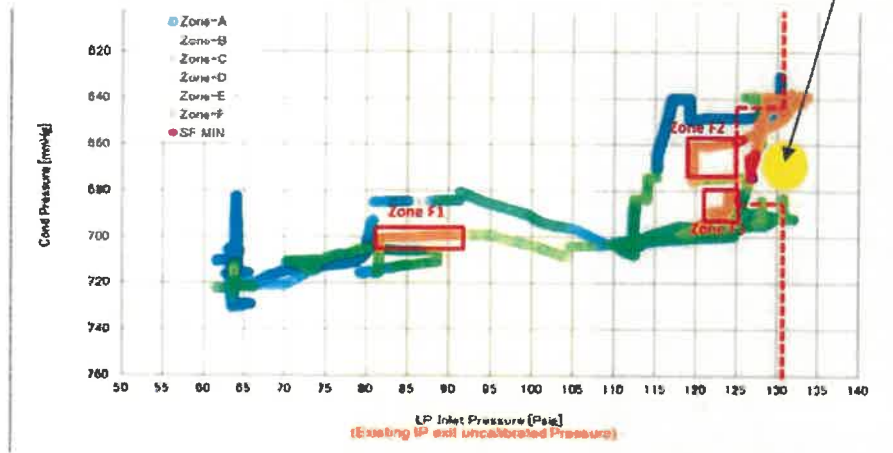
Unable to test due to excessive blade response

- Blade response is evaluated through the integration of the stress response all the modes between 180Hz to 120Hz

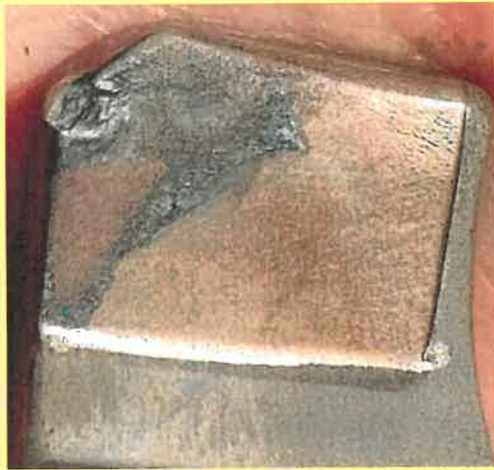
The main reason for conducting this analysis stems from the observed amount of wear seen on the contact surfaces for Period 5. Period 5 did not have any operation time in the exclusion zone and the amount of wear for the amount of operation time seems excessive. A photo showing the amount of wear seen is shown in Figure 4. There was a varying degree of wear seen on the Period 5 Z-notches, however, the wear is higher than what one would expect given the relatively low operating hours.

Figure 4 -- Photo of an L-0 blade Z-Lock from Period 5 Showing Contact Surface Wear

Period 5 did have high energy blends as detected by the blend energy method. However, in terms of operating hours in blend mode, Period 5 is not excessive in terms of percentage time blending as compare to time operated in Zone F1.

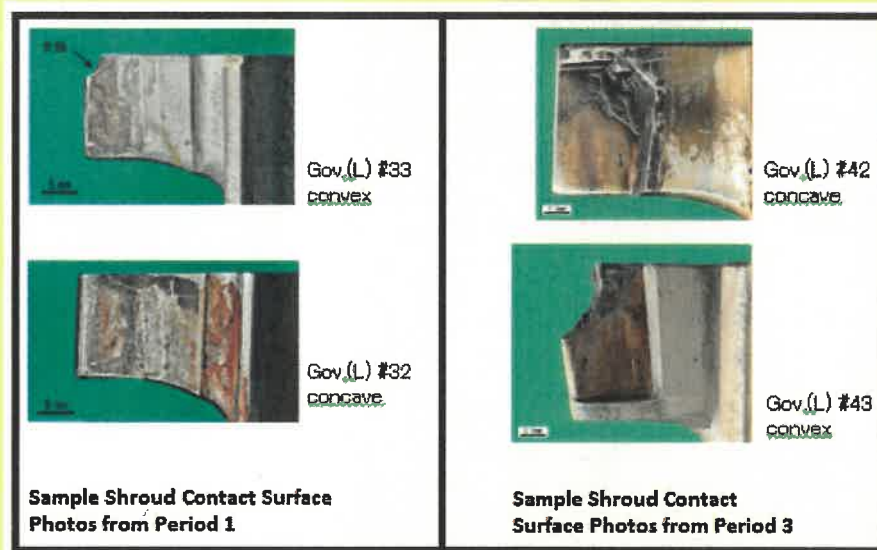
By a considerable margin, Period 1 had the greatest amount of run hours in exceedance of the "avoidance zone" relative to total operating hours – 2,466 out of 21,734 total hours. However, blade damage was relegated to five (5) broken mid-span snubbers on the turbine end of the machine and a minimal degree of fretting on the shroud Z-Lock contact surfaces for both turbine and generator ends of the machine.

Conversely, during Period 3, there were only 240 hours (out of 10,286 total hours) of operation in the "avoidance zone", approx. 11 hours of which occurred during the instrumented blade telemetry test performed by MHPS in December 2014. Even with a significantly fewer number of "avoidance zone" hours for Period 3 relative to Period 1 – a factor of 10 fewer hours for Period 3 – there was significantly greater amounts of blade damage and fretting on both ends of the machine. While the amount of Z-Lock wear is not quantified for Periods 1 and 3, photographic evidence suggests that the amount of wear is much greater for Period 3, as shown below in Figure 1. It is therefore difficult to conclude that damage to the L-0 blades in Period 3 is solely due to unit operation above the exhaust flow limit.

Figure 1 -- Comparative Photos of Shroud Contact Surface Wear for Periods 1 and 3

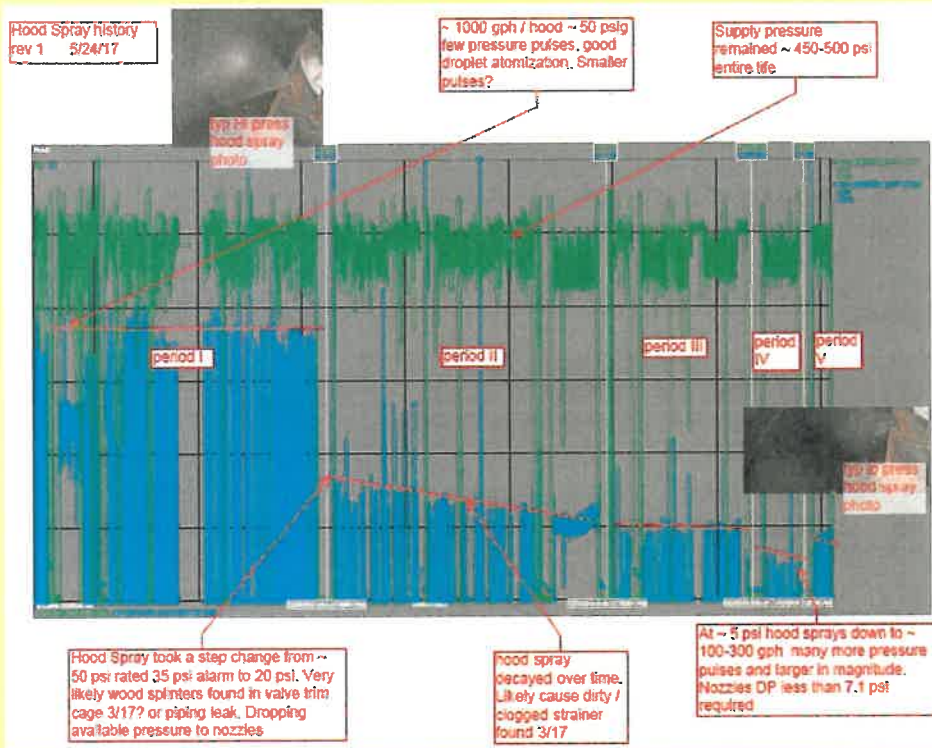
Careful attention was also paid to the hood spray pressure over time. This was found to steadily decrease over successive Periods. Maintenance of the hood sprays control valve in Spring 2017 revealed debris in the valve passageways. Review of historical records also indicate the strainer ahead of the same control valve had filled with debris in prior years' operating.

Figure 2 -- Hood Spray Pressure Degradation Over Periods 1-5

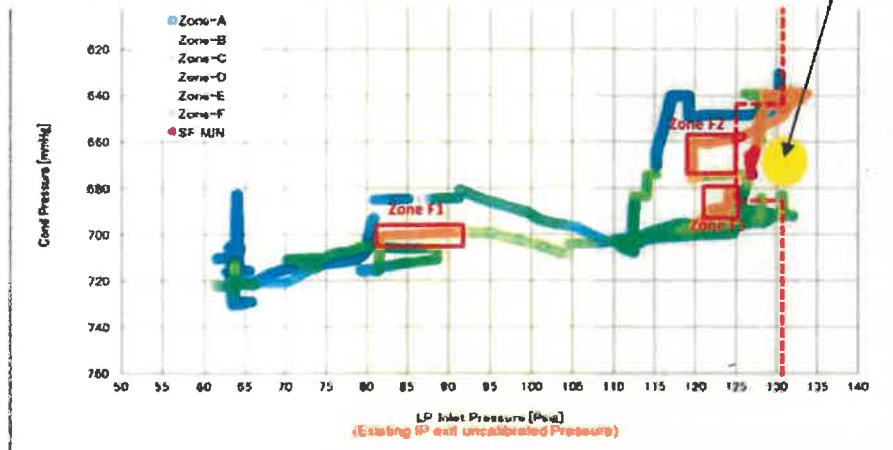
Unable to test due to excessive blade response

- Blade response is evaluated through the integration of the stress response all the modes between 180Hz to 120Hz

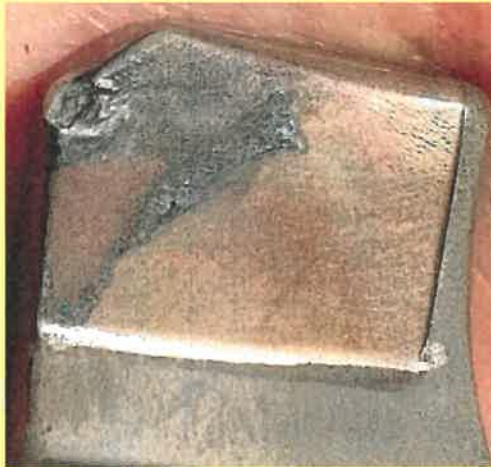
The main reason for conducting this analysis stems from the observed amount of wear seen on the contact surfaces for Period 5. Period 5 did not have any operation time in the exclusion zone and the amount of wear for the amount of operation time seems excessive. A photo showing the amount of wear seen is shown in Figure 4. There was a varying degree of wear seen on the Period 5 Z-notches, however, the wear is higher than what one would expect given the relatively low operating hours.

Figure 4 -- Photo of an L-0 blade Z-Lock from Period 5 Showing Contact Surface Wear

Period 5 did have its share of higher energy blends as detected by the blend energy method. However, in terms of operating hours in blend mode, Period 5 is not excessive in terms of percentage time blending. The total of 20 hours of blend time does not appear to justify the wear seen.

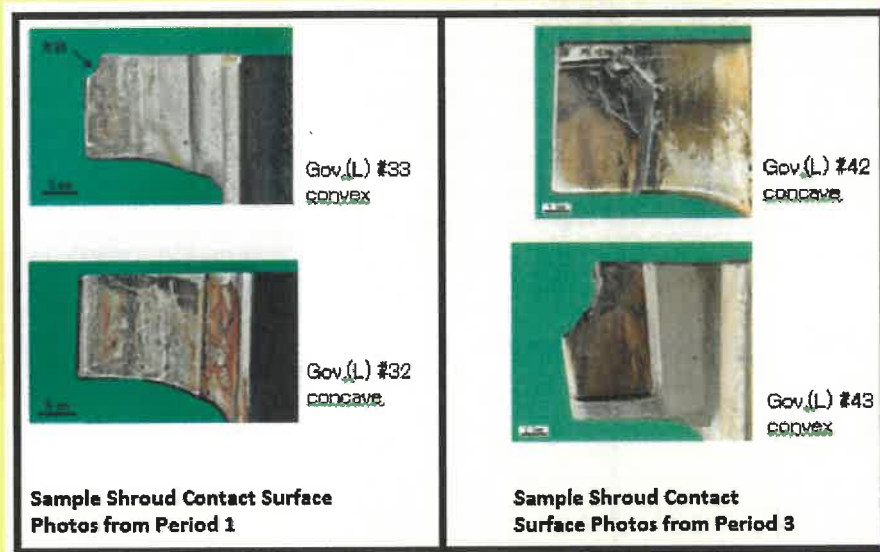
Conversely, during Period 3, there were only 240 hours (out of 10,286 total hours) of operation in the "avoidance zone", approx. 11 hours of which occurred during the instrumented blade telemetry test performed by MHPS in December 2014. Even with a significantly fewer number of "avoidance zone" hours for Period 3 relative to Period 1 – a factor of 10 fewer hours for Period 3 – there was significantly greater amounts of blade damage and fretting on both ends of the machine. While the amount of Z-Lock wear is not quantified for Periods 1 and 3, photographic evidence suggests that the amount of wear is much greater for Period 3, as shown below in Figure 1. It is therefore difficult to conclude that damage to the L-0 blades in Period 3 is solely due to unit operation above the exhaust flow limit.

Figure 1 -- Comparative Photos of Shroud Contact Surface Wear for Periods 1 and 3

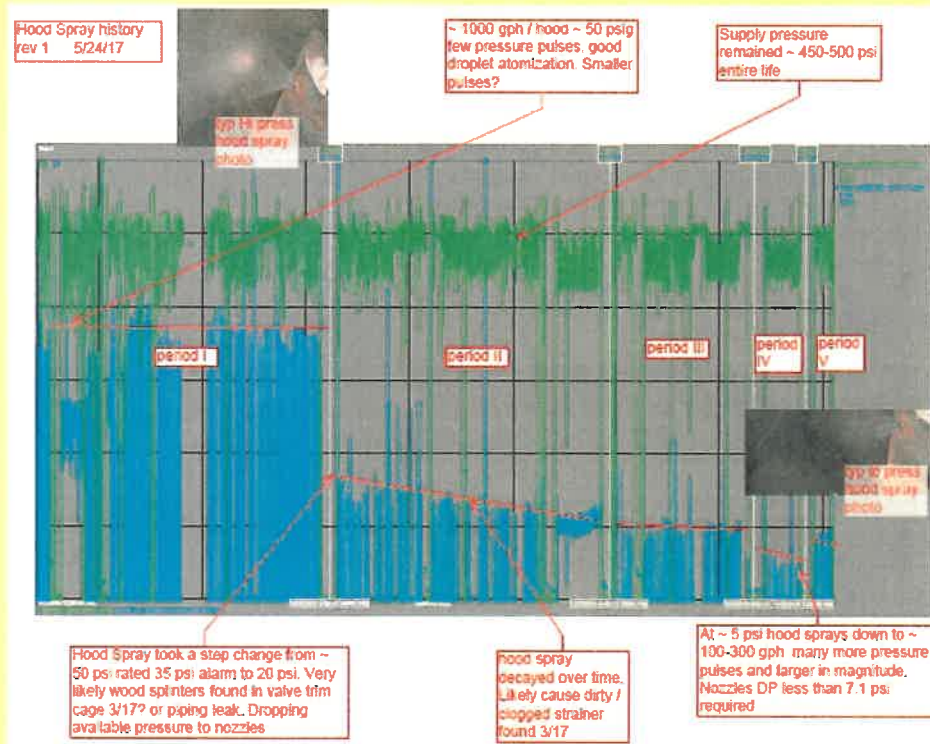
Figure 2 -- Hood Spray Pressure Degradation Over Periods 1-5

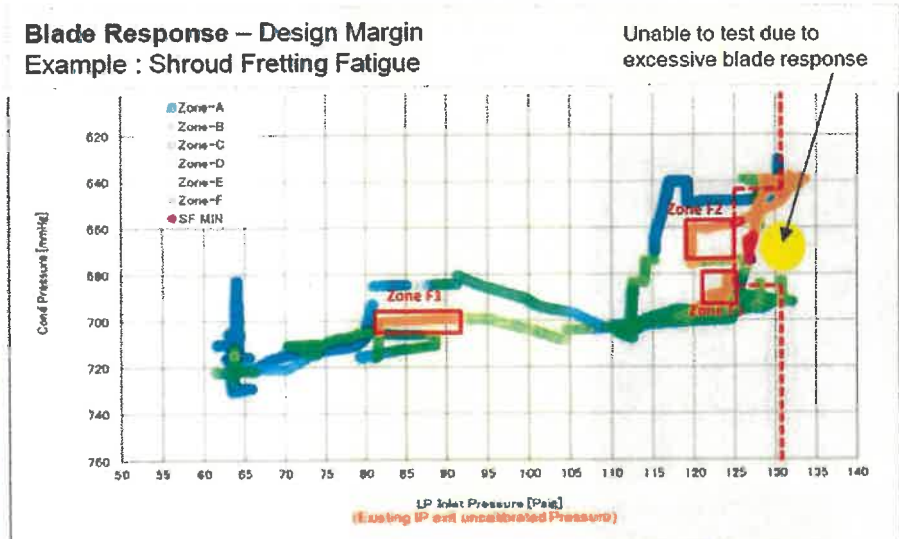
- Blade response is evaluated through the integration of the stress response all the modes between 180Hz to 120Hz

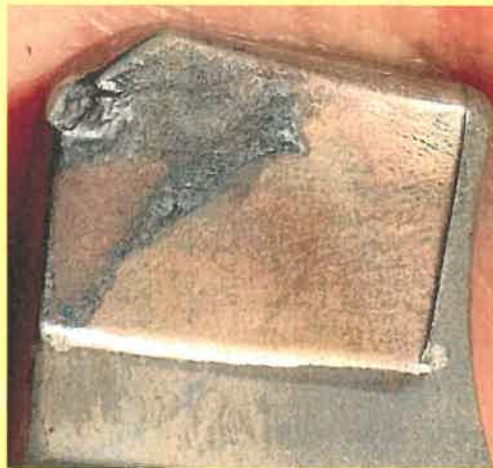
The main reason for conducting this analysis stems from the observed amount of wear seen on the contact surfaces for Period 5. Period 5 did not have any operation time in the exclusion zone and the amount of wear for the amount of operation time seems excessive. A photo showing the amount of wear seen is shown in Figure 4. There was a varying degree of wear seen on the Period 5 Z-notches, however, the wear is higher than what one would expect given the relatively low operating hours.

Figure 4 -- Photo of an L-0 blade Z-Lock from Period 5 Showing Contact Surface Wear

Period 5 did have high energy blends as detected by the blend energy method. However, in terms of operating hours in blend mode, Period 5 is not excessive in terms of percentage time blending as compared to operating hours in Zone F1.

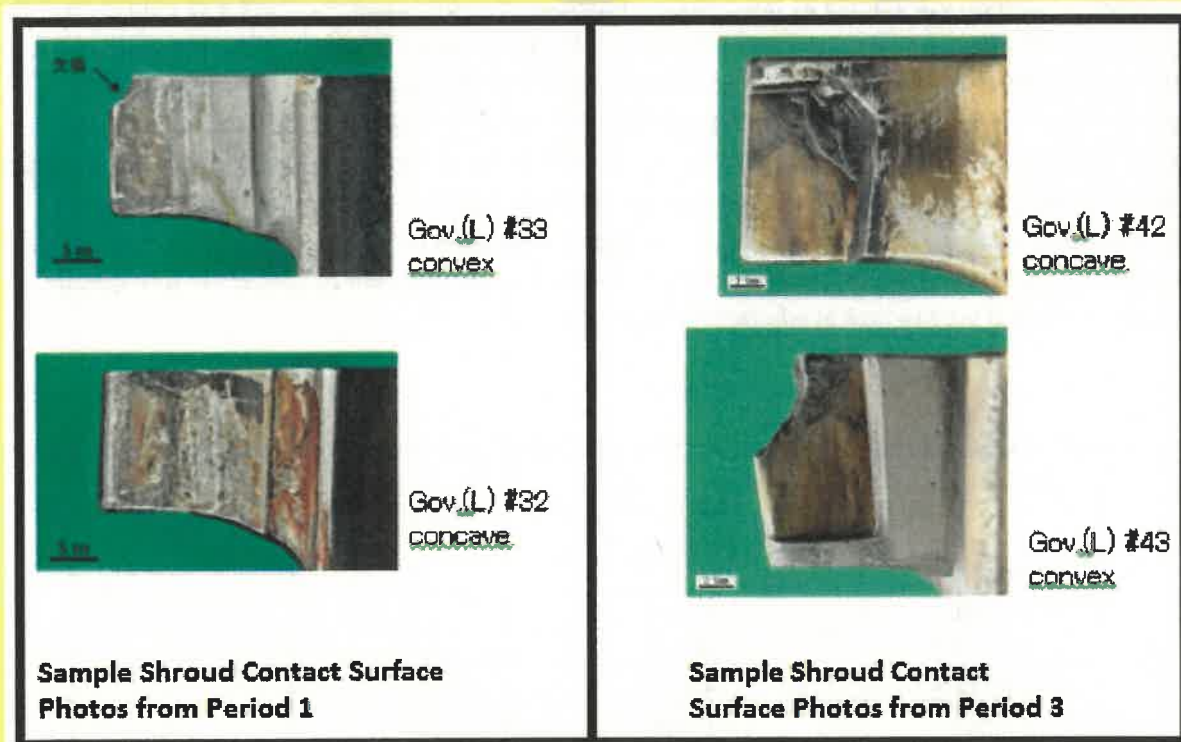
Conversely, during Period 3, there were only 240 hours (out of 10,286 total hours) of operation in the "avoidance zone", approx. 11 hours of which occurred during the instrumented blade telemetry test performed by MHPS in December 2014. Even with a significantly fewer number of "avoidance zone" hours for Period 3 relative to Period 1 – a factor of 10 fewer hours for Period 3 – there was significantly greater amounts of blade damage and fretting on both ends of the machine. While the amount of Z-Lock wear is not quantified for Periods 1 and 3, photographic evidence suggests that the amount of wear is much greater for Period 3, as shown below in Figure 1. It is therefore difficult to conclude that damage to the L-0 blades in Period 3 is solely due to unit operation above the exhaust flow limit.

Figure 1 -- Comparative Photos of Shroud Contact Surface Wear for Periods 1 and 3

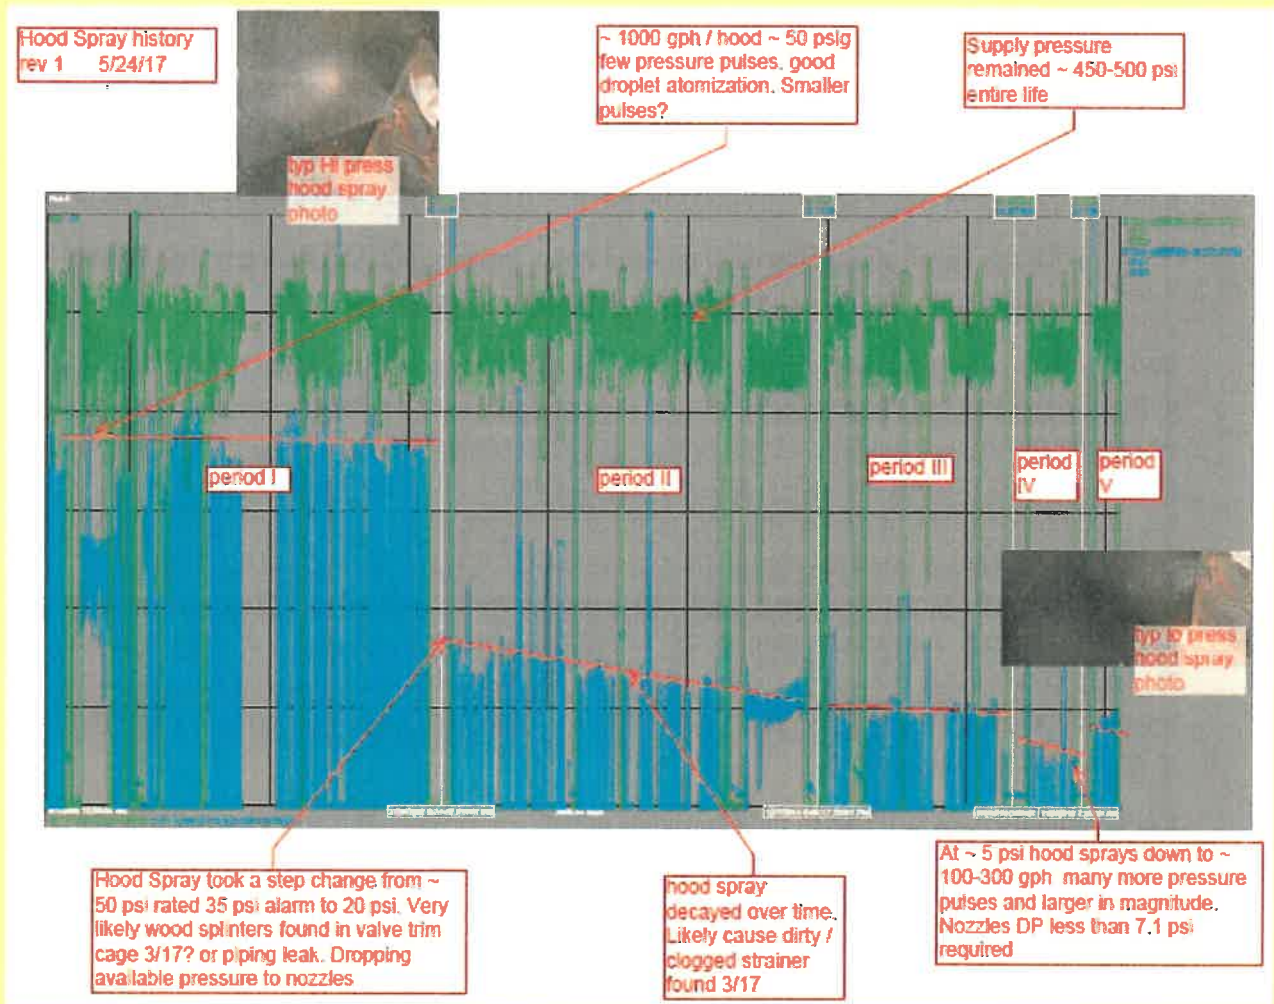
Figure 2 -- Hood Spray Pressure Degradation Over Periods 1-5

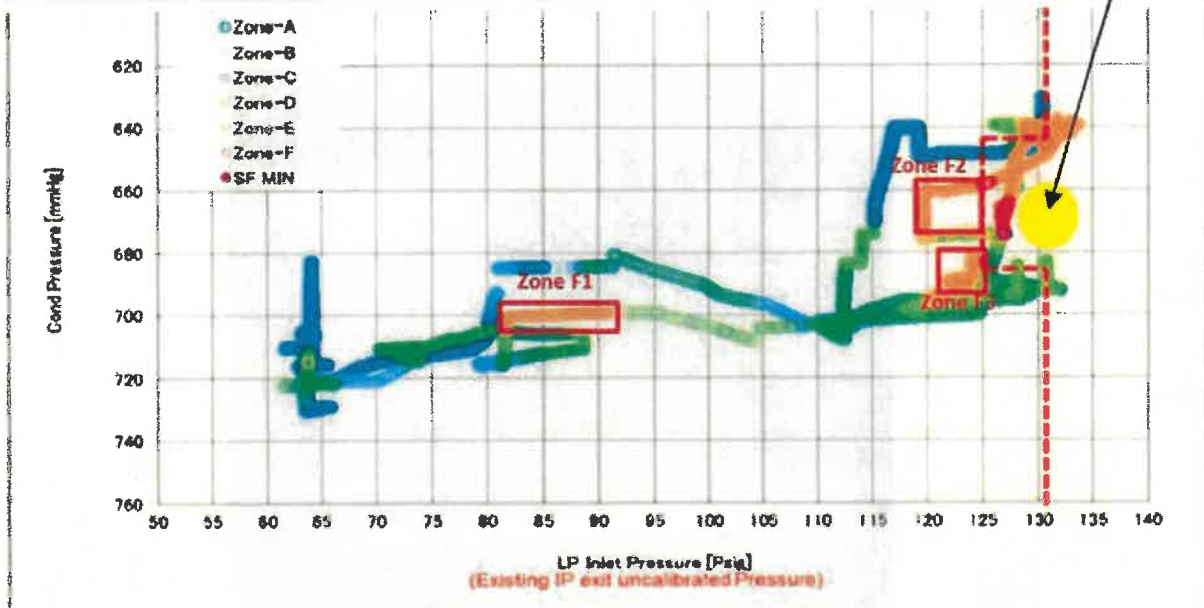
Unable to test due to excessive blade response

- Blade response is evaluated through the integration of the stress response all the modes between 180Hz to 120Hz

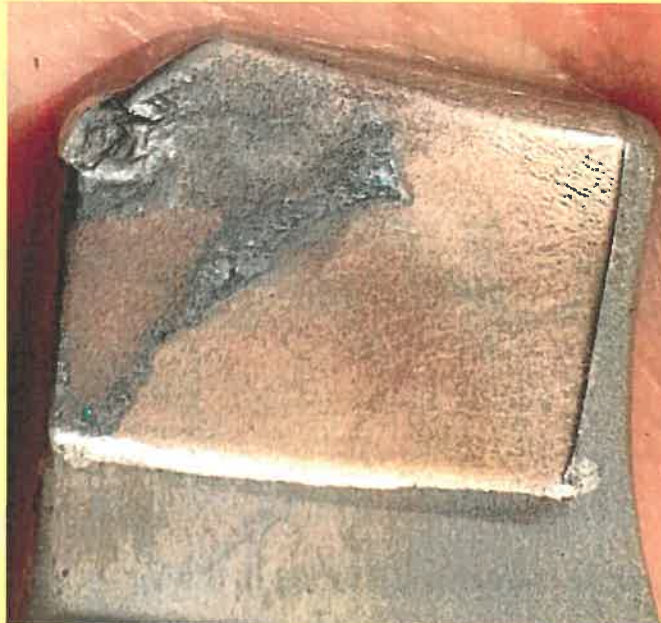
The main reason for conducting this analysis stems from the observed amount of wear seen on the contact surfaces for Period 5. Period 5 did not have any operation time in the exclusion zone and the amount of wear for the amount of operation time seems excessive. A photo showing the amount of wear seen is shown in Figure 4. There was a varying degree of wear seen on the Period 5 Z-notches, however, the wear is higher than what one would expect given the relatively low operating hours.

Figure 4 -- Photo of an L-0 blade Z-Lock from Period 5 Showing Contact Surface Wear

Period 5 did have high energy blends as detected by the blend energy method. However, in terms of operating hours in blend mode, Period 5 is not excessive in terms of percentage time blending as compared to operating hours in Zone F1.

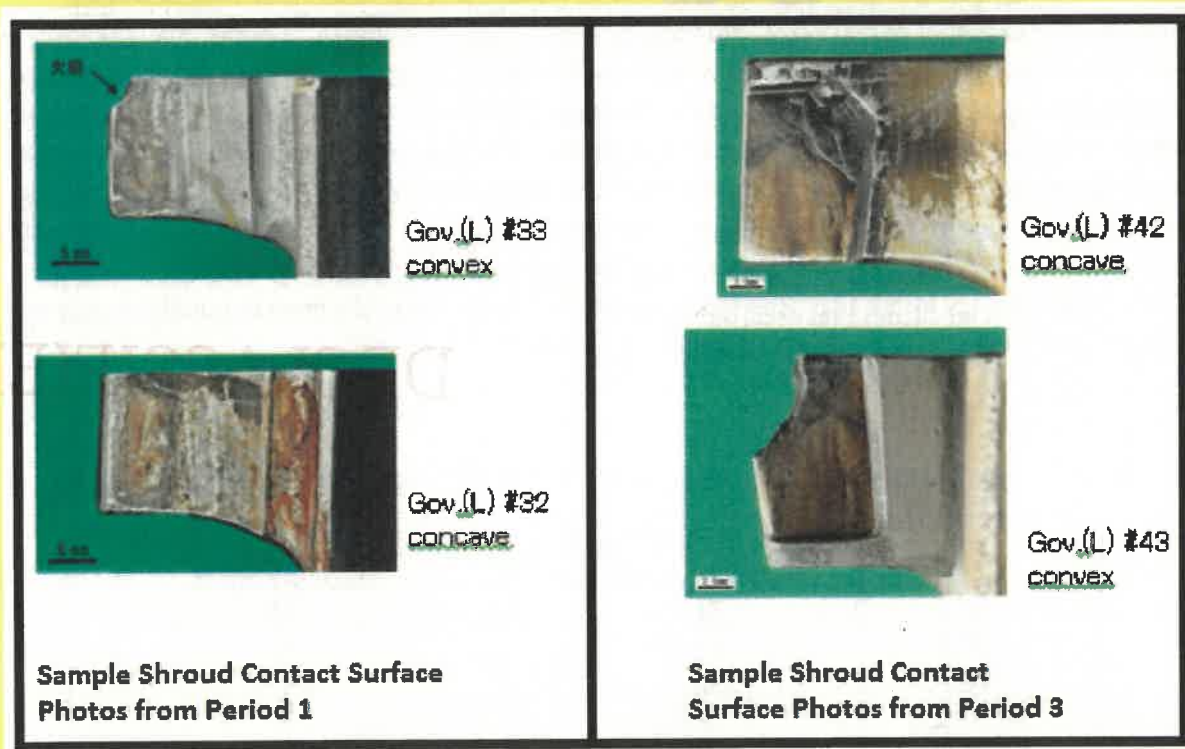
Conversely, during Period 3, there were only 240 hours (out of 10,286 total hours) of operation in the “avoidance zone”, approx. 11 hours of which occurred during the instrumented blade telemetry test performed by MHPS in December 2014. Even with a significantly fewer number of “avoidance zone” hours for Period 3 relative to Period 1 – a factor of 10 fewer hours for Period 3 – there was significantly greater amounts of blade damage and fretting on both ends of the machine. While the amount of Z-Lock wear is not quantified for Periods 1 and 3, photographic evidence suggests that the amount of wear is much greater for Period 3, as shown below in Figure 1. It is therefore difficult to conclude that damage to the L-0 blades in Period 3 is solely due to unit operation above the exhaust flow limit.

Figure 1 -- Comparative Photos of Shroud Contact Surface Wear for Periods 1 and 3
