DOCUMENTS: Panel deposition of Jeffrey Swartz, Anthony Salvarezza and C. Wayne Toms, August 30, 2019.

CONFIDENTIAL**Bartow 4S Root Cause Analysis – Evaluation of Contributing Factors**

Duke and Mitsubishi Hitachi Power Systems (MHPS) have worked both independently and together over the past 12 months to determine what has caused the Bartow Unit 4S L-0 blades to crack and break during operation. During a presentation given at Bartow Station on 15 March 2017, MHPS suggested the sole root cause for Period 3 (Dec 2014-Mar 2016) was “operation in the avoidance zone”. While Duke Engineering would agree that operation in the “avoidance zone” is certainly a *contributing factor* to the shroud chipping experienced in Period 3, it is not the only driving mechanism that should be considered when trying to determine root cause for the Period 3 Bartow Unit 4S event, or any of the previous/subsequent events for that matter.

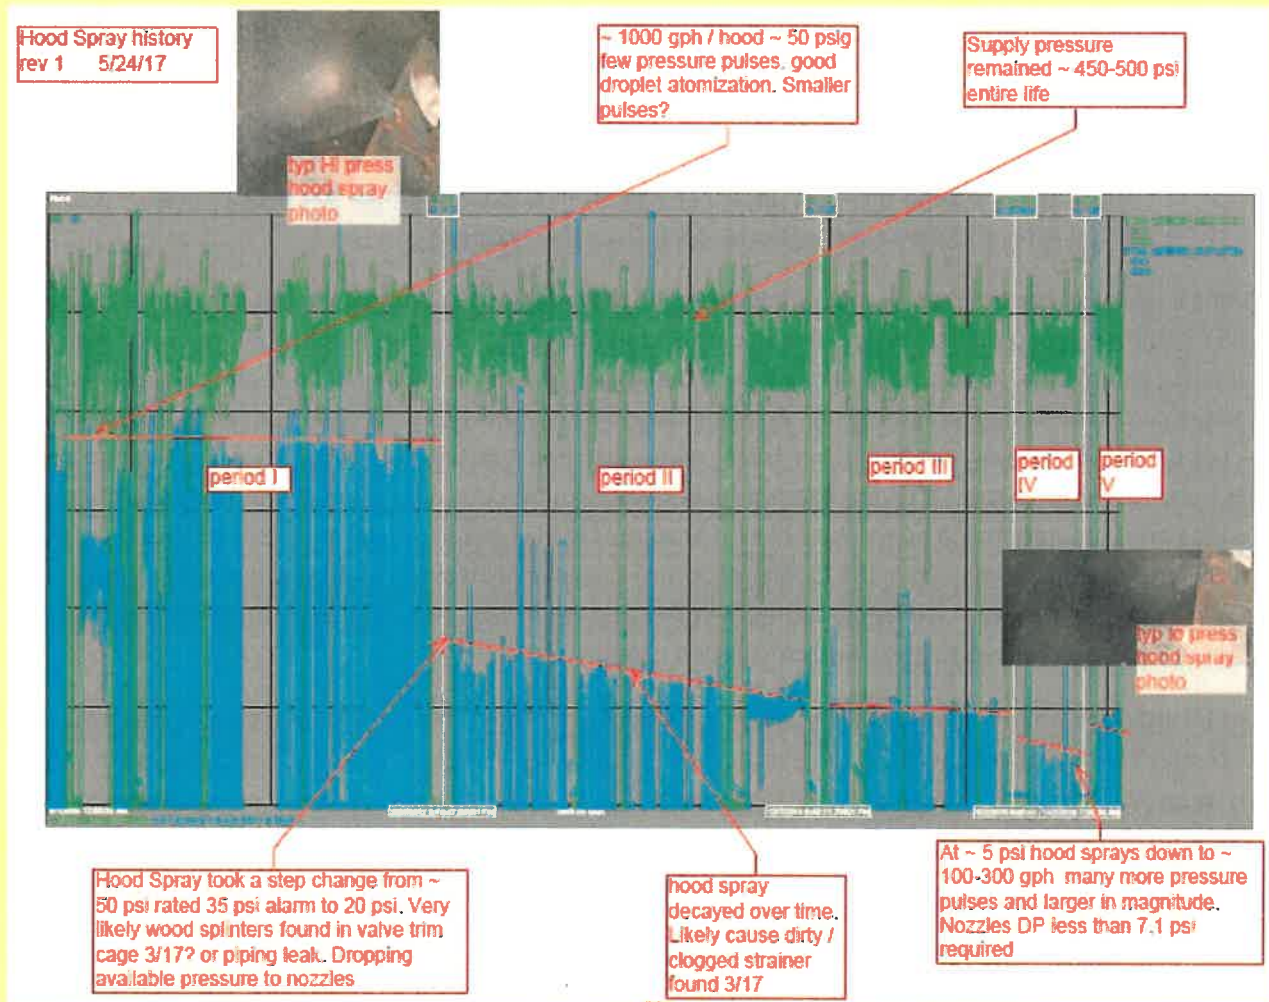
Figure 2 -- Hood Spray Pressure Degradation Over Periods 1-5

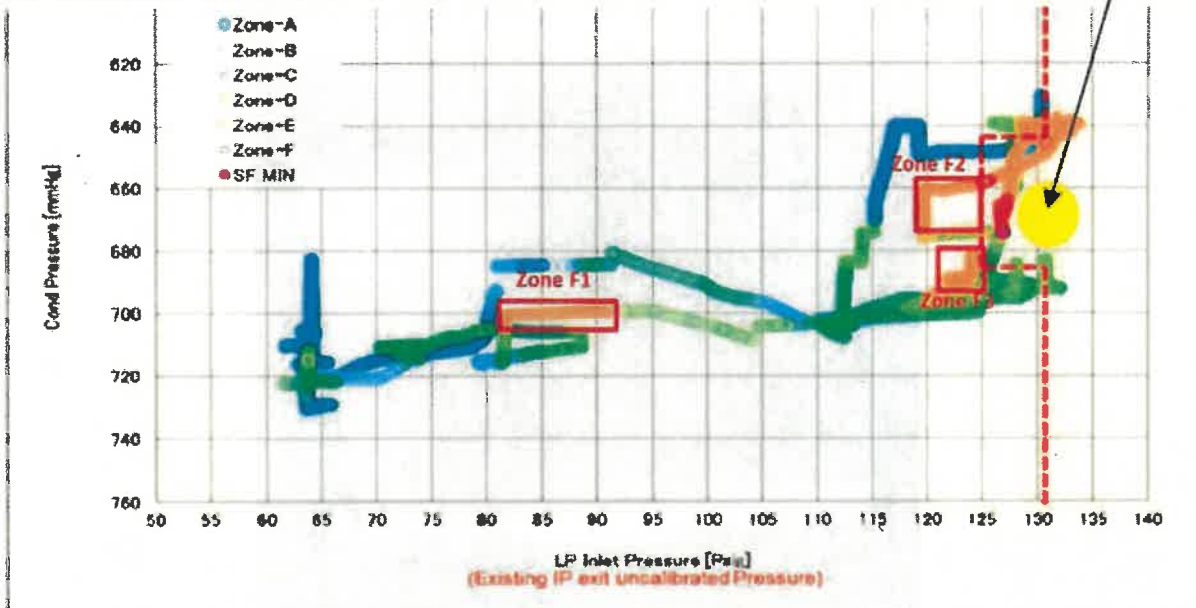
Unable to test due to excessive blade response

- Blade response is evaluated through the integration of the stress response all the modes between 180Hz to 120Hz

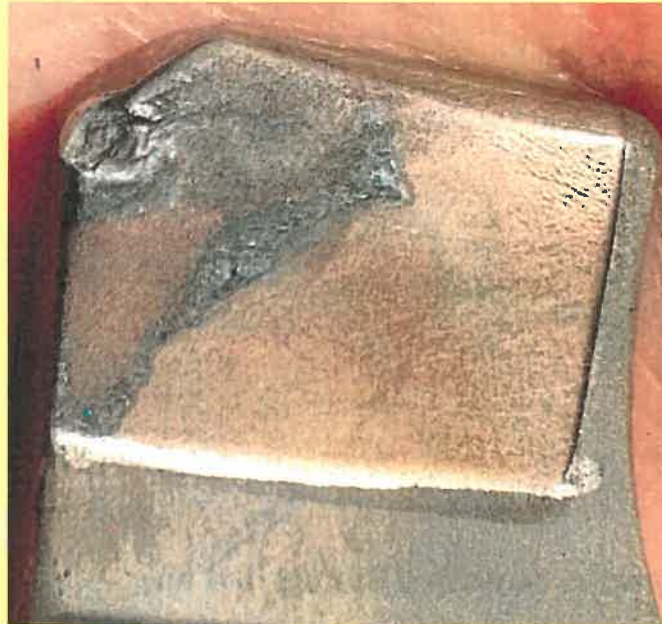
The main reason for conducting this analysis stems from the observed amount of wear seen on the contact surfaces for Period 5. Period 5 did not have any operation time in the exclusion zone and the amount of wear for the amount of operation time seems excessive. A photo showing the amount of wear seen is shown in Figure 4. There was a varying degree of wear seen on the Period 5 Z-notches, however, the wear is higher than what one would expect given the relatively low operating hours.

Figure 4 -- Photo of an L-0 blade Z-Lock from Period 5 Showing Contact Surface Wear

Period 5 did have high energy blends as detected by the blend energy method. However, in terms of operating hours in blend mode, Period 5 is not excessive in terms of percentage time blending as compared to operating hours in Zone F1.

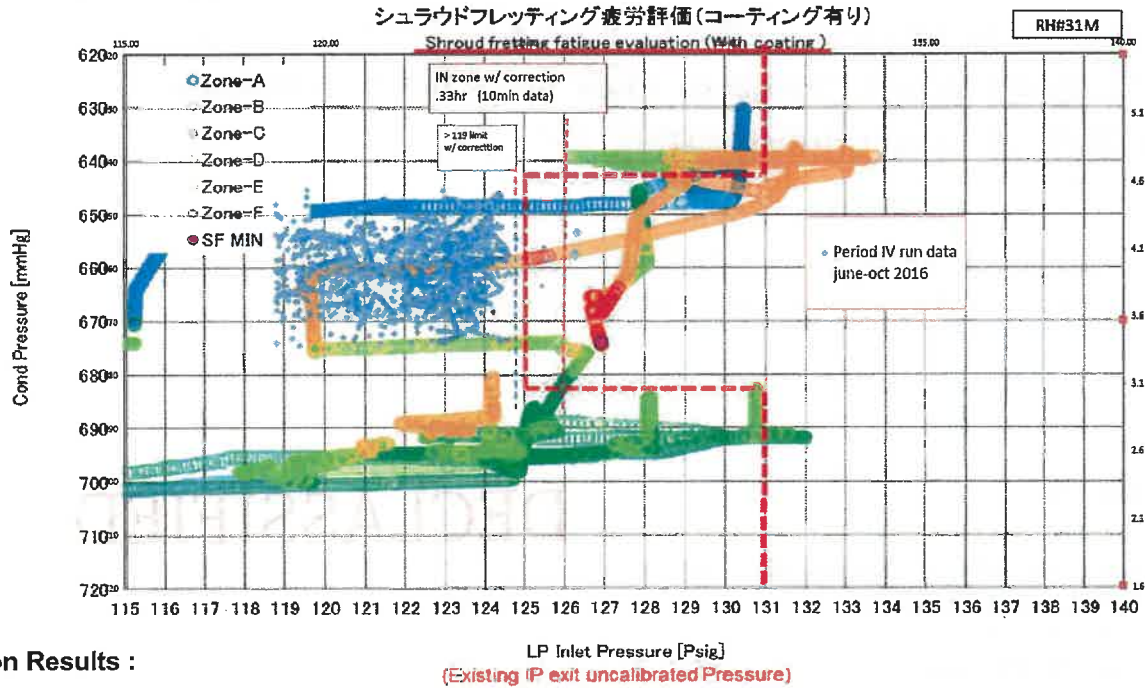
1.4) Operating Time 4 : Jun 2016 to Oct 2016

Location	Blades	Service	Mid Span Snubber	Shroud	Disposition
Gen End	Type 3 + HVOF++	4 Months	1 Liberation	3 Shroud Liberations	Replace Row
Gov End	Type 3 + HVOF++	4 Months	No significant damage	1 Shroud Liberation	Replace Row

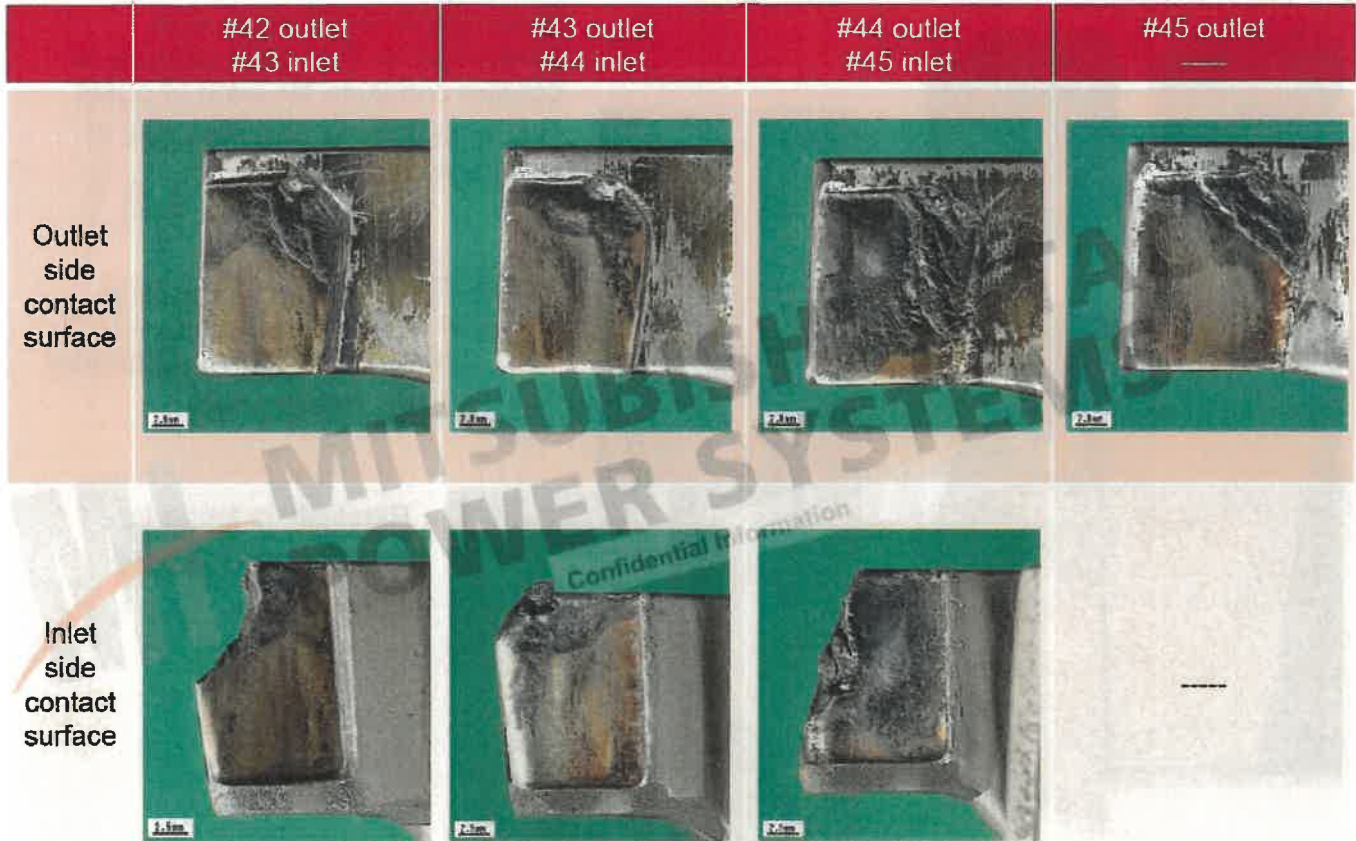
Blade Inspection Results

Shroud Chipping is starting at same location for all blades

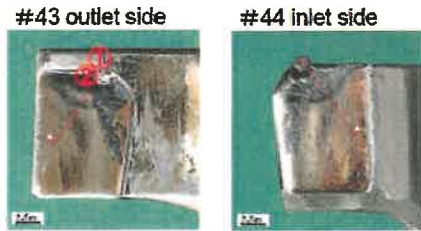
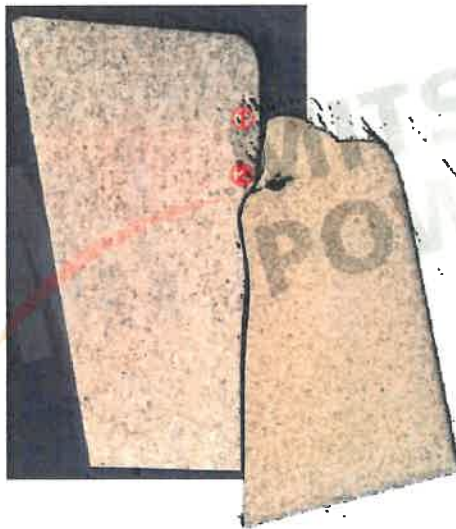
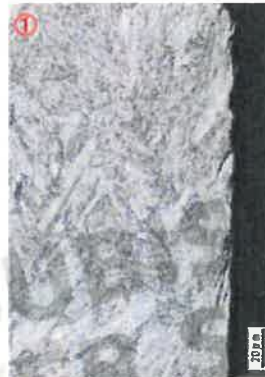
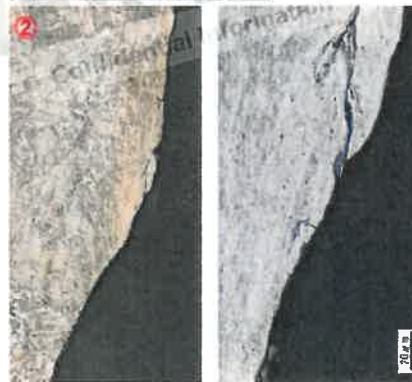
Metallurgical Evaluation of Blades

Microscopic observation was performed on the same sections in contact condition for each of outlet side of #43 blade and inlet side of #44 blade.

- Fine cracks, caused by fretting fatigue, are found near the end of contact part with local deformation of inlet side of #44 blade.

- Plasticity is found in concave part of local deformation.

Fretting fatigue identified as crack initiation source.

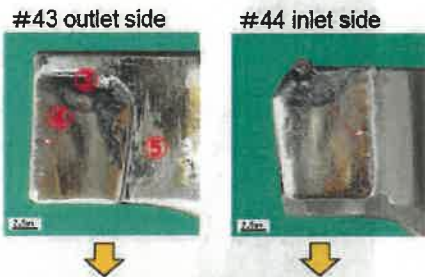
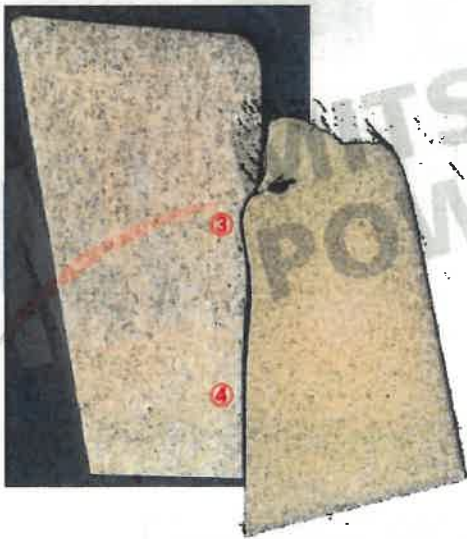
Metallurgical Evaluation of Blades

- ③: Oxide scale was found on black surface of local deformation area.
- ④: Dark brown surface of worn and thinned part is free of oxide scale and smoother than non-contact surface of ⑤.

Oxide scale with local deformation observed on black surface

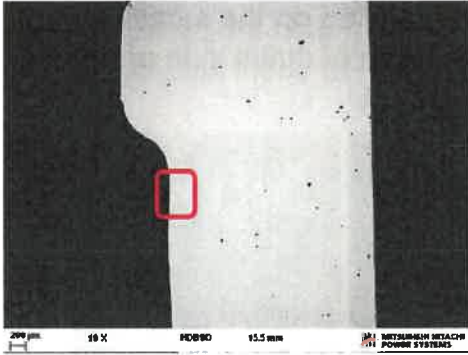
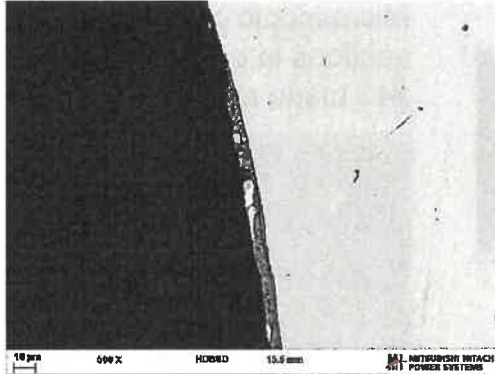
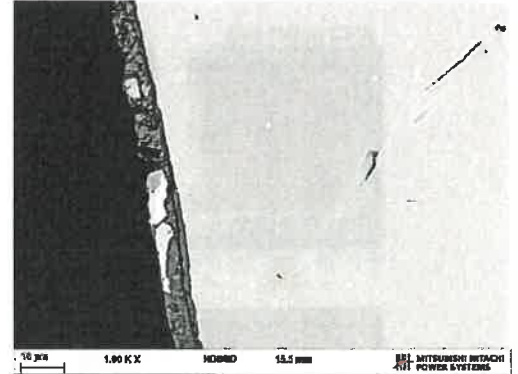
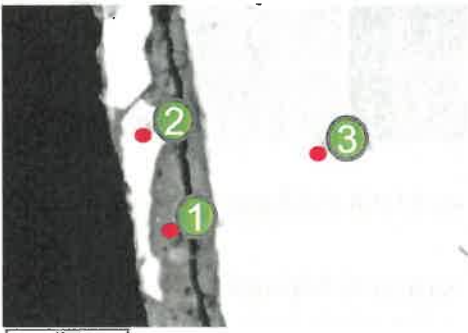
Metallurgical Evaluation of Blades

- Oxidation/corrosion was observed on the trailing edge contact surface of the tip shroud.
- Material removal from wear is from abrasion.

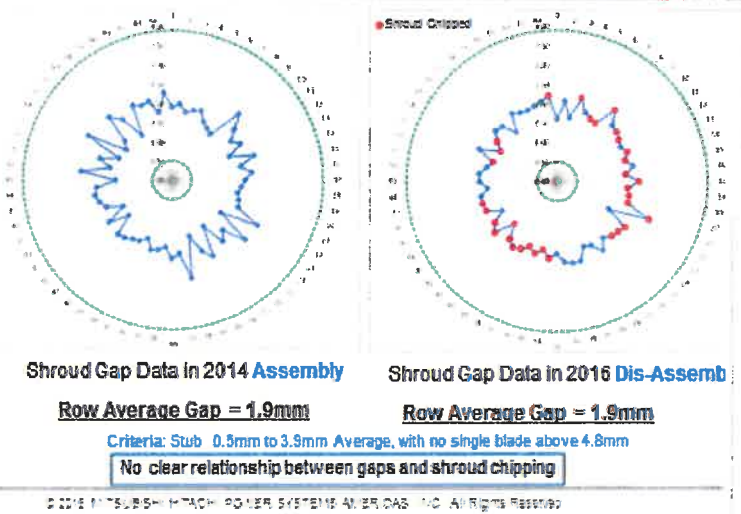
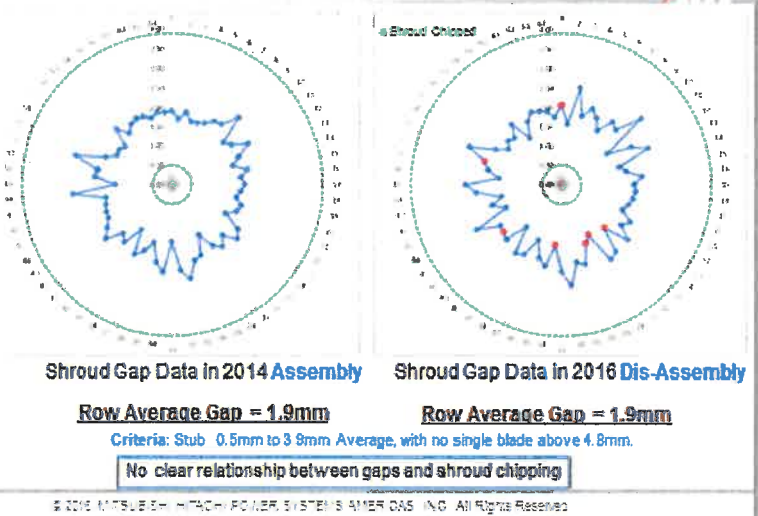
Stub Gap Data

**LH and RH stub average gaps are nearly same.
No clear relationship between gap and shroud chipping.**

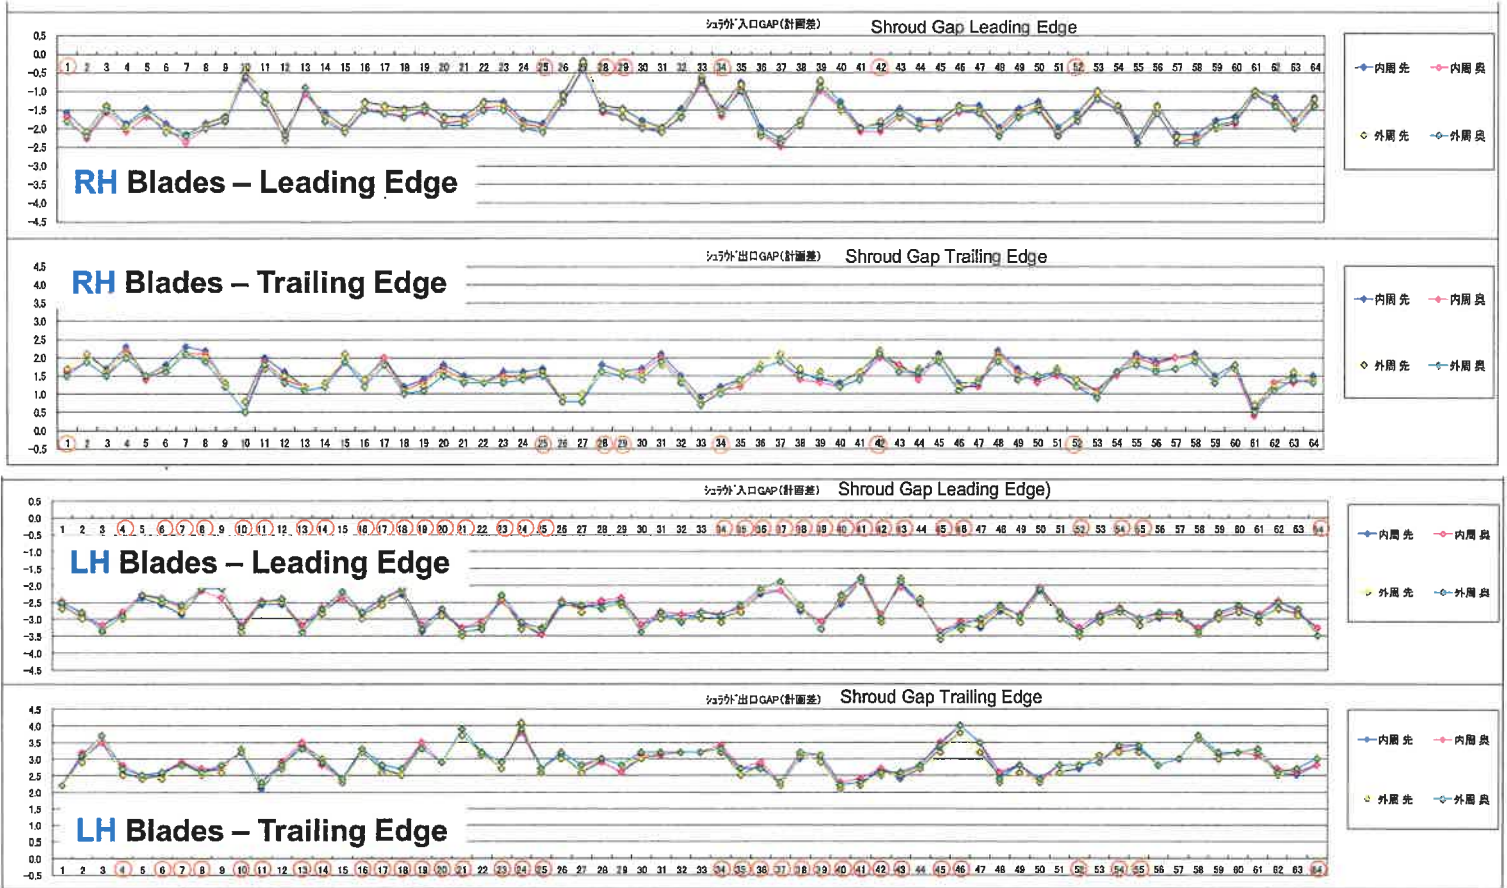
Box Gauge Measurement Results - 2014 blades

Blade manufacturing data show variation within criteria

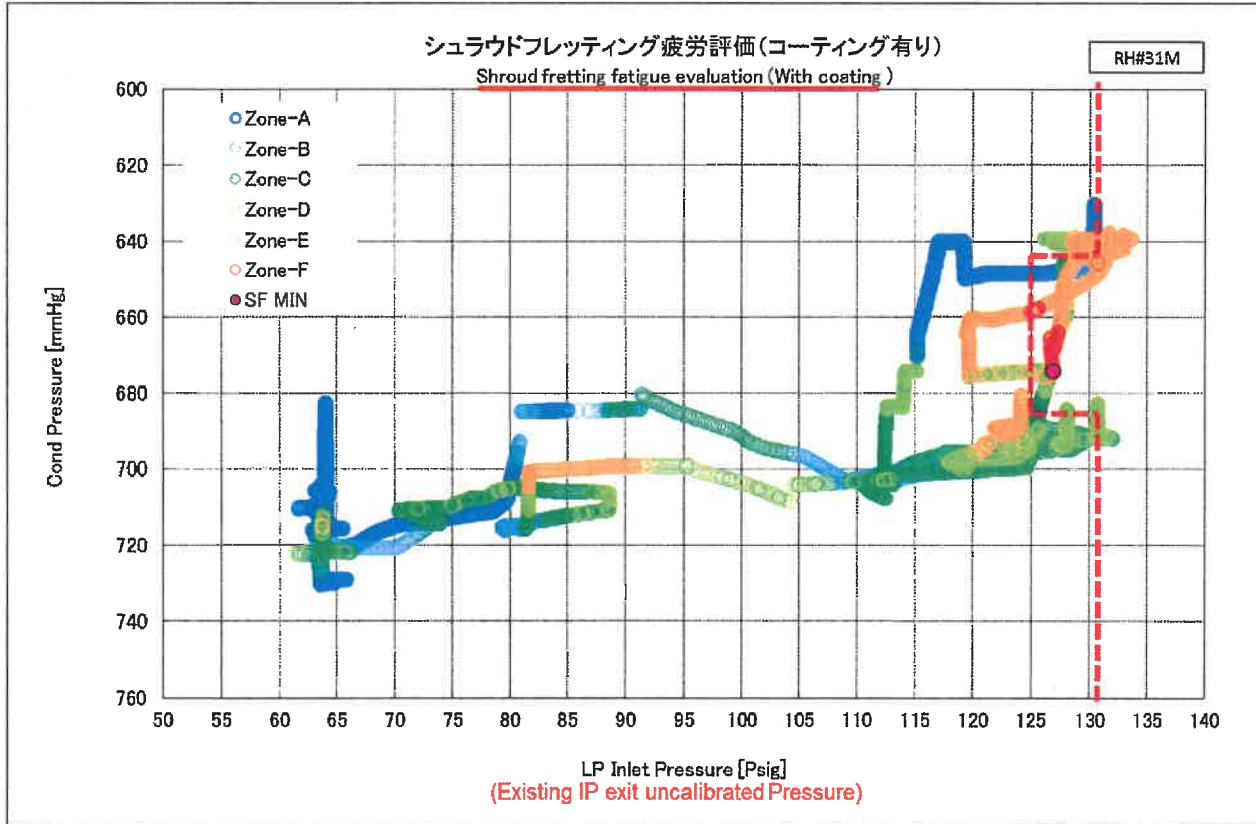
Telemetry Test Results – Shroud Fretting

Fretting fatigue calculations for shroud with coating show acceptable margins outside avoidance zone

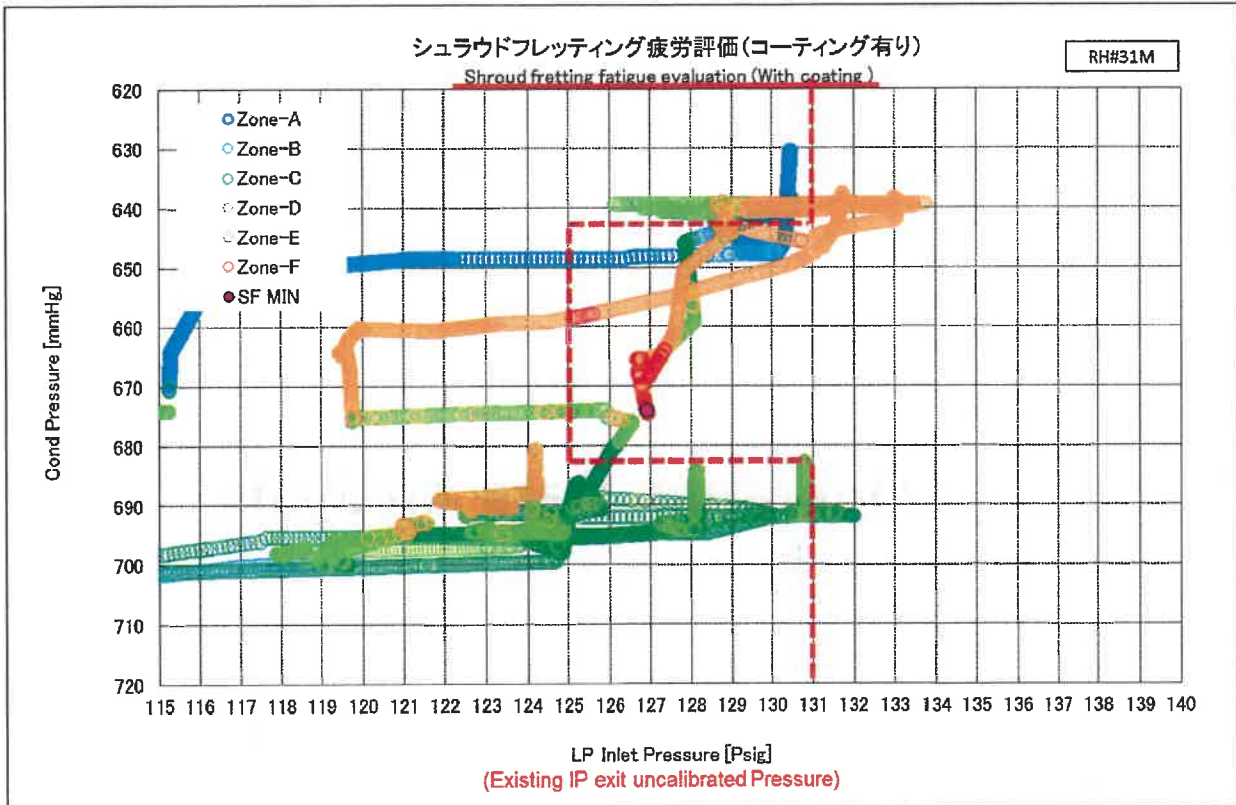
Telemetry Test Data – Shroud Fretting

Fretting fatigue calculations for shroud with coating show acceptable margins outside avoidance zone

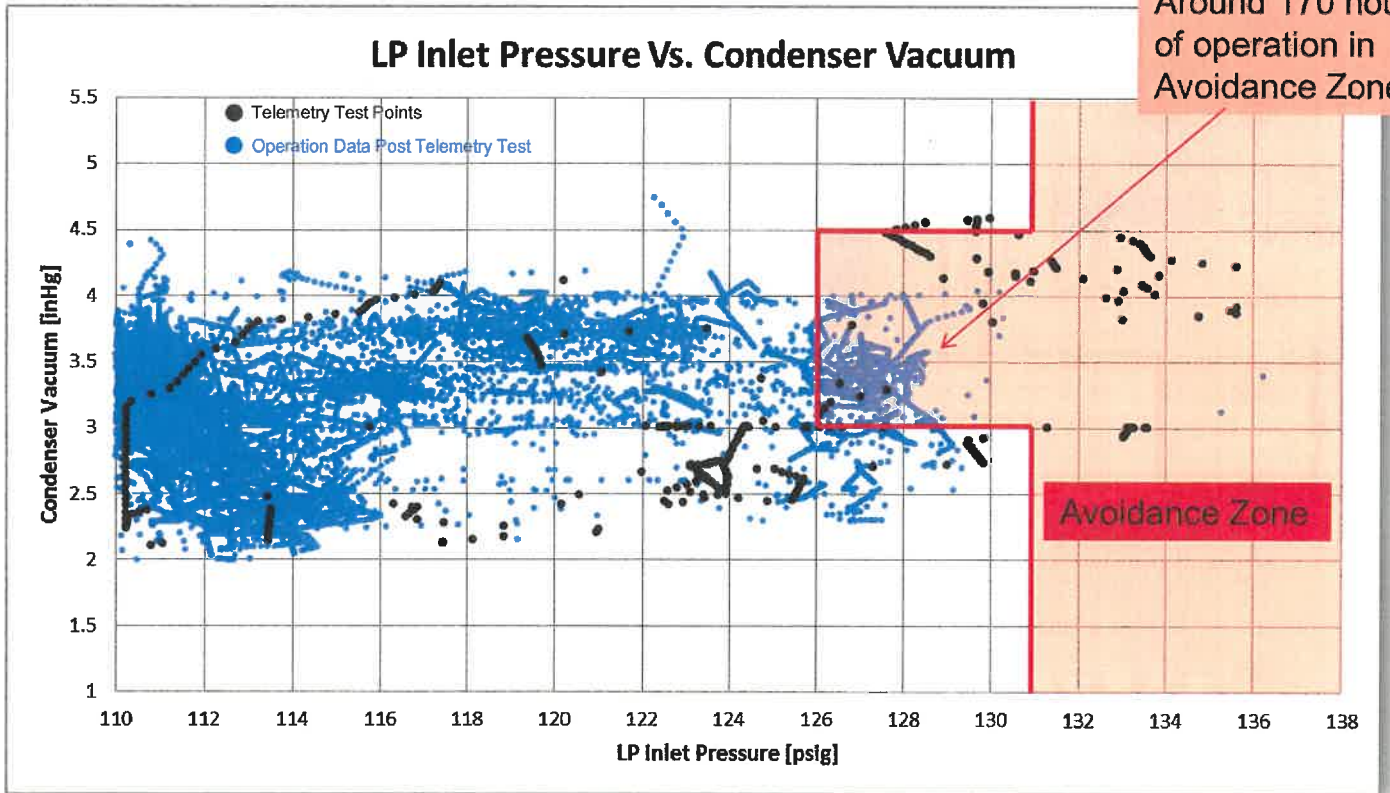
Operation Data Review

Around 170 hours of operation in Avoidance Zone

170+ hours of operation in avoidance zone with a response frequency ~200Hz = 1.2E8 Cycles

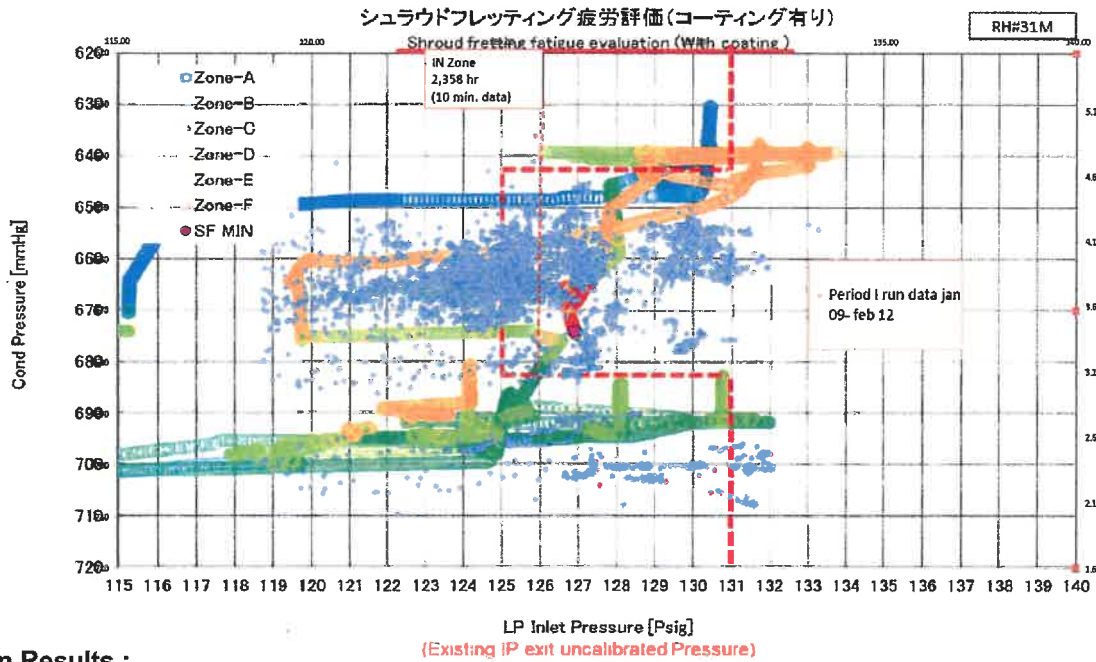
Location	Blades	Service	Mid Span Snubber	Shroud	Disposition
Gen End	Type 1	3 yrs	No significant damage	No significant damage	Continue operation until 2014 planned replacement
Gov End	Type 1	3 yrs	5 Major Chip	3 minor chips	Replace blades as continues midspan chipping could results in a free standing blade

1.1) Operating Time 1 : Jan 2009 to Feb 2012
Significant operation in the avoidance zone.
Significant damage observed on the blades.

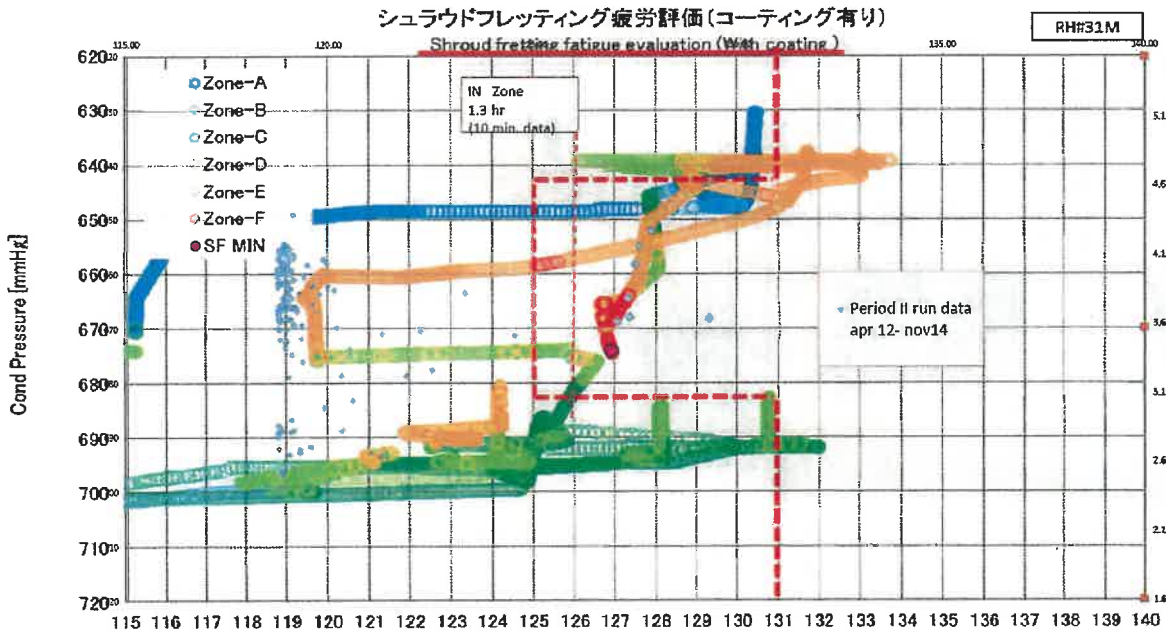
Location	Blades	Service	Mid Span Snubber	Shroud	Disposition
Gen End	Type 1	5 yrs	No significant damage	12 minor chips	Scheduled change out to blades with midspan HVOF
Gov End	Type 1	2 yrs	No significant damage	3 minor chips	Scheduled change out to blades with midspan HVOF

1.2) Operating Time 2 : Apr 2012 to Nov 2014
Minimal operation in the avoidance zone.
Minor chipping observed.

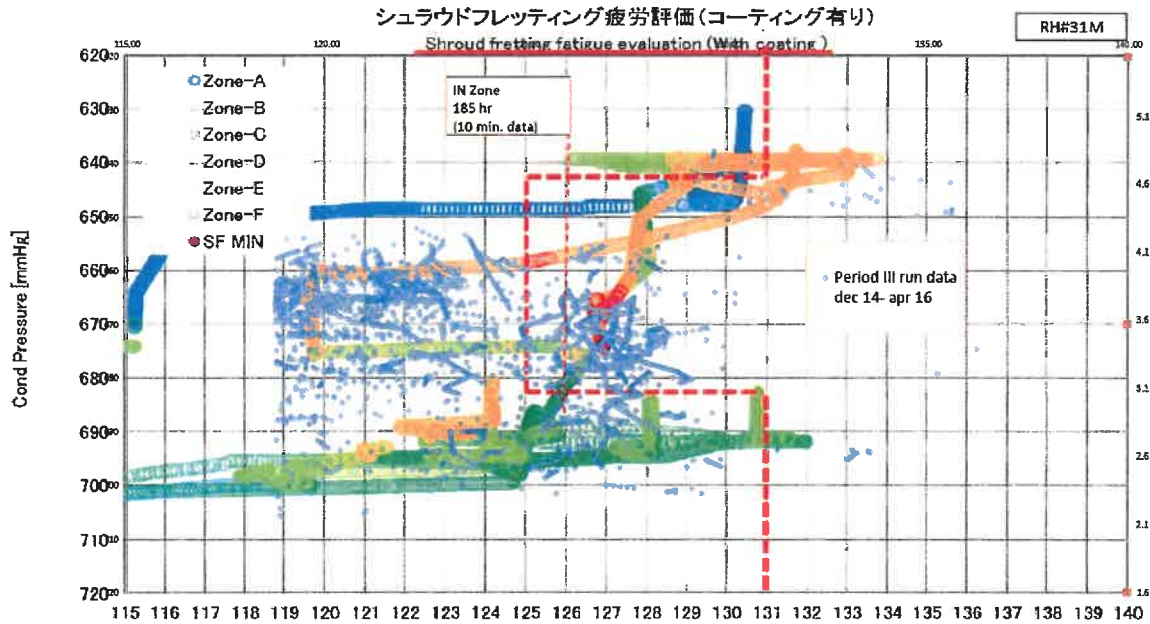
Location	Blades	Service	Mid Span Snubber	Shroud	Disposition
Gen End	Type 3 + HVOF	15 Months	No significant damage	7 minor chips	Fit for continued operation. Shroud contact on all blades.
Gov End	Type 3 + HVOF	15 Months	No significant damage	33 chips including significant damage	Replace row as free shroud contact has been lost on 1 blade.

1.3) Operating Time 3 : Dec 2014 to Apr 2016
Significant operation in the avoidance zone.
Significant damage observed on the blades.

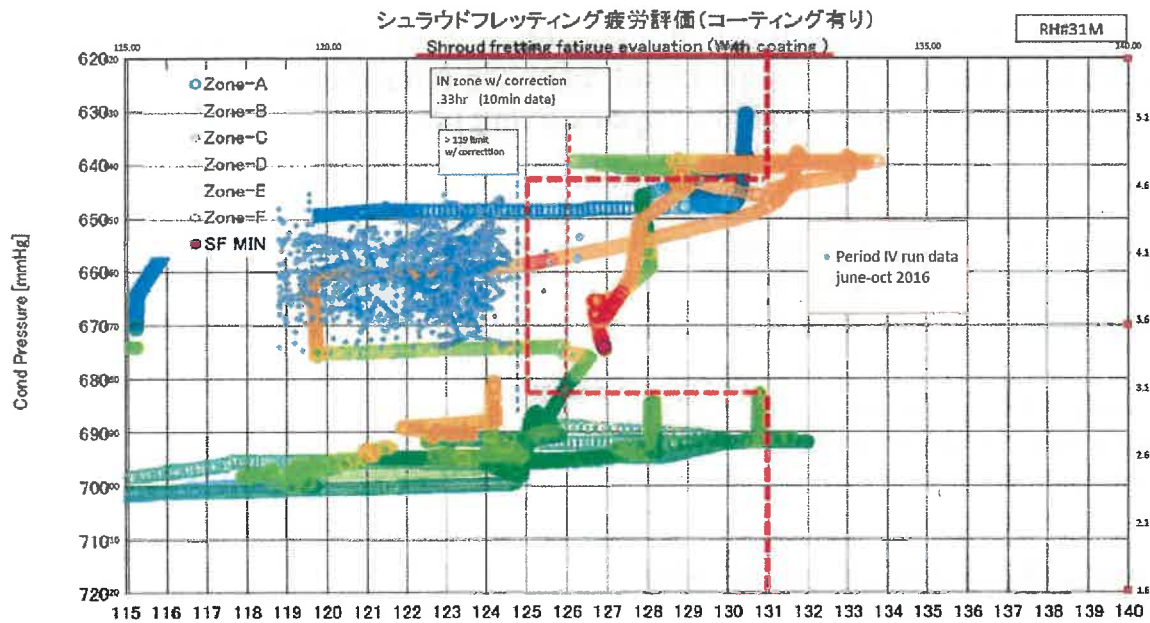
1.4) Operating Time 4 : Jun 2016 to Oct 2016

Location	Blades	Service	Mid Span Snubber	Shroud	Disposition
Gen End	Type 3 + HVOF++	4 Months	No significant damage	7 minor chips	Fit for continued operation. Shroud contact on all blades.
Gov End	Type 3 + HVOF++	4 Months	No significant damage	33 significant damage	Replace row as free shroud contact has been lost on 1 blade.

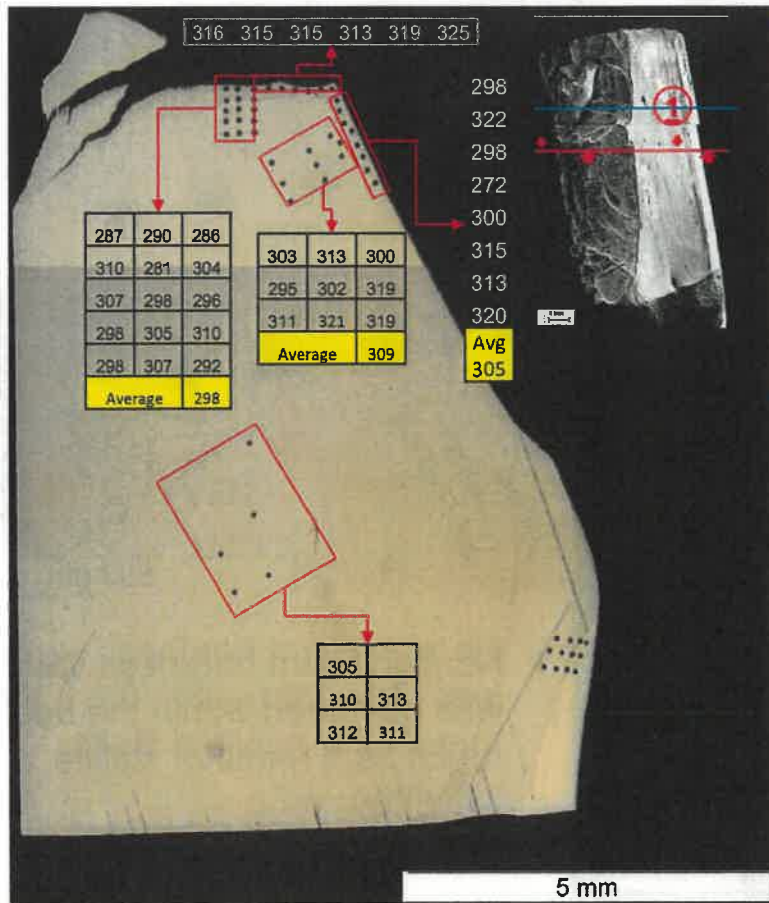
2 - Hardness Variation – Presented

- From hardness observation no significant decrease was observed where the crack initiated.
- A decrease in hardness was observed on the contact surface.

➤ No significant hardness variation was observed within the base metal as a result of stellite welding.
