**MANAGEMENT REVIEW BOARD
ATTACHMENT 1 – COMPLETED ITEM REVIEW
ST. LUCIE NUCLEAR STATION
JUNE 4, 2019**

Unit 1 Main Generator Ground Fault Interim Root Cause Evaluation Report

Event Date: 04/25/2019

CR Number: 02312208

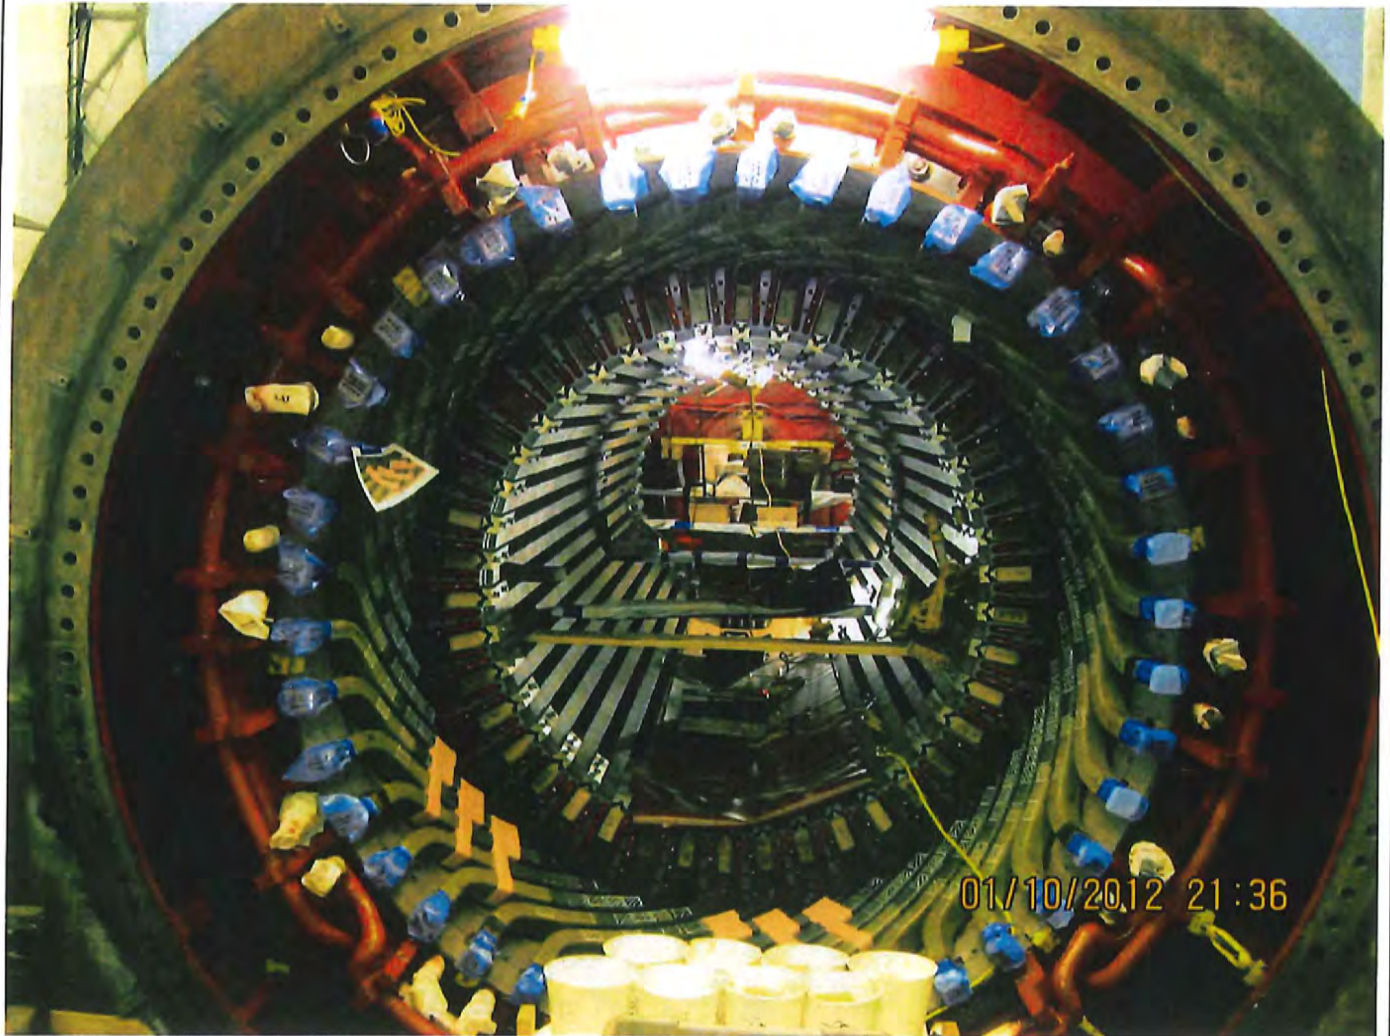
Figure 2 – Bottom Half-Coil installation

The 'stator' is the primary stationary component of the generator consisting of a stator core, three phase windings, and the generator leads which conduct the electrical power from the stator windings. Several images of the Unit 1 generator during rewind in SL1-24 are presented on the following pages to illustrate the stator construction. The core is constructed using laminations of steel with slots to receive the stator coils (Figure 1). The windings each consist of a series of distributed single turn coils. The coils are constructed using half coil 'stator bars' installed within slots in the core (Figure 2 and 3) and connected at the ends of the stator outside of the core Figure 4).
