Docket No. 20210001-EI

**DUKE ENERGY FLORIDA LLC'S
REQUEST FOR CONFIDENTIAL CLASSIFICATION**

Bartow 4A Generator Major Inspection Sp 19

Stator Winding Report (#112726)

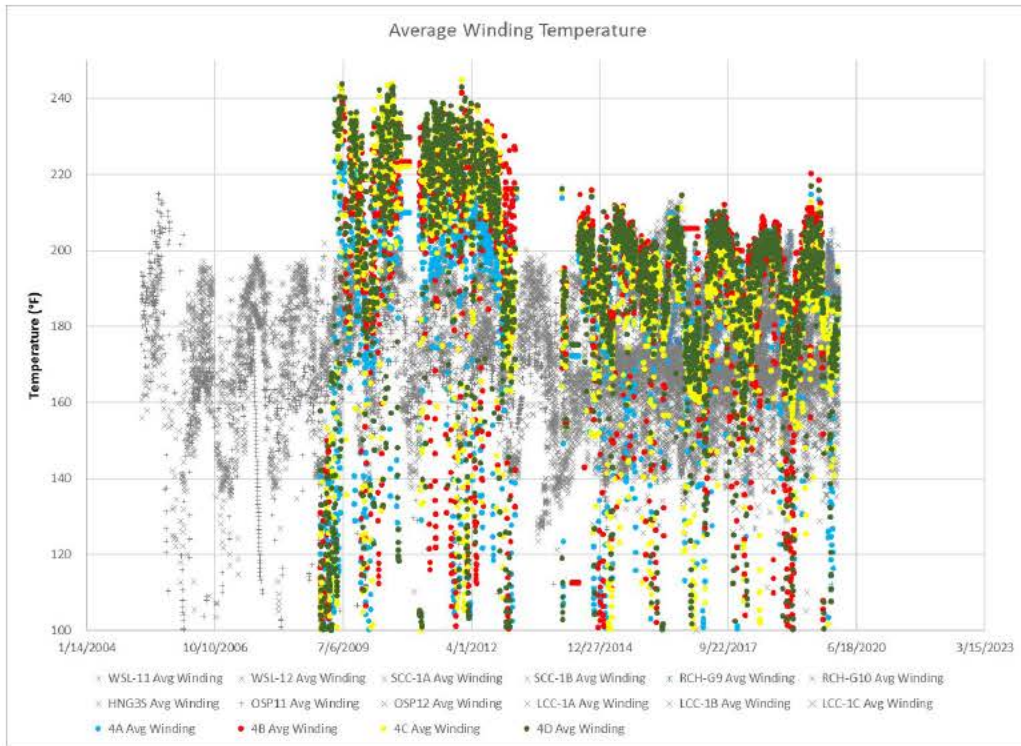
Further investigation by Siemens into the operational history of the 4B generator identified that early in life the average winding temperatures had run hotter than typical for the fleet. Historically the fleet has operated in the range of 160 - 200F winding temperature (as measured by embedded RTDs), but from June 2009 until 2012/2013 the 4B generator ran with temperatures in the 200 - 240F range. These temperatures were still below the OEM recommended alarm. (OEM alarm is based on temperature rise across the stator winding when compared to cold gas, giving an alarm around 270F and unload of 279F for typical generator cold gas temperatures during this period). Expanding this investigation, it was found that all four CTG at Bartow had experienced these hotter temperatures. Review of the 2012/2013 outage reports showed that degraded core seals were found and replaced during those outages, and upon startup following the outage the winding temperatures took a step change decrease of ~30F back to the normal fleet operating temperature.
