BEFORE THE FLORIDA PUBLIC SERVICE COMMISSION

In re: Fuel and Purchased Power Cost Recovery
Clause with Generating Performance Incentive
Factor

Docket No. 20220001-EI

**FLORIDA POWER & LIGHT COMPANY'S PROVISIONAL MOTION
FOR EXTENSION OF TIME TO FILE REBUTTAL TESTIMONY ADDRESSING
CERTAIN PORTIONS OF OPC WITNESS RICHARD A. POLICH'S TESTIMONY**

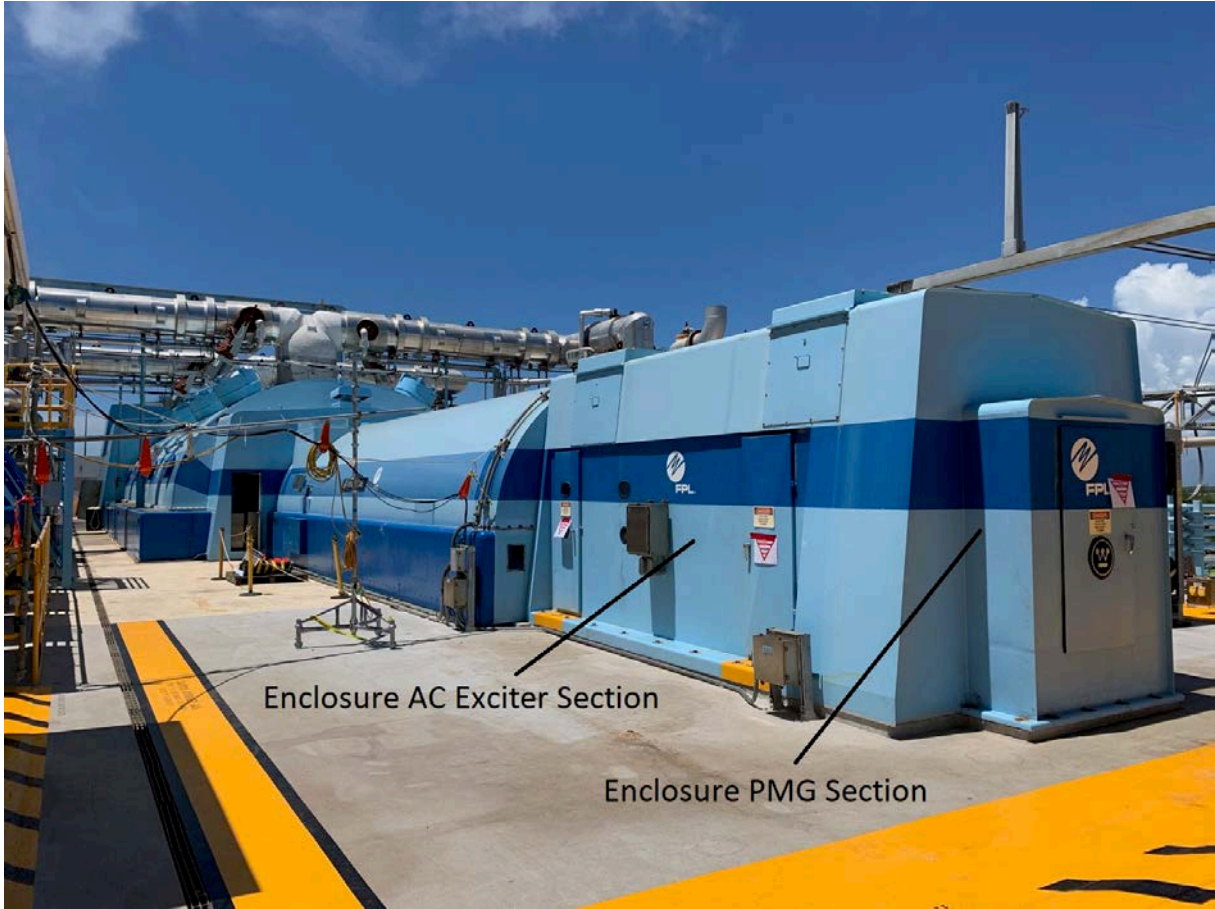
Fig. 1 U4 Exciter Housing

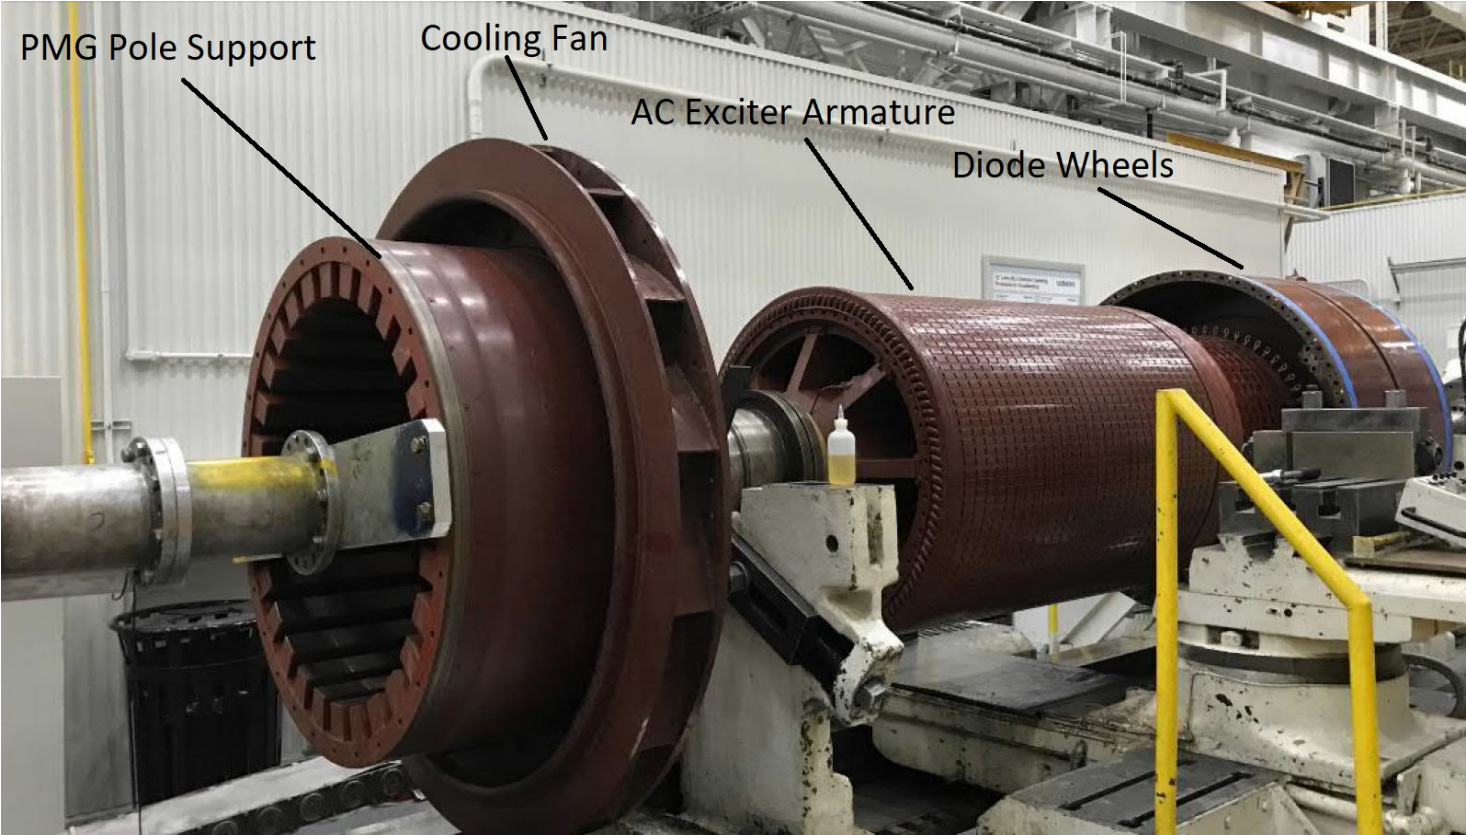
Fig 4 Exciter Rotating Element Removed

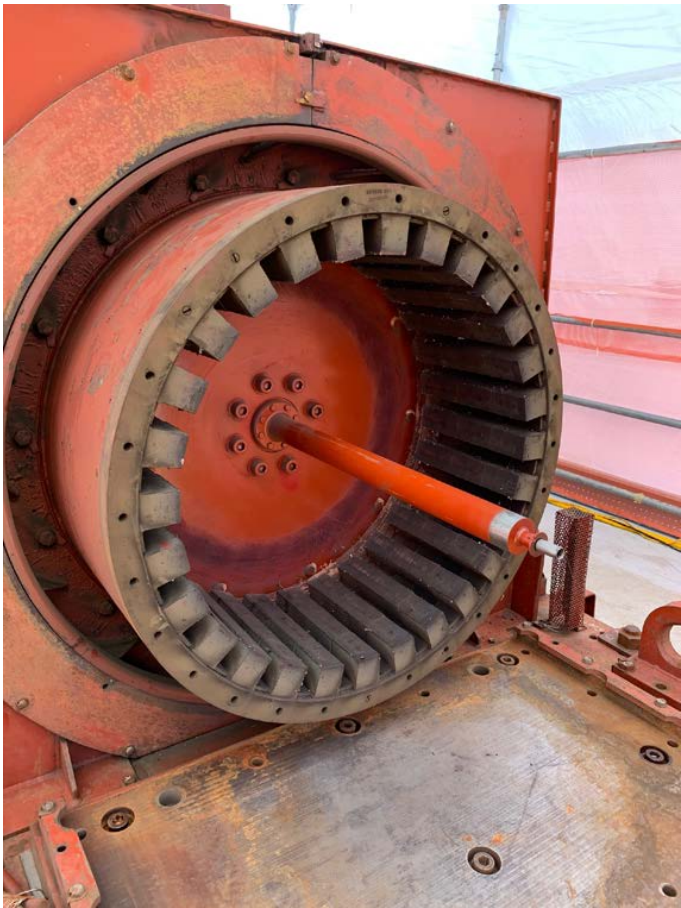
Fig. 8 PMG Pole Support w/ Magnets

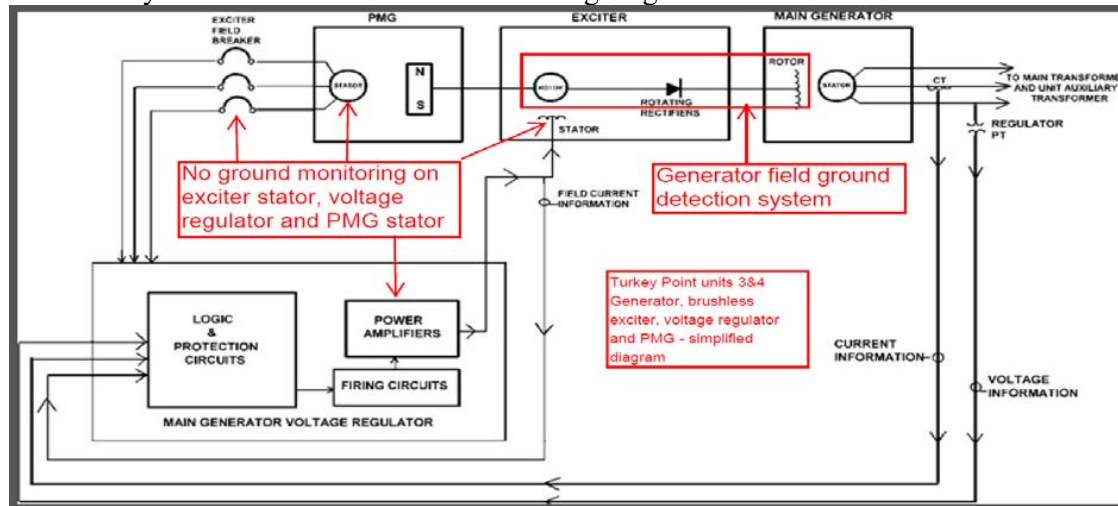
- Turkey Point units 3 and 4 have Generator field ground monitoring system and do not have exciter field ground monitoring. Generator field ground system monitors ground on Generator rotor, rectifier diode wheel and exciter rotor (armature). Exciter field ground monitors continuous ground on exciter stator (field), Voltage Regulator, cables and PMG stator.
- Point Beach WTA-300B installed in 2000 have exciter field ground monitoring addition to the generator field ground monitor system. PB voltage regulator drawing no: 97-MK365SAA. 64B is Generator field ground detector and 64F is exciter field ground detector.

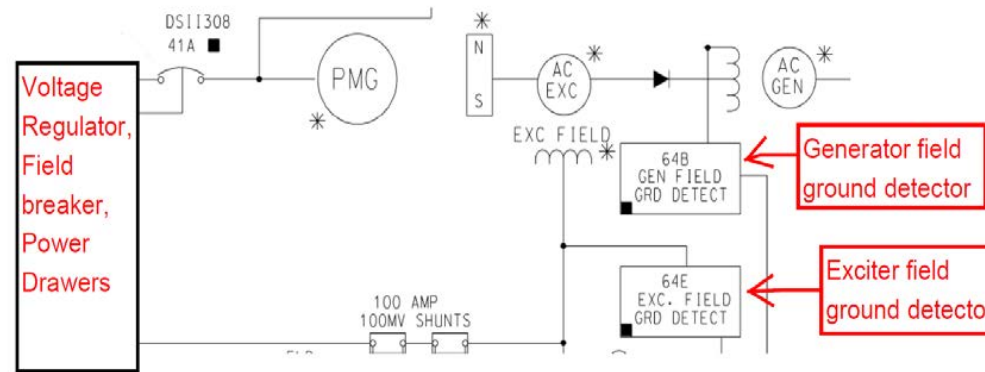
Simplified Drawing of AVR, PMG, and AC Exciter Circuits

- Exciter Field Ground identify small ground which can accelerate over time if undetected and result in catastrophic event like PMG winding fail or exciter stator winding fail. Field Ground provides early detection of degradation of winding insulation in some fault scenario however Exciter Field Ground will not help to identify catastrophic fault on PMG or exciter field winding which do not give enough time for operator action for troubleshoot and analysis.
- Exciter field ground module connects to exciter field terminal of voltage regulator output with ground and provides continuous ground monitoring.

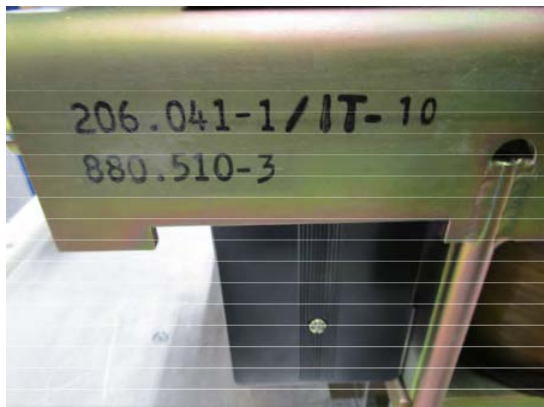
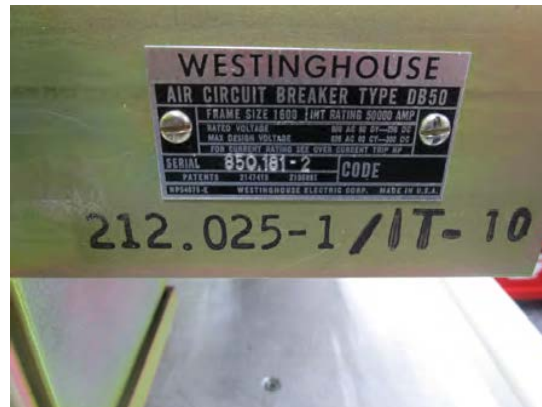
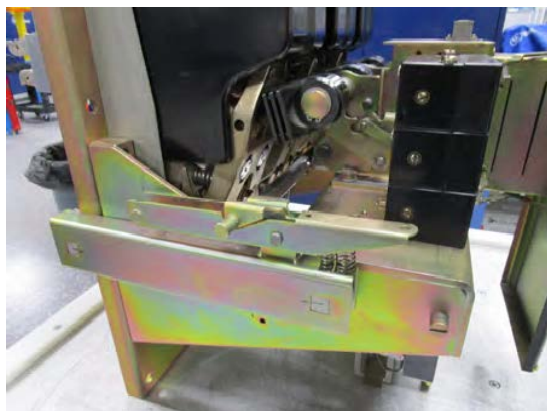
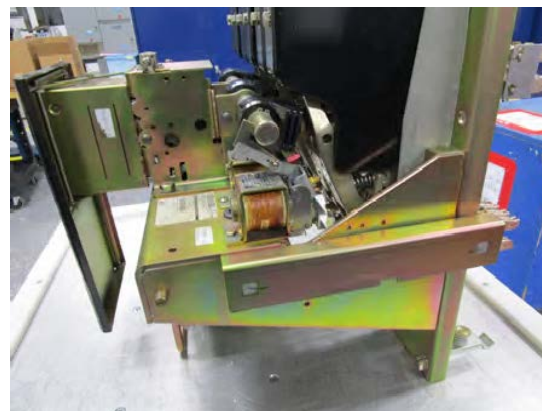
This breaker was received looking as it had just been refurbished, there were no visible areas of concern.

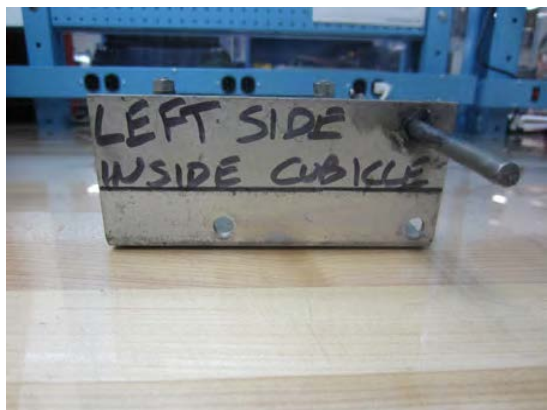
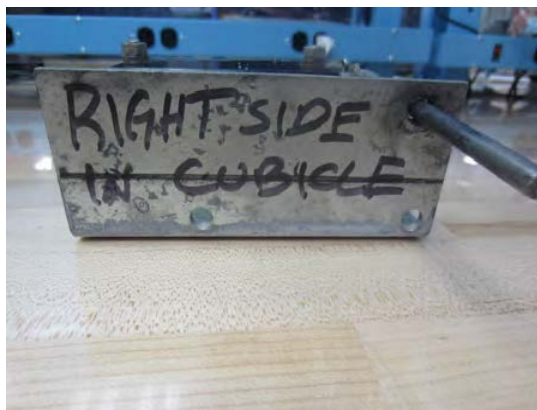
As Received Left-Side Cell Switch

As Received Right-Side Cell Switch

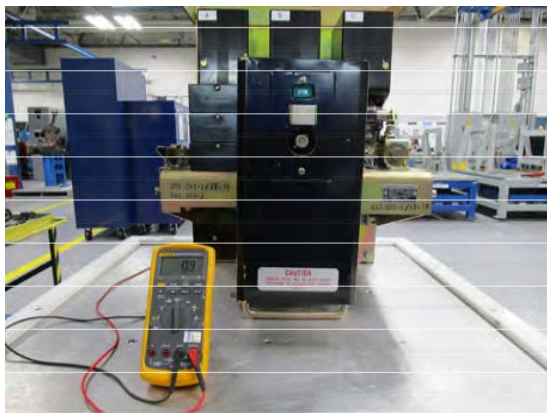
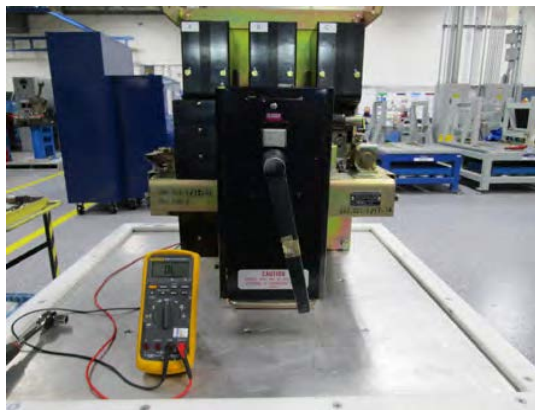
The UVTA reset arm was restrained to allow the breaker to be closed, the breaker was manually closed. These photos show that this NC contact changed state when the breaker was closed. Also verified was that there was no interference from closing the breaker.

Breaker Open, Switch Contact Closed

Breaker Closed, Switch Contact Open

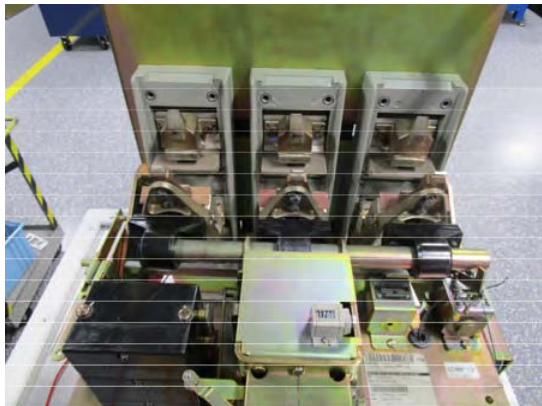
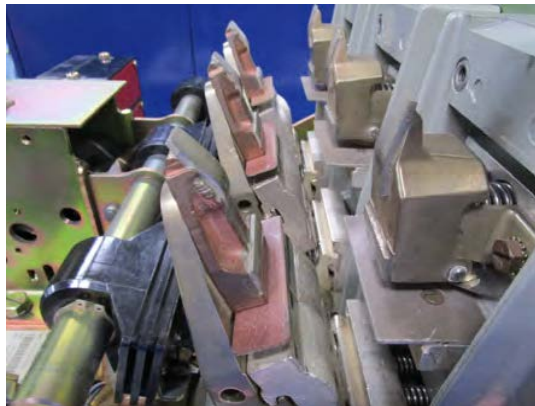
The arc chute assemblies were removed, and no concerns were found. The assemblies were not disassembled at this time.

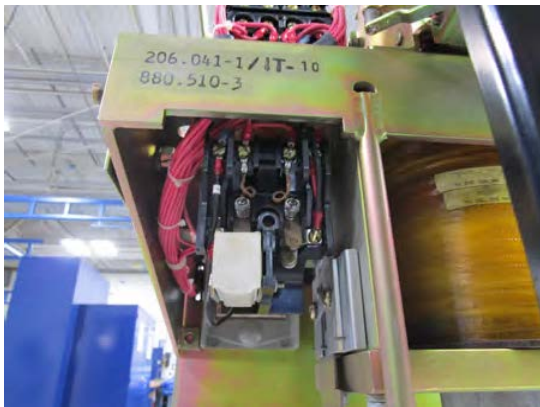
Control Relay with Front Cover Removed

The front cover of the control relay was removed, and the relay was visually inspected, no concerns were found.

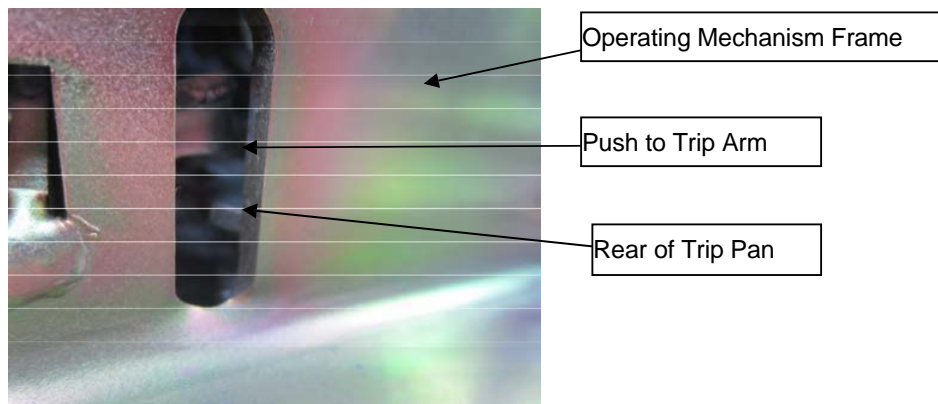
Operating Mechanism Inspection Hole

The face plate was reinstalled onto the breaker operating mechanism so that the gap between the Push to Trip arm and the rear of the operating mechanism trip pan can be verified, as shown below.

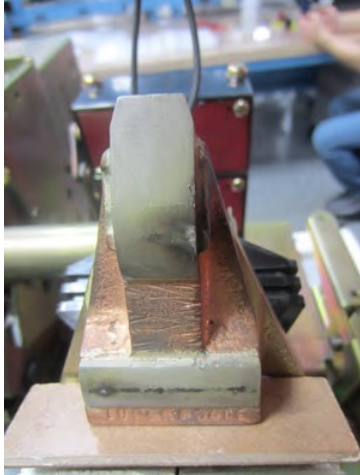
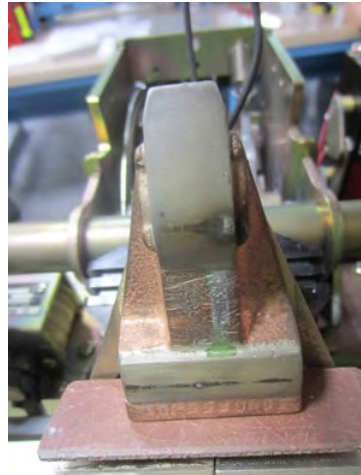
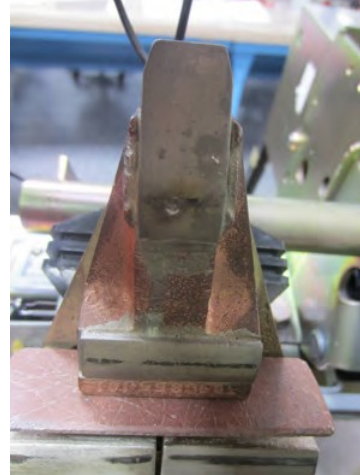
Stationary Arcing Contacts

These values were greater than expected. Photos were taken of these contacts and then the contacts were cleaned with Scotchbrite and isopropyl alcohol. Additional photos were taken to show the cleaned contacts.

After receiving values greater than expected the pole bases will need to be disassembled and cleaned as a standard part of a DB breaker refurbishment. These values are not a concern for the tripping of the breaker, simply that the contacts were slightly oxidized. After applying operating current to the pole bases the oxidation would burn off and the breaker would operate fine.

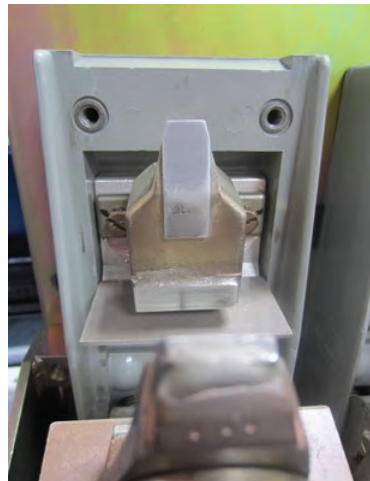
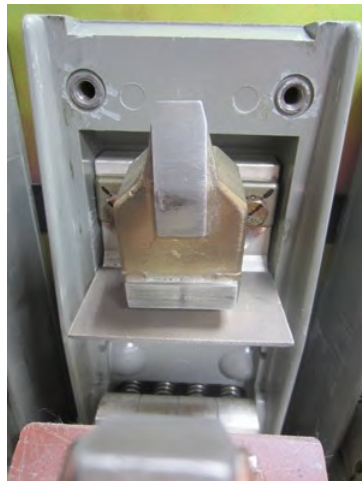
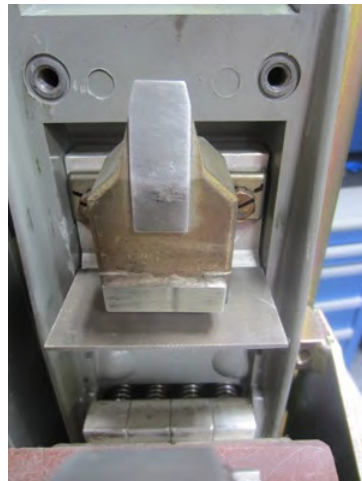
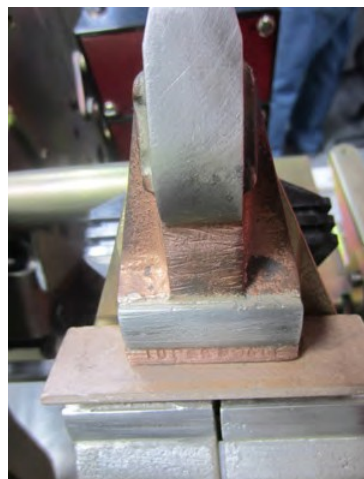
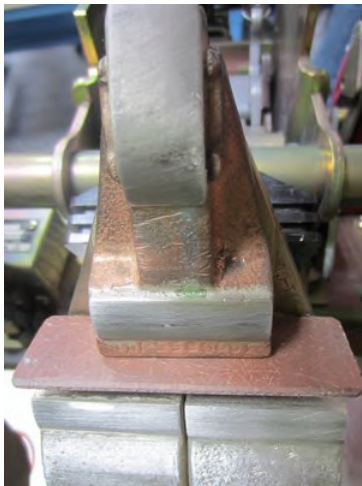
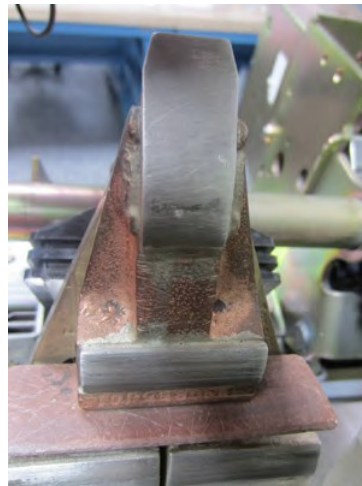
Stationary Arcing Contacts After Cleaning

Cleaned Contacts

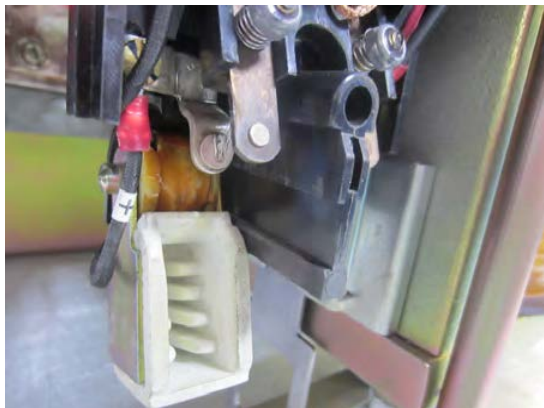
The mechanical set-up of the control relay was verified and the closing solenoid moving core relay release arm was verified to be correct by manually slow closing the breaker and having the closing solenoid relay trip window assembly moving before the operating mechanism pawl drops. The anti-pump function of the relay was verified, and the contact sequence was correct and the contact overtravel was also found to be acceptable.

Control Relay with Arc Chamber Pulled Down The breaker was electrically cycled as outlined here.

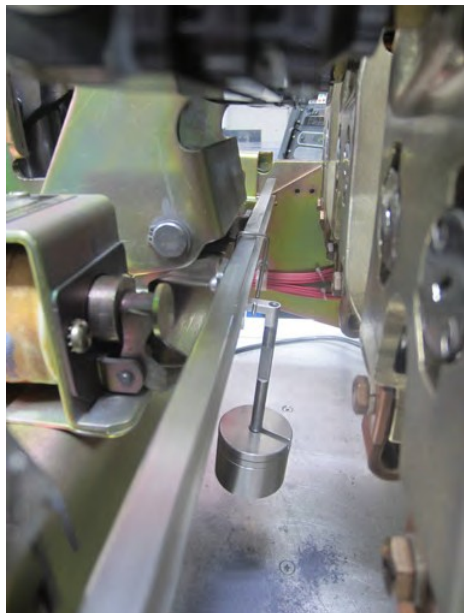
After this weight was established the weight was removed and the breaker was closed with 125 V DC, the weight was added back onto the trip bar and the STA was energized with 69 V DC, thus tripping the breaker showing margin in the weight that the STA is able to pull with the minimum voltage applied. The breaker was successfully tripped 3 times with this setup. A photo has been provided to show the weight hung of the trip bar.

Additional Weight Added to the Operating Mechanism Trip Bar

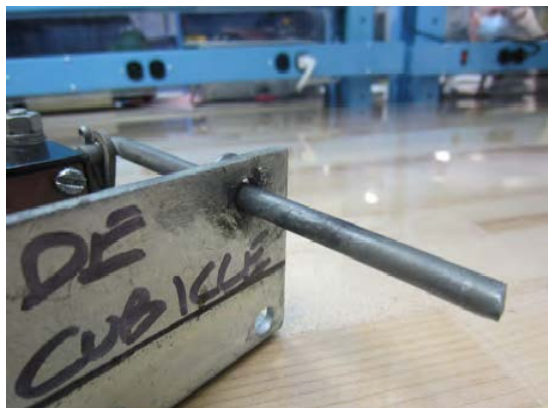
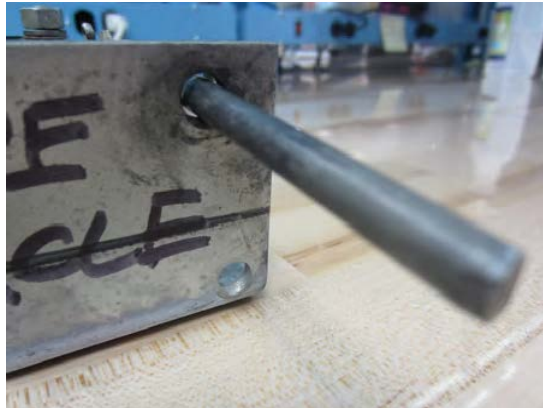
These cell switches were received and looked like they were the original switches provided with the switchgear. The switch plungers were improperly lubricated, and the plunger return spring was not lubricated.

The push rod of the cell switches were lubricated with a foreign lubrication and the return springs were not lubricated with anything. These two locations are to be lubricated with Molybdenum Disulfide in Isopropyl Alcohol (53701GW) lubricant during maintenance intervals.

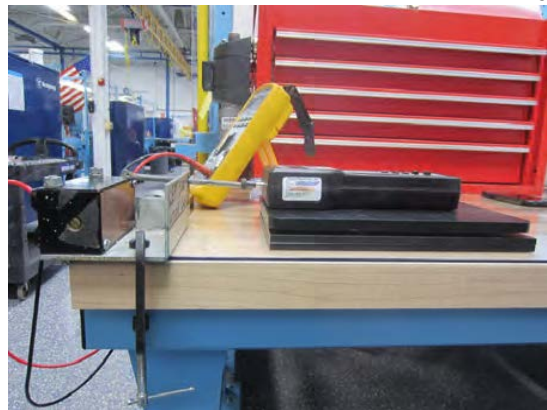
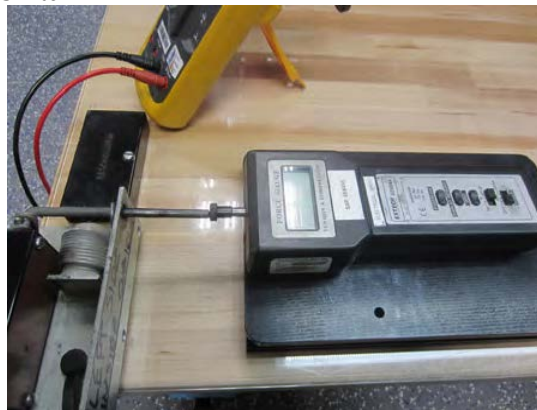
Plunger force testing and distance to change state testing were performed on this switch, the photos provided show the force test setup.

Force Test Set-Up

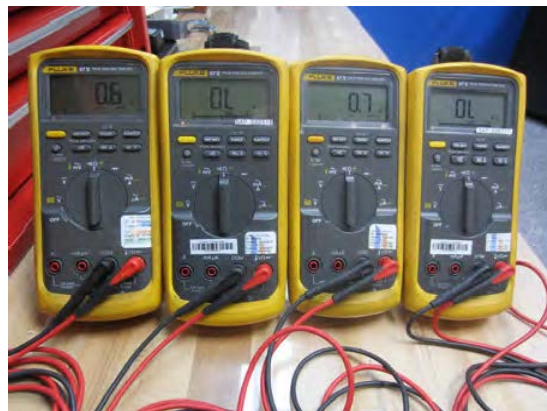
The single contact that was monitored worked 100% of the time. Four multimeters were then connected to each of the 4 switches. The switch was cycled and the switch at the end (switch terminals 7 & 8) remained open in both states of the switch as shown in these photos.

Breaker Open Switch Position
(Plunger Not Actuated)

Breaker Closed Switch Position
(Plunger Actuated)

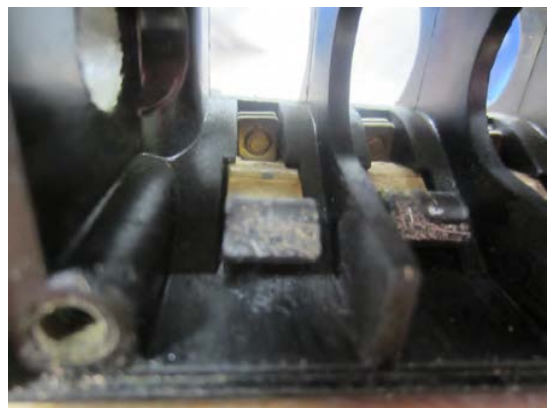
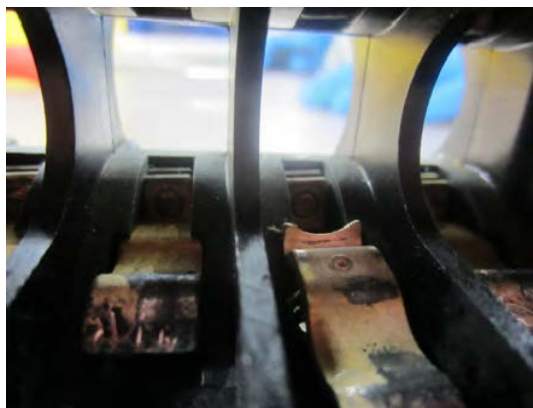
The switch rotors were removed from each of the switches and the bottom stationary contact finger in each case had come loose from the terminal point as shown here (left-hand switch and right)

Right-Side Switch Stationary Contacts

Left-Side Switch Stationary Contacts

Right-Side Switch Stationary Contacts A

The cell switches appeared to be original supplied equipment. They were not properly maintained, and the hardened lubrication could cause the stationary contacts to become dislodged, as documented above. In addition, to contributing to the dislodging the stationary contacts, excess or dry grease can cause improper indications from the switch contacts. This could be considered a possible cause of failure.

If these were the original cell switches that were provided with the switchgear, it is recommended that they be replaced with safety related switch assemblies provided by Westinghouse Electric Company.

In addition, the spring and plunger of the cell switch may be lubricated per the recommendations in the MPM manual, Chapter 9. It is acceptable to apply 53701GW lubricant to the spring during maintenance intervals. Furthermore, the 53701GW lubricant can be applied to the cell switch plunger's penetration point through the mounting plate. The cell switches included in this investigation did not have any lubrication applied to the spring and the plungers were lubricated with a foreign type grease.

It is recommended that all original cell switches be replaced and after the cell switches are replaced that they be maintained to the requirements provided in the Maintenance Program Manual for Westinghouse Safety Related Type DB Circuit Breakers and Associated Switchgear, Revision 1, July 2011.

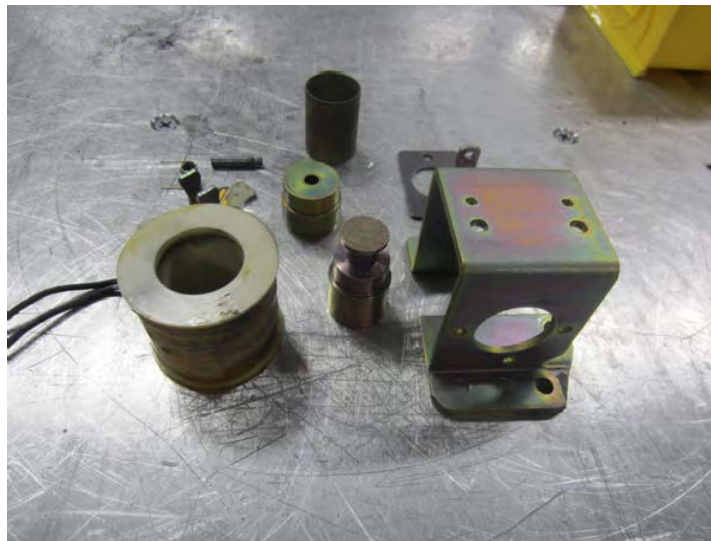
Disassembled STA

The STA was visually inspected and disassembled, no issues were found.

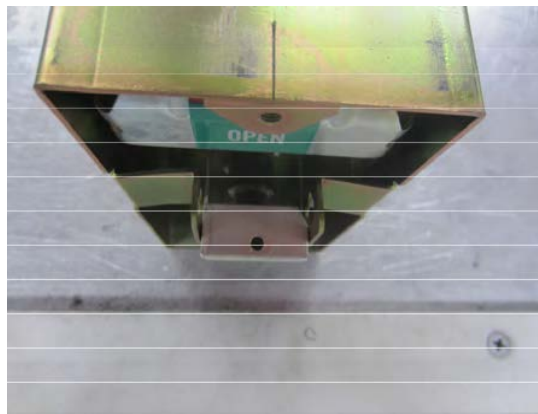
The breaker lock-out tabs on the front of the operating mechanism were found to be slightly bent, however the breaker operated without incident during all mechanical and electrical testing. If these tabs had been bent enough to prevent the Push to Trip button from fully returning to the reset position the linkage within the mechanism could prevent the breaker from closing or could cause a situation that the breaker might close, but not remain closed. These photos show that without the face plate attached to the operating mechanism the Push to Trip button is free to fall below its normal position. This is not a concern as it shows that the tabs are not tight enough to hold the Push to Trip button.

Bent Breaker Lock-Out Tabs

The breaker was received in very good condition and properly lubricated. This breaker as received was acceptable for use. The possible cause of failure could have been the bent breaker lock-out tabs on the front of the operating mechanism, they were found to be slightly bent, however the breaker operated without incident during all mechanical and electrical testing.

It is recommended that the breaker be handled outside the switchgear cubicle with additional care. The breaker lock-out tabs on the front of the operating mechanism can cause the breaker not to function properly. When a breaker is shipped from Westinghouse the breaker lock-out tabs will include an operating mechanism lock-out bar as shown below.

Please remove the Lock-Out Bar before testing and use of the breaker. It is also recommended that all DB breakers receive the attention during maintenance that this breaker has received.

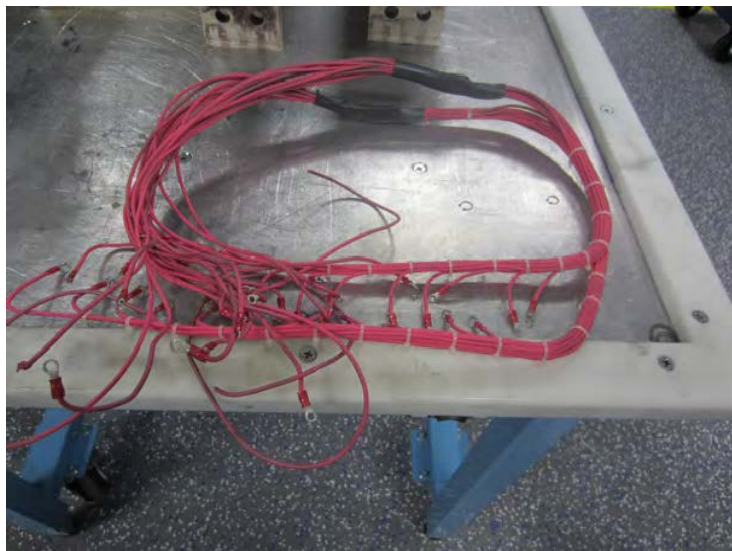
Breaker Wiring Harness

No areas of concern were found with the wiring harness or any of the terminations. 23-
