BEFORE THE FLORIDA PUBLIC SERVICE COMMISSION

In re: Fuel and Purchased Power Cost Recovery
Clause with Generating Performance Incentive
Factor

Docket No. 20220001-EI

**FLORIDA POWER & LIGHT COMPANY'S
MOTION TO STRIKE PORTIONS OF TESTIMONY OF
OFFICE OF PUBLIC COUNSEL WITNESS RICHARD POLICH**

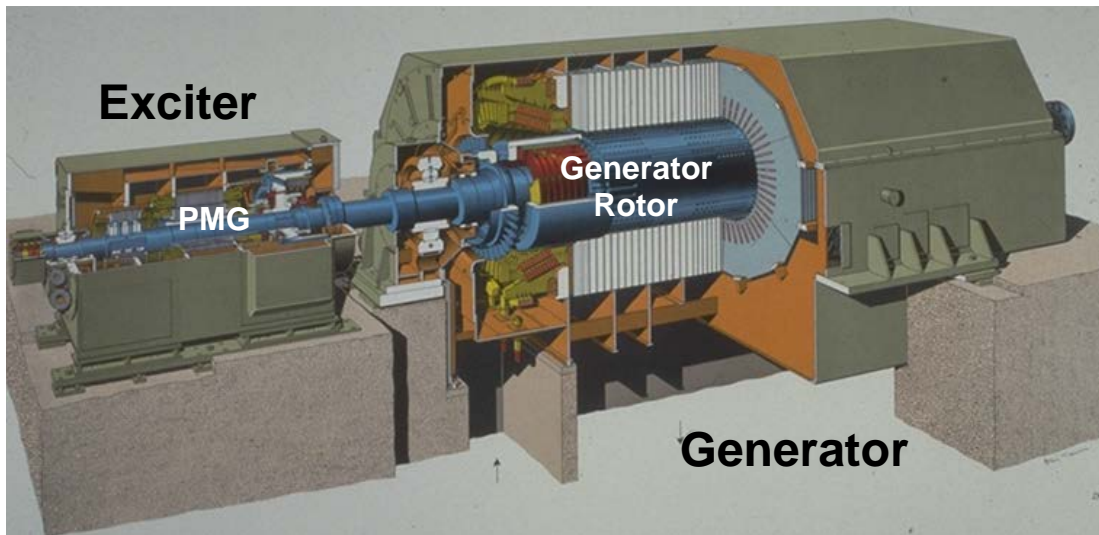
Figure 4 - Generator Exciter Configuration

5 A. The generator exciter creates a DC current by rotating the PMG inside of exciter windings
6 (wire coil). This DC current is fed to the rotor of the synchronous generator to create a
7 magnetic field which is rotated inside the generator to create electricity. The exciter is
8 connected to the generator shaft. The exciter PMG is what initiates the process of
9 energizing the generator for production of electricity. Without the exciter, the generator is
10 a rotating mass and cannot produce power because there is no magnetic field.

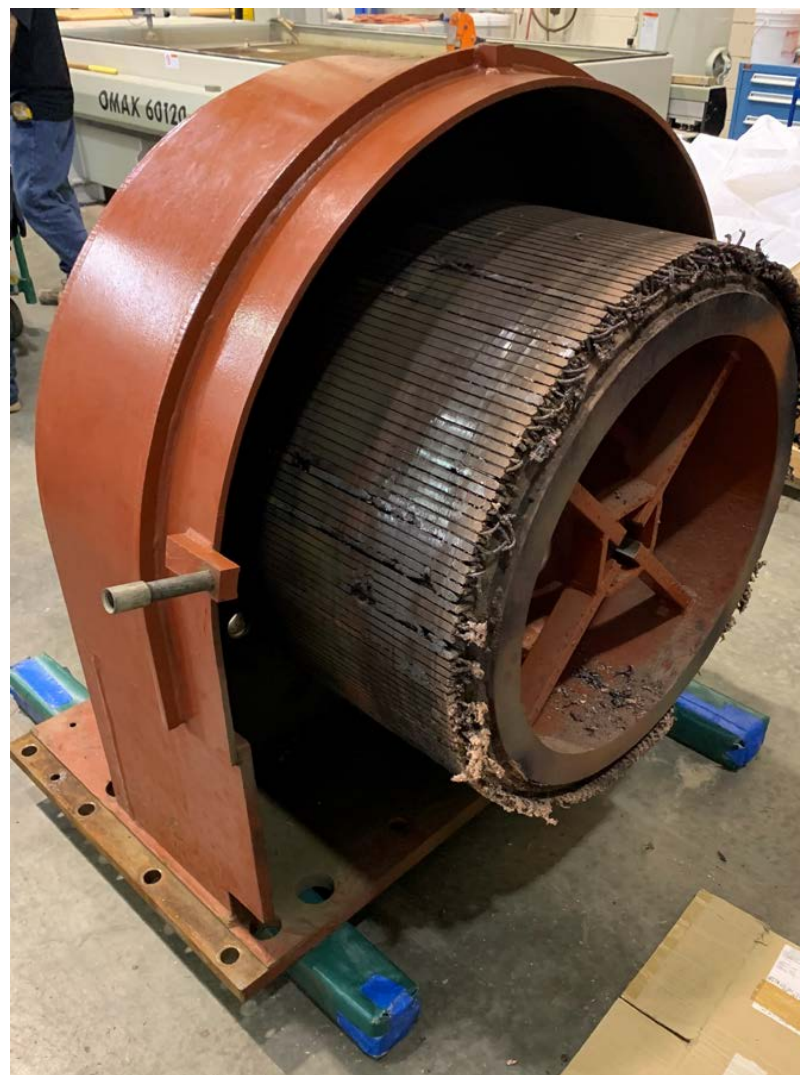
Fig. 5 U4 PMG Stator Removed

3 A. Upon disassembly of the exciter, the investigation revealed water intrusion and found that
4 the PMG was damaged. The root cause team found the failure of the PMG was likely due
5 to a culmination of age-related breakdown of the PMG stator winding insulation, along
6 with water intrusion due to inadequate sealing of the Exciter housing. The RCE claims the
7 overall root casue to be weakness in the Exciter PM program resulted from a failure to fully
8 assess risk of PMG stator winding age, thus making it more susceptible to failure when
9 exposed to water/moisture. Contibuting factors to the failure were found by FPL to inlcude:

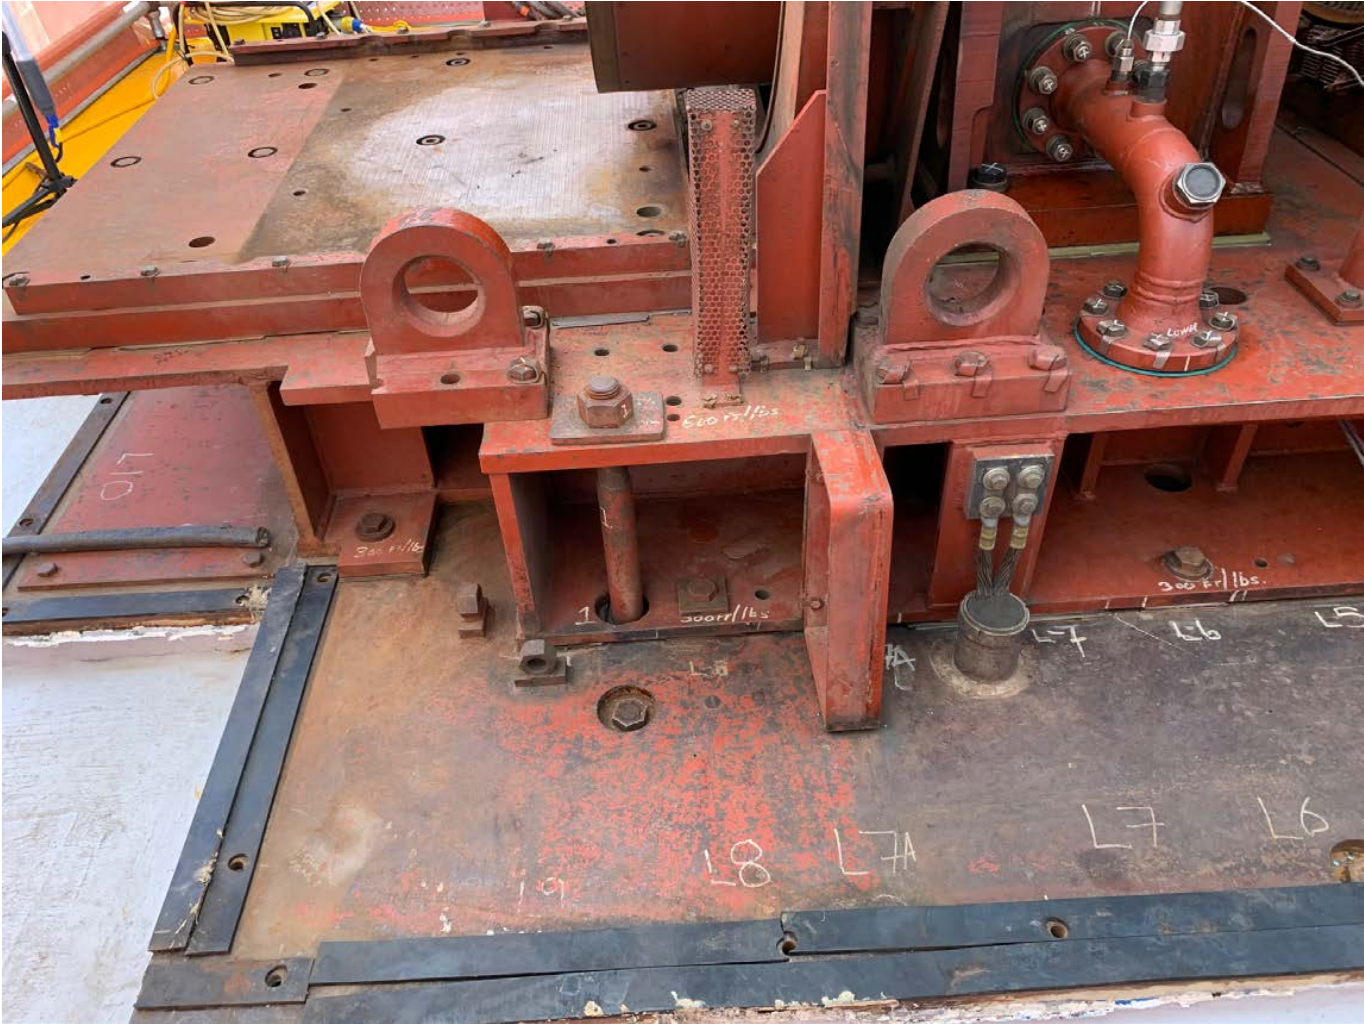
1 inside the PMG and pedestal bolt holes. The following degradation of seals were also
2 discovered:

- 3 1. The partition seal between the AC Exciter compartment and PMG
4 compartment.
- 5 2. Housing floor gaskets which were found dislodged in sections
6 around the perimeter of the PMG compartment.
- 7 3. The site-specific vertical foam weather seal designed under MSP
8 02-055 and required in site procedure 0-GMM-090.1 was not
9 installed.

Fig. 13 Exciter Base to Housing Seal / Gasket Arrangement

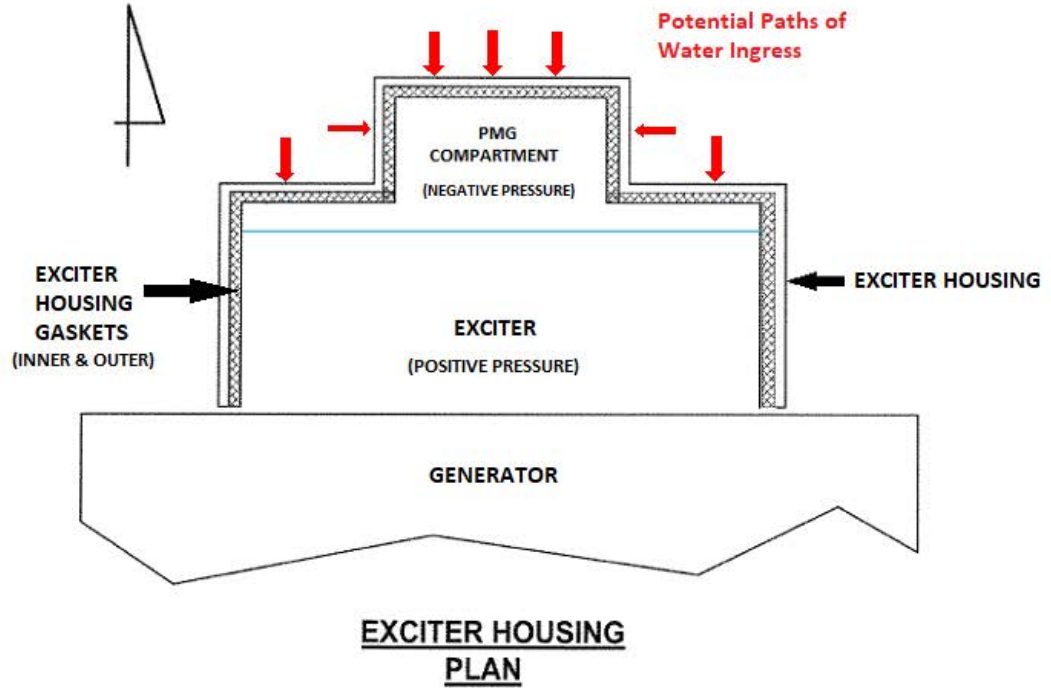
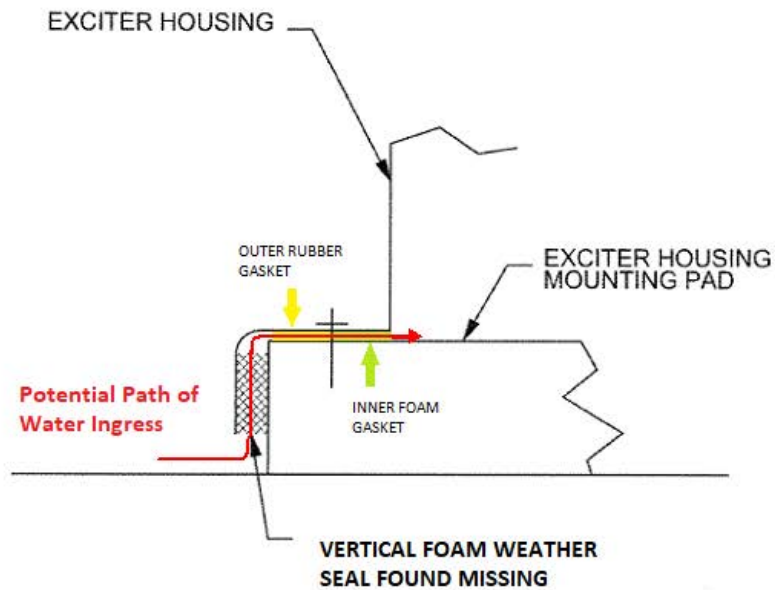
Attachment 9: Potential Paths of Water Ingress

10 As a result, the investigation team determined the most probable path of water ingress was
11 through the missing vertical foam seal and the degraded and dislodged floor gaskets. **The**
12 **RCE concluded that the failure of the PMG stator was due to insulation degradation**
13 **coupled with additional stressors; water intrusion being the likely cause.**

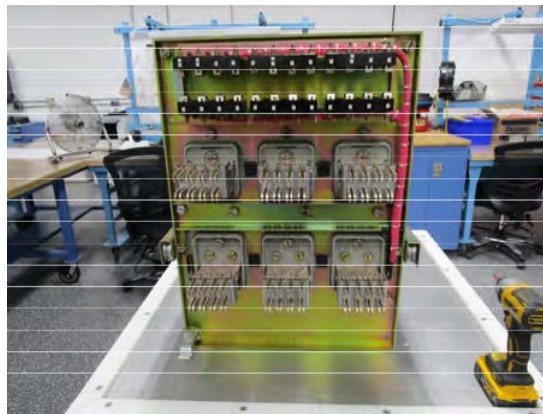
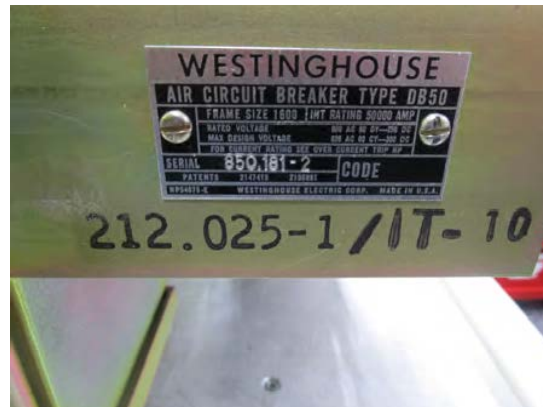
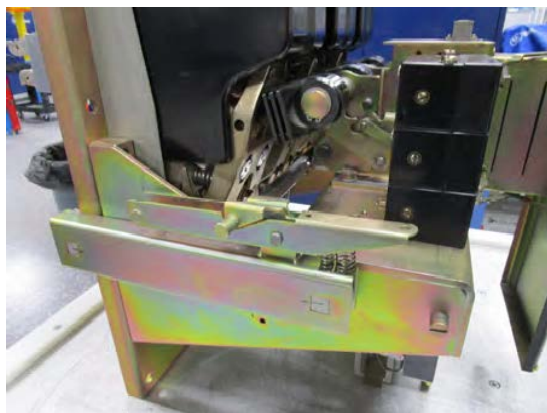
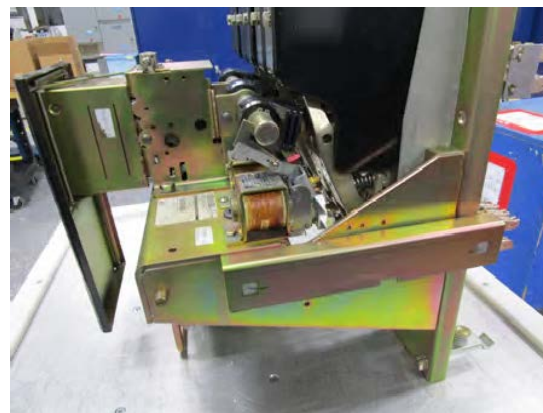
This breaker was received looking as it had just been refurbished, there were no visible areas of concern.

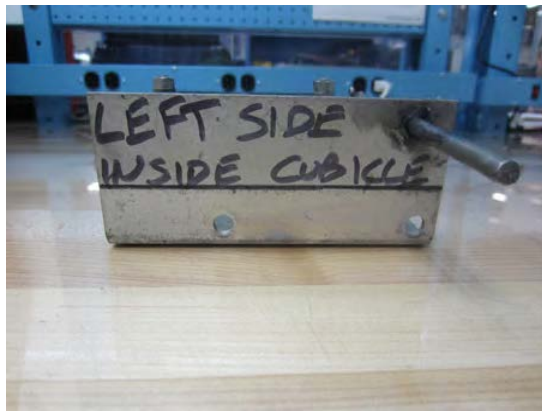
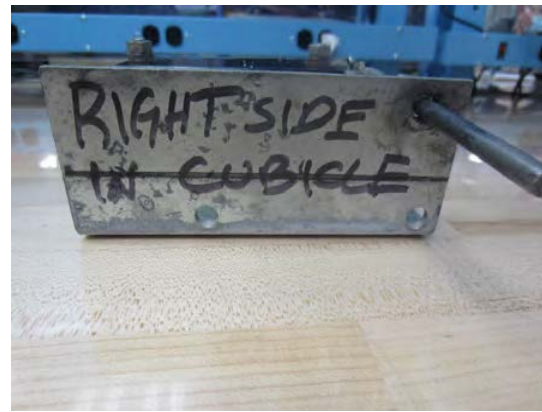
As Received Left-Side Cell Switch

As Received Right-Side Cell Switch

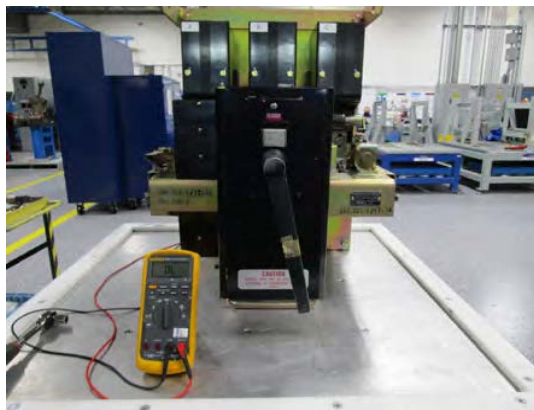
The UVTA reset arm was restrained to allow the breaker to be closed, the breaker was manually closed. These photos show that this NC contact changed state when the breaker was closed. Also verified was that there was no interference from closing the breaker.

Breaker Open, Switch Contact Closed

Breaker Closed, Switch Contact Open

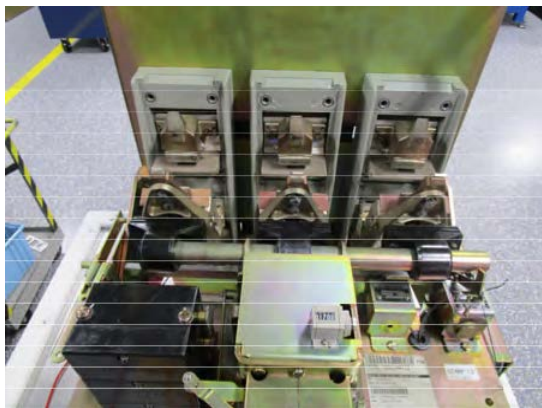
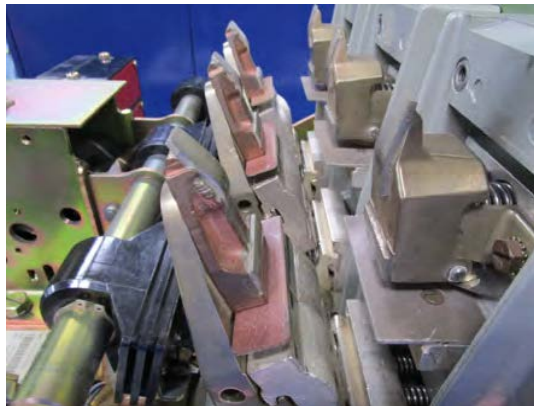
The arc chute assemblies were removed, and no concerns were found. The assemblies were not disassembled at this time.

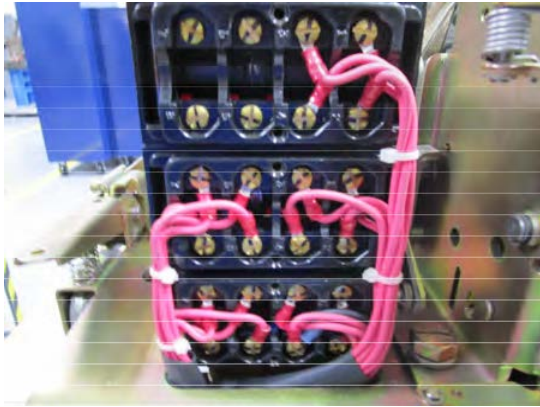
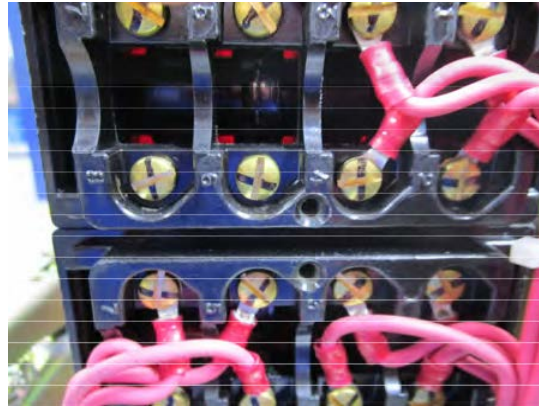
The front auxiliary switch covers were removed, and the switches were visually inspected. No concerns were found, and the switch contacts appeared to be properly lubricated.

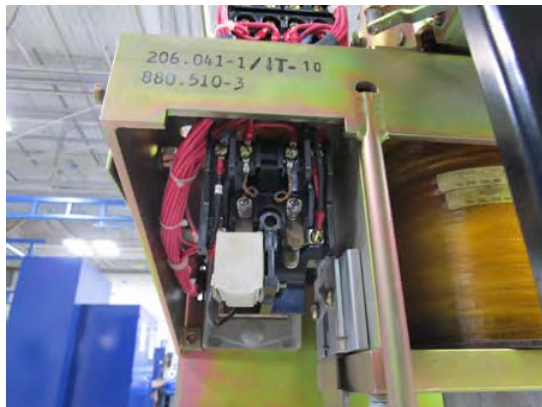
The front cover of the control relay was removed, and the relay was visually inspected, no concerns were found.

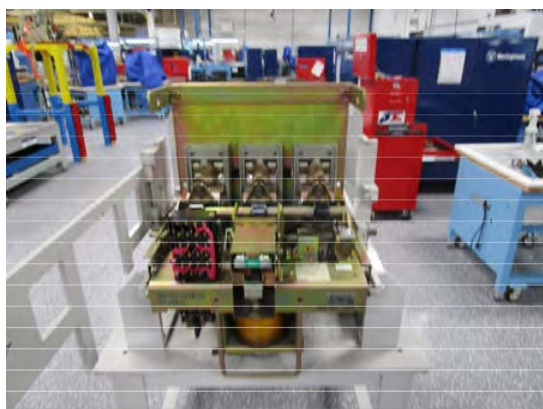
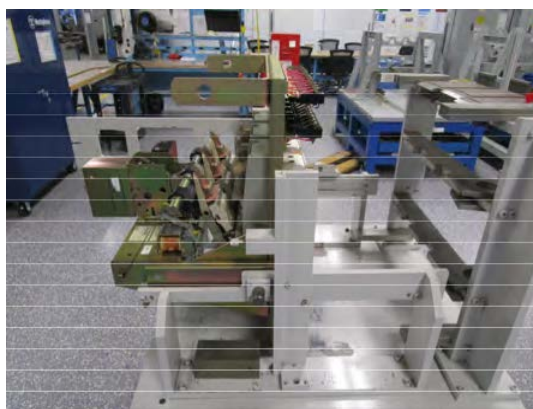
Breaker in Alignment Fixture

The breaker is shown in the alignment fixture. The back panel was properly aligned with the rear stops, the four rollers were all aligned to make contact with the rail assemblies, and the door could be properly closed without interference. The breaker was manually closed, and the DB-50 positioning trip lever trip tab and the operating trip bar gap was verified to be acceptable (0.122”).

The main and secondary contact alignment were verified and found to be acceptable. The alignment fixture door was opened to verify that the breaker would trip open, it did. The auxiliary switches changed state. The breaker was removed and moved to a breaker work cart.

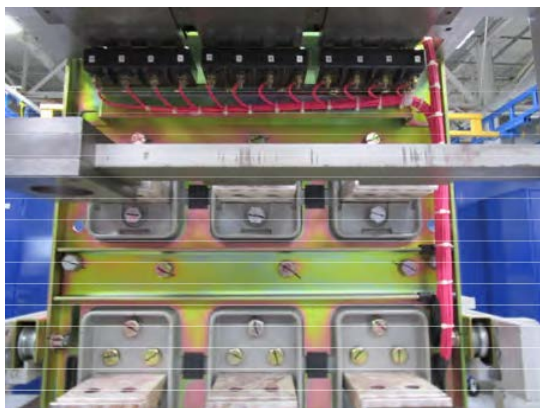
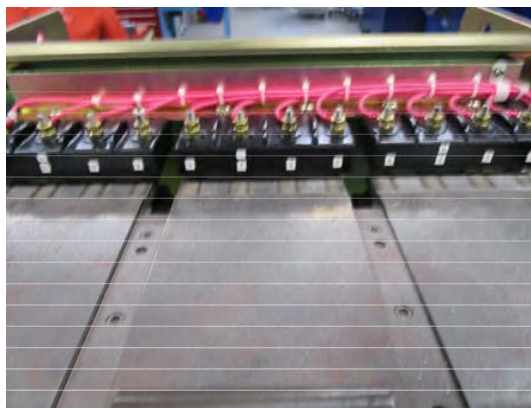
Breaker Stud Alignment

Breaker Secondary Alignment

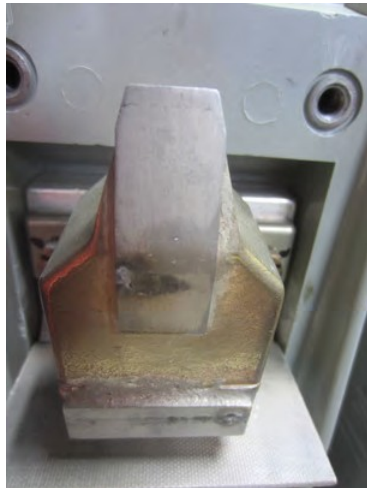
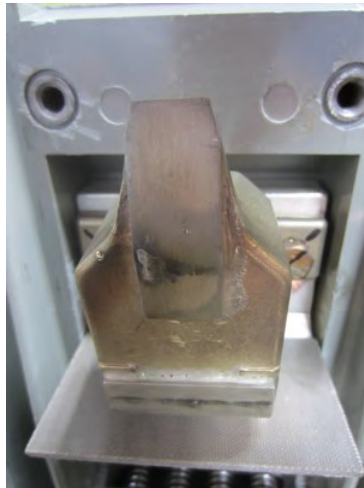
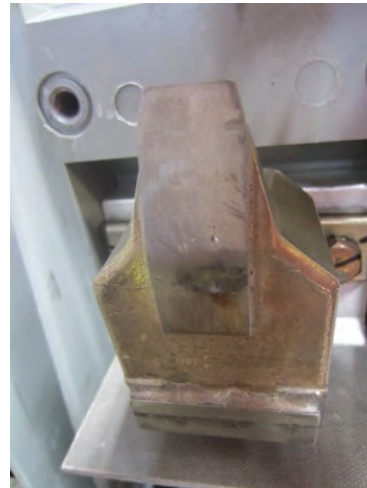
Stationary Arcing Contacts

These values were greater than expected. Photos were taken of these contacts and then the contacts were cleaned with Scotchbrite and isopropyl alcohol. Additional photos were taken to show the cleaned contacts.

After receiving values greater than expected the pole bases will need to be disassembled and cleaned as a standard part of a DB breaker refurbishment. These values are not a concern for the tripping of the breaker, simply that the contacts were slightly oxidized. After applying operating current to the pole bases the oxidation would burn off and the breaker would operate fine.

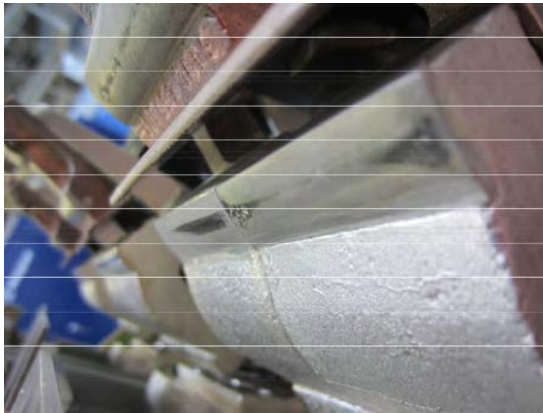
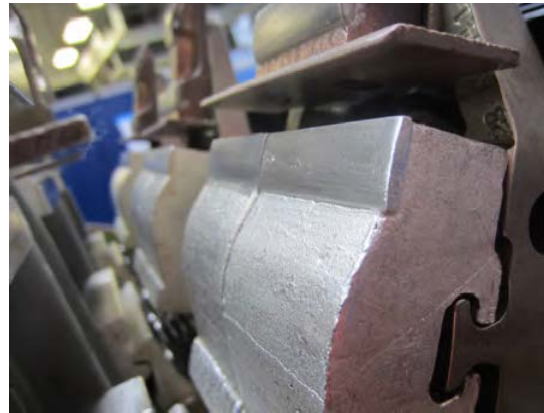
Main Moving Contacts

Before Cleaning

Cleaned Contacts

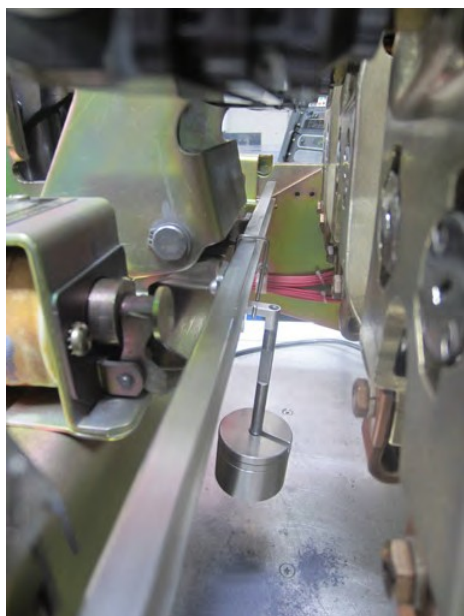
After this weight was established the weight was removed and the breaker was closed with 125 V DC, the weight was added back onto the trip bar and the STA was energized with 69 V DC, thus tripping the breaker showing margin in the weight that the STA is able to pull with the minimum voltage applied. The breaker was successfully tripped 3 times with this setup. A photo has been provided to show the weight hung of the trip bar.

Additional Weight Added to the Operating Mechanism Trip Bar

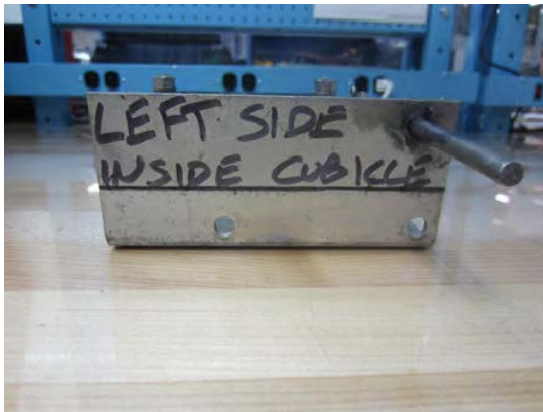
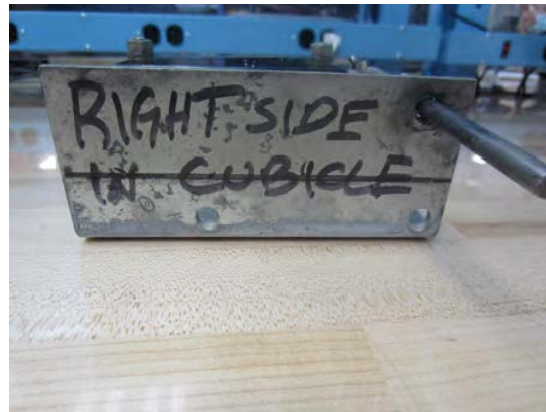
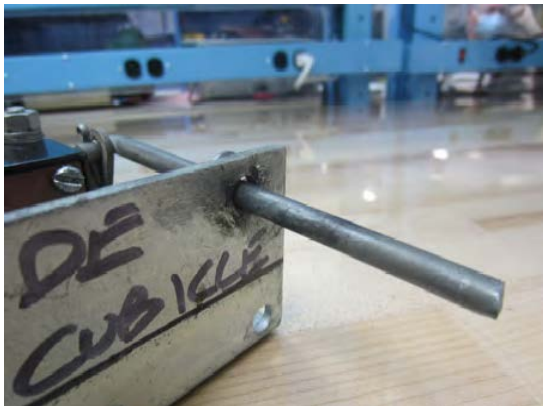
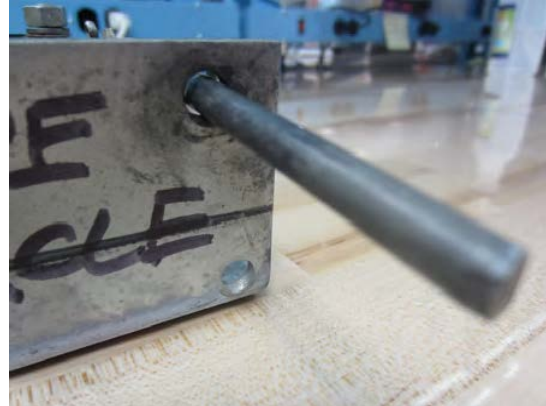
These cell switches were received and looked like they were the original switches provided with the switchgear. The switch plungers were improperly lubricated, and the plunger return spring was not lubricated.

The push rod of the cell switches were lubricated with a foreign lubrication and the return springs were not lubricated with anything. These two locations are to be lubricated with Molybdenum Disulfide in Isopropyl Alcohol (53701GW) lubricant during maintenance intervals.

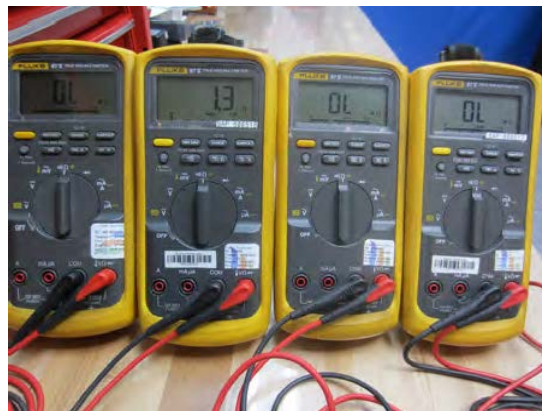
The single contact that was monitored worked 100% of the time. Four multimeters were then connected to each of the 4 switches. The switch was cycled and the switch at the end (switch terminals 7 & 8) remained open in both states of the switch as shown in these photos.

Breaker Open Switch Position
(Plunger Not Actuated)

Breaker Closed Switch Position
(Plunger Actuated)

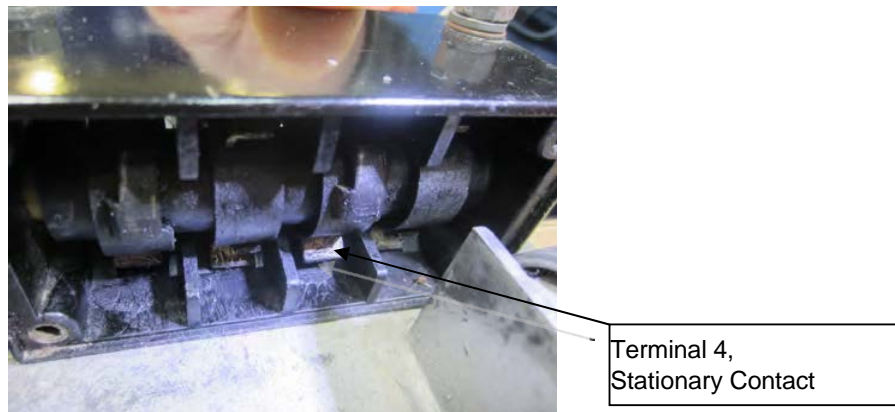
Switch Contact 2, Terminal 4

The rear cover of the switch was removed, the contact rotor can be seen moving. The resistance was then measured between the terminal screws and the stationary contacts. It was a closed circuit between terminal 3 and the top stationary contact, it was an open circuit between terminal 4 and the bottom stationary contact. The switch plunger was cycled 50 times while monitoring the switch contacts. Switch contacts 1, 3 and 4 changed state each time the plunger was cycled. Switch contact 2 (terminals 3 & 4) remained open for each of the cycles. The bottom stationary contact associated with terminal 4 appears to be out of place as seen in the photo below.

If these were the original cell switches that were provided with the switchgear, it is recommended that they be replaced with safety related switch assemblies provided by Westinghouse Electric Company.

It is recommended that all original cell switches be replaced and after the cell switches are replaced that they be maintained to the requirements provided in the Maintenance Program Manual for Westinghouse Safety Related Type DB Circuit Breakers and Associated Switchgear, Revision 1, July 2011.

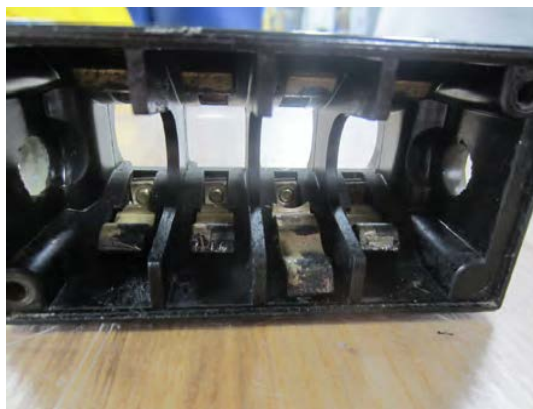
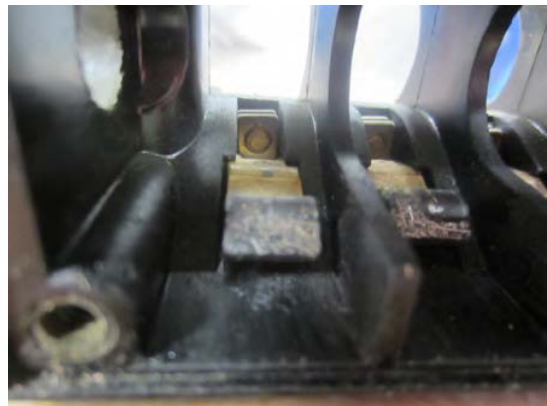
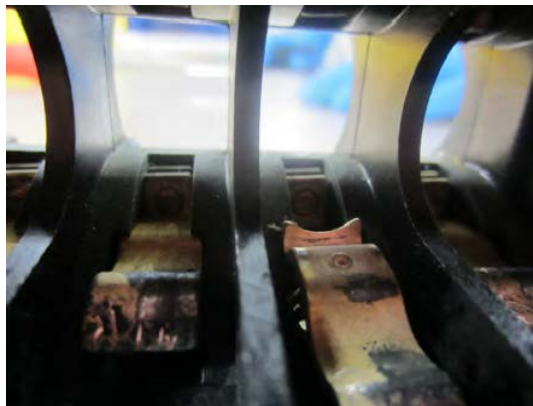
The switch rotors were removed from each of the switches and the bottom stationary contact finger in each case had come loose from the terminal point as shown here (left-hand switch and right)

The cell switches appeared to be original supplied equipment. They were not properly maintained, and the hardened lubrication could cause the stationary contacts to become dislodged, as documented above. In addition, to contributing to the dislodging the stationary contacts, excess or dry grease can cause improper indications from the switch contacts. This could be considered a possible cause of failure.

In addition, the spring and plunger of the cell switch may be lubricated per the recommendations in the MPM manual, Chapter 9. It is acceptable to apply 53701GW lubricant to the spring during maintenance intervals. Furthermore, the 53701GW lubricant can be applied to the cell switch plunger's penetration point through the mounting plate. The cell switches included in this investigation did not have any lubrication applied to the spring and the plungers were lubricated with a foreign type grease.

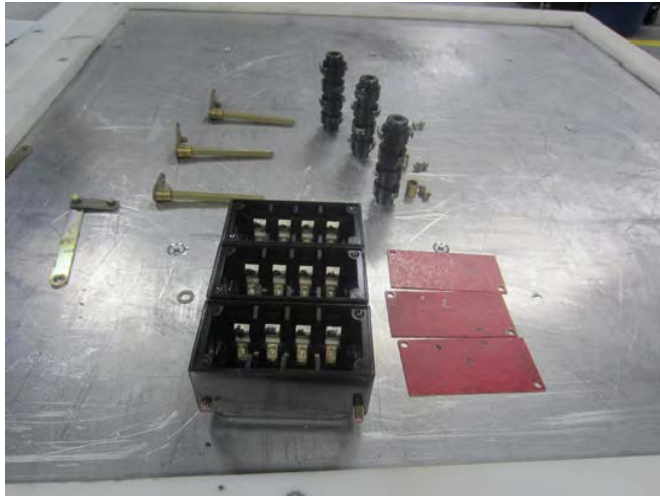
Disassembled Auxiliary Switches No issues were found with the auxiliary switch assembly.

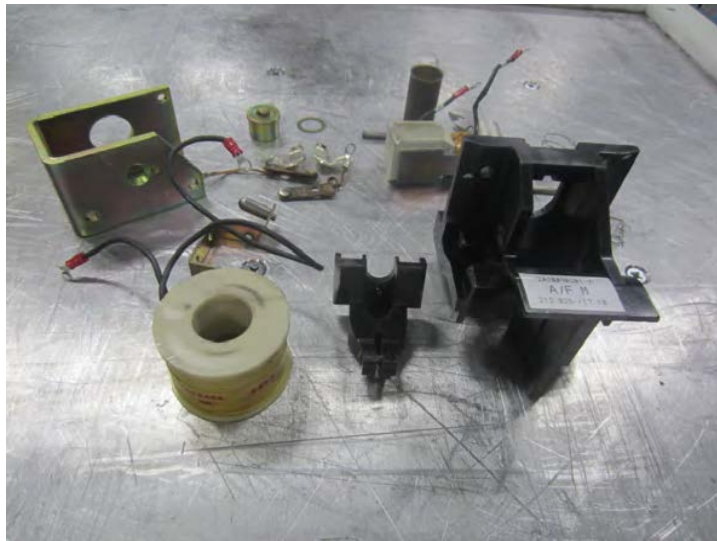
Disassembled Control Relay No issues were found with the control relay assembly.

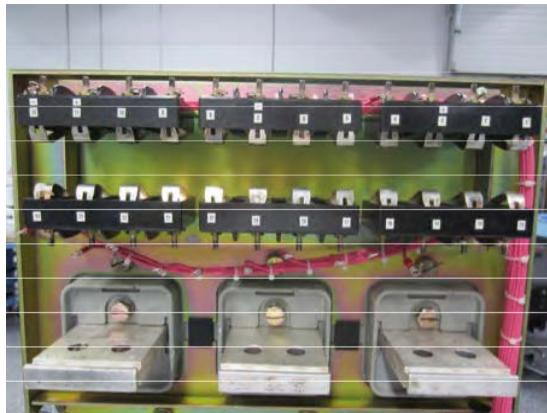
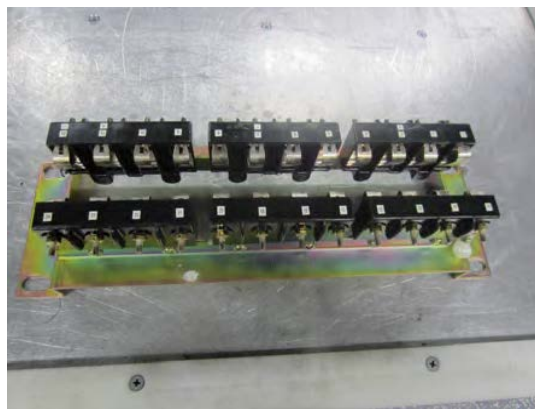
No issues were found with the secondary contact assembly.

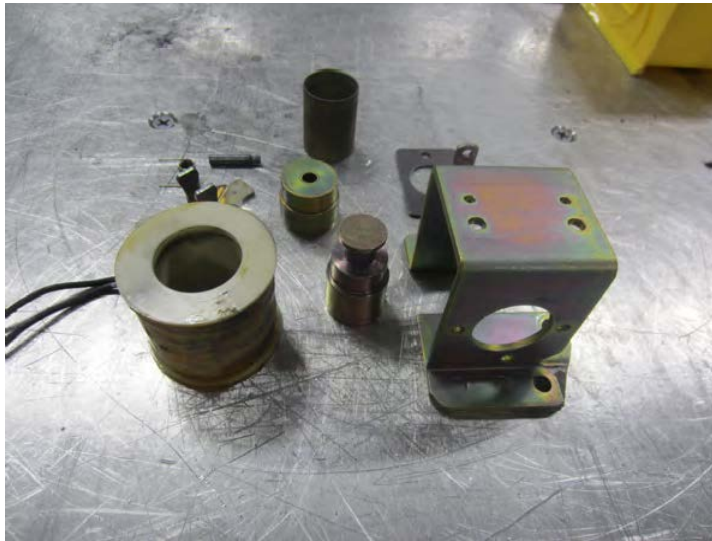
Disassembled STA

The STA was visually inspected and disassembled, no issues were found.

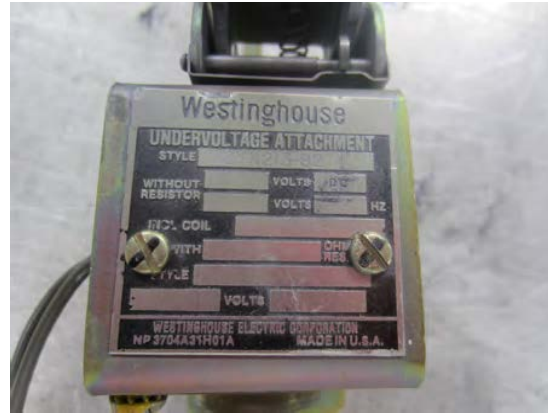
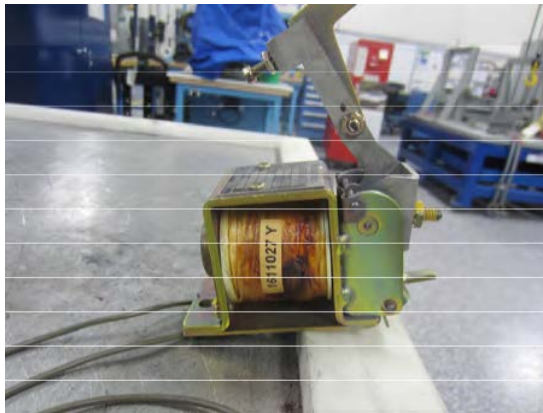
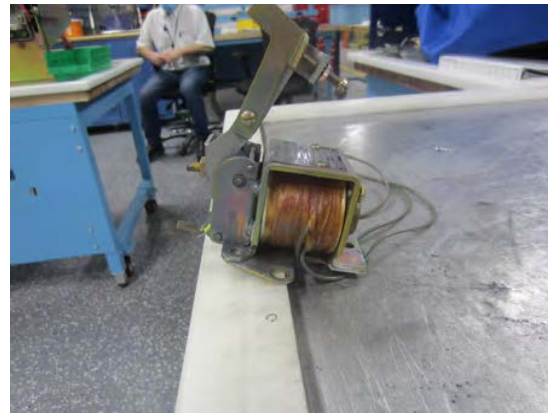
The visual inspection of the UVTA did not provide anything to be concerned about.

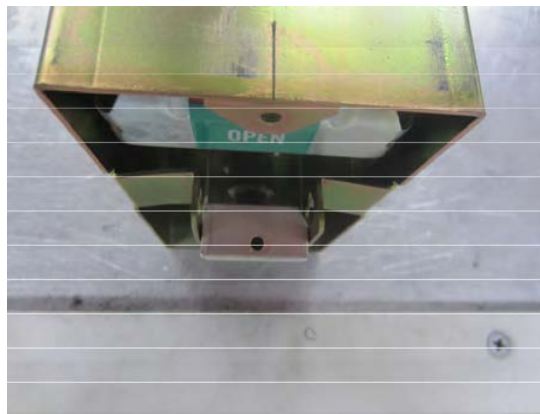
Bent Breaker Lock-Out Tabs

The breaker lock-out tabs on the front of the operating mechanism were found to be slightly bent, however the breaker operated without incident during all mechanical and electrical testing. If these tabs had been bent enough to prevent the Push to Trip button from fully returning to the reset position the linkage within the mechanism could prevent the breaker from closing or could cause a situation that the breaker might close, but not remain closed. These photos show that without the face plate attached to the operating mechanism the Push to Trip button is free to fall below its normal position. This is not a concern as it shows that the tabs are not tight enough to hold the Push to Trip button.

The breaker was received in very good condition and properly lubricated. This breaker as received was acceptable for use. The possible cause of failure could have been the bent breaker lock-out tabs on the front of the operating mechanism, they were found to be slightly bent, however the breaker operated without incident during all mechanical and electrical testing.

It is recommended that the breaker be handled outside the switchgear cubicle with additional care. The breaker lock-out tabs on the front of the operating mechanism can cause the breaker not to function properly. When a breaker is shipped from Westinghouse the breaker lock-out tabs will include an operating mechanism lock-out bar as shown below.

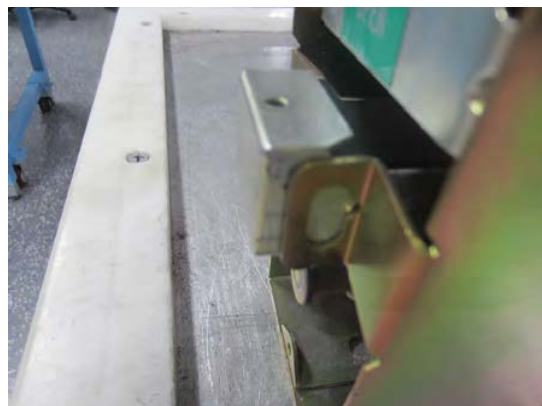
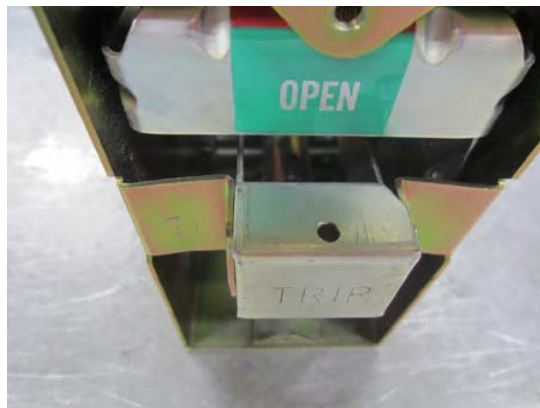
The following photos show the Push to Trip button in its normal position.

In either of these two positions above the Push to Trip lever would not make contact with the rear of the trip pan.

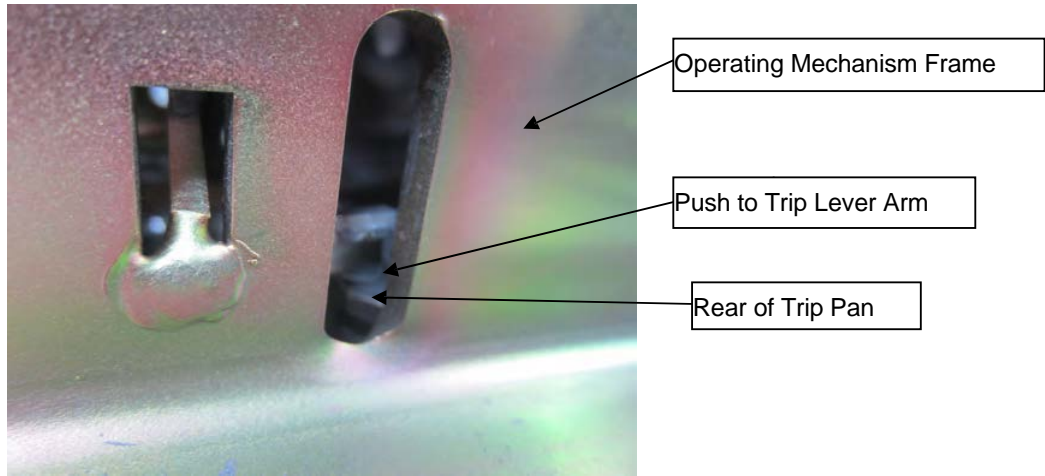
Operating Mechanism Inspection Hole

If the Push to Trip button is held in like shown below, or if the breaker lock-out tabs on the front of the operating mechanism are bent sufficiently to hold this button in the Push to Trip lever would make contact with the rear of the trip pan. This scenario could cause the breaker to be trip free and it would not close, or if the trip pan was only partially held down the breaker may have closed, but the operating mechanism trip faces may not have been completely seated and a shock in the area of the breaker cell could cause the breaker to open. Either of these cases could cause the breaker to open unexpectedly.

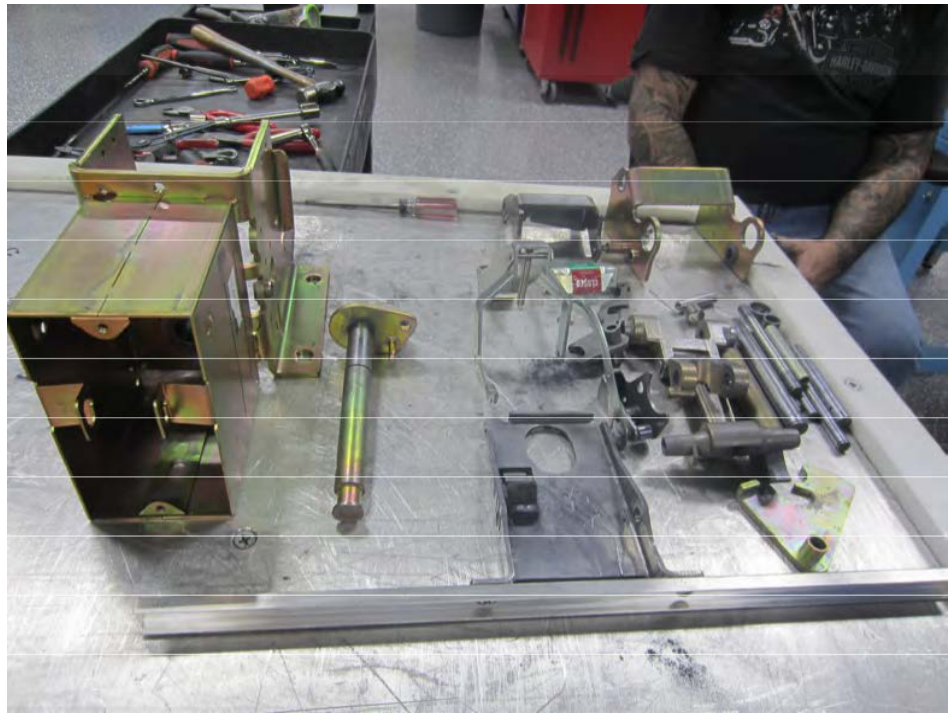
The operating mechanism was disassembled and visually inspected. No issues were found.

Disassembled Operating Mechanism This photo shows the trip pan and the Push to Trip linkage.

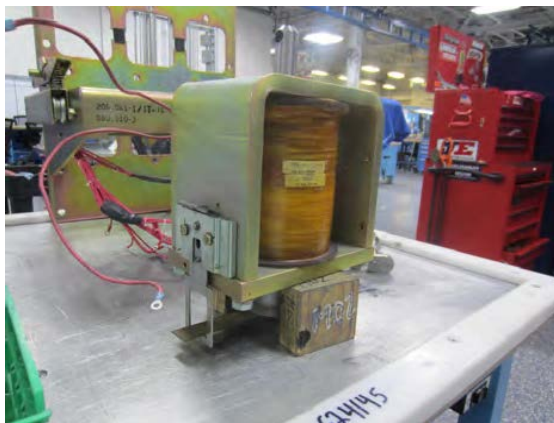
Closing Solenoid Assembly

The closing solenoid was removed, and the closing solenoid relay release window assembly was removed and disassembled.

areas of concern were found with these items.

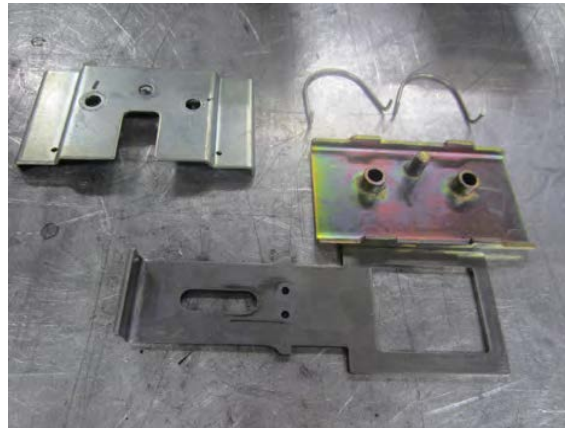
Closing Solenoid Relay Release Window Disassembled No

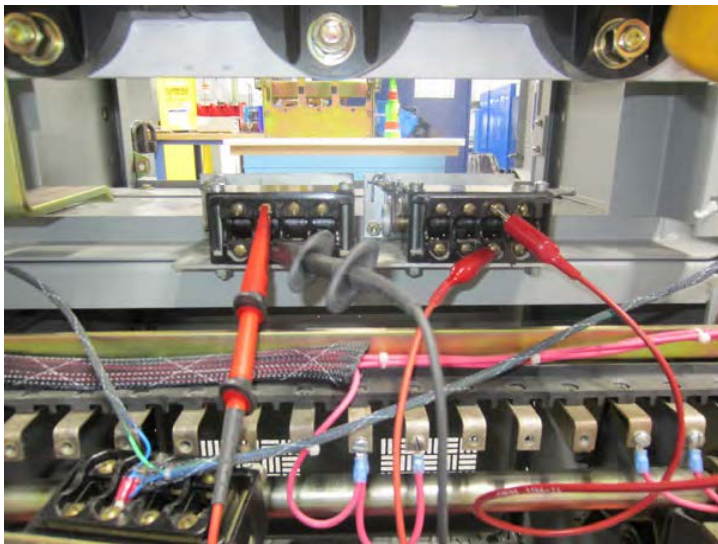
Cell Switch Monitoring Set-up

The Right-Side Switch is monitoring a Normally Open contact on switch terminals 3 and 4. The Left-Side Switch is monitoring a Normally Closed contact on switch terminals 5 and 6.

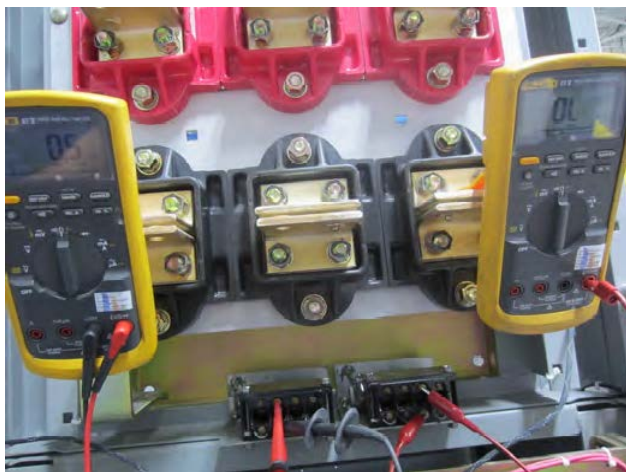
Switch Monitoring Shows a Change of State
