Review of

Florida's
Investor-Owned
Electric Utilities

Service Reliability reports

Florida Public Service Commission
Division of Safety, Reliability & Consumer Assistance

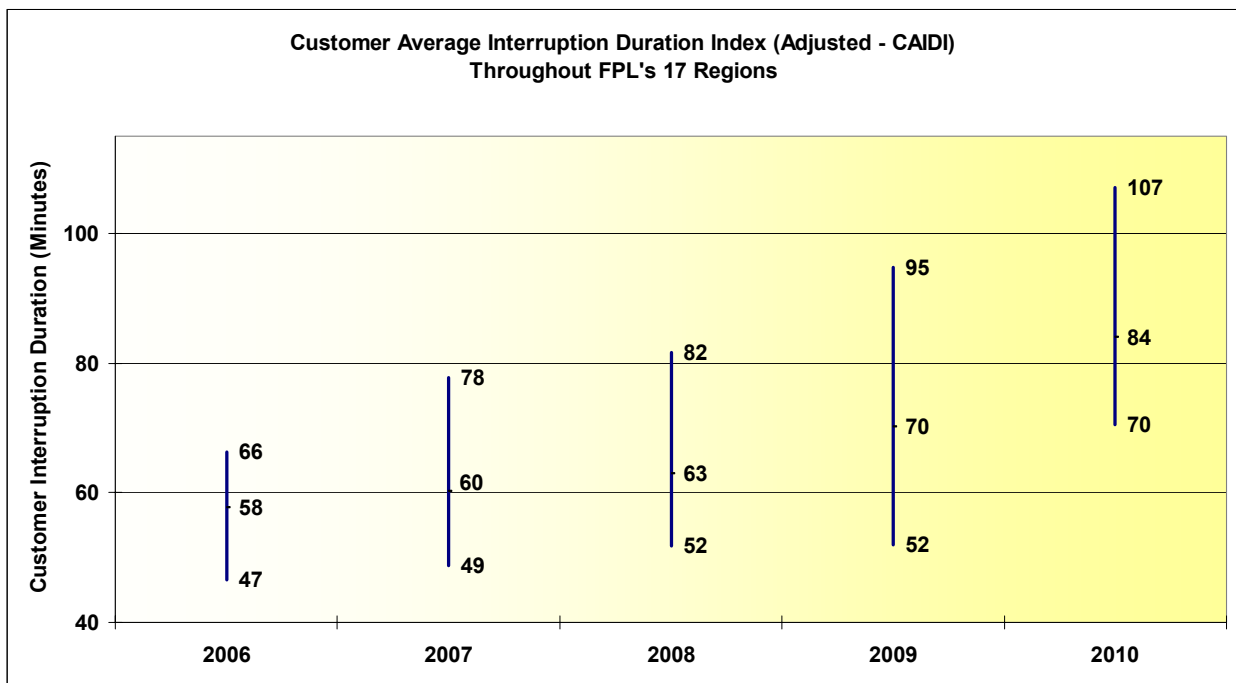
Figure 3-3. CAIDI across FPL's 17 Regions (Adjusted)

Figure 3-3 is a chart of FPL’s highest, average, and lowest customer interruption duration indexes expressed in minutes. FPL’s adjusted average CAIDI (Customer Average Interruption Duration Index) has risen approximately 20 percent from 70 minutes in 2009, to 84 minutes in 2010. The average duration of CAIDI, or the average number of minutes a customer is without power when a service interruption occurs, is trending upwards. For 2010, the Brevard service area reported the lowest duration of CAIDI, which was 70 minutes; however, the lowest CAIDI for 2010, is 35 percent higher than the Boca Raton service area, reported as 52 minutes in 2009.

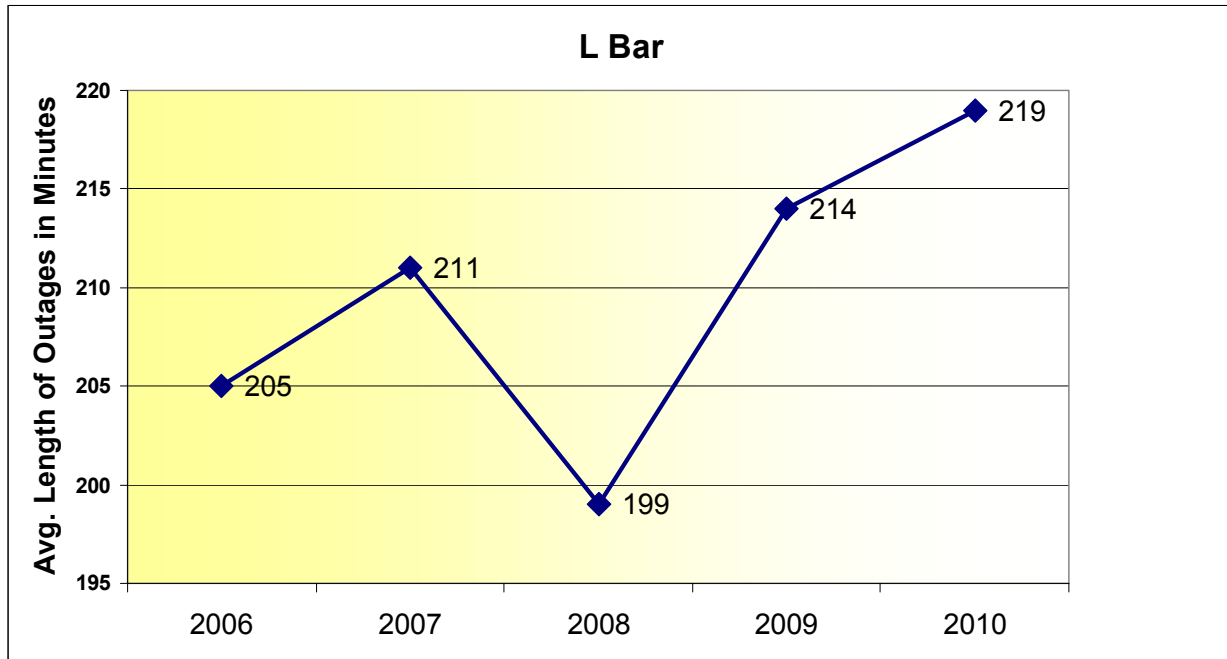
Figure 3-4. FPL's Average Duration of Outages (Adjusted)

Figure 3-4 depicts the average length of time that FPL spends recovering from outage events, excluding hurricanes and other extreme outage events and is the index known as L-Bar (Average Service Restoration Time). FPL had a two percent increase in L-Bar (the time required to restore service) from 214 minutes in 2009, to 219 minutes in 2010, which represents the highest average duration of outages since 2006. The L-Bar measures the average length of time of a single service interruption. The IEEE standard for calculation of L-Bar is the summation of the minutes of interruption divided by the total number of outages.

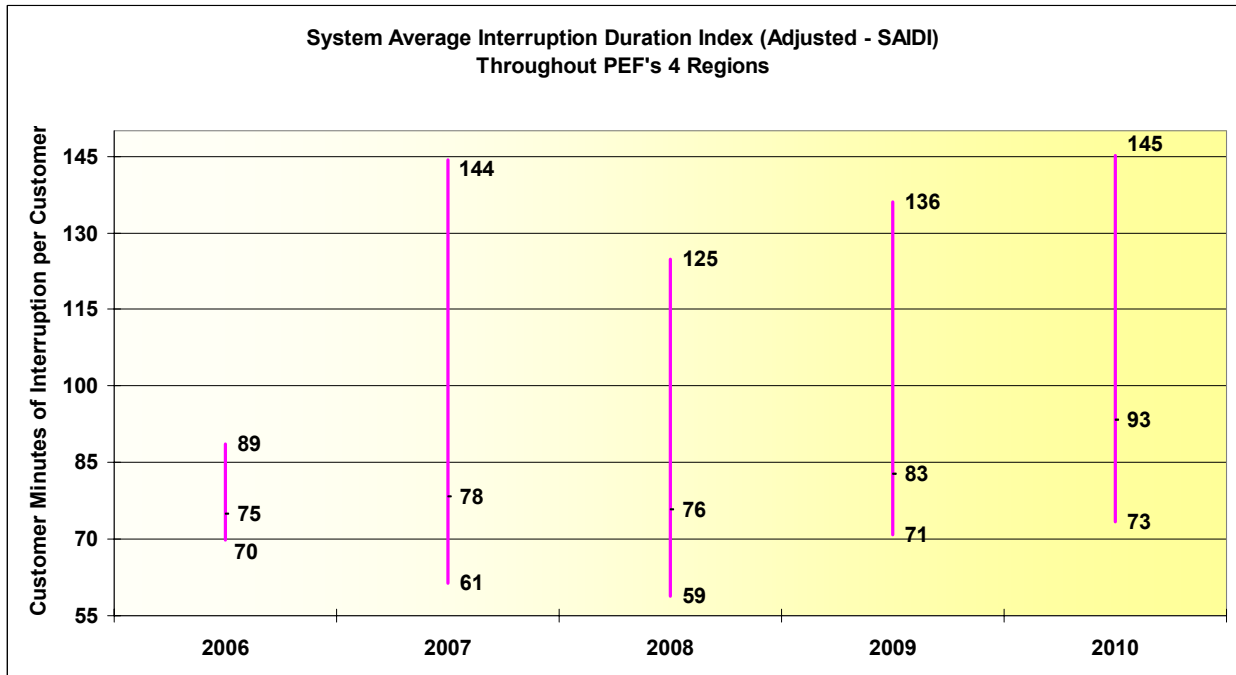
Figure 3-9. SAIDI across PEF's Four Regions (Adjusted)

Figure 3-9 charts the adjusted SAIDI recorded across PEF’s system and depicts an increase in the highest, average, and lowest values for 2010. PEF notes that in 2010, two tornadoes and one named storm affected its service territory. Only 2.5 SAIDI minutes were excluded due to the weather events. The adjusted SAIDI for 2010 was reported as 93.3 minutes. PEF notes that it continues to focus on “reliability projects including, but not limited to, small wire upgrades, storm hardening, and pole replacements.”

Figure 3-9 illustrates that the North Coastal region continue to report the poorest SAIDI over the last five years, fluctuating between 89 minutes and 145 minutes. While the South Coastal and South Central regions have the best or lowest SAIDI for the same period. PEF’s service territory is comprised of four regions: North Coastal, South Coastal, North Central, and South Central.

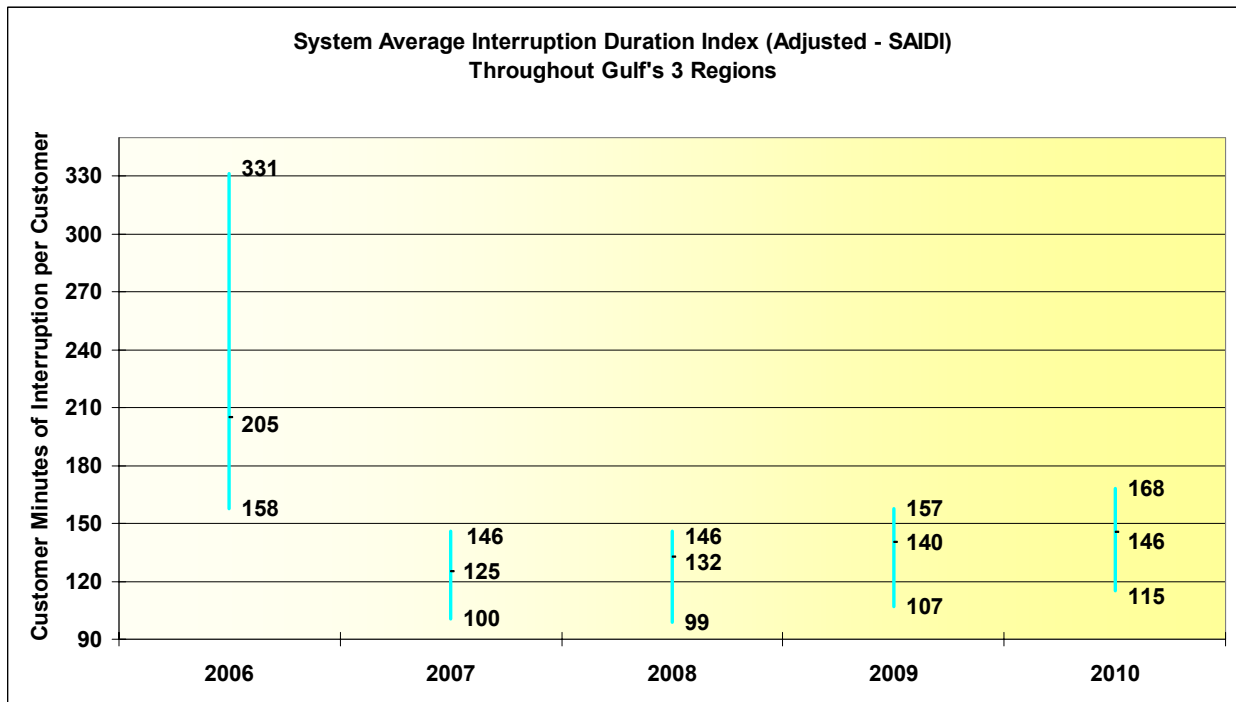
Figure 3-25. SAIDI across Gulf’s Three Regions (Adjusted)

Figure 3-25 illustrates Gulf’s SAIDI minutes, or the interruption duration minutes on a system basis. The chart depicts an increase in the average SAIDI value by 6 minutes in Gulf’s combined regions over the 2009 results. Gulf’s 2010 average performance was 4 percent worse than the 2009 SAIDI results. Gulf reported there was an extreme January weather event that was not excludable because it was not a named storm or NWS recordable tornado. The total SAIDI impact for this significant event was 7.43 minutes, which would have resulted in a Gulf adjusted SAIDI of 138 minutes instead of the reported 146 minutes. Even though the average SAIDI value increased this year, it appears that the maximum, minimum, and average SAIDI indexes are trending downward, showing improvements.

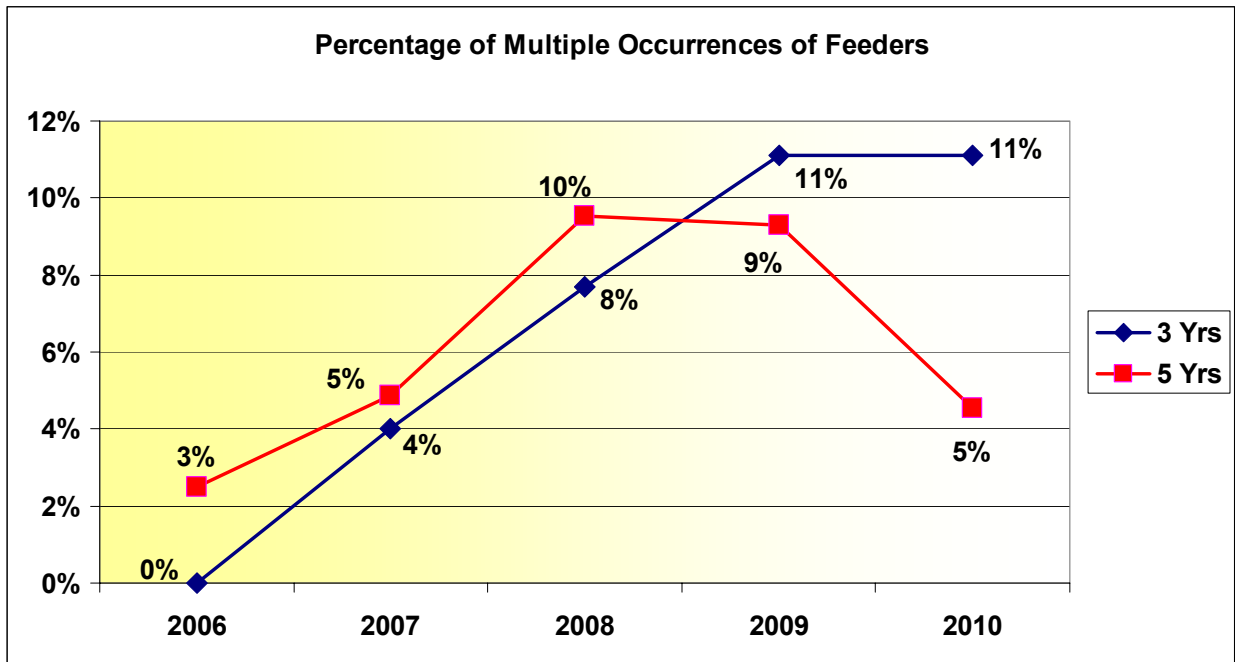
Figure 3-31. Gul f’s Three Percent Feeder Report t (Adjusted)

Figure 3-31 shows the multiple occurrences of feeders using the utility’s Three Percent Feeder Report and is analyzed on a three-year and five-year basis. The five-year multiple occurrences analysis showed a decrease from the prior trend, which implies improving performance. The Three Percent Feeder Report is a listing of the top three percent of feeders that have the most feeder outage events. The supporting data illustrates that the five-year multiple occurrences have dropped from 9 percent to 5 percent from 2009 to 2010 as the three-year multiple occurrences remained steady at 11 percent. Even though the five-year multiple occurrences showed an improving performance for the two-year period from 2009 to 2010, the five-year period of 2006 to 2010 indicates overall that the five-year index is trending upward. The three-year multiple occurrences index appears to be trending upward as well.

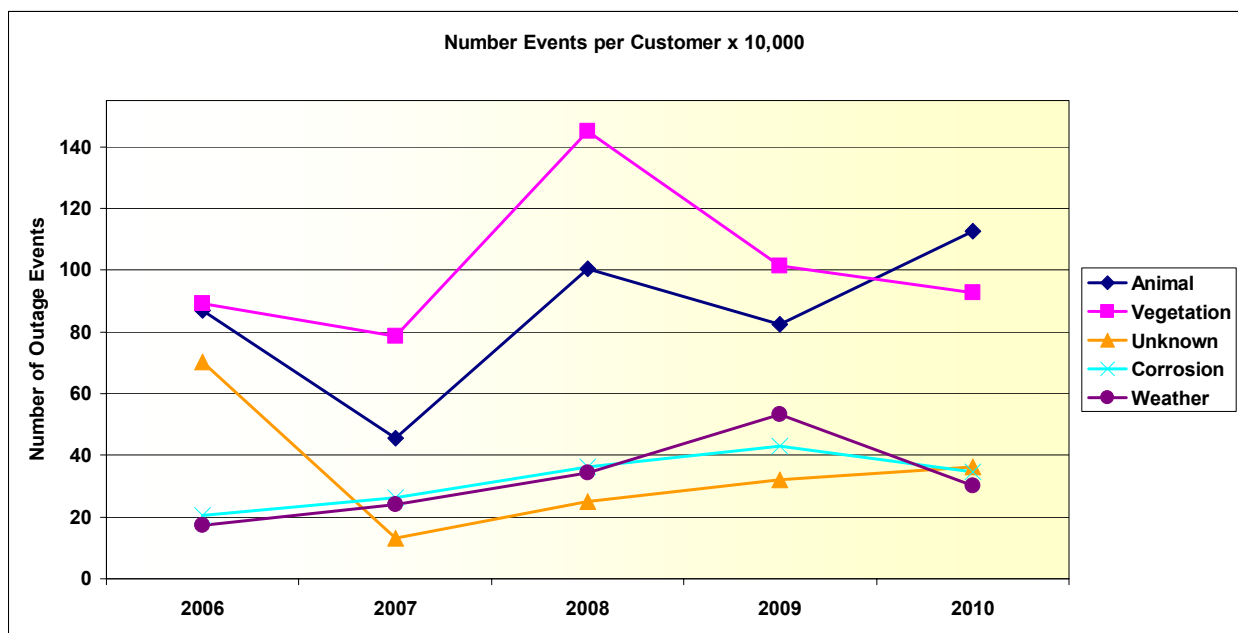
Figure 3-37. FPUC's Top Five Outage Causes (Adjusted)

Figure 3-37 shows the top five causes of outage events on FPUC’s distribution system normalized to a 10,000-customer base. The figure is based on FPUC’s adjusted data of the top ten causes of outage. For the five-year period, the top five causes of outage events were animal (31 percent), vegetation (26 percent), unknown (10 percent), corrosion (10 percent), and weather (8 percent). These five factors represent 84.9 percent of the total adjusted outage causes in 2010. Four of the five-outage causes are trending upward. The four causes are animal, vegetation, corrosion, and weather. Vegetation, corrosion, and weather outages did decrease from 2009 to 2010, even though they are trending upward. Animal and unknown outages increased 36 percent and 12 percent, respectively, from 2009 to 2010. Even though the unknown caused outages increased from 2009 to 2010, it is still trending downward.

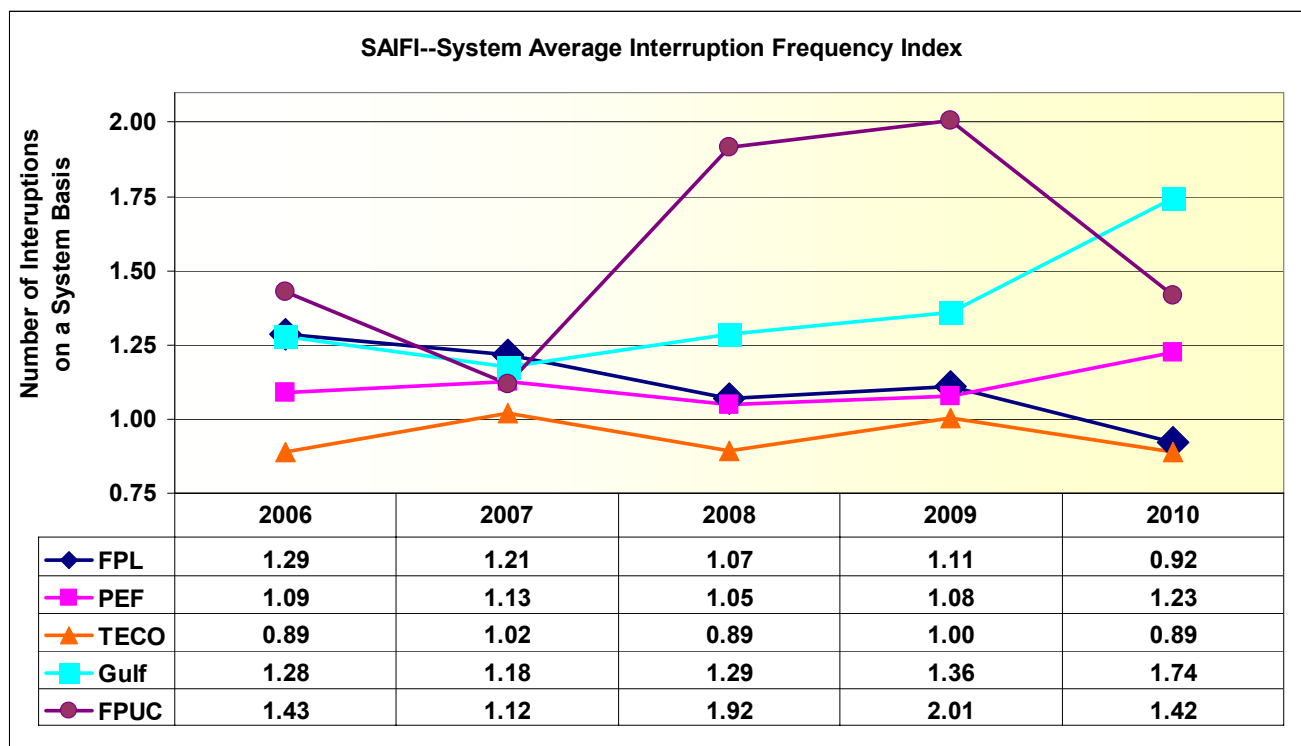
Figure 4-2. Number of Service Interruptions (Adjusted SAIFI)

Figure 4-2 is a five-year graph of the adjusted SAIFI (System Average Interruption Frequency Index) for each IOU. The 2010 data shows FPL and FPUC's SAIFI indices decreased (improved) from the 2009 results. TECO's indices fell as well, but appear cyclical per the yearly data. Gulf's and PEF's SAIFI metrics trended upward.

System Average Interruption Frequency Index (SAIFI) is the average number of service interruptions per retail customer within a specified area of service over a given period. It is determined by dividing the Sum of Service (aka Customer) Interruptions (CI) by the total Number of Customers Served (C) for the respective area of service.

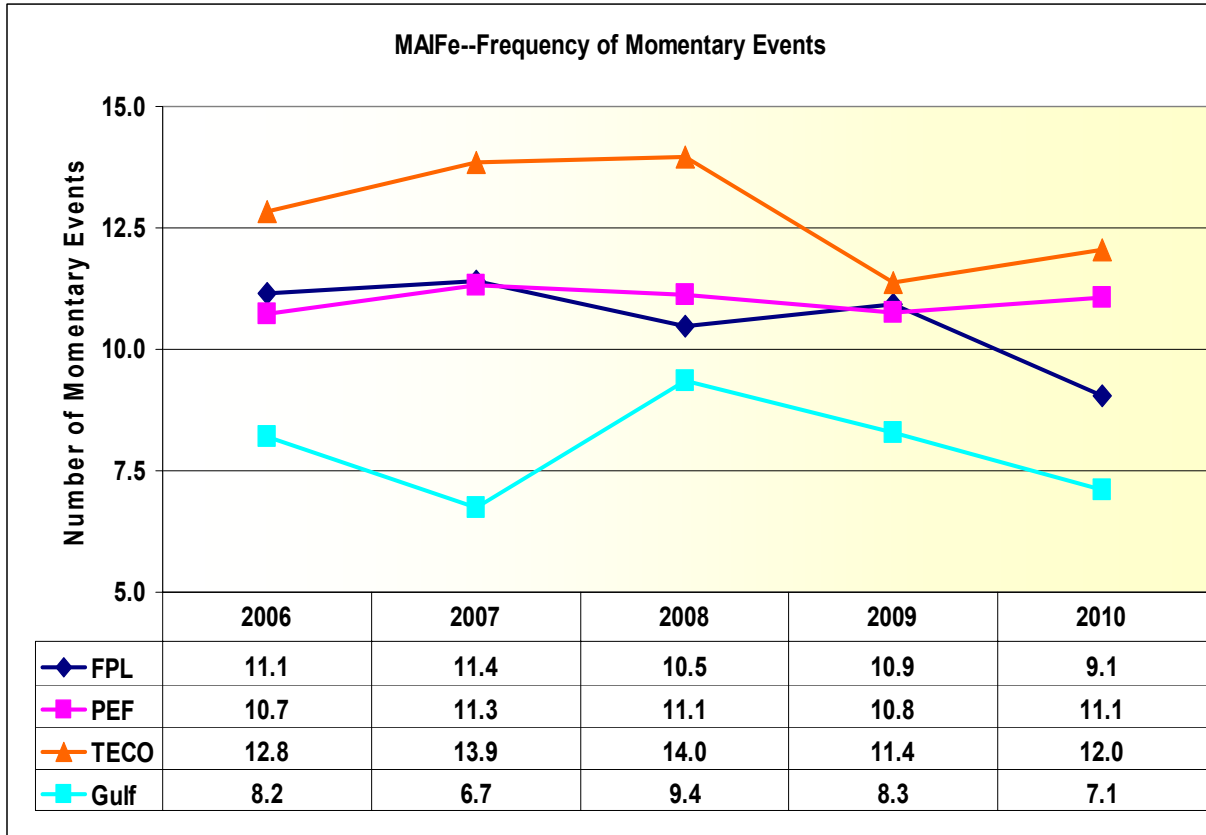
Figure 4-4. Average Number of Feeder Momentary Events (Adjusted MAIFe)

Figure 4-4 shows a five-year graph of the adjusted MAIFe (Momentary Average Interruption Frequency Index) for FPL, PEF, TECO and GULF. All four companies' MAIFE indices are consistent with the previous four years. FPUC is exempt from reporting MAIFe and CEMI5 (Customers Experiencing More Interruptions than 5) because it has fewer than 50,000 customers.
