Review of

Florida's
Investor-Owned
Electric Utilities

2 0 1 1
Service Reliability reports

Florida Public Service Commission
Division of ENGINEERING

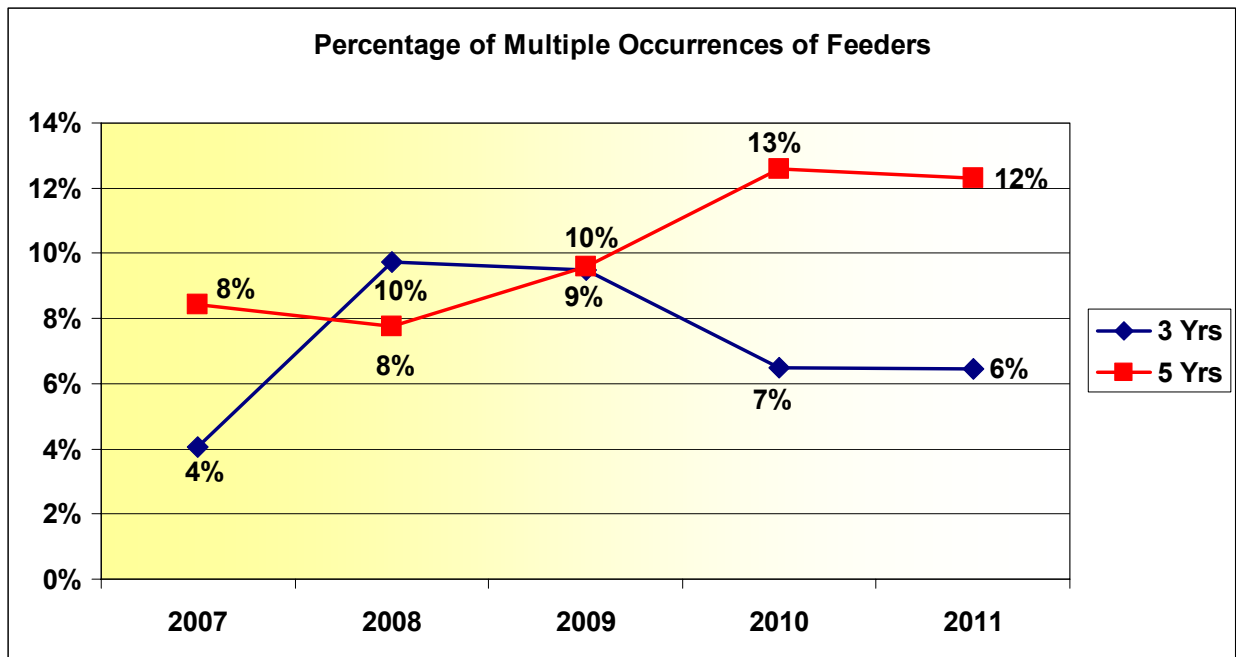
Figure 3-7 is a graphical representation of the percentage of multiple occurrences of FPL's feeders and is derived from The Three Percent Feeder Report, which is a listing of the top three percent of problem feeders reported by the utility. The percentage of multiple occurrences is calculated from the absolute number of multiple occurrences divided by the ending total number of feeders reported on a three-year and five-year feeder analysis. The three-year percentage improved from seven percent in 2010 to six percent in 2011. The five-year percentage also improved from 13 percent in 2010 to 12 percent in 2011. Even though both the three-year and five-year percentages did improve from 2010 to 2011, the five year percentage appears to be trending upwards as the three year percentage is slightly trending upwards for the five year period of 2007 to 2011.

Figure 3-7. FPL's Three Percent Feeder Report (Adjusted)
