Review of
Electric Service Quality and Reliability

December 1997

By Authority of
The State of Florida for
The Public Service Commission
Division of Research and Regulatory Review
Bureau of Regulatory Review

RR-97-01-002

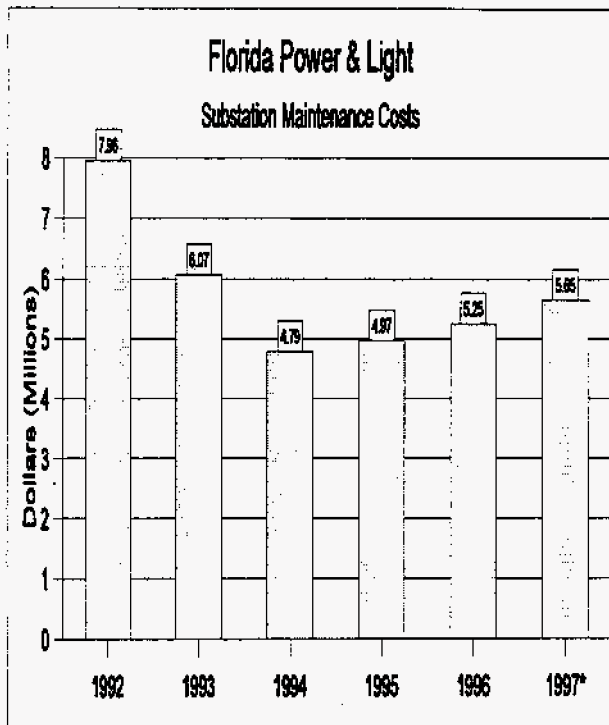
EXHIBIT FPL-19

Exhibit FPL-19 displays 1992 through 1997 total maintenance expenditures for FPL's distribution substations. These expenditures declined in 1993 and 1994, then increased steadily through 1997. Maintenance activities, including inspections of each distribution substation every other month, are coordinated within each of five geographical service areas. These inspections are performed by electrician specialists, covering specified checkpoints including: station perimeter security, station grounding, bushing connections, battery condition, and counter
