Re: 2010 Storm Implementation Plan & Annual Reliability Performance Reports

**2010
STORM IMPLEMENTATION PLAN
&
ANNUAL RELIABILITY PERFORMANCE
REPORTS**

FILED: MARCH 1, 2011

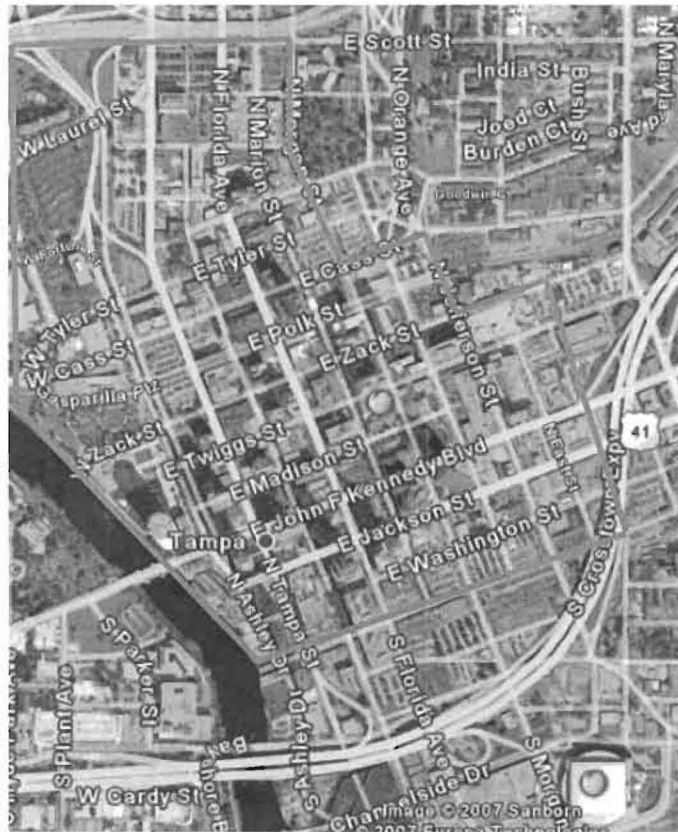
Fig. 5 - Downtown Network Boundaries

substation serves the downtown network with six underground distribution circuits. The boundaries shown in Fig. 5 are as follows: Interstate 275 on the north, Morgan Street to Cass Street to Jefferson Street to Zack Street to Governor Street to Whiting Street on the east; Whiting Street on the south and the Hillsborough River on the west.

The downtown network consists of 361 manholes and 56 network vaults. Most contain two network transformers and two network protectors. The typical elevation in the downtown area is twelve feet or greater, however, there are a few areas with lower elevation. These areas are west of Ashley Street and south of the Crosstown Expressway. In these areas, there are eight below grade vaults and two additional vaults that have historical flooding tendencies. Although network protectors are designed to be waterproof, Tampa Electric has pressure tested the 18 network protectors located in the 10 low lying manholes and vaults. The results of the tests required multiple gaskets to be replaced.

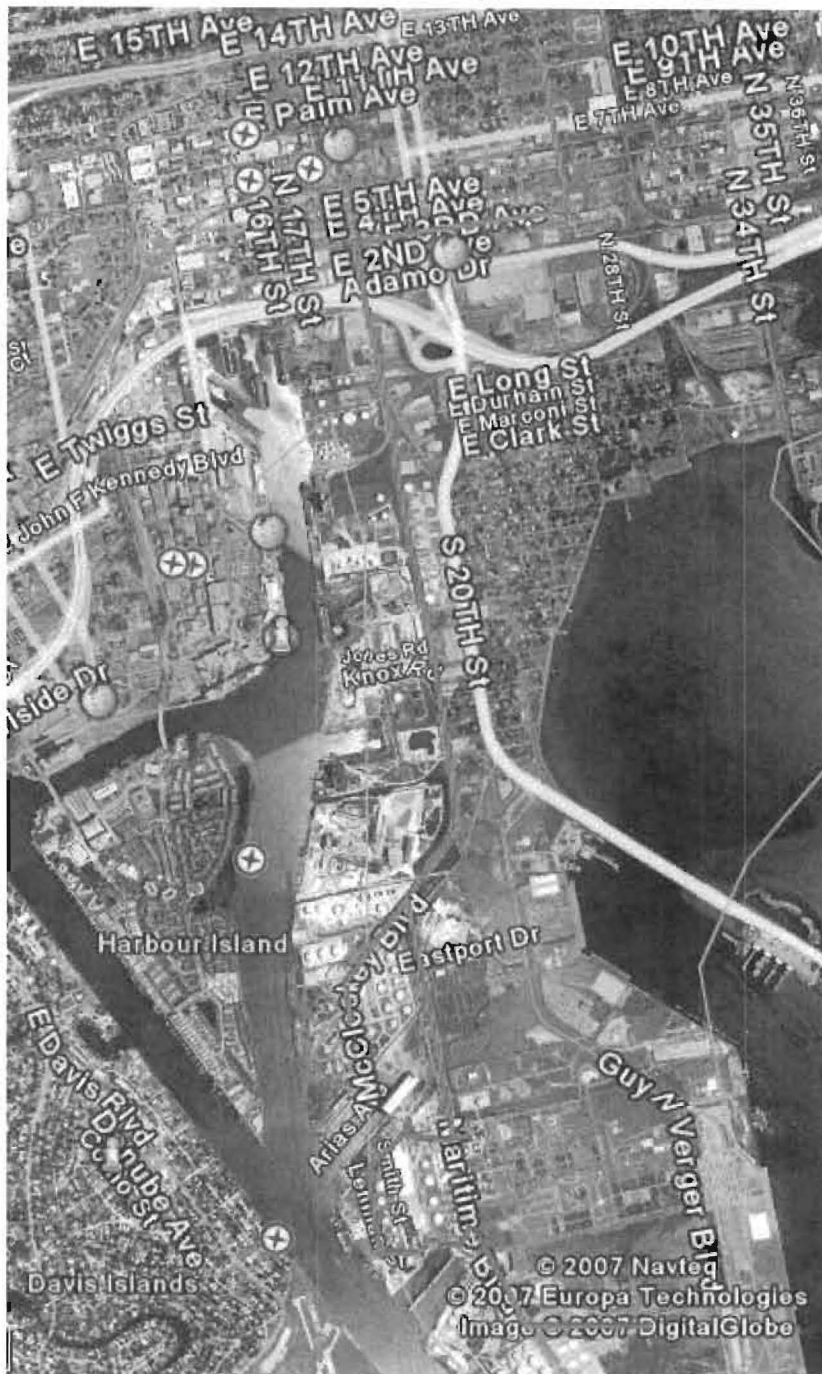
Fig. 6 – Aerial photograph of Port of Tampa with outlined distribution route

The Port of Tampa is a critical facility as it serves 10 petroleum distribution customers that deliver 40 percent of the gasoline in the state of Florida. Approximately six miles of transmission and distribution feeder has been rebuilt to meet the extreme wind requirements as shown in Fig. 6.

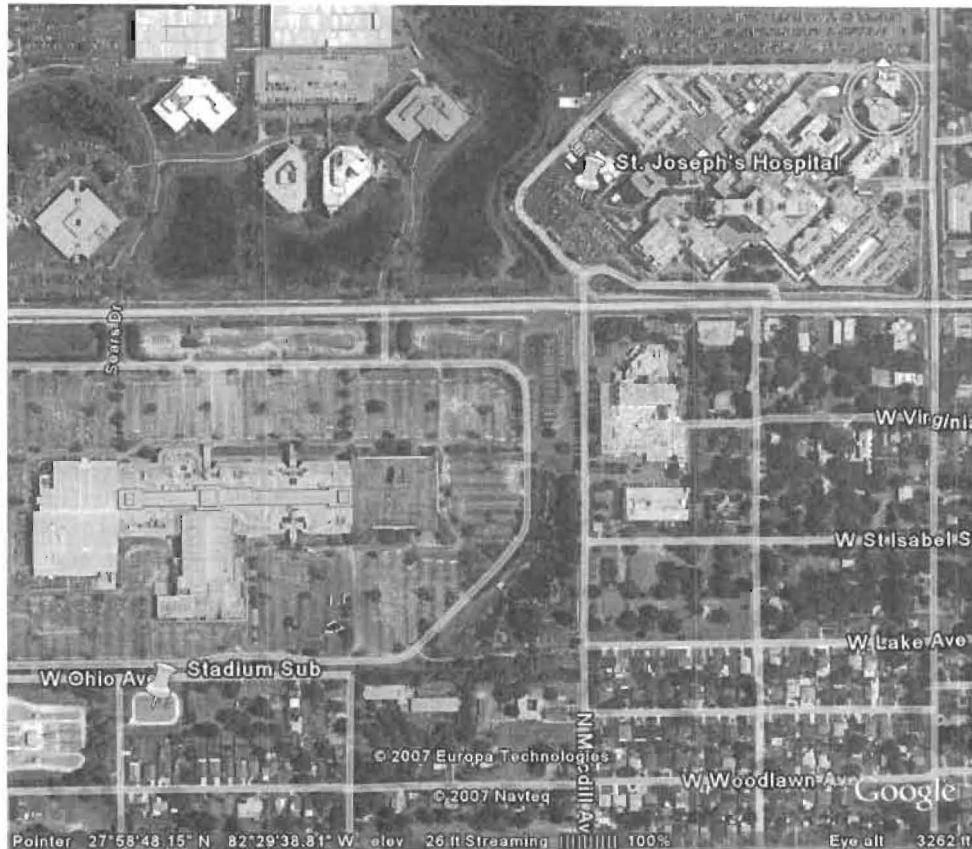
The hardening measures included replacing 37 distribution poles with a stronger class wood pole and six wood transmission poles with non-wood poles. This project location is shown in Fig. 7 and was completed in 2008.

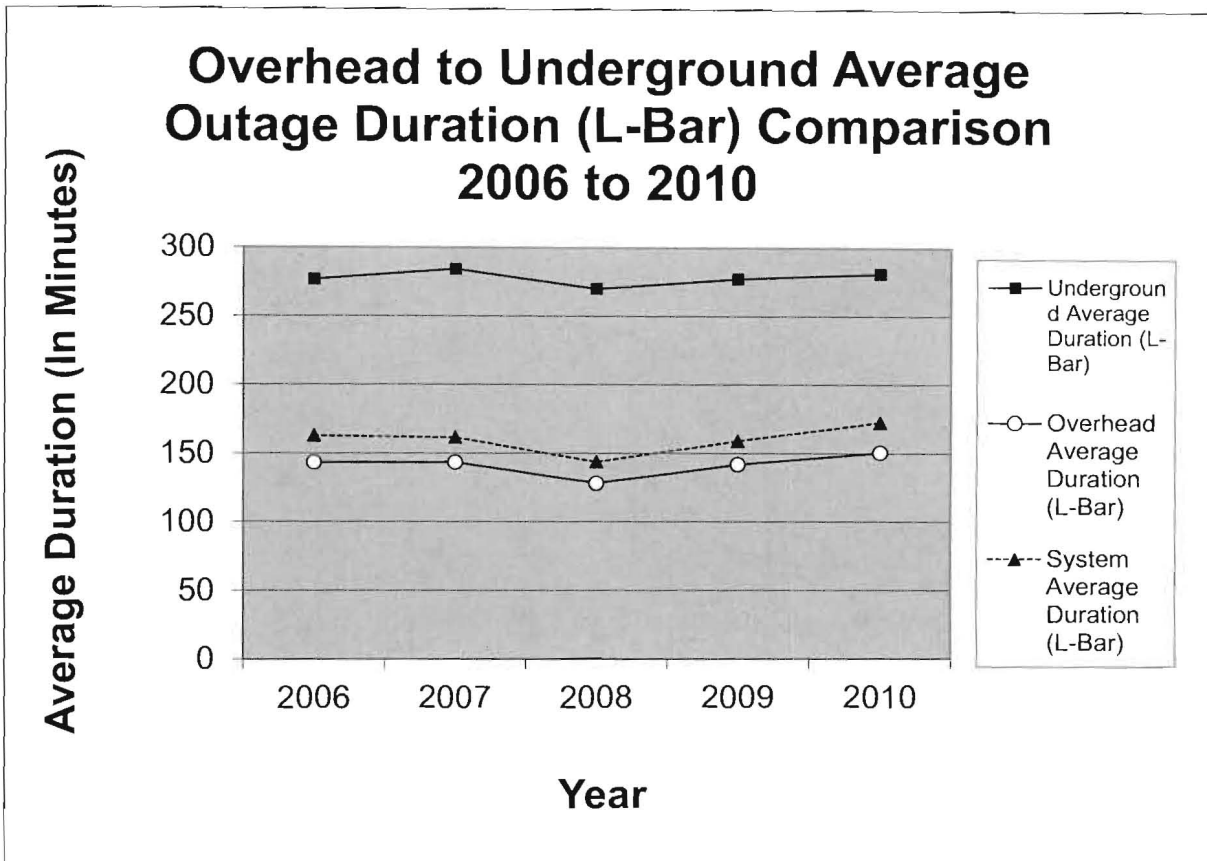
Exhibit 9: Overload to Underground Outage Duration

represents average outage duration (L-Bar) for the past five years. Overhead L-Bar increased in 2010 and has a five-year average of 141.36 minutes, while underground L-Bar has a five-year average of 277.90 minutes which also increased in 2010. The five-year system L-Bar average is 159.93 minutes.
