Re: **Docket No. 020408-SU; Application of Alafaya Utilities, Inc., for Rate Increase in Seminole County, Florida**
Our File No.: 30057.46

Enclosed please find the original and five (5) copies of Alafaya Utilities, Inc.'s Response to the Commission's First Data Request dated October 31, 2002.

ALAFAYA UTILITIES, INC.

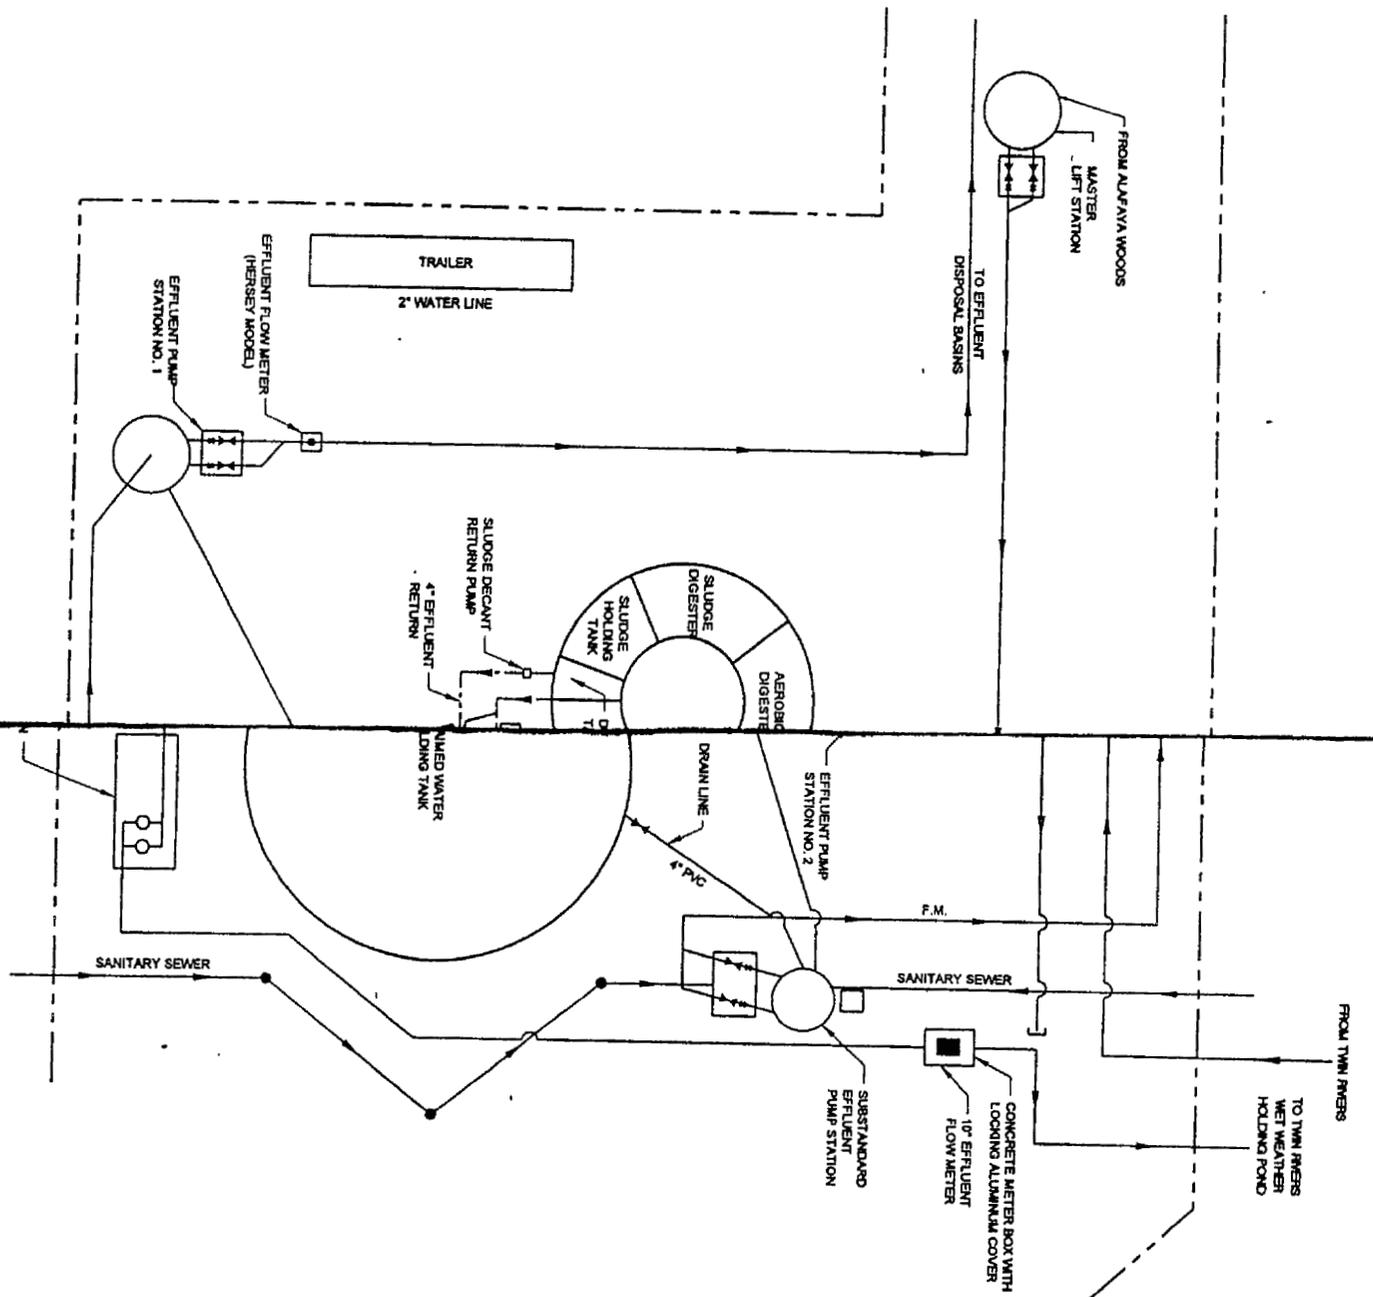
5. Design Treatment Levels

Parameter	Effluent Concentration	Units	Basis	Percent Removal
pH	6-8.5	Standard Units		
CBOD ₅	20	mg/L	Annual Average	90%
TSS	5	mg/L	Annual Average	90%
Fecal Coliform	0 ct, 75% of samples	Fecal value/100 ml		
NO	12.0	mg/L		
Cl	1.0	mg/L	15 min @ pHF
