**Docket No. 100264-EI: Review Of 2010 Electric Infrastructure Storm Hardening Plan filed pursuant to Rule 25-6.0342, Florida Administrative Code, submitted by Florida Public Utilities Company**

2010-2012  
UPDATED STORM HARDENING PLAN AND SPECIFICATIONS

# Florida Public Utilities Company

Storm Hardening Plan  
2010 - 2012

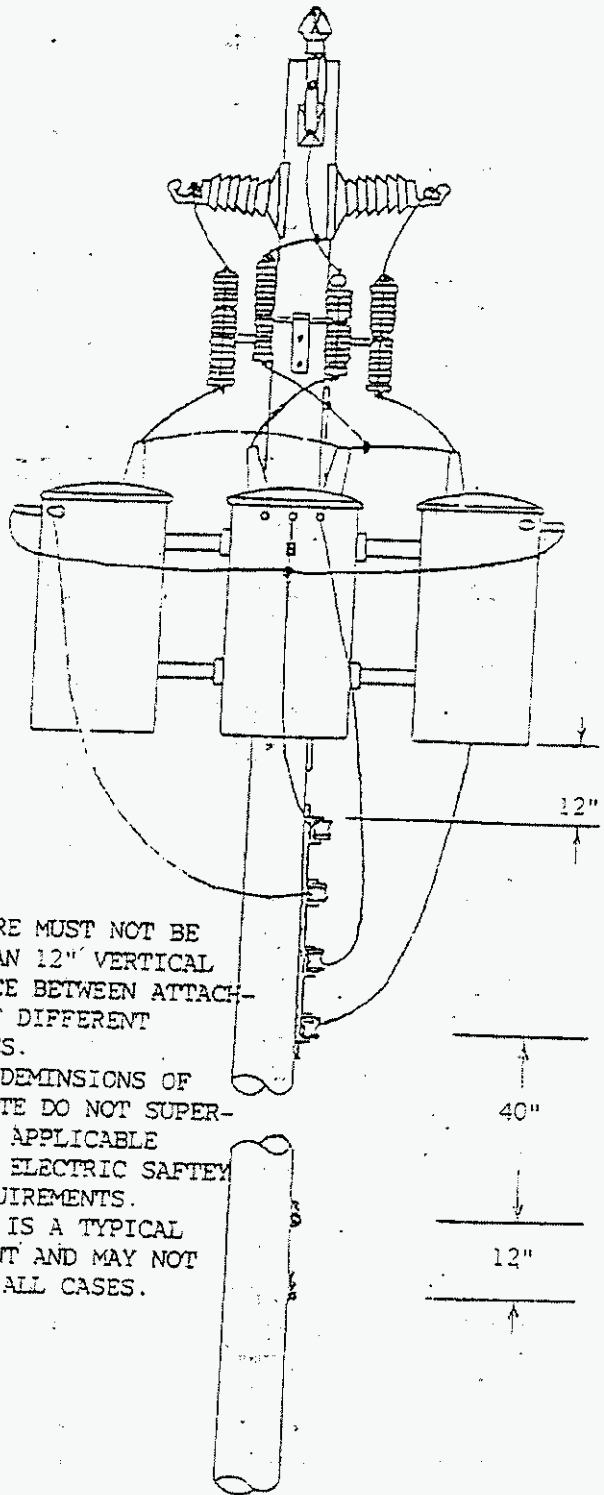
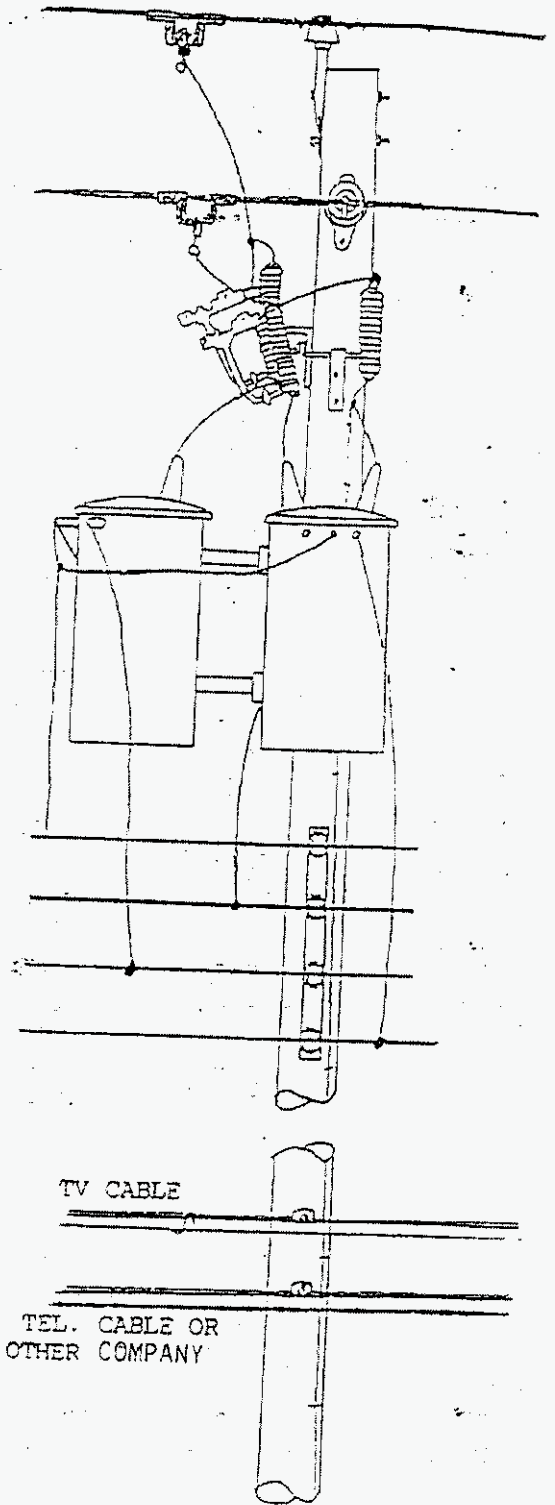
T CAL COMPANY ATTACHMENT TO FPU POLE

- (1) THERE MUST NOT BE LESS THAN 12" VERTICAL CLEARANCE BETWEEN ATTACHMENTS OF DIFFERENT COMPANIES.
- (2) THE DEMINSIONS OF THIS PLATE DO NOT SUPERSEDE ANY APPLICABLE NATIONAL ELECTRIC SAFTEY CODE REQUIREMENTS.
- (3) THIS IS A TYPICAL ATTACHMENT AND MAY NOT APPLY IN ALL CASES.

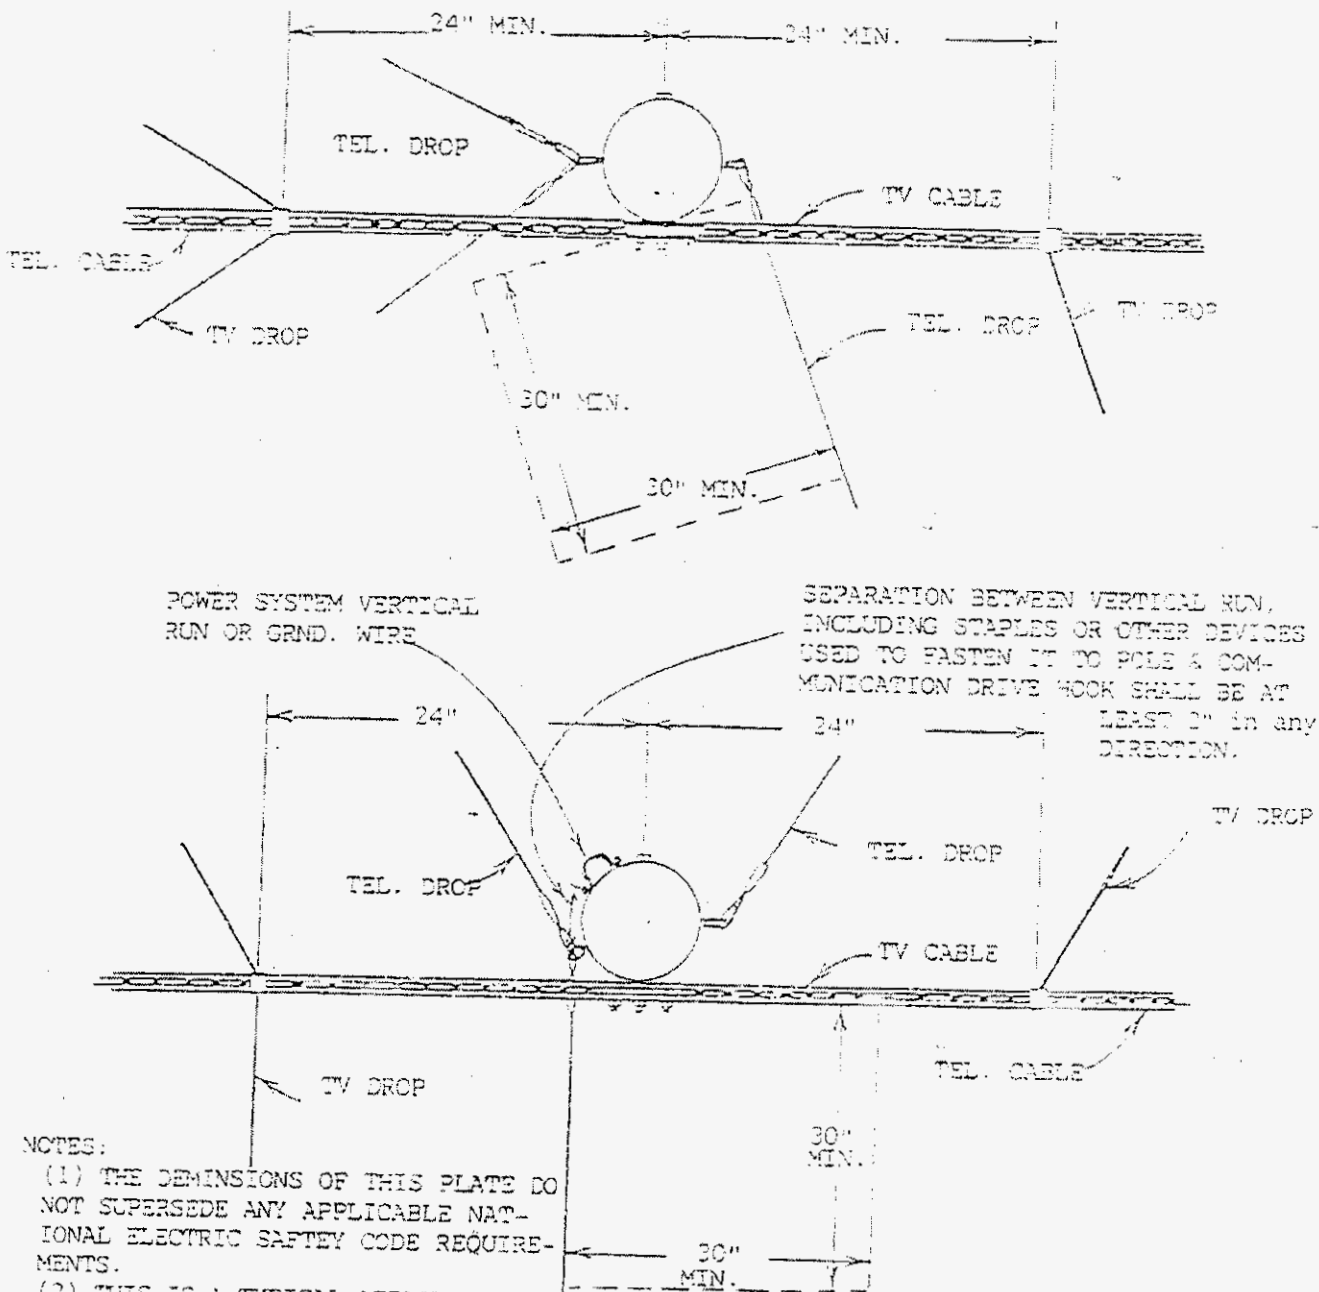
TYPICAL CO. ATTACHMENT TO FPU CO POLE

- NOTES:
- (1) THE DIMENSIONS OF THIS PLATE DO NOT SUPERSEDE ANY APPLICABLE NATIONAL ELECTRIC SAFETY CODE REQUIREMENTS.
  - (2) THIS IS A TYPICAL ATTACHMENT AND MAY NOT APPLY IN ALL CASES.
  - (3) THERE MUST NOT BE LESS THAN 12" CLEARANCE BETWEEN ATTACHMENTS OF DIFFERENT COMPANIES.

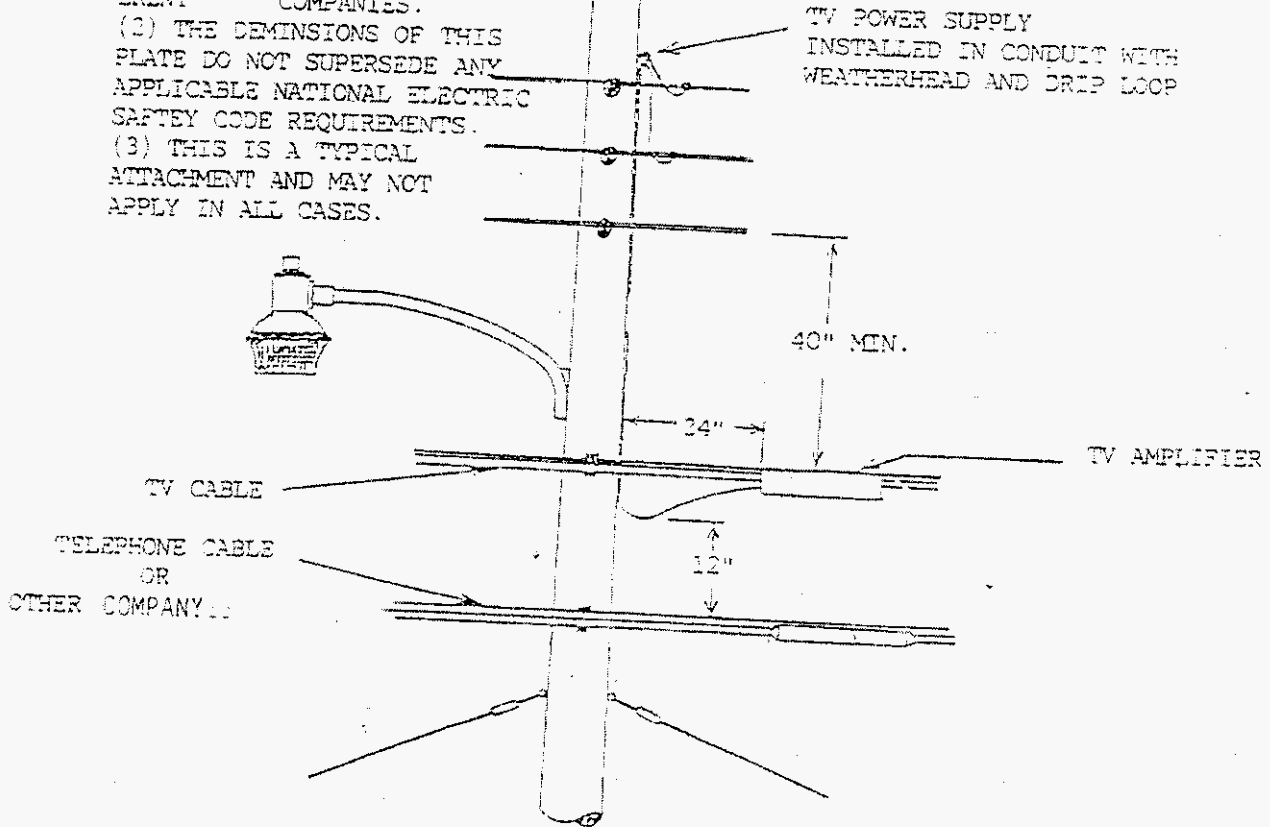
TYPE AL CO. ATTACHMENT TO FPU POLE

- (1) THERE MUST NOT BE LESS THAN 12" VERTICAL CLEARANCE BETWEEN ATTACHMENTS OF DIFFERENT COMPANIES.
- (2) THE DIMENSIONS OF THIS PLATE DO NOT SUPERSEDE ANY APPLICABLE NATIONAL ELECTRIC SAFETY CODE REQUIREMENTS.
- (3) THIS IS A TYPICAL ATTACHMENT AND MAY NOT APPLY IN ALL CASES.

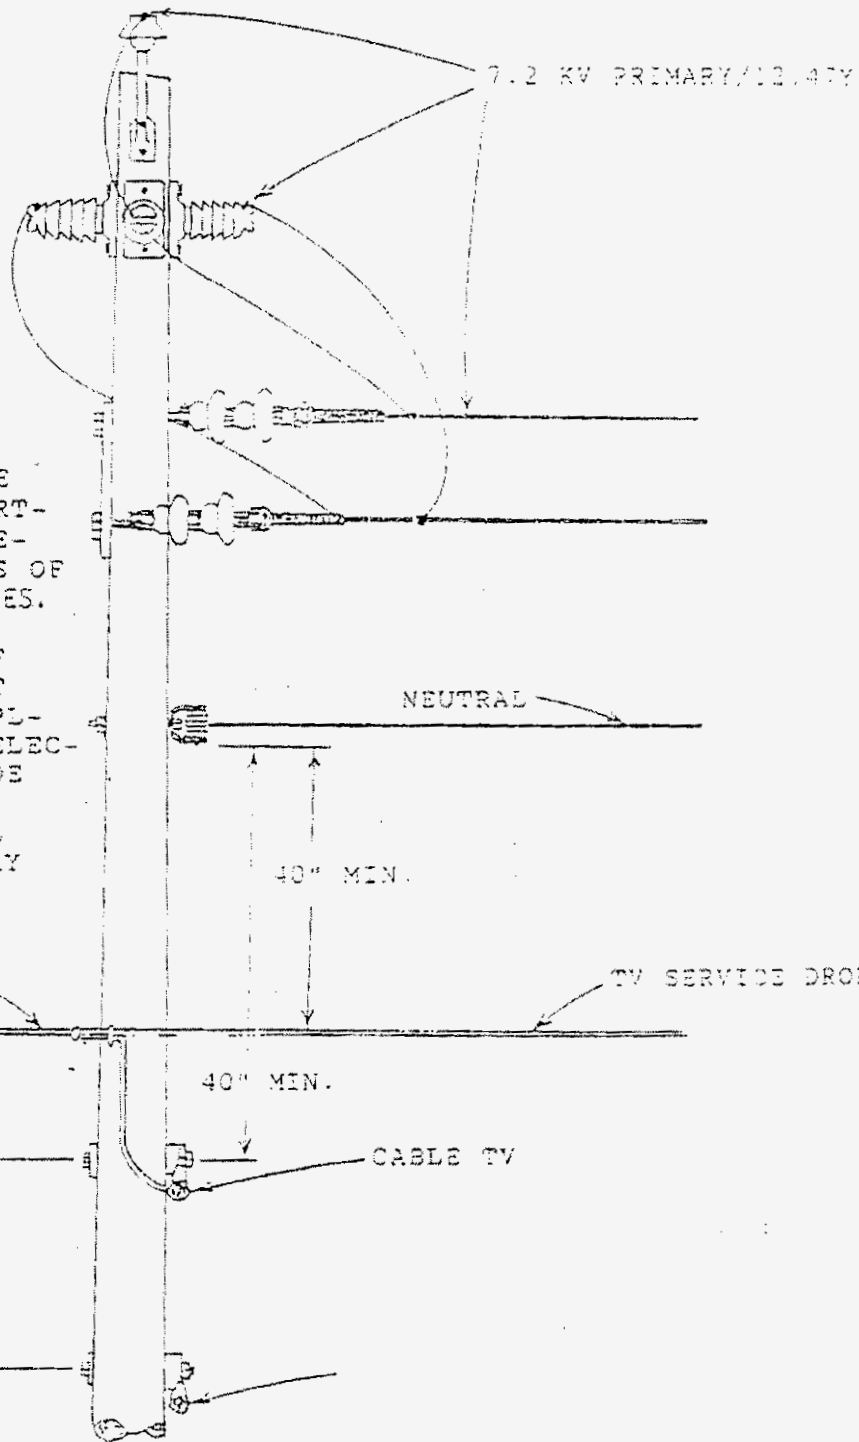
- (1) THERE MUST NOT BE LESS THAN 12" VERTICAL CLEARANCE BETWEEN ATTACHMENTS OF DIFFERENT COMPANIES.
- (2) THE DIMENSIONS OF THIS PLATE DO NOT SUPERSEDE ANY APPLICABLE NATIONAL ELECTRICAL SAFETY CODE REQUIREMENTS.
- (3) THIS IS A TYPICAL ATTACHMENT AND MAY NOT APPLY IN ALL CASES.

TYPICAL CO. ATTACHMENT TO FPU POLE  
SINGLE TRANSFORMER INSTALLATION

7.2 KV CONSTRUCTION

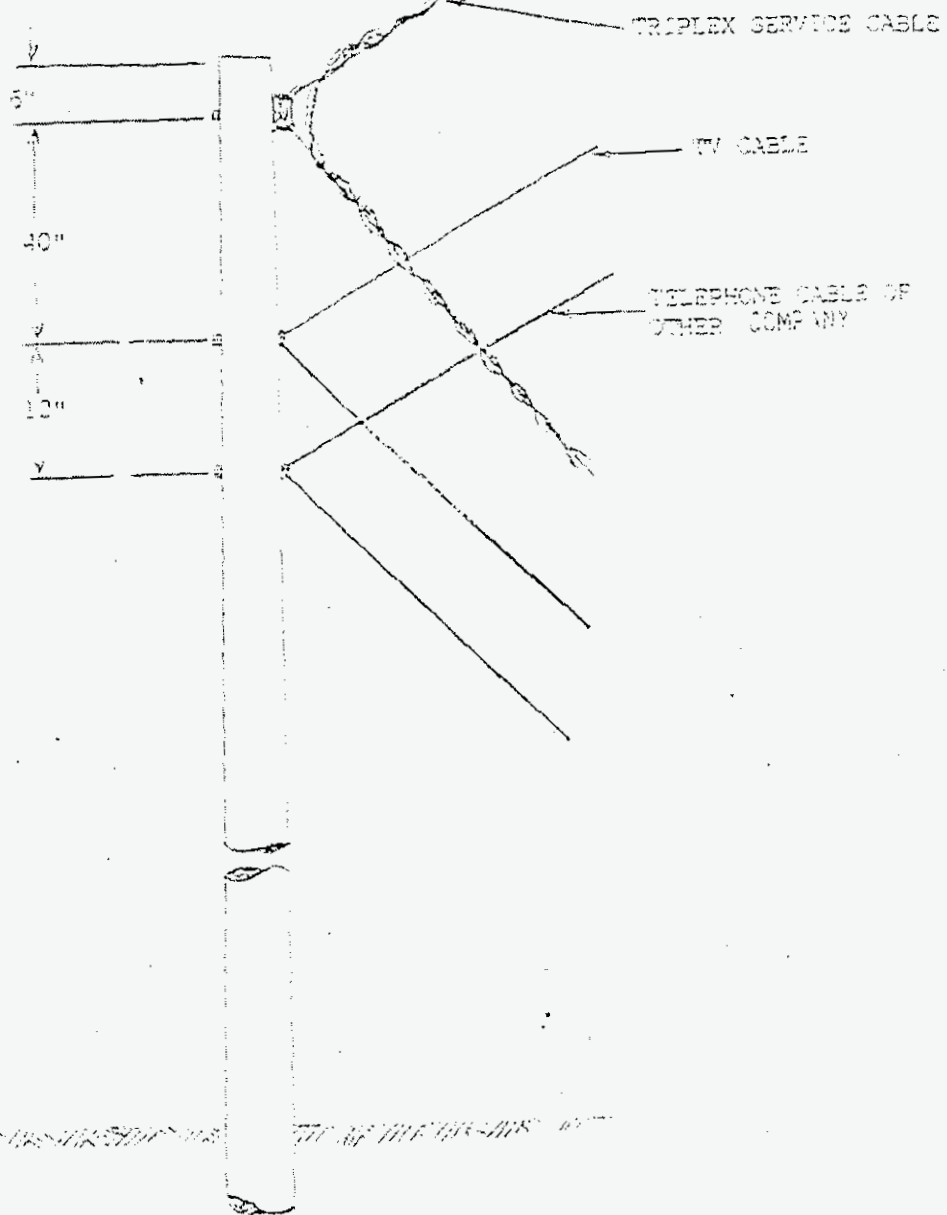
- (1) THERE MUST NOT BE LESS THAN 12" VERTICAL CLEARANCE BETWEEN ATTACHMENTS OF DIFFERENT COMPANIES.
- (2) THE DIMENSIONS OF THIS PLATE DO NOT SUPERSEDE ANY APPLICABLE NATIONAL ELECTRIC SAFTEY CODE REQUIREMENTS.
- (3) THIS IS A TYPICAL ATTACHMENT AND MAY NOT APPLY IN ALL CASES.
