**2011
STORM IMPLEMENTATION PLAN
&
ANNUAL RELIABILITY PERFORMANCE
REPORTS**

**2011 Storm Implementation Plan & Annual
Reliability Performance Reports**

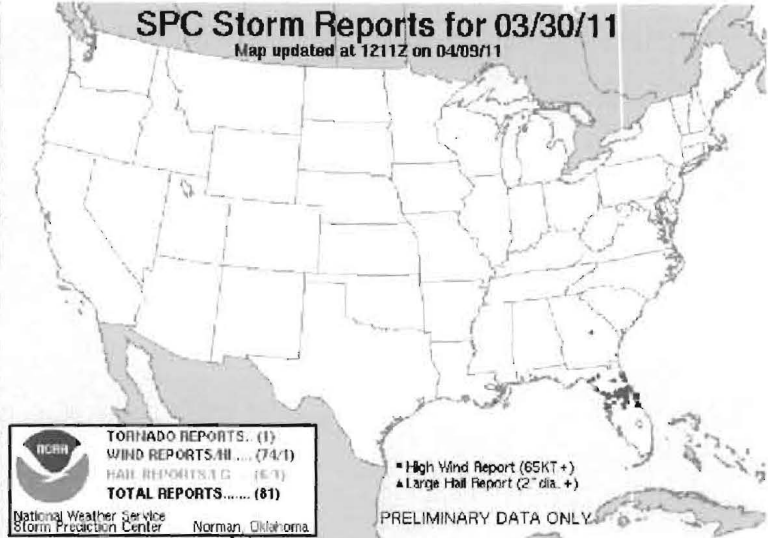
SPC Storm Reports for 03/30/11

TORNADO REPORTS: (1)
WIND REPORTS/HR ... (74/1)
HAIL REPORTS/100 ... (6/1)
TOTAL REPORTS..... (81)

High Wind Report (65KT+)
Large Hail Report (2" dia. +)
