TECO's Response to OPC's Third Set of  
Interrogatories Nos. 51-149

**TAMPA ELECTRIC COMPANY  
DOCKET NO. 20220048-EI  
OPC'S THIRD SET OF  
INTERROGATORIES  
INTERROGATORY NO. 51  
BATES PAGE: 1  
FILED: MAY 25, 2022**

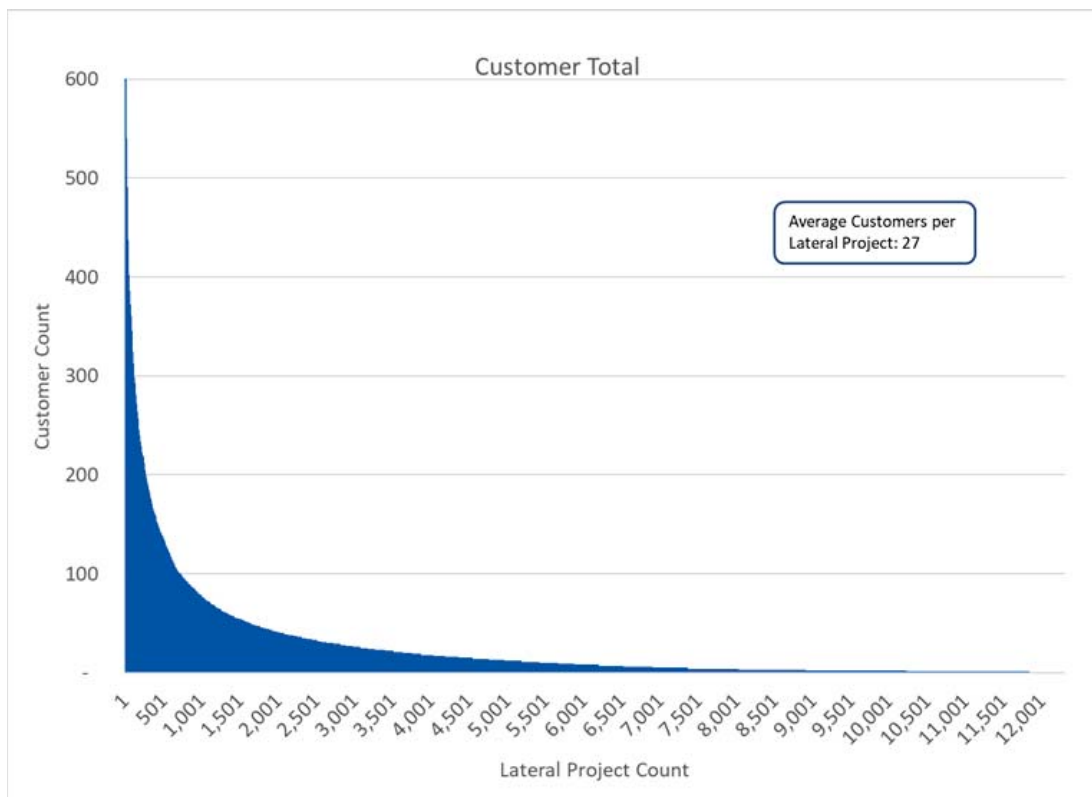
- 72.** For the number of laterals shown in the Table of Exhibit DAP-1, Page 32 of 78, what is the average number of customers on a lateral?
- A.** The number of customers on a lateral varies significantly from a low of just a few customers, sometimes one, to hundreds. The following figure shows the range of customers on approximately 13,000 laterals. As the figure shows the average customer count is 27.

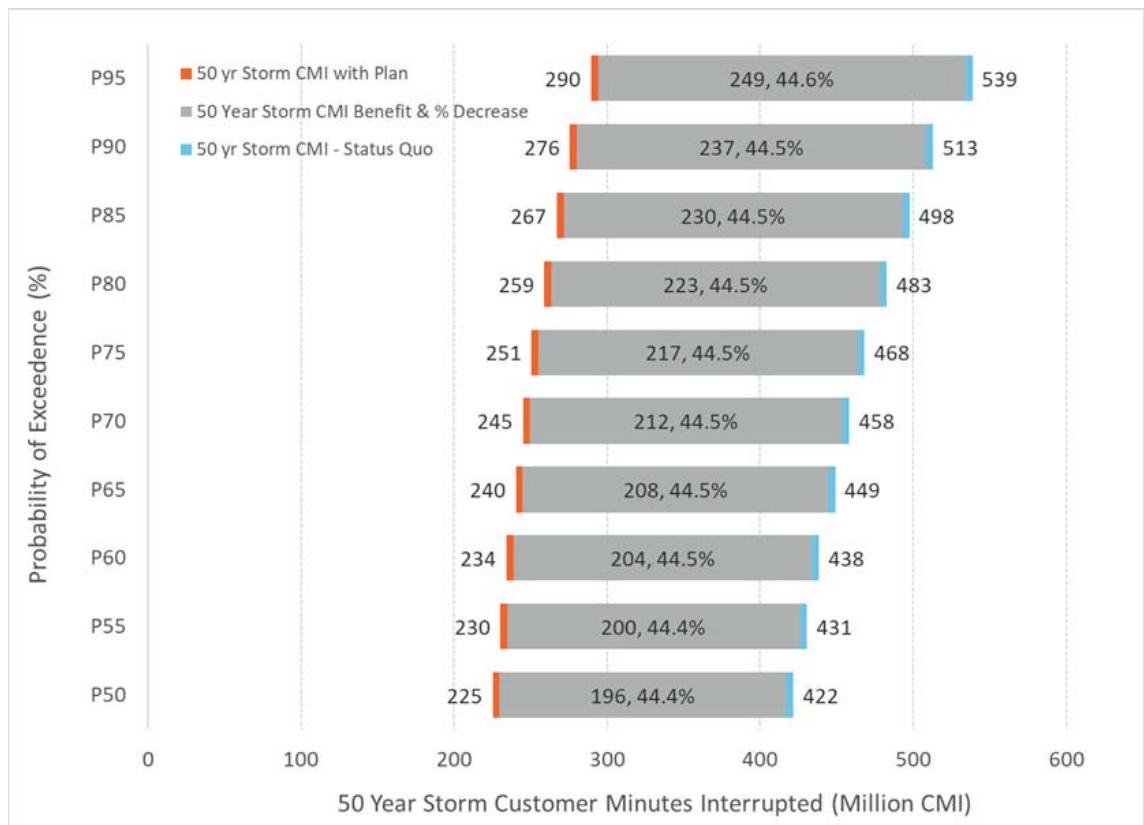
**Lateral Undergrounding**

The percentage in the grey areas map to the values in the table on page 71 of 78 references in the question. Adding all these figures together produces the results for the entire plan.

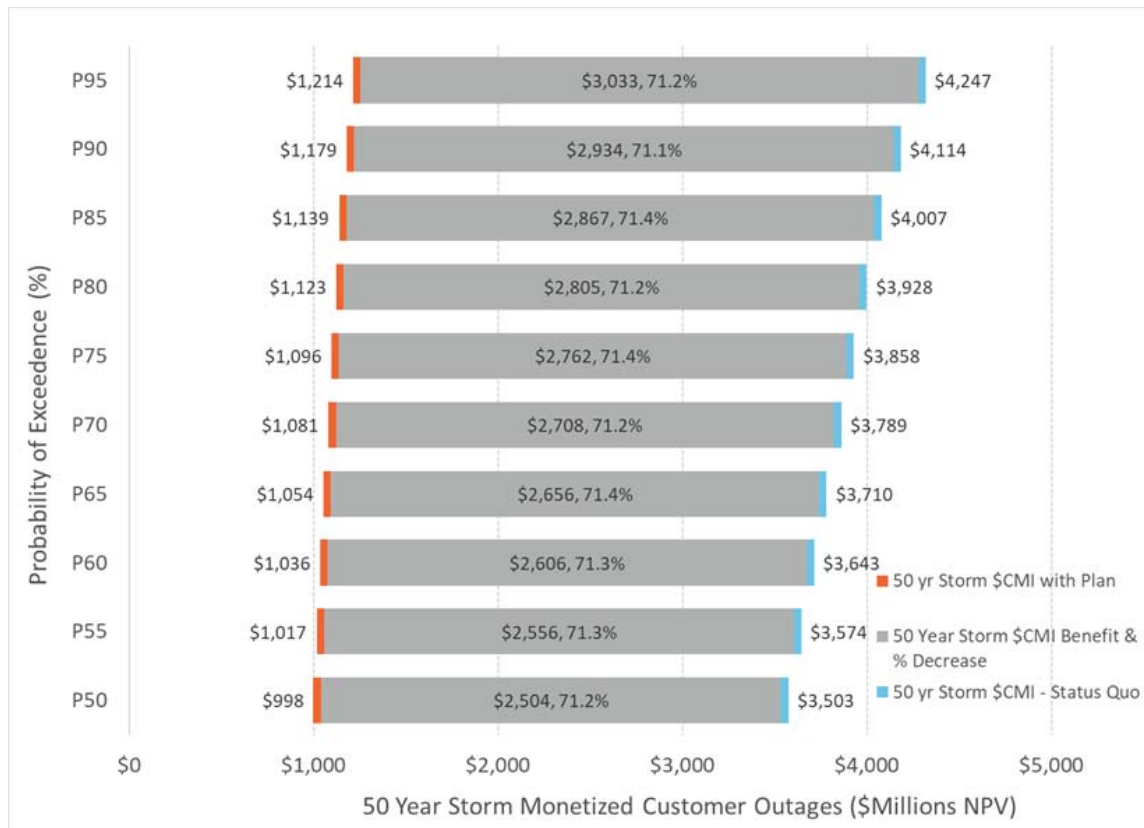
**Lateral Undergrounding**

The following figures convert the CMI values to dollars using the DOE ICE Calculator and described in the plan.

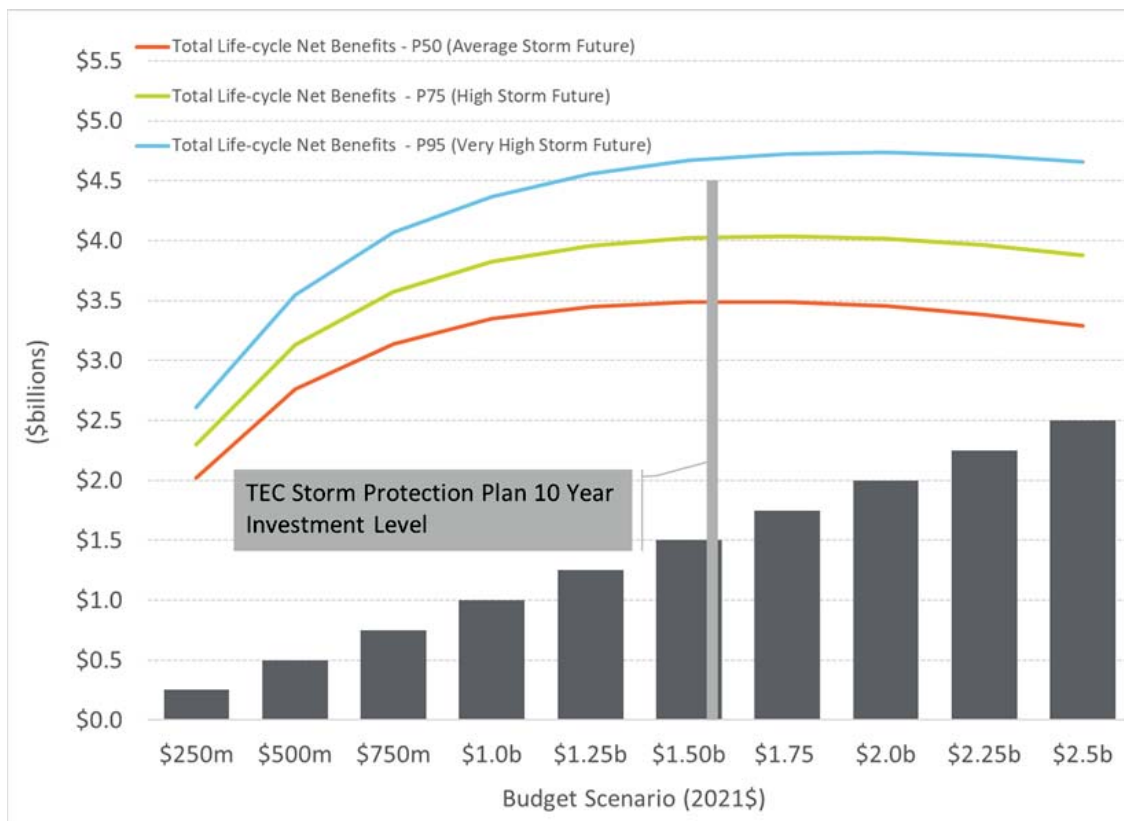
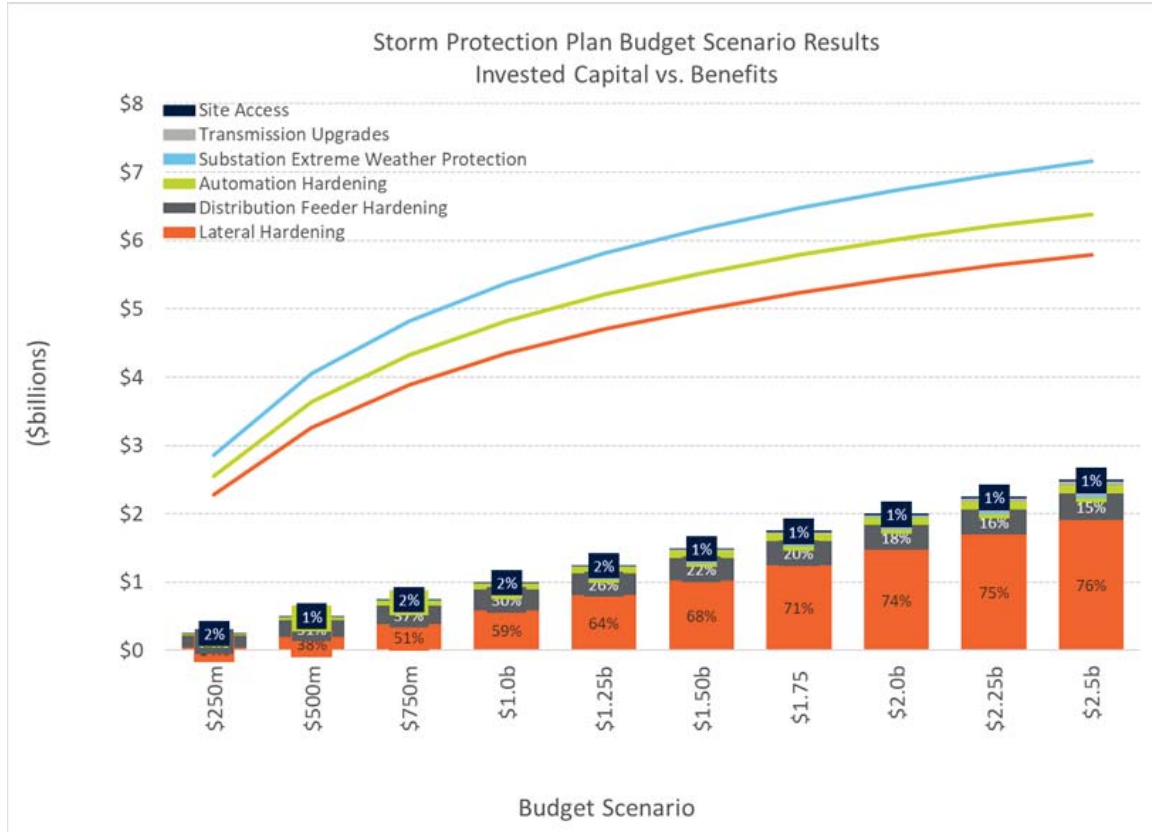
**A.** The 1898 & Co. Report includes additional information on the budget optimization analysis. Please see Exhibit DAP-1, Appendix F, page 70 of 82, section 6.0 Budget Optimization and Project Selection. Please note that the first figure includes the Net Benefits while the second figure includes the Gross Benefits. Net Benefits = Gross Benefits – Invested Capital

- 136.** Referring to Exhibit DAP-1, page 77 of 78, provide benefit levels from each budget optimization scenario (\$250 million to \$2.5 billion)
- A.** See Response No. 135, this set.

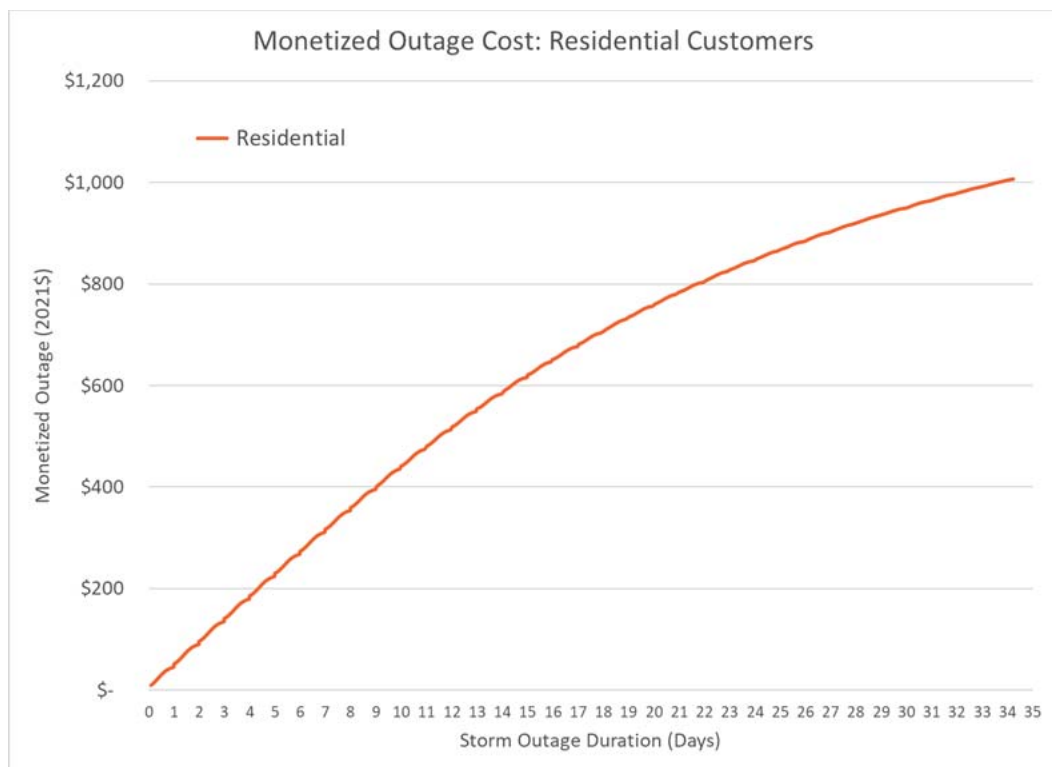
**Monetized Outage Costs: Residential Customers**

Calculator results are done for each of the 13,350 for 99 different storm scenarios (~1,335,000 calculations). The approach also factors in customer counts and types (residential, Small C&I, Large C&I, critical) for each of the projects.
