DOCKET NO. 050958-EI

IN RE: Petition for Approval of New
Environmental Program for Cost Recovery
through Environmental Cost Recovery Clause

REBUTTAL TESTIMONY

JOHN V. SMOLENSKI

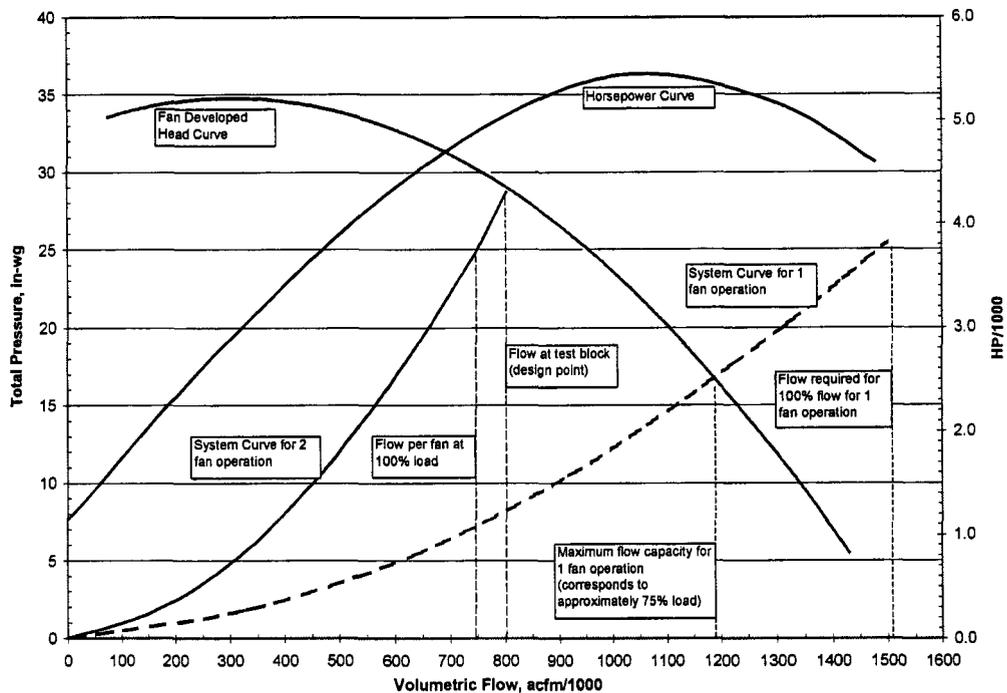
Figure 1. System Curve Per Fan for Centrifugal ID Fans

In the ID centrifugal example shown in Figure 1 above, the system curves for both one and two fan operation are shown. The two fan system curve includes test block margin. Total ID fan flow required at 100% load is about 1,500,000 acfm, so with two fans operating, the requirement is 750,000 acfm per fan. As shown in the figure above, the system curve for one fan operation intersects the fan pressure curve at about 1,200,000 acfm. This indicates that one fan should be able to deliver flow corresponding to approximately 75% load, although at a lower efficiency.

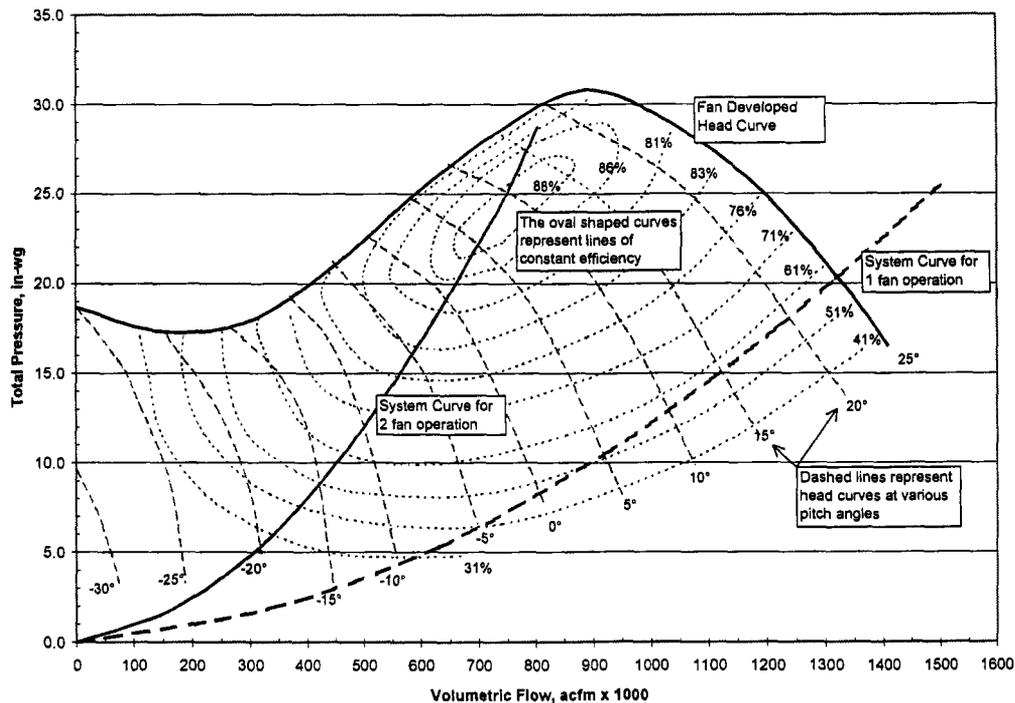
Figure 2. System Curve per Fan for Axial ID Fans

This also applies to axial fans as shown in the Figure 2:

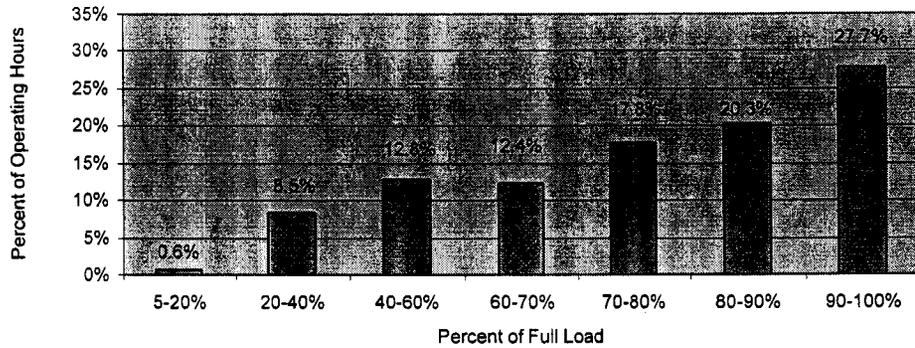
Figure 3. Big Bend Unit 3 Operating Hour Breakdown from 1/2002 to 6/2004

The operating data (Input 2.1) was examined in order to determine the percentage of operating time at various load ranges. Only data points indicating plant operation are used in the evaluation by omitting all data points that indicate a gross unit load less than 5% of full load (full load is assumed to be 450 MW, see Assumption 3.1). Seven different load intervals were chosen for this study to allow for evaluation of fan performance across the range of normal operation. The load ranges chosen (as percent of full load) are: 5-20%, 20-40%, 40-60%, 60-70%, 70-80%, 80-90%, and 90-100%. Figure 3, below, shows the percent of operating hours at each of these load ranges:

Variable frequency drives are not typically used with axial fans due to the higher efficiency of variable pitch blades. However, they may be considered on units that operate at low loads for extended periods. This alternative will not be evaluated as part of this study since the unit generally operates at higher loads as shown in Figure 3.

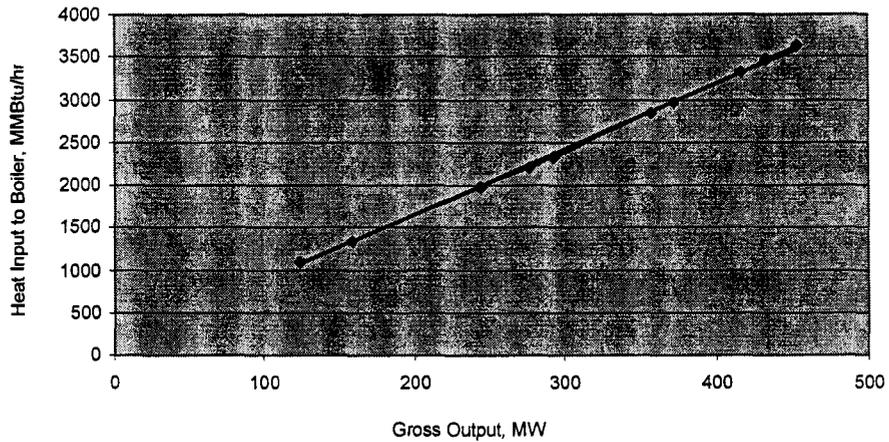
Figure 4. Unit 3 Boiler Duty vs. Generation Based on Heat Balance Data

The heat input corresponding to the average gross output (MW) for each load range is obtained by using a trend line based on the heat balance data (Input 2.2). Figure 4 shows the trend line based on this data. Note that the calculations performed in this evaluation are for comparative purposes only. The results are not meant to be absolute design values, but only provide a means to evaluate the various fan alternatives. Using different heat input values would impact all alternatives similarly and would not impact the conclusions of this evaluation.

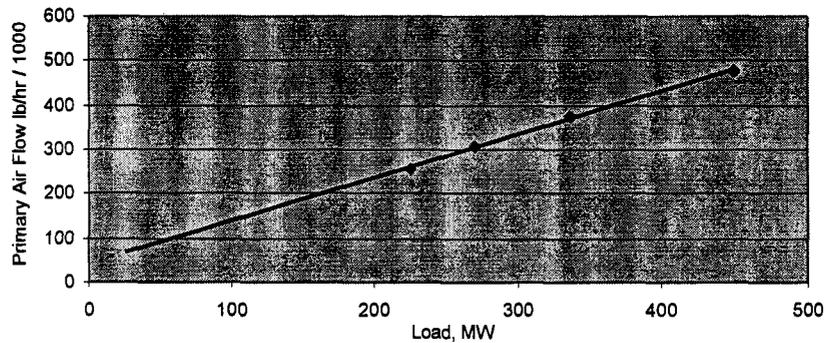
Figure 5. Primary Air Flow

Primary Air input is from the trend line shown below in Figure 5. The trend line is based on data points from Ref 9.7. This is used in computation of FD fan flow.

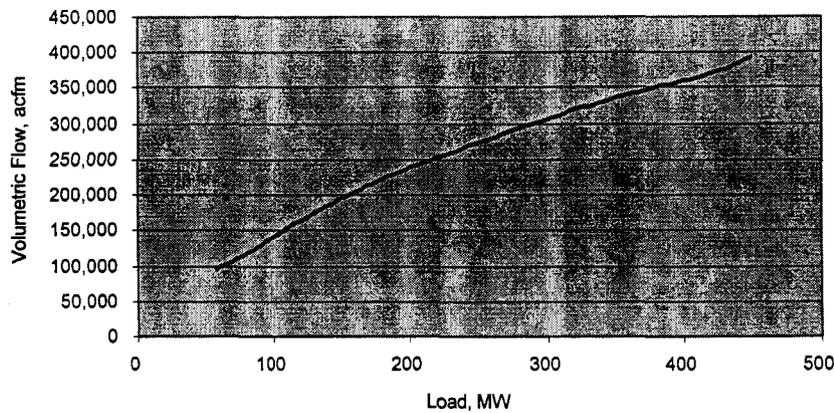
Figure 6. Big Bend Unit 3 FD Flow vs Load, based on calculations

developed from a plot of the gross load and the resulting volumetric flow from the fan sizing calculations discussed in section 6.2. This trend line is shown in Figure 6:

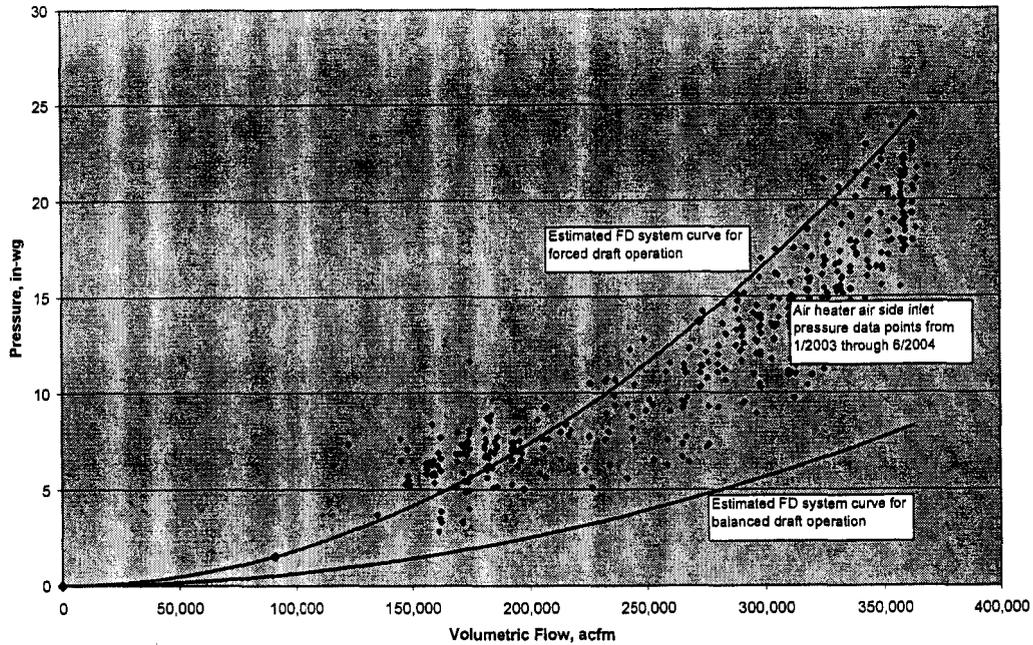
Figure 7. Big Bend Unit 3 Estimated FD Fan System Curve based on Operating Data

By choosing a higher starting point for developing this curve, the plotted line is on the higher side of the data points, which establishes a more conservative curve than if it were in the middle of the data points. From this estimated FD fan system curve for existing forced draft operation, a new system curve for balanced draft operation is then derived. To accomplish this, the difference in the operating pressure of the furnace during full load forced draft operation (15.6 in-wg per Input 2.7) and balanced draft operation (-0.5 in-wg per Assumption 3.4) is calculated (16.1 in-wg). This difference in pressure is then subtracted from the maximum point on the system curve in order to determine the maximum point for a new, lower system curve. The remainder of the curve is established using the equation as described above. The development of these curves is illustrated in Figure 7 below:

The new FD Fan system curve developed above is also extrapolated further to represent flow at 100% load, as well as to a test block point for fan sizing. [A 15% margin on pressure is added to establish the test block point. This is a typical margin for new fans, since actual data can be collected for most of the draft system, a lower margin may be used during the detailed design.]

The calculated volumetric flow and air heater air side inlet pressure are plotted as shown in the figure below. A high point on the data plot is chosen as the maximum point for an assumed system curve and the remainder of the curve is plotted using the following relation from Reference 9.8.

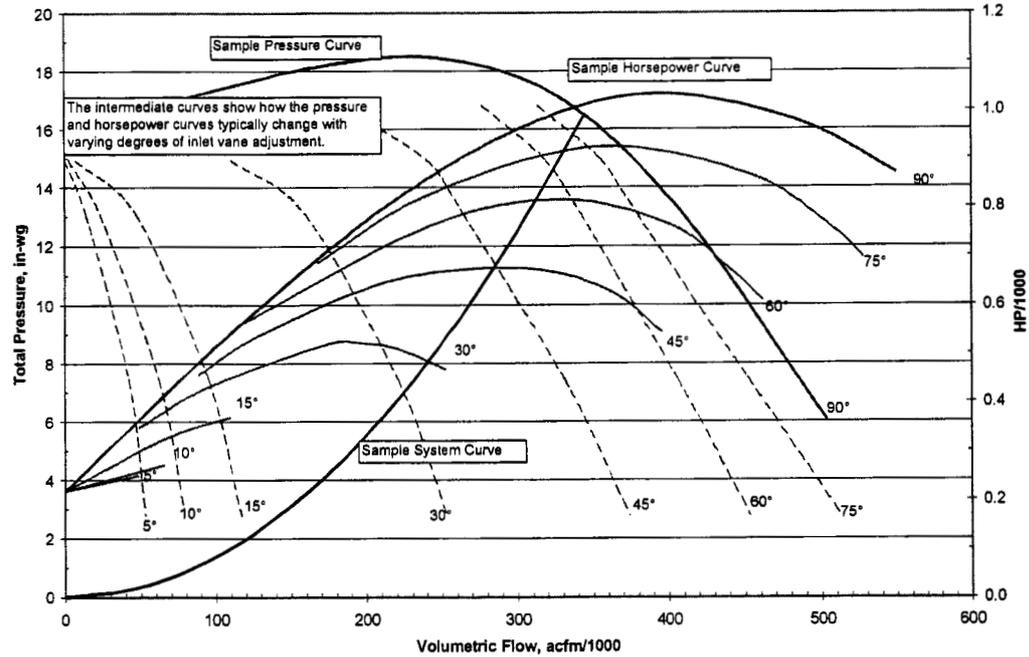
Figure 8. Sample Fan Curves for Centrifugal with Inlet Vane Control

sample fan curve and trend line for typical inlet vane performance are shown below in Figures 8 and 9.

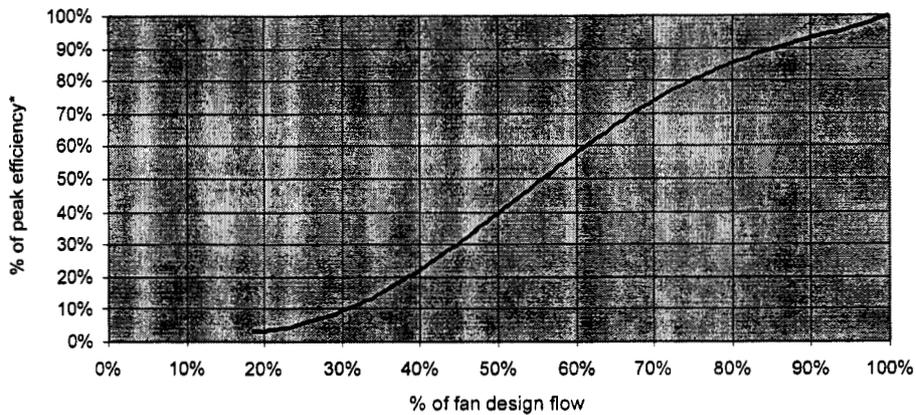
Figure 9. Trend Line of Typical Inlet Vane Performance

* Peak efficiency occurs at the fan design point, where the inlet vanes are in a neutral position

This trend line is used with an assumed peak efficiency of 87% for predicting the performance of new ID and FD centrifugal fans with inlet vane control. Operation with the existing FD fan will be less efficient, since the fan curve is not optimal for the new system curve. The performance of the existing FD fan is determined using a peak efficiency of 70% based on the position of the new system curve within the pressure curve for the 885 rpm pressure curve. Note that the original vane control horsepower curve cannot be used for this evaluation since it was developed based on the original system curve for forced draft operation.

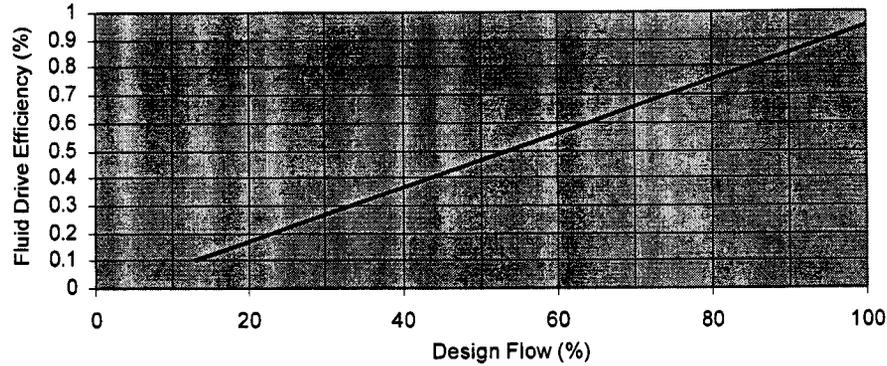
Figure 11. Fluid Drive Efficiency vs. Design Flow
from MES-13.1 p19

To calculate the performance of the fans with hydraulic coupling, Reference 9.10 is used. A trend line based on Reference 9.10 is shown in Figure 11. This trend line is used with the fluid drive fixed loss identified in Reference 9.10 to calculate the fluid drive performance. With a hydraulic coupling, the fan itself is assumed to operate at peak efficiency over the load range, while the efficiency of the hydraulic coupling decreases at lower speeds according to Figure 11:

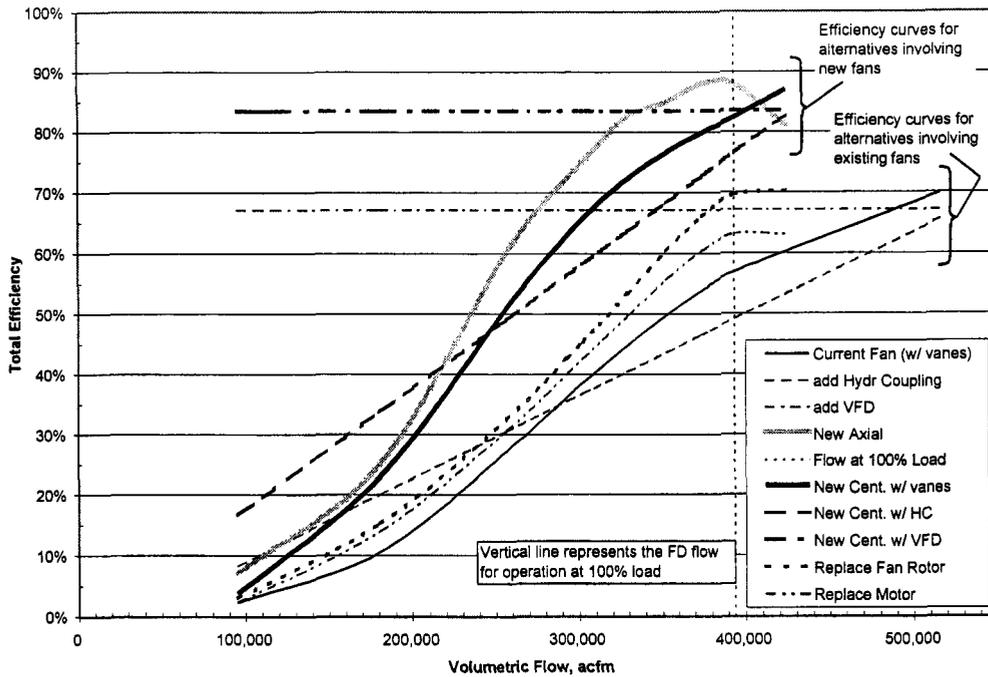
Figure 13. Efficiency of FD Fan Alternatives

Figure 13 shows how the efficiency for each FD fan alternative changes with the fan volumetric flow. Note that using the existing fan to meet the new system curve (for balanced draft operation) results in less efficiency since it is oversized for the application as discussed in section 6.8. The alternatives involving the existing fan would require significant vane throttling or speed reduction to operate in the required range (to the left of the vertical line representing flow at 100% load). New fans would be designed for an optimal fit with the new system curve, with margin for test block. Some alternatives have higher efficiency than others do at the higher flows, but decrease below others at lower loads. Alternatives with VFDs maintain their efficiency throughout the load range. Note that the best alternative for Big Bend Unit 3 depends on the operating load profile, which is summarized in Table 3.

Two other options are to replace the existing fan rotating element with a new element, and to replace the existing fan motor with a new, slower, single-speed motor. A new rotating element would modify the fan curve to better fit the new system curve. With the smaller element, the existing fan housing and foundation should be acceptable. Replacing the motor only will allow for the existing fan curve to be reduced due to the lower speed, allowing it to better fit the new system curve. However, the lower speed motor will change the frequency response of the fan and motor system, probably requiring some foundation modification. The efficiencies for these options are based on the vendor supplied fan curves included in Attachment 10.9 and are shown in Figure 13.

Figures 13 through 16 summarize the efficiency and auxiliary power requirements of various alternatives for both FD and ID fans. The difference in the FD and ID fan flow is due to the different temperature between the flow streams, the different pressure, and leakage flows. Table 3 summarizes the operating points used in performing the economic evaluation.

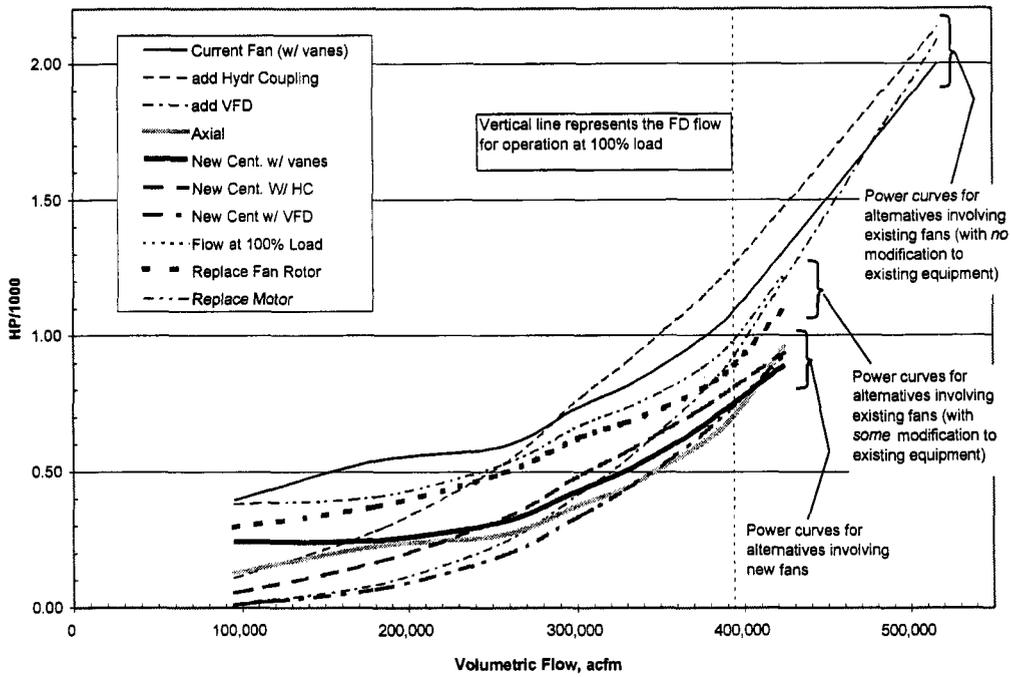
Figure 14. Auxiliary Power Requirement for FD Fan Alternatives

The efficiencies discussed above affect the amount of auxiliary power used by the fan as shown in Figure 14. The auxiliary power requirement for any of the fan alternative decreases with load. However, the more efficient alternatives will require less power at a given load.

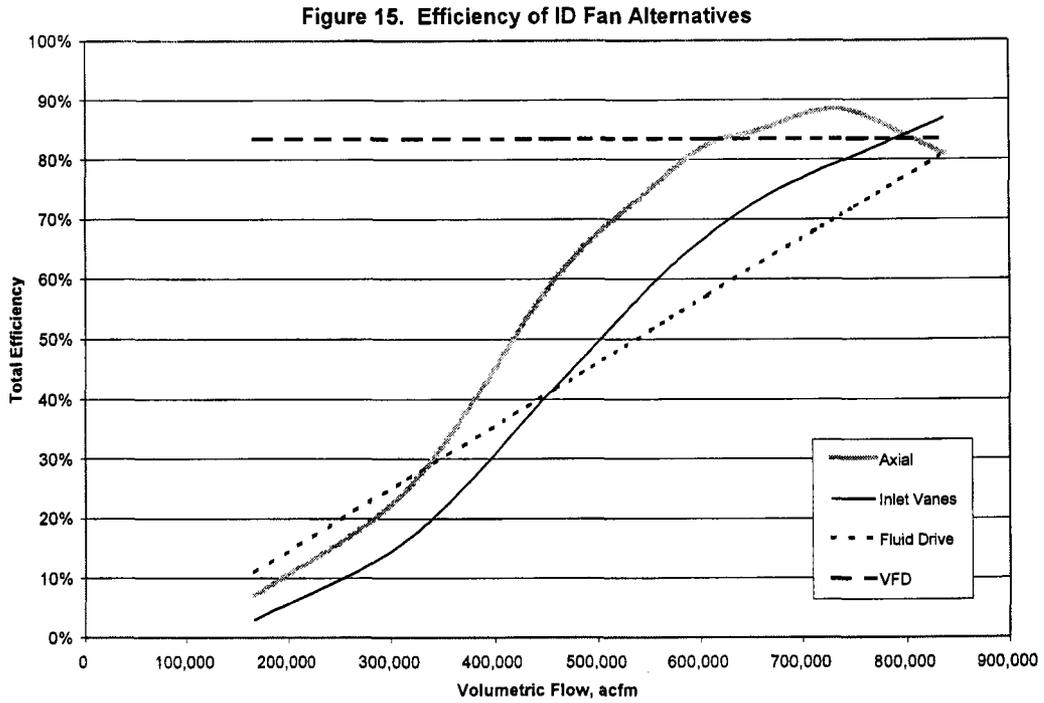
Figure 15 shows the efficiency for each ID fan alternative.

The ID fan efficiencies from Figure 15 affect the amount of auxiliary power used by the fan as shown in Figure 16. The auxiliary power requirement for any of the fan alternative decreases with load, however, the more efficient alternatives will require less power at a given load.

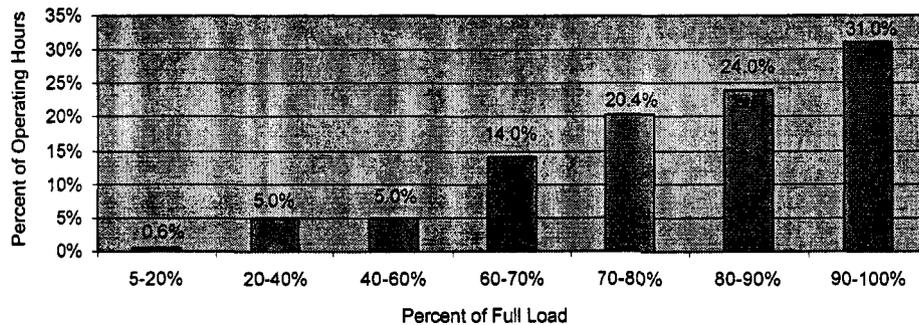
Figure 17. Hypothetical Operating Hour Breakdown for Base Loaded Scenario

The plant operating load profile determines the economic impact of the auxiliary power requirements of section 6.9. A plant that operates consistently at high loads will not gain as much benefit from a fan setup that provides high efficiency at low loads, as would a plant that has a tendency to operate at lower loads. The load profile used in this evaluation is based on historical data as discussed in section 6.1. However, Big Bend 3 may plan to operate the plant in a different manner in the future. To investigate the sensitivity of the results, a more base-loaded profile was used as shown in Figure 17.

This scenario favored the FD fan rotor replacement by an additional \$100,000 over the 20 year life. This effect is relatively insignificant.
