DATE: November 12, 2015
TO: Carlotta S. Stauffer, Commission Clerk, Office of Commission Clerk
FROM: Clayton Lewis, US Engineering Specialist, Division of Engineering *CKL*
RE: Docket No. 140219-WU- Application for staff-assisted rate case in Polk County by *JB*
Alturas Utilities, L.L.C.

**HYDROPNEUMATIC TANK
INSPECTION REPORT
FOR
THE ALTURAS WATER COMPANY**

DECEMBER 2011

**PREPARED BY
THE COLINAS GROUP, INC.
2031 E. EDGEWOOD DR. SUITE 5
LAKELAND, FL 33803
LB # 7934
For
CFDB, LLC
6039 CYPRESS GARDENS BLVD.
WINTER HAVEN, FL 33884**

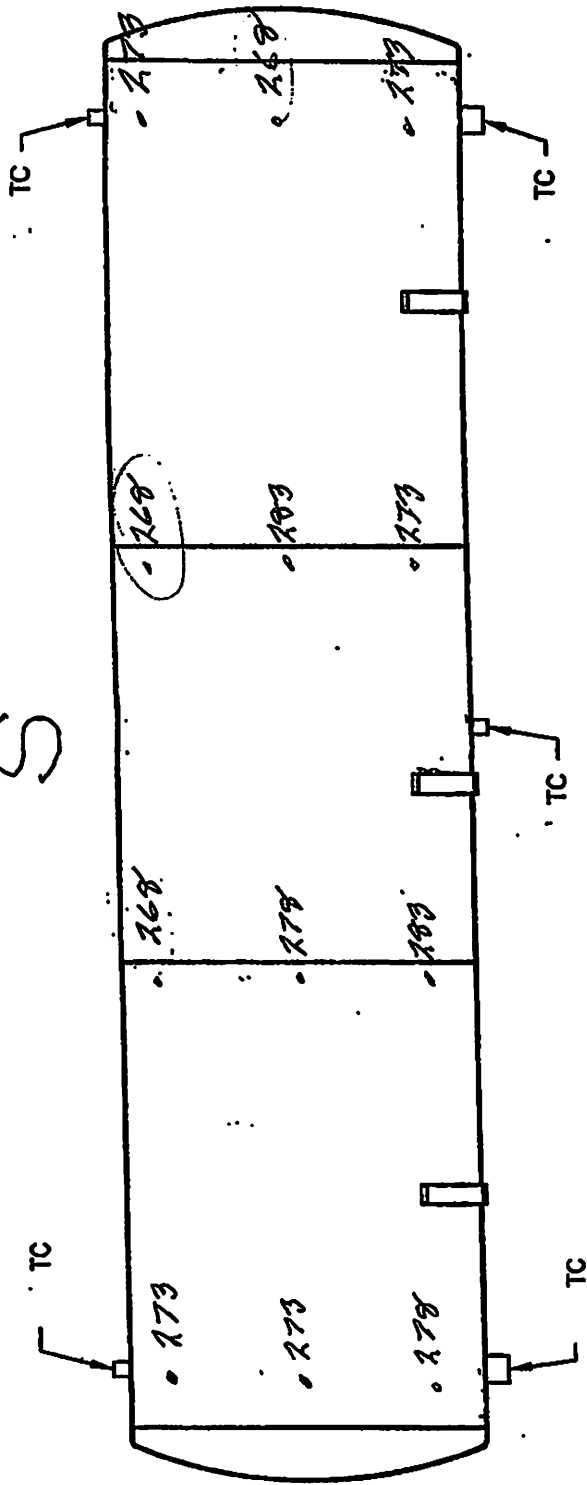
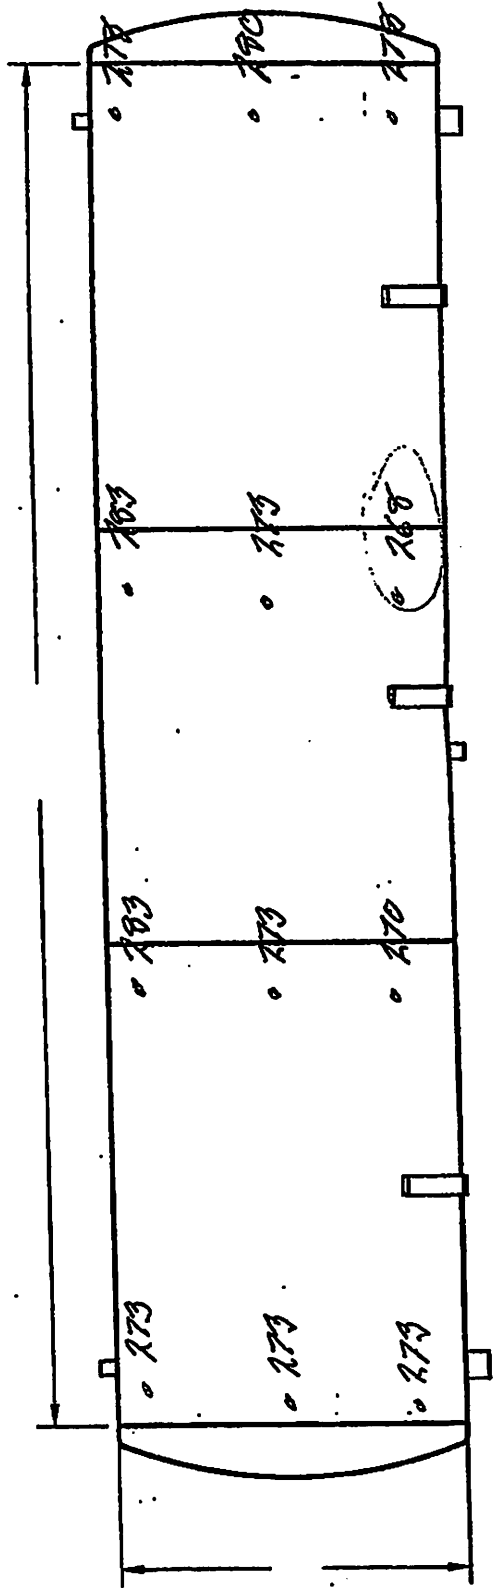
TANK DRAWINGS
AND
MEASUREMENT LOCATIONS

The tank is 22' in length and 5' in diameter. It rests on its side and is supported by three concrete cradles. The tank was installed in 2001 by the Dixie Tank Company. The plates are butt welded as are the torospherical ends. A 12" x 16" manway is located on the west end. The pressure type seal on the entrance is in good condition and was not replaced.

- The tank was measured and the inside and outside were visually inspected for rust and deterioration. The cradles are in poor condition.
- Ultrasonic thickness measurements were taken at 24 points on the shell and 9 points on each end.
- The equipment used was a Reliability Direct TM8812 Ultrasonic Thickness Gauge.
- Photographs of the interior and exterior of the tank were taken and are made a portion of this report.
