RE: Docket No. 160065-WU; Application for an increase in water rates in Charlotte County by  
Bocilla Utilities, Inc.  
Our File No. 47016.04

Attached are the responses of Bocilla Utilities, Inc., (“BUI”) to Staff’s Third Data Request dated November 8, 2016.

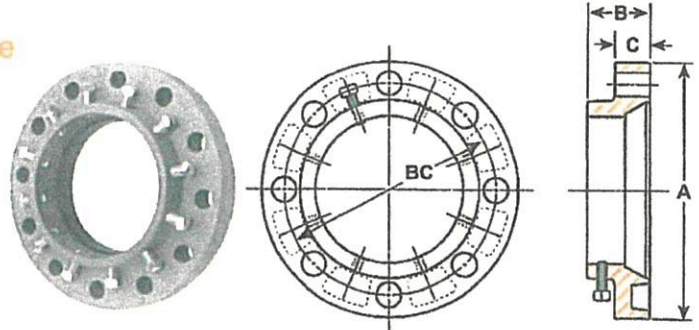
# Uni-Flange® Adapter Flanges

Series 420 Extra Heavy Adapter Flange  
for Steel and Ductile Iron Pipe  
Flange Drilling ANSI B16.1 250 lb. /  
ANSI B16.5 300 lb.  
(MATCHES CLASS F FLANGE)  
WORKING PRESSURE - 2" THROUGH 12" 400 PSI

NOM. PIPE SIZE	STEEL PIPE		DUCTILE IRON PIPE		APPROX. WT. LBS.	DIMENSIONS					SET SCREWS	
	O.D. (INCHES)	CATALOG NUMBER	O.D. (INCHES)	CATALOG NUMBER		A	B	BC	C	BOLT HOLE DIA.	SET SCREWS	
											No.	SIZE
2"	2.38	UFA420-S-2	2.50	UFA420-C-2	7.0	6-1/2"	2-1/4"	5"	1.12"	3/4"	8	1/2" x 1"
3"	3.50	UFA420-S-3	3.96	UFA420-C-3	13.0	8-1/4"	2-7/16"	6-5/8"	1.12"	7/8"	8	1/2" x 1"
4"	4.50	UFA420-S-4	4.80	UFA420-C-4	21.0	10"	2-7/16"	7-7/8"	1.25"	7/8"	8	1/2" x 1"
5"	5.56	UFA420-S-5	-	-	27.0	11"	2-9/16"	9-1/4"	1.38"	7/8"	8	5/8" x 1-1/4"
6"	6.63	UFA420-S-6	6.90	UFA420-C-6	38.0	12-1/2"	2-9/16"	10-5/8"	1.44"	7/8"	12	5/8" x 1-1/4"
8"	8.63	UFA420-S-8	9.05	UFA420-C-8	57.0	15"	2-5/8"	13"	1.62"	1"	12	5/8" x 1-1/4"
10"	10.75	UFA420-S-10	11.10	UFA420-C-10	74.0	17-1/2"	2-5/8"	15-1/4"	1.88"	1-1/8"	16	5/8" x 1-1/4"
12"	12.75	UFA420-S-12	13.20	UFA420-C-12	104.0	20-1/2"	3"	17-3/4"	2.00"	1-1/4"	16	5/8" x 1-1/4"

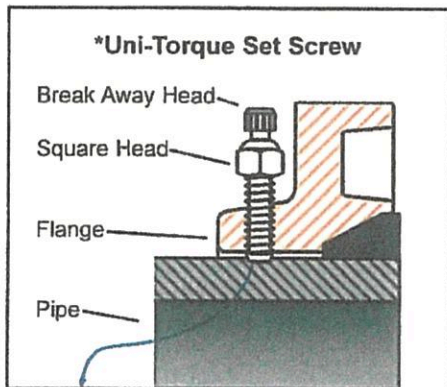
## \*Optional Uni-Torque Set Screws

*Example of how Set screw system works*

*Deformation*

Optional Uni-Torque Set Screws are available for use with Uni-Flange® Adapters, 2" through 16" nominal pipe sizes with the pipe thickness shown in the table below. These set screws feature a "break away head" that shears at the recommended torque for the recommended pipe (see table below), leaving a square head that can be used if future removal of the flange is required. To order an adapter flange with Uni-Torque set screws add "-UT" to the catalog number. Example: UFA200-S-2-UT.

\* **Caution:** Uni-Torque set screws should not be used on steel pipe thinner than schedule 40 or ductile iron pipe thinner than class 52.

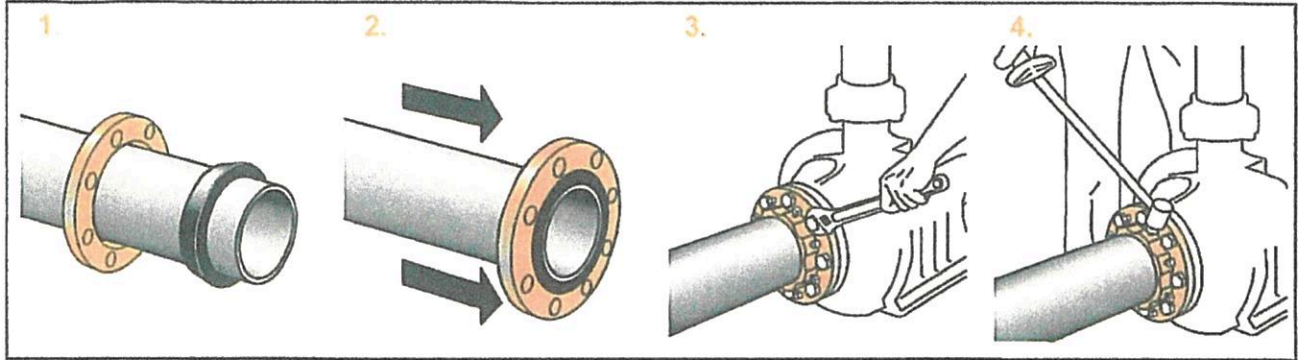
# Uni-Flange® Installation Instructions

1. Pipe end should be cut square for most installations. (Deflected joints may require angular cut. See deflection chart on page 11.) Remove burrs and bevels. Scrape and clean the plain end of the pipe to ensure proper bare metal surface for set screw engagement and gasket seal. Thoroughly lubricate the pipe and gasket with a soap based pipe lubricant. Slide the flange onto the pipe with the gasket cavity facing the end of the pipe. Slide the lubricated gasket over the pipe end with the tapered end facing the gasket cavity in the flange. (No other gasket is necessary or should be used to seal the flange faces.)

2. Slide the flange forward until the gasket is evenly seated in the flange cavity and the Uni-Flange® face is flush with the end of the pipe. (The end of the pipe should butt against the facing flange, it cannot be more than 1/4" from the facing flange.) Hand tighten the set screws against the pipe surface.

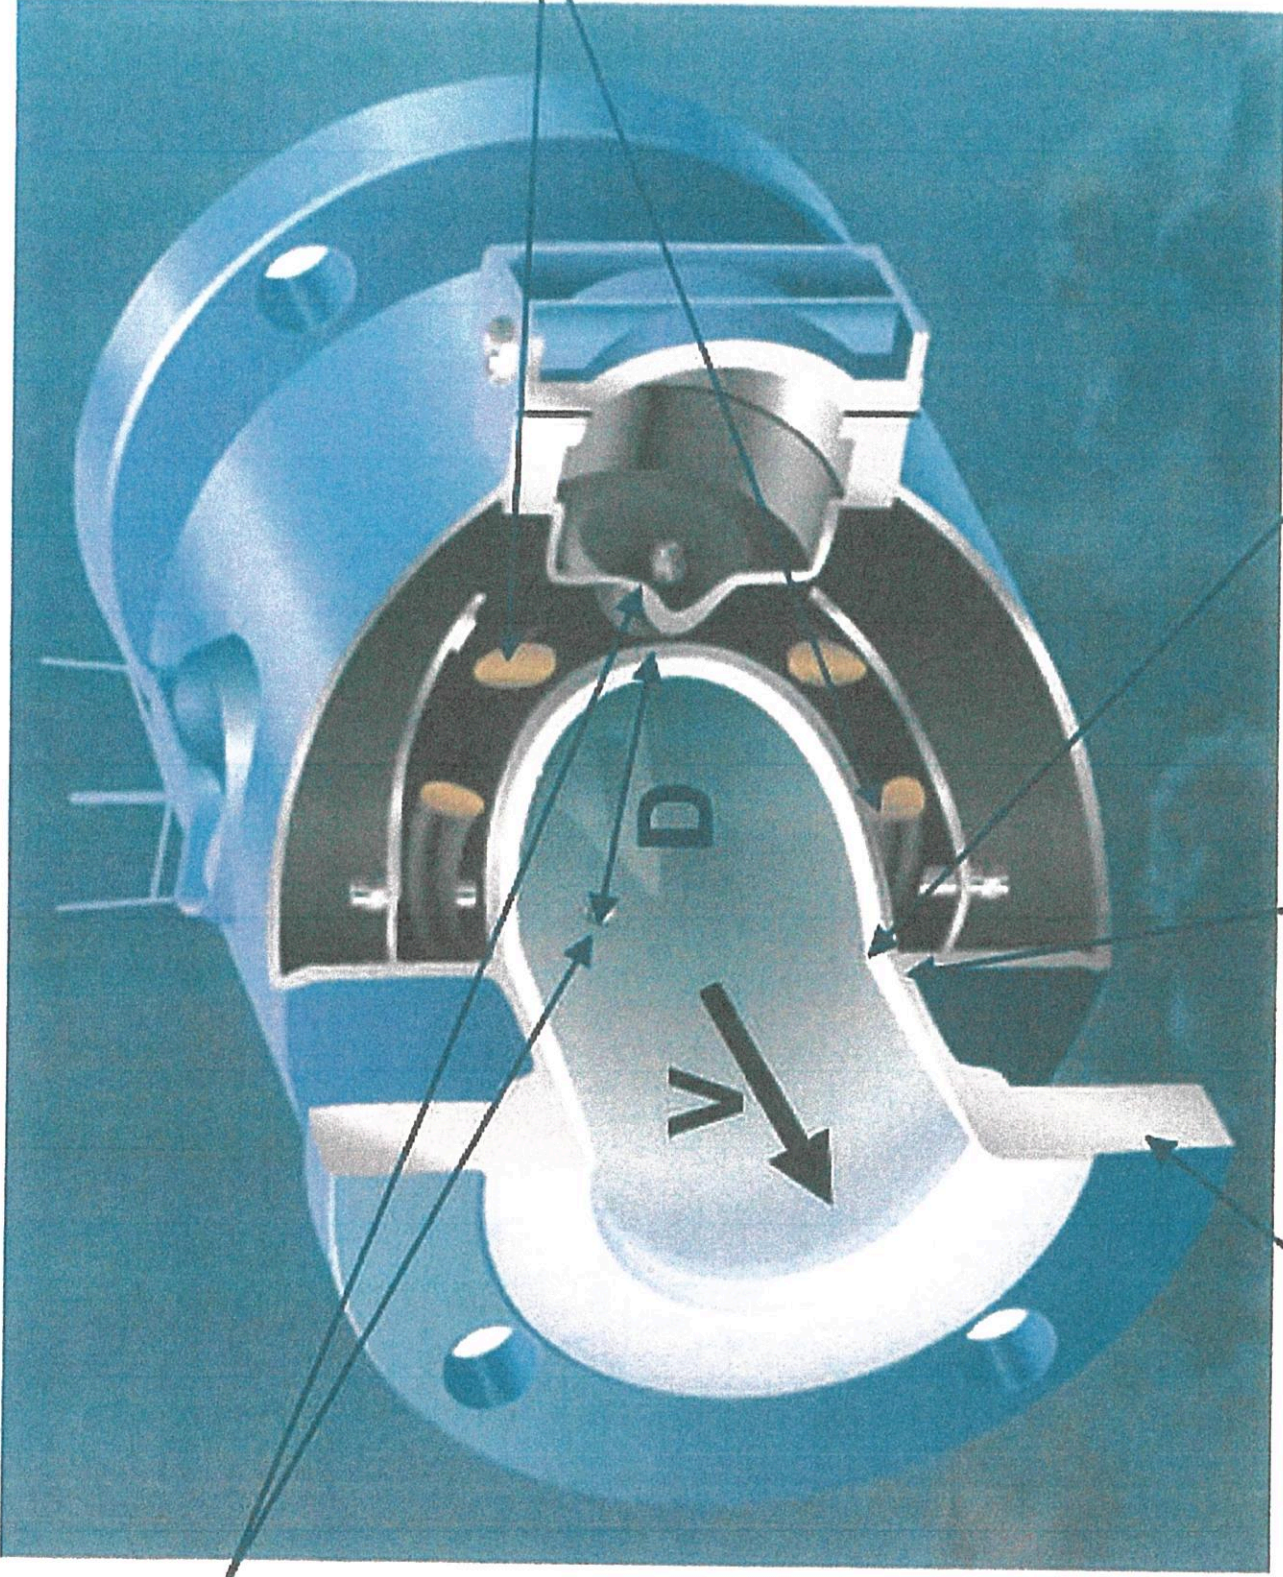
# OPERATION AND MAINTENANCE MANUAL

5-1/4" B-84-B-5  
FIRE HYDRANT
