BEFORE THE FLORIDA PUBLIC SERVICE COMMISSION

DOCKET NO. 20240001-EI - Fuel and purchased power cost recovery clause with generating performance incentive factor.

WITNESS: Direct Testimony of Carl Vinson appearing on behalf of the Staff of the Florida Public Service Commission

Review of  
**Nuclear Operations**  
Florida Power & Light Company

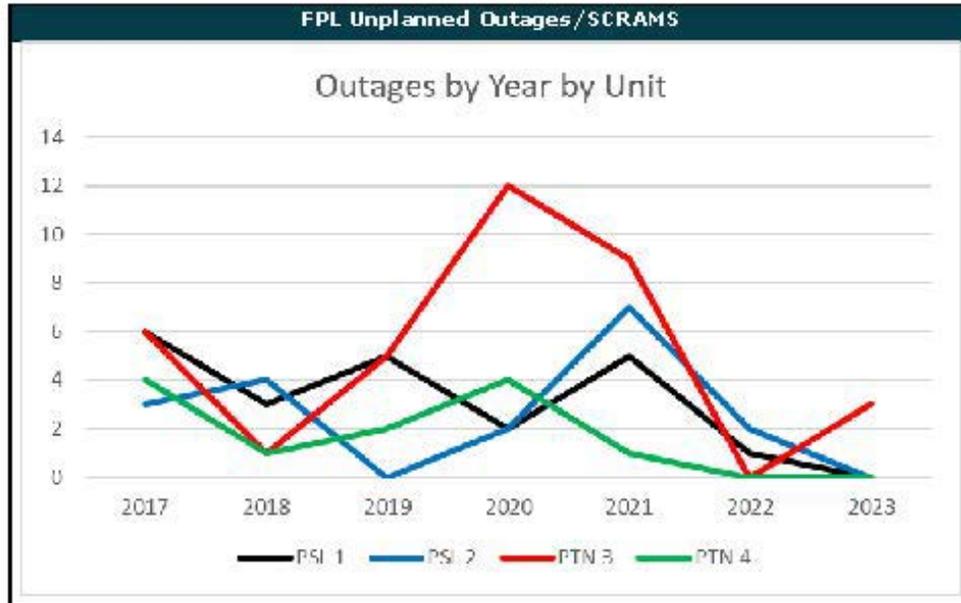
**Exhibit 1**

Commission audit staff reviewed the outage record for both PTN and PSL over the years 2017 through mid-2023, a period during which over 80 planned, forced, and partially-forced outages occurred. **Exhibit I** below depicts FPL's unplanned outages and SCRAMS for each units separately over the 2017 through 2023 period. Unplanned outages for both PTN 3 and PTN 4 peaked in 2020. PSL 1 and PSL 2 unplanned outages peaked in 2021.

*Source: Document Response 1-20*
