*Review of Florida's Electric Utility Hurricane
Preparedness and Restoration Actions
2018*

**State of Florida
Florida Public Service Commission**

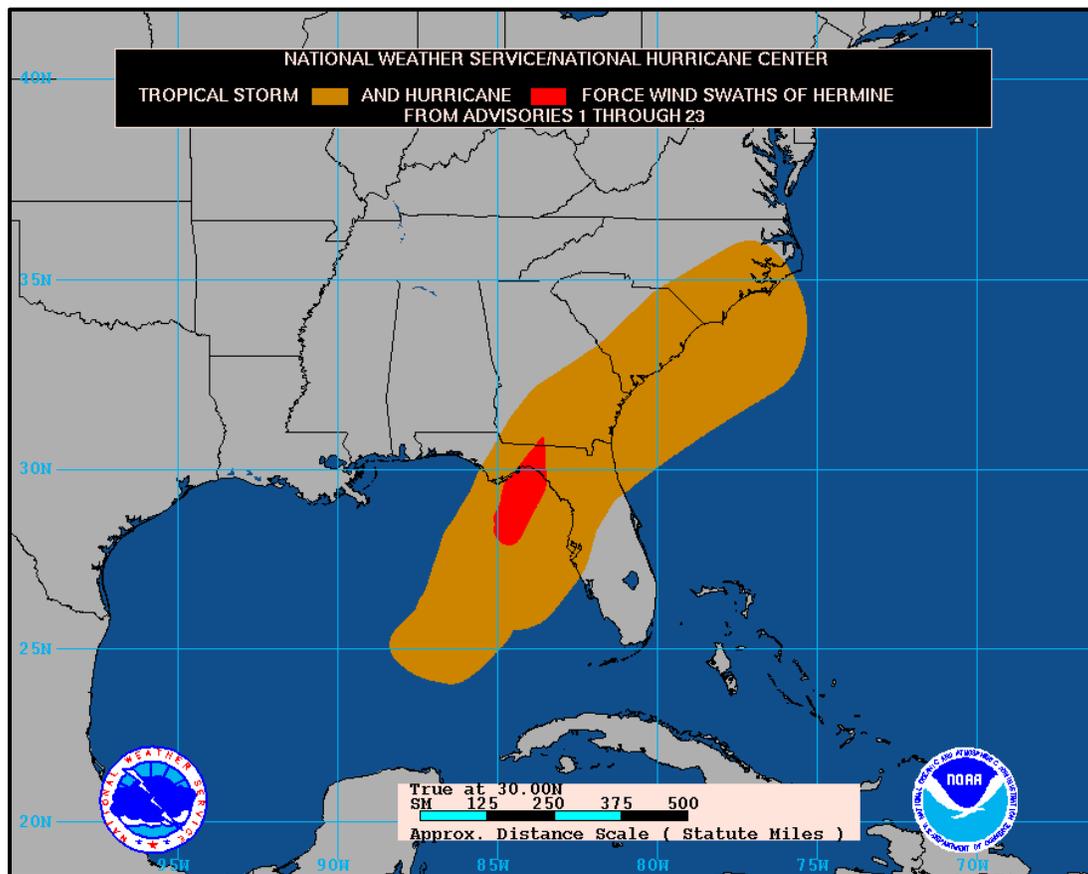
Figure 3-1
Hurricane Hermine – Tropical Storm and Hurricane Force Winds

Hurricane Hermine made landfall on September 2, 2016, near Wakulla and Jefferson counties. Hurricane Hermine was a Category 1 hurricane when it made landfall, primarily affecting the Big Bend area. Figure 3-1 illustrates the path of Hurricane Hermine, and the areas that experienced tropical storm and hurricane force winds. The National Hurricane Center defines tropical storm force winds as winds between 39 miles per hour (mph) to 73 mph. Winds that are equal to or exceeding 74 mph are defined as hurricane force winds.

Wind, rainfall, and storm surge data was requested from IOUs, Municipals, and Cooperatives for each hurricane. A total of 36 utilities provided data and the maximum reported sustained winds, wind gusts, rainfall, and storm surge for Hurricane Hermine, summarized in Appendix C. The three counties that experienced some of the highest sustained winds and wind gusts from Hermine were Jefferson, Madison, and Taylor. These counties also received high levels of

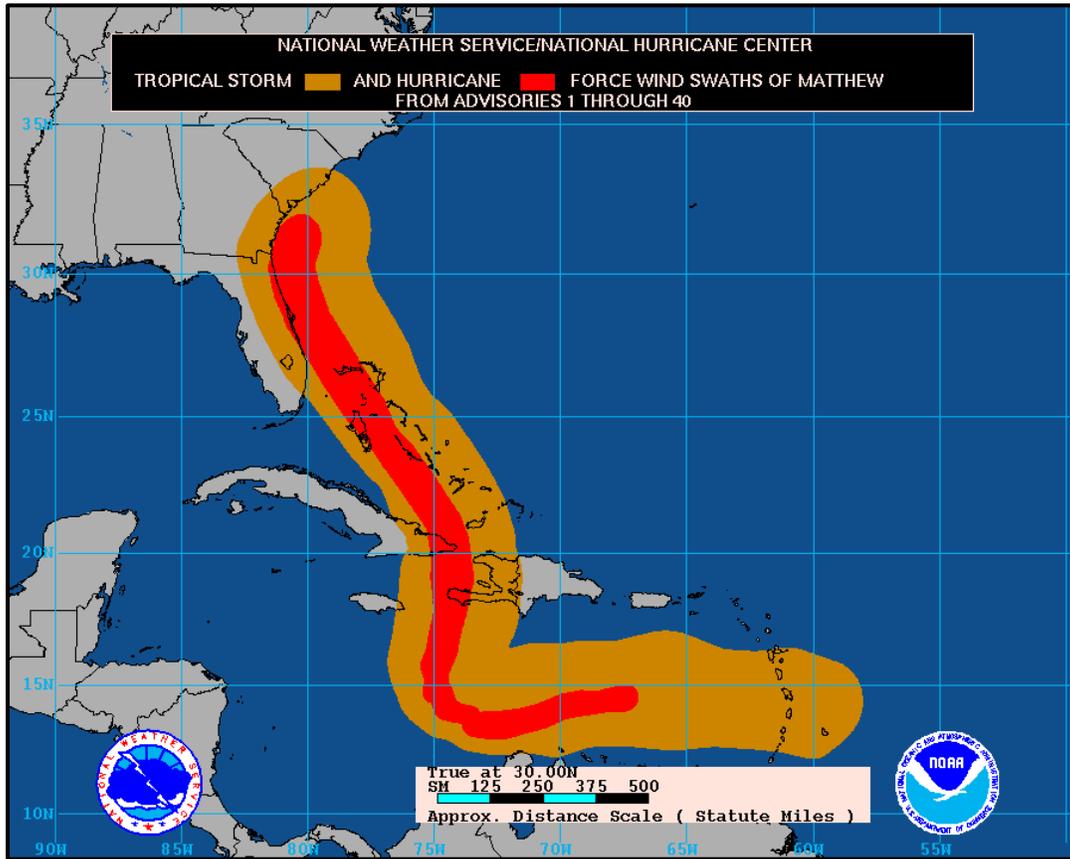
**Figure 3-2
Hurricane Matthew – Tropical Storm and Hurricane Force Winds**

While Hurricane Matthew never made landfall in Florida, it passed along Florida's east coast shoreline, where some areas experienced sustained hurricane force winds. Hurricane Matthew began as a Category 4 hurricane on October 7, 2016, but weakened and later became a Category 2 hurricane northeast of Jacksonville Beach on October 8, 2016. Figure 3-2 illustrates the path of Hurricane Matthew, and the areas that experienced tropical storm and hurricane force winds.

Wind speed, rainfall, and storm surge data for Hurricane Matthew is contained in Appendix D. The three counties that experienced some of the highest sustained winds and wind gusts for Hurricane Matthew were Brevard, St. Johns, and Volusia. From the reported rainfall data, the counties with the three highest amounts of rainfall were Brevard, Indian River, and St. Lucie. The three counties that had the largest storm surges were Flagler, Nassau, and St. Johns. All of these counties are located on Florida's east coast and correspond to the path of the storm. Table 3-2 provides the five counties with the highest number of outages for Hurricane Matthew. The total peak percentage of customer accounts in the state without power was 11 percent.

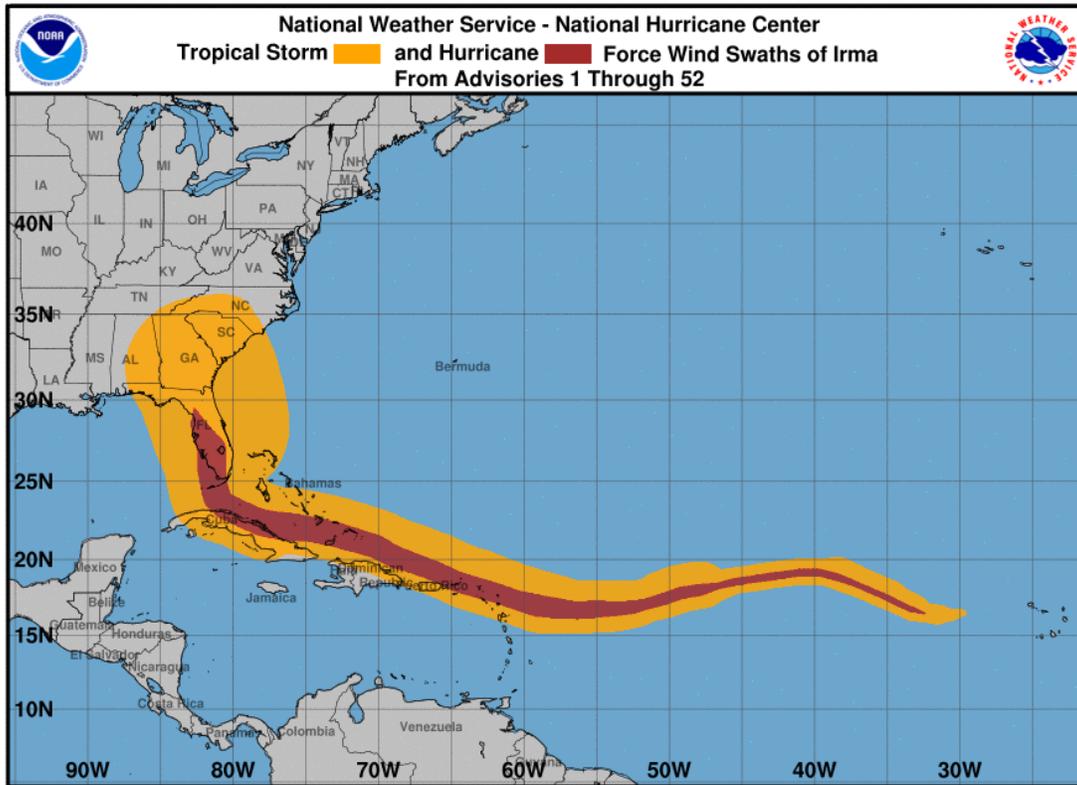
**Figure 3-3
Hurricane Irma – Tropical Storm and Hurricane Force Winds**

Hurricane Irma was the first major hurricane to make landfall in Florida since the 2004 and 2005 hurricane seasons. On September 10, 2017, Hurricane Irma made landfall in the Florida Keys as a Category 4 hurricane and weakened to a Category 3 hurricane as it made a second landfall near Marco Island, Florida on the same day. The storm continued to weaken as it moved over Florida, affecting all 67 counties in the state and resulting in widespread power outages. Figure 3-3 illustrates the path of Hurricane Irma, and the areas that experienced tropical storm and hurricane force winds.

Wind speed, rainfall, and storm surge data for Hurricane Irma is contained in Appendix E. The three counties that experienced the highest maximum sustained winds for Hurricane Irma were Collier, Monroe, and Polk. The largest amount of rainfall was reported for Bradford, Hillsborough, and St. Lucie counties. The three counties that had the largest maximum storm surge were Collier, Monroe, and Nassau. Due to the path of Hurricane Irma, many of the southernmost counties, such as Monroe and Collier, experienced high winds and storm surges, while parts of central Florida had large amounts of rain. Additionally, parts of northeast Florida, such as Nassau County, experienced high winds and storm surges due to the outer bands and the path of the storm.

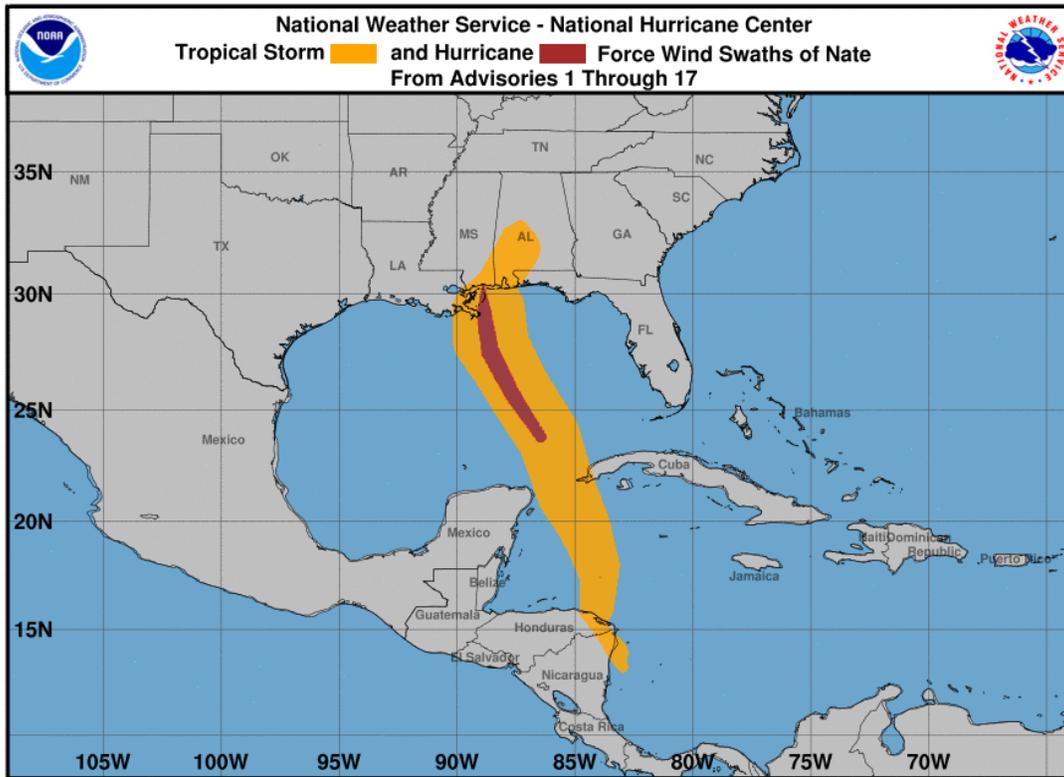
**Figure 3-4
Hurricane Nate – Tropical Storm and Hurricane Force Winds**

On October 7, 2017, Florida was impacted by a second storm, Hurricane Nate, which made its first landfall at the mouth of the Mississippi River as a Category 1 hurricane, followed by a second landfall near Biloxi, Mississippi on the same day. While Hurricane Nate did not make landfall in Florida, parts of the panhandle were impacted by the hurricane. Figure 3-4 illustrates the path of Hurricane Nate, and the areas that experienced tropical storm and hurricane force winds.

Wind speed, rainfall, and storm surge data for Hurricane Nate is contained in Appendix F. The impact of Hurricane Nate was much smaller in scope compared to the previous three hurricanes. The three counties that experienced the highest sustained winds, wind gusts, and rainfall were Escambia, Okaloosa, and Santa Rosa. The three counties that had the highest storm surges were Escambia, Franklin, and Santa Rosa. All of these counties are located in Florida’s panhandle, close to where Hurricane Nate made landfall. Table 3-4 provides the five counties with the highest number of outages for Hurricane Nate. The total peak percentage of accounts in the state without power was 0.1 percent.

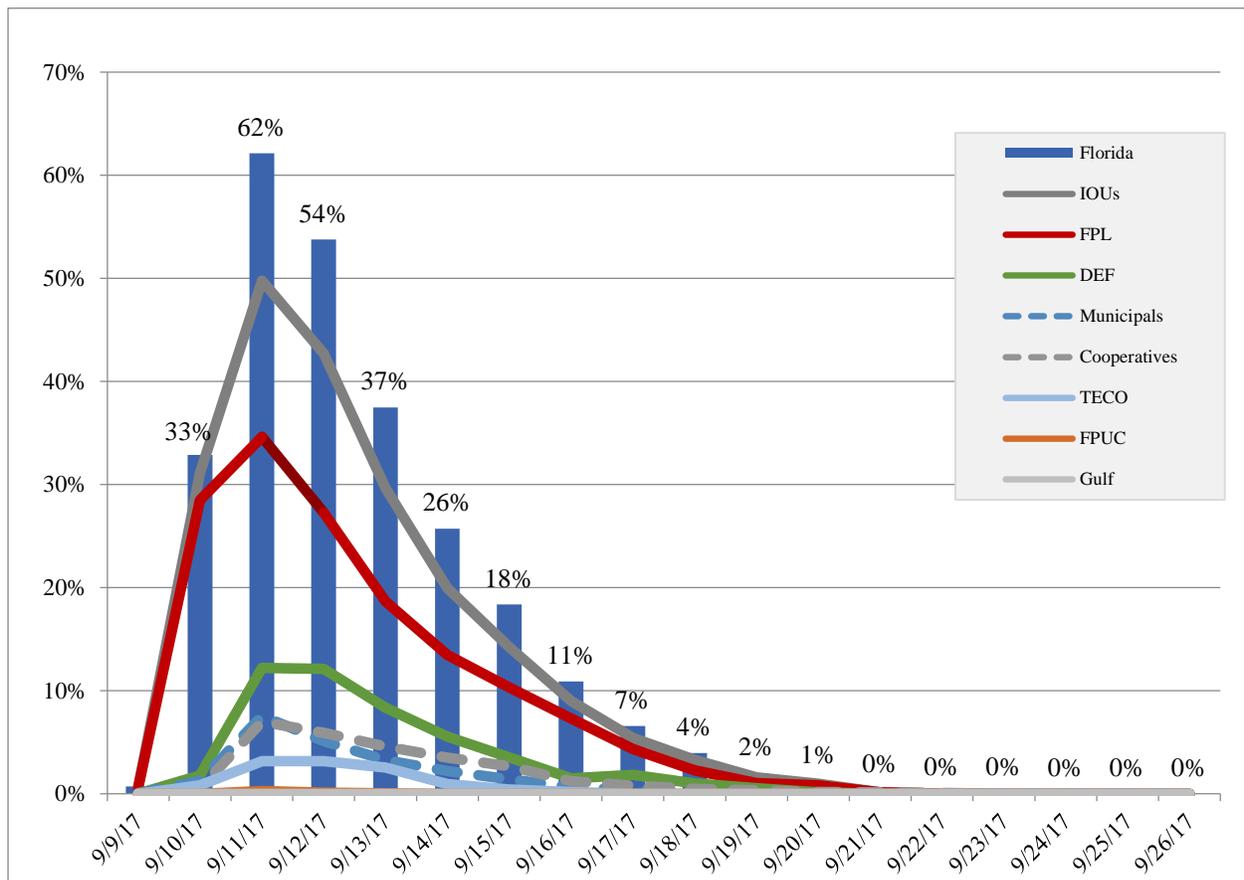
Figure 4-1
Hurricane Irma – Percent of Florida's Total Customers without Power

Using outage data reported to DEM, Figure 4-1 provides the number of customer accounts without power in proportion to the total number of customers in the state. The peak outages occurred on September 11, 2017, when more than 6.5 million customers (62 percent of the state's approximately 10.5 million customers) were without power. Five days following this peak, the number of outages dropped to approximately 11 percent. On September 20, 2017, ten days following the outage peak, the percent of customer accounts without power dropped below 1 percent.

Note: Individual utility outage maximums occurred at different times and do not add to the total.

Overall, Figures 4-1 and 4-2 illustrate that the graphs for IOUs are similar in shape to the Municipals and Cooperatives, demonstrating comparable power restoration achievements for the different utility groups. No irregularities were observed in the data.

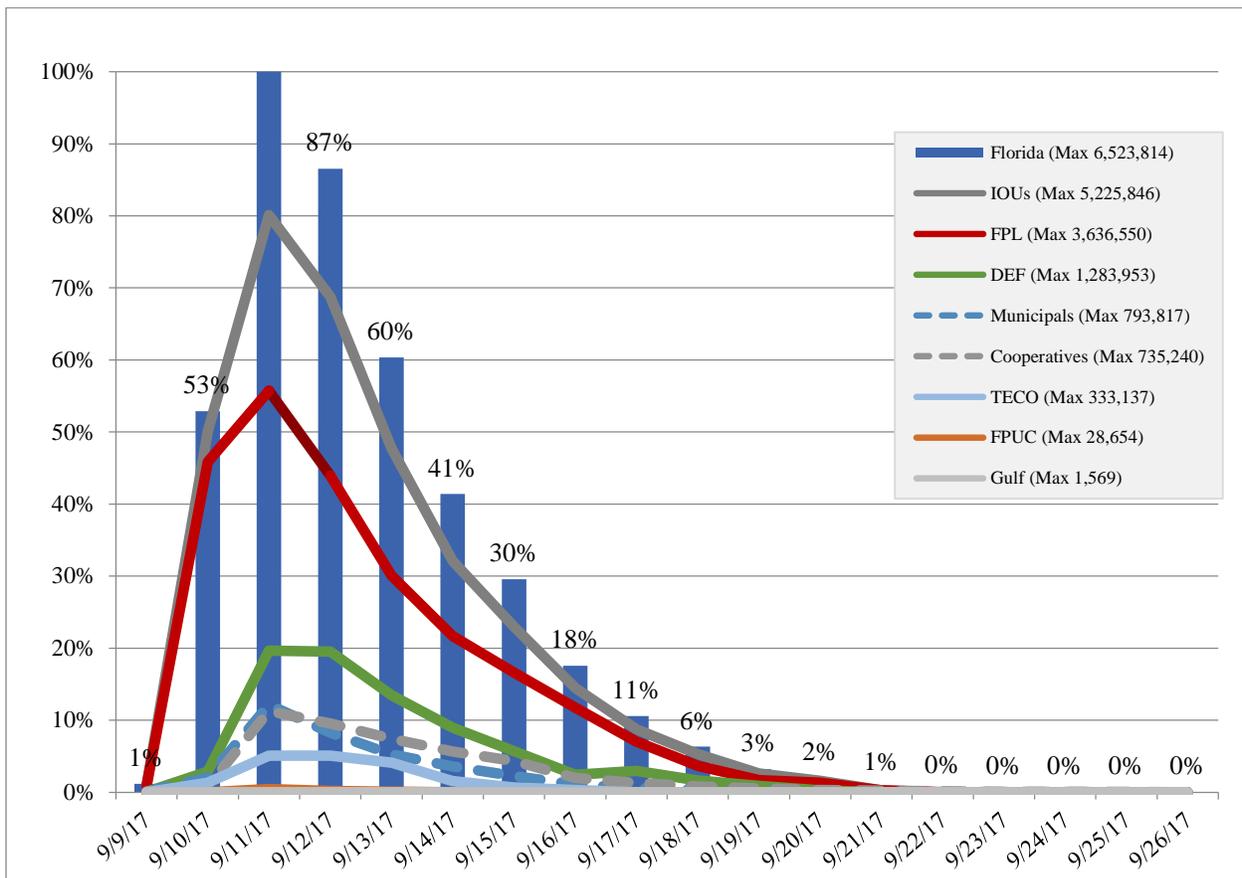
Figure 4-2
Hurricane Irma – Percent of Affected Customers without Power

As previously stated, the peak number of outages occurred on September 11, 2017. Figure 4-2 provides the daily percentages of customers without power based on the peak outages. Following September 11, 2017, the proportion of affected customers that were still without power was below 50 percent three days later on September 14, 2017. Additionally, by September 20, 2017, the number of customers that were without power dropped to 2 percent. For several utilities, once the number of customers without power dropped to 2 percent or less, the utility stopped reporting outages to the DEM as these outages could be unrelated to the storm event.

Note: Individual utility outage maximums occurred at different times and do not add to the total.
