Review of  
**Nuclear Operations**

**Florida Power & Light Company**

January 2024

**PA 23-03-002**

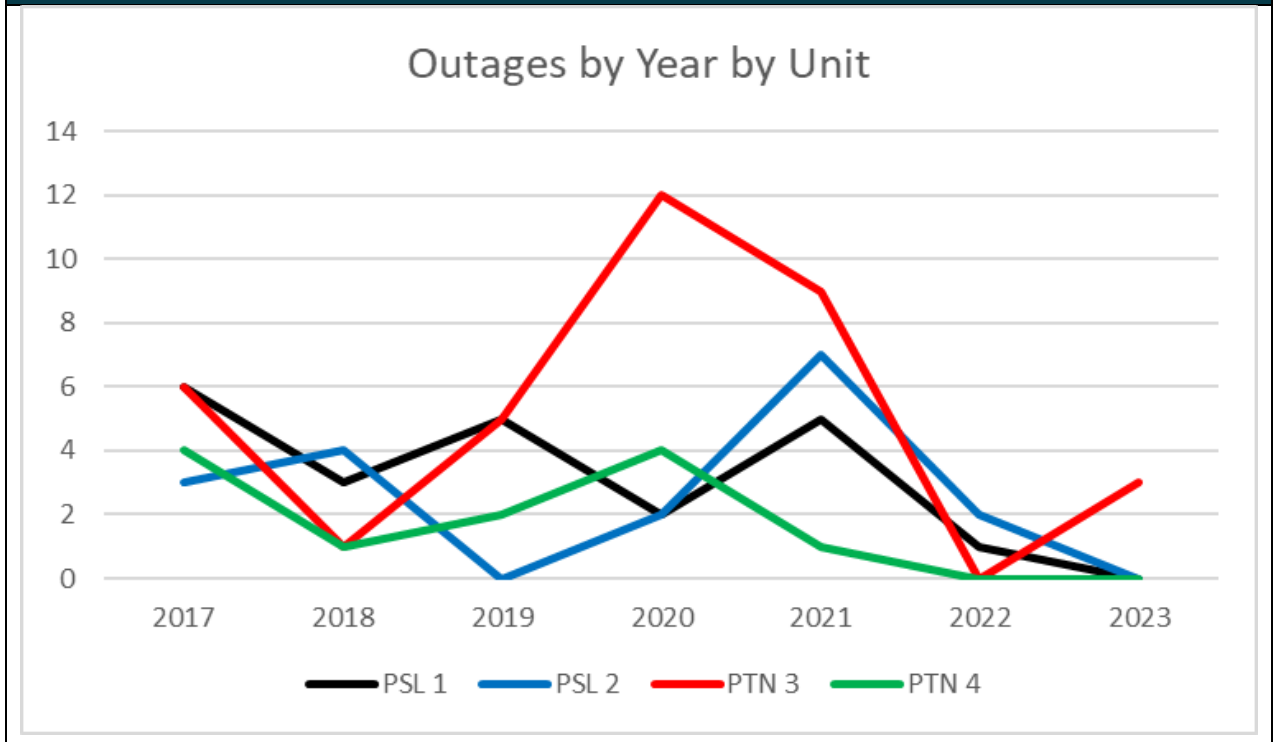
## FPL Unplanned Outages/SCRAMS

Commission audit staff reviewed the outage record for both PTN and PSL over the years 2017 through mid-2023, a period during which over 80 planned, forced, and partially-forced outages occurred. **Exhibit 1** below depicts FPL's unplanned outages and SCRAMS for each units separately over the 2017 through 2023 period. Unplanned outages for both PTN 3 and PTN 4 peaked in 2020. PSL 1 and PSL 2 unplanned outages peaked in 2021.
