Review of
Electric Service Quality and Reliability

December 1997

By Authority of
The State of Florida for
The Public Service Commission
Division of Research and Regulatory Review
Bureau of Regulatory Review

RR-97-01-002

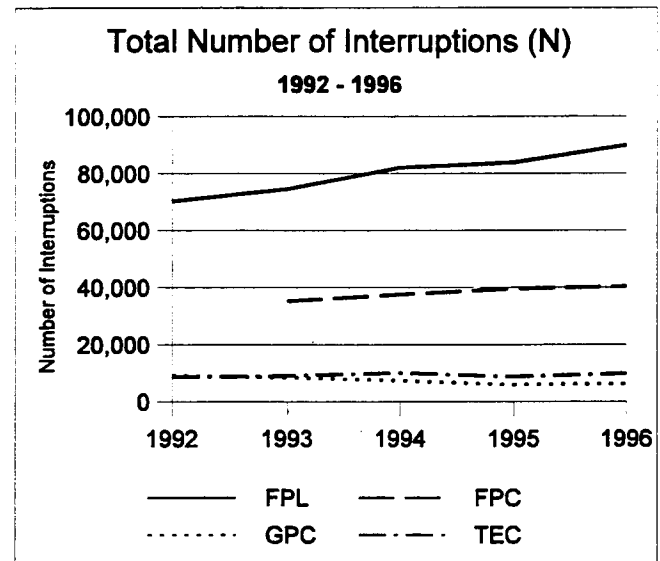
EXHIBIT GEN-1 Source: FPSC Reliability Reports.

Exhibits GEN-1 and GEN-2 display the trends in numbers of interruptions experienced by each of the utilities examined in this review as reported in the Distribution Service Reliability Reports over the period 1992 through 1996. Exhibit GEN-1 shows the trend in actual total interruptions, while Exhibit GEN-2 equalizes for the size differences between these companies by presenting the interruption data on a per 1,000 customer basis.

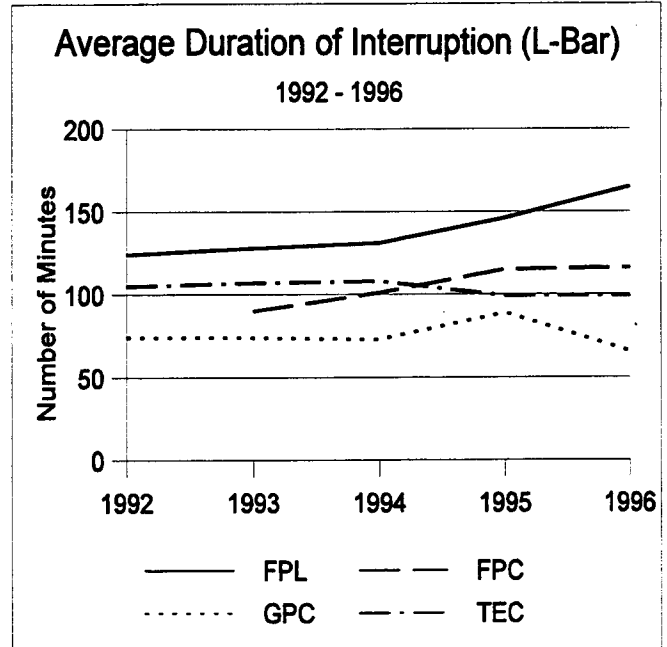
EXHIBIT GEN-3 Source: FPSC Reliability Reports.

Exhibit GEN-3 displays the trend in average duration of interruptions (L-Bar) over the 1992 through 1996 period. The calculation of L-Bar provides a simple average of all interruptions, but does not provide a “weighting” to adjust for the number of customers interrupted.

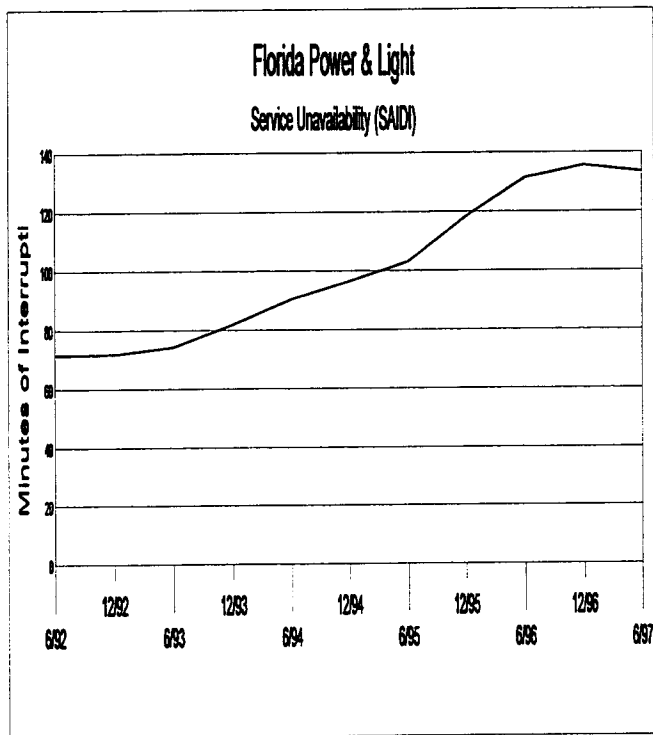
EXHIBIT FPL-5 Source: FPL Response to Document Request 2-9.

The primary indicator of overall system distribution service quality tracked by FPL today is the service unavailability index. Exhibit FPL-5 graphically displays service unavailability data

“L-Bar” indicator of average interruption duration, SU (SAIDI) also reflects the impact of the vast majority of customers who actually experience zero or very few minutes of interruptions. Therefore SU (SAIDI) provides an overall, weighted-average picture of total system interruption time, while L-Bar shows the average length of all interruptions without regard for the number of customers affected.

for FPL for the period from June 1992 through June 1997. Within this five-year period, the average FPL-served customer experienced a nearly 100 percent increase in total annual interruption time as measured by service unavailability. An analysis of individual service unavailability results for FPL’s 15 geographical service areas indicated this increase was experienced throughout FPL’s service territory, rather than being isolated to just a few areas.

The service unavailability index, also abbreviated “SU,” indicates the system-wide annual number of minutes of service interruption experienced by the average customer served by FPL. SU is equivalent to System Average Interruption Duration Index (SAIDI) discussed in section 2.2.1 of the report, which is widely used throughout the electric industry. Although it is similar in some ways to the FPSC Reliability Report’s

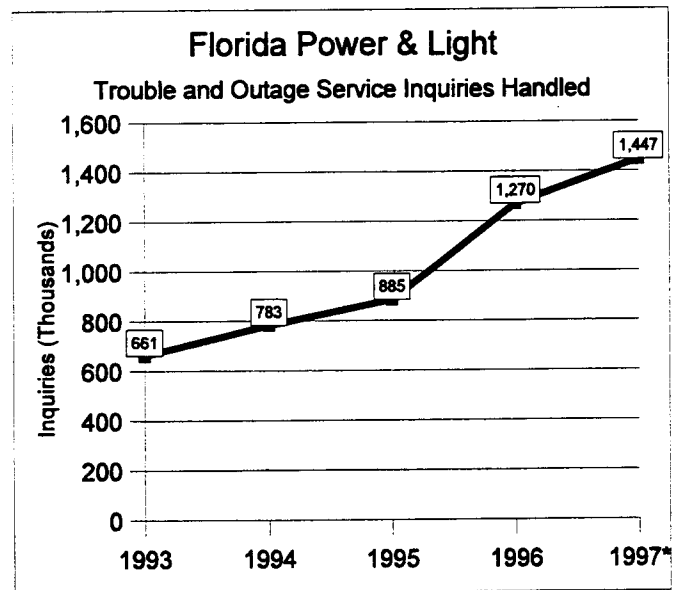
EXHIBIT FPL-9 Source: FPL Response to Document Request 4-23.

Over the same period, incoming inquiries relating to trouble reports or outages increased by 119 percent, as shown in Exhibit FPL-9. With inquiries regarding trouble reports and outages growing at over four times the rate of total inquiries including billing and all other topics, it is clear that problems affecting service quality were increasingly an issue of concern to FPL's customers over the study period.

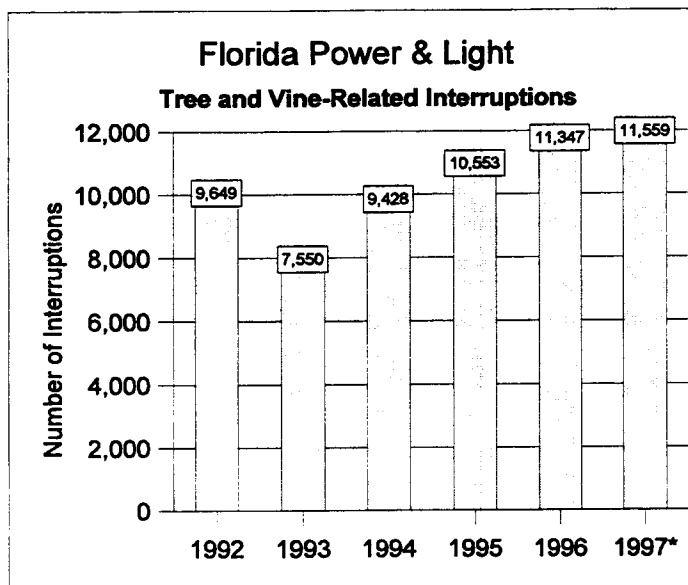
EXHIBIT FPL-16 Source: FPL Response to Document Request 3-10.

Exhibits FPL-16 and FPL-17 depict both tree and vine-related outages and tree-

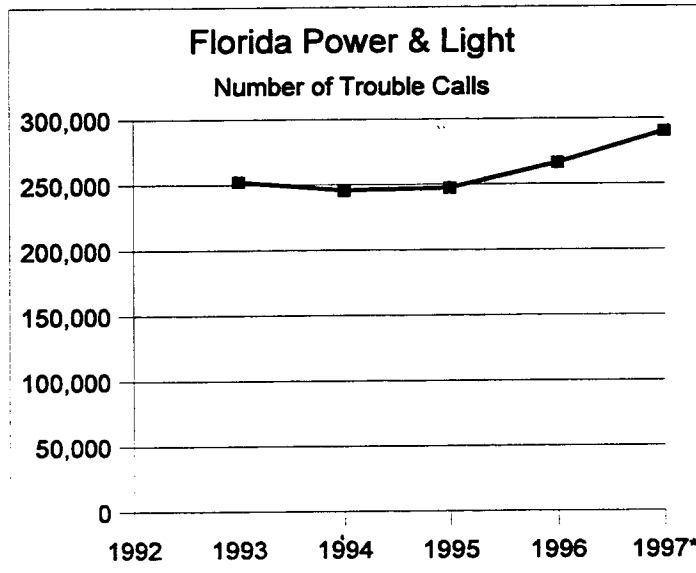
EXHIBIT FPL-23

The total volume of trouble tickets handled can provide a measure of repair workload and frequency of problems experienced by customers. The number of trouble tickets created and investigated by FPL has increased in recent years, as shown in Exhibit FPL-23. After decreasing from a high point in 1993, caused in part by the effects of Hurricane Andrew, the number of trouble tickets held steady in 1994 and 1995. Then, trouble tickets increased by 7.7% in 1996, and based upon the 1997 count through September, could grow another 8.9% for the year.

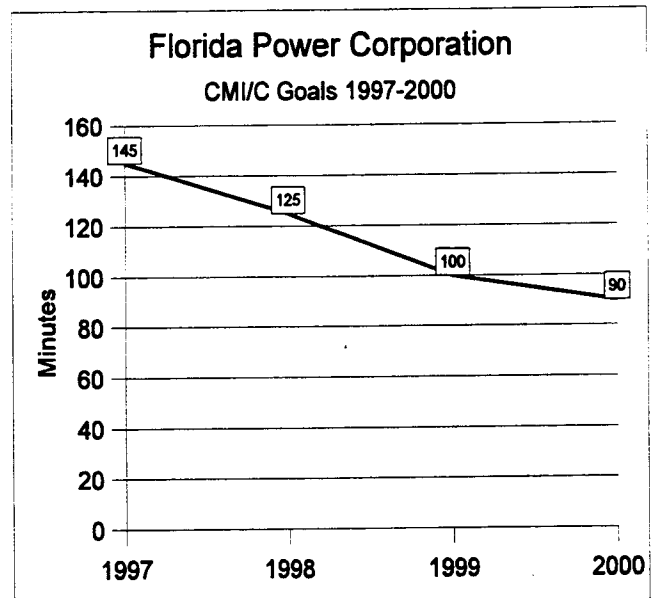
EXHIBIT FPC-6

A component of CMI/C is the average outage duration for customers interrupted, otherwise known as CAIDI (Customer Average Interruption Duration Index) in the electric industry. CAIDI is determined by dividing the sum of all customer minutes of interruption by the number of customer interruptions. CAIDI is FPC's primary internal indicator for measuring response

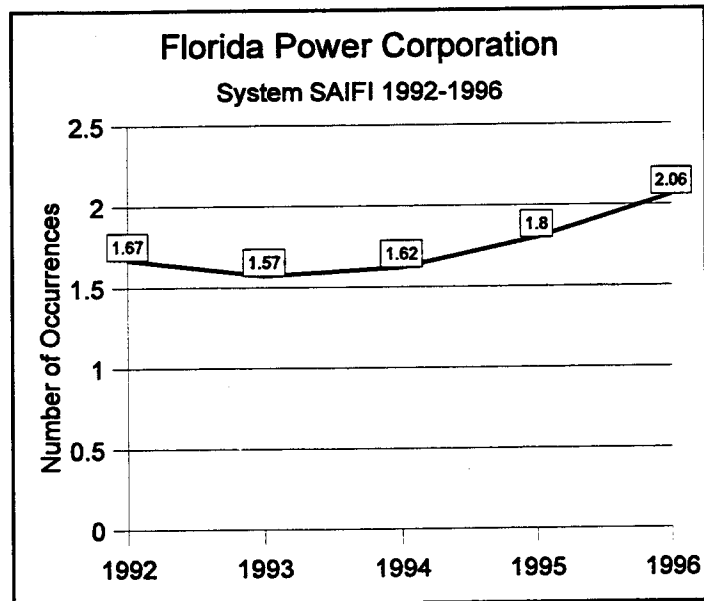
EXHIBIT FPC-8

- Average number of customers whose service is interrupted by each interruption (ACPI).
- Multiple interruptions to the same customer (CAIFI).
- Percentage of customers having more than five interruptions.
- Percentage of customer minutes of interruption greater than two hours.
- Percentage of time during a given year that an average customer was in service (ASAI).
