REVIEW OF

FLORIDA'S
INVESTOR-OWNED
ELECTRIC UTILITIES

SERVICE RELIABILITY REPORTS

FLORIDA PUBLIC SERVICE COMMISSION
DIVISION OF ENGINEERING

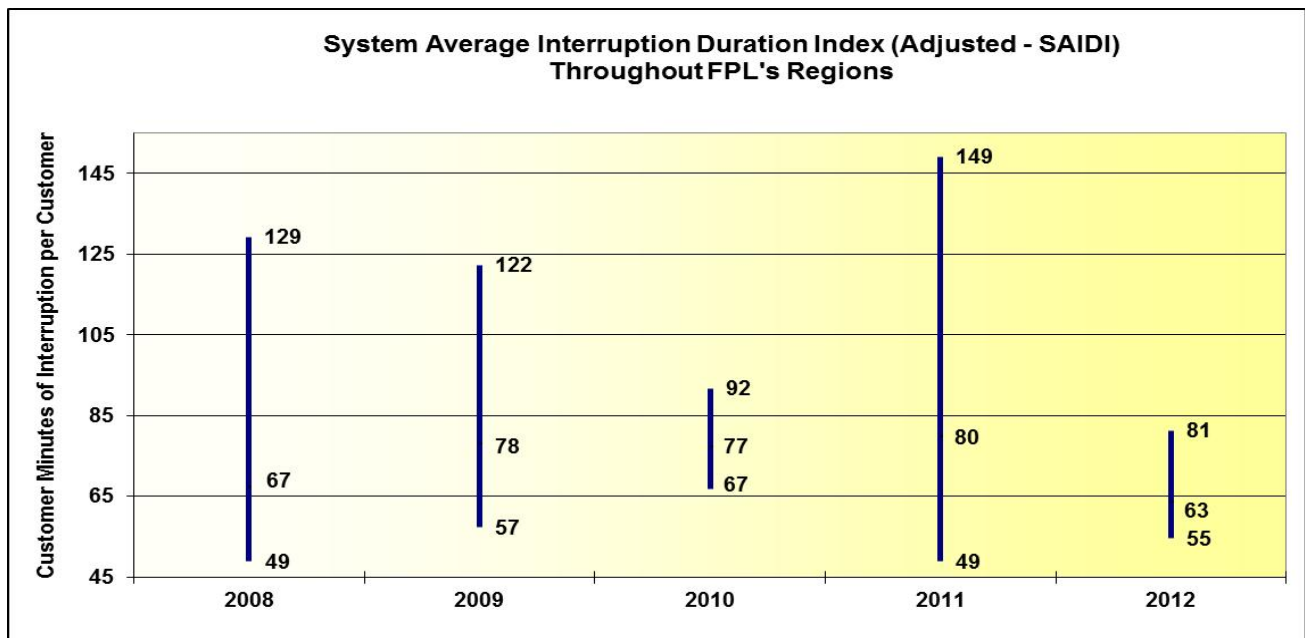
Figure 3-1. SAIDI ACROSS FPL’S SIXTEEN REGIONS (ADJUSTED)

Figure 3-1 shows the highest, average, and lowest adjusted SAIDI recorded across FPL’s system that encompasses four management regions with 16 service areas. The highest and lowest SAIDI values are the values reported for a particular service area. FPL had an overall decrease of 17 minutes (21 percent) to the average SAIDI results for 2012 compared to 2011. The average SAIDI appears to be slightly trending downward over the five-year period of 2008 through 2012. The 2012 average SAIDI results are the lowest (best) for the five-year period. “FPL primarily attributes this excellent performance to its targeted reliability initiatives.”¹⁶

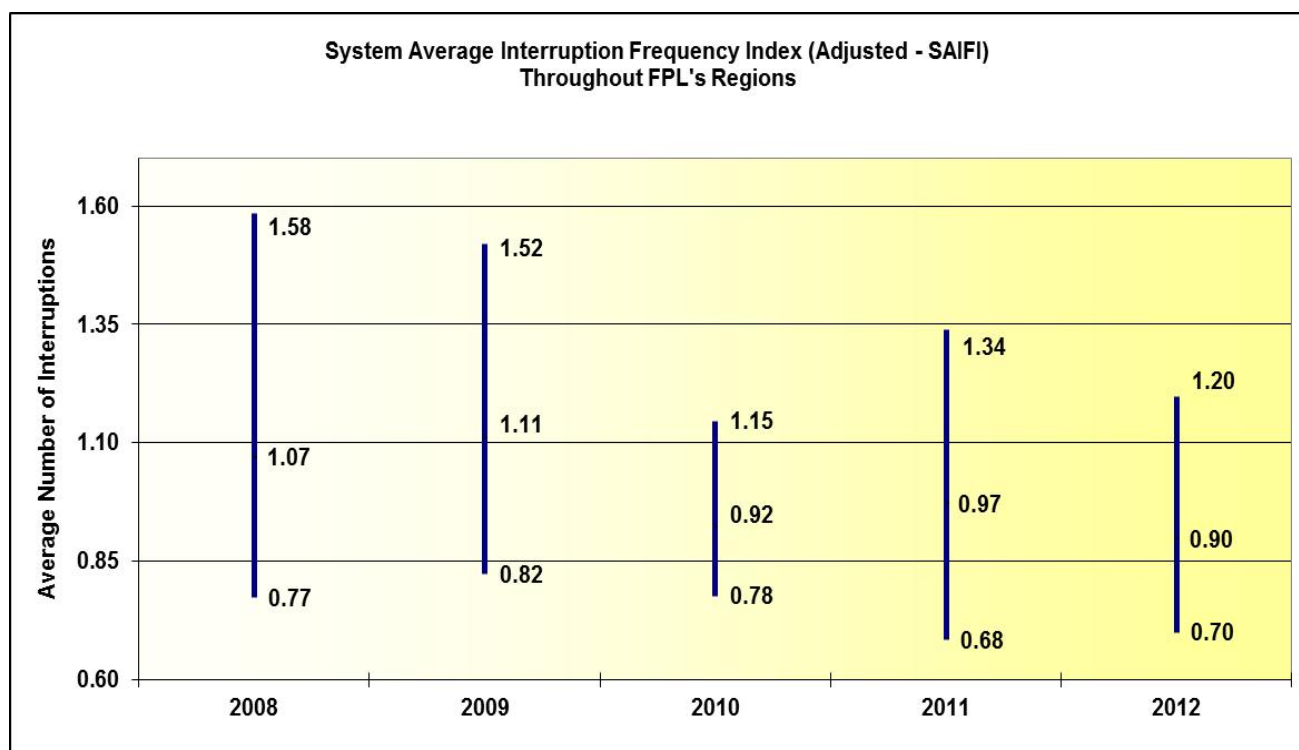
Figure 3-2. SAIFI ACROSS FPL'S SIXTEEN REGIONS (ADJUSTED)

Figure 3-2 is a chart of the highest, average, and lowest adjusted SAIFI across FPL's system. FPL had a decrease in the system average results to 0.90 outages in 2012, compared to 0.97 outages in 2011, which is a 7 percent decrease. FPL reported a decrease to the highest SAIFI for West Dade of 1.20 interruptions in 2012 compared to North Florida's 1.34 interruptions in 2011. The region reporting the lowest adjusted SAIFI for 2012 was North Dade at 0.70 interruptions compared to Central Dade's 0.68 interruptions in 2011. The highest, average and lowest SAIFI appear to be trending downward suggesting improvements. The 2012 average SAIFI results are the lowest (best) for the five-year period of 2008 through 2012.

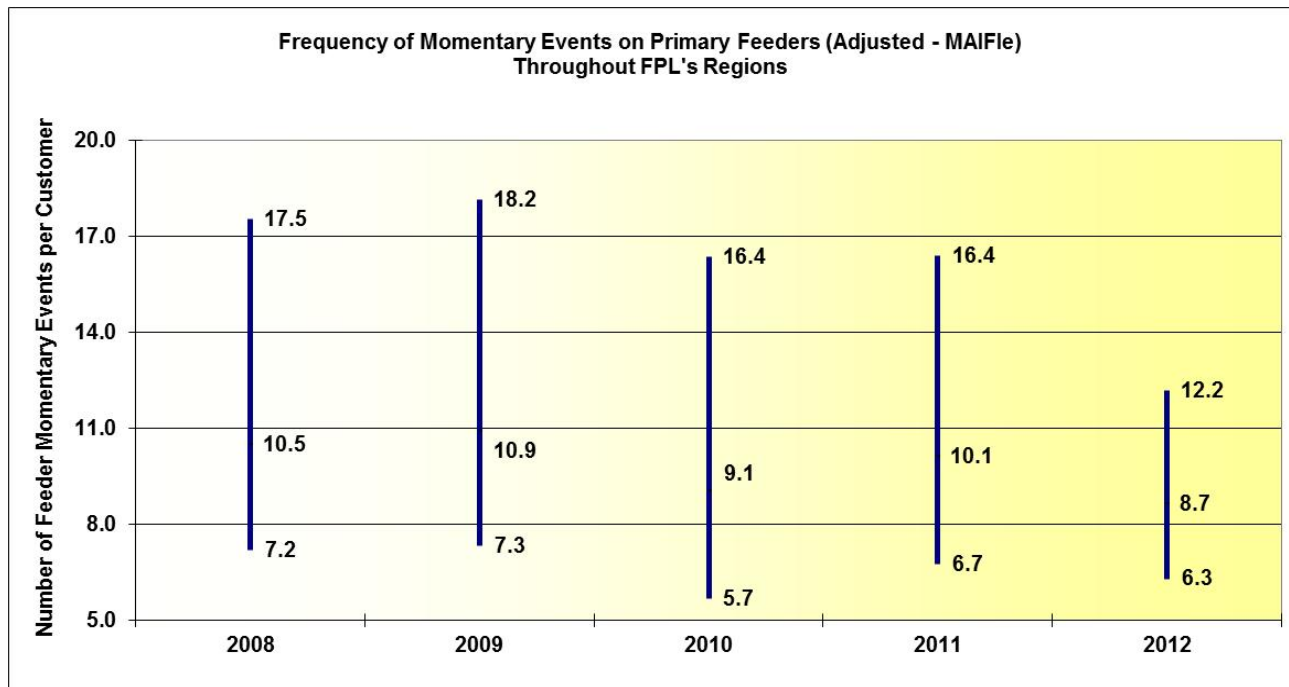
Figure 3-5. MAIFle ACROSS FPL'S SIXTEEN REGIONS (ADJUSTED)

Figure 3-5 is the highest, average, and lowest adjusted MAIFle recorded across FPL's system. These momentary events often affect a small group of customers. FPL's Toledo Blade, Treasure Coast, and North Florida service areas have experienced the least reliable MAIFle results of the 16 service areas of FPL since 2008. The Pompano, Central Dade, and Naples service areas had the fewest momentary events since 2008. There is a 14 percent decrease of the average MAIFle results from 2011 to 2012 and the results have been trending downward (improving) over the last five years.

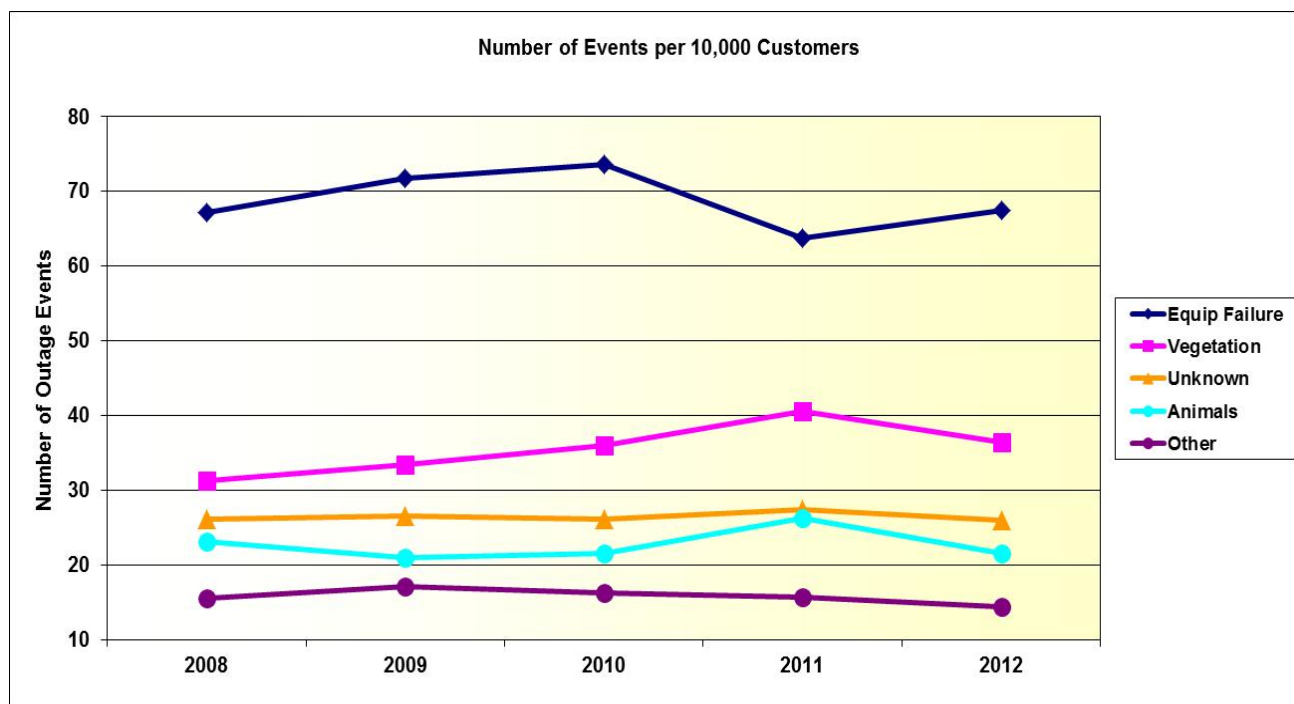
Figure 3-8. FPL’S TOP FIVE OUTAGE CAUSES (ADJUSTED)

Figure 3-8 depicts the top five causes of outage events on FPL’s distribution system normalized to a 10,000-customer base. The graph is based on FPL’s adjusted data of the top ten causes of outage events. For the five-year period, the five top causes of outage events included equipment failures (33 percent), vegetation (18 percent), unknown (13 percent), animals (11 percent), and other causes (7 percent) on a cumulative basis. The data shows an increasing trend in outage events caused by vegetation, even though the number of outages decreased from 2011 to 2012. The outage events due to equipment failure are trending downward, which continues to dominate the highest percentage of outage causes throughout the FPL regions, even though the number of outages increased from 2011 to 2012. The outage events due to unknown, animals, and other causes are remaining relatively flat over the five-year period.

Equipment failure and vegetation outages continue to be the leading cause of the number of outage events per customer for the past five years. For 2012, the category of service and sub-category cable appear to be the largest cause of equipment failure outages. Analysis of **Figure 3-8** shows an increasing trend in the number of outage events attributed to vegetation, even though the number of outages decreased 9 percent from 2011 to 2012. The analysis shows a decreasing trend in the number of outage events caused by equipment failure, even though the number of outages increased 7 percent from 2011 to 2012.

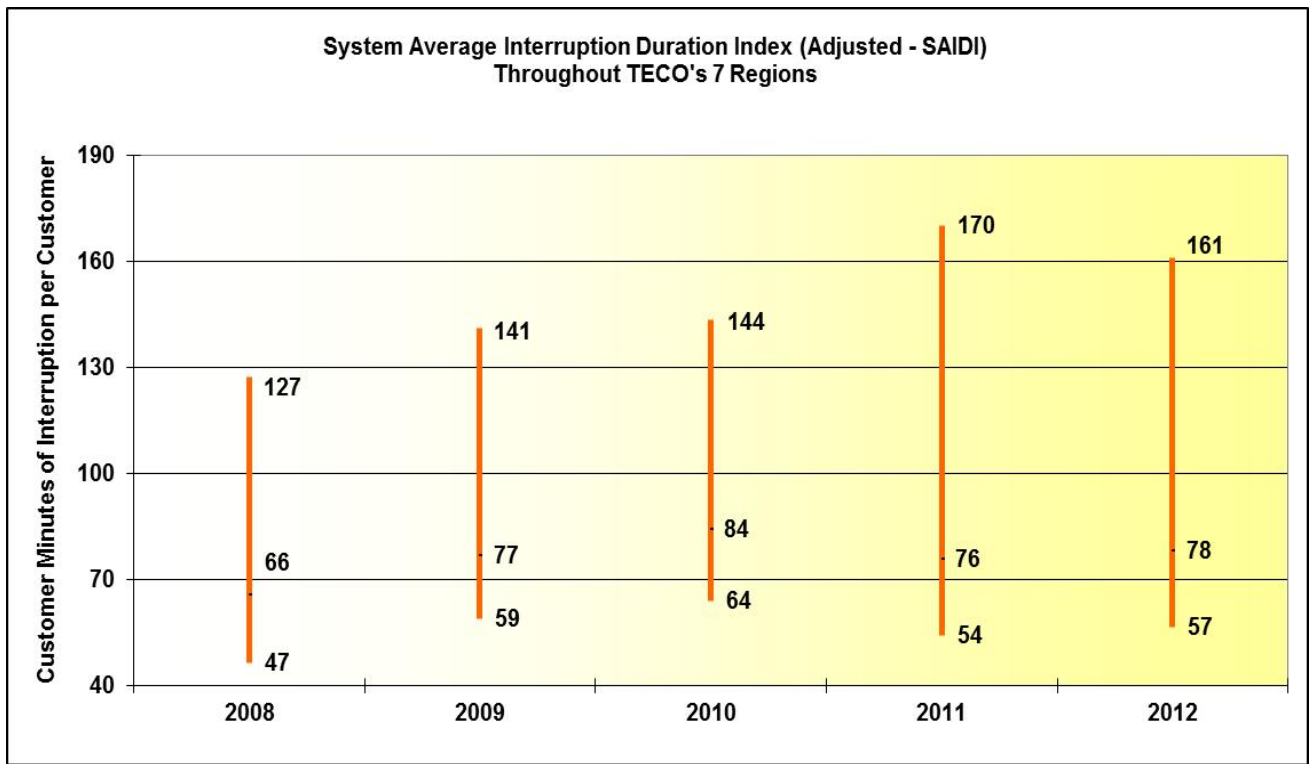
Figure 3-17. SAIDI ACROSS TECO'S SEVEN REGIONS (ADJUSTED)

Figure 3-17 shows the adjusted SAIDI values recorded by TECO’s system. Three of the seven TECO regions had an increase in SAIDI performance during 2012, with Plant City and Dade City having the highest SAIDI performance results for the five-year period of 2008 to 2012. The lowest SAIDI index for the seven regions appears to be trending upward. The average SAIDI index increased 3 percent from 2011 to 2012 and appears to be trending upward. The Central, Eastern, and Winter Haven regions recorded the lowest SAIDI indices for the five-year period. Dade City, Plant City, and South Hillsborough regions have the fewest customers and represent the most rural, lowest customer density per line mile in comparison to the other four TECO divisions.

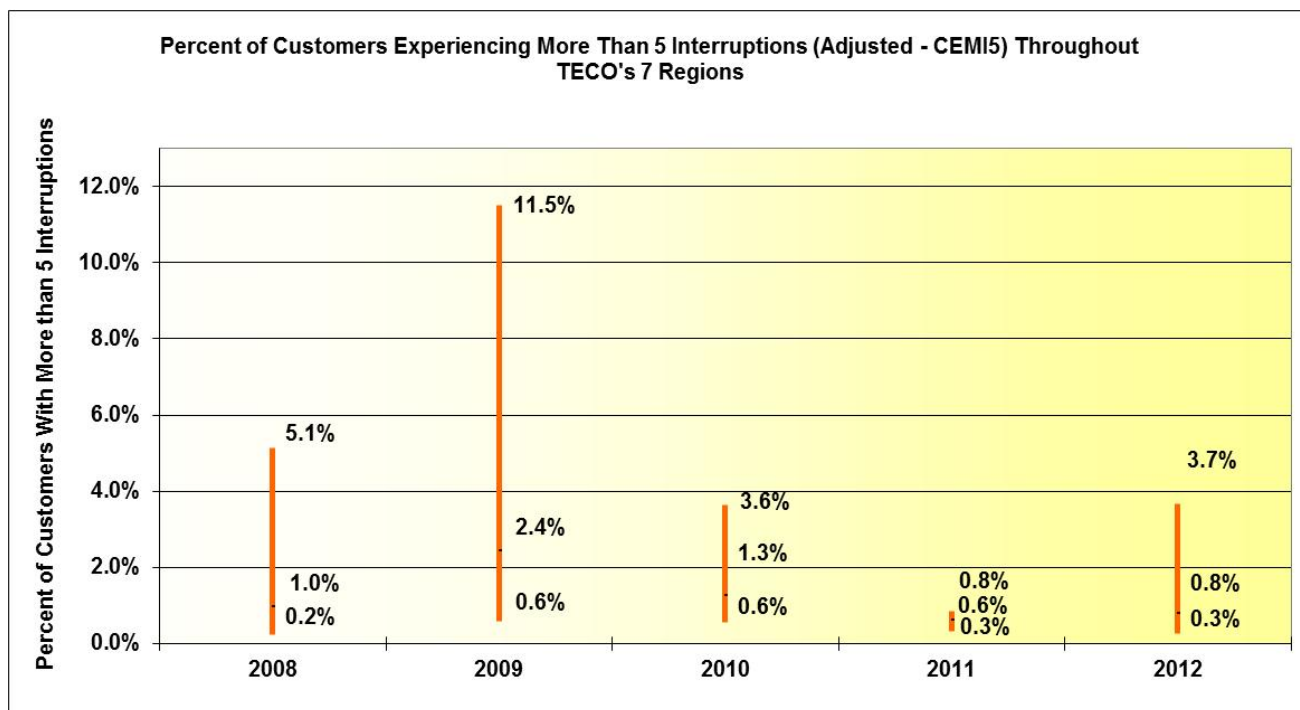
Figure 3-22. CEMI5 ACROSS TECO'S SEVEN REGIONS (ADJUSTED)

Figure 3-22 shows the percent of customers experiencing more than five interruptions. Four regions in TECO's territory experienced a decrease in the CEMI5 results for 2012. The Dade City, Plant City, and South Hillsborough regions experienced an increase in the CEMI5 index. Dade City reported the highest CEMI5 percentage for 2012. With TECO's results for this index varying for the past five years, the average CEMI5 index appears to be trending downward suggesting improvement, even though there was a 25 percent increase from 2011 to 2012.

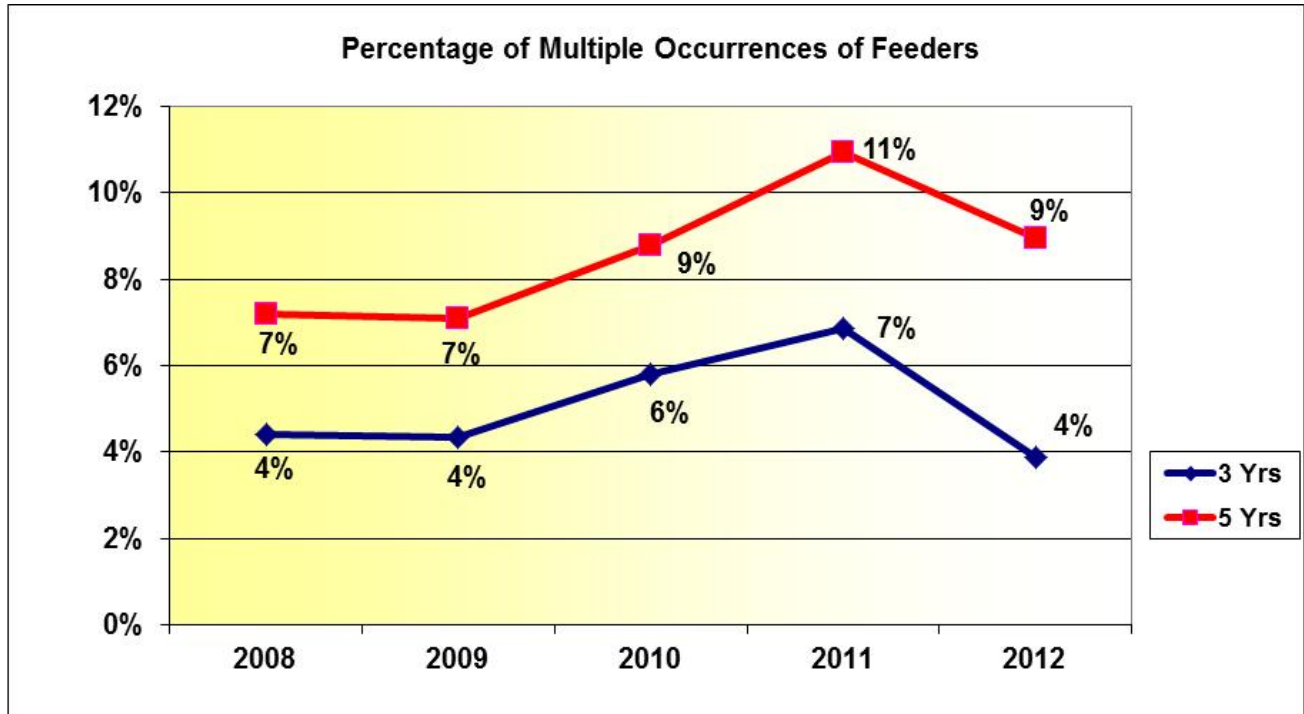
Figure 3-23. TECO'S THREE PERCENT FEEDER REPORT (ADJUSTED)

Figure 3-23 represents an analysis of TECO's top 3 percent of problem feeders that have reoccurred (appeared on the Three Percent Feeder Report) on a five-year and three-year basis. The graph is developed using the number of recurrences divided by the number of feeders reported. The five-year average of outages per feeder decreased from 2011 to 2012, as well as the three-year average. Both the three-year and five-year averages of outages per feeder appear to be trending upward.

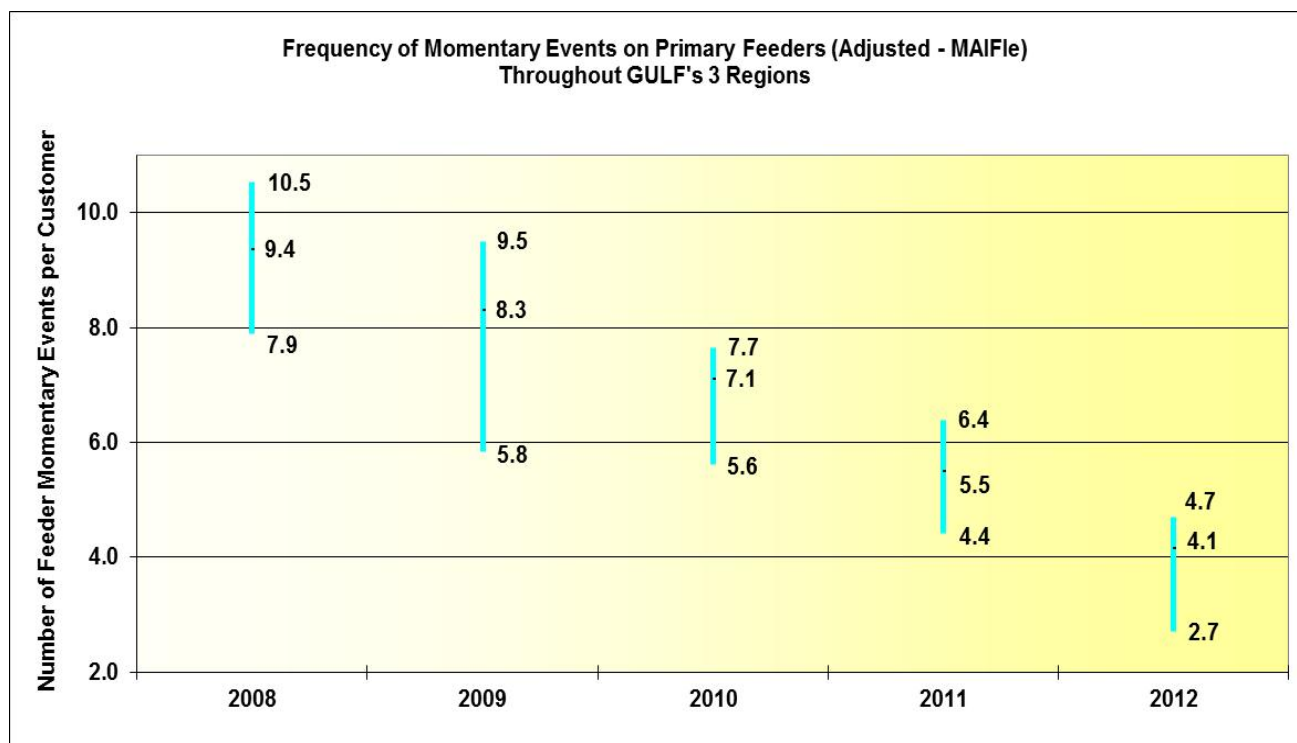
Figure 3-29. MAIFle ACROSS GULF'S THREE REGIONS (ADJUSTED)

Figure 3-29 is the adjusted MAIFle recorded across Gulf's system. The adjusted MAIFle results by region show that the Eastern region once again had the lowest frequency of momentary events on primary feeders. The Western region has the highest MAIFle index in 2012, with a 25 percent improvement when compared to 2011. The data suggests that the level of service reliability for the highest, average, and lowest MAIFle are all continuing to trend downward, suggesting improvement.

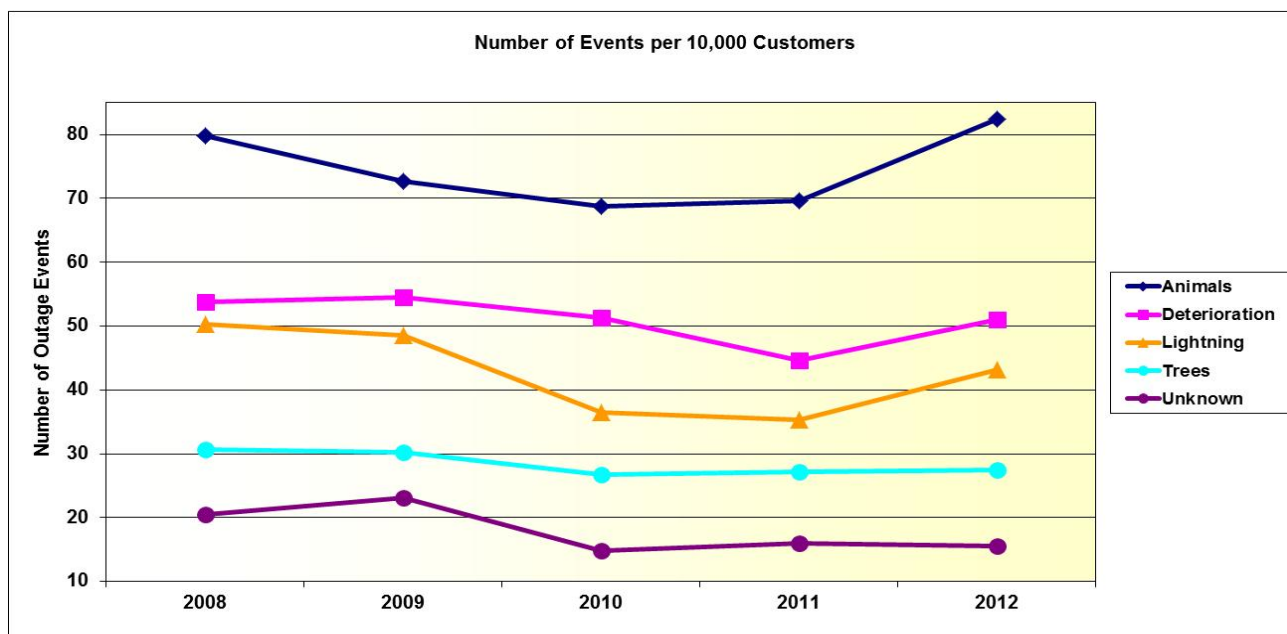
Figure 3-32. GULF’S TOP FIVE OUTAGE CAUSES (ADJUSTED)

Figure 3-32 is a graph of the top five causes of outage events on Gulf’s distribution system normalized to a 10,000-customer base. The figure is based on Gulf’s adjusted data of the top ten causes of outage events and represents 87 percent of the total adjusted outage events that occurred during 2012. The top five causes of outage events were animals (33 percent), deterioration (20 percent), lightning (17 percent), trees (11 percent), and unknown causes (6 percent). The percentage of outages caused due to animals remains the highest cause of outages. As the number of outage events due to animals is remaining relatively flat, the number of outage events due to deterioration, lightning, unknown, and trees are trending downward.

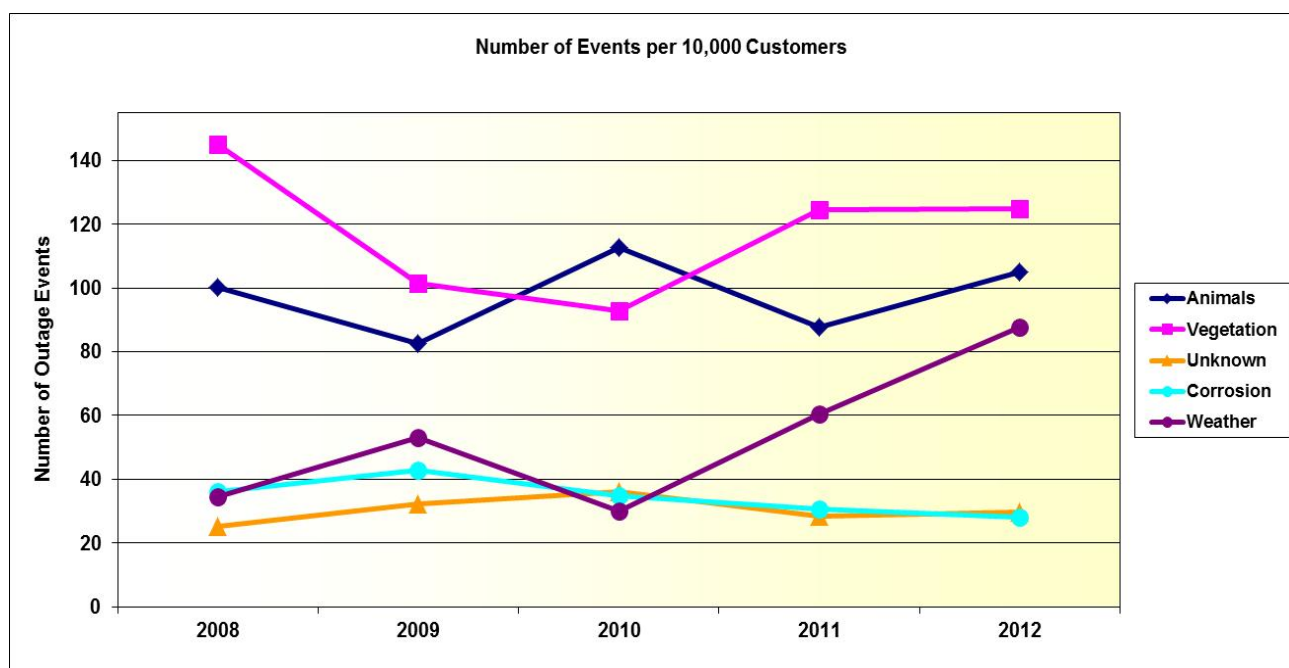
Figure 3-37. FPUC'S TOP FIVE OUTAGE CAUSES (ADJUSTED)

Figure 3-37 shows the top five causes of outage events on FPUC's distribution system normalized to a 10,000-customer base. The figure is based on FPUC's adjusted data of the top ten causes of outages. For 2012, the top five causes of outage events were vegetation (29 percent), animals (24 percent), weather (20 percent), unknown (7 percent), and corrosion (7 percent). These five factors represent 87 percent of the total adjusted outage causes in 2012. The causes by animals and weather are trending upwards and both causes did increase 17 percent and 32 percent from 2011 to 2012, respectively. The causes by vegetation and corrosion are trending downward. Vegetation had a 1 percent increase from 2011 to 2012, as corrosion had a 7 percent decrease. The unknown caused outages remain relatively flat over the five-year period of 2008 to 2012, even though there was a 5 percent increase from 2011 to 2012.
