*Review of
Florida's
Investor-Owned
Electric Utilities*

*2 0 1 3
Service Reliability Reports*

State of Florida
Florida Public Service Commission
Division of Engineering

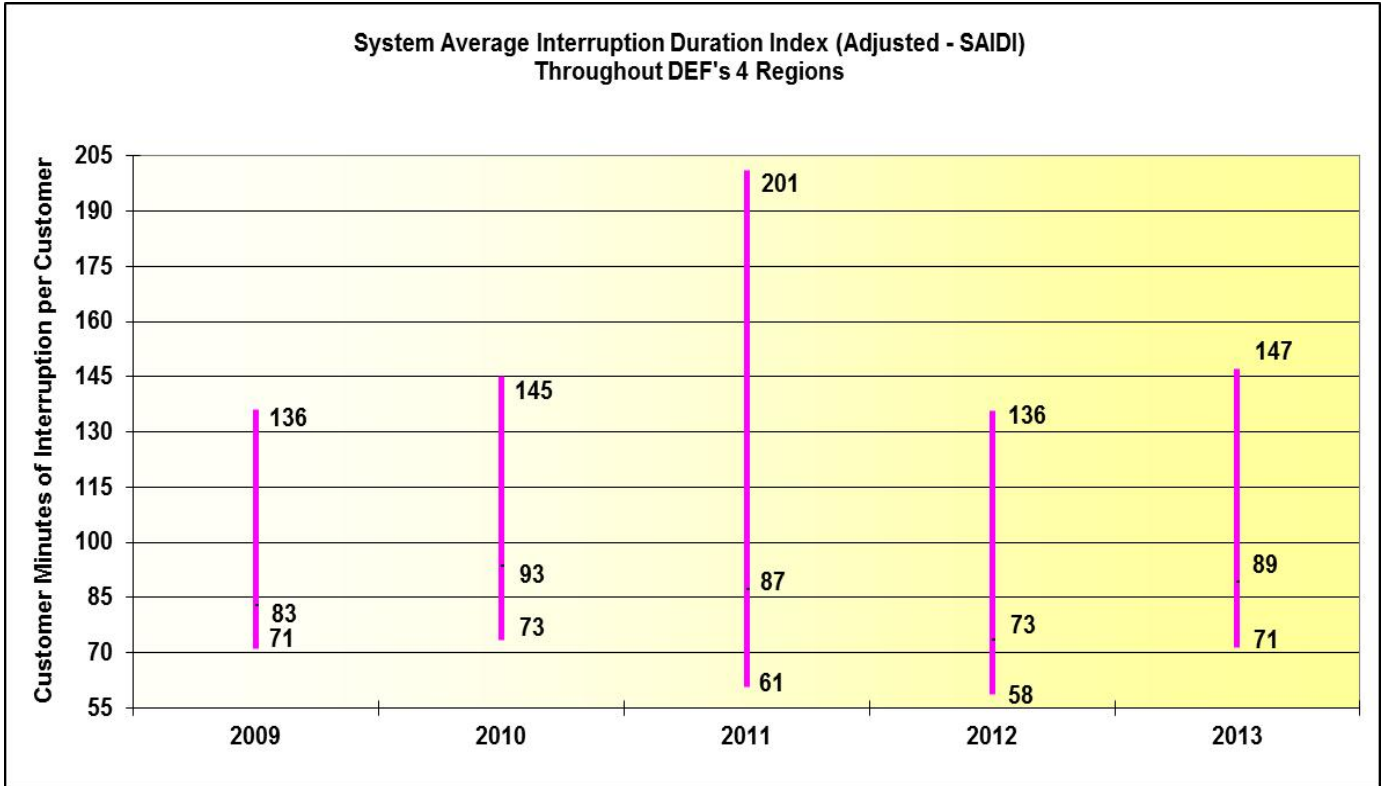
Figure 3-1. SAIDI across DEF's Four Regions (Adjusted)

Figure 3-1 charts the adjusted SAIDI recorded across DEF's system and depicts an increase in the highest, average and lowest values for 2013. DEF reported that in 2013, three tornados and one tropical storm affected its service territory. DEF also noted that there were seven days of extreme weather that were not excludable. These extreme weather events caused the North Coastal region to have higher indexes.

DEF's service territory is comprised of four regions: North Coastal, South Coastal, North Central, and South Central. **Figure 3-1** illustrates that the North Coastal region continues to report the poorest SAIDI over the last five years, fluctuating between 136 minutes and 201 minutes. While the South Coastal and South Central regions have the best or lowest SAIDI for the same period. The North Coastal region is rural and has more square miles when compared to the other regions. It is also served by predominantly long circuits with approximately 7,700 miles of overhead and underground main circuits. DEF explained that these factors result in higher exposure to outage causes and higher reliability indices.

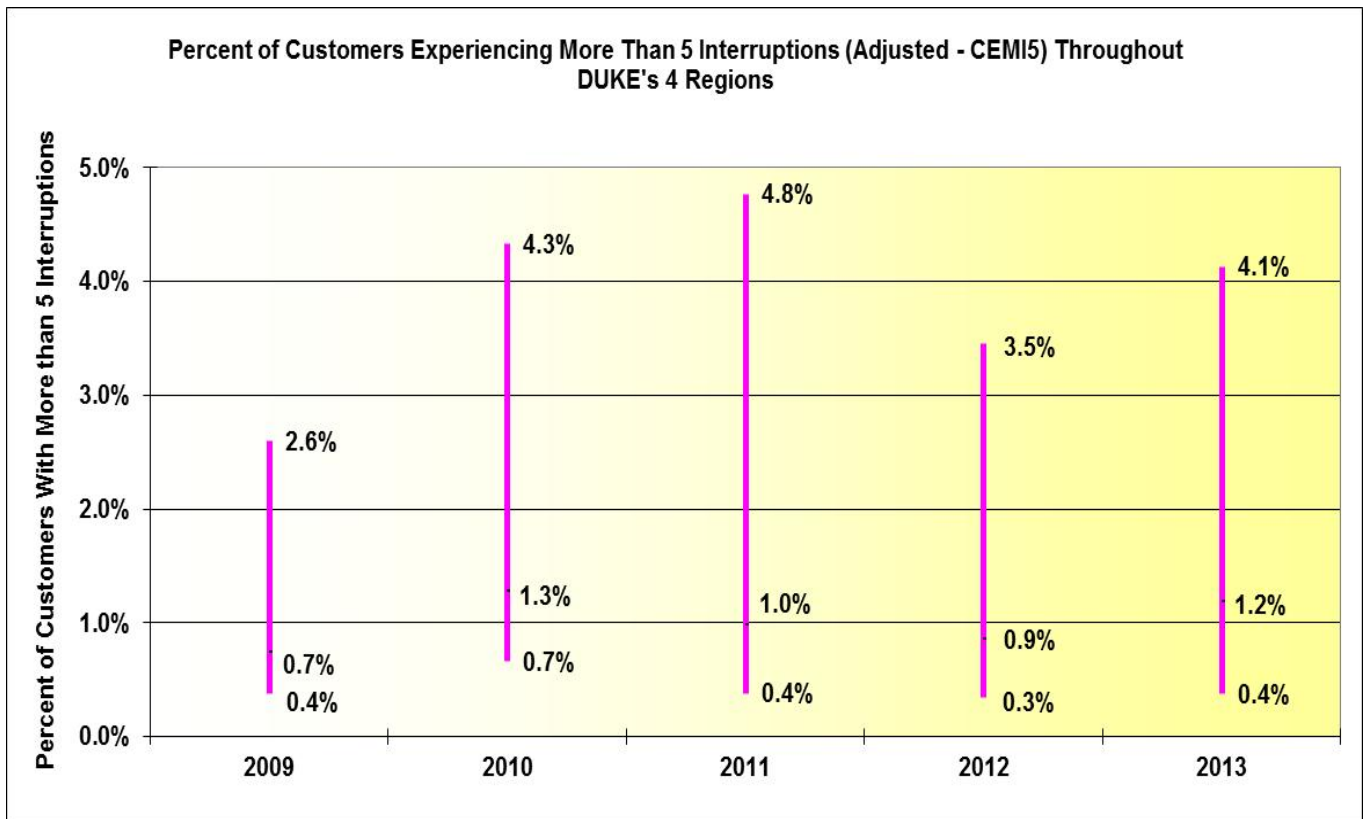
Figure 3-6. CEMI5 across DEF’s Four Regions (Adjusted)

Figure 3-6 charts the percentage of DEF’s customers experiencing more than five interruptions over the last five years. DEF reported an increase in the average CEMI5 performance from 0.9 percent in 2012 to 1.2 percent in 2013. The average CEMI5 is trending slightly upward over the past five years. The South Coastal region continues to have the lowest reported percentage for all of DEF’s regions and the North Coastal region continues to have the highest reported percentage.

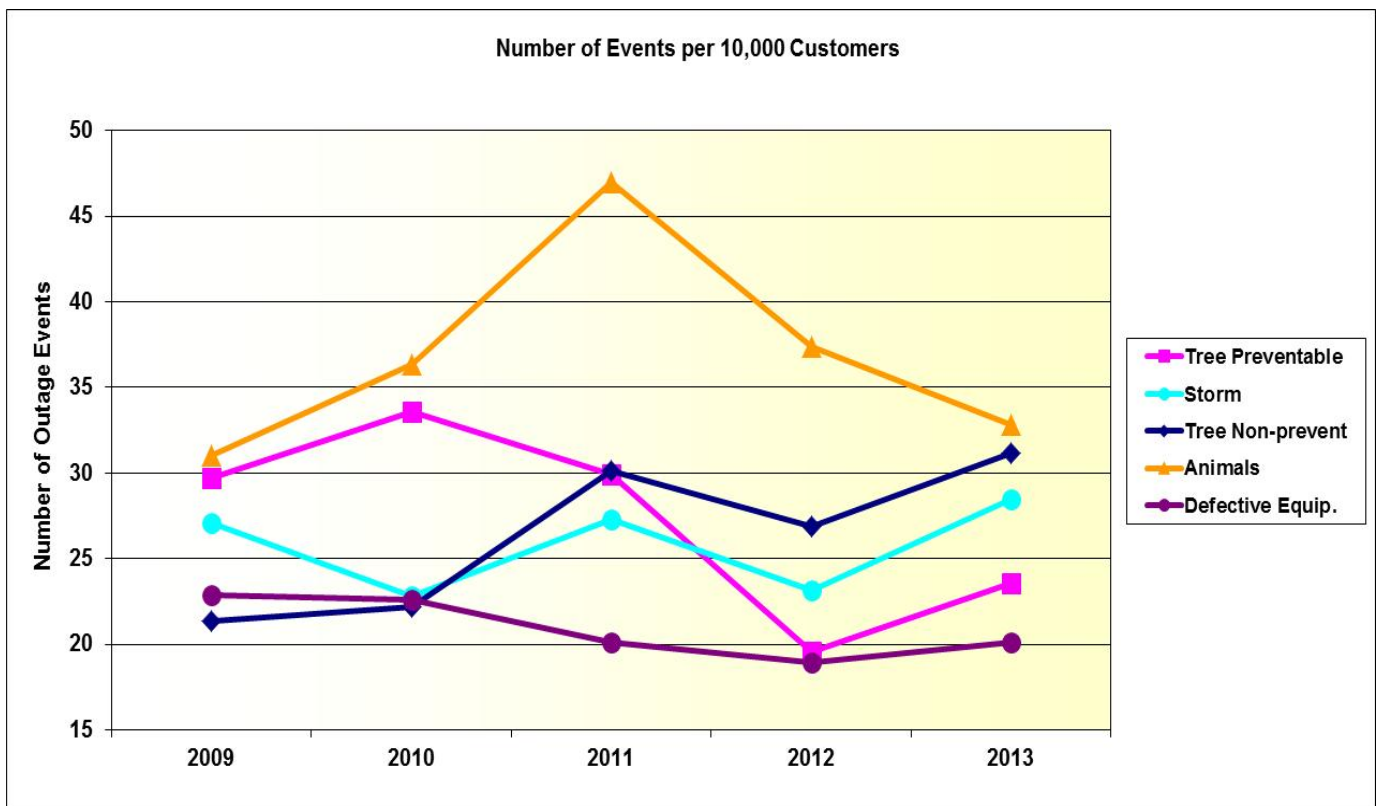
Figure 3-8. DEF’s Top Five Outage Causes (Adjusted)

Figure 3-8 shows the top five causes of outage events on DEF’s distribution system normalized to a 10,000-customer base. The figure is based on DEF’s adjusted data and represents approximately 57 percent of the top ten causes of outage events that occurred during 2013. For the five-year period, the top five causes of outage events were Animals (14 percent), Tree Non-Preventable (13 percent), Storm (12 percent), Tree Preventable (10 percent), and Defective Equipment (8 percent) on a cumulative basis. The outage events caused by animals is trending upward even though there was an 18 percent decrease from 2012 to 2013. DEF noted that it installs animal guards proactively on all new overhead equipment installations and installs animal guards on a targeted basis based upon outage investigations and trends identified in the field. Tree Non-Preventable, and Storms are trending upward and both had a 7 percent and 12 percent increases, respectively, in the number of outages from 2012 to 2013. The outages caused by Tree-Preventable and Defective Equipment are both trending downward. There was an 11 percent increase for Tree-Preventable and a 1 percent increase from Defective Equipment in the number of outages from 2012 to 2013.

In **Figure 3-8**, DEF's Top Five Outage Categories, the category Animals remains in the top spot representing 14 percent of the ten outage categories. The next two highest categories were Tree Non-Preventable, i.e. fallen trees (13 percent) and Storms (12 percent). Tree Preventable (10 percent) and Defective Equipment (8 percent) are the next two causes of outages. Animals and Defective Equipment outage categories decreased in 2013 when compared to the 2012 data. Tree Non-Preventable, Storms, and Tree Preventable all showed increases in 2013 compared to 2012. For the five-year period of 2009 to 2013, outages caused by Animals, Tree Non-Preventable, and Storms are trending upward as outages caused by Tree Preventable and Defective Equipment are trending downward.

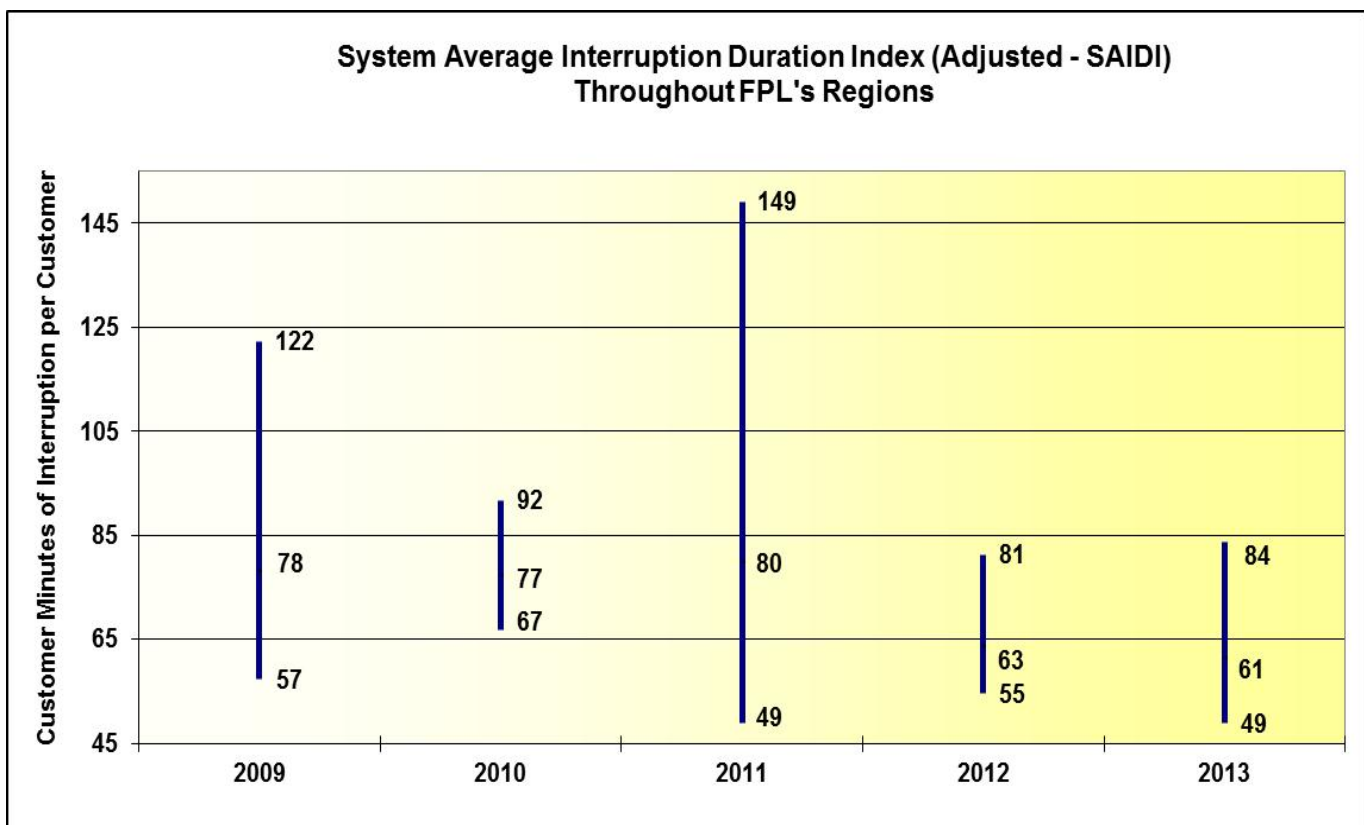
Figure 3-9. SAIDI across FPL’s Sixteen Regions (Adjusted)

Figure 3-9 shows the highest, average, and lowest adjusted SAIDI recorded across FPL’s system that encompasses four management regions with 16 service areas. The highest and lowest SAIDI values are the values reported for a particular service area. FPL had an overall decrease of two minutes (3 percent) to the average SAIDI results for 2013 compared to 2012. The average SAIDI appears to be trending downward over the five-year period of 2009 to 2013. The 2013 average SAIDI results are the lowest (best) for the five-year period for a second consecutive year.

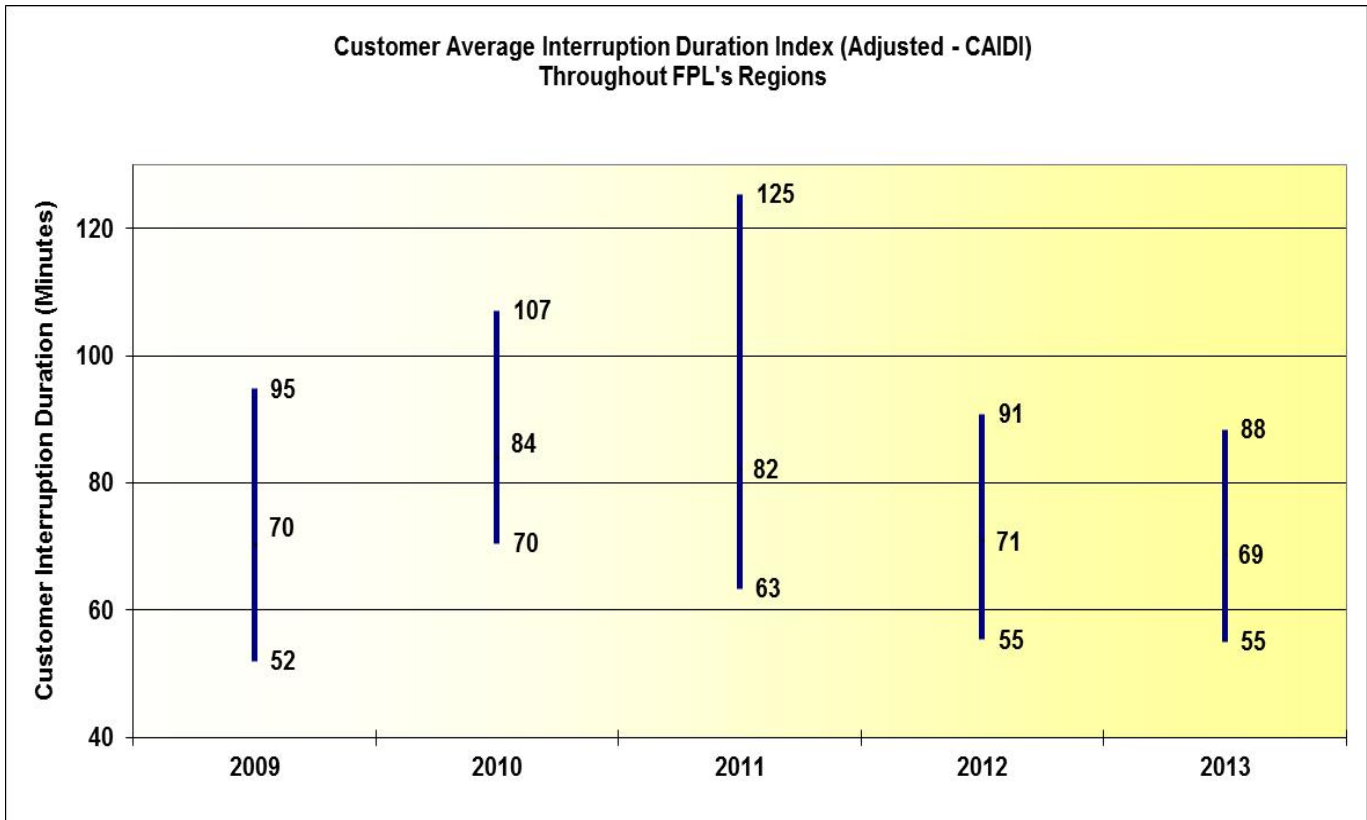
Figure 3-11. CAIDI across FPL’s Sixteen Regions (Adjusted)

Figure 3-11 is a chart of FPL’s highest, average, and lowest CAIDI expressed in minutes. FPL’s adjusted average CAIDI has dropped approximately 2 percent from 71 minutes in 2012, to 69 minutes in 2013. The average duration of CAIDI is trending downward. For 2013, the Boca Raton service area once again reported the lowest duration of CAIDI, which was 55 minutes and was the same as 2012. The highest duration of CAIDI was 88 minutes for the North Dade service area for 2013, which is 3 percent lower than the highest CAIDI minutes in 2012.

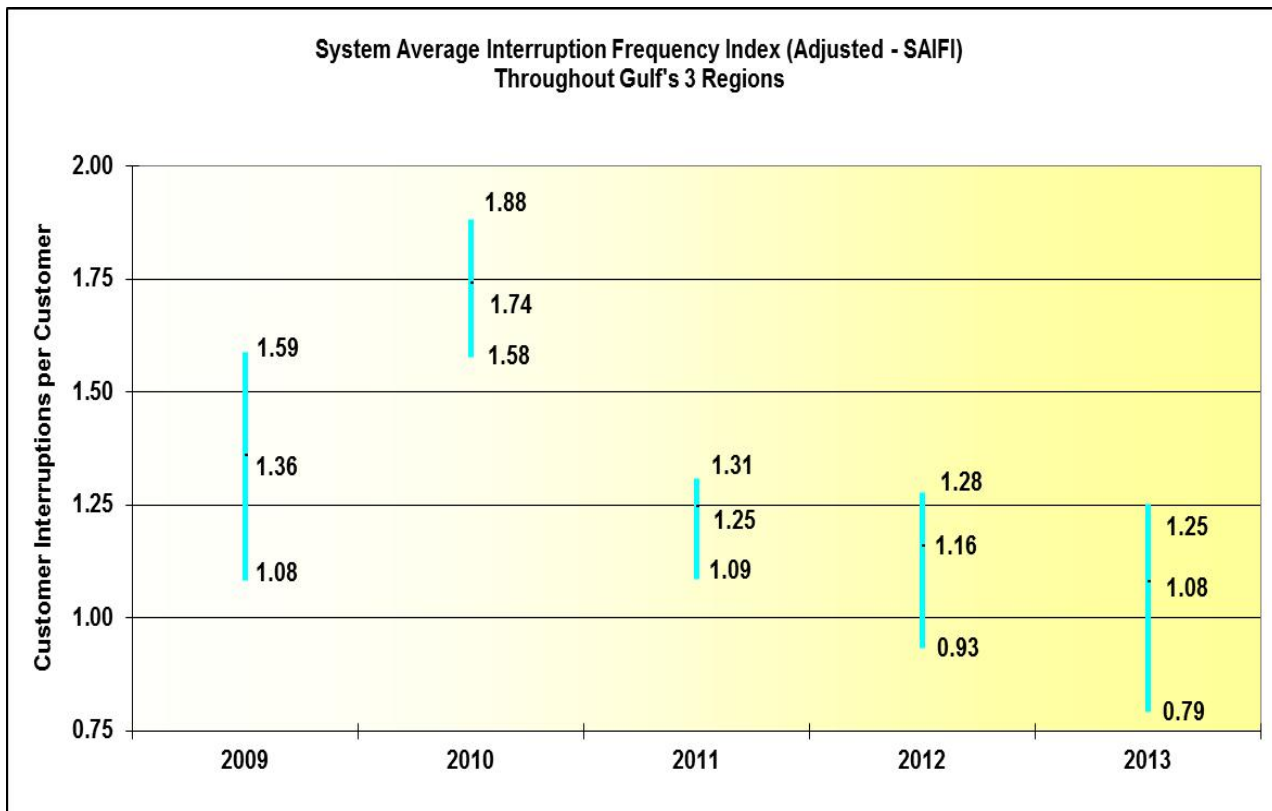
Figure 3-23. SAIFI across Gulf’s Three Regions (Adjusted)

Figure 3-23 illustrates that Gulf’s SAIFI had a 7 percent decrease in 2013 when compared to 2012. Gulf’s Western region had the highest SAIFI values in three of the last five years, while the Eastern region had the highest SAIFI in the other two years. The lowest values appear to fluctuate between the Central region and the Eastern region. The maximum, minimum, and average SAIFI values still appear to be trending downward.

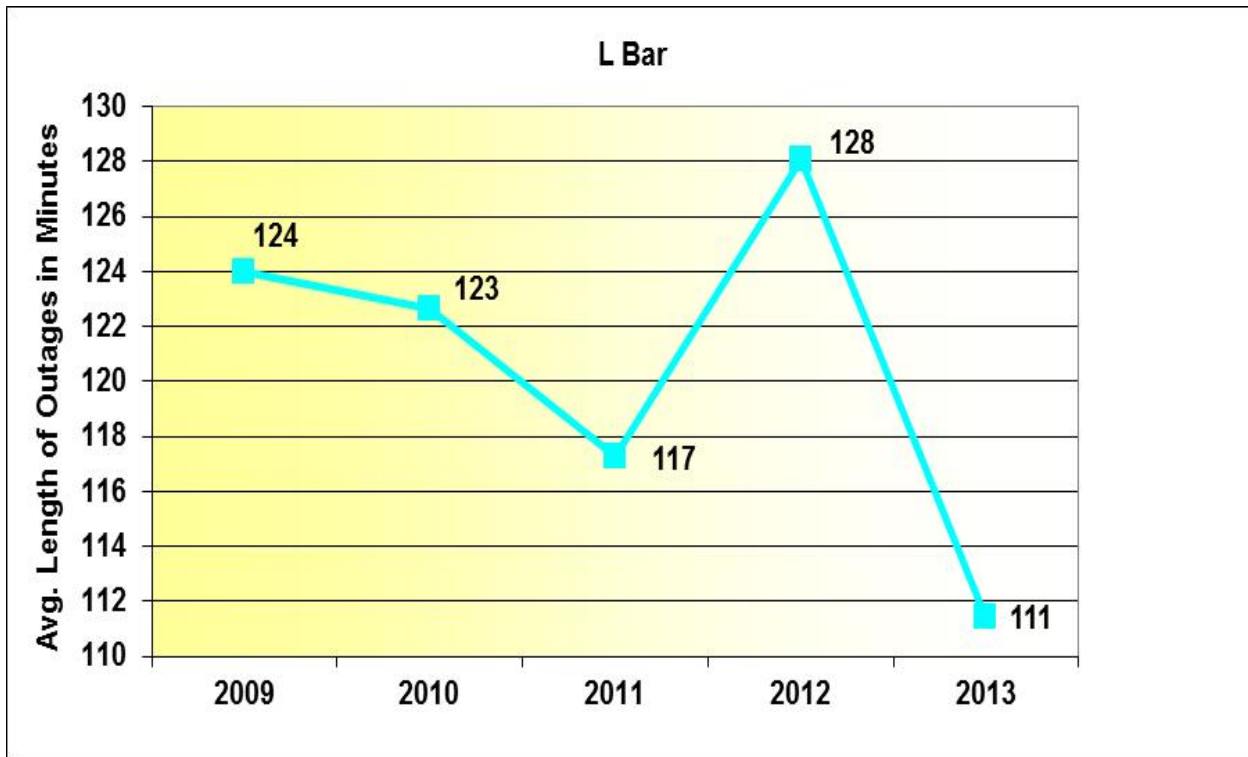
Figure 3-25. Gulf’s Average Duration of Outages (Adjusted)

Figure 3-25 illustrates Gulf’s L-Bar or the average length of time Gulf spends recovering from outage events, excluding hurricanes and other allowable excluded outage events. Gulf’s L-Bar showed a 13 percent decrease from 2012 to 2013. The data for the five-year period of 2009 to 2013 shows a downward trend.

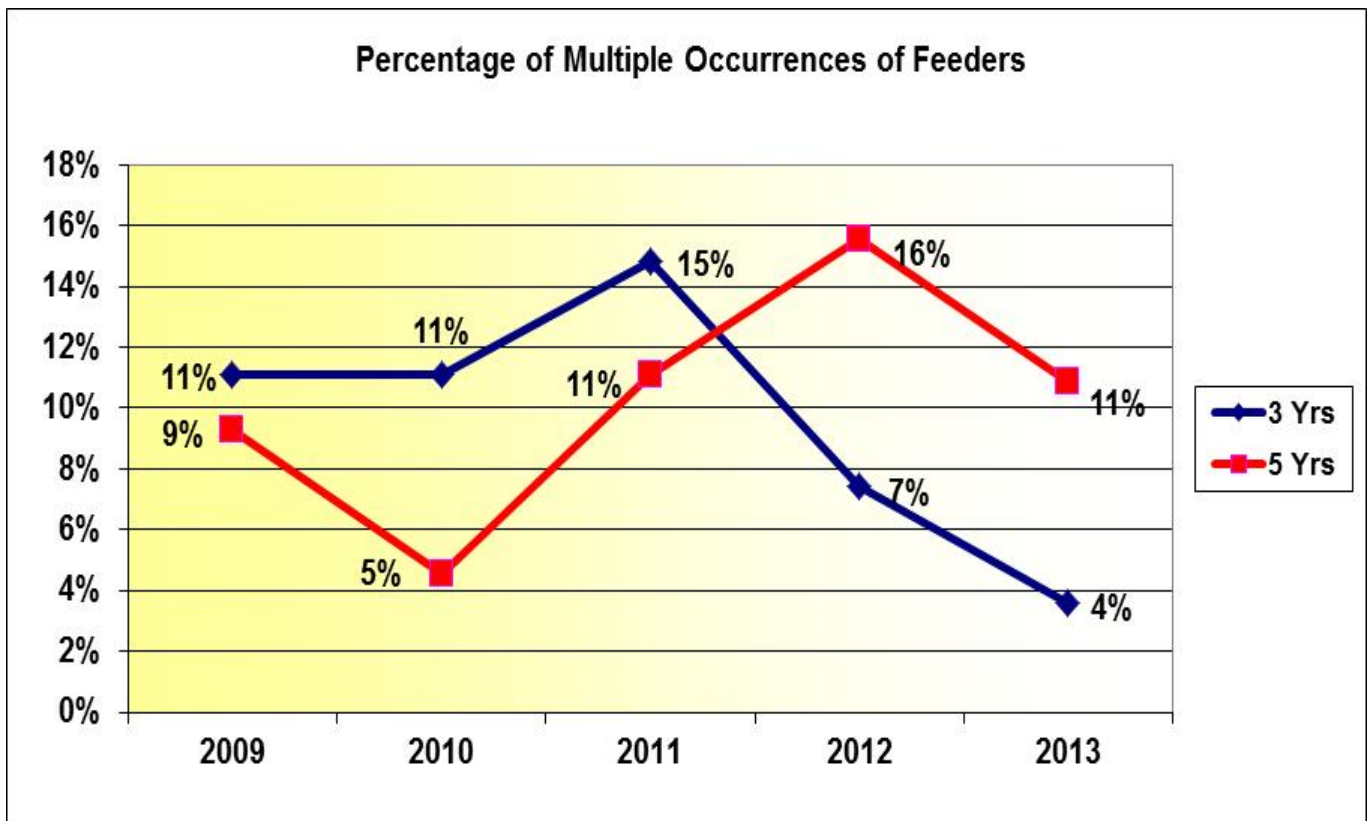
Figure 3-28. Gulf’s Three Percent Feeder Report (Adjusted)

Figure 3-28 shows the multiple occurrences of feeders using the utility’s Three Percent Feeder Report and is analyzed on a three- and five-year basis. The Three Percent Feeder Report is a listing of the top three percent of feeders that have the most feeder outage events. The supporting data illustrates that the five-year multiple occurrences have decreased from 16 percent to 11 percent from 2012 to 2013 along with the three-year multiple occurrences which decreased from 7 percent to 4 percent. The five-year period of 2009 to 2013 indicates overall that the five-year index is trending upward even though there was a decrease in percentages from 2012 to 2013. The three-year multiple occurrences index appears to be trending downward.

Staff notes there was one feeder that was on the Three Percent Feeder Report for two years consecutively. Gulf explained that its initial review of the Feeder Report showed that the associated feeder problems were all corrected. Additionally, Gulf mentioned that its review of the 2013 outage information were the same type of outages that occurred in 2012. Two of the three 2013 outages were related to weather events with high winds. The other 2013 outage was due to an emergency planned outage where power was interrupted to allow construction crews to safely perform their work. Gulf stated that a full-line patrol of this feeder was performed and all mitigation work was completed in 2013.

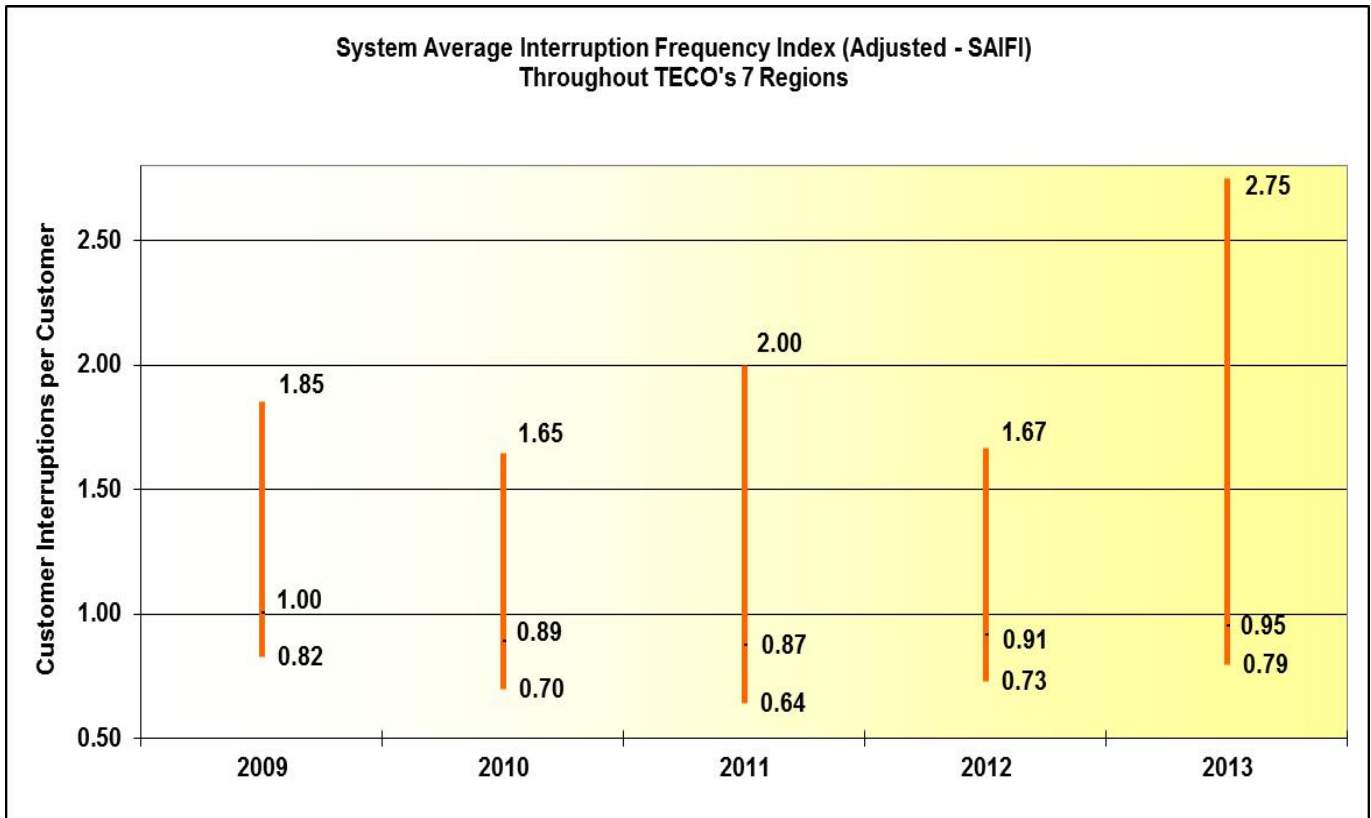
Figure 3-31. SAIFI across TECO’s Seven Regions (Adjusted)

Figures 3-31 illustrates TECO’s adjusted frequency of interruptions per customer reported by the system. TECO’s data represents a 4 percent increase in the SAIFI average from 0.91 interruptions in 2012 to 0.95 interruptions in 2013. TECO’s Dade City region continues to have the highest frequency of service interruptions when compared to TECO’s other regions. The maximum SAIFI index is trending upward and the minimum and average indices appears to be staying relatively flat.

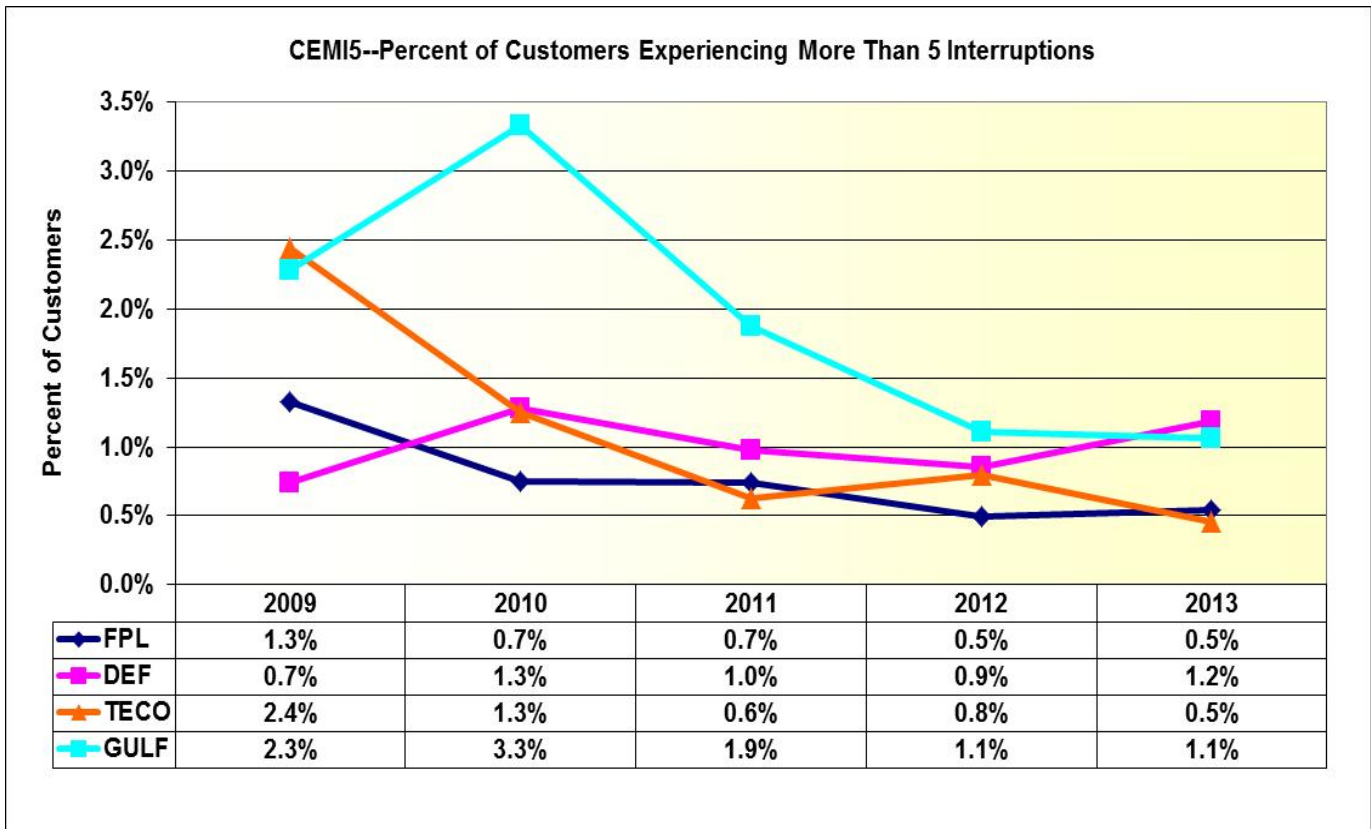
Figure 4-5. Percent of Customer with More Than Five Interruptions (Adjusted CEMI5)

Figure 4-5 is a five-year graph of the adjusted CEMI5 for FPL, Gulf, DEF, and TECO. CEMI5 is a percentage. It represents the number of customers that experienced more than five service interruptions in the year divided by the total number of customers. Gulf’s adjusted CEMI5 stayed the same at 1.1 percent in 2013 as in 2012. FPL’s CEMI5 also stayed the same in 2013 at 0.5 percent as in 2012. DEF’s CEMI5 percent increased to 1.2 percent in 2013 from 0.9 percent in 2012 and is slightly trending upward. TECO’s CEMI5 had a decrease in the percent of customers experiencing more than five interruptions in 2013 compared to its 2012 results.

The inter-utility trend comparison focuses on a graphical presentation that combines all of the IOUs' distribution reliability indices for the years 2009 to 2013. **Figures 4-1** through **4-3** apply to all five utilities while **Figures 4-4** and **4-5** do not apply to FPUC because it is not required to report MAIFle and CEMIS due to the size of its customer base. The adjusted data is used in generating the indices in this report and is based on the exclusion of certain events allowed by Rule 25-6.0455(4), F.A.C. Generalizations can be drawn from the side-by-side comparisons; however, any generalizations should be used with caution due to the differing sizes of the distribution systems, the degree of automation, and the number of customers. The indices are unique to each IOU.
