*Review of
Florida's
Investor-Owned
Electric Utilities*

*2 0 1 5
Service Reliability Reports*

State of Florida
Florida Public Service Commission
Division of Engineering

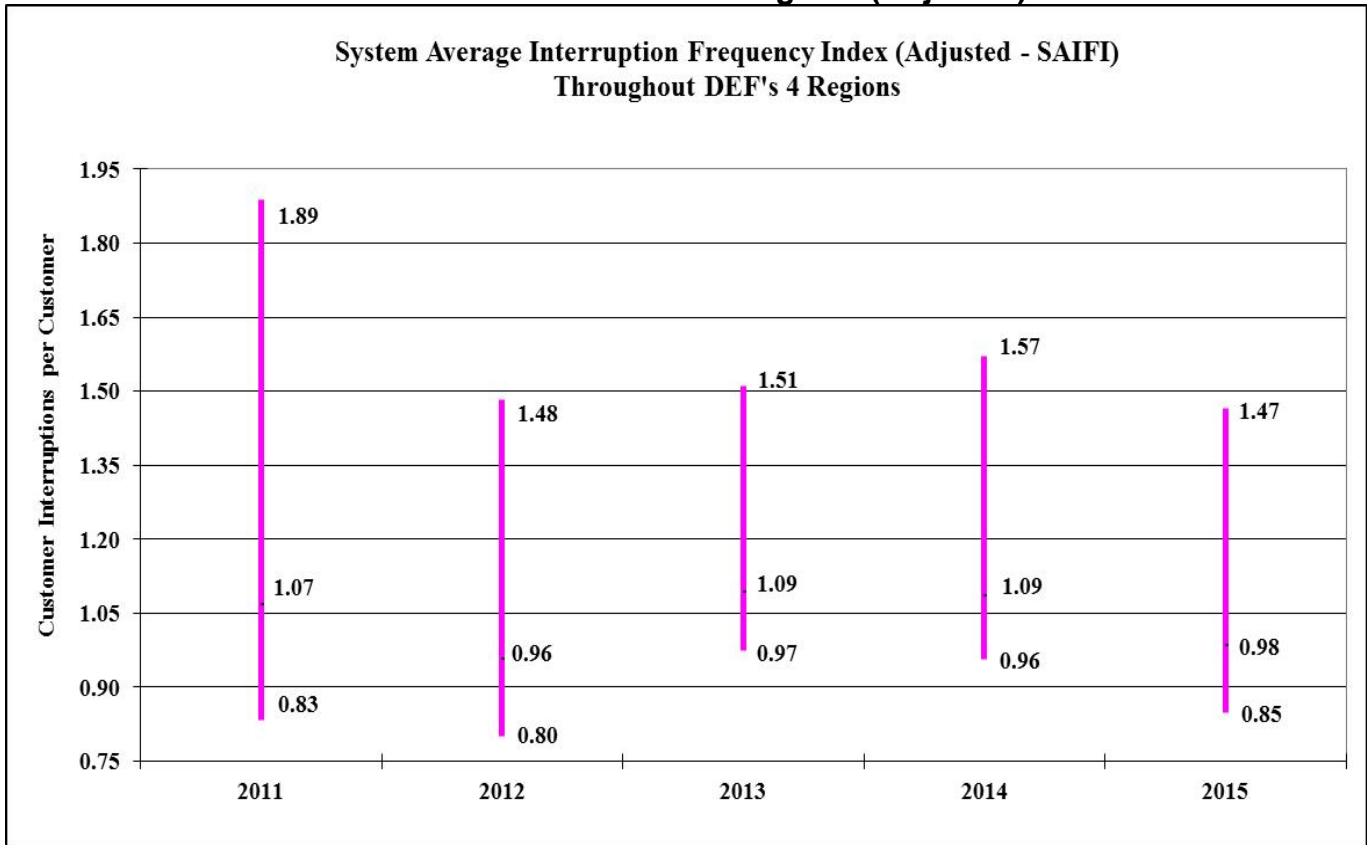
**Figure 3-2.
SAIFI across DEF’s Four Regions (Adjusted)**

Figure 3-2 shows the adjusted SAIFI across DEF’s system. The maximum and average SAIFI indexes are trending downward as the minimum SAIFI is trending slightly upward. There were decreases of 6 percent for the maximum value, 10 percent for the average value, and 11 percent for the minimum value, in 2015. The North Central region had the lowest number of interruptions, while the North Coastal region continues to have the highest number of interruptions.

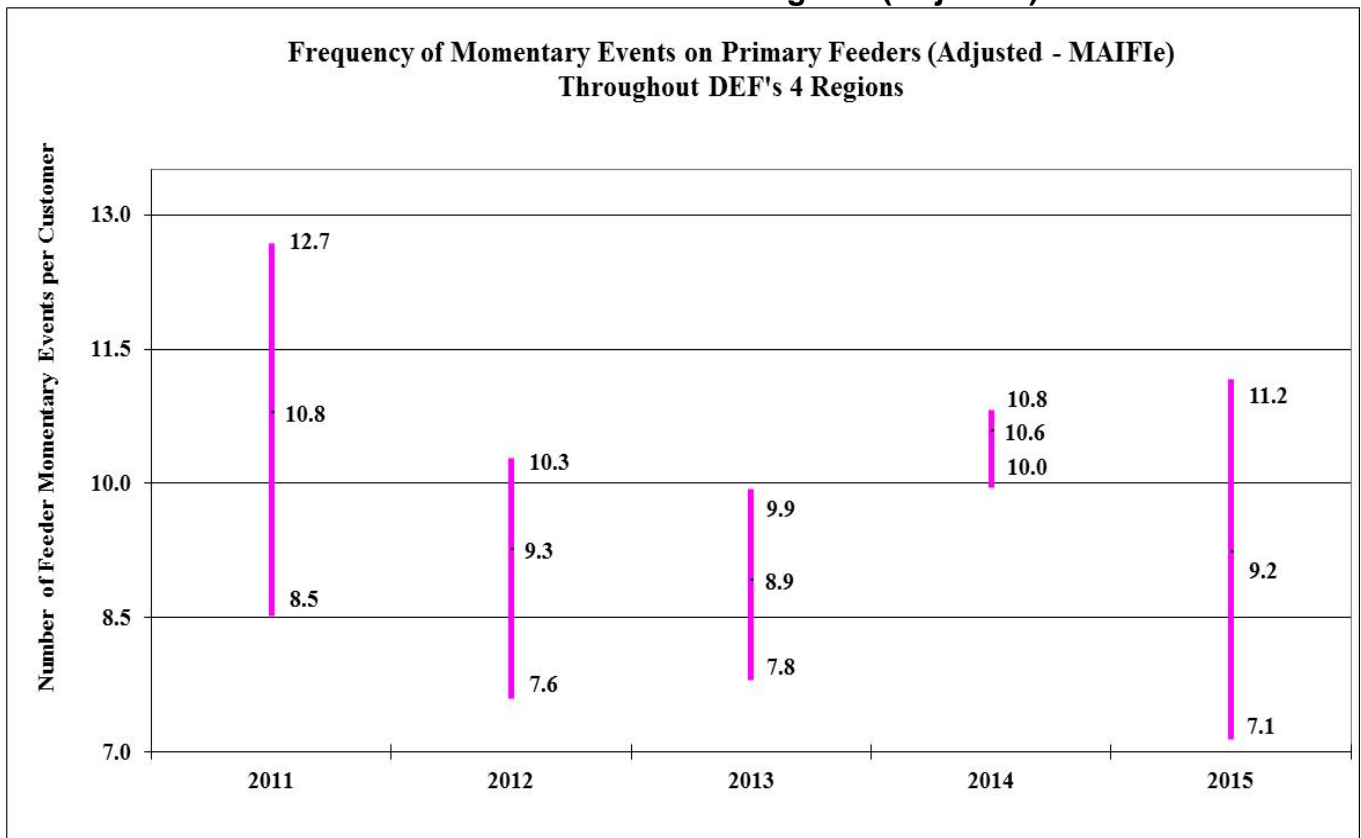
**Figure 3-5.
MAIFIE across DEF’s Four Regions (Adjusted)**

Figure 3-5 illustrates the frequency of momentary events on primary circuits for DEF’s customers recorded across its system. These momentary events often affect a small group of customers. A review of the supporting data suggests that the MAIFIE results between 2011 and 2015 appear to be trending downward showing improvement and there was a decrease in the average MAIFIE of 13 percent from 2014 to 2015. The North Coastal and South Central regions appear to have the best (lowest) results for the last five years. There was a 29 percent decrease for the lowest MAIFIE from 2014 to 2015. The South Coastal and North Central regions appear to have the worst (highest) results for the last five years. There was a 4 percent increase from 2014 to 2015.

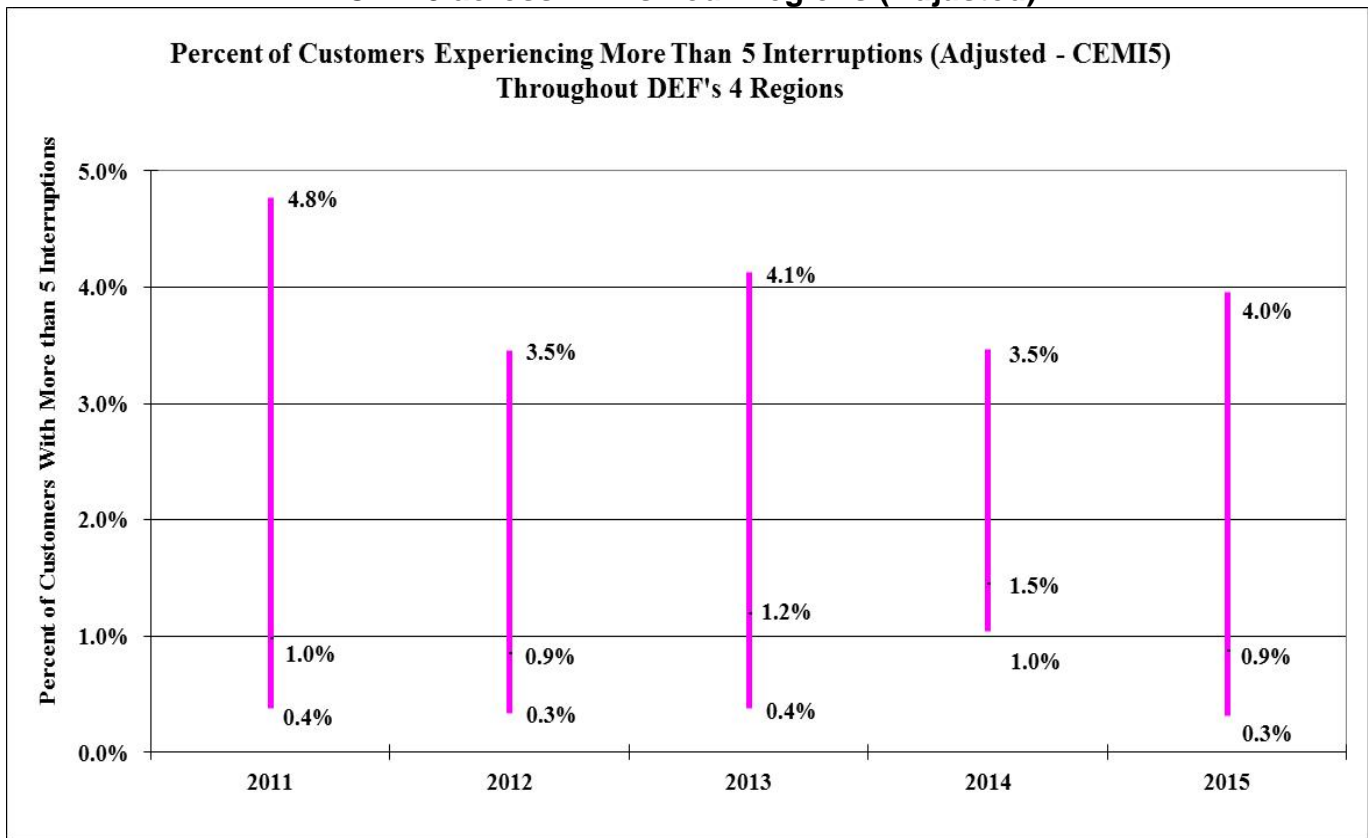
**Figure 3-6.
CEMI5 across DEF’s Four Regions (Adjusted)**

Figure 3-6 charts the percentage of DEF’s customers experiencing more than five interruptions over the last five years. DEF reported a decrease in the average CEMI5 performance from 1.5 percent in 2014 to 0.9 percent in 2015; however the average CEMI5 is trending upward over the past five years. The North Central region has the lowest reported percentage for all of DEF’s regions and the North Coastal region continues to have the highest reported percentage.

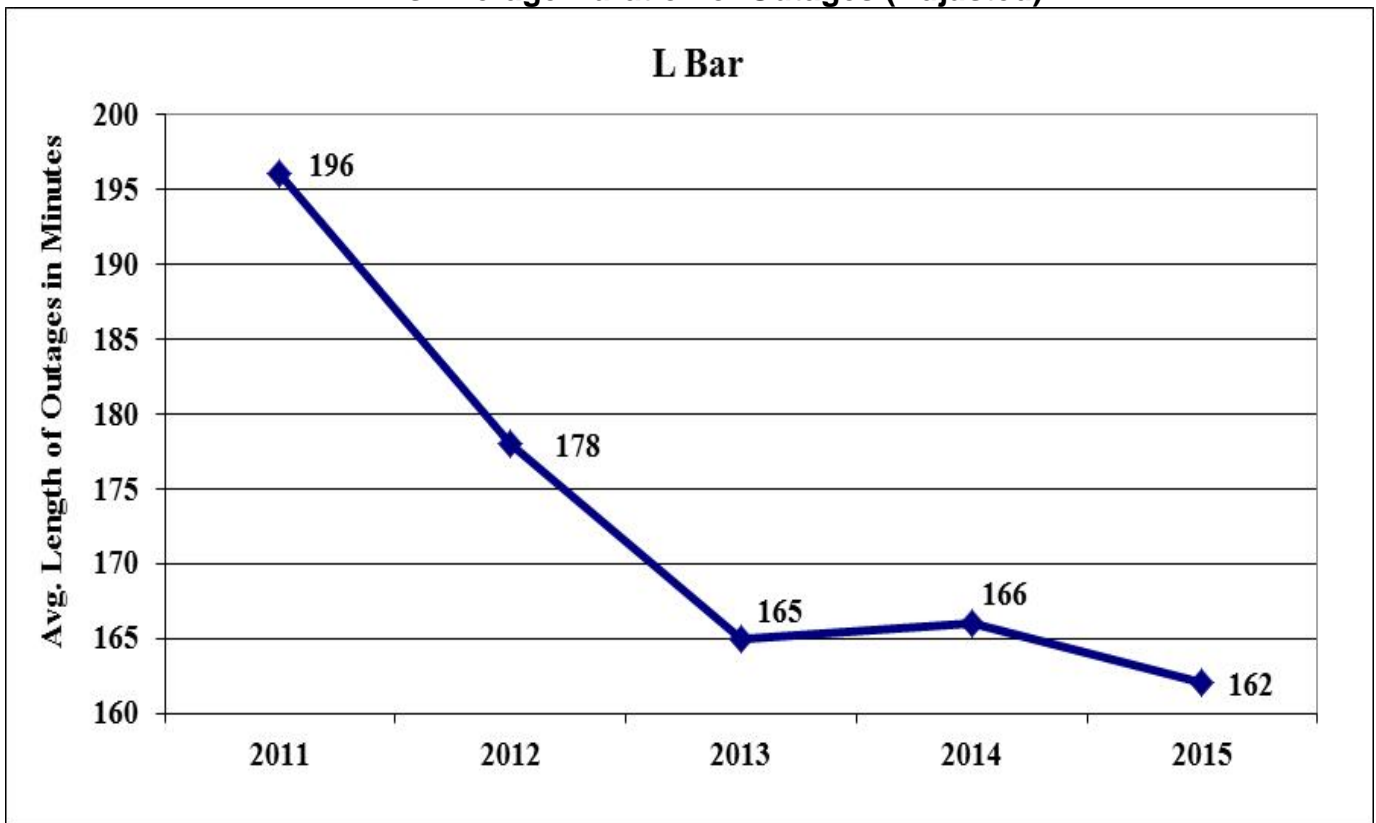
**Figure 3-12.
FPL's Average Duration of Outages (Adjusted)**

Figure 3-12 depicts the average length of time that FPL spends recovering from outage events, excluding hurricanes and other extreme outage events and is the index known as L-Bar (Average Service Restoration Time). FPL had a 2.4 percent decrease in L-Bar from 166 minutes in 2014, to 162 minutes in 2015. There is a 17 percent overall decrease since 2011, indicating FPL is spending less time restoring service.

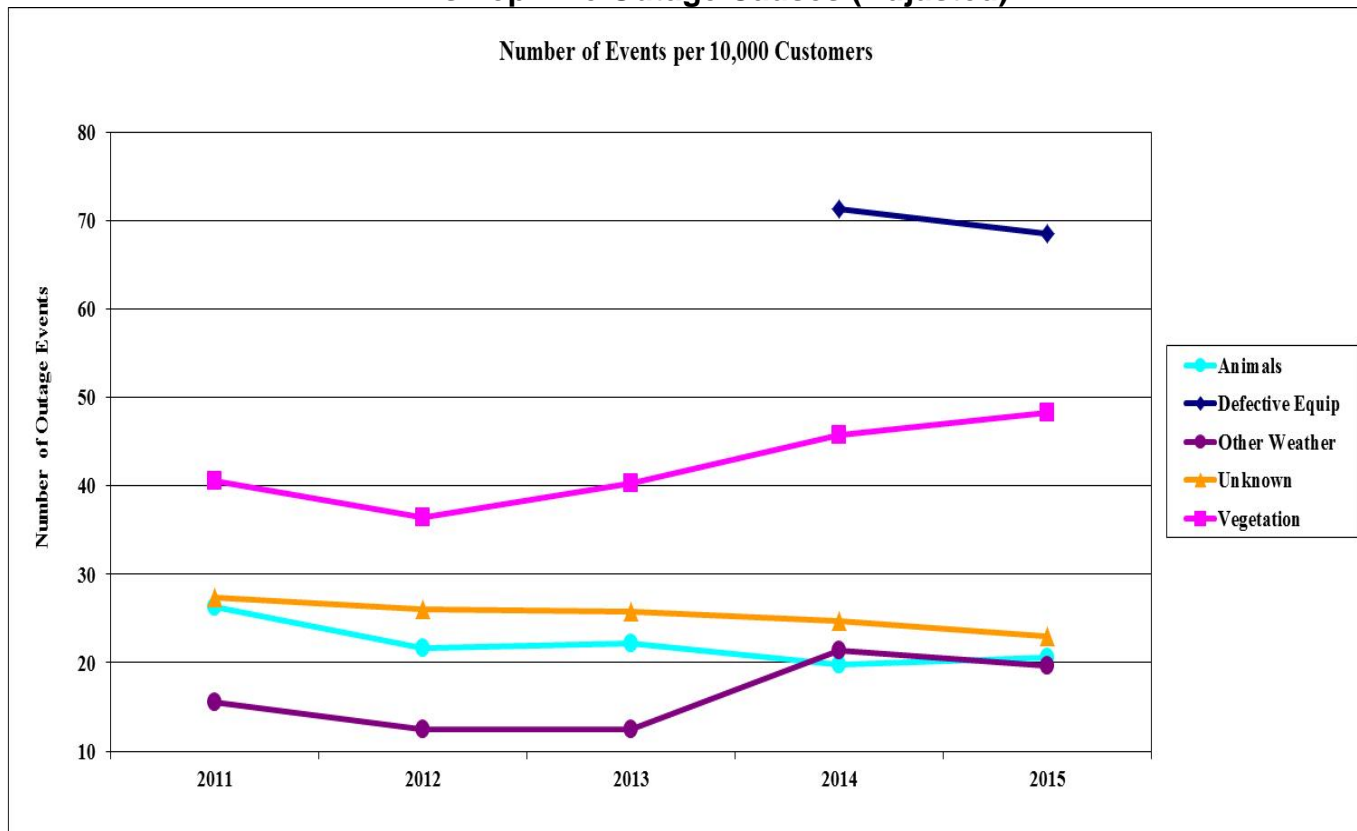
**Figure 3-16.
FPL's Top Five Outage Causes (Adjusted)**

Figure 3-16 depicts the top five causes of outage events on FPL’s distribution system normalized to a 10,000-customer base. The graph is based on FPL’s adjusted data of the top 10 causes of outage events. For the five-year period, the five top causes of outage events included Defective Equipment (33 percent), Vegetation (23 percent), Unknown (11 percent), Animals (10 percent), and Other Weather (9 percent) on a cumulative basis. The data shows an increasing trend in outage events caused by Vegetation and Other Weather. The number of outages increased for the Vegetation category and decreased for the Other Weather category from 2014 to 2015. The outage events due to Animals and Unknown are trending downward. The Defective Equipment category dominates the highest percentage of outage causes throughout the FPL regions. Starting in 2014, Defective Equipment includes Equipment Failure, Equipment Connect and Dig-in, which were all separate categories, in prior years.

Annually, FPL evaluates its current reliability remediation programs and verifies the program’s need and/or existence. In addition, FPL proposes new reliability remediation programs to improve its reliability performance concentrating on the highest cause codes and those cause codes that have shown trends needing attention. FPL has 17 reliability programs listed for its 2016 budget. The programs include: priority feeder inspection, distribution automation (installing and maintaining automated feeder switches, automated lateral switches and fault current indicators), and replacing oil circuit reclosers with electronic reclosers. Six programs are designed to help improve the Vegetation cause code, which had an increase in 2015. Along with those six programs, FPL has several other initiatives to address vegetation issues, including FPL’s “Right Tree, Right Place” and Palm Management programs. Four programs are intended to help improve the Animal cause code, which also had an increase in 2015.

Defective Equipment (33 percent) and Vegetation (23 percent) outages were the leading causes of the number of outage events per customer for 2015. Starting in 2014, Defective Equipment includes Equipment Failure, Equipment Connect and Dig-in, which were all separate categories, in prior years. Outages caused by vegetation are addressed through FPL's Vegetation Management Program. The next three outage causes are Unknown (11 percent), Animals (10 percent) and Other Weather (9 percent). Analysis of **Figure 3-16** shows an increasing trend in the number of outage events attributed to Vegetation, causing the number of outages to increase by 8 percent from 2014 to 2015. The analysis shows a decreasing trend in the number of outage events caused by Defective Equipment, causing the number of outages to decrease by 1 percent from 2014 to 2015 and a decreasing trend of outage events by Unknown, causing a decrease of 4 percent from 2014 to 2015. The analysis shows that the trend for the Animals category is trending downward even though there was an increase in outages of 6 percent and the Other Weather category is trending upward even though there was a decrease in outages of 5 percent.

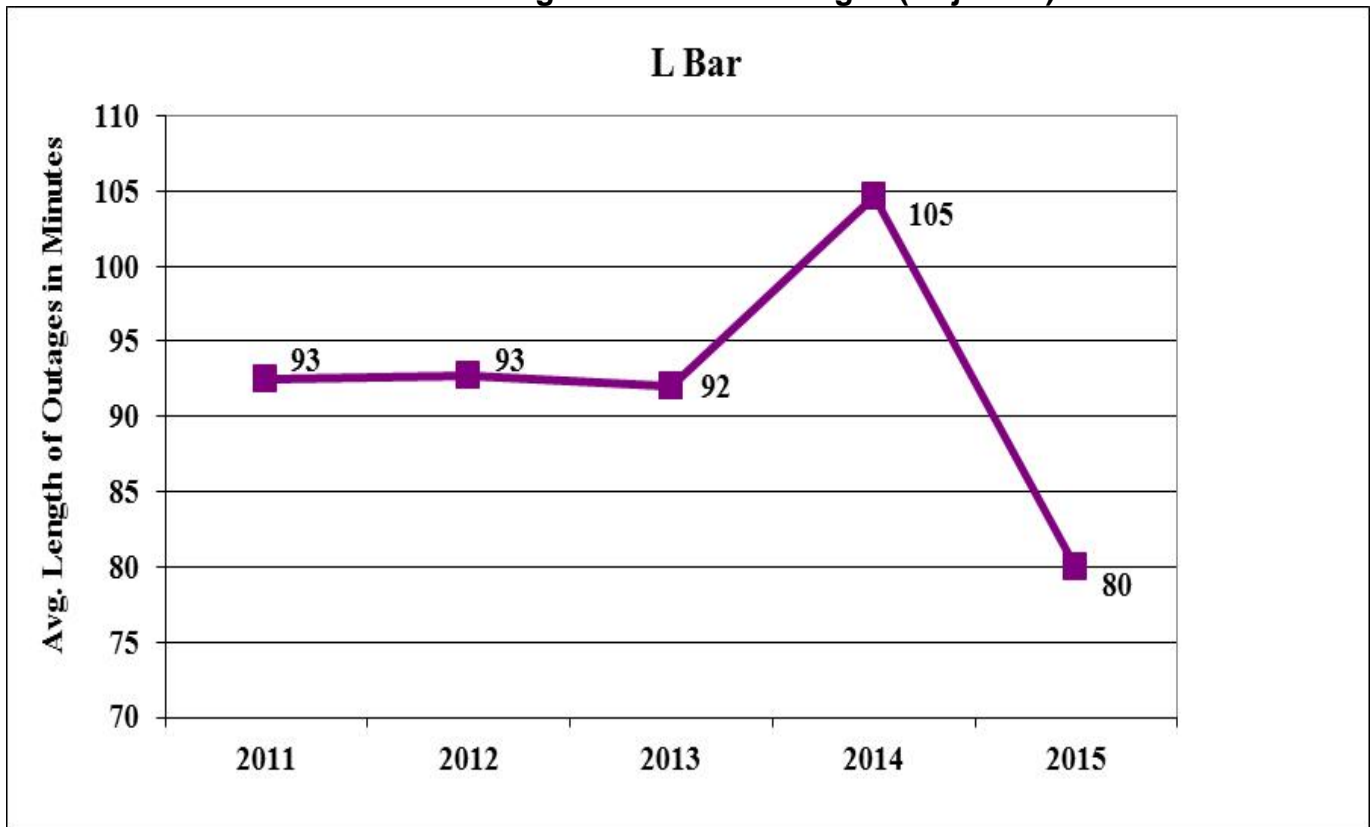
Figure 3-20.
FPUC's Average Duration of Outages (Adjusted)

Figure 3-20 is the average length of time FPUC spends recovering from outage events (adjusted L-Bar). There was a 24 percent decrease in the L-Bar value from 2014 to 2015. The data for the five-year period of 2011 to 2015 suggests that the L-Bar index is trending downward indicating FPUC is taking less time to restore service after an outage event.

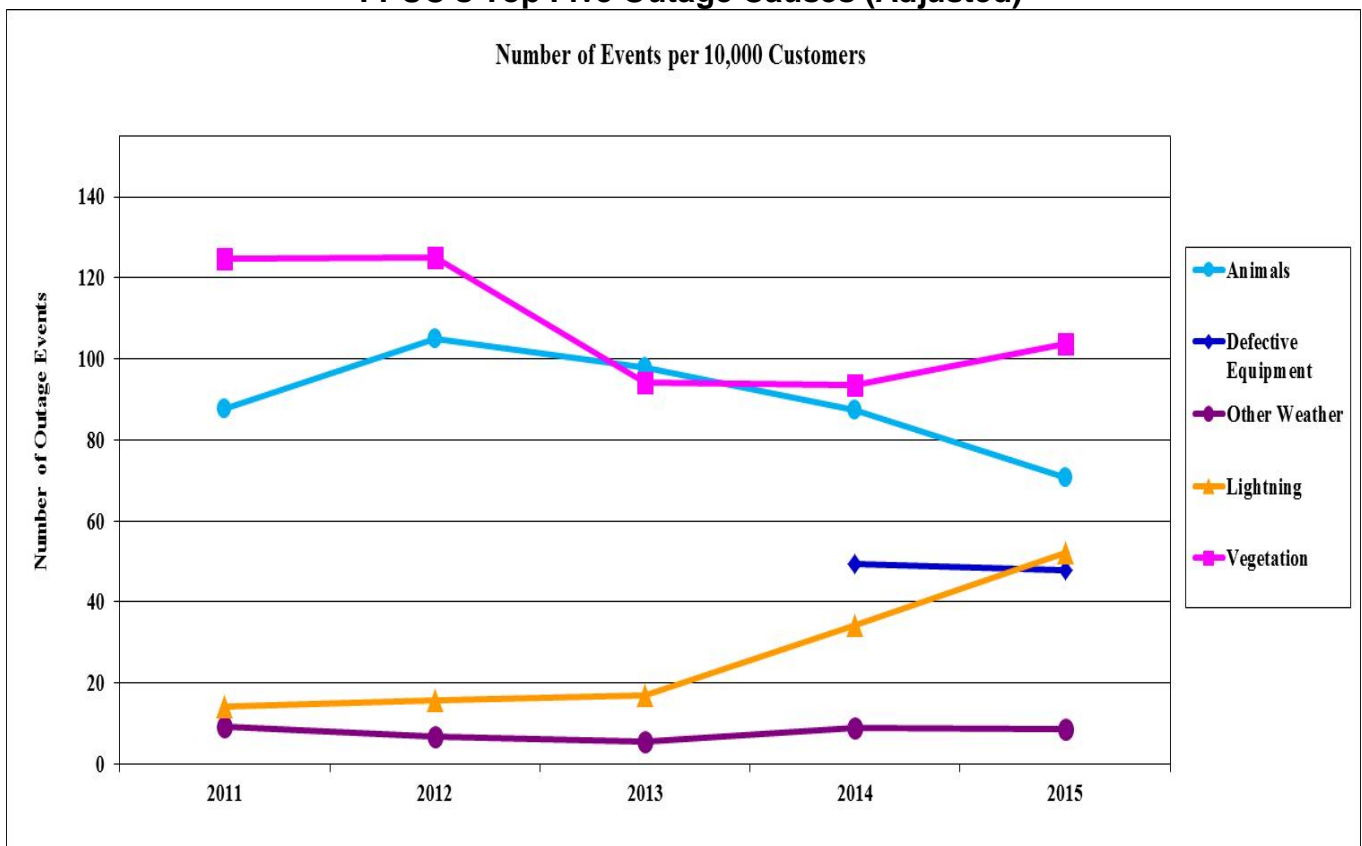
Figure 3-21.
FPUC’s Top Five Outage Causes (Adjusted)

Figure 3-21 shows the top five causes of outage events on FPUC’s distribution system normalized to a 10,000-customer base. The figure is based on FPUC’s adjusted data of the top 10 causes of outages. For 2015, the top five causes of outage events were Vegetation (27 percent), Animals (19 percent), Other Weather (16 percent), Lightning (14 percent), and Defective Equipment (13 percent). These five factors represent 89 percent of the total adjusted outage causes in 2015. The cause by Lightning is trending upward and increased 46 percent from 2014 to 2015. The causes by Defective Equipment, Animals, and Vegetation are trending downward. Defective Equipment and Vegetation increased 12 percent and 24 percent from 2014 to 2015, respectively. The Animals category decreased 5 percent during the same time period. The Other Weather category caused outages has remained relatively flat over the five-year period of 2011 to 2015, even though there was a 46 percent decrease from 2014 to 2015. Beginning with 2014, the Defective Equipment category now includes outage categories that in the past were separately identified.

FPUC's top five causes of outages included Vegetation, Animals, Other Weather, Lightning, and Defective Equipment events. Vegetation (27 percent) related outages were the number one cause of outages in 2015 as shown in **Figure 3-21** followed by Animals (19 percent), Other Weather (16 percent), Lightning (14 percent), and Defective Equipment (13 percent). Animal and Other

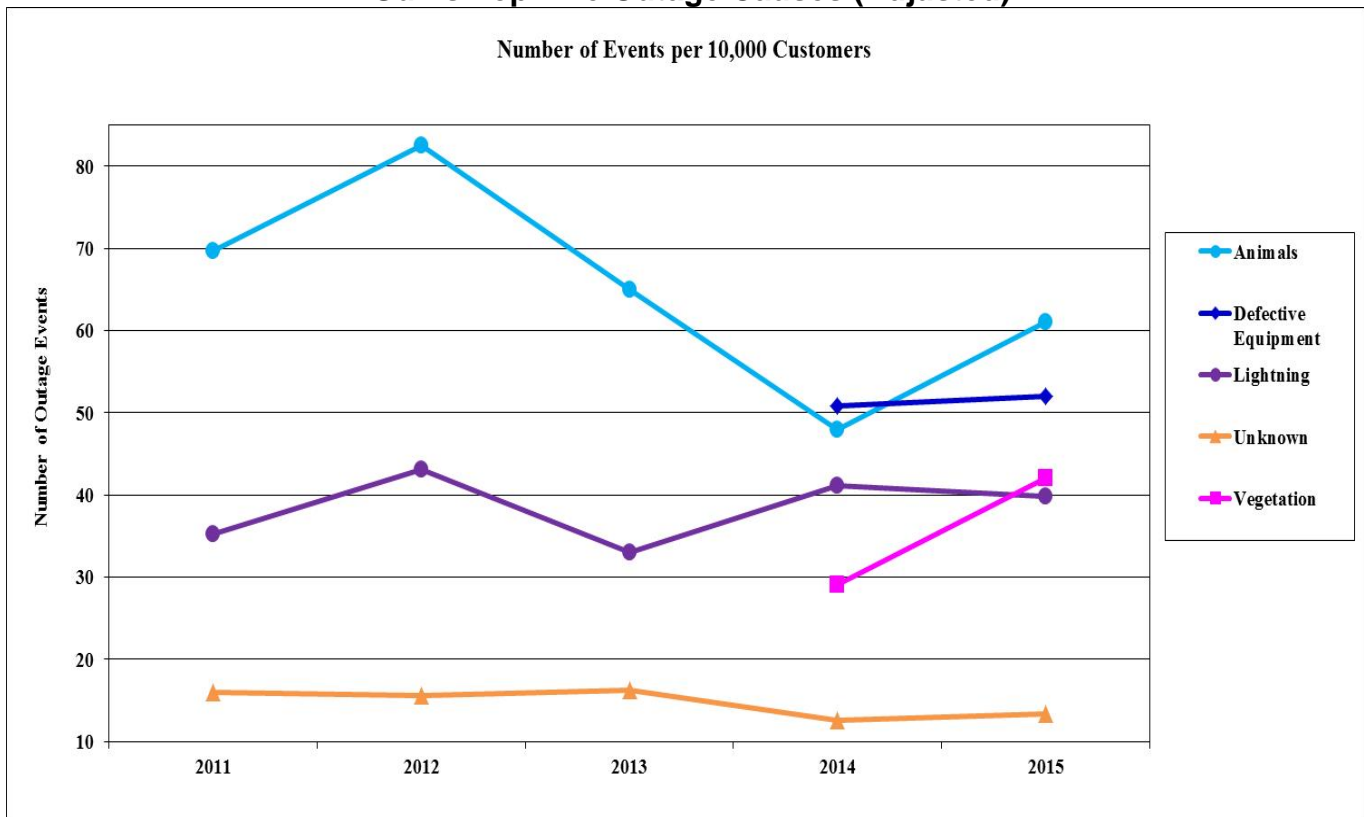
**Figure 3-29.
Gulf’s Top Five Outage Causes (Adjusted)**

Figure 3-29 is a graph of the top five causes of outage events on Gulf’s distribution system normalized to a 10,000-customer base. The figure is based on Gulf’s adjusted data of the top 10 causes of outage events and represents 91 percent of the total adjusted outage events that occurred during 2015. The top five causes of outage events were Animals (27 percent), Defective Equipment (23 percent), Vegetation (18 percent), Lightning (17 percent), and Unknown Causes (6 percent). The percentage of outages due to Animals was the highest cause of outages. As the number of outage events due to Animals is trending downward, even though there was an increase in 2015, the number of outage events due to Lightning and Unknown causes has remained relatively flat. The number of outage events due to Defective Equipment and Vegetation are both trending upward. The Defective Equipment and Vegetation categories now include outage categories that in the past were separately identified. To improve reliability, Gulf continues to install animal protection on all major equipment and transformers. Gulf added Animal related outages as a stand-alone initiative in 2016 to its Root Cause Mitigation program. Through the Root Cause Mitigation program, Gulf will review feeders with a high number of Animal related outages and install additional animal protection when needed. In addition, Gulf continues to encourage its employees to report vegetation conditions so those issues can be remedied as soon as possible.

Gulf's top five causes of outages were listed as Animals, Defective Equipment, Vegetation, Lightning, and Unknown. Animal (27 percent) caused outages was the number one cause of outages followed by Defective Equipment (23 percent), Vegetation (18 percent), Lightning (17 percent), and Unknown (6 percent). The number of outages decreased for three of the top five outage categories in 2015 when compared to 2014, which were outages due to Defective Equipment, Lightning, and Unknown as shown in **Figure 3-29**. The Defective Equipment and Vegetation categories now include outage categories which in the past were separately identified.

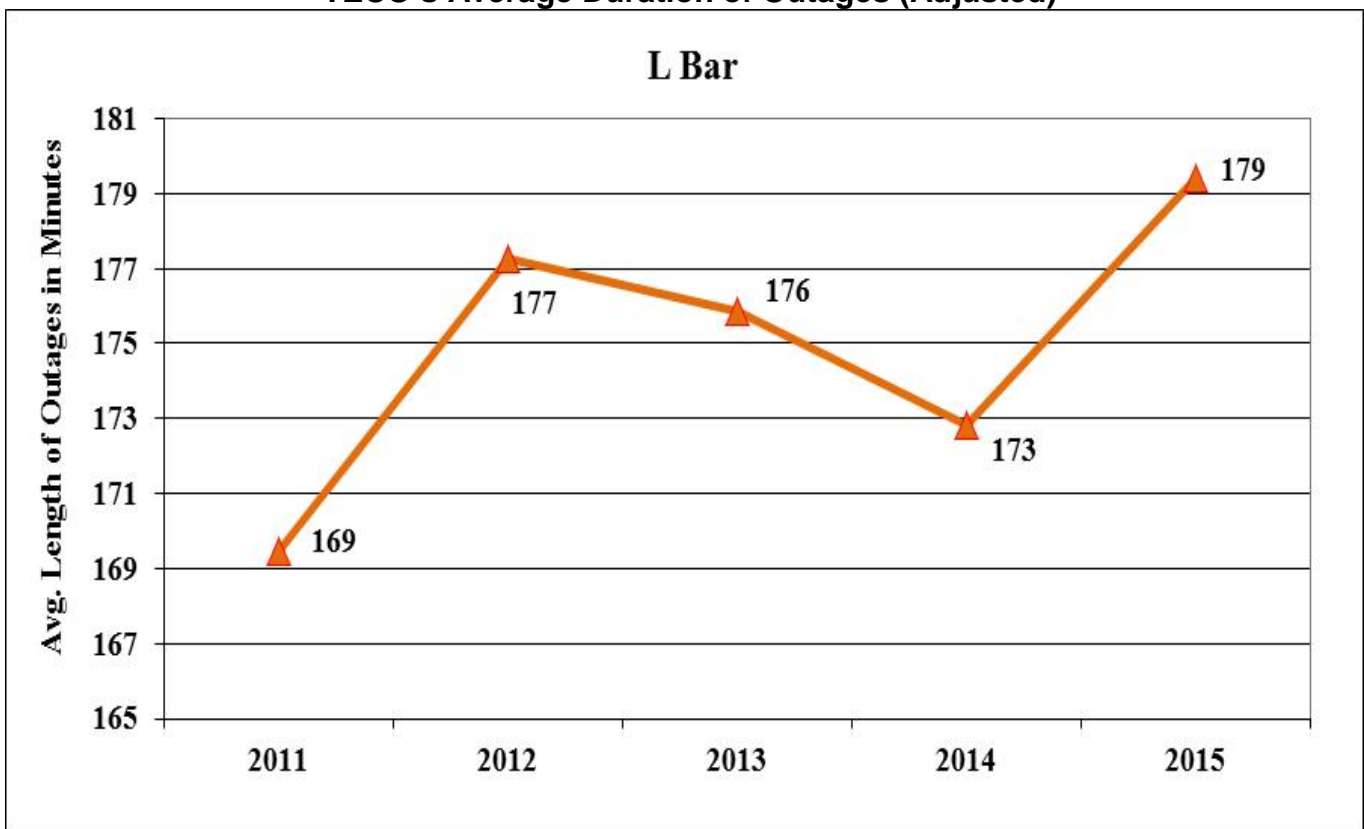
Figure 3-33.
TECO's Average Duration of Outages (Adjusted)

Figure 3-33 denotes a 3 percent increase in outage durations for the period from 2014 to 2015 for TECO. The average length of time TECO spends restoring service to its customers affected by outage events, excluding hurricanes and other allowable excluded outage events is shown in the L-Bar index. The L-Bar index continues to be trending upward for the five-year period of 2011 to 2015, suggesting longer restoral times. TECO reported that the increasing value of L-Bar is due to lightning, other weather and defective equipment type of outages. TECO has initiated plans to reduce the total minutes of interruptions related to theses type of outages by: (1) identifying and replacing lightning arrestors on overhead transformers and (2) changing its standard for previously installing live-front switchgears to dead-front switchgears.

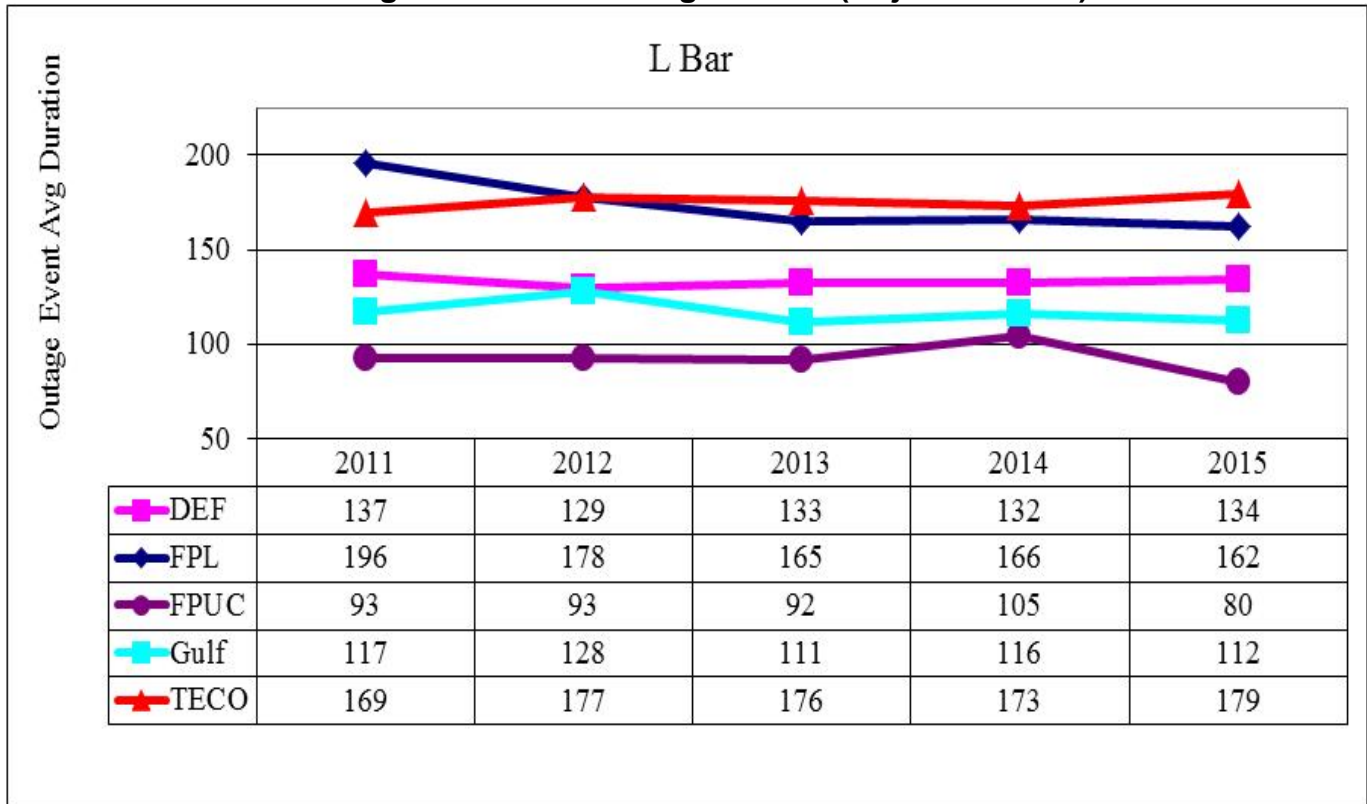
Figure 4-7 represents the average duration of outage events (Adjusted L-Bar) for each IOU. From the data shown, it appears that the utilities are more consistent with their restoral times for the five-year period of 2011 to 2015.

**Figure 4-7.
Average Duration of Outage Events (Adjusted L-Bar)**
