*Review of
Florida's
Investor-Owned
Electric Utilities*

*2 0 1 6
Service Reliability Reports*

State of Florida
Florida Public Service Commission
Division of Engineering

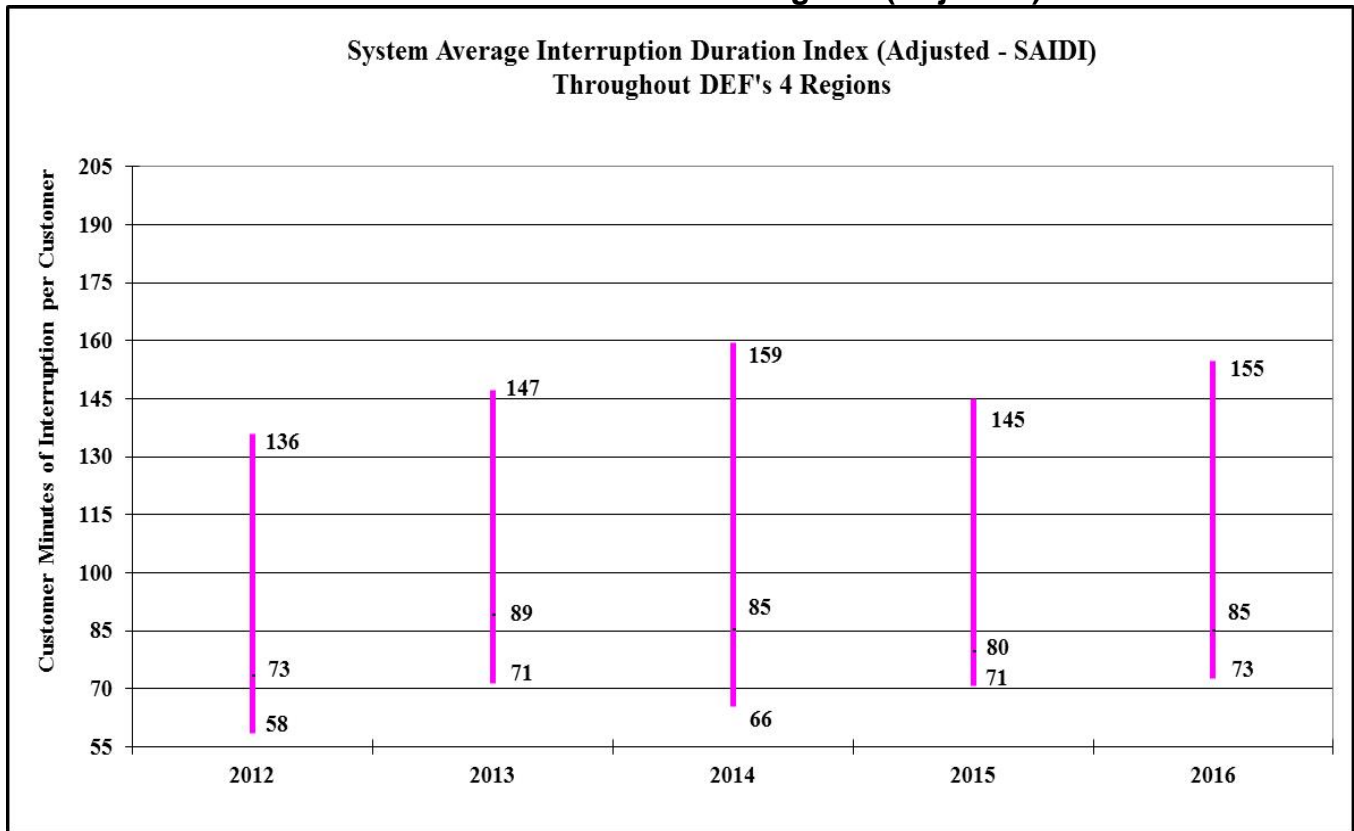
**Figure 3-1.
SAIDI across DEF's Four Regions (Adjusted)**

Figure 3-1 charts the adjusted SAIDI recorded across DEF's system and depicts increases in the lowest, the average and highest values for 2016. DEF reported that in 2016 its service territory was affected by an active weather pattern caused by El Niño events in the first half of the year. DEF also reports that its service territory was impacted by three named storms, record level heat in July, and many severe afternoon thunderstorms. Not all the extreme weather events qualified for exclusion.

DEF's service territory is comprised of four regions: North Coastal, South Coastal, North Central, and South Central. **Figure 3-1** illustrates that the North Coastal region continues to report the poorest SAIDI over the last five years, fluctuating between 136 minutes and 159 minutes. While the South Coastal and South Central regions have the best or lowest SAIDI for the same period. The North Coastal region is rural and has more square miles when compared to the other regions. This region is also served by predominantly long circuits with approximately 7,700 miles of overhead and underground main circuits. DEF explained that these factors result in higher exposure to outage causes and higher reliability indices.

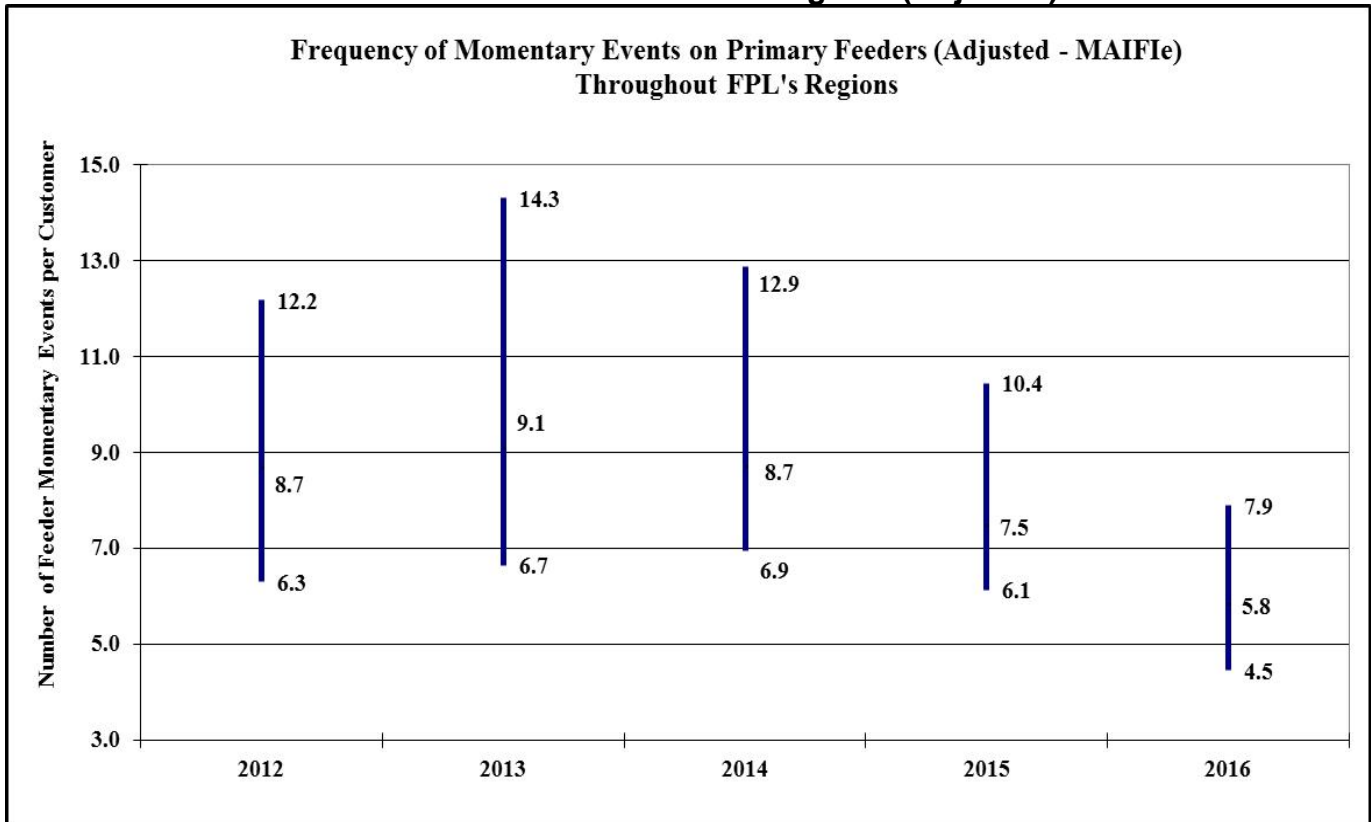
**Figure 3-13.
MAIFie across FPL’s Sixteen Regions (Adjusted)**

Figure 3-13 is the highest, average, and lowest adjusted MAIFie recorded across FPL’s system. FPL’s Treasure Coast and Wingate service areas have experienced the least reliable MAIFie results of the 16 service areas of FPL since 2012. The Pompano, Central Dade, Naples, and Manasota service areas had the fewest momentary events since 2012. The results have been trending downward (improving) over the last five years. There is a 23 percent decrease in the average MAIFie results from 2015 to 2016.

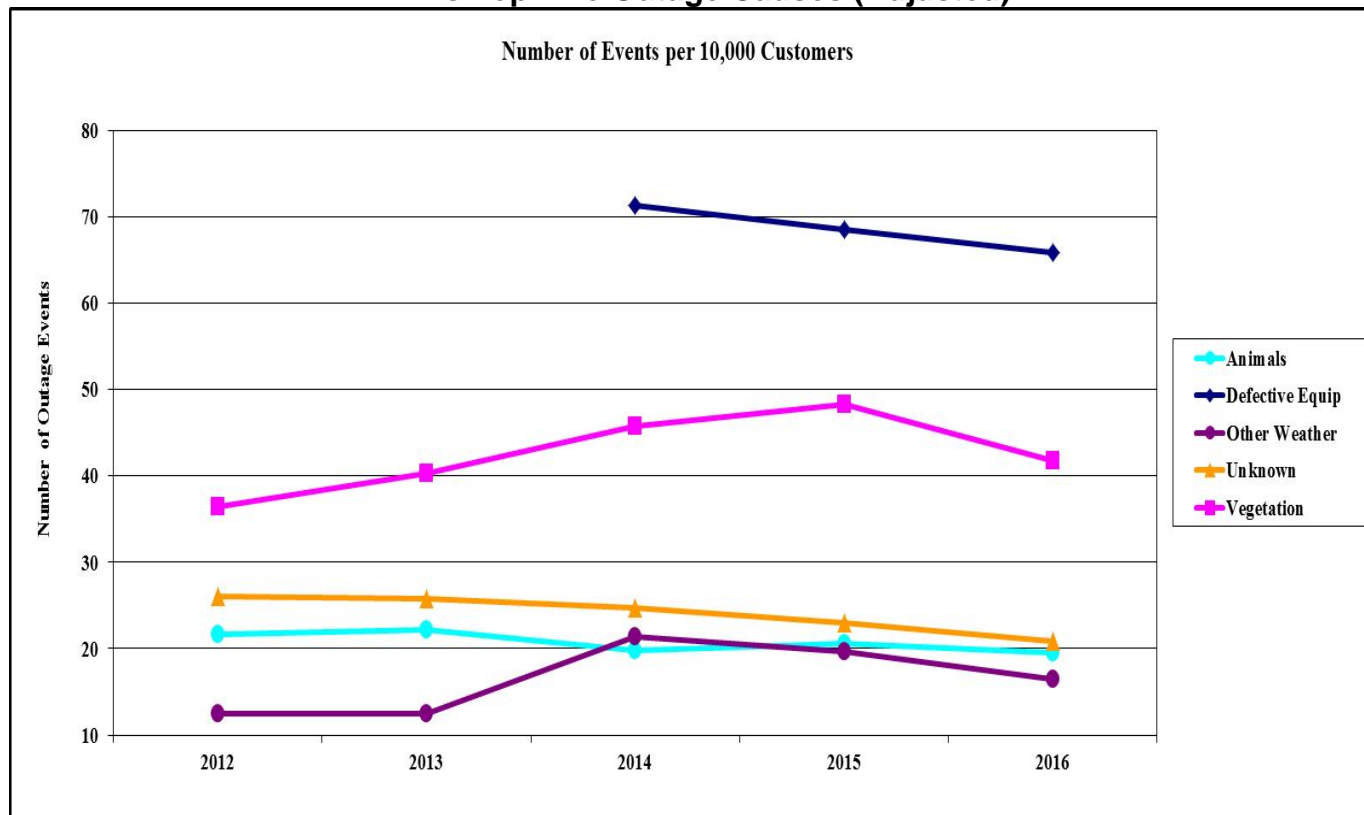
**Figure 3-16.
FPL's Top Five Outage Causes (Adjusted)**

Figure 3-16 depicts the top five causes of outage events on FPL’s distribution system normalized to a 10,000-customer base. The graph is based on FPL’s adjusted data of the top 10 causes of outage events. For the five-year period, the five top causes of outage events included Defective Equipment (35 percent), Vegetation (22 percent), Unknown (11 percent), Animals (10 percent), and Other Weather (9 percent) on a cumulative basis. The data shows an increasing trend in outage events caused by Vegetation and Other Weather. The number of outages decreased for both the Vegetation and the Other Weather categories from 2015 to 2016. The outage events due to Animals and Unknown are trending downward. The Defective Equipment category dominates the highest percentage of outage causes throughout the FPL regions. Starting in 2014, Defective Equipment includes Equipment Failure, Equipment Connect and Dig-in, which were all separate categories, in prior years.

Annually, FPL evaluates its current reliability remediation programs and verifies the program’s need and/or existence. In addition, FPL proposes new reliability remediation programs to improve its reliability performance concentrating on the highest cause codes and those cause codes that have shown trends needing attention. FPL has 18 reliability programs listed for its 2017 budget. The programs include: priority feeder inspection, distribution automation (installing and maintaining automated feeder switches, automated lateral switches and fault current indicators), and replacing oil circuit reclosers with electronic reclosers. Fifteen programs are designed to help improve the Defective Equipment cause code, which had an increase in 2016. Five programs will help to improve the Animals cause code, which also had an increase in 2016. In addition to the reliability programs identified by FPL in its report, the Utility is planning to inspect and repair or replace auto transformers, as necessary. This program will also help address the Defective Equipment and Animals cause codes.

Defective Equipment (35 percent) and Vegetation (22 percent) outages were the leading causes of the number of outage events per customer for 2016. Starting in 2014, Defective Equipment includes Equipment Failure, Equipment Connect and Dig-in, which were all separate categories, in prior years. The next three outage causes are Unknown (11 percent), Animals (10 percent) and Other Weather (9 percent). **Figure 3-16** shows an increasing trend in the number of outage events attributed to Vegetation, even though the number of outages decreased by 12 percent from 2015 to 2016. The analysis shows a decreasing trend in the number of outage events caused by Defective Equipment. The number of outages decreased by 3 percent from 2015 to 2016 and a decreasing trend of outage events by Unknown, which decreased by 8 percent from 2015 to 2016. The analysis shows that the trend for the Animals category is trending downward and there was a decrease in outages of 4 percent and the Other Weather category is trending upward even though there was a decrease in outages of 15 percent.

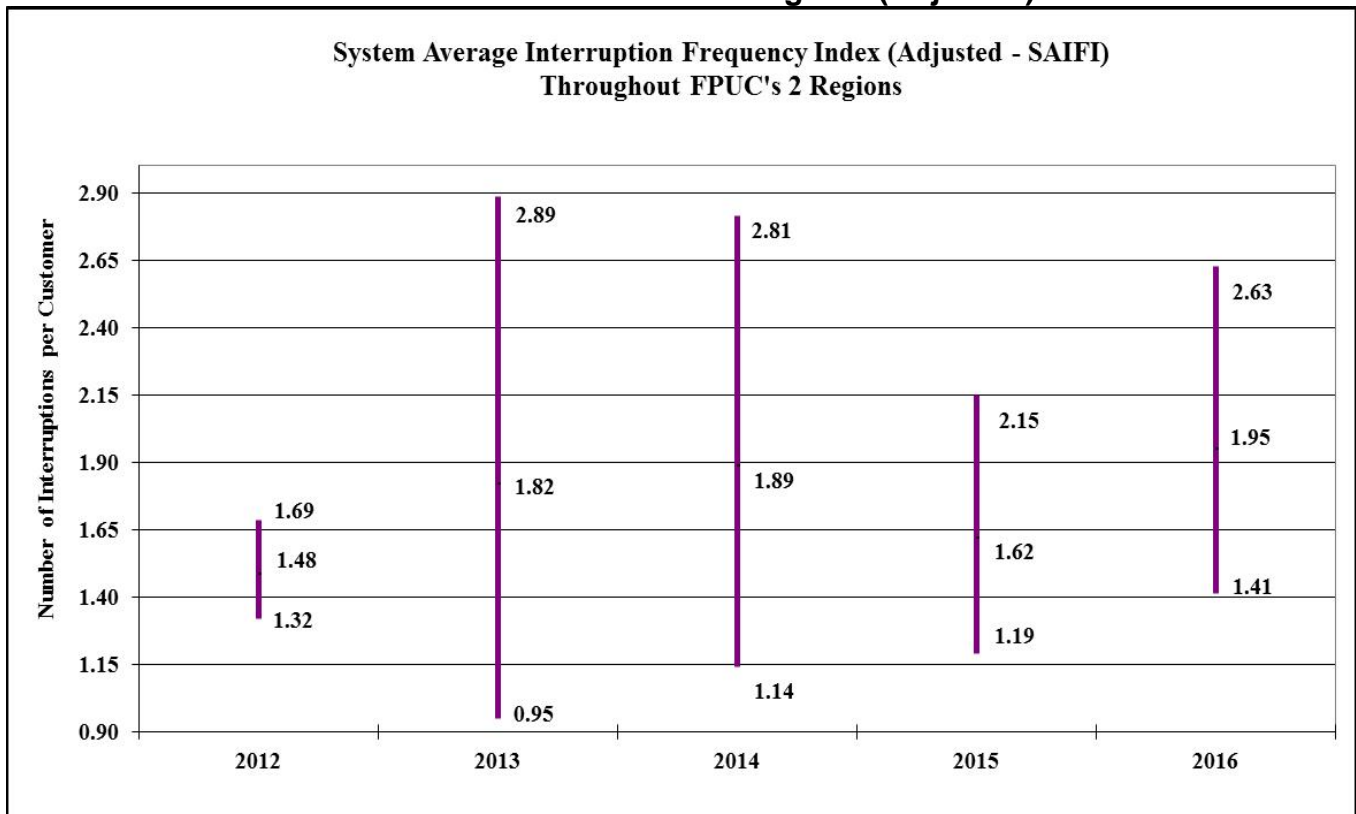
**Figure 3-18.
SAIFI across FPUC’s Two Regions (Adjusted)**

Figure 3-18 shows the adjusted SAIFI across FPUC’s two divisions. The data depicts a 17 percent increase in the 2016 average SAIFI reliability index from 2015. The data for the minimum, average, and maximum SAIFI values are trending upward over the five-year period of 2012 to 2016.

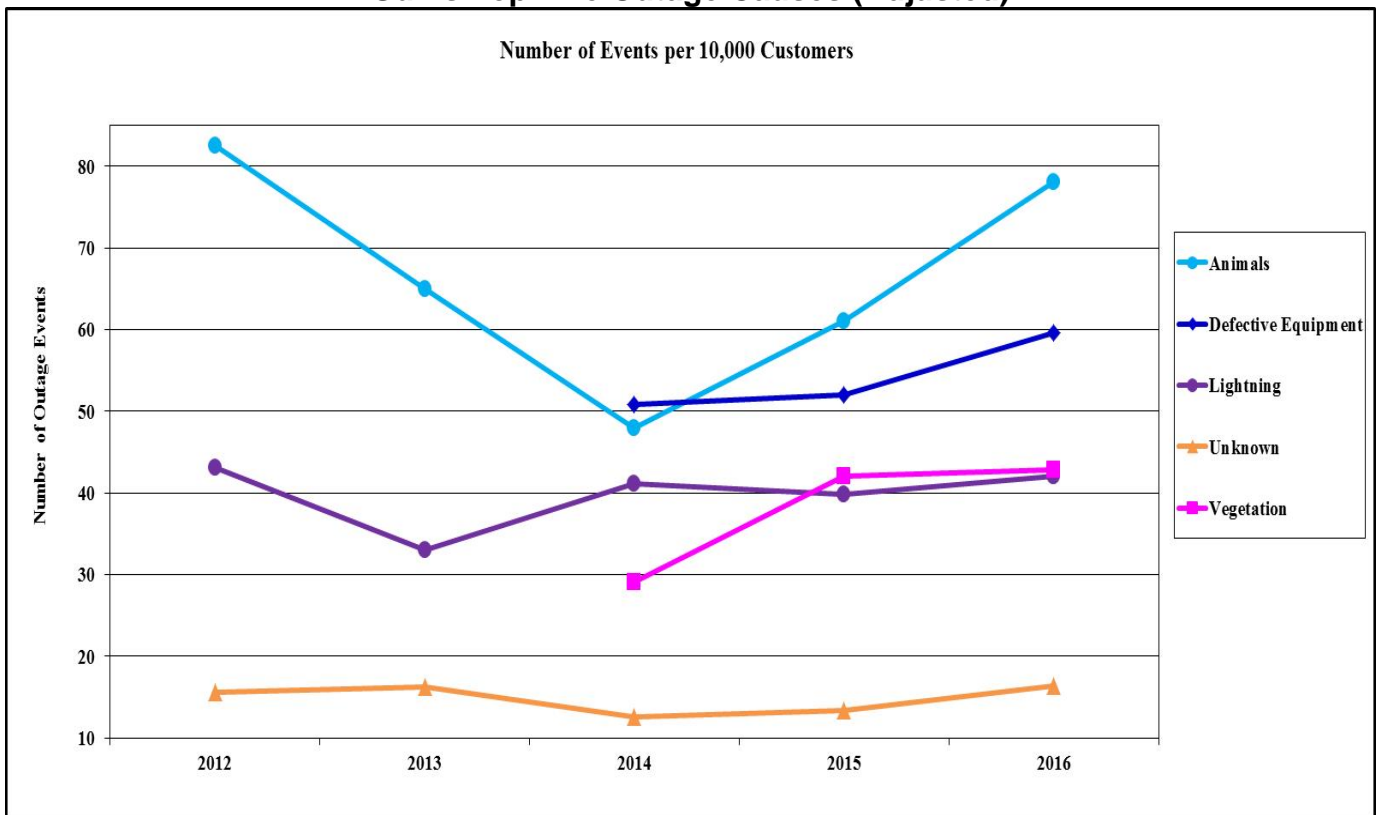
**Figure 3-29.
Gulf’s Top Five Outage Causes (Adjusted)**

Figure 3-29 is a graph of the top five causes of outage events on Gulf’s distribution system normalized to a 10,000-customer base. The figure is based on Gulf’s adjusted data of the top 10 causes of outage events and represents 91 percent of the total adjusted outage events that occurred during 2016. The top five causes of outage events were Animals (30 percent), Defective Equipment (23 percent), Vegetation (16 percent), Lightning (16 percent), and Unknown Causes (6 percent). The percentage of outages due to Animals was the highest cause of outages. The number of outage events due to Animals is trending upward and there was a 10 increase in 2016. The numbers of outage events due to Lightning and Unknown causes are trending downward. The number of outages due to Defective Equipment and Vegetation are both trending upward. The Defective Equipment and Vegetation categories now include outage categories that in the past were separately identified. Gulf continues to focus its process improvement efforts on the system wide top outage causes through its existing programs and storm hardening efforts.

Gulf's top five causes of outages were listed as Animals, Defective Equipment, Vegetation, Lightning, and Unknown. Animals (30 percent) caused outages was the number one cause of outages followed by Defective Equipment (23 percent), Vegetation (16 percent), Lightning (16 percent), and Unknown (6 percent). The number of outages decreased for three of the top five outage categories in 2016 when compared to 2015, which were outages due to Defective Equipment, Lightning, and Vegetation as shown in **Figure 3-29**. The Defective Equipment and Vegetation categories now include outage categories that in the past were separately identified.

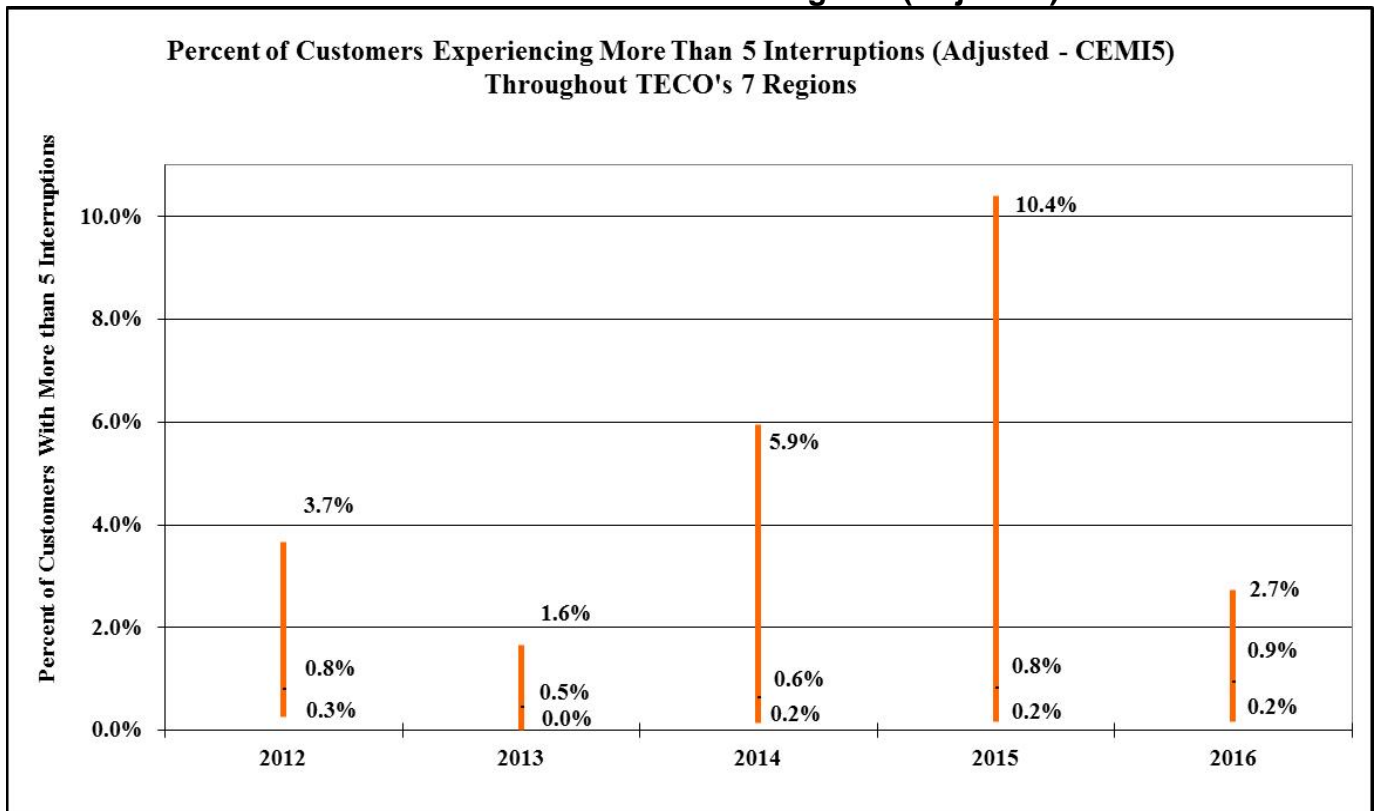
**Figure 3-35.
CEMI5 across TECO’s Seven Regions (Adjusted)**

Figure 3-35 shows the percent of TECO’s customers experiencing more than five interruptions. Three regions in TECO’s territory experienced a decrease in the CEMI5 results for 2016. The Central, Eastern, Western, and Winter Haven regions experienced an increase in the CEMI5 index. Dade City reported the highest CEMI5 percentage for 2016. With TECO’s results for this index varying for the past five years, the average CEMI5 index appears to be trending upward indicating a decline in performance. There was a 13 percent increase in the average CEMI5 index from 2015 to 2016.
