*Review of
Florida's
Investor-Owned
Electric Utilities*

2 0 1 7

Service Reliability Reports

State of Florida
Florida Public Service Commission
Division of Engineering

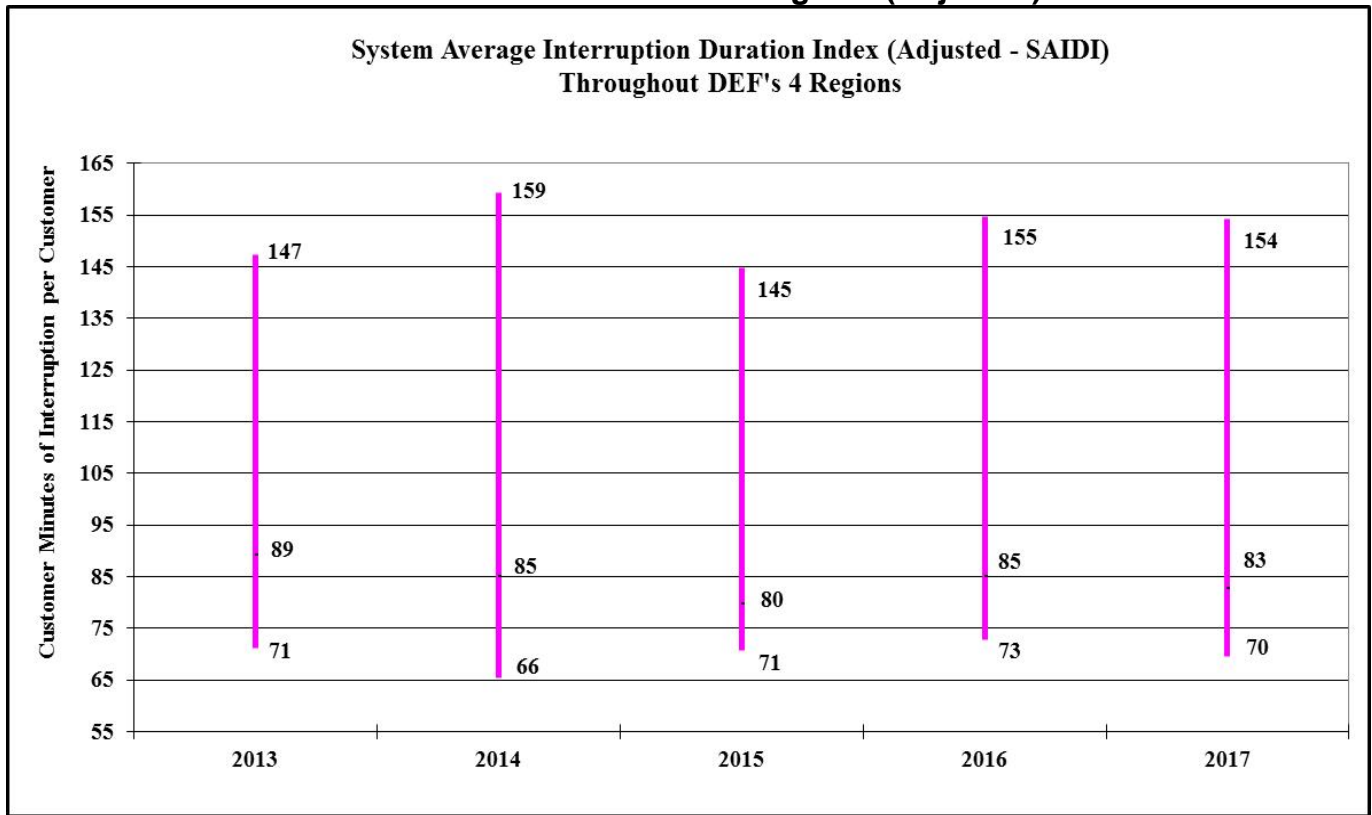
**Figure 3-1
SAIDI across DEF's Four Regions (Adjusted)**

Figure 3-1 charts the adjusted SAIDI recorded across DEF's system and depicts decreases in the lowest, the average and highest values for 2017. DEF reported that 2017 presented the Utility with the most challenging weather related year. DEF notes that there were seven days in 2017 that had weather-related outages from afternoon thunderstorms, which caused more than 50 percent of customer outages on those days.

DEF's service territory is comprised of four regions: North Coastal, South Coastal, North Central, and South Central. **Figure 3-1** illustrates that the North Coastal region continues to report the poorest SAIDI over the last five years, fluctuating between 147 minutes and 154 minutes. While the South Coastal and South Central regions have the best or lowest SAIDI for the same period. The North Coastal region is rural and has more square miles when compared to the other regions. This region is also served by predominantly long circuits with approximately 7,700 miles of overhead and underground main circuits. DEF explained that these factors result in higher exposure to outage causes and higher reliability indices.

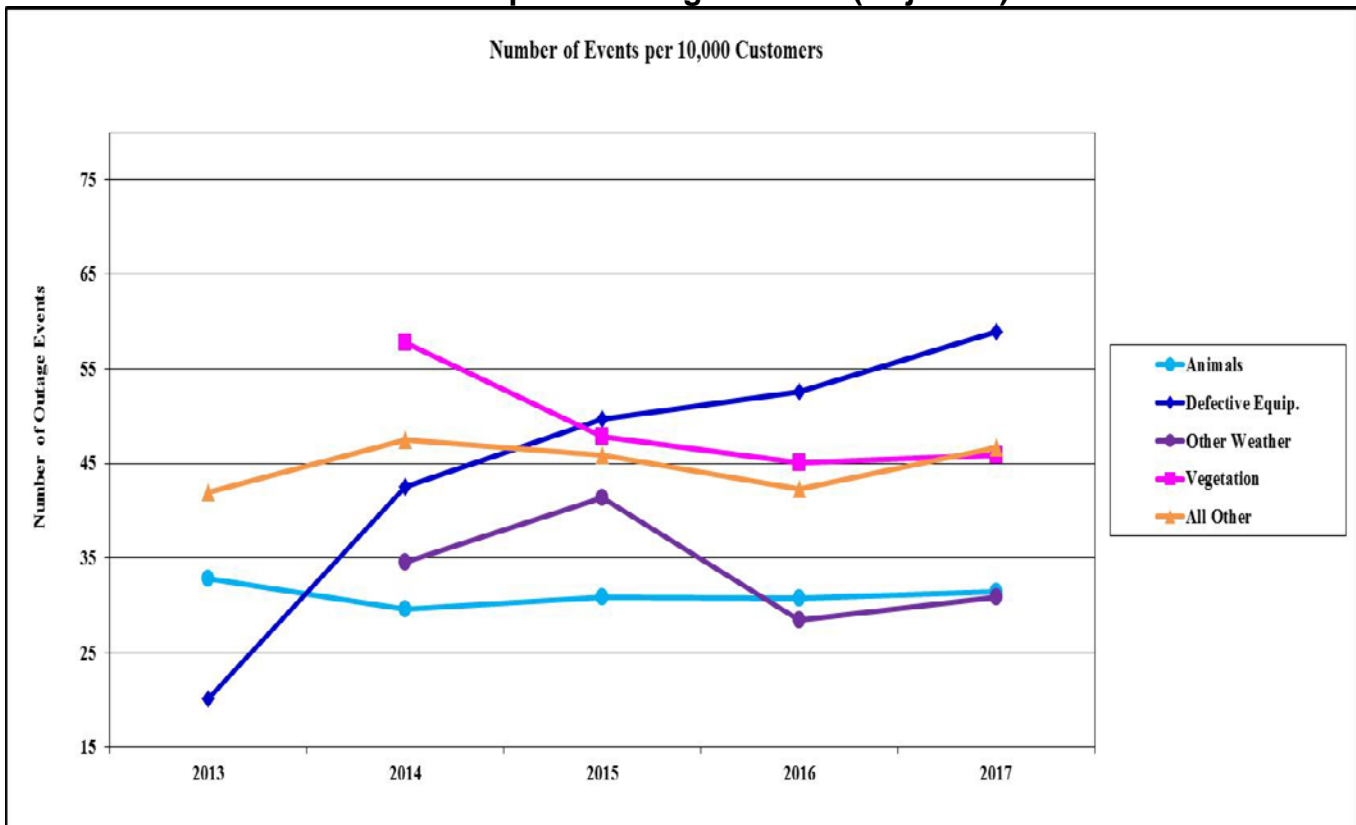
Figure 3-8
DEF’s Top Five Outage Causes (Adjusted)

Figure 3-8 shows the top five causes of outage events on DEF’s distribution system normalized to a 10,000-customer base. The figure is based on DEF’s adjusted data and represents approximately 93 percent of the top 10 causes of outage events that occurred during 2017. For the five-year period, the top five causes of outage events were “Defective Equipment” (26 percent), “Vegetation” (20 percent), “Other Causes” (20 percent), “Animals” (14 percent), and “Other Weather” (13 percent) on a cumulative basis. Commission staff requested that, beginning with 2014 data, all IOU’s use the same outage categories for comparison purposes. As such, the “Vegetation,” “Defective Equipment,” and “Other Weather” now include outage categories that in the past were separately identified. The outage events caused by “Vegetation” and “Other Weather” are trending downward even though the “Other Weather” category had an increase of 10 percent in 2017. DEF reported that it prioritizes the reliability improvements action plan by balancing historical and current year performance. In addition, current year performance is monitored monthly to identify emergent and seasonal issues including load balancing for cold weather and the need for foot patrols of devices experiencing multiple interruptions.

To address outages related to “Defective Equipment,” DEF is continuing to invest in proactive system maintenance activities, such as pole replacements, pad-mounted transformer replacements, and underground cable replacements. In 2018, DEF plans to invest in proactive switchgear replacements, overhead transformer retrofits, and other reliability programs.

In **Figure 3-8**, DEF’s Top Five Outage Categories, the category “Defective Equipment” is in the top spot representing 26 percent of the top 10 outage categories. The next two highest categories were “Vegetation” (20 percent) and “Other Causes” (20 percent). “Other Weather” (13 percent) and “Animals” (14 percent) are the next two causes of outages. Commission staff requested that, beginning with 2014 data, all IOU’s use the same outage categories for comparison purposes. As such, the “Vegetation,” “Defective Equipment,” and “Other Weather” now include outage categories that in the past were separately identified. The “Vegetation” and “Other Weather” outage categories are trending downward for the five-year period of 2013 to 2017 even though the “Other Weather” category had a 10 percent increase in 2017 and the “Vegetation” category had a 3 percent increase. The “Defective Equipment” category had an increase between 2016 and 2017 and continues to trend upward for the five-year period. The “Other Causes” category had an increase in 2017 compared to 2016 and continues to trend upward for the five-year period. The “Animals” category had a decrease in 2017 and is relatively flat for the five-year period.

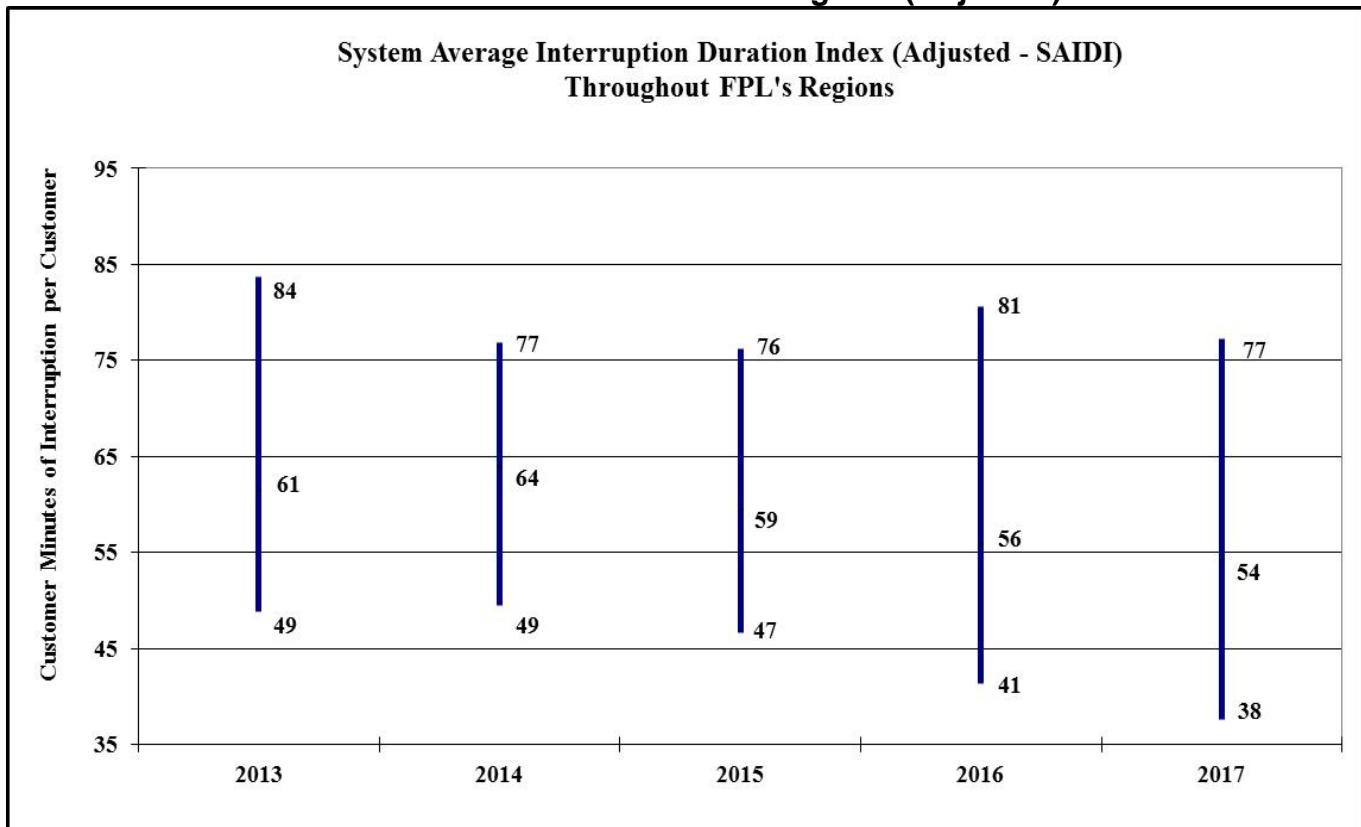
**Figure 3-9
SAIDI across FPL’s Sixteen Regions (Adjusted)**

Figure 3-9 shows the highest, average, and lowest adjusted SAIDI recorded across FPL’s system that encompasses four management regions with 16 service areas. The highest and lowest SAIDI values are the values reported for a particular service area. FPL had an overall decrease of 2 minutes (4 percent) to its average SAIDI results for 2017 compared to 2016. The average SAIDI appears to be trending downward over the five-year period of 2013 to 2017. The Pompano region has the best SAIDI results for two out of the five years.

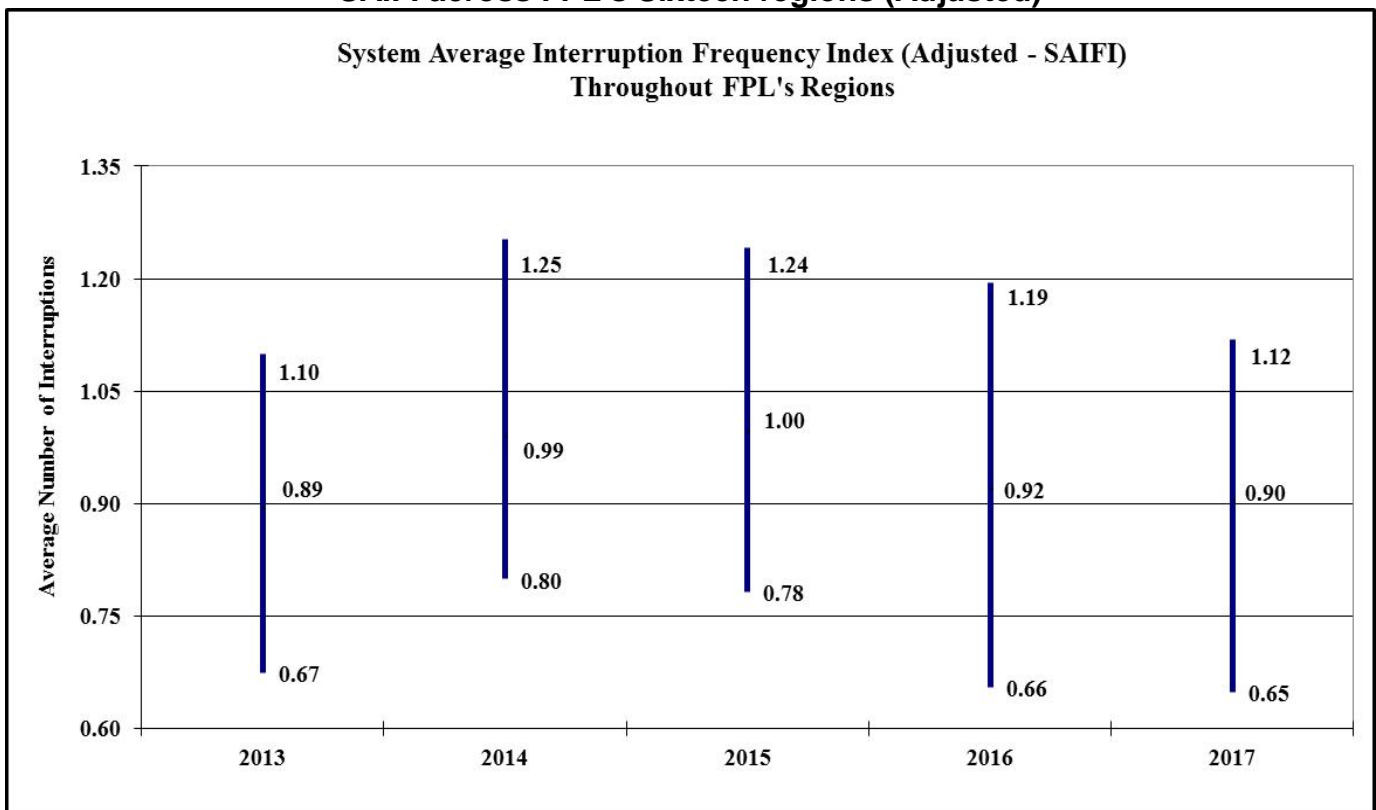
**Figure 3-10
SAIFI across FPL’s Sixteen regions (Adjusted)**

Figure 3-10 is a chart of the highest, average, and lowest adjusted SAIFI across FPL’s system. FPL had a decrease in the system average results to 0.90 outages in 2017, compared to 0.92 outages in 2016, which is a 2 percent decrease. FPL reported a decrease in the highest SAIFI of 1.12 interruptions in 2017 compared to 1.19 interruptions in 2016. The region reporting the lowest adjusted SAIFI for 2017 was Pompano at 0.65 interruptions compared to 0.66 interruptions in the Central Dade region in 2016. The highest, average and lowest SAIFI appear to be trending downward during the period of 2013 to 2017.

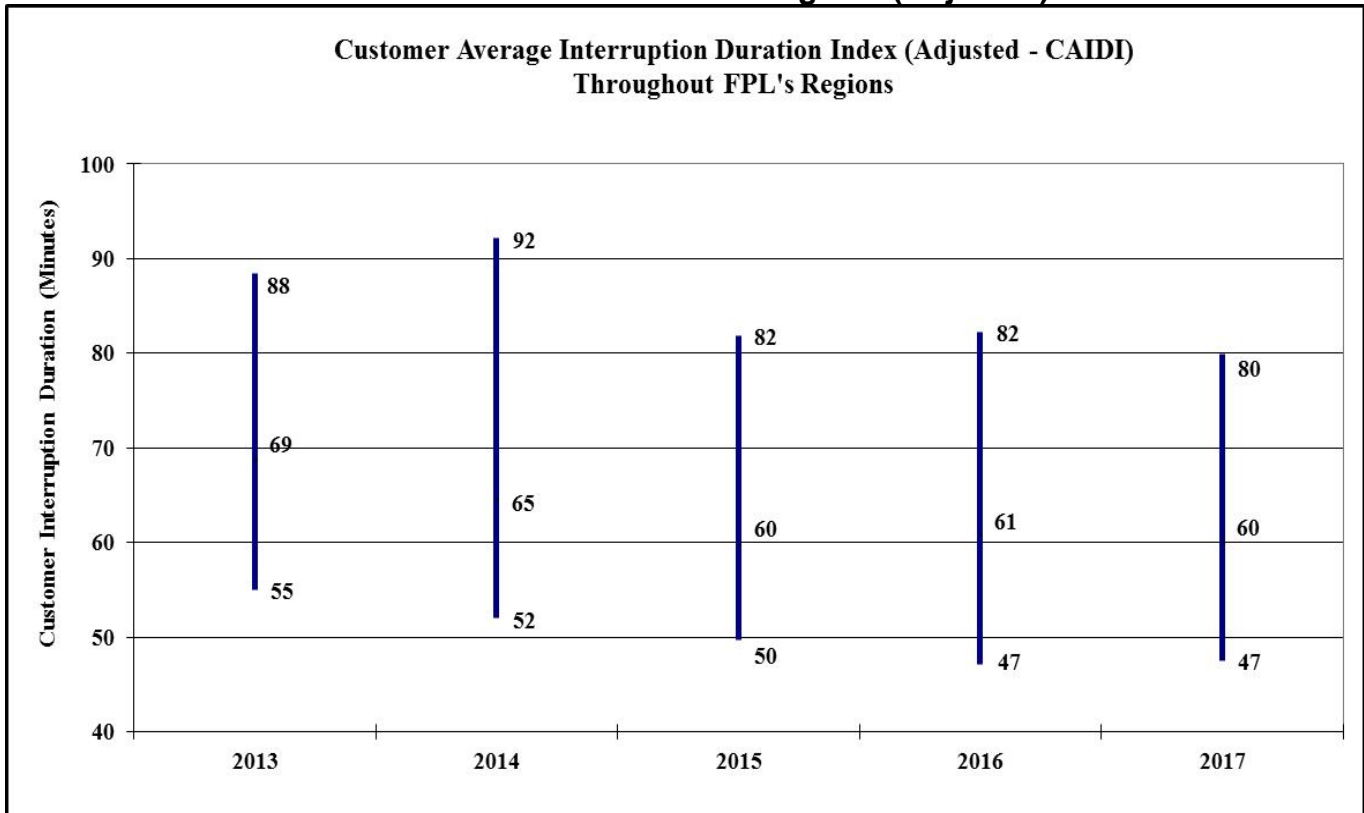
**Figure 3-11
CAIDI across FPL’s Sixteen Regions (Adjusted)**

Figure 3-11 depicts FPL’s highest, average, and lowest CAIDI expressed in minutes. FPL’s adjusted average CAIDI has decreased approximately 2 percent from 61 minutes in 2016 to 60 minutes in 2017. The average duration of CAIDI is trending downward. For 2016 and 2017, the West Palm service area reported the lowest duration of CAIDI at 47 minutes. The highest duration of CAIDI was 80 minutes for the South Dade service area for 2017, which is a decrease from the recorded 82 minutes in 2016.

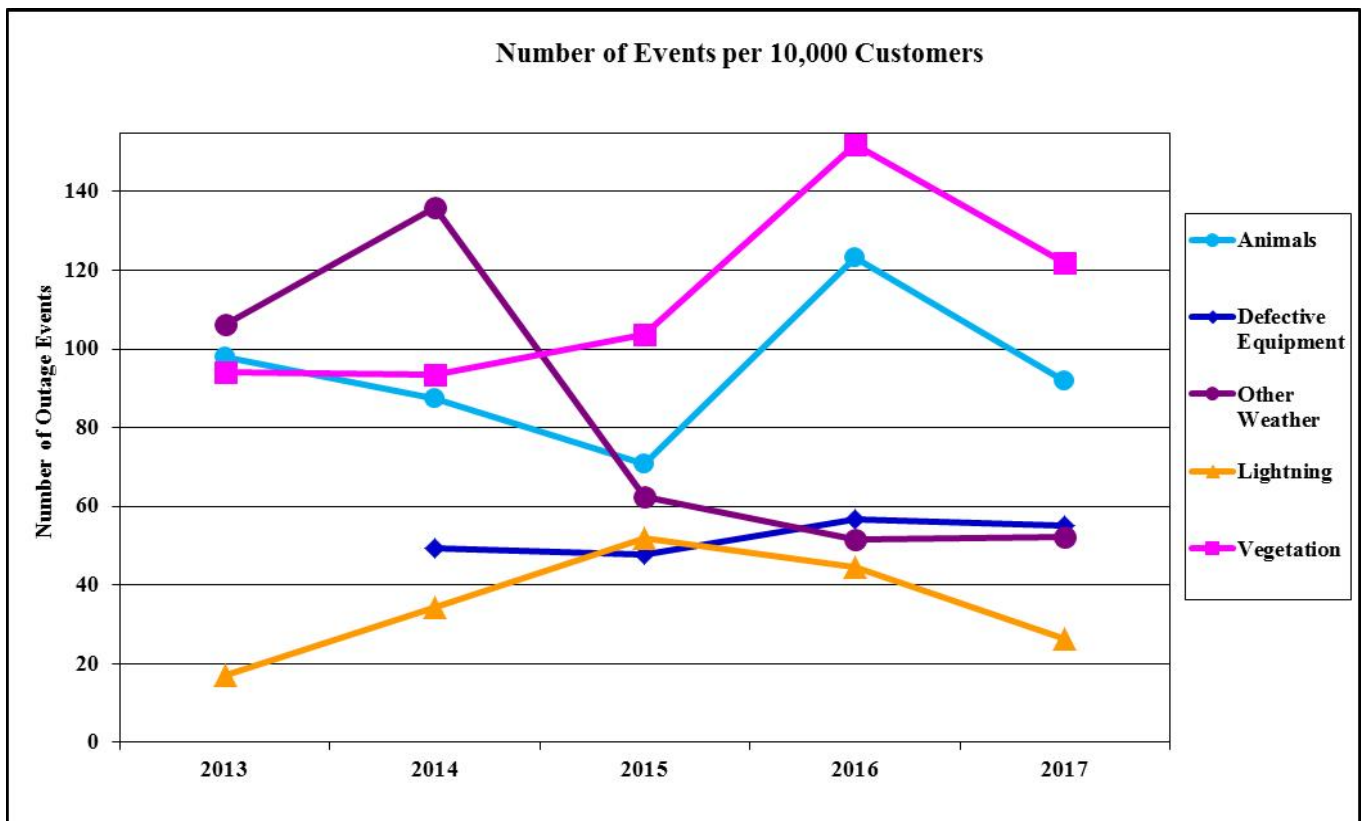
**Figure 3-21
FPUC’s Top Five Outage Causes (Adjusted)**

Figure 3-21 shows the top five causes of outage events on FPUC’s distribution system normalized to a 10,000-customer base. The figure is based on FPUC’s adjusted data of the top 10 causes of outages. For 2017, the top five causes of outage events were “Vegetation” (31 percent), “Animals” (23 percent), “Defective Equipment” (14 percent), “Other Weather” (13 percent), and “Lightning” (7 percent). These five factors represent 88 percent of the total adjusted outage causes in 2017. The “Lightning” category is trending upward even though there was a 40 percent decrease from 2016 to 2017. The causes by “Defective Equipment,” “Animals,” and “Vegetation” are also trending upward. “Defective Equipment” decreased 2 percent from 2016 to 2017. The “Animals” and “Vegetation” category decreased 25 percent and 19 percent during the same time period, respectively. The “Other Weather” category caused outages is trending downward over the five-year period of 2013 to 2017, even though there was a 3 percent increase from 2016 to 2017. Beginning with 2014, the “Defective Equipment” category now includes outage categories that in the past were separately identified.

FPUC's top five causes of outages included "Vegetation," "Animals," "Other Weather," "Lightning," and "Defective Equipment" events. As shown in **Figure 3-21**, "Vegetation" (31 percent) was the number one cause of outages in 2017 followed by "Animals" (23 percent), "Defective Equipment" (14 percent), "Other Weather" (13 percent), and "Lightning" (7 percent). "Vegetation," "Animals," and "Lightning" attributed outages decreased in 2017, as "Defective

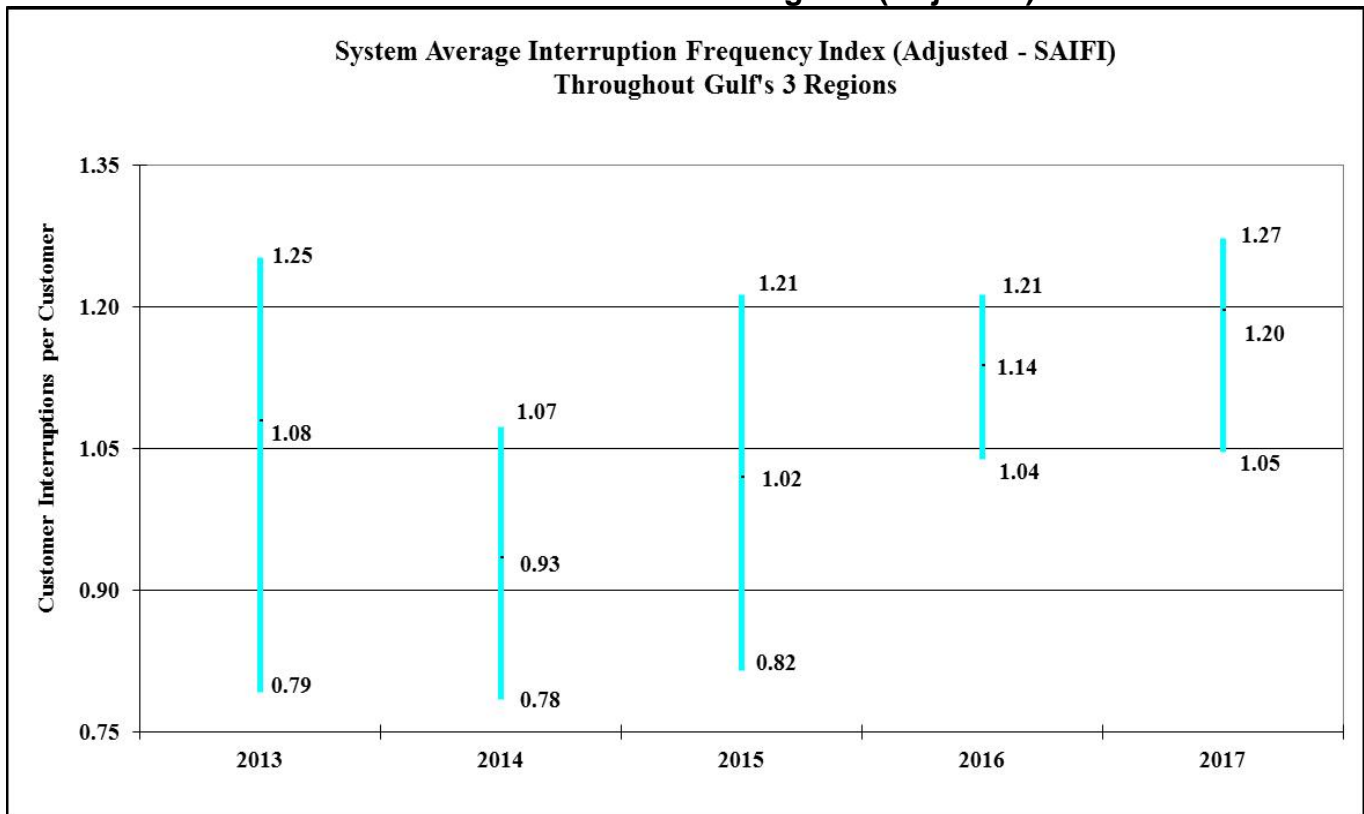
**Figure 3-23
SAIFI across Gulf’s Three Regions (Adjusted)**

Figure 3-23 illustrates that Gulf’s SAIFI had a 5 percent increase in 2017 when compared to 2016. The highest SAIFI value for the past five years has fluctuated between the three regions. The lowest values appear to fluctuate between the Central region and the Eastern region. The maximum, average, and minimum SAIFI values appear to be trending upward.
