*Review of
Florida's
Investor-Owned
Electric Utilities*

*2 0 1 9
Service Reliability Reports*

August 2020

State of Florida
Florida Public Service Commission
Division of Engineering

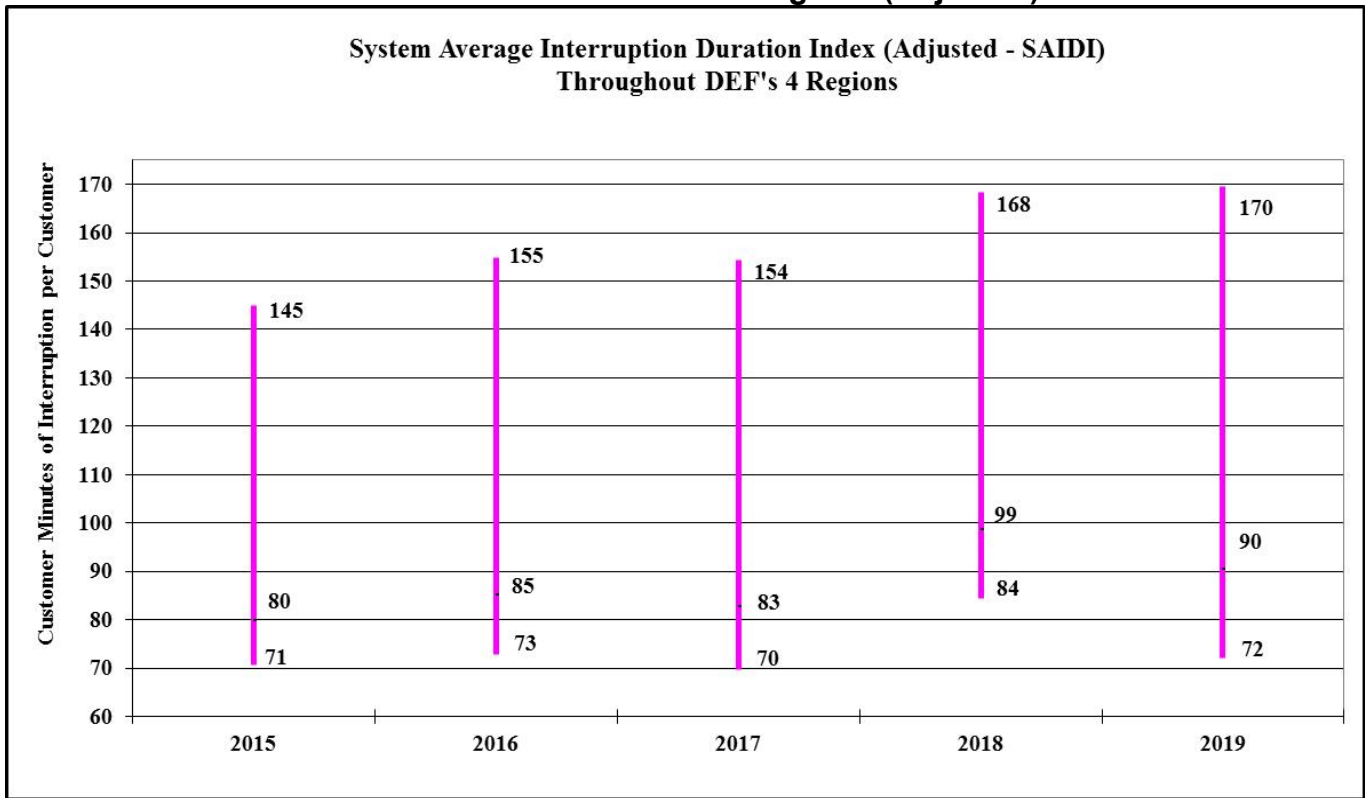
**Figure 3-1
SAIDI across DEF's Four Regions (Adjusted)**

Figure 3-1 charts the adjusted SAIDI recorded across DEF's system and depicts decreases in the lowest and the average values in 2019. DEF reported that it saw a drop in the Excluded Weather SAIDI compared to the prior three years. Even with the decrease in adjusted SAIDI, there were eight days in 2019 that caused increases to the SAIDI minutes. Those outages were weather related but not excludable per Rule because the events were not related to a named storm or a tornado. In addition, DEF reported the two named storms that it experienced caused increases to its SAIDI minutes in 2019.

DEF's service territory is comprised of four regions: North Coastal, South Coastal, North Central, and South Central. **Figure 3-1** illustrates that the North Coastal region continues to report the poorest SAIDI over the last five years, fluctuating between 145 minutes and 170 minutes. While the South Coastal and South Central regions have the best or lowest SAIDI for the same period. The North Coastal region is predominantly a rural area and has more square miles when compared to the other regions. This region is also served by predominantly long circuits with approximately 7,700 miles of overhead and underground main circuits. DEF explained that these factors result in higher exposure to outage causes and higher reliability indices.

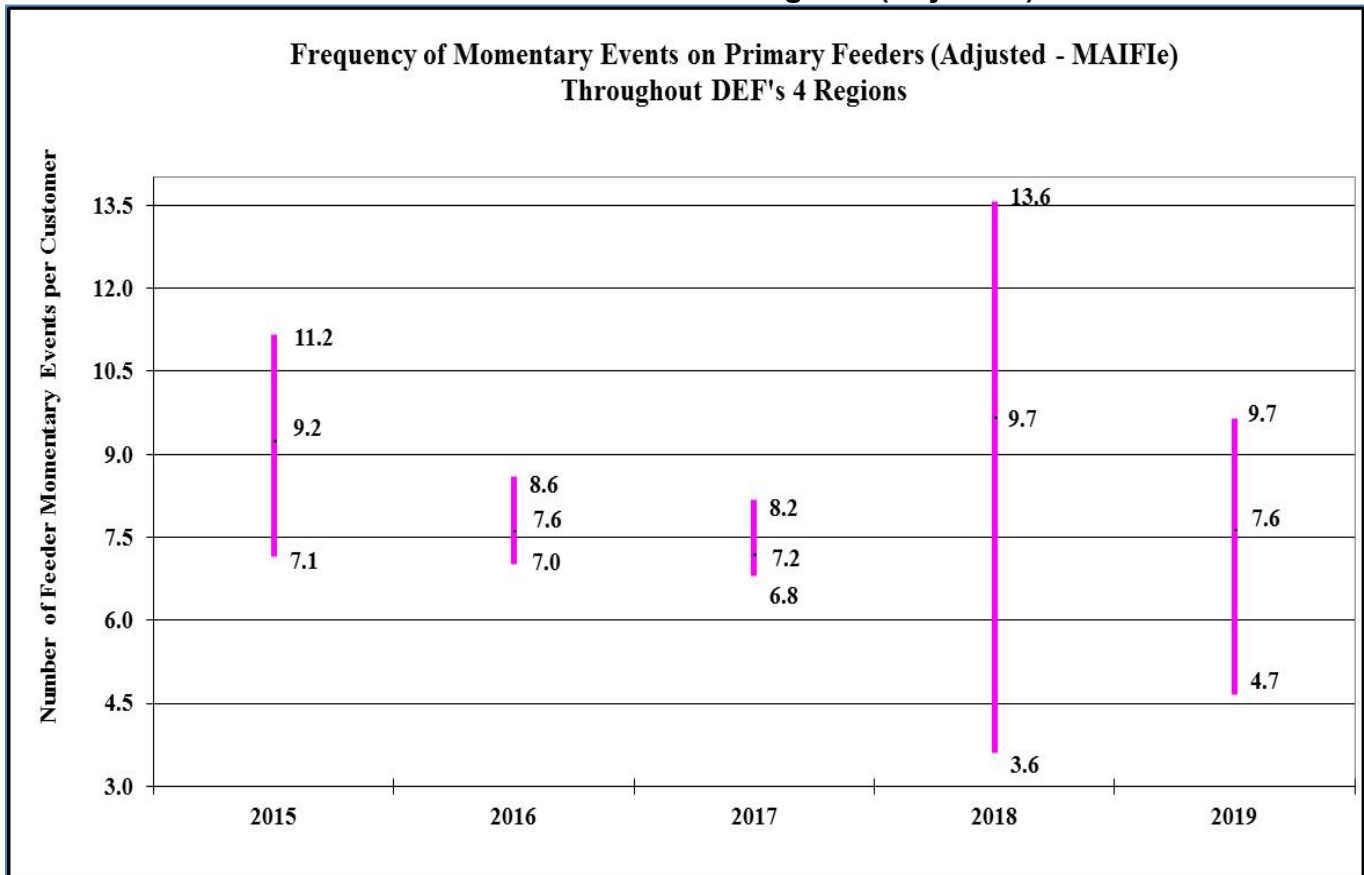
**Figure 3-5
MAIFle across DEF’s Four Regions (Adjusted)**

Figure 3-5 illustrates the frequency of momentary events on primary circuits for DEF’s customers recorded across its system. These momentary events often affect a small group of customers. A review of the supporting data suggests that the MAIFle results between 2015 and 2019 appear to be trending downward showing improvement and there was a decrease in the average MAIFle of 22 percent from 2018 to 2019. All four regions appear to fluctuate between having the best (lowest) results to having the worst (highest) results. From 2018 to 2019, the lowest MAIFle increased 31 percent and the highest MAIFle decreased 29 percent.

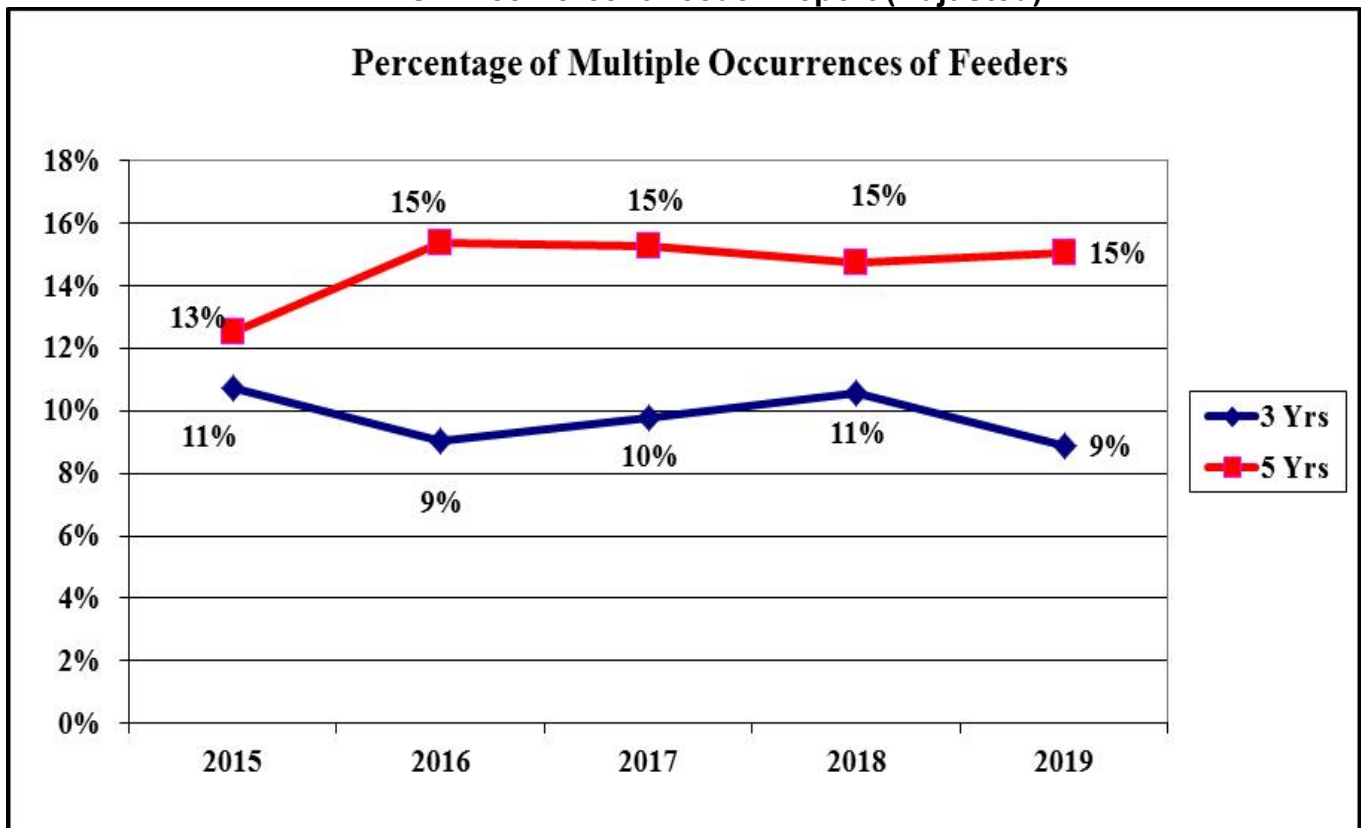
Figure 3-7
DEF’s Three Percent Feeder Report (Adjusted)

Figure 3-7 shows the fraction of multiple occurrences of feeders using a three-year and five-year basis. During the period of 2015 to 2019, the five-year fraction of multiple occurrences is trending upward as the three-year fraction of multiple occurrences is trending downward. The Three Percent Feeder Report lists the top 3 percent of feeders with the most feeder outage events. The fraction of multiple occurrences is calculated from the number of recurrences divided by the number of feeders reported.

Four of DEF’s feeders have been on the Three Percent Feeder Report for the last two years consecutively. The outages varied from equipment failure, animals, vehicular accidents, and vegetation. DEF replaced the failing equipment, trimmed trees, and performed infrared scans on the feeders. All issues found during the infrared scans were corrected. DEF is also using radio frequency technology to assist in detecting issues with the feeders. DEF explained radio frequency identifies the presence of arcing before it is visible to infrared or the unaided eye. The presence of arcing signals potential risks to reliability and identifying these in advance may allow DEF to mitigate the hazards earlier.

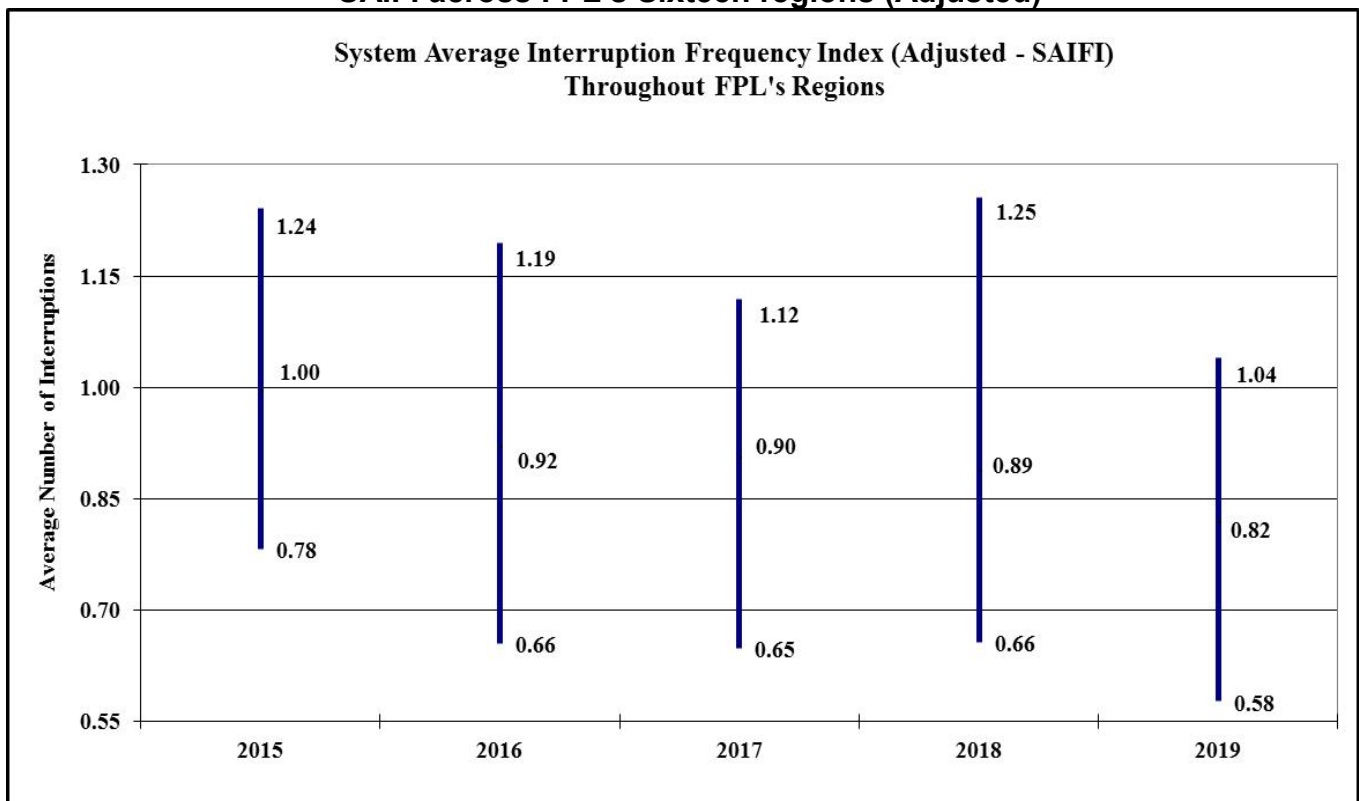
**Figure 3-10
SAIFI across FPL’s Sixteen regions (Adjusted)**

Figure 3-10 is a chart of the highest, average, and lowest adjusted SAIFI across FPL’s system. FPL had a decrease in the system average results to 0.82 outages in 2019, compared to 0.89 outages in 2018, which is a 9 percent decrease. FPL reported a decrease in the highest SAIFI of 1.04 interruptions in 2019 compared to 1.25 interruptions in 2018. The region reporting the lowest adjusted SAIFI for 2019 was Manasota at 0.58 interruptions compared to 0.66 interruptions in the North Broward region in 2018. During the period of 2015 to 2019 the highest, average, and lowest SAIFI appears to be trending downward.

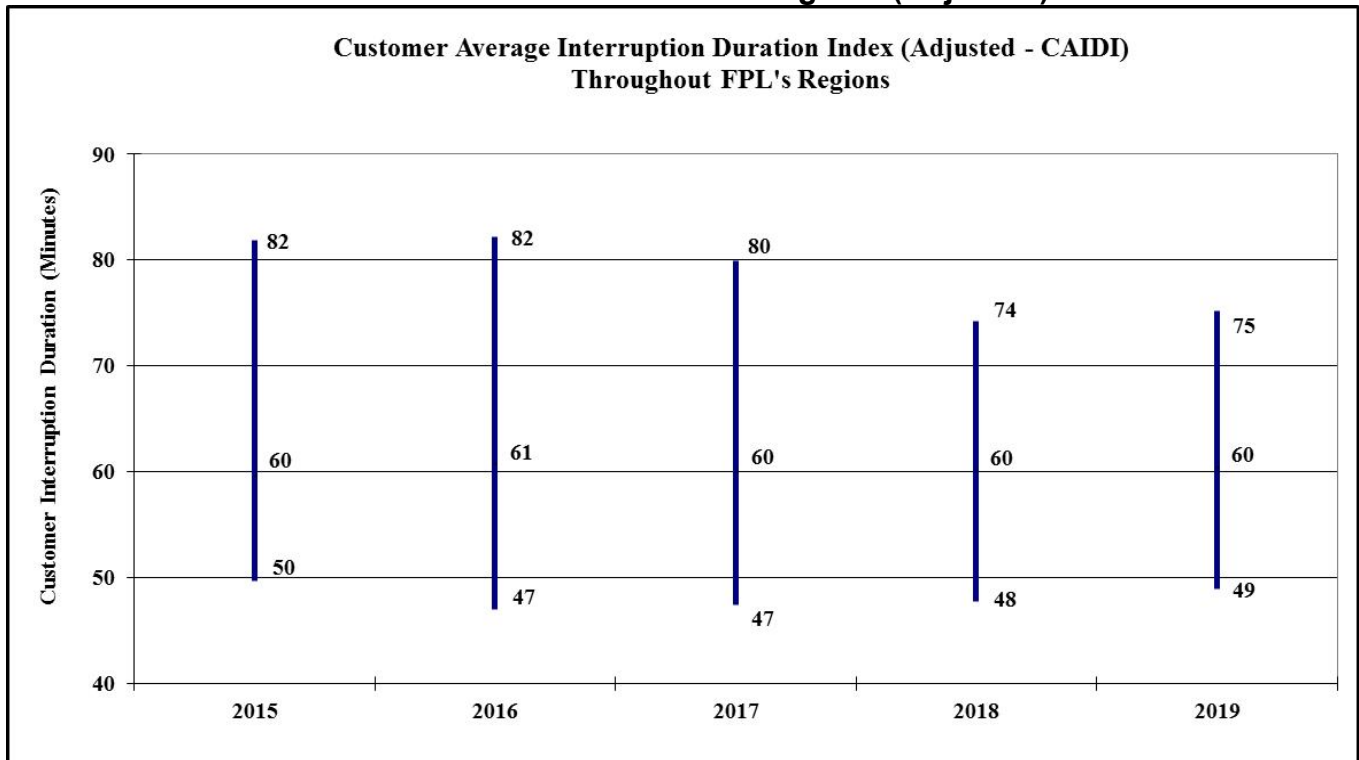
**Figure 3-11
CAIDI across FPL’s Sixteen Regions (Adjusted)**

Figure 3-11 depicts FPL’s highest, average, and lowest CAIDI expressed in minutes. FPL’s adjusted average CAIDI did not decrease or increase and remained at 60 minutes for both 2018 and 2019. The average duration of CAIDI remains relatively flat. For 2019, the West Palm service area reported the lowest duration of CAIDI at 49 minutes. The highest duration of CAIDI was 75 minutes for the South Dade service area for 2019.

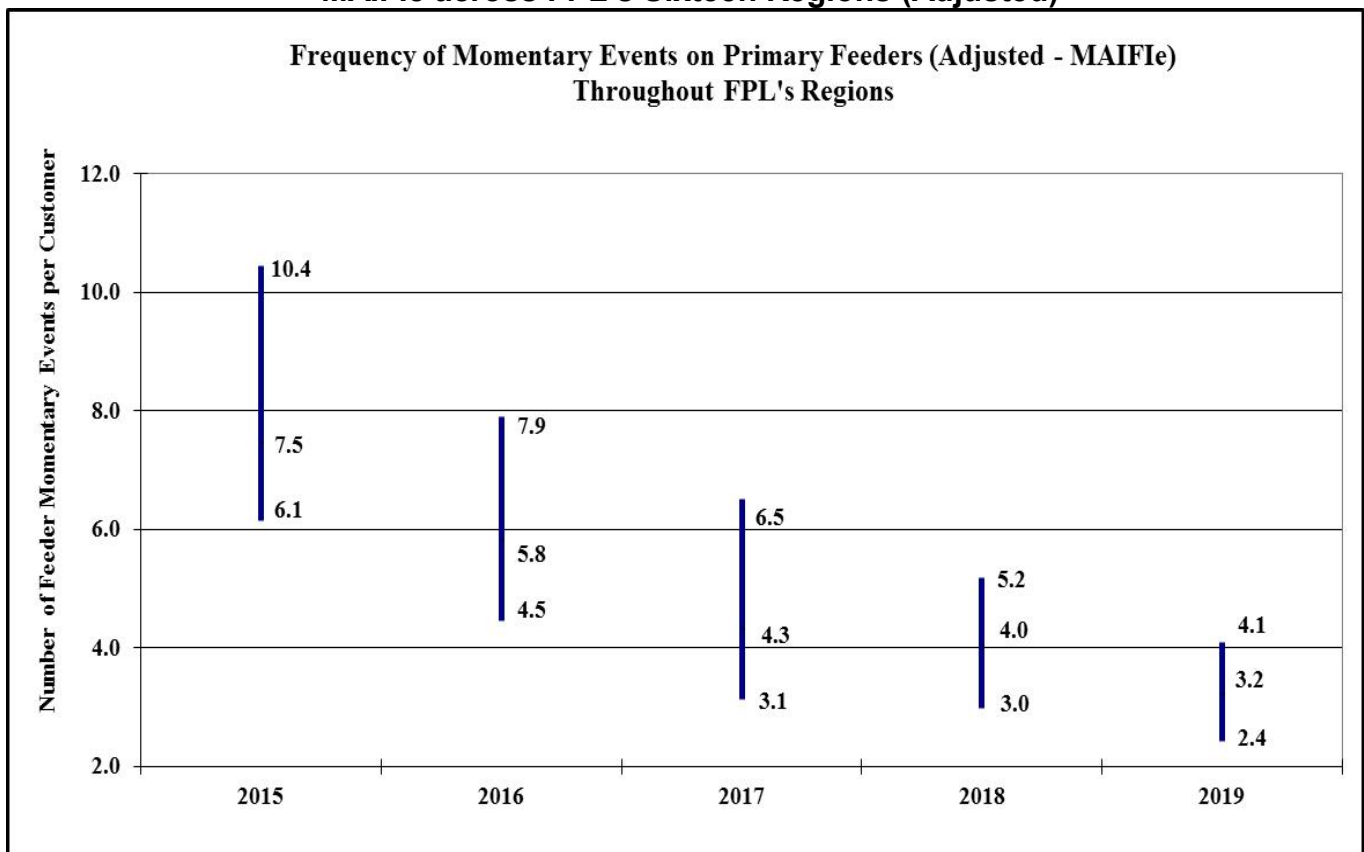
**Figure 3-13
MAIFle across FPL’s Sixteen Regions (Adjusted)**

Figure 3-13 is the highest, average, and lowest adjusted MAIFle recorded across FPL’s system. FPL’s Wingate, Toledo Blade, and West Palm service areas have experienced the least reliable MAIFle results of the 16 service areas of FPL since 2015. The Pompano, Central Dade, and Manasota service areas had the fewest momentary events since 2015. The results have been trending downward (improving) over the last five years. There is a 20 percent decrease in the average MAIFle results from 2018 to 2019. As a note, FPL calculates MAIFle differently. Specifically, if a feeder begins in one region and crosses another region, all customers on that feeder are impacted by the MAIFle event and are counted in the starting region. Therefore, the number of customers per region will be different.

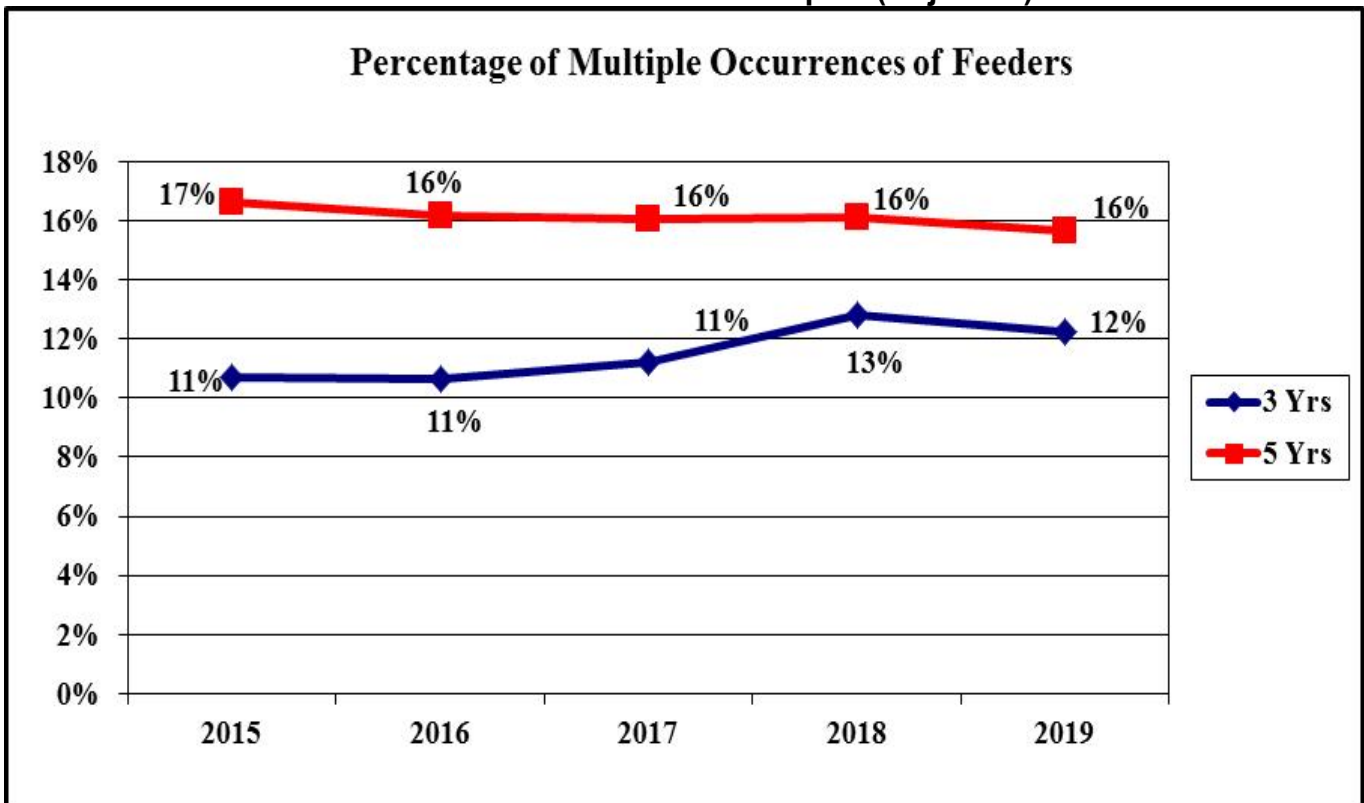
Figure 3-15
FPL’s Three Percent Feeder report (Adjusted)

Figure 3-15 is a graphical representation of the percentage of multiple occurrences of FPL’s feeders and is derived from The Three Percent Feeder Report, which is a listing of the top three percent of problem feeders reported by the Utility. The fraction of multiple occurrences is calculated from the number of recurrences divided by the number of feeders reported. The three-year percentage had a decrease to 12 percent in 2019 from 13 percent in 2018. The five-year percentage was 16 percent in 2018 and 2019. The five-year percentage appears to be trending downward as the three-year percentage appears to be trending upward.

Staff notes ten feeders were on the Three Percent Feeder Report the last two years. FPL reported that visual/thermovision assessment follow-up work is scheduled for two feeders, repairs have been completed on six feeders, and automated feeder switches will be installed on seven feeders. FPL also reported that in 2019, approximately 157 miles of trimming was performed on nine feeders, which is about 90 percent of the feeders’ overhead facilities. FPL will continue repairs on four of the feeders and plans to harden four additional feeders during 2020 through 2022.

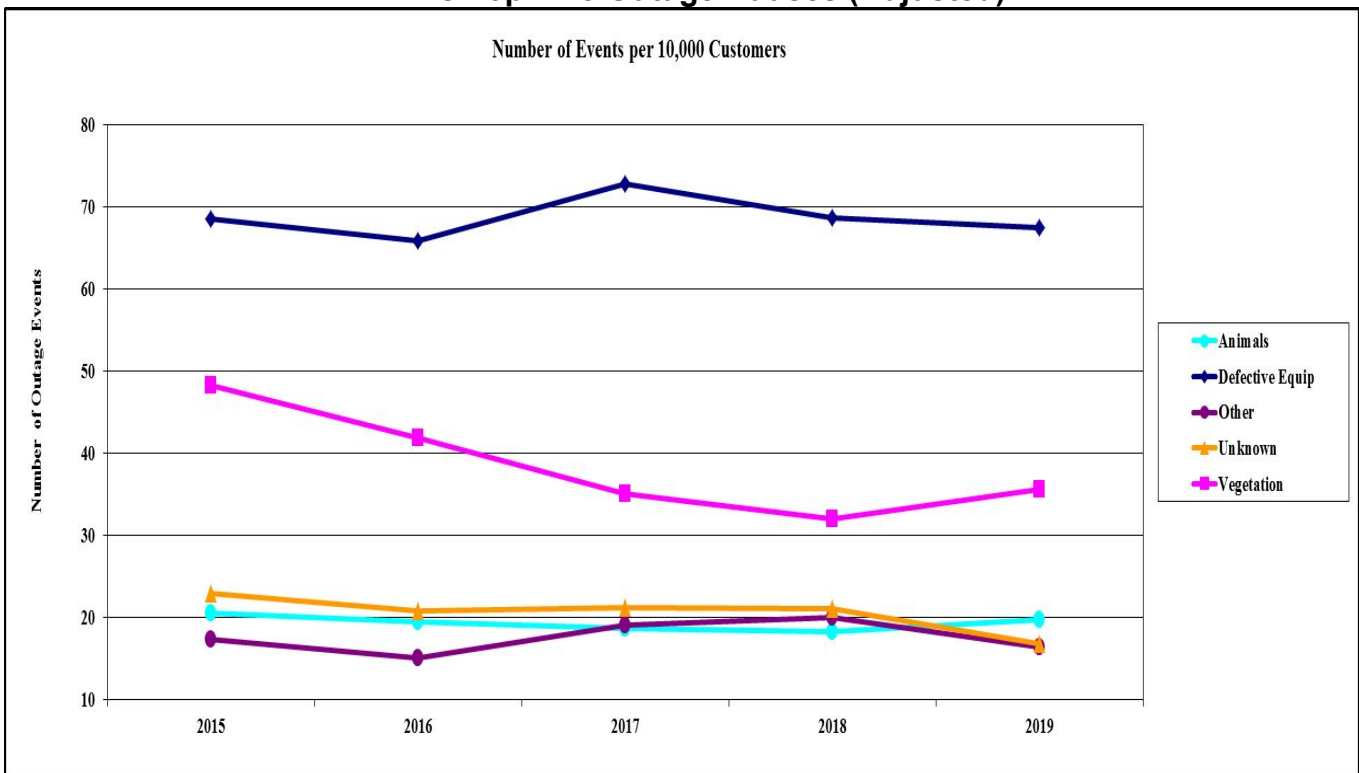
Figure 3-16
FPL’s Top Five Outage Causes (Adjusted)

Figure 3-16 depicts the top five causes of outage events on FPL’s distribution system normalized to a 10,000-customer base. The graph is based on FPL’s adjusted data of the top 10 causes of outage events. For the five-year period, the five top causes of outage events included “Defective Equipment” (37 percent), “Vegetation” (20 percent), “Animals” (11 percent), “Unknown Causes” (9 percent), and “Other Causes” (9 percent) on a cumulative basis. Since 2015, the outage events due to “Vegetation” and “Unknown Causes” are trending downward as the “Defective Equipment” and “Animals” categories are remaining relatively flat. The category “Other Causes” is slightly trending upward. The category “Defective Equipment” dominates the highest percentage of outage causes throughout the FPL regions and there was a 2 percent increase in the number of outages from 2018 to 2019.

Annually, FPL evaluates its current reliability remediation programs and verifies the program’s need and/or existence. In addition, FPL proposes new reliability remediation programs to improve its reliability performance concentrating on the highest cause codes and those cause codes that have shown trends needing attention. FPL has 21 reliability programs listed for its 2020 budget. The programs include: distribution automation, system expansion, reduce the number of direct buried feeder and lateral cables, install feeder line covers to reduce vegetation related interruptions, and replace oil circuit reclosers with electronic reclosers. Sixteen programs are designed to improve the “Defective Equipment” cause code. Eleven programs will improve the “Vegetation” cause code and eight programs will improve the “Animals” cause code, both of which had increases in 2019.

“Defective Equipment” (37 percent) and “Vegetation” (20 percent) outages were the leading causes of outage events per customer for 2019. The next three outage causes are “Animals” (11 percent), “Other Causes” (9 percent), and “Unknown Causes” (9 percent). **Figure 3-16** shows an increasing trend in the number of outage events attributed to “Other Cause,” which had decreased by 14 percent from 2018 to 2019. The analysis shows a decrease in the number of outage events caused by “Unknown Causes” in which it is trending downward. In addition, since 2015, “Vegetation” is also trending downward. The analysis shows that the “Animals” and “Defective Equipment” categories are remaining relatively flat.

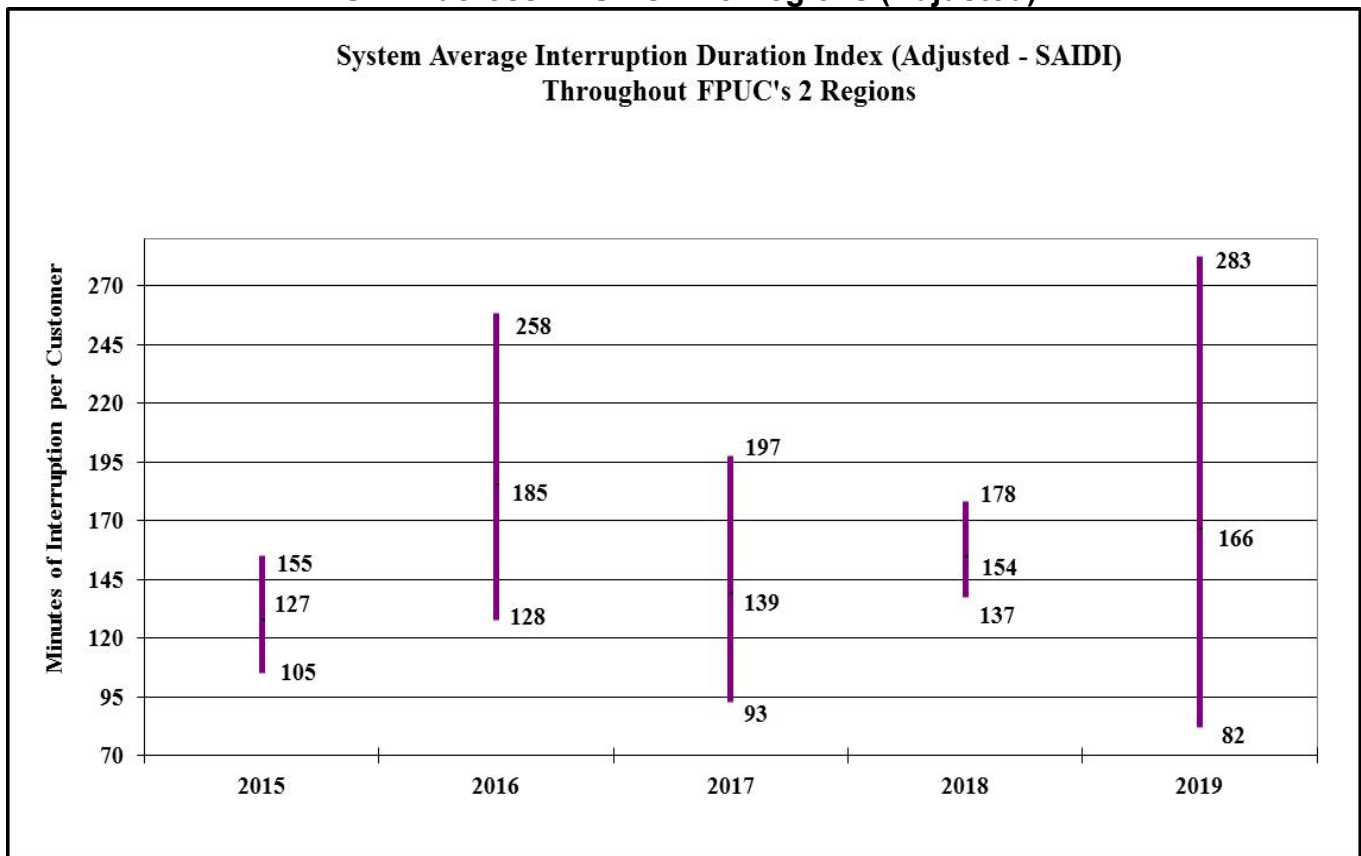
Figure 3-17
SAIDI across FPUC’s Two Regions (Adjusted)

Figure 3-17 shows the highest, average, and lowest adjusted SAIDI values recorded by FPUC’s system. The data shows the average SAIDI index is trending upward for the five-year period of 2015 to 2019 and there was an 8 percent increase from 2018 to 2019.

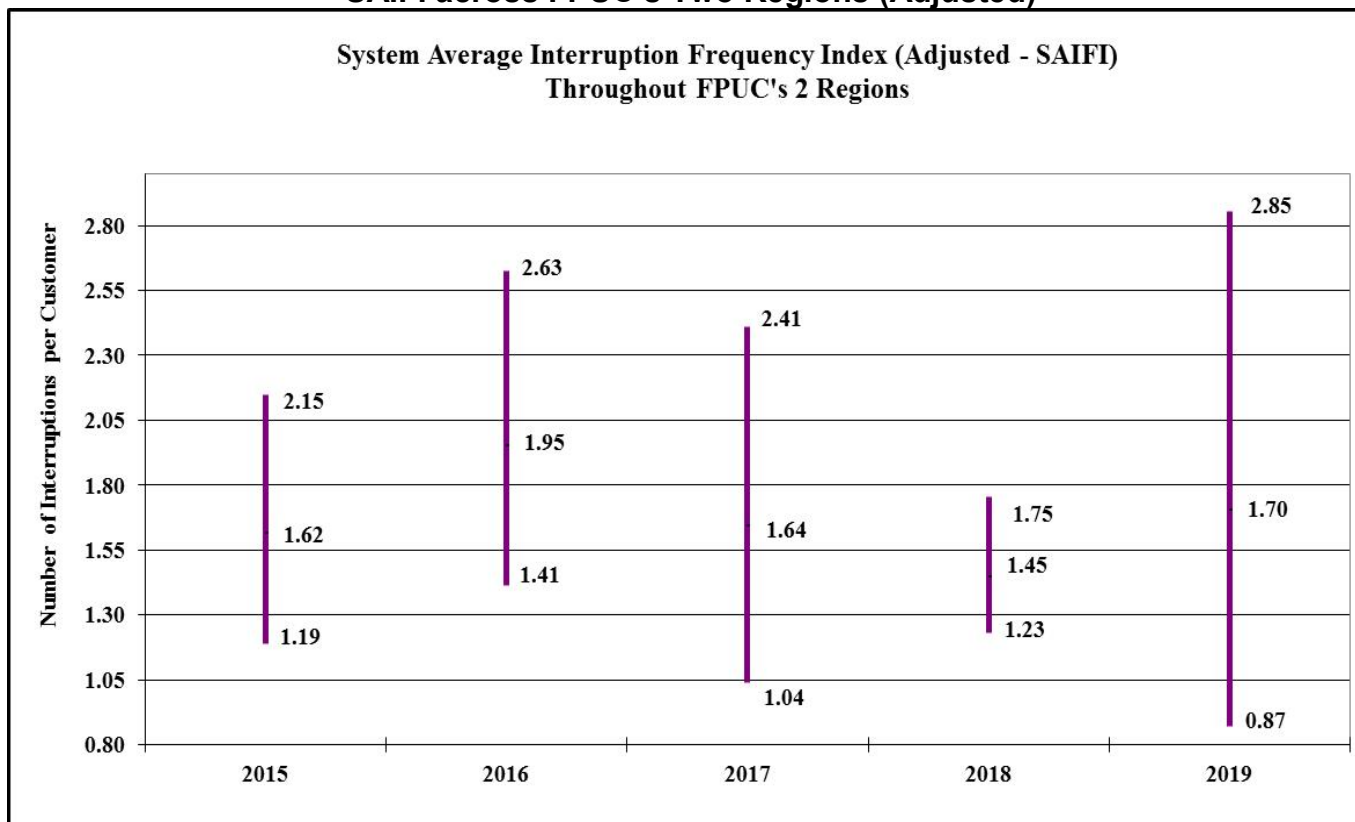
**Figure 3-18
SAIFI across FPUC’s Two Regions (Adjusted)**

Figure 3-18 shows the adjusted SAIFI across FPUC’s two divisions. The data depicts a 17 percent increase in the 2019 average SAIFI reliability index from 2018. The data for the average and maximum SAIFI values are trending downward as the minimum SAIFI value is trending upward over the five-year period of 2015 to 2019.

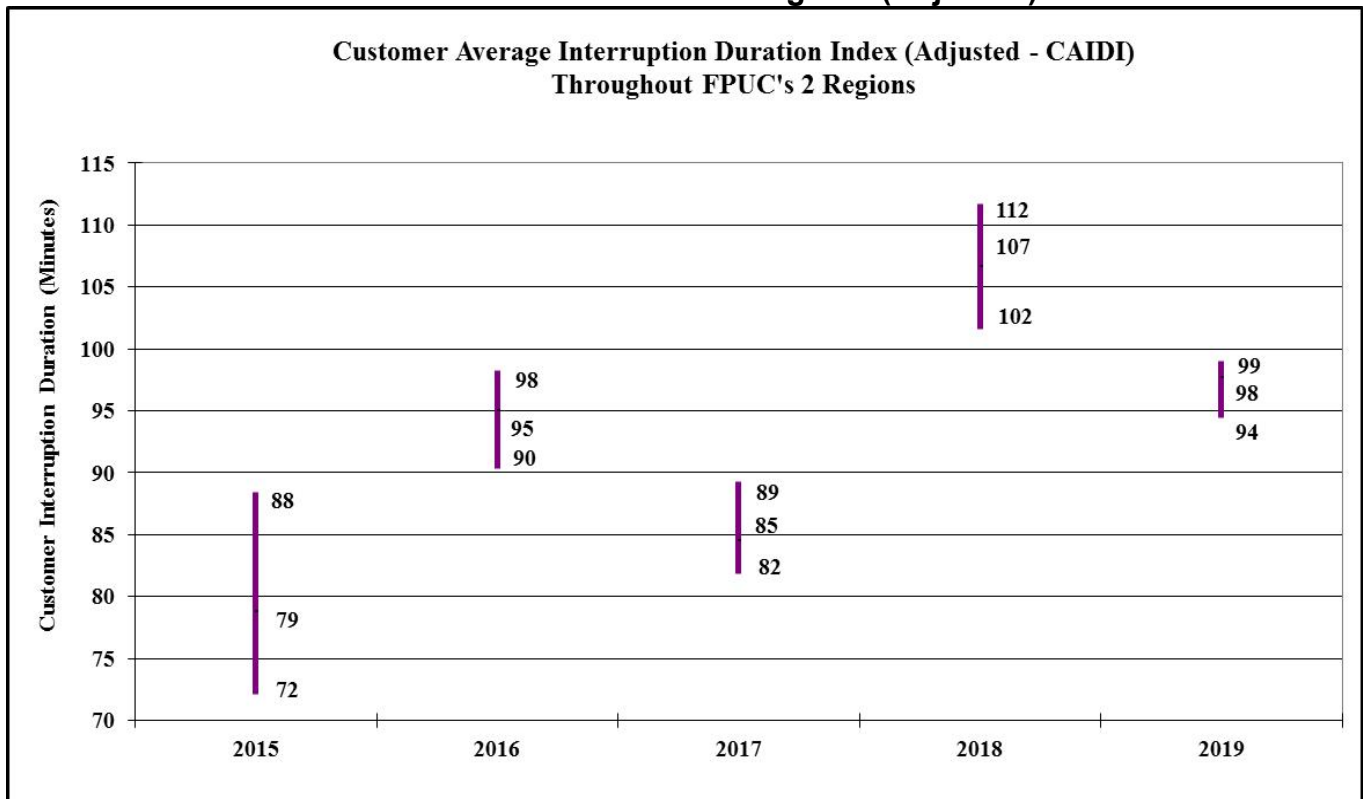
**Figure 3-19
CAIDI across FPUC’s Two Regions (Adjusted)**

Figure 3-19 shows the highest, average, and lowest adjusted CAIDI values across FPUC’s system. FPUC’s data shows the average CAIDI value decreased by 8 percent for 2019 (98 minutes) when compared to 2018 (107 minutes). For the past five years, the maximum, the minimum, and the average CAIDI values are trending upward.

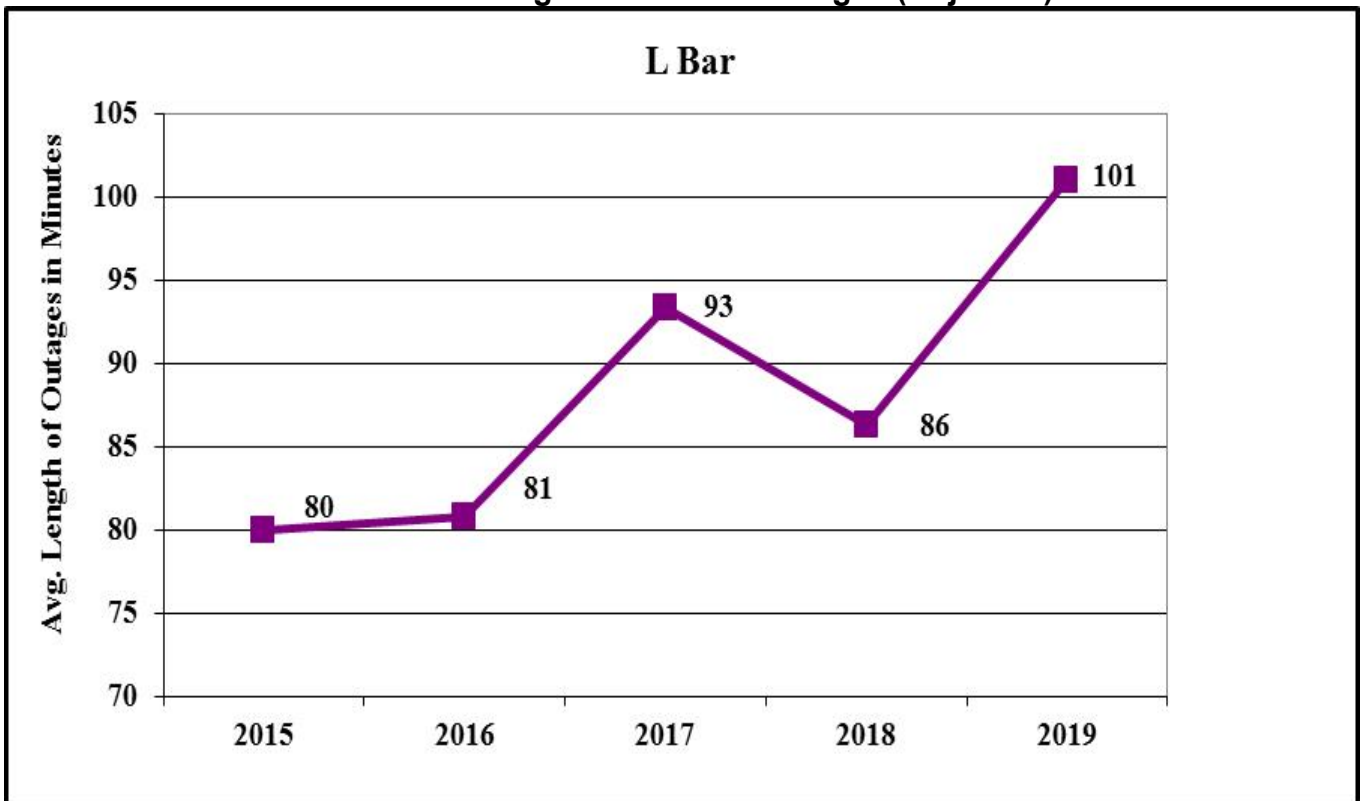
Figure 3-20
FPUC's Average Duration of Outages (Adjusted)

Figure 3-20 is the average length of time FPUC spends recovering from outage events (adjusted L-Bar). There was a 17 percent increase in the L-Bar value from 2018 to 2019. The data for the five-year period of 2015 to 2019 suggests that the L-Bar index is trending upward indicating FPUC is taking additional time to restore service after an outage event.

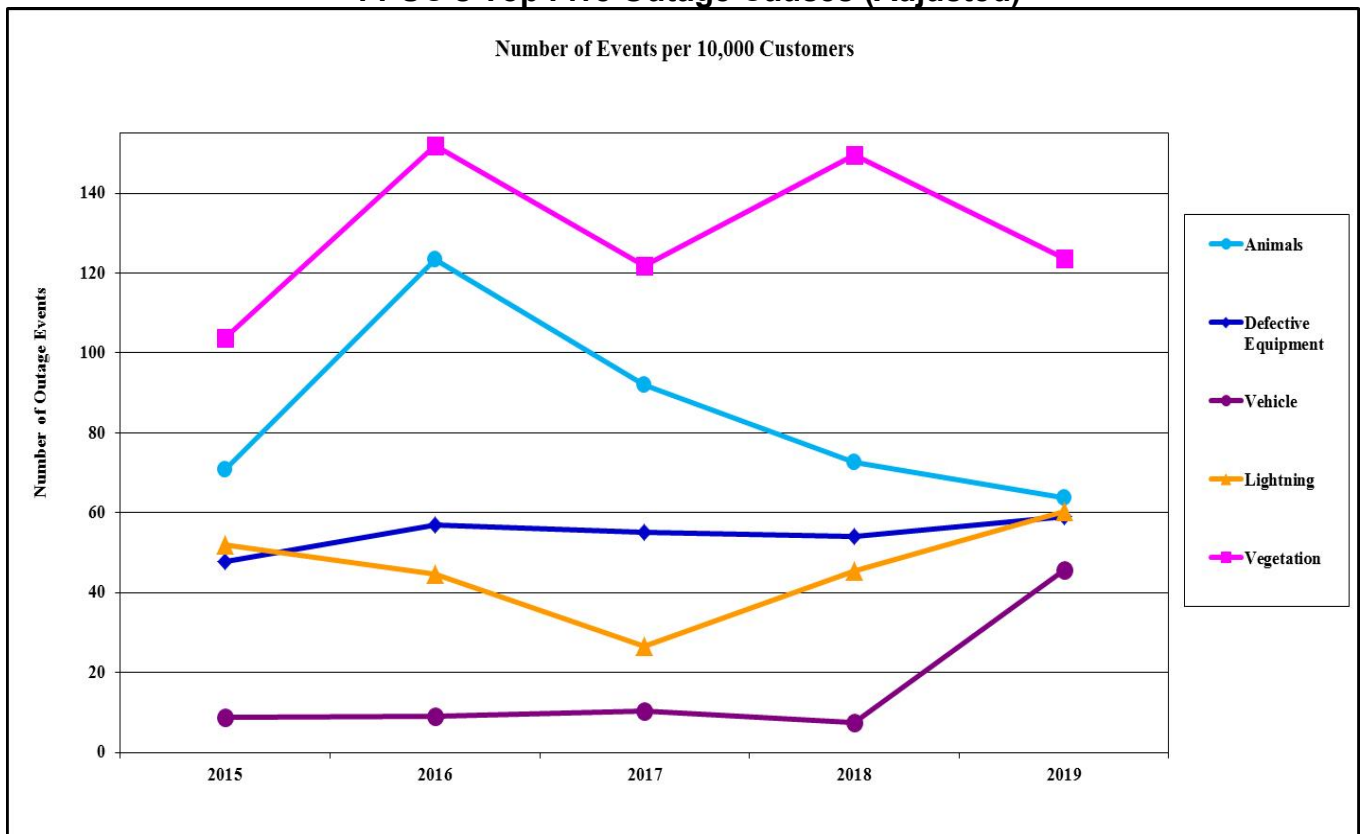
**Figure 3-21
FPUC’s Top Five Outage Causes (Adjusted)**

Figure 3-21 shows the top five causes of outage events on FPUC’s distribution system normalized to a 10,000-customer base. The figure is based on FPUC’s adjusted data of the top 10 causes of outages. For 2019, the top five causes of outage events were “Vegetation” (27 percent), “Animals” (14 percent), “Defective Equipment” (13 percent), “Lightning” (13 percent), and “Vehicle” (10 percent). These five factors represent 76 percent of the total adjusted outage causes in 2019. The “Vegetation” category is trending upward even though there was a 15 percent decrease from 2018 to 2019. The causes by “Defective Equipment,” “Lightning,” and “Vehicle” are also trending upward. “Defective Equipment” increased 12 percent from 2018 to 2019. The “Lightning” and “Vehicle” category increased 36 percent and 80 percent during the same time period, respectively. The “Animals” category caused outages is trending downward over the five-year period of 2015 to 2019 and there was a 10 percent decrease from 2018 to 2019.

FPUC’s top five causes of outages included “Vegetation,” “Animals,” “Defective Equipment,” “Lightning,” and “Unknown” events. As shown in **Figure 3-21**, “Vegetation” (27 percent) was the number one cause of outages in 2019 followed by “Animals” (14 percent), “Defective Equipment” (13 percent), “Lightning” (13 percent), and “Vehicle” (10 percent). “Animals,” and “Vegetation” attributed outages decreased in 2019, as “Defective Equipment,” “Lightning,” and “Vehicle” caused outages increased.

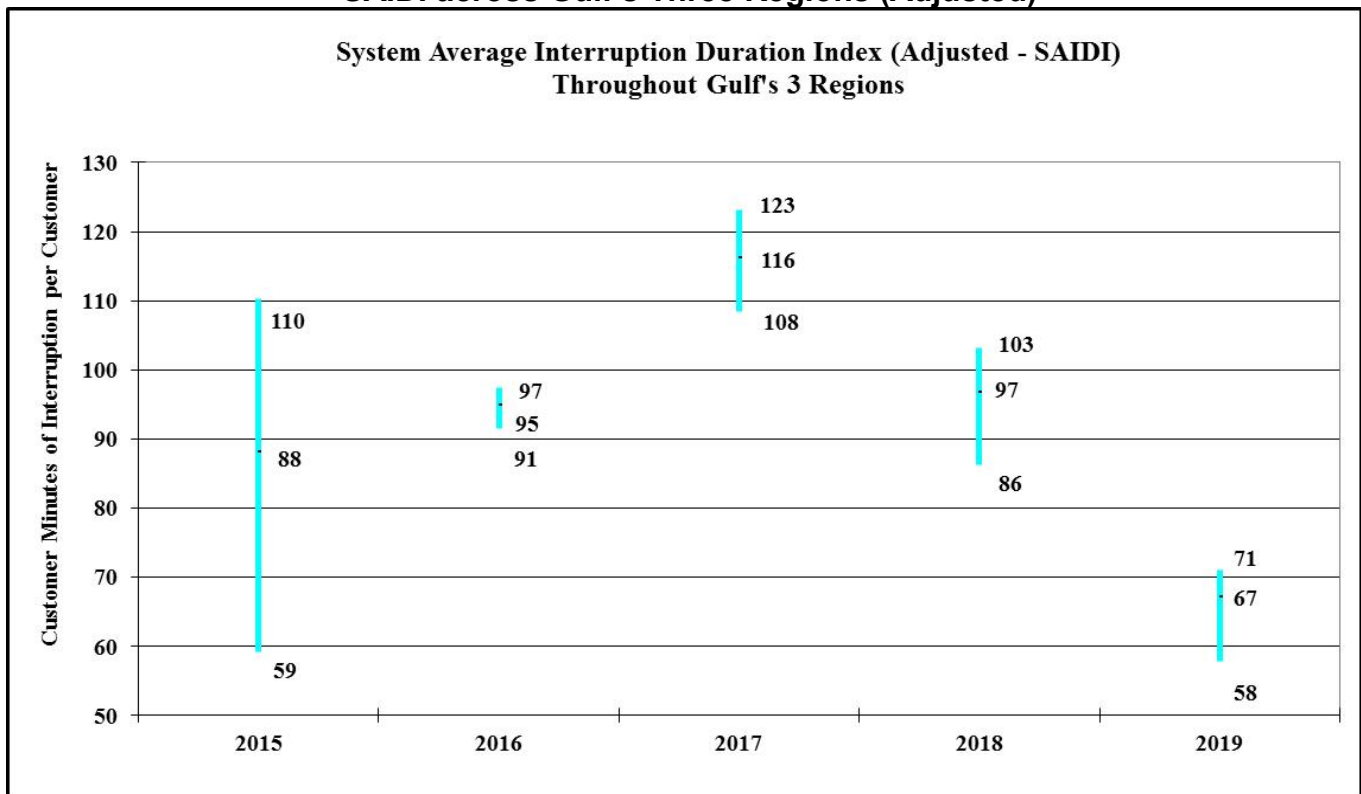
Figure 3-22
SAIDI across Gulf’s Three Regions (Adjusted)

Figure 3-22 illustrates Gulf’s SAIDI minutes, or the interruption duration minutes on a system basis. The chart depicts a 31 percent decrease in the average SAIDI in Gulf’s combined regions when compared to the 2018 results. Gulf’s 2019 average performance was 67 minutes compared to 97 minutes in 2018. The highest SAIDI value for 2018 was the Western region as the Central region had the best or lowest SAIDI value. The maximum, minimum, and average SAIDI indices are trending downward.

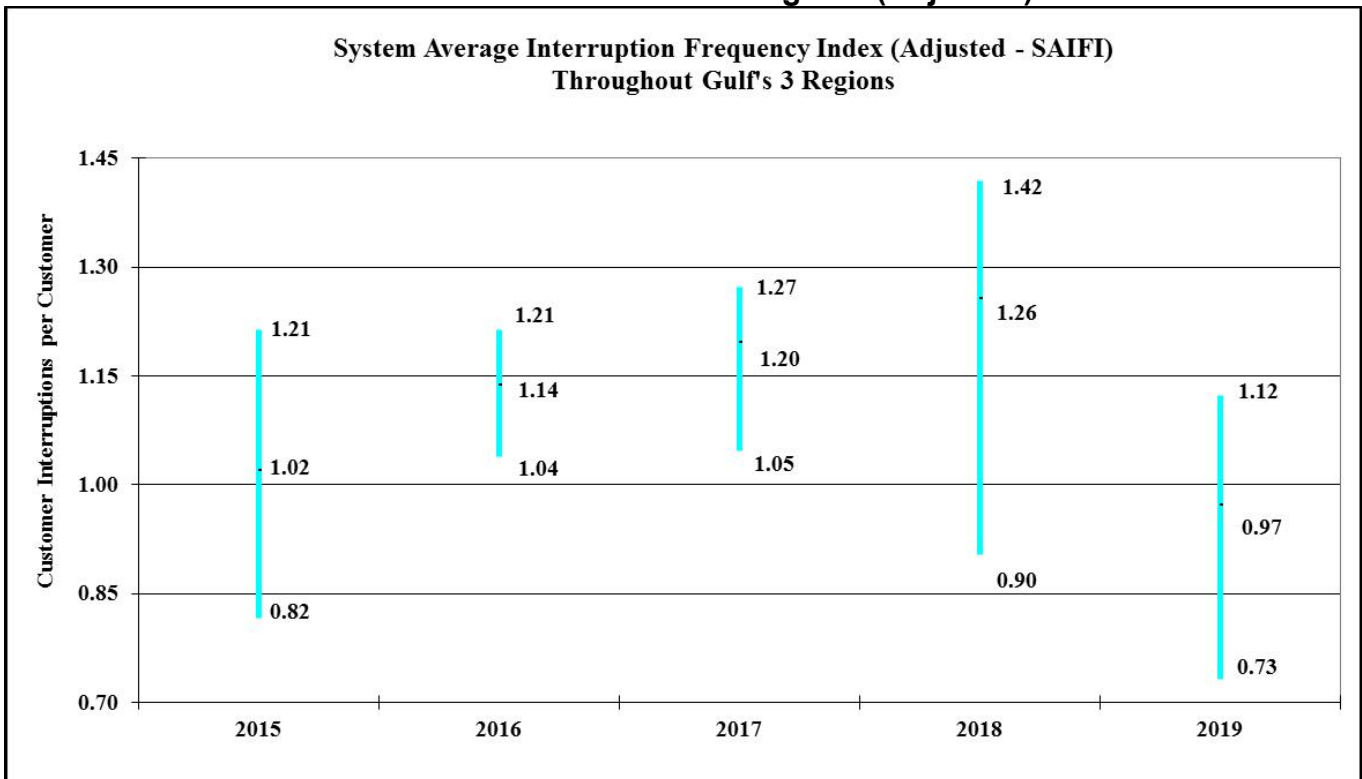
**Figure 3-23
SAIFI across Gulf’s Three Regions (Adjusted)**

Figure 3-23 illustrates that Gulf’s SAIFI had a 23 percent decrease in 2019 when compared to 2018. The highest SAIFI value for the past five years has fluctuated between the Eastern and Western regions. The lowest values appear to be in the Central region. The maximum and average SAIFI values appear to be trending upward while the minimum SAIFI value appears to be trending downward.

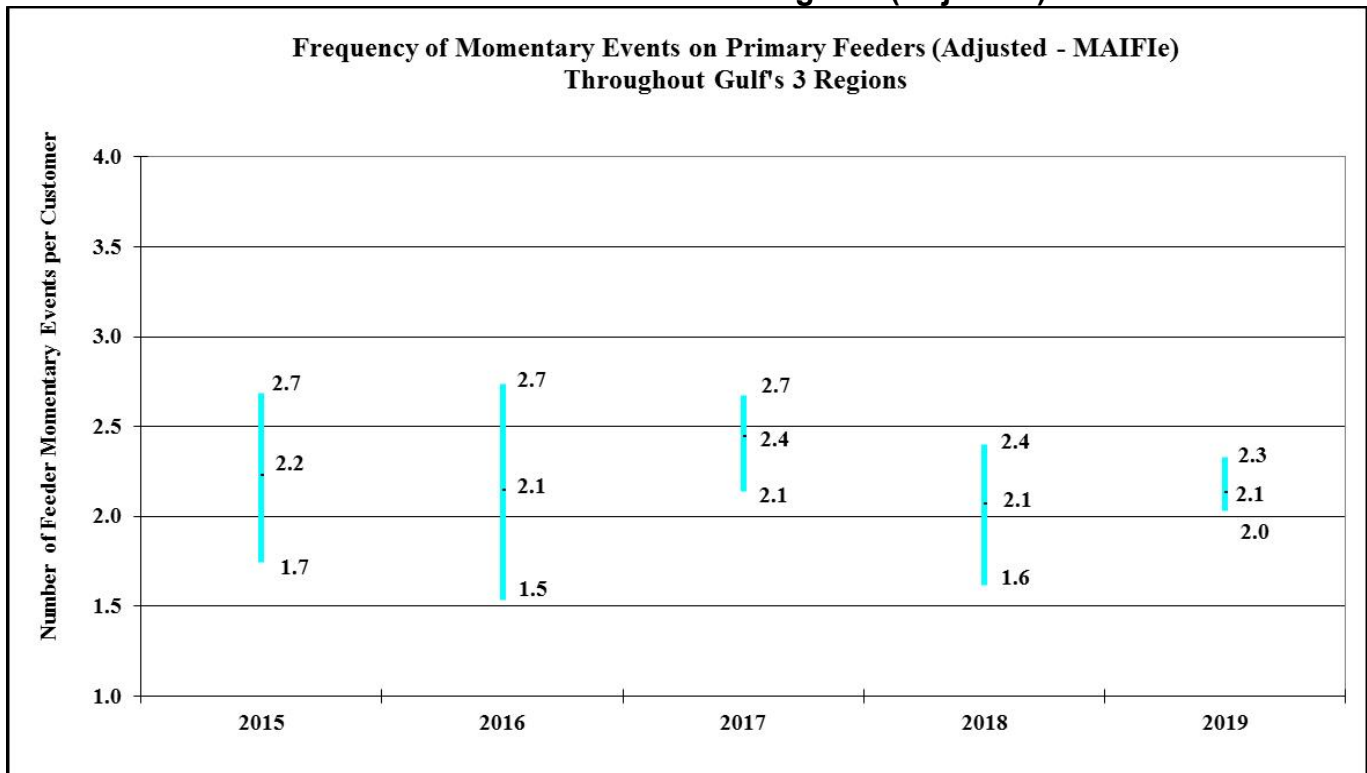
**Figure 3-26
MAIFle across Gulf’s Three Regions (Adjusted)**

Figure 3-26 is the adjusted MAIFle recorded across Gulf’s system. The adjusted MAIFle results by region show that the Central region had the lowest frequency of momentary events on primary feeders. The Eastern region has the highest MAIFle index in 2019. The average MAIFle remained the same as in 2018. The data suggest that the highest, average, and lowest MAIFle are all continuing to trend downward, suggesting improvement.

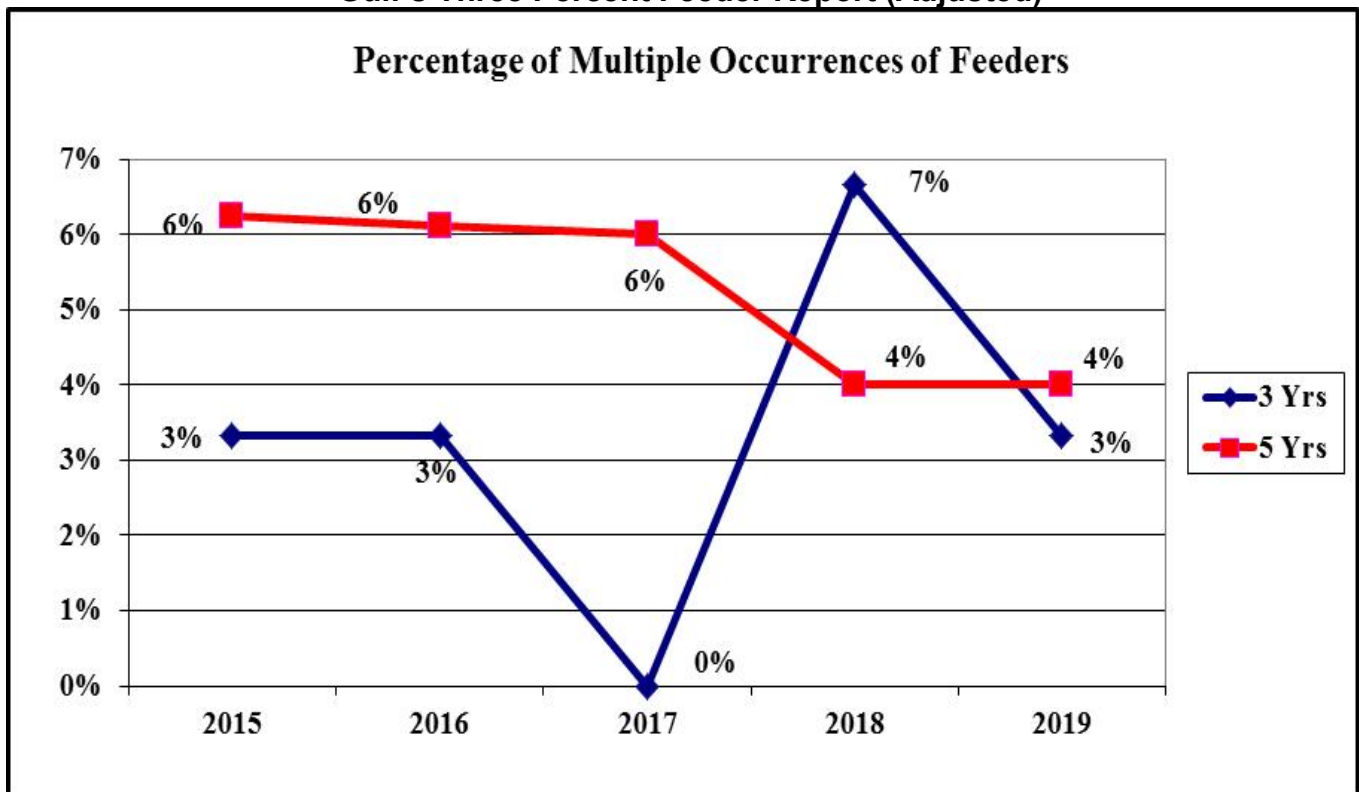
Figure 3-28
Gulf’s Three Percent Feeder Report (Adjusted)

Figure 3-28 shows the multiple occurrences of feeders using the Utility’s Three Percent Feeder Report and is analyzed on a three- and five-year basis. The Three Percent Feeder Report is a listing of the top 3 percent of feeders that have the most feeder outage events. The supporting data illustrates that the five-year multiple occurrences were unchanged from 2018 to 2019 as the three-year multiple occurrences decreased by 57 percent. The five-year period of 2015 to 2019 indicates overall that the five-year index is trending downward, as the three-year multiple occurrences index is trending upward.

There were 10 feeders on the Three Percent Feeder Report. Gulf reported that the three top causes of the outages associated with the 10 feeders listed were “Other Causes,” “Lightning,” and “Vegetation.” Gulf reported that the “Other Causes” category is used to track outages associated with manually opening a device to safely make repairs or safely operate downstream devices that need to be de-energized. Gulf continues to focus on eliminating breaker outages by installing additional lightning protection, installing Automatic Feeder Switches, and creating Self-Healing Networks. Gulf also maintains its vegetation trimming cycle on feeders to reduce tree related outages. In addition, Gulf seeks additional vegetation trimming easements as it upgrades/reconfigures its mainline circuits as part of the feeder storm hardening program.
