*Review of
Florida's
Investor-Owned
Electric Utilities*

*2 0 1 9
Service Reliability Reports*

August 2020

State of Florida
Florida Public Service Commission
Division of Engineering

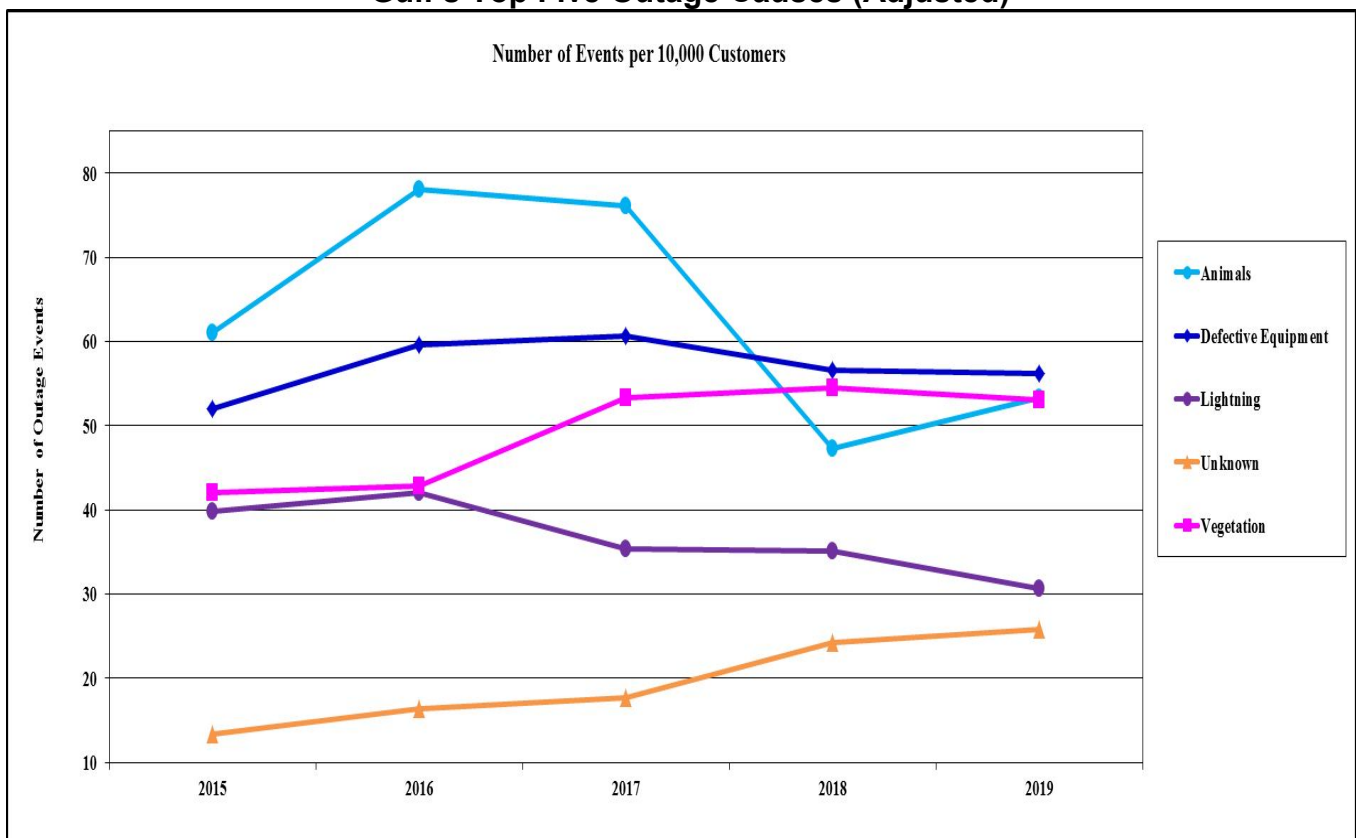
**Figure 3-29
Gulf’s Top Five Outage Causes (Adjusted)**

Figure 3-29 shows the top five causes of outage events on Gulf’s distribution system normalized to a 10,000-customer base. The Figure is based on Gulf’s adjusted data of the top 10 causes of outage events and represents 88 percent of the total adjusted outage events that occurred during 2019. The top five causes of outage events were “Defective Equipment” (23 percent), “Vegetation” (21 percent), “Animals” (21 percent), “Lightning” (12 percent), and “Unknown Causes” (10 percent). The percentage of outages due to “Defective Equipment” was the highest cause of outages. The number of outage events due to “Defective Equipment” is trending upward and there was a 0.5 percent increase in 2019. The numbers of outage events due to “Vegetation” and “Unknown Causes” are trending upward. The number of outages due to “Animals” and “Lightning” are trending downward.

Gulf's top five causes of outages were "Defective Equipment" (23 percent), "Vegetation" (21 percent), "Animals" (21 percent), "Lightning" (12 percent), and "Unknown Causes" (10 percent). As shown in **Figure 3-29**, the number of outages decreased for "Vegetation" and "Lightning" in 2019 when compared to 2018.

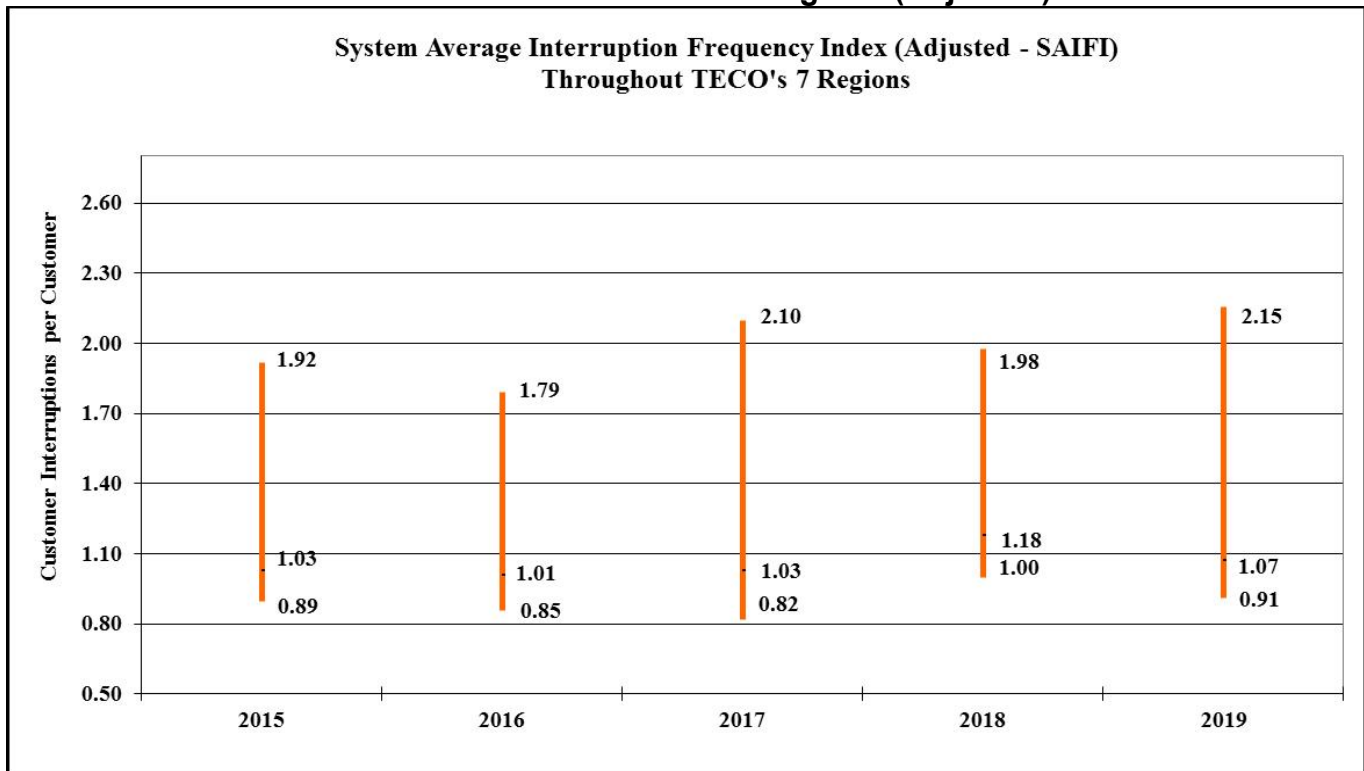
**Figure 3-31
SAIFI across TECO’s Seven Regions (Adjusted)**

Figures 3-31 illustrates TECO’s adjusted frequency of interruptions per customer reported by the system. TECO’s data represent a 9 percent decrease in the SAIFI average from 1.18 interruptions in 2018 to 1.07 interruptions in 2019. TECO’s Dade City region continues to have the highest frequency of service interruptions when compared to TECO’s other regions. The maximum, minimum, and average SAIFI are trending upward.

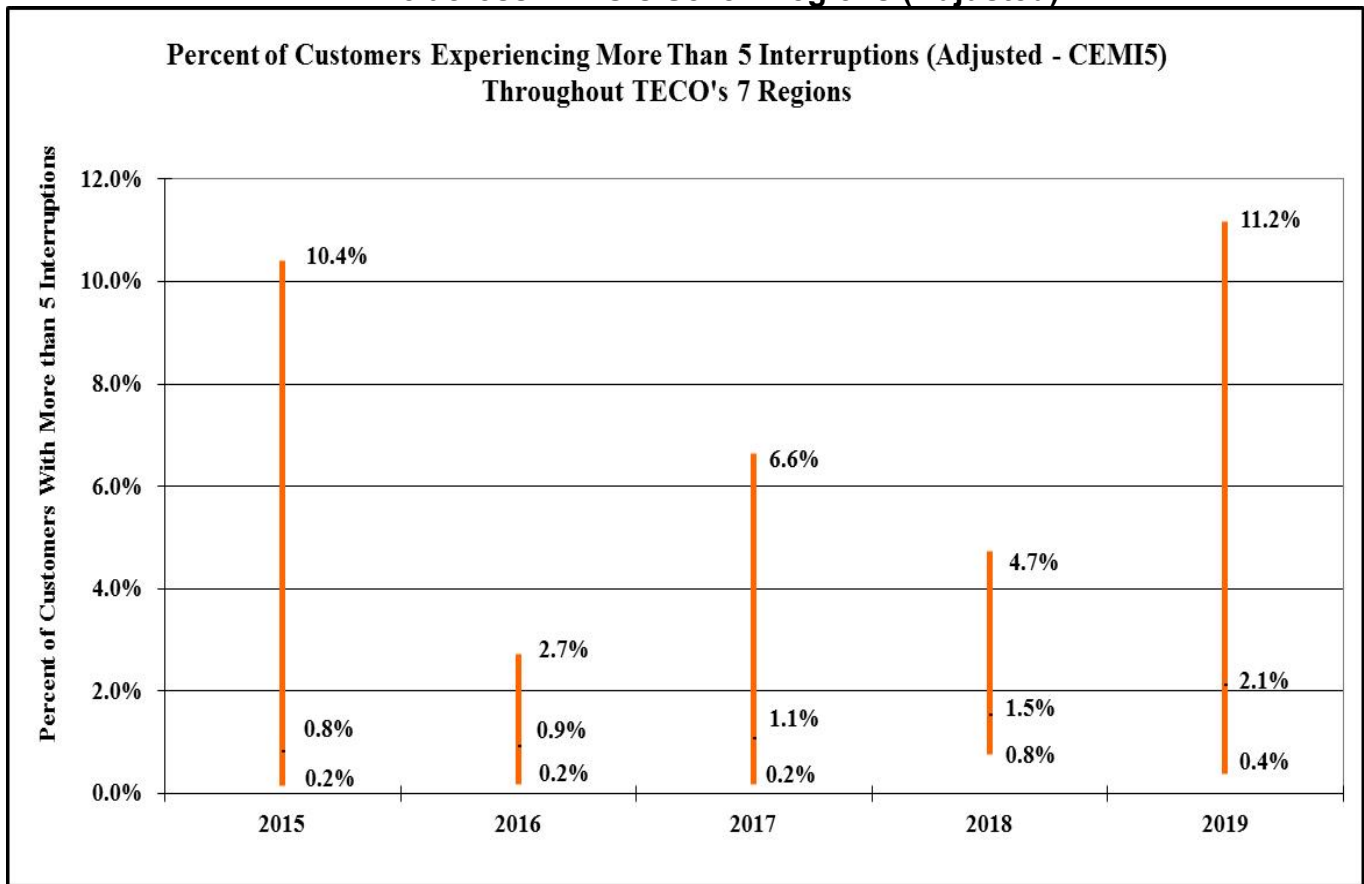
**Figure 3-35
CEMI5 across TECO’s Seven Regions (Adjusted)**

Figure 3-35 indicates that the percent of TECO’s customers experiencing more than five interruptions. Two regions in TECO’s territory experienced a decrease in the CEMI5 results for 2019. The Dade City, Eastern, Plant City, South Hillsborough, and Western regions experienced an increase in the CEMI5 index. Dade City reported the highest CEMI5 percentage for 2019. With TECO’s results for this index varying for the past five years, the average CEMI5 index appears to be trending upward indicating a decline in performance. There was a 40 percent increase in the average CEMI5 index from 2018 to 2019.

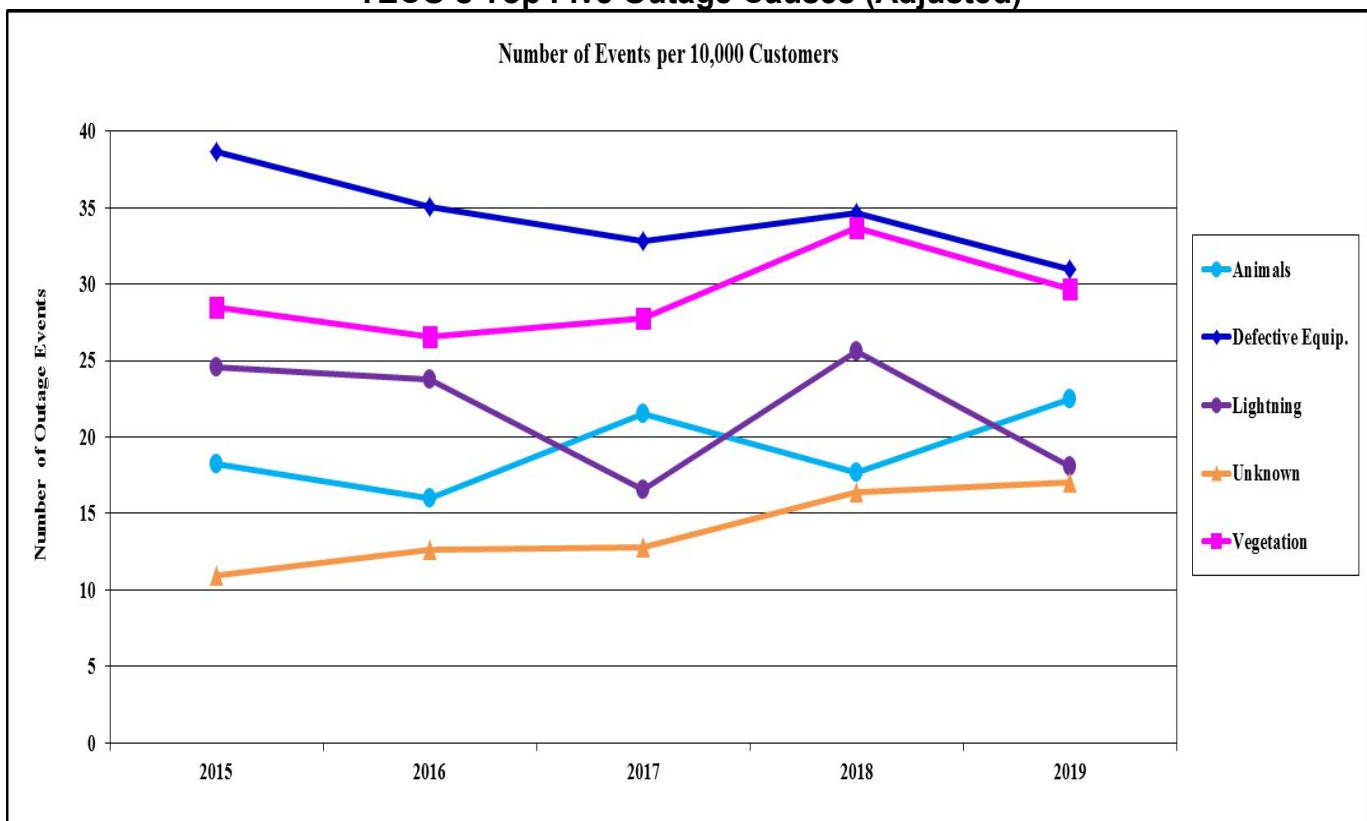
**Figure 3-37
TECO’s Top Five Outage Causes (Adjusted)**

Figure 3-37 indicates that the top five causes of outage events on TECO’s distribution system normalized to a 10,000-customer base. The Figure is based on TECO’s adjusted data of the top 10 causes of outage events and represents 90 percent of the total outage events that occurred during 2019. For the five-year period, the five top causes of outage events included “Defective Equipment” (23 percent), “Vegetation” (22 percent), “Animals” (17 percent), “Lightning” (14 percent), and “Unknown Causes” (13 percent) on a cumulative basis. “Defective Equipment” is the highest cause of outages for 2019. “Vegetation” and “Animals” causes are the next two top problem areas for TECO. The outages due to “Animals” increased 37 percent from 2018 to 2019. The outages from “Unknown Causes” increased 13 percent for the same time period. The numbers of outages due to “Vegetation,” “Animals,” and “Unknown Causes” are trending upward while the number of outages due to “Defective Equipment” and “Lightning” are trending downward.

“Defective Equipment” (23 percent) and “Vegetation” (22 percent) were the largest contributors to TECO’s causes of outage events followed by “Animals” (17 percent), “Lightning” (14 percent), and “Unknown Causes” (13 percent). **Figure 3-37** illustrates the top five outage causes. “Defective Equipment,” the leading cause of outages, has been trending downward since 2015 and “Defective Equipment” had a 3 percent decrease in outages when compared to the previous year. “Lightning” related causes are also trending downward. “Vegetation,” “Animals,” and “Unknown Causes” related causes are trending upward.

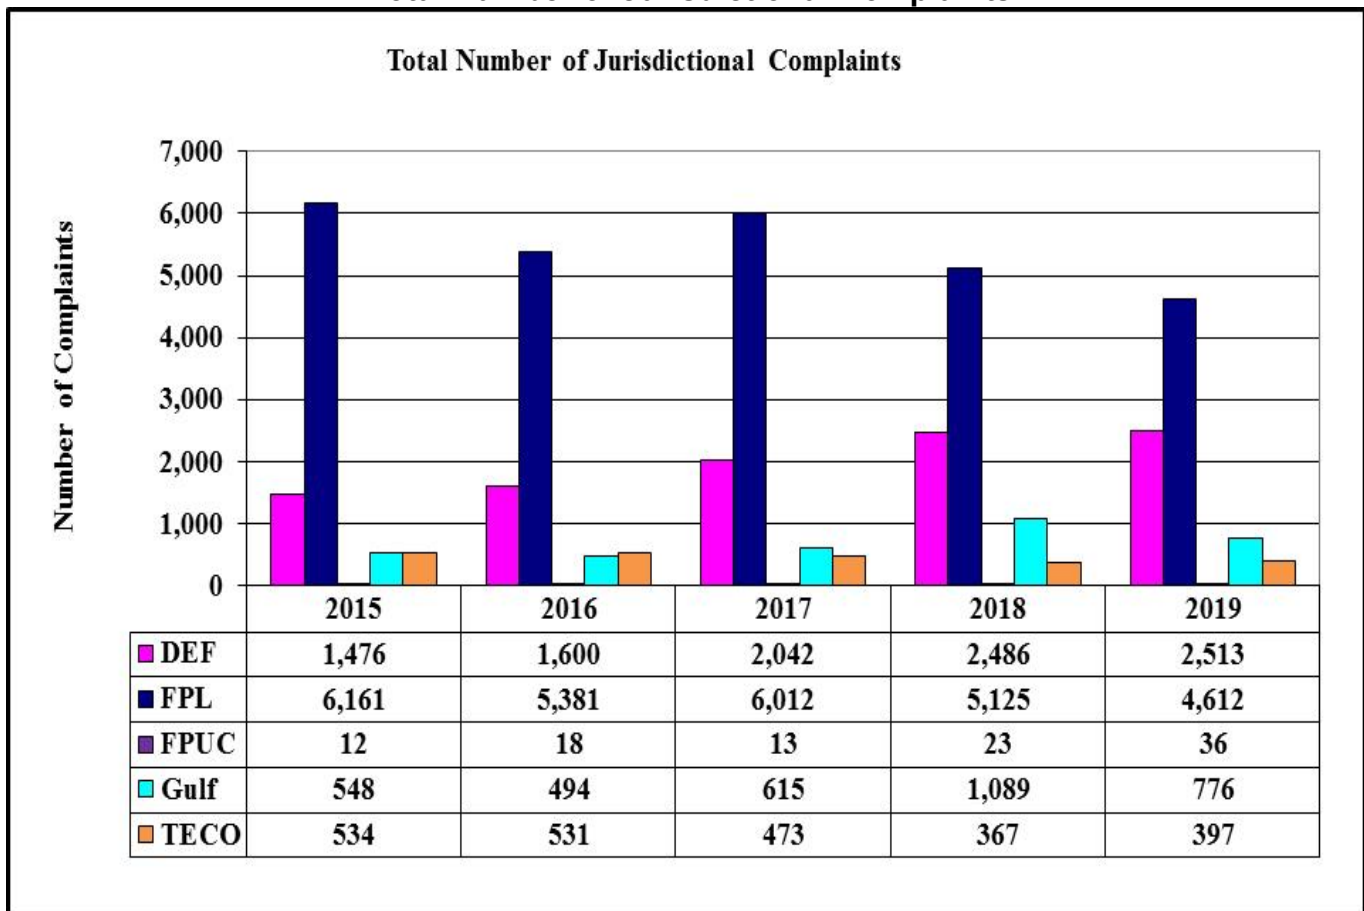
Figure 4-8
Total Number of Jurisdictional Complaints

Figure 4-8 shows the total number of jurisdictional complaints¹⁶ for each IOU. In comparing the number of complaints by the different companies, the total number of customers should be considered. FPL has the higher number of complaints, but FPL also has more customers than the other companies.

Figures 4-8, 4-9, 4-10, and 4-11 represent consumer complaint data that was extracted from the Commission’s Consumer Activity Tracking System (CATS). Each consumer complaint received by the Commission is assigned a code after the complaint is resolved. Reliability related complaints have 10 specific category types and typically pertain to “Trees,” “Safety,” “Repairs,” “Frequent Outages,” and “Momentary Service Interruptions.”

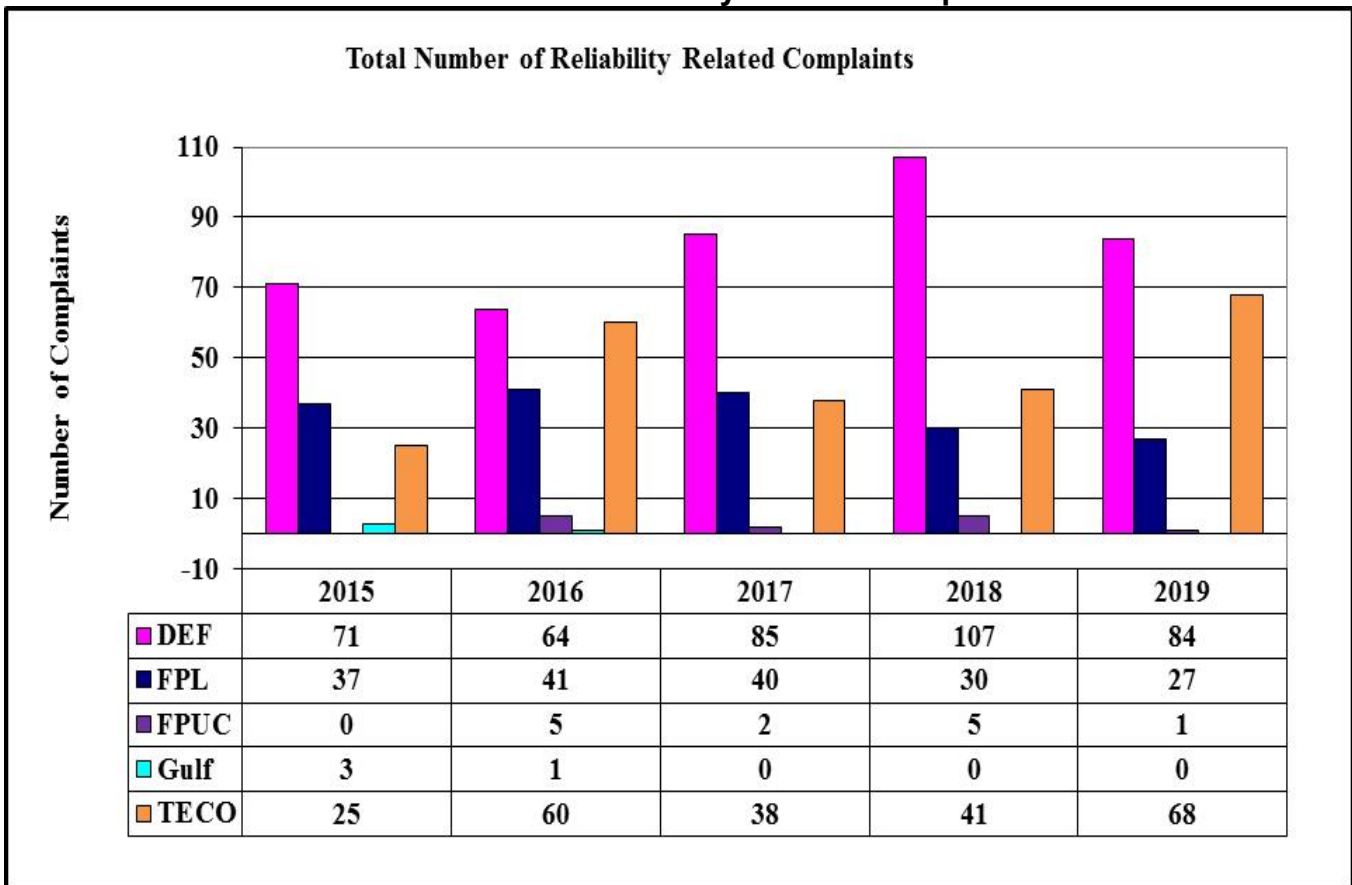
**Figure 4-9
Total Number of Reliability Related Complaints**

Figure 4-9 charts the total number of reliability related complaints for the IOUs. DEF is showing the largest amount of reliability complaints for the five-year period of 2015 to 2019 with FPUC and Gulf showing the least amount. FPL, FPUC, and Gulf are trending downward in the number of reliability complaints, while DEF and TECO are trending upward.

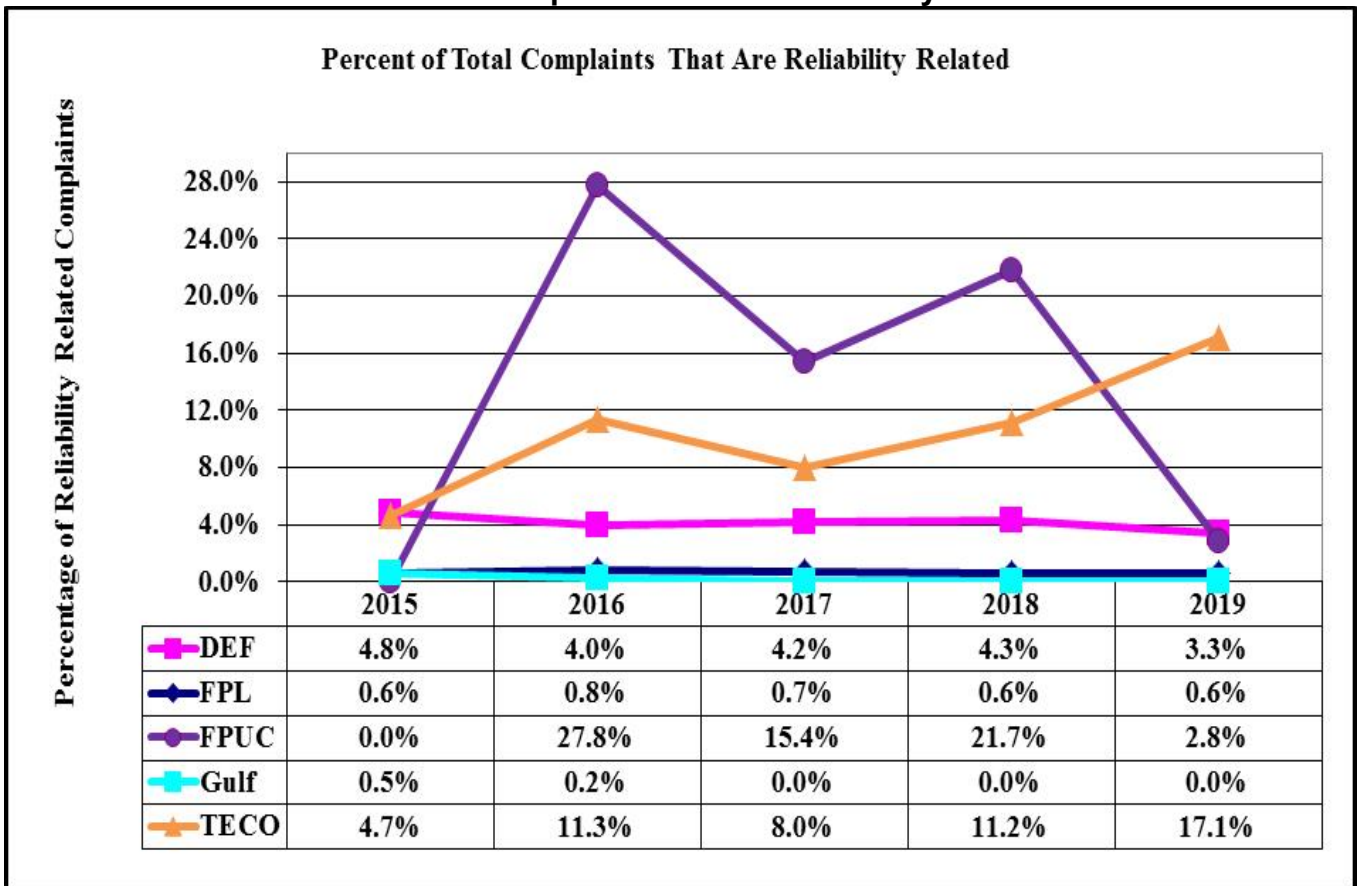
Figure 4-10
Percent of Complaints that are Reliability Related

Figure 4-10 shows the percentage of reliability related customer complaints in relation to the total number of complaints for each IOU. DEF, FPL and Gulf appear to be trending downward as FPUC and TECO are trending upward. The percentages of FPUC complaints compared to the other companies appears high, however FPUC has fewer customers and fewer complaints in total.

Complaints related to FPL’s reliability did not change from 2018 to 2019, and stayed at 0.6 percent. FPL’s reliability related complaints appear to be trending downward as shown in **Figure 4-10**.

There were no complaints reported to the Commission against Gulf that were reliability related in 2019. Gulf's percentage of total complaints for the five-year period of 2015 to 2019 has remained relatively flat. Overall, as shown in **Figure 4-10**, Gulf has the lowest percentage of total complaints related to reliability.
