*Review of
Florida's
Investor-Owned
Electric Utilities*

*2 0 2 0
Service Reliability Reports*

August 2021

State of Florida
Florida Public Service Commission
Division of Engineering

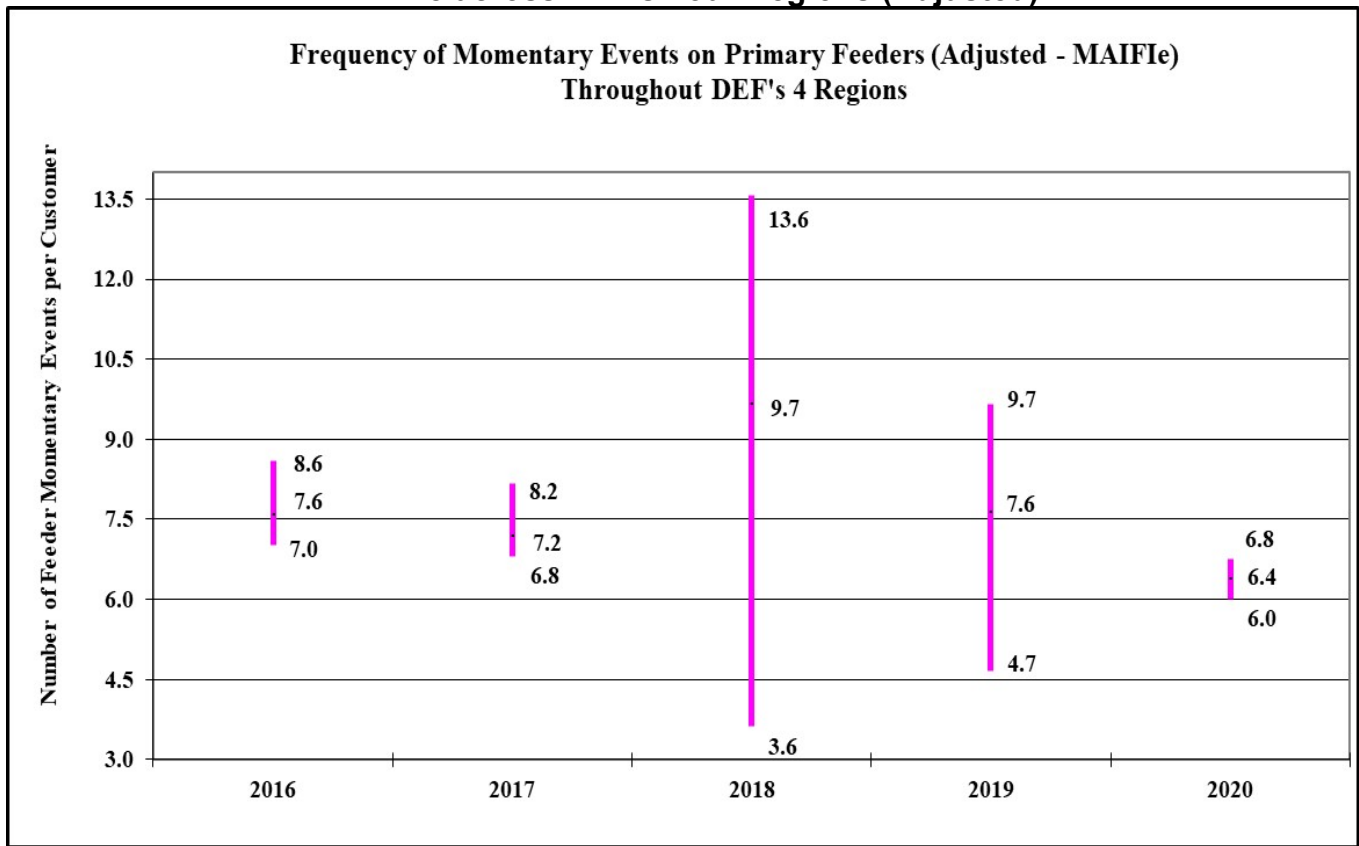
**Figure 2-5
MAIFIE across DEF’s Four Regions (Adjusted)**

Figure 2-5 illustrates the frequency of momentary events on primary circuits for DEF’s customers recorded across its system. These momentary events often affect a small group of customers. A review of the supporting data suggests that the MAIFIE results between 2016 and 2020 appear to be trending downward showing improvement and there was a decrease in the average MAIFIE of 16 percent from 2019 to 2020. All four regions appear to fluctuate between having the best (lowest) results to having the worst (highest) results. From 2019 to 2020, the highest MAIFIE decreased by 29 percent as the lowest MAIFIE increased by 28 percent.

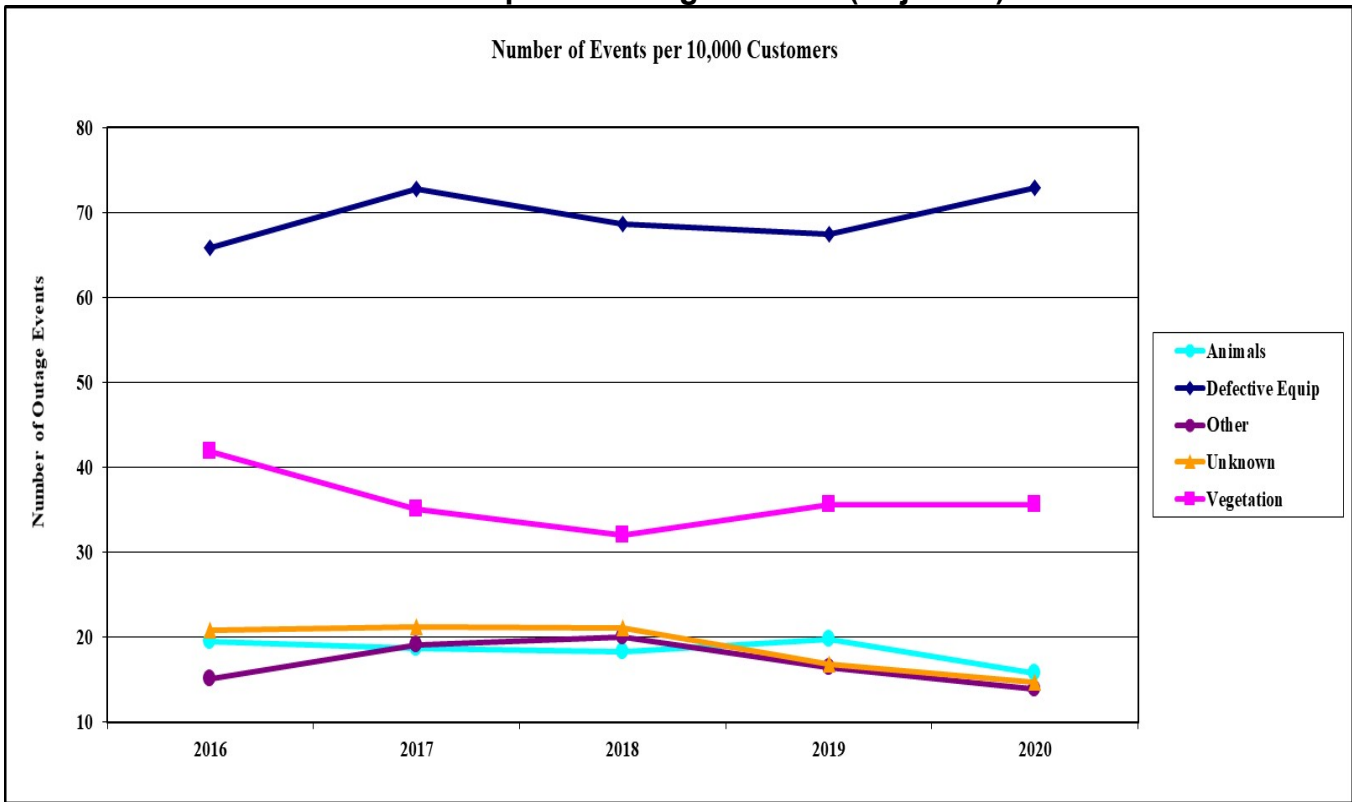
**Figure 2-16
FPL's Top Five Outage Causes (Adjusted)**

Figure 2-16 depicts the top five causes of outage events on FPL’s distribution system normalized to a 10,000-customer base. The graph is based on FPL’s adjusted data of the top 10 causes of outage events. For the five-year period, the five top causes of outage events included “Defective Equipment” (42 percent), “Vegetation” (20 percent), “Animals” (9 percent), “Unknown Causes” (8 percent), and “Other Causes” (8 percent) on a cumulative basis. Since 2016, the outage events due to “Vegetation,” “Animals,” and “Unknown Causes” are trending downward as the “Defective Equipment” categories is trending upward. The category “Other Causes” is remaining relatively flat. The category “Defective Equipment” dominates the highest percentage of outage causes throughout the FPL regions and there was a 10 percent increase in the number of outages from 2019 to 2020.

Annually, FPL evaluates its current reliability remediation programs and verifies the program’s need and/or existence. In addition, FPL proposes new reliability remediation programs to improve its reliability performance concentrating on the highest cause codes and those cause codes that have shown trends needing attention. FPL has 22 reliability programs listed for its 2021 budget. The programs include: distribution automation, system expansion, reduce the number of direct buried feeder and lateral cables, install feeder line covers to reduce vegetation related interruptions, and replace oil circuit reclosers with electronic reclosers. Sixteen programs are designed to improve the “Defective Equipment” cause code. Twelve programs will improve the “Vegetation” cause code and nine programs will improve the “Animals” cause code. The “Vegetation” cause code had an increase in 2020 as the “Animals” cause code had a decrease.

“Defective Equipment” (42 percent) and “Vegetation” (20 percent) outages were the leading causes of outage events per customer for 2020. The next three outage causes are “Animals” (9 percent), “Other Causes” (8 percent), and “Unknown Causes” (8 percent). **Figure 2-16** shows an increasing trend in the number of outage events attributed to “Defective Equipment,” which had increased by 10 percent from 2019 to 2020. The analysis shows a decrease in the number of

outage events caused by “Animals,” and “Unknown Causes” in which they are trending downward. In addition, since 2016, “Vegetation” is also trending downward. The analysis shows that the “Other Causes” category is remaining relatively flat.

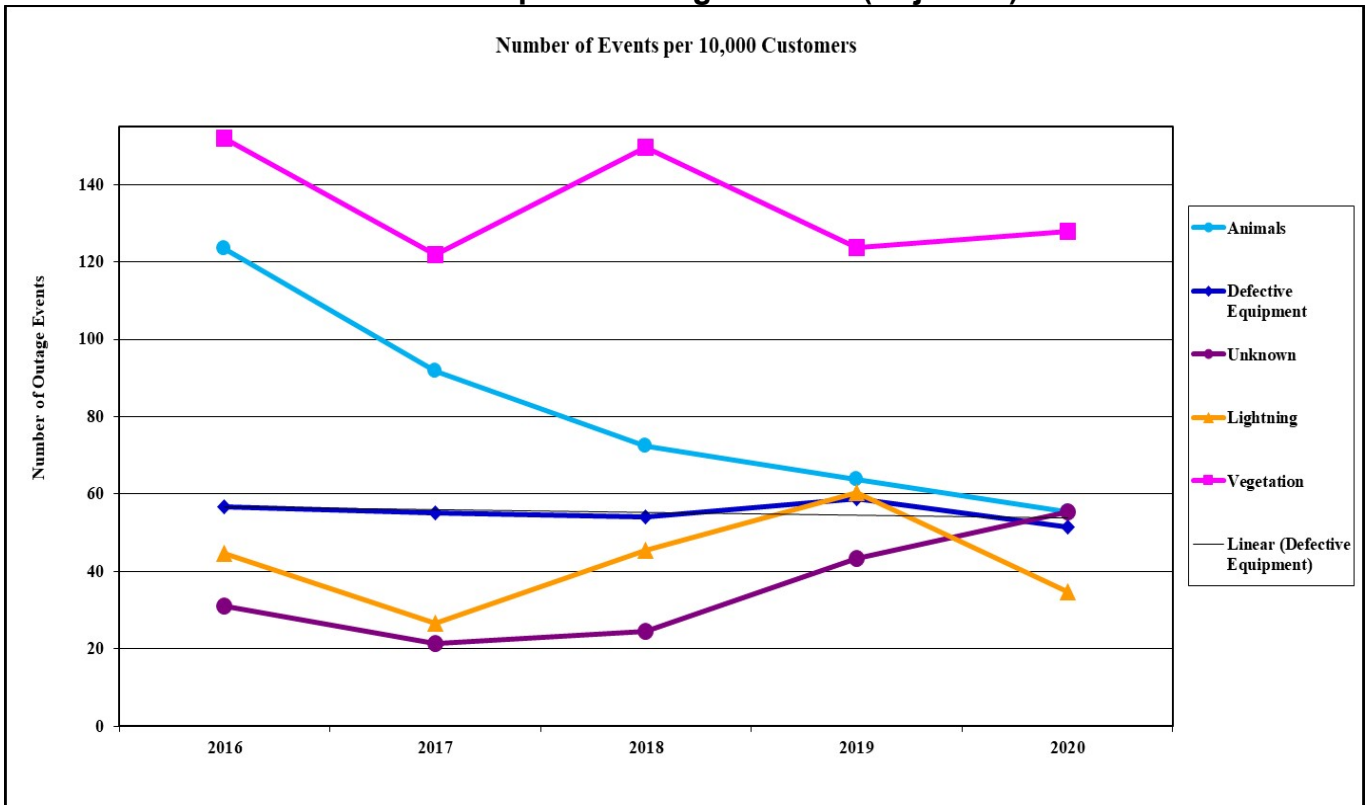
**Figure 2-21
FPUC’s Top Five Outage Causes (Adjusted)**

Figure 2-21 shows the top five causes of outage events on FPUC’s distribution system normalized to a 10,000-customer base. The figure is based on FPUC’s adjusted data of the top 10 causes of outages. For 2020, the top five causes of outage events were “Vegetation” (34 percent), “Animals” (15 percent), “Unknown” (15 percent), “Defective Equipment” (14 percent), and “Lightning” (9 percent). These five factors represent 87 percent of the total adjusted outage causes in 2019. The “Vegetation” category is trending downward even though there was a 5 percent increase from 2019 to 2020. The outage causes by “Animals” is also trending downward. The causes by “Lightning,” and “Unknown” are trending upward. “Defective Equipment” is remaining relatively flat decreasing by 11 percent from 2019 to 2020. The “Lightning” category had a 41 percent decrease and the “Unknown” category increased 30 percent during the same time period. The “Animals” category caused outages had an 11 percent decrease from 2019 to 2020. FPUC reported that it added additional tree crews in both Divisions to address the issue with vegetation caused outages. In addition, during Hurricane Michael, a large number of animal guards were destroyed. FPUC is currently replacing the animal guards and also adding new ones to help mitigate the animal caused outages.

FPUC’s top five causes of outages included “Vegetation,” “Animals,” “Unknown,” “Defective Equipment,” and “Lightning” events. As shown in **Figure 2-21**, “Vegetation” (34 percent) was the number one cause of outages in 2020 followed by “Animals” (15 percent), “Unknown” (15 percent), “Defective Equipment” (14 percent), and “Lightning” (9 percent). “Animals,” “Defective Equipment,” and “Lightning,” attributed outages decreased in 2020, as “Vegetation” and “Unknown” caused outages increased.

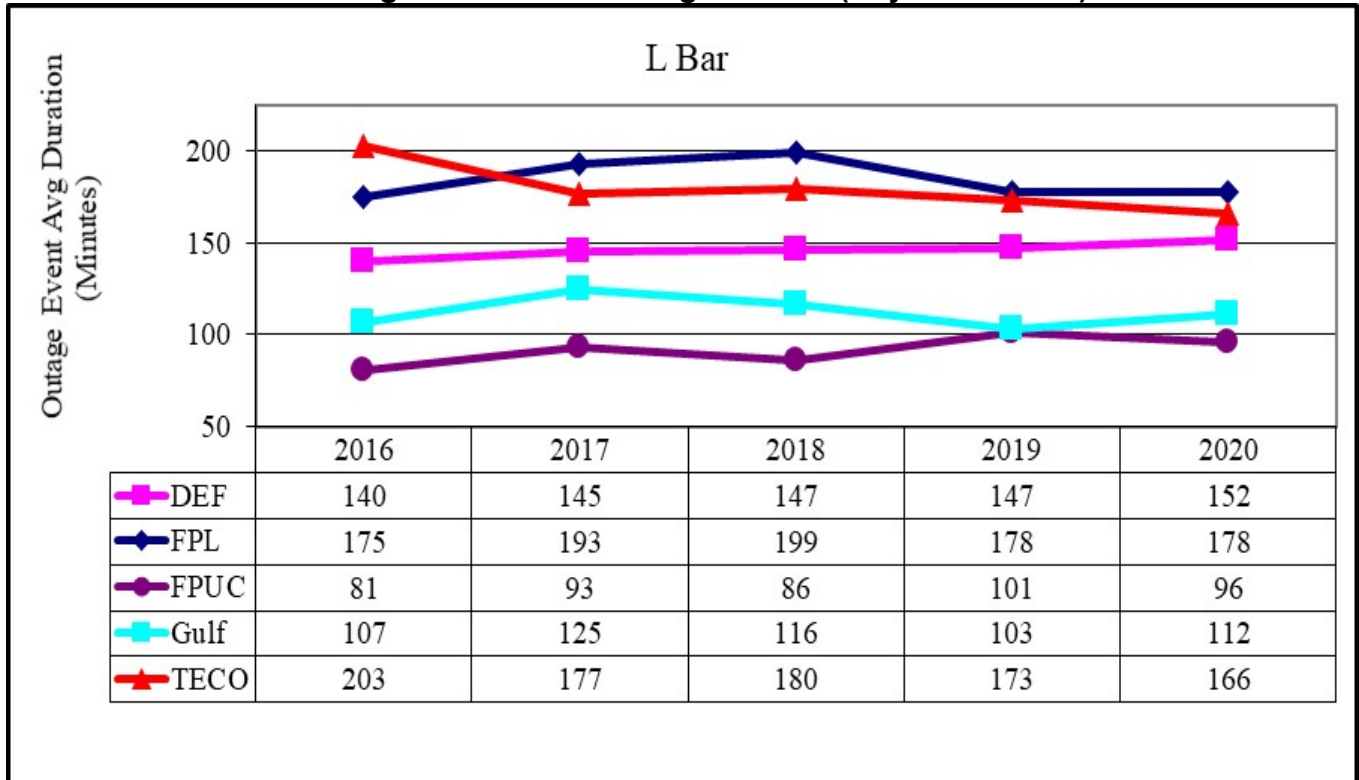
Figure 3-7
Average Duration of Outage Events (Adjusted L-Bar)

Figure 3-7 represents the average duration of outage events (Adjusted L-Bar) for each IOU. From the data shown, it appears that the utilities have been consistent with their restoral times for the five-year period of 2016 to 2020, even with increases from 2019 to 2020.
