Review of Florida's Investor-Owned Electric Utilities' Service Reliability in 2007

> Florida Public Service Commission Division of Economic Regulation December 2008

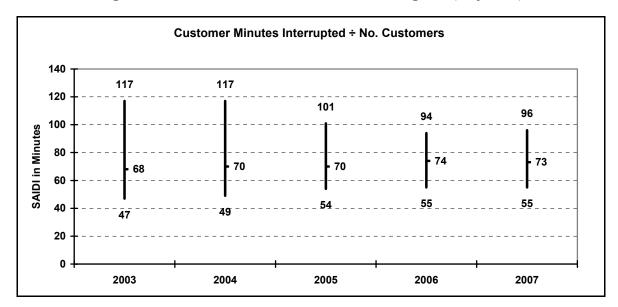
Figure 3-1. SAIDI across FPL's Seventeen Regions (Adjusted)

Figure 3-1 shows the maximum, average, and minimum adjusted SAIDI recorded across FPL's system. FPL's average SAIDI improved slightly from 2006 to 2007, declining by one minute from 74 to 73 (1%).

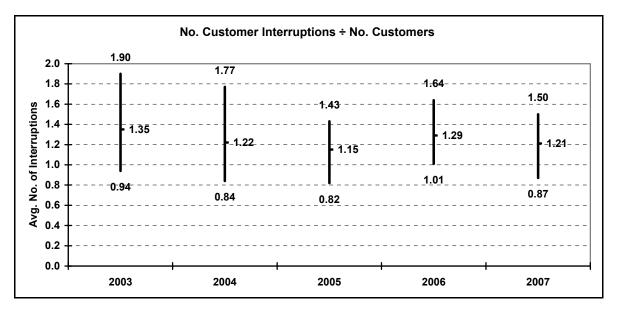
Figure 3-2. SAIFI across FPL's Seventeen Regions (Adjusted)

Figure 3-2 shows the maximum, average, and minimum adjusted SAIFI across FPL's system. FPL's SAIFI fell from 1.29 in 2006, to 1.21 in 2007, indicating a 6% improvement.

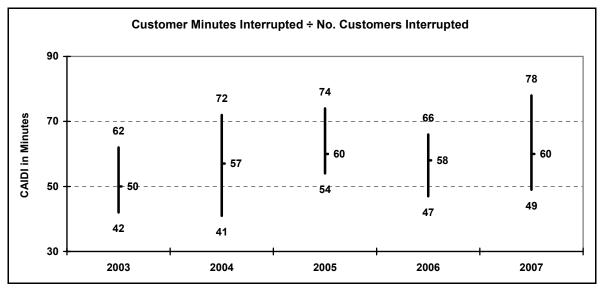
Figure 3-3 shows the maximum, average, and minimum CAIDI across FPL's system. FPL's average CAIDI increased from 58 minutes in 2006 to 60 minutes in 2007, a 3% decrease in CAIDI measured reliability.

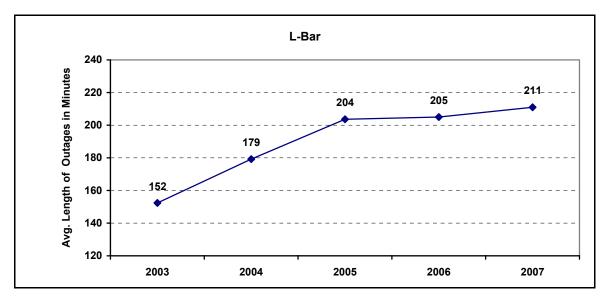
Figure 3-4. FPL's Average Duration of Outages (Adjusted)

The average length of time FPL spends recovering from outage events, excluding hurricanes and other extreme outage events, is represented by its L-Bar index shown in Figure 3-4. FPL's average service restoration length increased from 205 minutes in 2006 to 211 minutes in 2007 (3%). Many factors can contribute to increases in L-Bar, including increased numbers of underground outages, the cause and location of the outage event, the amount of distribution facilities needing replacement or repair, and the number of available trained and equipped personnel. Frequent outage problems experienced by a subset of customers indicate a need for improvement.

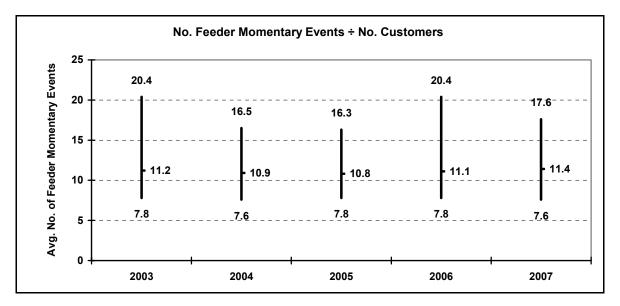
Figure 3-5. MAIFIe across FPL's Seventeen Regions (Adjusted)

Figure 3-5 shows the maximum, average, and minimum adjusted MAIFIe recorded across FPL's system. Isolated momentary events also occur on segments of the distribution circuit remote from the substation where the MAIFIe data is measured. These remote momentary events often affect a small group of customers or even just one customer. Such outage problems can be masked by the previously discussed indices of SAIDI, SAIFI, CAIDI, and L-Bar. FPL's average MAIFIe increased from 11.1 to 11.4 (3%) from 2006 to 2007.

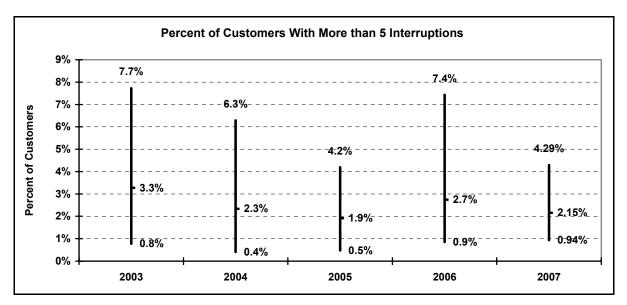
Figure 3-6. CEMI5 across FPL's Seventeen Regions (Adjusted)

Figure 3-6 displays the maximum, average, and minimum adjusted CEMI5. FPL's average CEMI5 shows improvement from 2006 to 2007, falling from 2.7%, to 2.15% (20%).

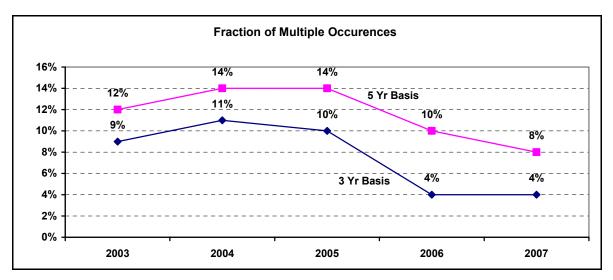
The Three Percent Feeder Report is a listing of the top three percent of feeders with the most feeder outage events. The fraction of multiple occurrences, Figure 3-7, is calculated from the number of recurrences divided by the number of feeders reported on a three-year and five-year basis. Reporting the fraction of multiple outage occurrences on a three-year and a five-year basis allows a more rigorous analysis of trend patterns. As shown, FPL data indicates a general decline in outage reoccurrences of feeders that appeared on its Three Percent Feeder Report, indicating improved feeder reliability.

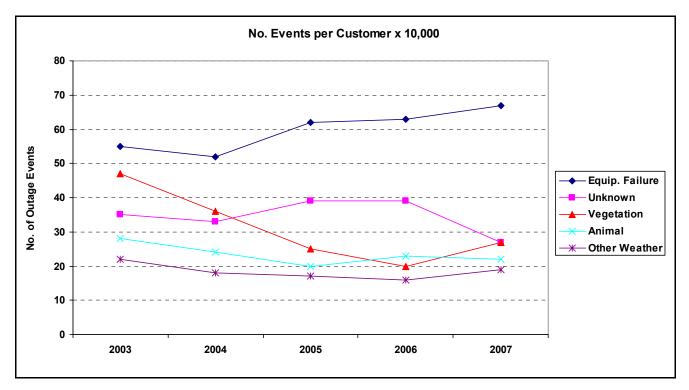
Figure 3-8. FPL's Top Five Outage Causes (Adjusted)

Figure 3-8 shows the top five causes of outage events on FPL's distribution system per 10,000 customers. The figure is based on FPL's adjusted data of the top ten causes of outage events and represents most of the outage events that occurred between December 31, 2003, and January 1, 2008.

The review of FPL's supporting data, adjusted for customer growth, shows a decrease in the total number of outage events over the five-year period 2003 thru 2007.

~		Adj	usted Num	ber of Outa	age Events		Adjus	sted L-Ba	ar - Leng	gth of Ou	itages
Cause	2003	2004	2005	2006	2007	Cumulative Percentages	2003	2004	2005	2006	2007
Equipment Failure	22,728	21,633	26,752	27,692	30,102	27.44%	200	217	249	255	256
Unknown	14,469	13,811	16,970	17,273	12,016	15.87%	128	149	149	183	170
Vegetation	19,307	15,225	10,571	8,911	12,201	14.09%	155	174	199	192	206
Animal	11,445	10,153	8,711	10,006	9,655	10.64%	74	79	113	113	115
All Other	4,296	6,261	5,842	5,318	7,343	6.19%	149	287	223	203	191
Other Weather	9,083	7,413	7,250	7,148	8,318	8.35%	106	132	144	156	164
Other	4,956	6,575	8,865	10,165	4,536	7.47%	155	178	184	193	208
Lightning	5,074	4,212	4,682	4,575	6,059	5.24%	233	262	289	301	306
Equipment Connect	2,339	1,932	2,288	2,925	2,631	2.58%	163	171	217	227	228
Vehicle	1,791	1,751	1,905	2,181	1,678	1.98%	194	204	236	231	228
Dig-in	767	-	-	-	-	0.16%	207	-	-	-	-
FPL System	96,255	88,966	93,836	96,194	94,539	100.0%	150	179	204	205	211

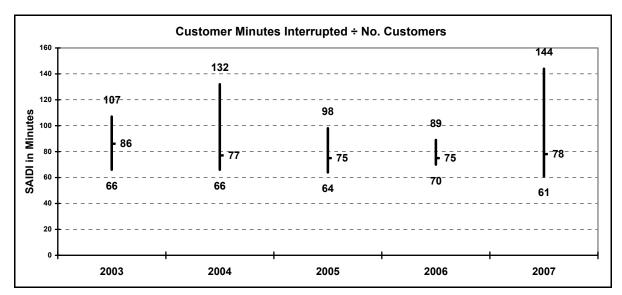
Figure 3-9 shows the maximum, average, and minimum adjusted SAIDI recorded across PEF's system. PEF's average SAIDI increased from 75 minutes in 2006 to 78 in 2007 (4%).

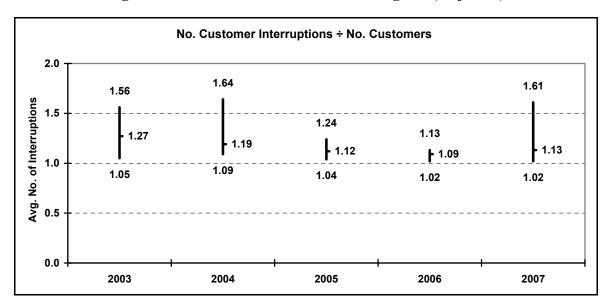
Figure 3-10. SAIFI across PEF's Four Regions (Adjusted)

Figure 3-10 shows the maximum, average, and minimum adjusted SAIFI across PEF's system. PEF's average SAIFI increased from 1.09 in 2006 to 1.13 in 2007 (4%).

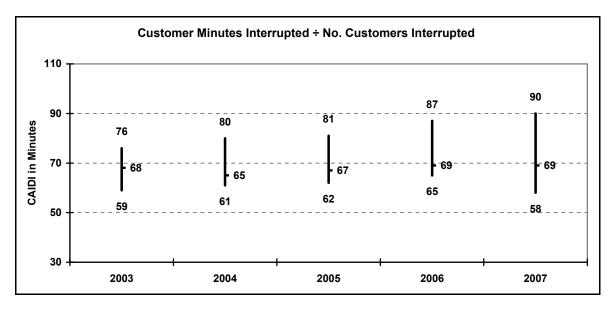
Figure 3-11. CAIDI across PEF's Four Regions (Adjusted)

Figure 3-11 represents PEF's adjusted CAIDI. PEF's average CAIDI remained unchanged from 2006 to 2007, holding at 69 minutes.

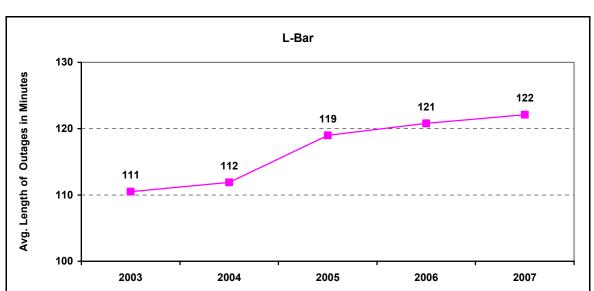
Figure 3-12. PEF's Average Duration of Outages (Adjusted)

The average length of time PEF spends recovering from outage events, excluding hurricanes and other extreme outage events, is the index L-Bar shown in Figure 3-12. PEF's average service restoration length increased from 121 minutes in 2006 to 122 in 2007 (<1%).

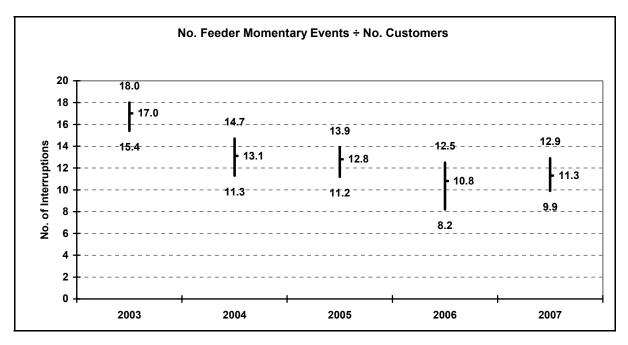
Figure 3-13. MAIFIe across PEF's Four Regions (Adjusted)

Figure 3-13 shows the maximum, average, and minimum adjusted MAIFIe recorded across PEF's system. PEF's average MAIFIe increased from 10.8 to 11.3 (5%) from 2006 to 2007.

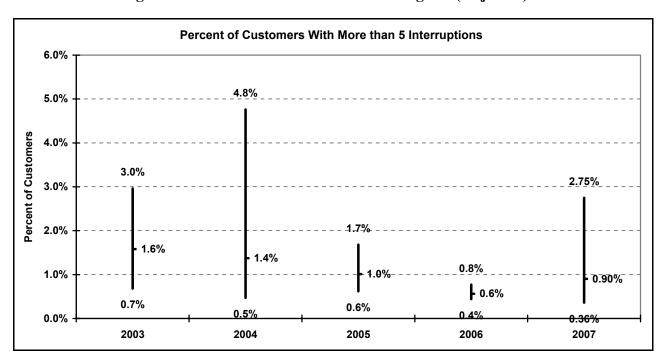
Figure 3-14. CEMI5 across PEF's Four Regions (Adjusted)

Figure 3-14 shows the maximum, average, and minimum adjusted CEMI5. PEF's 2007 reliability data demonstrate an increase in the average percent of customers with more than 5 service interruptions, from 0.6% to 0.9%.

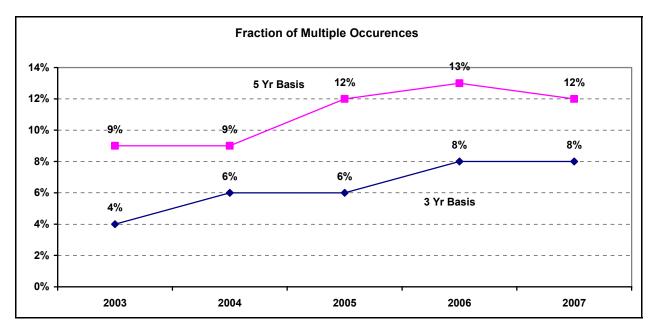
Figure 3-15. PEF's Three Percent Feeder Report (Adjusted)

The Three Percent Feeder Report lists the top three percent of feeders with the most feeder outage events. The fraction of multiple occurrences is calculated from the number of recurrences, divided by the number of feeders reported. Figure 3-15 shows the fraction of multiple occurrences of feeders using a three-year and five-year basis.

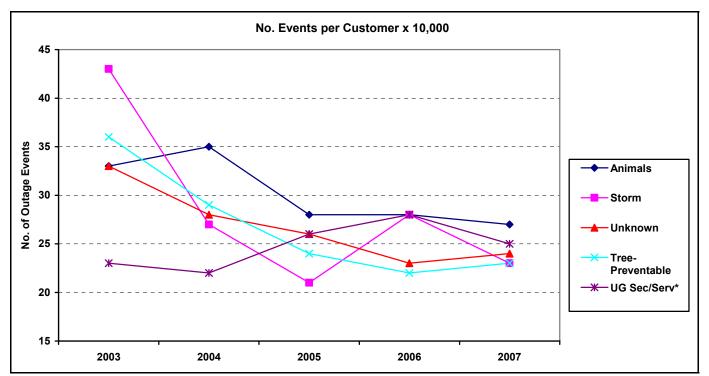
Figure 3-16. PEF's Top Five Outage Causes (Adjusted)

Figure 3-16 shows the top five causes of outage events on PEF's distribution system per 10,000 customers. The figure is based on PEF's adjusted data of the top ten causes of outage events. PEF uses its "Tree-Preventable" code to denote instances where it believes additional tree trimming could have avoided the outage event.

* Underground Secondary/Service cause description is used when outages are caused by a fault in the underground secondary or service cables. Secondary cable is underground cable located between a transformer and a pedestal. Service underground cable is underground cable located between a pedestal or transformer and the meter.

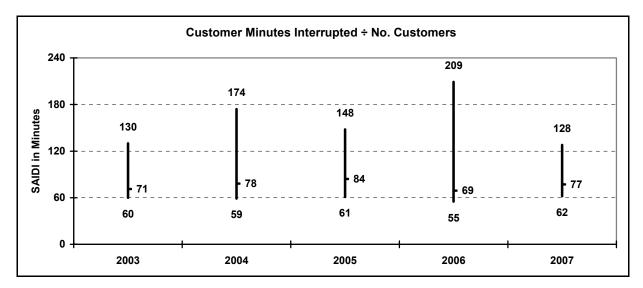
Figure 3-17. SAIDI across TECO's Seven Regions (Adjusted)

Figure 3-17 shows the maximum, average, and minimum adjusted SAIDI recorded across TECO's system. TECO's average SAIDI increased from 69 minutes in 2006 to 77 minutes in 2007 (12%).

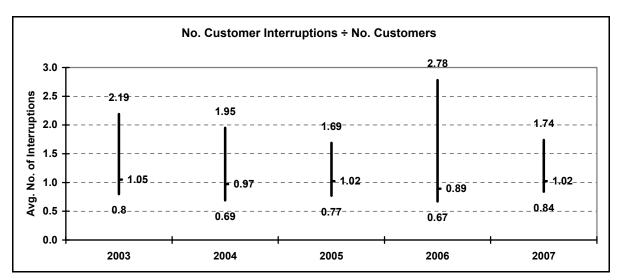
Figure 3-18. SAIFI across TECO's Seven Regions (Adjusted)

Figure 3-18 graphs the maximum, average, and minimum adjusted SAIFI across TECO's system. TECO's average adjusted SAIFI increased from 0.89 interruptions per customer in 2006, to 1.02 interruptions per customer in 2007 (15%).

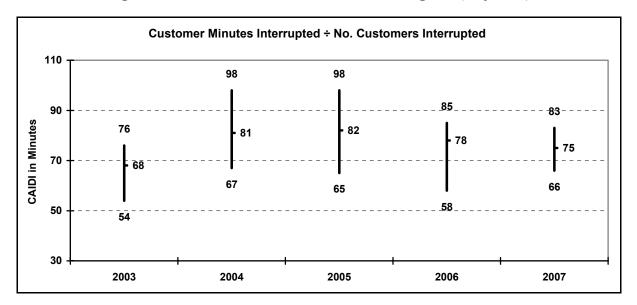
Figure 3-19. CAIDI across TECO's Seven Regions (Adjusted)

Figure 3-19 shows the maximum, average, and minimum adjusted CAIDI across TECO's system. TECO's average CAIDI improved by 3 minutes (4%) in the review period, moving from 78 minutes in 2006 to 75 minutes in 2007.

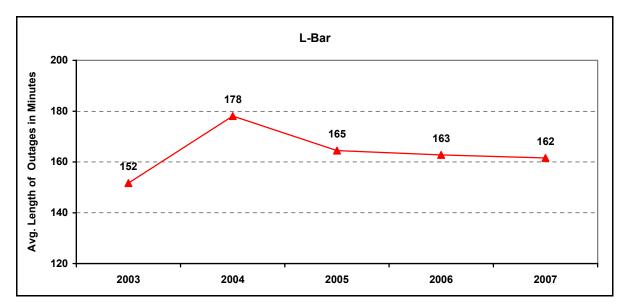
Figure 3-20. TECO's Average Duration of Outages (Adjusted)

The average length of time TECO spends recovering from outage events, excluding hurricanes and other extreme outage events, is the index L-Bar shown in Figure 3-20. TECO's L-Bar decreased slightly, from 163 minutes in 2007 to 162 minutes in 2007 (<1%).

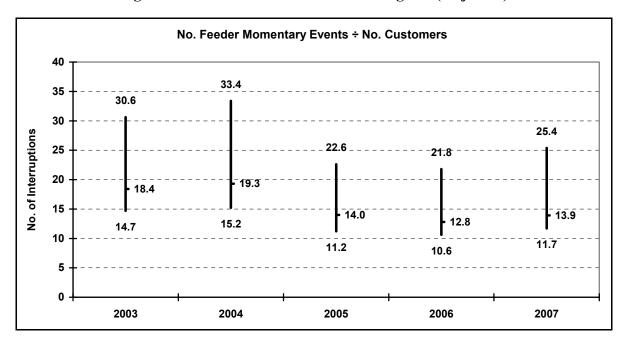
Figure 3-21. MAIFIe across TECO's Regions (Adjusted)

Figure 3-21 shows the maximum, average, and minimum adjusted MAIFIe recorded across TECO's system. TECO's average adjusted system MAIFIe increased from 12.8 in 2006 to 13.9 in 2007 (9%).

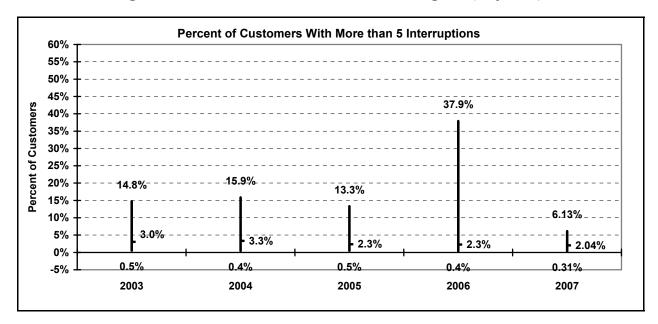
Figure 3-22 shows TECO's maximum, average, and minimum adjusted system CEMI5. TECO's average percent of customers experiencing more than five interruptions decreased from 2.30% in 2006, to 2.04% in 2007 (11%).

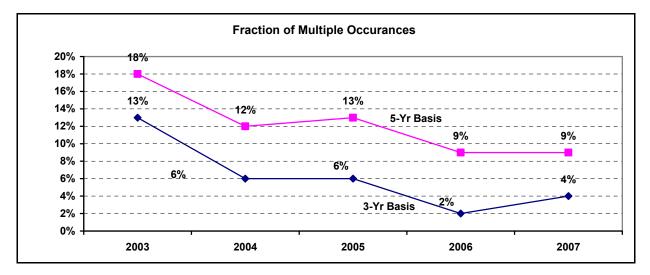
Figure 3-23. TECO's Three Percent Feeder Report (Adjusted)

The Three Percent Feeder Report lists the top three percent of feeders with the most feeder outage events. The fraction of multiple occurrences is calculated from the number of recurrences, divided by the number of feeders reported. Figure 3-23 shows the fraction of multiple occurrences of feeders using a three-year and five-year basis.

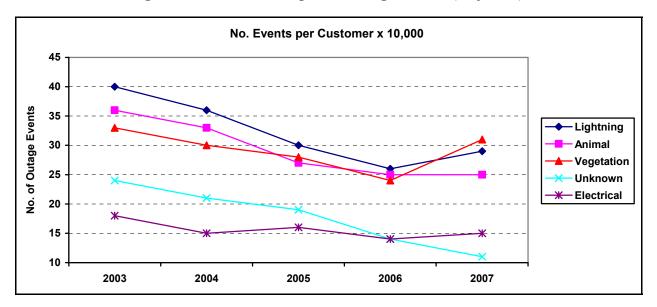
Figure 3-24 shows the top 5 causes of outage events on TECO's distribution system per 10,000 customers. The figure is based on TECO's adjusted data of the top ten causes of outage events.

Adjus	ted Numb	er of Out	age Even	ıts	Adjust	ted L-Ba	ar - Len	gth of O	utages
Cause	2003	2004	2005	2006	2007	Cumulative Percentages	2003	2004	2005	2006	2007
Lightning	2,481	2,283	1,962	1,723	1,921	19.30%	241	246	220	224	222
Animal	2,192	2,083	1,742	1,656	1,708	17.46%	79	93	91	82	81
Vegetation	2,003	1,880	1,797	1,564	2,086	17.36%	172	202	157	153	157
Unknown	1,487	1,335	1,243	895	727	10.58%	191	146	130	123	113
Other Weather	1,009	911	930	703	578	7.69%	160	187	161	163	151
Electrical	1,122	955	1,065	954	979	9.45%	154	180	190	189	179
Bad Connection	841	694	917	704	726	7.23%	158	179	182	186	188
Human Interference	-	222	266	-	-	0.91%	-	193	200	-	-
Vehicle	348	235	349	334	261	2.84%	163	169	182	180	184
Defective Equipment	317	210	291	441	508	3.29%	182	207	217	209	219
All Other	276	235	311	264	254	2.49%	138	187	174	177	152
Down Wire	265	-	-	237	249	1.40%	177	-	-	197	170
TECO System	12,341	11,043	10,873	9,475	9,997	100.0%	167	178	164	163	162

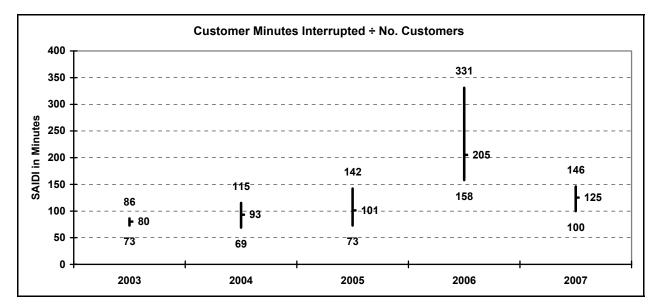
Figure 3-25 shows the maximum, average, and minimum adjusted SAIDI recorded across Gulf's system. Gulf previously provided two explanations for the significant increase in its SAIDI in 2006. First, Gulf cites lingering effects from the 2004 and 2005 hurricane seasons. Second, Gulf notes that the data reflects several adverse weather events that were not excluded because they were not documented as tornadoes or named weather systems. Gulf's 2007 adjusted data suggest a significant improvement in its system outage frequency and durations from 2006. Gulf's average adjusted SAIDI decreased by 80 minutes per customer, falling from 205 minutes in 2006 to 125 minutes in 2007 (39%).

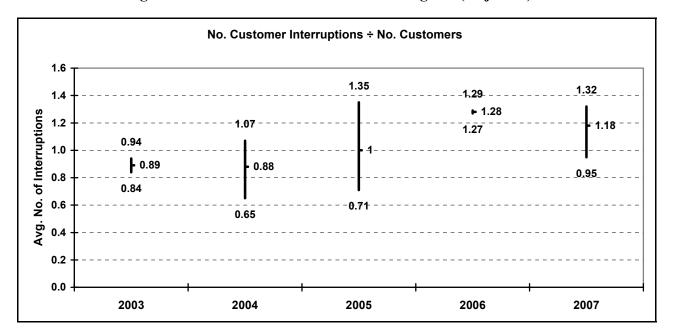
Figure 3-26. SAIFI across Gulf's Three Regions (Adjusted)

Figure 3-26 shows the maximum, average, and minimum adjusted SAIFI across Gulf's system. Gulf's average adjusted SAIFI decreased from 1.28 interruptions per customer in 2006, to 1.18 interruptions per customer in 2007 (8%).

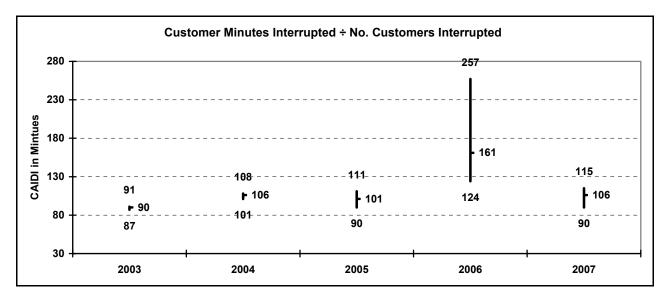
Figure 3-27 shows the maximum, average, and minimum adjusted CAIDI across Gulf's system. Gulf's average adjusted CAIDI improved by 55 minutes (34%) in the review period, moving from 161 minutes in 2006, to 106 in 2007.

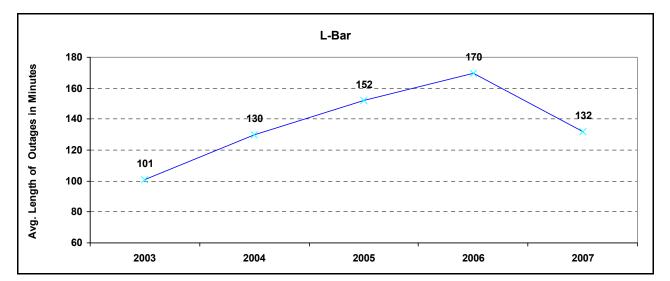
Figure 3-28. Gulf's Average Duration of Outages (Adjusted)

The average length of time Gulf spends recovering from outage events, excluding hurricanes and other outage events, is the index L-Bar shown in Figure 3-28. Gulf's L-Bar also decreased significantly in this review period, from 170 minutes in 2006 to 132 minutes in 2007 (22%).

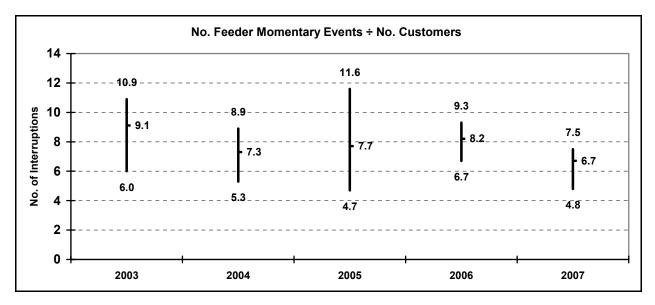
Figure 3-29 is the maximum, average, and minimum adjusted MAIFIe recorded across Gulf's system. Gulf's average MAIFIe fell from 8.2 in 2006, to 6.7 in 2007 (18%).

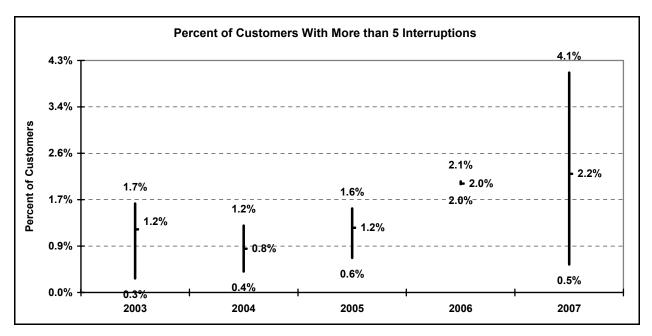
Figure 3-30. CEMI5 across Gulf's Three Regions (Adjusted)

Figure 3-30 shows Gulf's maximum, average, and minimum adjusted CEMI5. Gulf's 2007 average adjusted CEMI5 increased slightly to 2.2%, up from 2.0% in 2006.

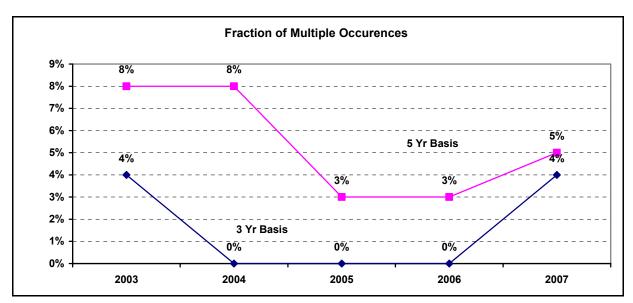
Figure 3-31. Gulf's Three Percent Feeder Report (Adjusted)

The Three Percent Feeder Report lists the top three percent of feeders with the most feeder outage events. The fraction of multiple occurrences is calculated from the number of recurrences, divided by the number of feeders reported. Figure 3-31 shows the fraction of multiple occurrences of feeders using a three-year and-five year basis.

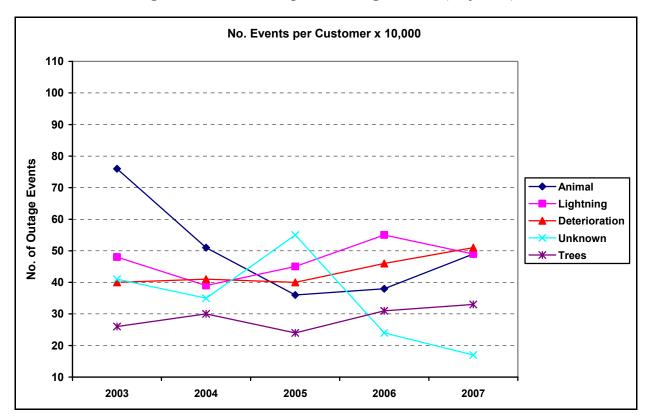
Figure 3-32. Gulf's Top Five Outage Causes (Adjusted)

Figure 3-32 details the top 5 outage event causes on Gulf's distribution system per 10,000 customers. The figure is based on Gulf's adjusted data of the top ten causes of outage events.

Adjust	ed Numb	oer of Ou	itage Eve	ents	Adjus	ted L-Ba	ar - Len	gth of O	utages
Cause	2003	2004	2005	2006	2007	Cumulative Percentages	2003	2004	2005	2006	2007
Animal	3,000	2,012	1,486	1,609	2,089	21.00%	67	81	92	163	83
Lightning	1,885	1,541	1,851	2,307	2,112	19.97%	123	151	192	170	151
Deterioration	1,594	1,611	1,634	1,914	2,188	18.42%	134	162	188	174	165
Unknown	1,616	1,390	980	987	742	11.77%	96	136	141	157	91
Trees	1,016	1,193	254	1,292	1,419	10.66%	106	129	139	157	144
Vehicle	227	303	2,239	284	336	6.98%	147	162	171	381	165
All Other	217	264	288	299	345	2.91%	132	126	110	139	96
Wind / Rain	100	118	235	680	175	2.69%	145	125	146	219	160
Overload	201	212	129	223	271	2.13%	93	125	108	156	99
Vines	128	117	424	-	-	1.38%	87	98	-	-	-
Other	85	121	129	-	-	0.69%	100	124	217	-	-
Contamination / Corrosion	-	-	118	137	143	0.82%	-	-	194	182	127
Dig-In	-	-	-	144	130	0.56%	-	-	-	109	210
Gulf System	10,069	8,882	9,767	9,876	9,950	100%	101	130	152	114	132

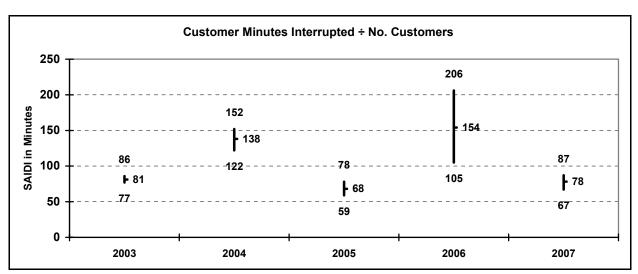
Figure 3-33. SAIDI across FPUC's Two Regions (Adjusted)

Figure 3-33 is the maximum, average, and minimum adjusted SAIDI recorded across FPUC's system. FPUC's average adjusted SAIDI improved significantly, from 154 minutes in 2006 to 78 minutes in 2007, a 49% decrease.

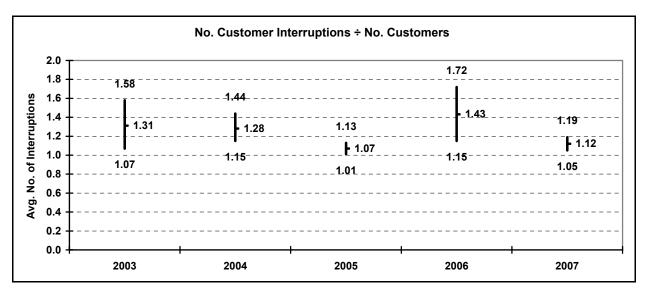
Figure 3-34. SAIFI across FPUC's Two Regions (Adjusted)

Figure 3-34 shows the maximum, average, and minimum adjusted SAIFI across FPUC's system. FPUC's average SAIFI fell from 1.43 in 2006 to 1.12 in 2007, a 22% improvement.

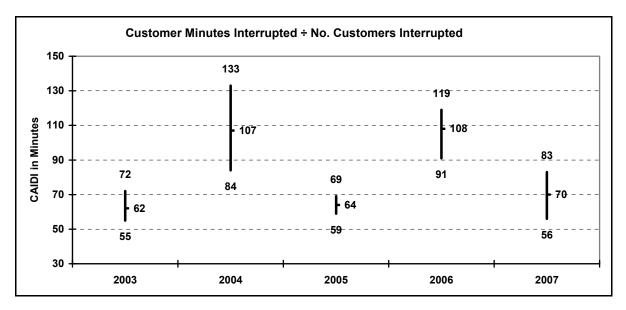
Figure 3-35. CAIDI across FPUC's Two Regions (Adjusted)

Figure 3-35 shows the maximum, average, and minimum adjusted CAIDI across FPUC's system. FPUC's average adjusted 2007 CAIDI index fell from 108 in 2006, to 70 in 2007 (35%).

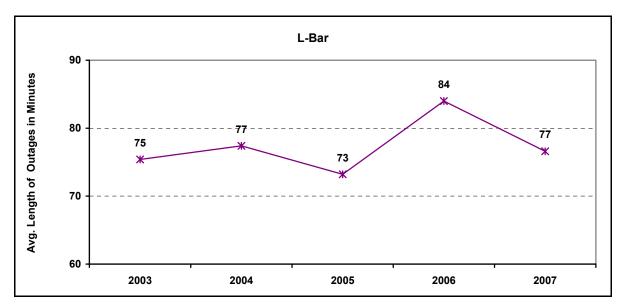
Figure 3-36. FPUC's Average Duration of Outages (Adjusted)

The average length of time FPUC spends recovering from outage events, excluding hurricanes and other outage events, is the index L-Bar shown in Figure 3-36. FPUC's L-Bar decreased in this review period, from 84 minutes in 2006 to 77 minutes in 2007 (8%).

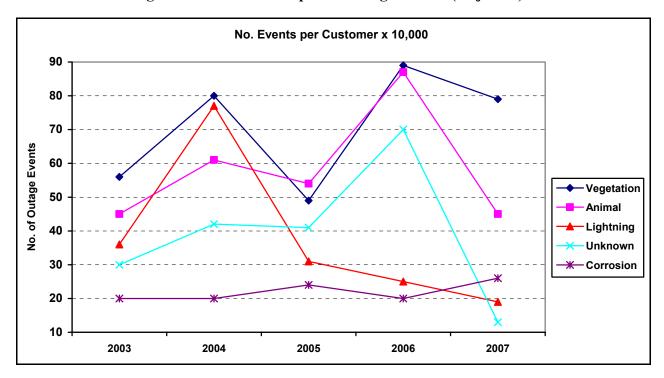
Figure 3-37. FPUC's Top Five Outage Causes (Adjusted)

Figure 3-37 shows the top 5 causes of outage events on FPUC's distribution system per 10,000 customers. Large variations in the causes of outage events are not uncommon for a smaller utility.

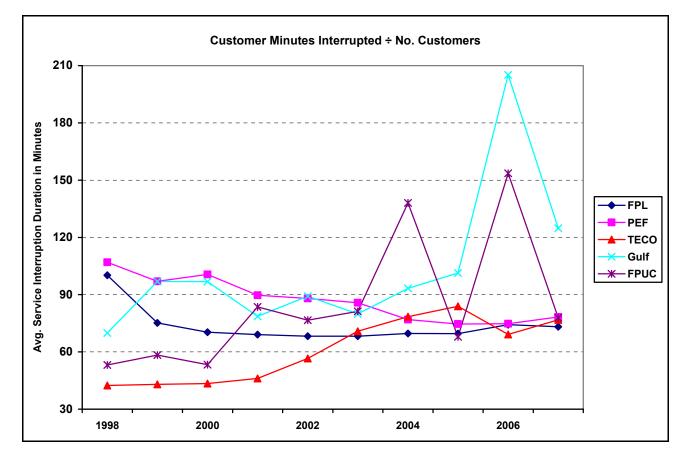
Figure 4-1. Average Interruption Duration (Adjusted SAIDI)

Figure 4-1 is a ten-year graph of the adjusted SAIDI for each IOU. The increases in SAIDI for Gulf prior to 2000, and for TECO prior to 2003, are associated with upgrades to their information systems that began capturing more detailed outage data.

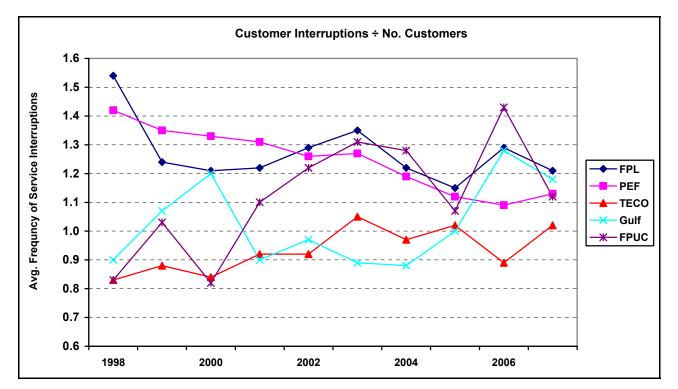
Figure 4-2 is a ten-year graph of the adjusted SAIFI of the Florida IOUs.

Figure 4-2. Average Number of Service Interruptions (Adjusted SAIFI)

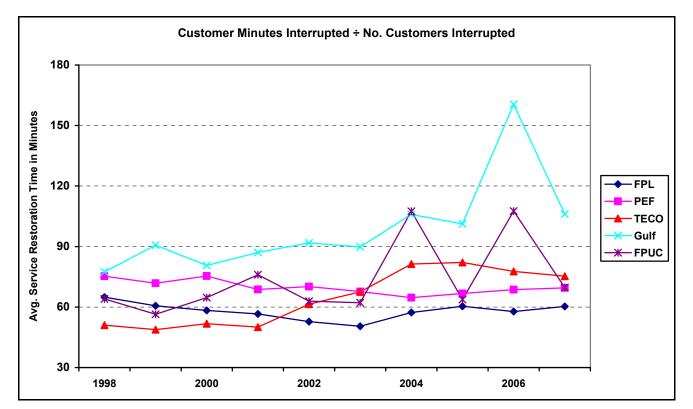
Figure 4-3 is a ten-year graph of the adjusted CAIDI of the Florida IOUs.

Figure 4-3. Average Service Restoration Time (Adjusted CAIDI)

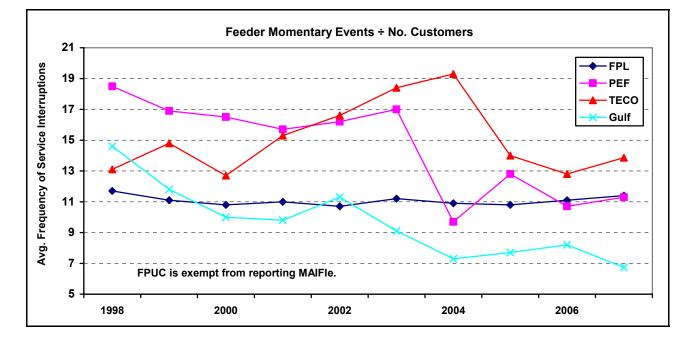
Figure 4-4 is a ten-year graph of the adjusted MAIFIe for FPL, PEF, TECO and Gulf.

Figure 4-4. Average Number of Feeder Momentary Events (Adjusted MAIFIe)

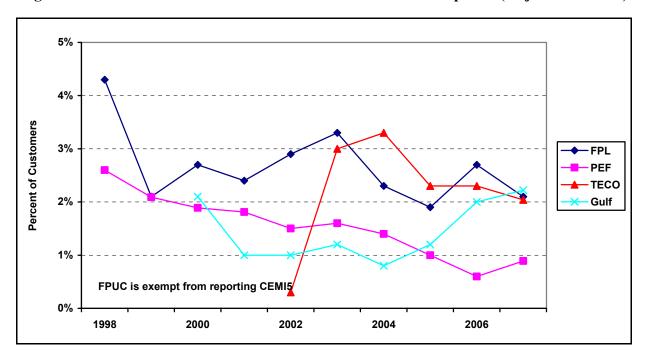
Figure 4-5 is a ten-year graph of the adjusted CEMI5 for FPL, PEF, TECO and Gulf. Prior to 2002, reporting was voluntary, which explains why data is not available for all IOUs during this ten-year period. IOUs with fewer than 50,000 customers are not required to report this metric; FPUC qualifies for this reporting waiver. TECO's increase in CEMI5 between 2002 and 2003 is attributable to the implementation of a new information system.

Figure 4-5. Percent of Customers with More Than Five Interruptions (Adjusted CEMI5)

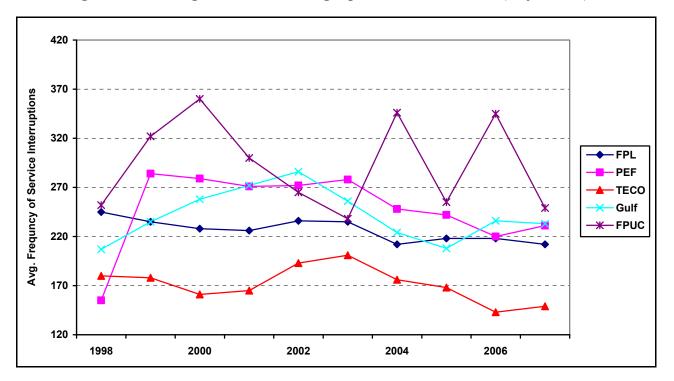
The index N measures the primary causes of outage events and is also used to identify feeders with the most outage events. Figure 4-6 depicts the adjusted average number of outages events (N) per 10,000 customers for each of the Florida IOUs over a 10-year period.

Figure 4-6. Average Number of Outages per 10,000 Customers (Adjusted N)

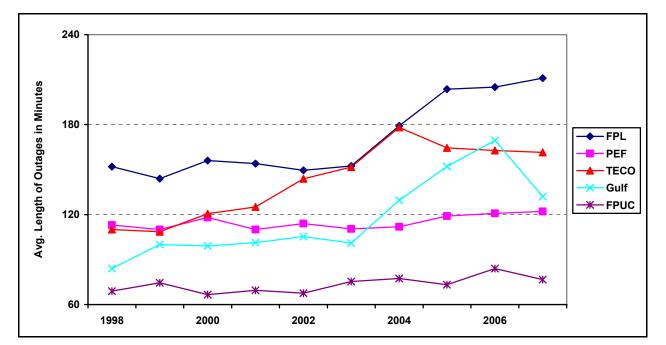
Figure 4-7 depicts the adjusted L-Bar for the Florida IOUs over a 10-year period.

Figure 4-7. Average Duration of Outage Events (Adjusted L-Bar)

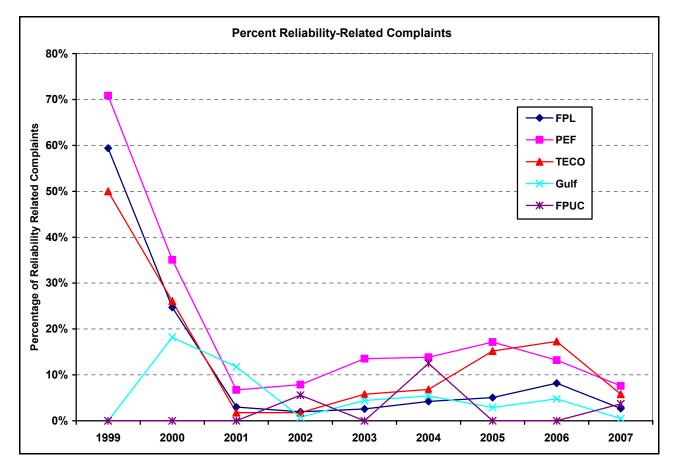
As shown in Figure 4-8, the percentage of reliability-related customer complaints for FPL, PEF, TECO, and Gulf has trended slightly downward from 2006 to 2007. The apparent volatility in FPUC's reliability-related customer complaints is due to FPUC's small customer base, which can exaggerate the significance of even a few complaints.

Figure 4-8. Percent of Complaints That Are Reliability-Related

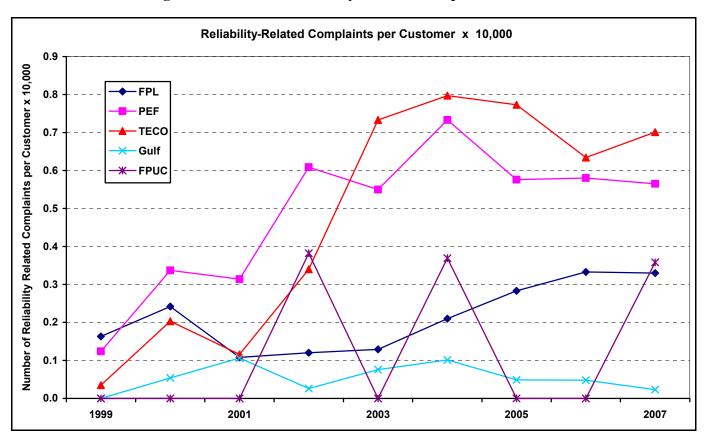
Figure 4-9 provides the number of reliability-related complaints per 10,000 customers for each utility. The data is normalized because utility size impacts both the volume of complaints and the significance of trends.

Figure 4-9. Service Reliability-Related Complaints

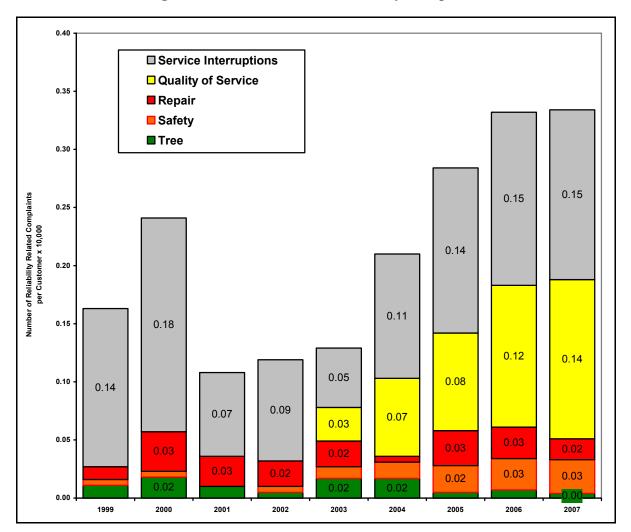
Each customer complaint received by the Commission is assigned a category after the complaint is resolved. Reliability-related complaints are those pertaining to trees, safety, repairs, quality of service, or service interruptions.²⁴ The "quality of service" category was established in July 2003, resulting in a shift of some complaints that previously would have been coded in another complaint category. The volume of service reliability-related complaints is multiplied to 10,000 customers for comparative purposes.
