*Review of Florida's  
Investor-Owned Electric Utilities' Service Reliability  
In 2009*

*Florida Public Service Commission  
Division of Service Quality, Safety, and Consumer Assistance  
December 21, 2010*

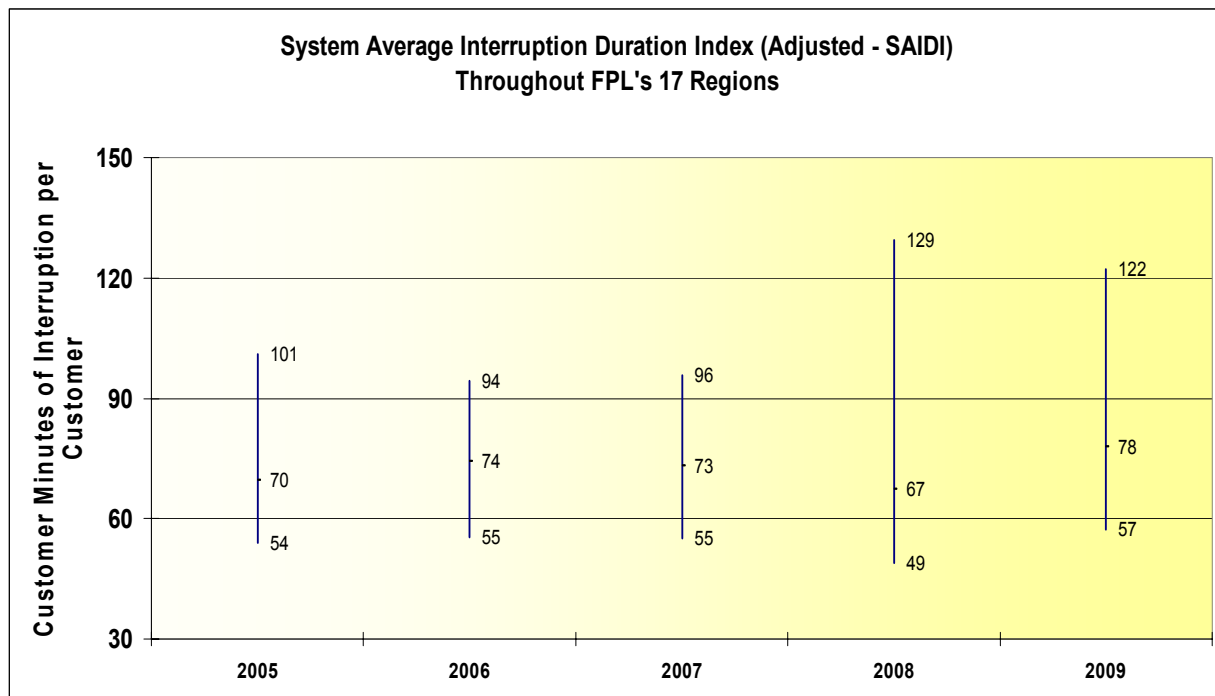
Figure 3-1. SAIDI across FPL's 17 Regions (Adjusted)

Figure 3-1 shows the highest, average, and lowest adjusted SAIDI (system average interruption duration index) recorded across FPL’s system that encompasses five management regions with seventeen service areas. The highest and lowest SAIDI values are the values reported for a particular service area. Figure 3-1 shows an increase in the lowest SAIDI to 57 minutes for the Pompano service area in 2009, and there is a significant increase in the highest SAIDI to 122 minutes for the South Dade service area. The South Dade service area has experienced the highest SAIDI values in two out of the last five years. FPL had an overall increase of 11 minutes (14 percent) to the average SAIDI results for 2009 compared to 2008, and the highest average SAIDI reported in the past 5 years. FPL attributes the SAIDI increase primarily to the increase in the 2009 CAIDI (average length of time a customer is without power) performance.

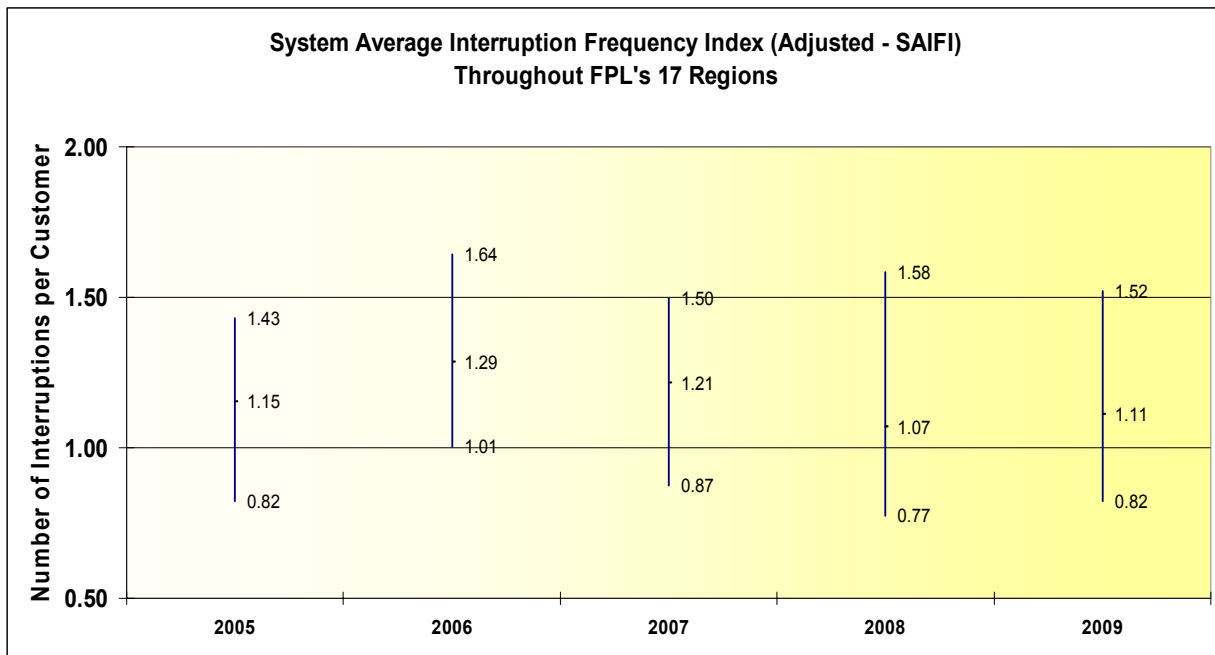
**Figure 3-2. SAIFI across FPL's 17 Regions (Adjusted)**

Figure 3-2 is a chart of the highest, average, and lowest adjusted SAIFI (frequency or number of interruptions per customer) across FPL’s system. FPL had a marginal increase in the average results of 1.11 outages in 2009, compared to 1.07 outages in 2008. FPL reported a decrease to the highest SAIFI for South Dade of 1.52 interruptions compared to North Florida’s 1.58 interruptions in 2008. The Toledo Blade area, within the last five years, has had the lowest SAIFI of 0.82 and 0.77 interruptions, respectively. Both the average and lowest SAIFI appear to be trending downward suggesting an improvement. The highest SAIFI trend appears to be relatively flat.

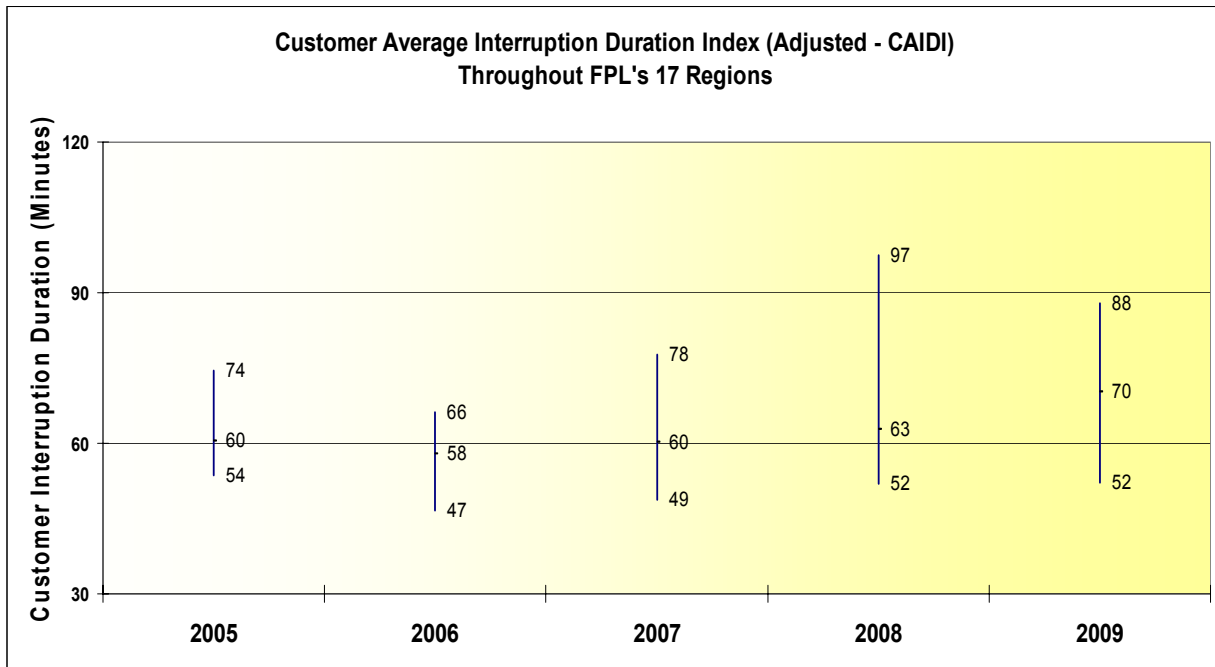
**Figure 3-3. CAIDI across FPL's 17 Regions (Adjusted)**

Figure 3-3 is a chart of the customer outage restoration times across FPL’s system. FPL’s adjusted average CAIDI has risen approximately 11 percent from 63 minutes in 2008, to 70 in 2009. For the five year period beginning in 2005, the average duration of CAIDI, or the average number of minutes a customer is without power when a service interruption occurs, has risen 17 percent. The Gulf Stream service area appears to have the lowest amount of time a customer is without power since it has experienced the lowest CAIDI for three of the last five years.

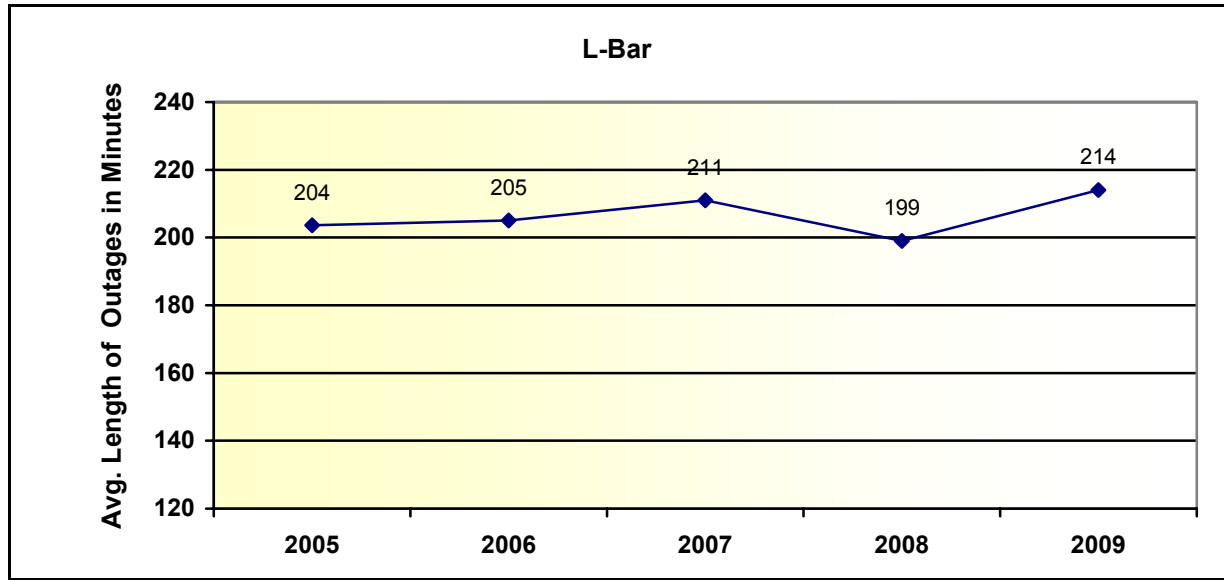
**Figure 3-4. FPL's Average Duration of Outages (Adjusted)**

The average length of time that FPL spends recovering from outage events, excluding hurricanes and other extreme outage events is the index known as L-Bar and is shown in Figure 3-4. FPL had a 7 percent increase in L-Bar (the time required to restore service) from 199 minutes in 2008, to 214 minutes in 2009, which represents the highest average duration of outages since 2005. The L-Bar measures the average length of time of a single service interruption. The IEEE standard for calculation of L-Bar is the summation of the minutes of interruption divided by the total number of outages.

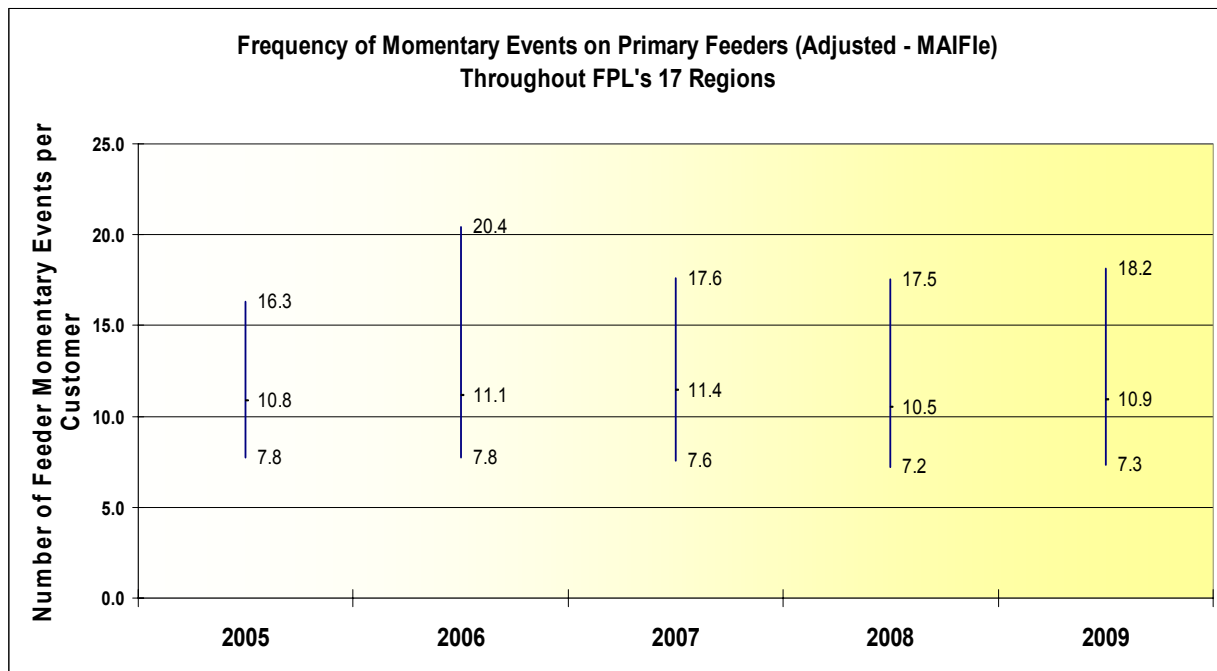
**Figure 3-5. MAIFle across FPL's 17 Regions (Adjusted)**

Figure 3-5 is the highest, average, and lowest adjusted MAIFle (frequency of momentary events on primary circuits per customer) recorded across FPL's system. These momentary events often impact a small group of customers. FPL's Toledo Blade and Treasure Coast service areas have experienced, and continue to have, the least reliable MAIFle results over the 17 regions of FPL since 2005. The Pompano service area had the fewest momentary events and the results have remained relatively stable over the last five years.

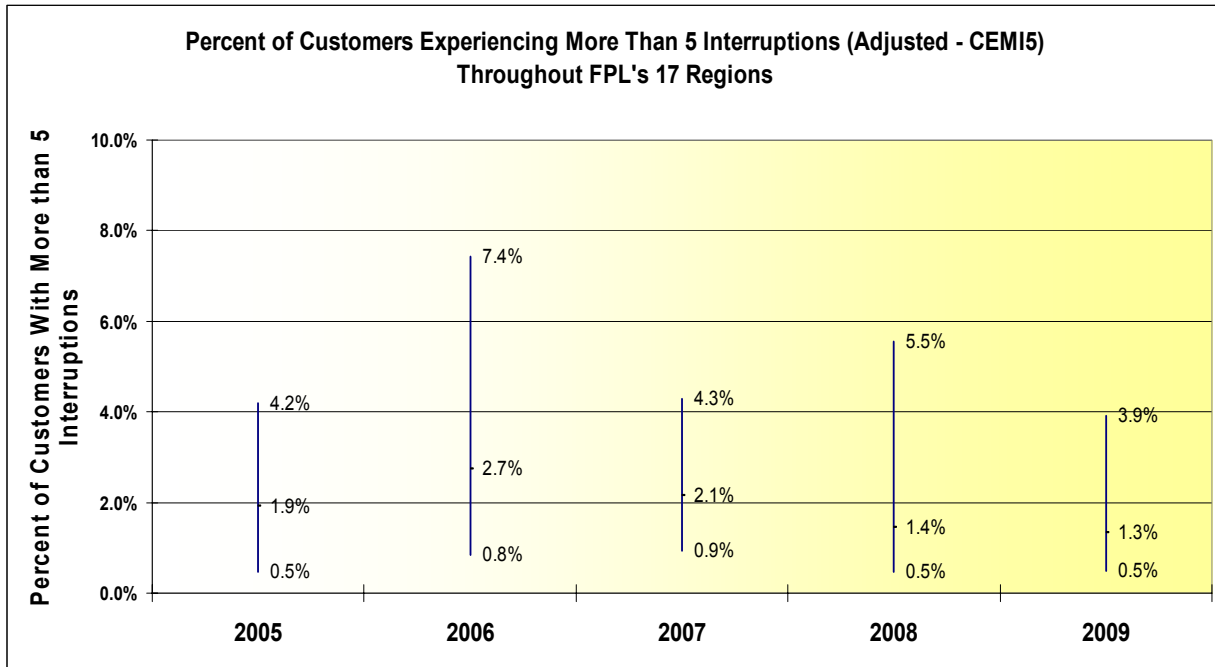
**Figure 3-6. CEMI5 across FPL's 17 Regions (Adjusted)**

Figure 3-6 shows the highest, average, and lowest adjusted CEMI5 (percent of customers experiencing more than five interruptions). FPL reported a decrease in CEMI5 for FPL’s combined 17 service areas indicating an improvement in the percentages across the board. FPL’s customers with more than five interruptions per year appear to be decreasing and represents an overall improvement that appears to be trending downward. The service areas experiencing the highest CEMI5 appears to fluctuate among the areas; however, Brevard is reported as having the lowest percentages in three of the last five years.

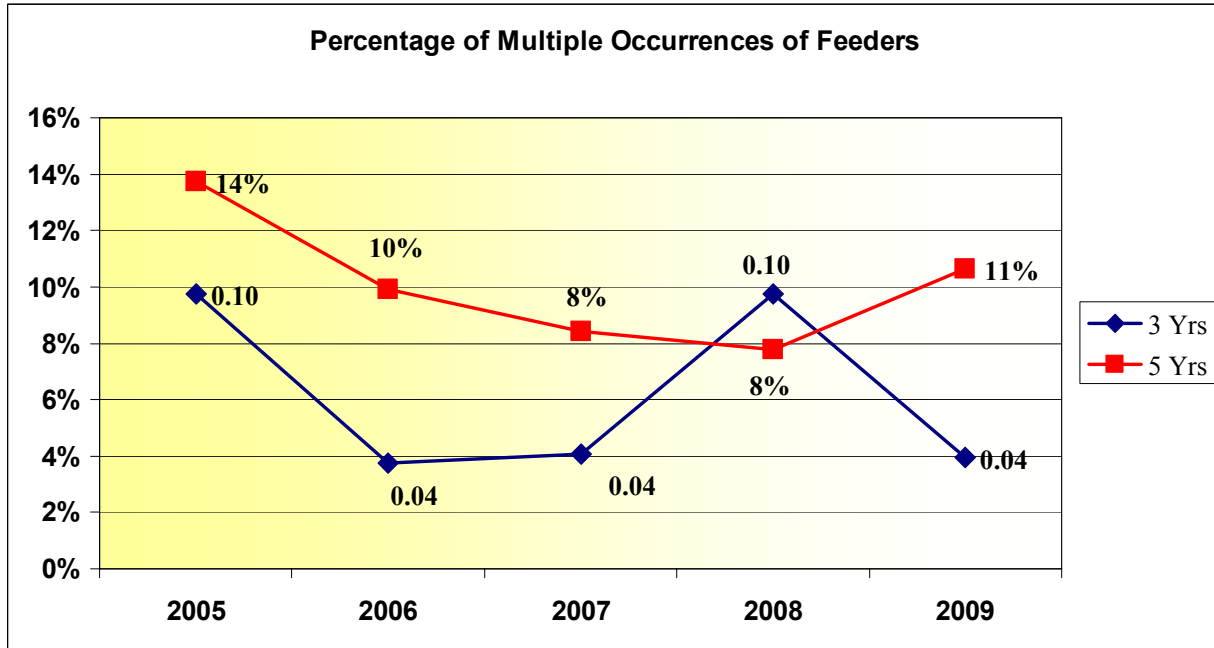
**Figure 3-7. FPL's Three Percent Feeder Report (Adjusted)**

The Three Percent Feeder Report is a listing of the top three percent of feeders with the most feeder outage events. The fraction of multiple occurrences, Figure 3-7, is calculated from the absolute number of multiple occurrences divided by the ending total number of feeders reported on a three-year and five-year feeder analysis. The three-year and five-year percentages of multiple occurrences have decreased since 2005 as shown in Figure 3-7.

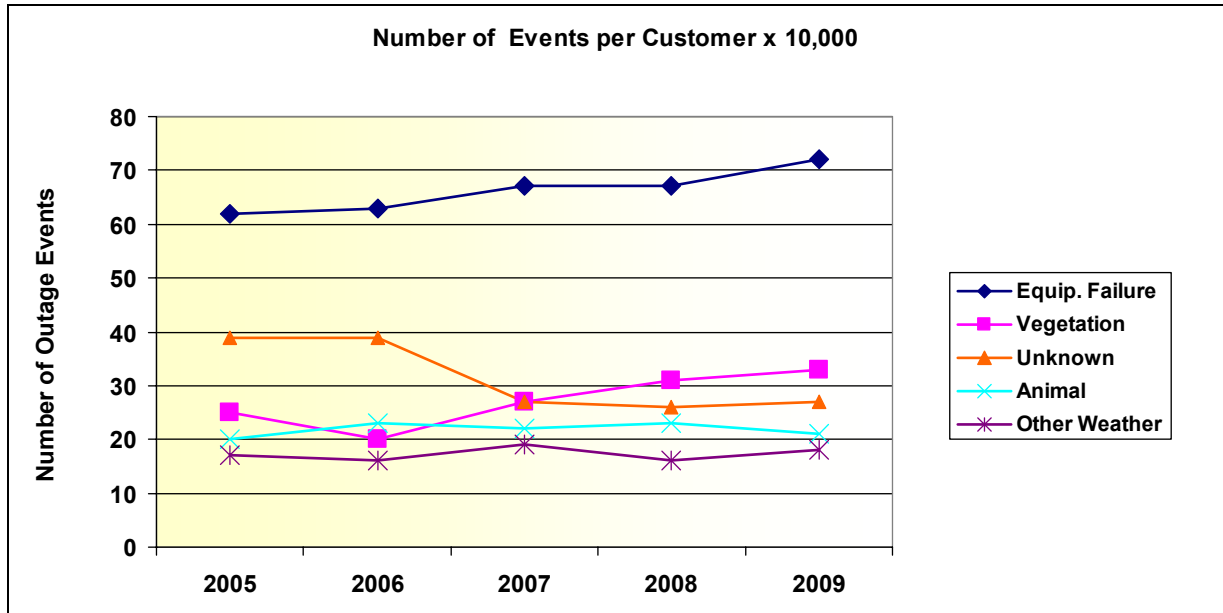
**Figure 3-8. FPL’s Top Five Outage Causes (Adjusted)**

Figure 3-8 shows the top five causes of outage events on FPL’s distribution system normalized to a 10,000 customer base. The graph is based on FPL’s adjusted data of the top ten causes of outage events. For the five-year period, the five top causes of outage events included equipment failures (33 percent), vegetation (16 percent), unknown (12 percent), animals (10 percent), and other weather (9 percent) on a cumulative basis. The data shows an increasing trend in outage events caused by equipment failure which continues to dominate the highest percentage of outage causes throughout the FPL regions. In addition, FPL’s supporting data, shows a 6 percent increase in outage events due to vegetation and little change in the total number of outage events due to unknown, animal, and other weather over the five-year period.

Equipment failure continues to be the leading cause of the number of outage events per customer for the past five years. Analysis of Figure 3-8 shows an increasing trend in the number of outage events attributed to equipment failure and between 2005 and 2009, there was a 16 percent increase. FPL states that it continues to focus on preventing outages before they occur, thus reducing the overall number of outages, and certain types of feeder outages that are typically shorter in duration. While the reduction of these outages benefits customers, it increases CAIDI. This is a direct result of the mathematical calculation of the CAIDI metric. In this case, the customer minutes of interruptions remains the same while the number of outages has decreased which in turn increases the length of time a customer is out of service.

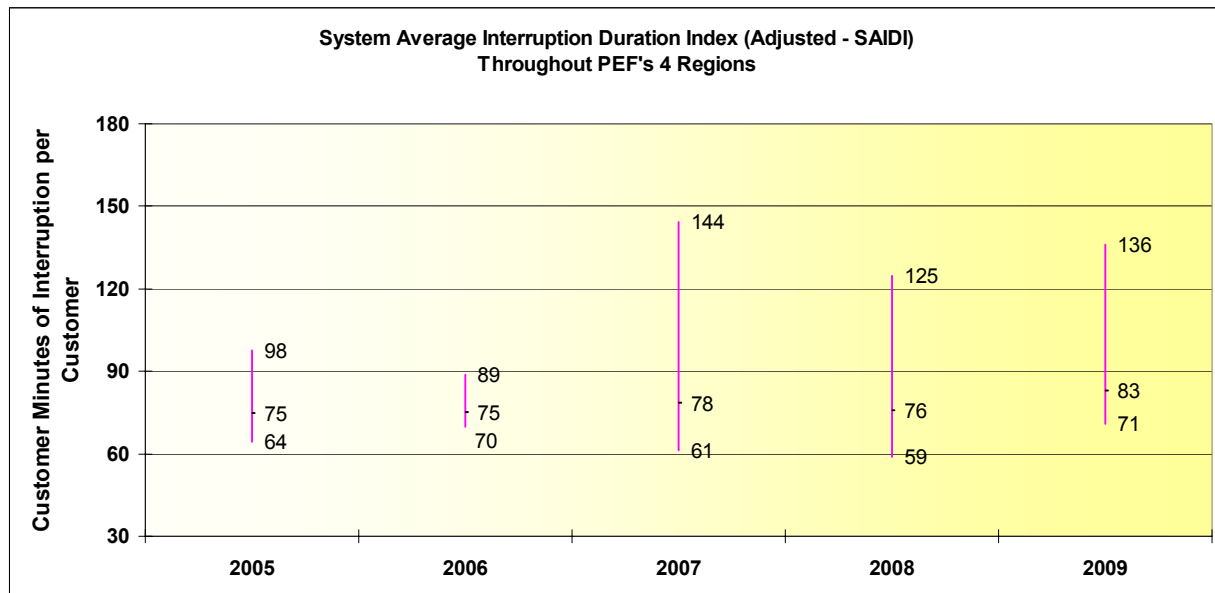
**Figure 3-9. SAIDI across PEF's Four Regions (Adjusted)**

Figure 3-9 charts the adjusted SAIDI recorded across PEF's system and depicts an increase in the highest, average, and lowest values for 2009. PEF notes that the annual adjusted reliability performance always includes a degree of variability due to the number of confirmed tornadoes by the National Weather Service (NWS) as opposed to those not confirmed by the NWS. PEF reported wind gusts reached over 50 mph at the Belleair substation on June 23, 2009 and added 4.8 minutes to the system SAIDI for that day. PEF stated this is 20 times higher than the average day and represented more than 6 percent of the SAIDI allotment for the year. The adjusted SAIDI for 2009 was reported as 82.8 minutes, and PEF noted that the results would have been 78.0 minutes for 2009, had the June 23<sup>rd</sup> event been excludable.

PEF's service territory is comprised of four regions; North Coastal, South Coastal, North Central and South Central. The North Coastal region has had the poorest SAIDI over the last five years, oscillating between 98 minutes and 136 minutes. While the South Coastal region has the best or lowest SAIDI for the same period.

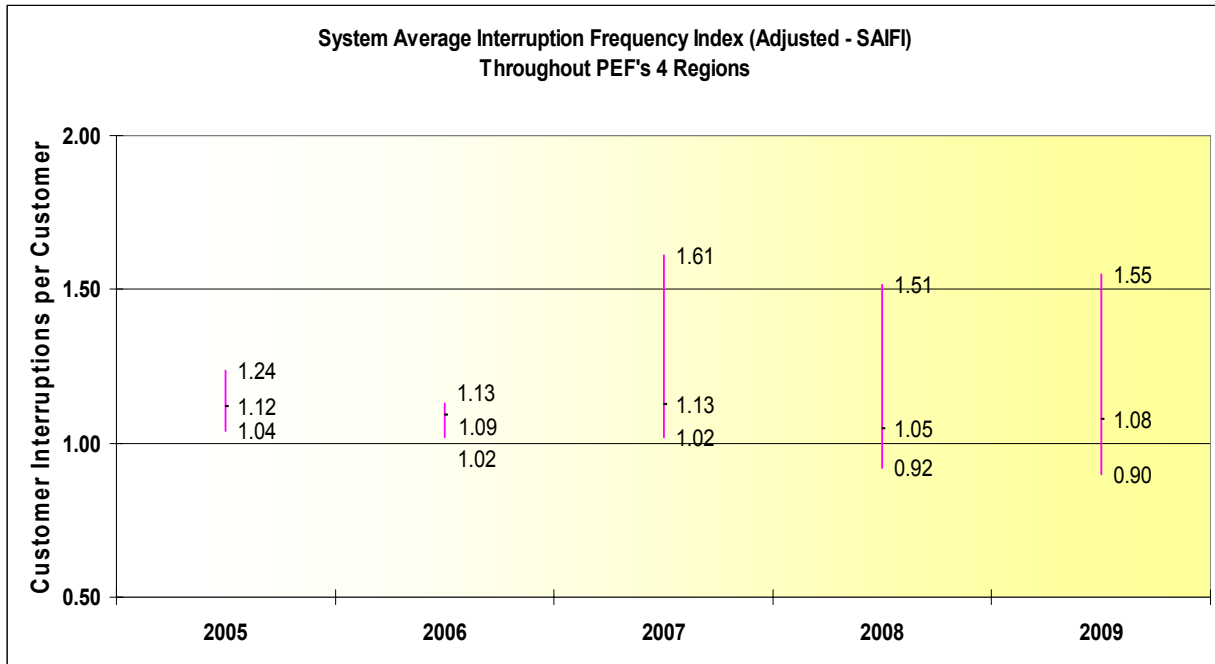
**Figure 3-10. SAIFI across PEF's Four Regions (Adjusted)**

Figure 3-10 shows the adjusted SAIFI (number of times a customer experiences a power interruption) across PEF’s system. Overall, there was little change in the average SAIFI index from 2008 to 2009, and a slight decline in the frequency of interruptions since 2005. The South Coastal region had the lowest number of interruptions while the highest numbers can be attributed to the South Central and North Coastal regions over the last five years.

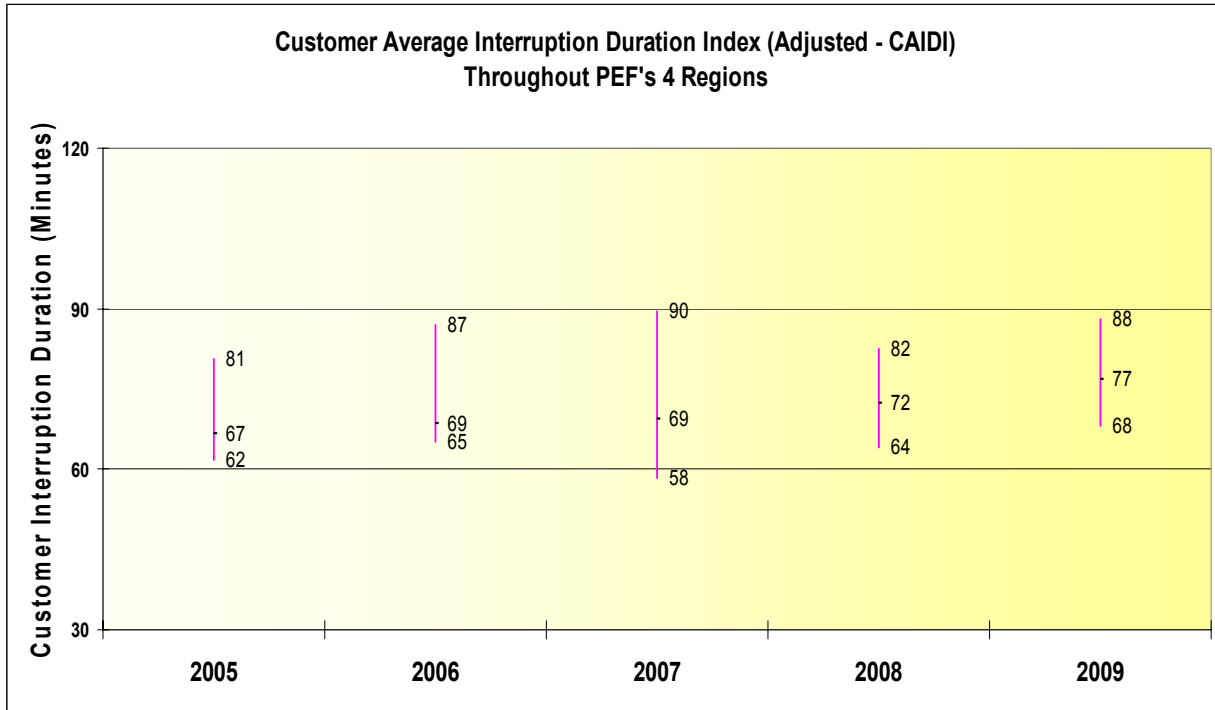
**Figure 3-11. CAIDI across PEF's Four Regions (Adjusted)**

Figure 3-11 is the interruption duration times across PEF’s four regions. PEF’s adjusted average duration of service interruption has risen approximately 15 percent from 67 minutes in 2005 to 77 minutes in 2009. The North Coastal region has continued to have the highest CAIDI level for the past five years, as compared to the other PEF regions, while the South Coastal region has maintained the lowest CAIDI level during the same time frame.

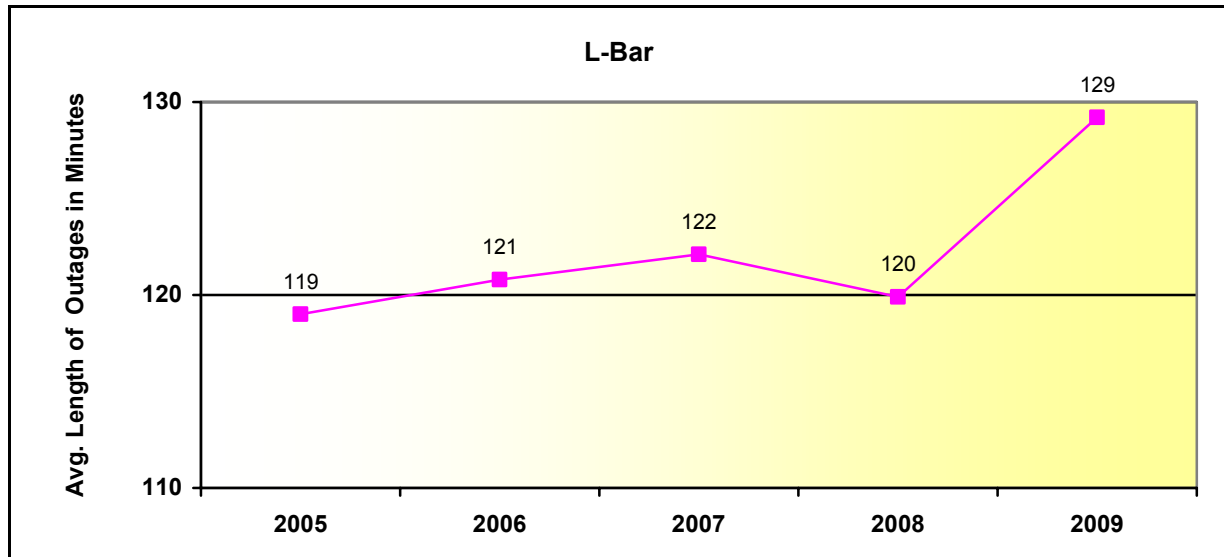
**Figure 3-12. PEF's Average Duration of Outages (Adjusted)**

The average length of time PEF spends restoring customers affected by outage events, excluding hurricanes and other extreme outage events is the index known as L-Bar shown in Figure 3-12. The data demonstrates an overall 8 percent increase of outage durations since 2005, and a 7 percent increase from 2008 to 2009, indicating that PEF is spending a longer time restoring service from outage events.

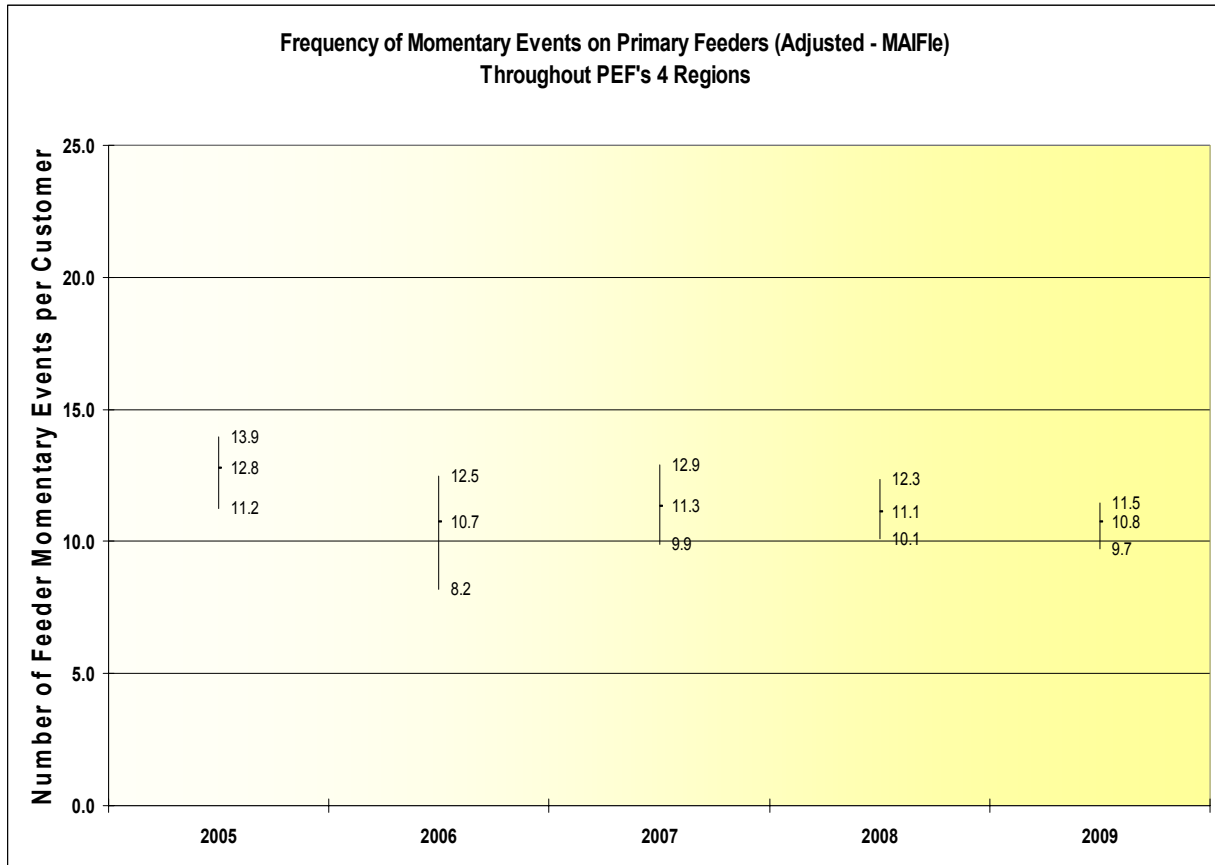
**Figure 3-13. MAIFle across PEF's Four Regions (Adjusted)**

Figure 3-13 illustrates the frequency of momentary events on primary circuits for PEF's customers recorded across its system. A review of the supporting data suggests that the MAIFle results between 2005 and 2009, appear to be trending downward. The best (lowest) results appear to be distributed among the regions.

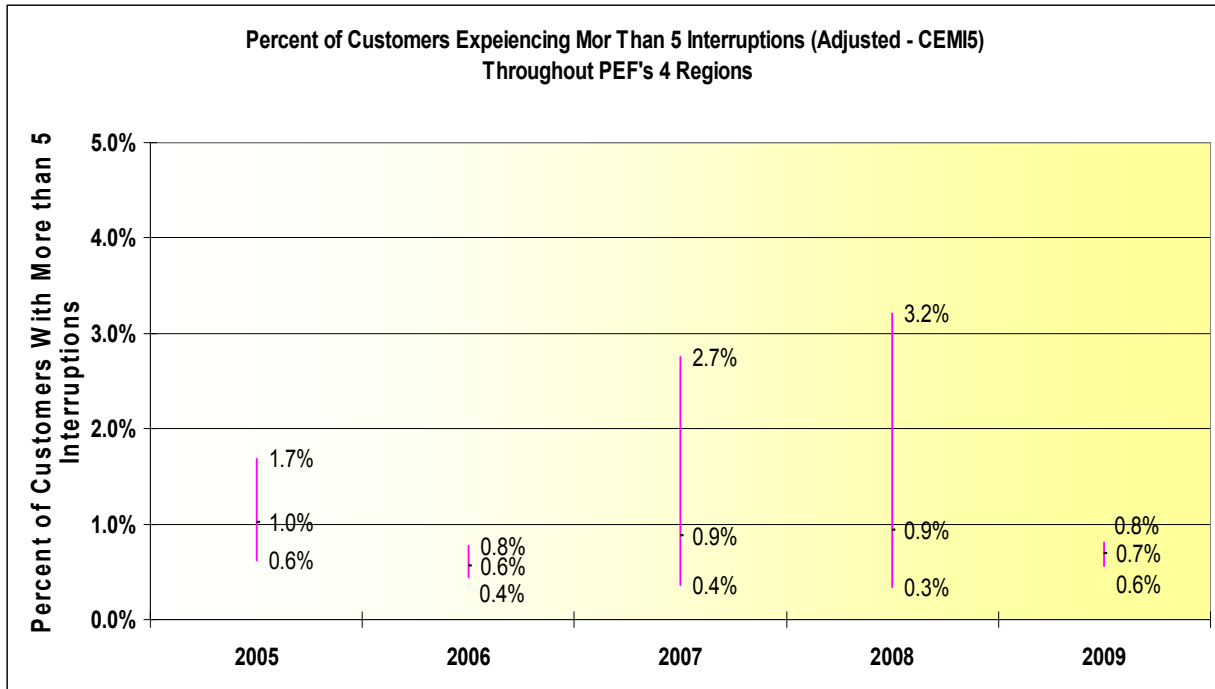
**Figure 3-14. CEMI5 across PEF's Four Regions (Adjusted)**

Figure 3-14 charts the percent of PEF’s customers experiencing more than five interruptions over the last five years. PEF reported a 22 percent decrease in the average CEMI5 performance from 2008 to 2009. The South Coastal region continues to have the lowest reported percentage for all of PEF’s regions. Overall, the reduced CEMI5 results indicate a significant improvement among all four PEF regions in 2009.

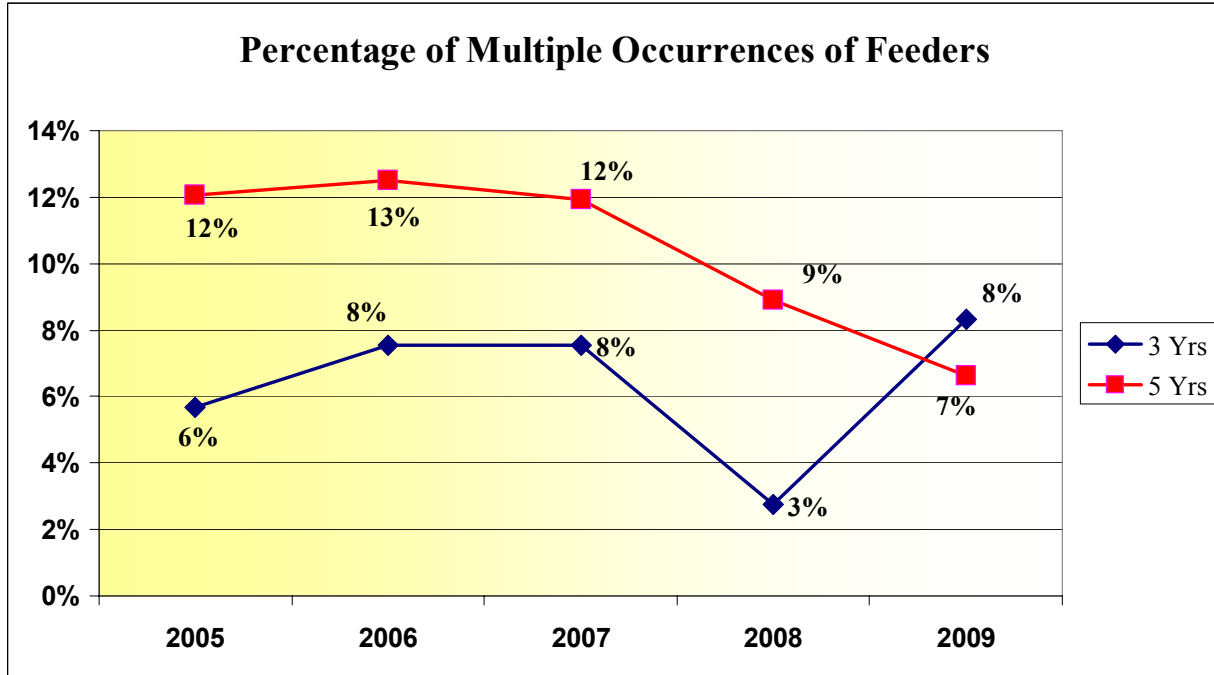
**Figure 3-15. PEF's Three Percent Feeder Report (Adjusted)**

The Three Percent Feeder Report lists the top three percent of feeders with the most feeder outage events. The fraction of multiple occurrences, Figure 3-15, is calculated from the number of recurrences divided by the number of feeders reported. Figure 3-15 shows the fraction of multiple occurrences of feeders using a three-year and five-year basis. During the period of 2008 to 2009, the five-year fraction of multiple occurrences continued to decline, while the three-year results had a significant increase compared to 2008 results.

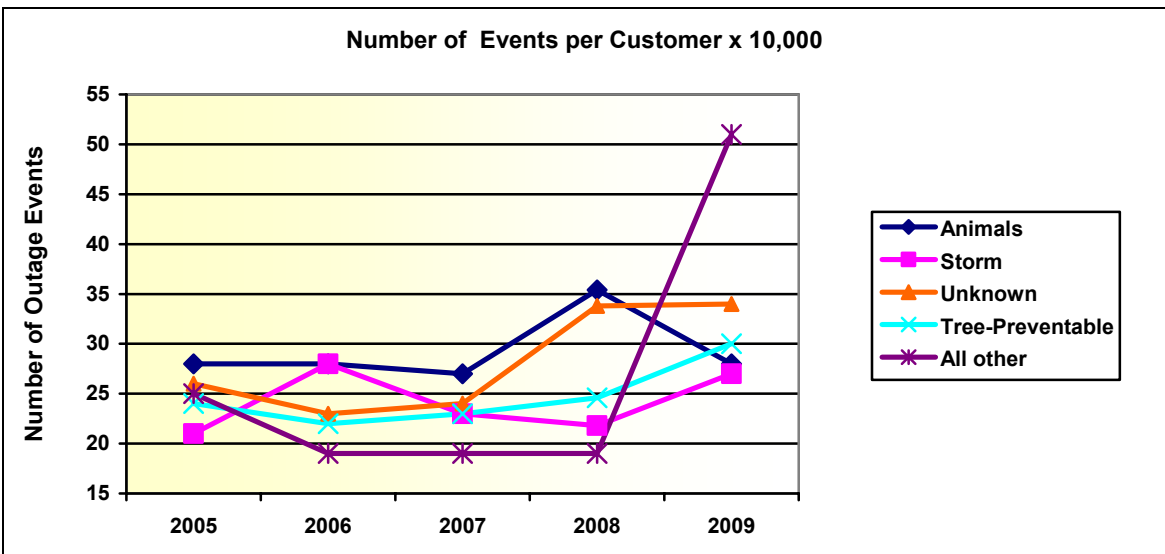
**Figure 3-16. PEF's Top Five Outage Causes (Adjusted)**

Figure 3-16 shows the top five causes of outage events on PEF’s distribution system normalized to a 10,000 customer base. The figure is based on PEF’s adjusted data of the top ten causes of outage events and represents 65.5 percent of the top ten causes of outage events that occurred during 2009. For the five-year period, the top five causes of outage events were: all other (20 percent), unknown (13 percent), animals (11 percent), tree-preventable (11 percent), and storm (10 percent) on a cumulative basis. The category “all other” is used when no reasonable evidence is available as to what caused the outage, and the figure climbed 266 percent from 2008 to 2009. PEF stated the increase can be attributed to the fact that underground service outages were included as a subset of the “all other” category in 2009 whereas in 2008 the underground service outages had not been included.

In Figure 3-16, PEF's Top Five Outage Categories, the category "all other" climbed 266 percent from 2008 to 2009. PEF stated this category is used when no reasonable evidence is available as to what caused the outage and the "all other" category includes cause codes that are not itemized on the PSC/ECR form 103. PEF also stated "in 2008, underground service outages were listed separately as opposed to 2009, where they were a subset of the 'all other' category. This would explain the 266 percent increase from 2008 to 2009." The "all other" outage cause has not fluctuated substantially from 2005 to 2008 and 2009 appears to be an abnormal year.

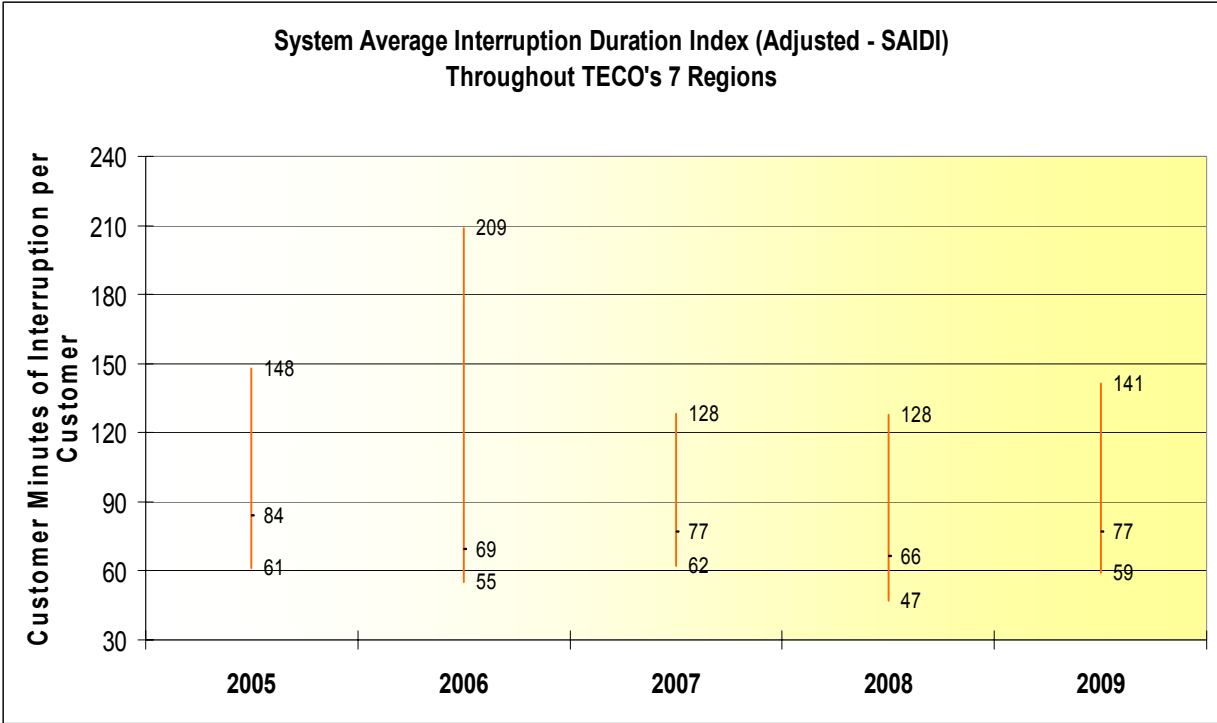
**Figure 3-17. SAIDI across TECO's Seven Regions (Adjusted)**

Figure 3-17 shows the adjusted SAIDI values recorded across TECO’s system. Six of the seven TECO regions had an increase in SAIDI performance during 2009, with Plant City and Dade City having the highest SAIDI performance results for the fifth year in a row. Figure 3-17 shows an increase in the highest, average, and lowest SAIDI recorded for all of TECO’s regions. Dade City and Plant City have the fewest customers and represent the most rural, lowest customer density per line mile in comparison to the other four Tampa Electric divisions. Actual reliability indices for the rural areas have varied from those of the more urban, densely populated areas for this period. The overall SAIDI values for TECO from 2005 to 2009 continue to go up and down, giving no indication of any patterns or trends on a company-wide basis.

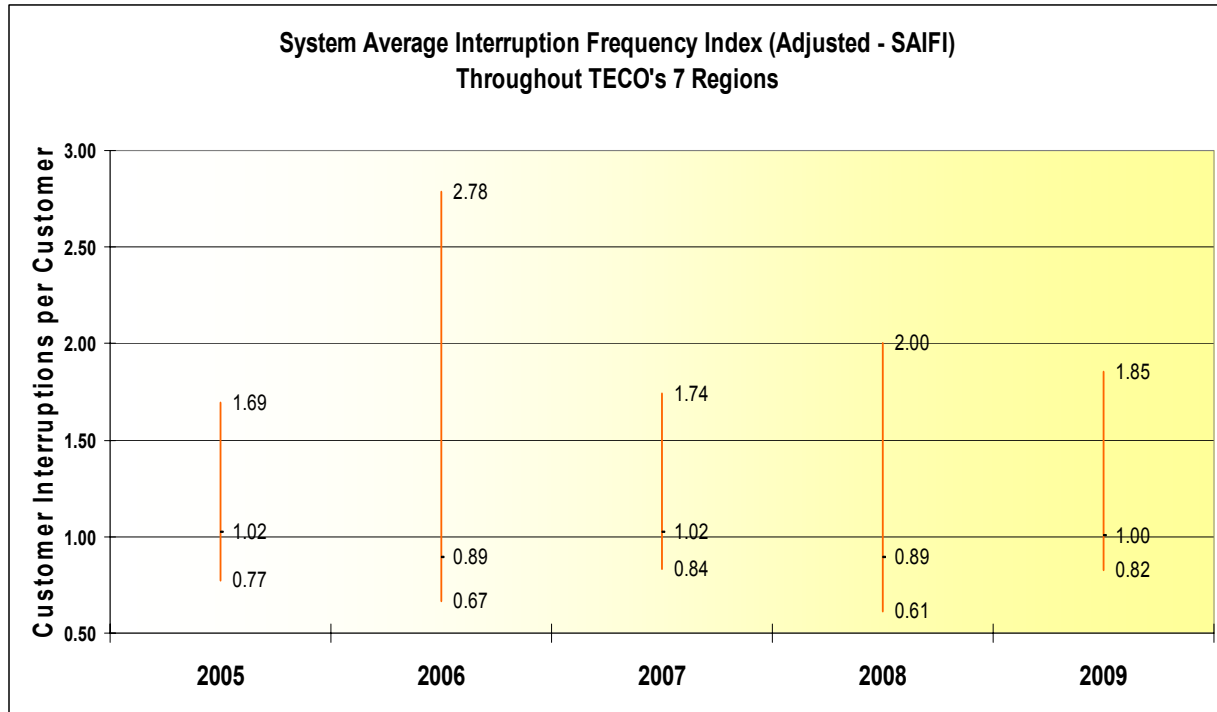
**Figure 3-18. SAIFI across TECO's Seven Regions (Adjusted)**

Figures 3-18 illustrates the adjusted number of interruptions per customer across TECO's system. TECO's data reported a decline in reliability in the average and lowest adjusted SAIFI results, with a 12 percent increase in the SAIFI average from 0.89 interruptions in 2008 to 1.00 interruptions in 2009. As noted in TECO's 2009 Reliability Report, all the service regions do not experience comparable reliability. TECO's Dade City and Plant City regions both have the highest service interruptions when compared to TECO's other regions. Staff has not identified any specific patterns among the SAIFI results throughout the seven TECO regions, as the average results varies between 1.02 to 0.89 interruptions.

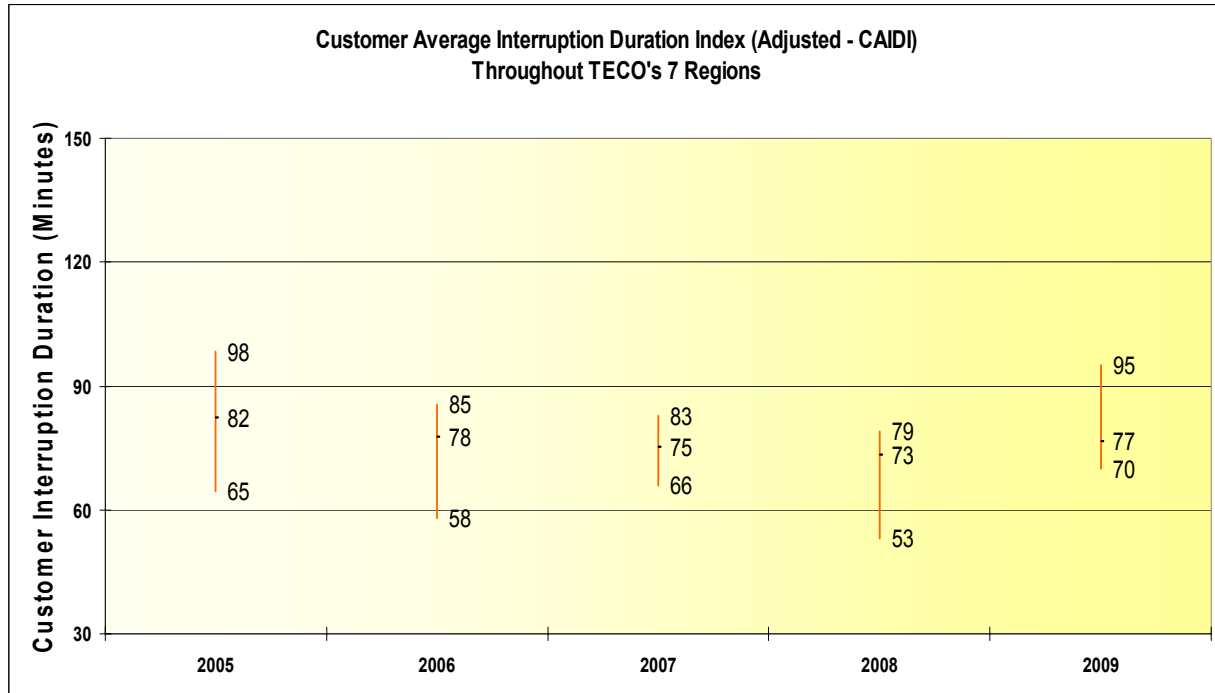
**Figure 3-19. CAIDI across TECO's Seven Regions (Adjusted)**

The length of time that a typical TECO customer experiences an outage is illustrated in Figure 3-19. The highest CAIDI minutes do not appear to be confined to any particular service area; however, Dade City and Plant City both make appearances. Winter Haven has had the lowest (best) results for four out of the last five years. The average seems to be trending along a flat line at this time suggesting stability in the duration of a customer's outage.

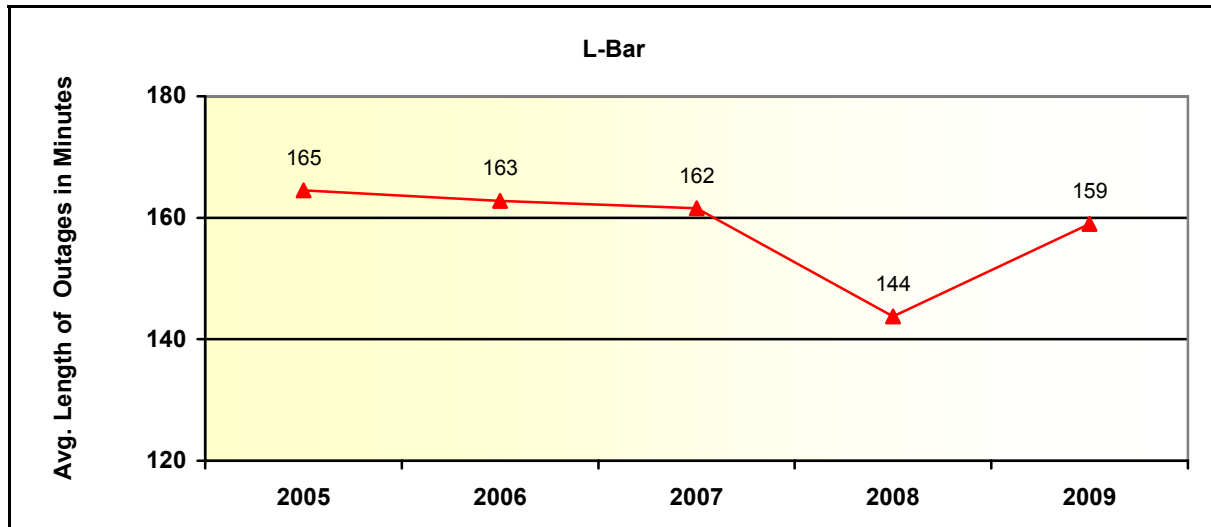
**Figure 3-20. TECO's Average Duration of Outages (Adjusted)**

The average length of time TECO spends restoring service to its customers affected by outage events, excluding hurricanes and other extreme outage events is shown in the index L-Bar. Figure 3-20 denotes a 10.4 percent increase in outage durations for the period from 2008 to 2009. TECO has made a 13 percent improvement in L-Bar since 2007 and L-Bar appears to be trending downward suggesting an overall improvement.

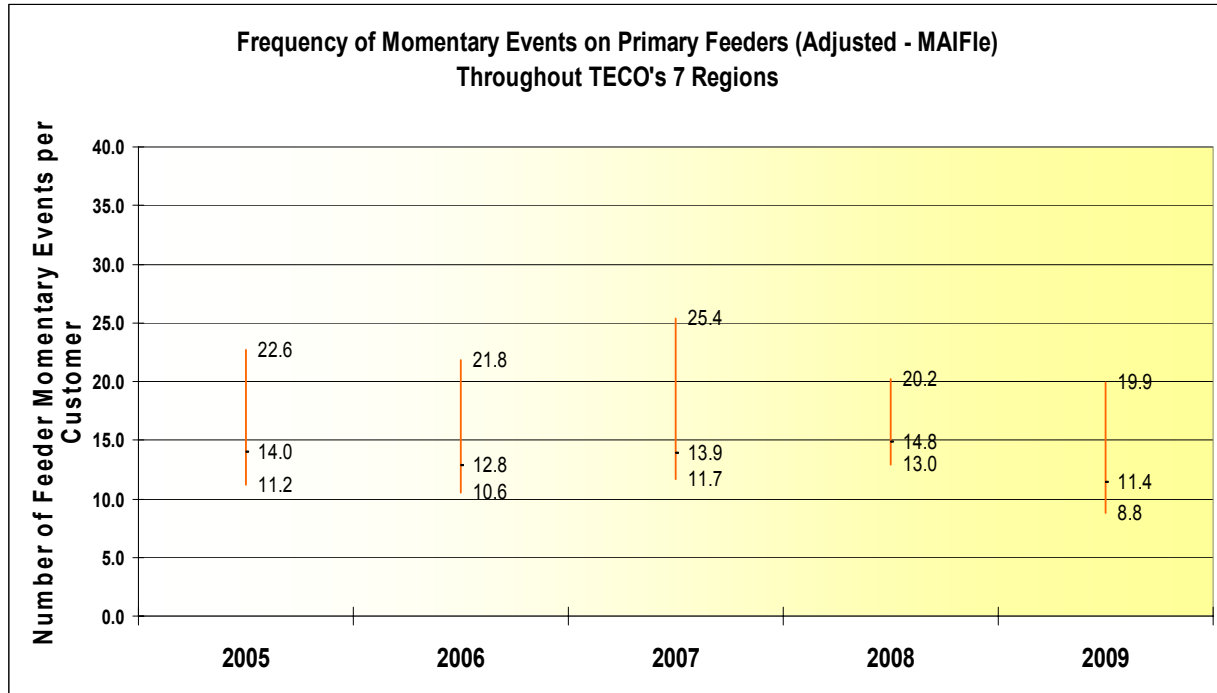
**Figure 3-21. MAIFle across TECO’s Seven Regions (Adjusted)**

Figure 3-21 illustrates TECO’s number of momentary events on primary circuits per customer recorded across its system. In 2009, MAIFle results improved in all seven divisions of TECO’s territory, which was a 23 percent improvement from 2008, suggesting a decrease in the number of feeder momentary events compared to the prior four years. Plant City also experienced improved results as indicated below.

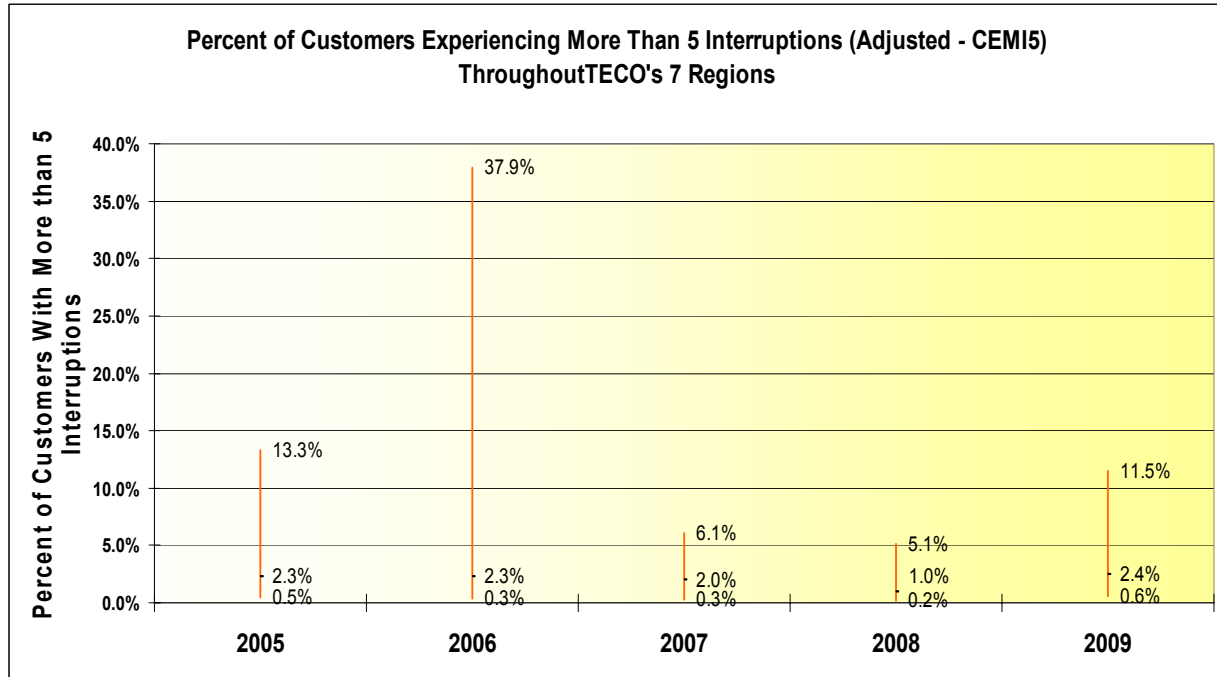
**Figure 3-22. CEMI5 across TECO's Seven Regions (Adjusted)**

Figure 3-22 shows the percent of customers experiencing more than five interruptions. As opposed to the MAIFIE results, all seven regions in TECO territory experienced an increase in the CEMI5 results for 2009, and the highest average in the past five years. TECO's results for these indices have varied for the past five years.

The number of service interruptions in TECO's Dade City and Plant City regions remains an area of concern. While these two regions were identified in previous reliability reports, any improvement in reliability continues to remain unchanged, and as Figure 3-22, CEMI5 Across TECO's Seven Regions (Adjusted) illustrates, the percentage of customers experiencing more than five service interruptions doubled in 2009 from 1.0 percent to 2.4 percent. TECO maintains that the long circuits in Dade City and Plant City regions contribute to the increased number of service interruptions in their respective regions.
