*Review of Florida's  
Investor-Owned Electric Utilities' Service Reliability  
In 2009*

*Florida Public Service Commission  
Division of Service Quality, Safety, and Consumer Assistance  
December 21, 2010*

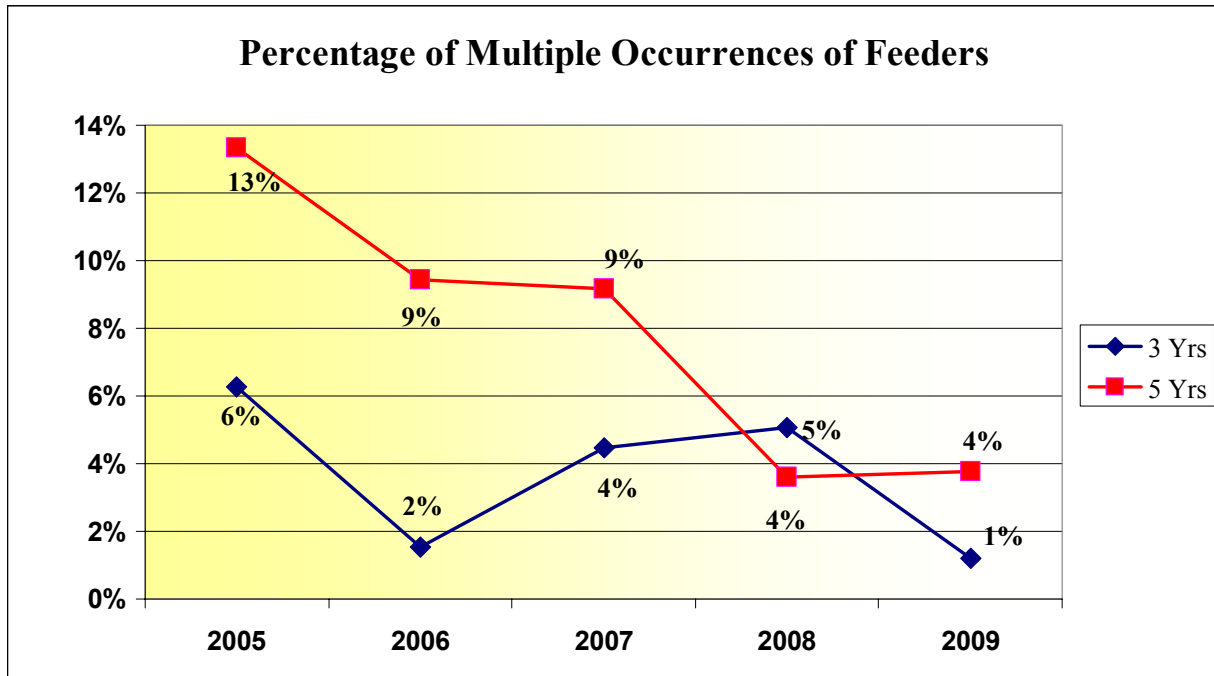
**Figure 3-23. TECO's Three Percent Feeder Report (Adjusted)**

The Three Percent Feeder Report is a listing of the top three percent of feeders with the most feeder outage events. Figure 3-23, is calculated using the number of recurrences divided by the number of feeders reported. The five-year average of outages per feeder remained the same from 2008 to 2009, while the three-year average has improved dramatically since 2006.

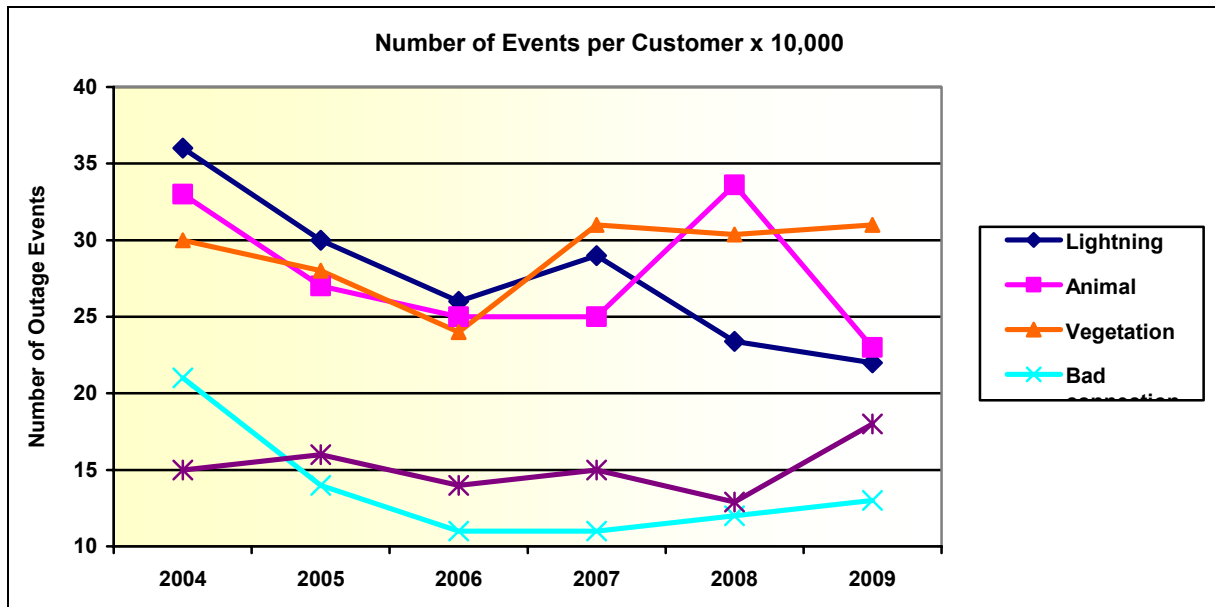
**Figure 3-24. TECO's Top Five Outage Causes (Adjusted)**

Figure 3-24 shows the top five causes of outage events on TECO’s distribution system normalized to a 10,000 customer base. The figure is based on TECO’s adjusted data of the top ten causes of outage events and represents 74 percent of the total outage events that occurred during 2009. Vegetation and animal causes continue to be the top two problem areas for TECO; however, the cause due to animal, was reduced by 31 percent from 2008 to 2009. TECO reports that from 2005 through 2009, outages due to animal contact have contributed the most to SAIDI. Beginning in 2004, TECO began installing animal protection in all new substation construction and substation upgrade projects. During 2009, animal protection was installed on an additional ten distribution busses in eight different substations. The result of these improvements showed a significant reduction in outages due to animals. A slight increase in bad connection and electrical causes also occurred between 2008 and 2009.

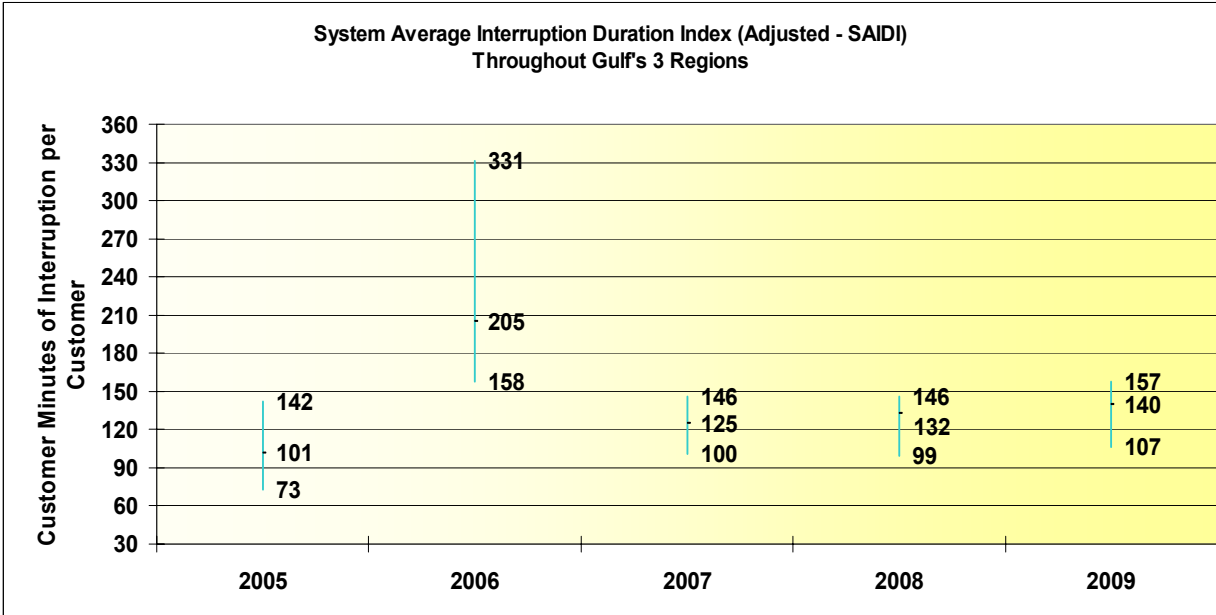
**Figure 3-25. SAIDI across Gulf’s Three Regions (Adjusted)**

Gulf’s SAIDI minutes, or the minutes of interruption per customer on a system basis, is shown in Figure 3-25. The chart illustrates an increase in SAIDI values by 8 minutes in Gulf’s combined regions over the 2008 results. Gulf’s 2009 average performance was 6 percent worse than the 2008 SAIDI results. Gulf reported there was an extreme March weather event that was not excludable because it was not a named storm or NWS recordable tornado. The total SAIDI impact for this significant event was 11.9 minutes, which would have resulted in a Gulf adjusted SAIDI of 128 minutes instead of the reported 140 minutes.

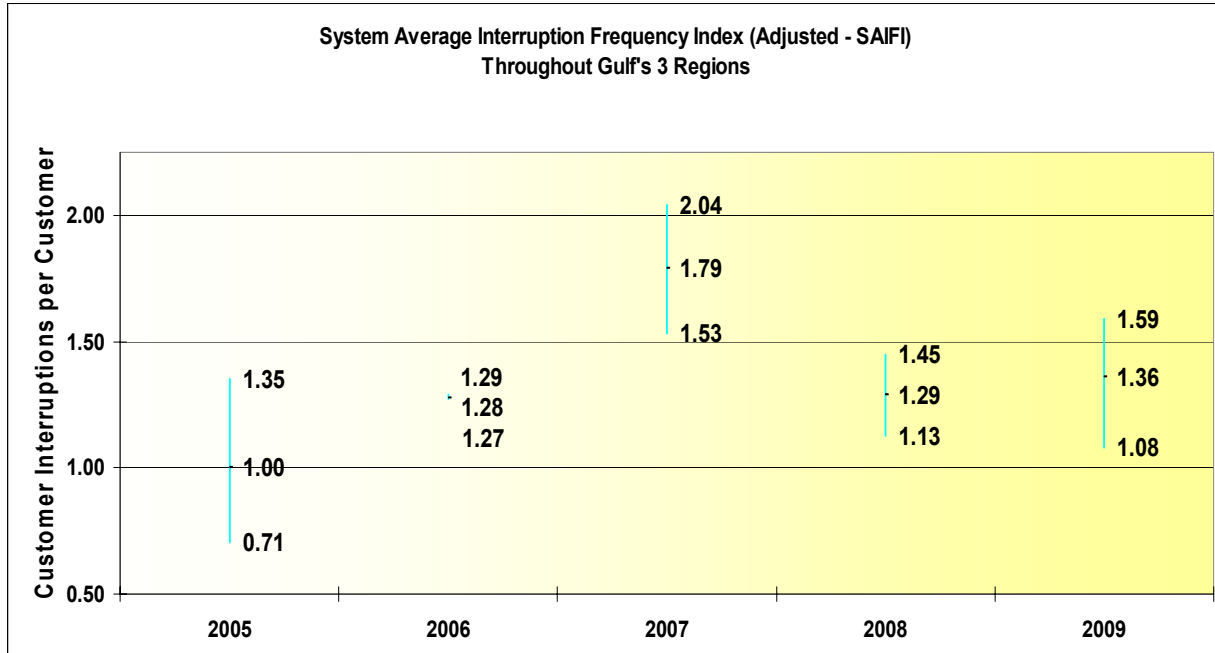
**Figure 3-26. SAIFI across Gulf’s Three Regions (Adjusted)**

Figure 3-26, adjusted SAIFI, illustrates that Gulf’s system average had a 5 percent increase in 2009 when compared to 2008. Gulf’s Western region had the highest SAIFI values in four of the last five years. The lowest values do not appear to be confined to any particular region; however, the Eastern region does appear in three of the last five years. Overall, the 2009 combined regional SAIFI values appear to be trending upward and the average SAIDI indicates a rise of 36 percent from 2005 to 2009.

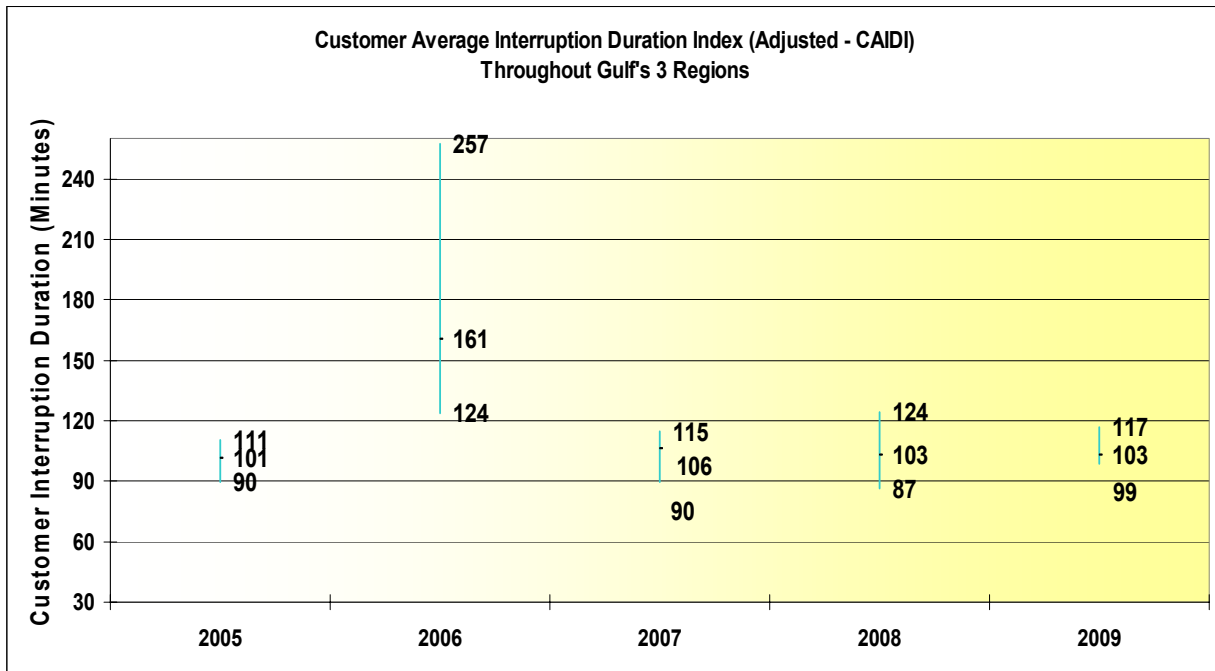
**Figure 3-27. CAIDI across Gulf’s Three Regions (Adjusted)**

Gulf’s adjusted CAIDI (Customer Average Interruption Duration Index) is shown in Figure 3-27. The average CAIDI in 2009 was 103 minutes and there was no change from the 2008 value. The Eastern and Central regions continue to be in the highest and lowest CAIDI values for the last five years. The Western region has not appeared in the highest CAIDI analysis. Staff notes that the difference or spread between the highest and lowest values is approximately 26 minutes except for the year 2006, suggesting that the CAIDI values are relatively stable and do not differ greatly between the average system performance.

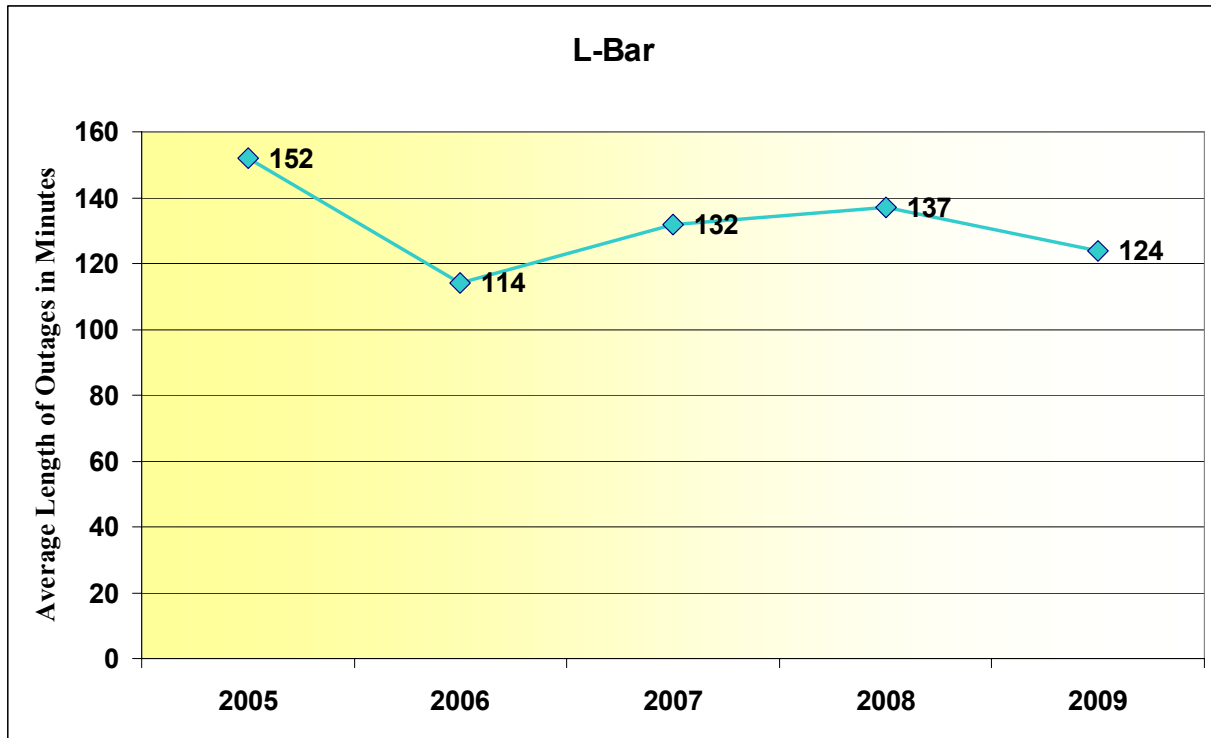
**Figure 3-28. Gulf's Average Duration of Outages (Adjusted)**

The average length of time Gulf spends recovering from outage events, excluding hurricanes and other outage events, is the index L-Bar shown in Figure 3-28. Gulf's L-Bar showed a 9% improvement from 2008 to 2009; 28 minutes, or an 18 percent improvement overall, in the average length of service outages since 2005.

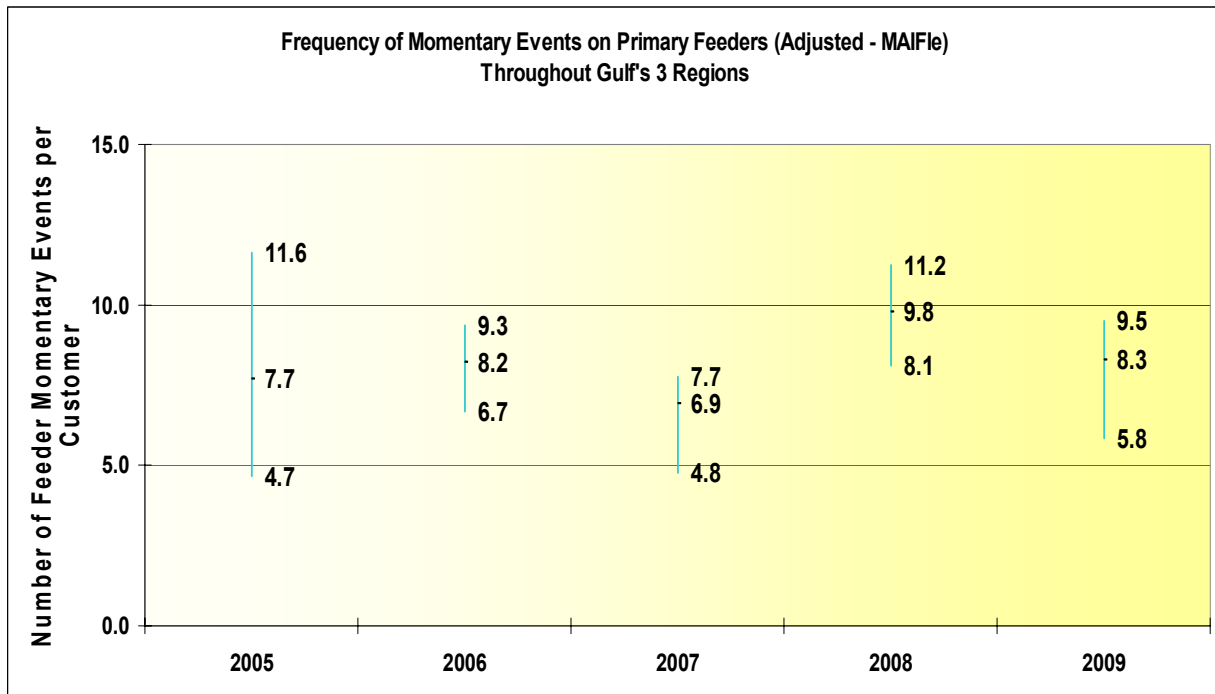
**Figure 3-29. MAIFle across Gulf’s Three Regions (Adjusted)**

Figure 3-29 is the adjusted MAIFle recorded across Gulf’s system. The adjusted MAIFI results by region show that the Central region had the lowest frequency of momentary events on primary feeders, with a 33% improvement from 2008 to 2009. The Western region has the highest average. It had a 15 percent improvement from 2008 to 2009. The data suggests that the level of service reliability for the highest MAIFle is trending downward which is good. However, the average and lowest MAIFle appear to be trending slightly upward for the last five years.

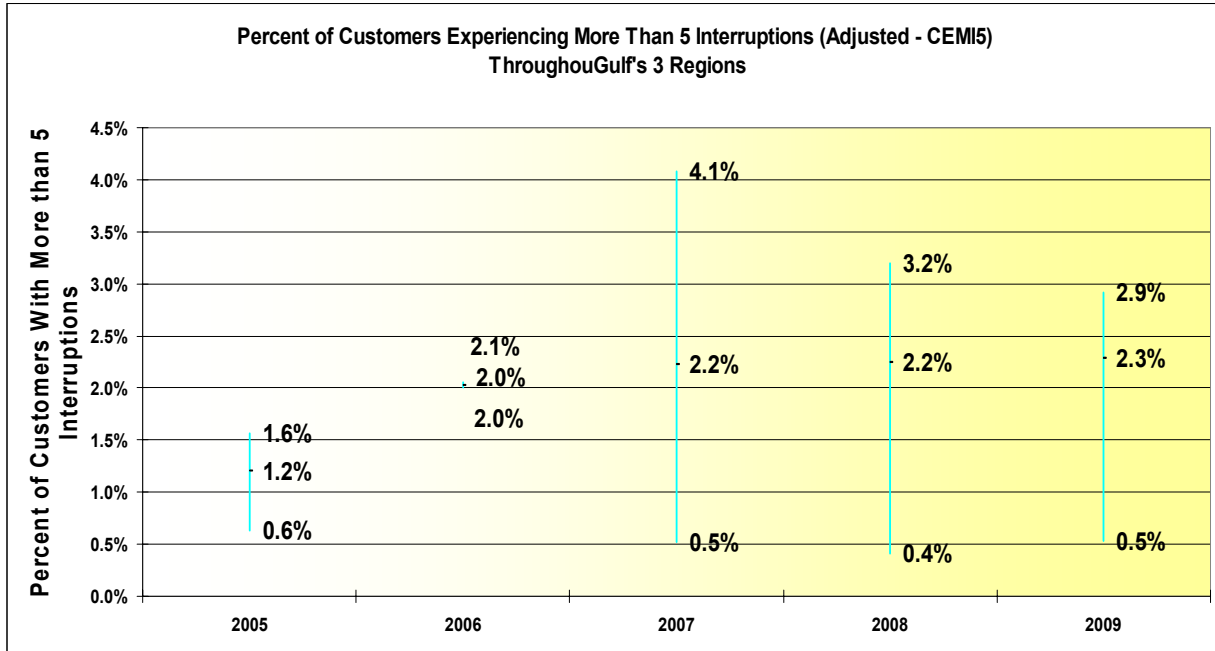
**Figure 3-30. CEMI5 across Gulf's Three Regions (Adjusted)**

Figure 3-30 shows the highest, average, and lowest adjusted CEMI5 across Gulf's Western, Central and Eastern regions. Gulf's 2009 results illustrate a slight decline when compared to 2008. The highest and lowest values have varied between the regions with regularity and with no discernable pattern. Overall, the average CEMI5 appears to be trending upward suggesting that the percentage of Gulf's customers experiencing more than five interruptions is gradually increasing over the last five years.

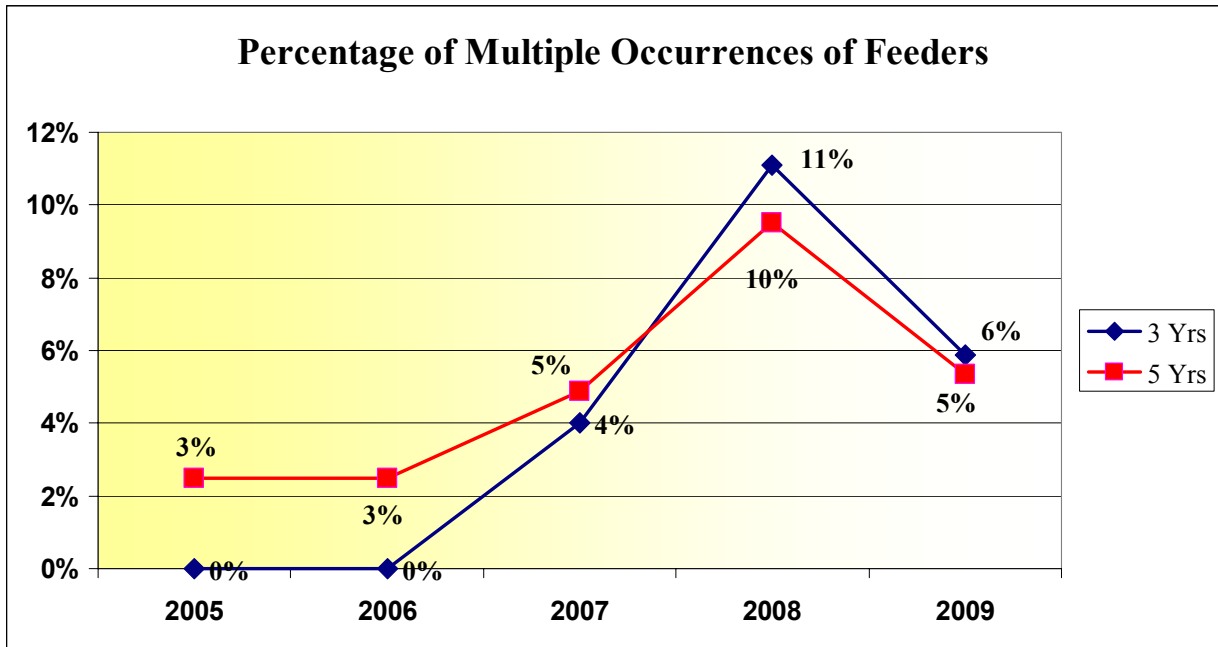
**Figure 3-31. Gulf's Three Percent Feeder Report (Adjusted)**

The Three Percent Feeder Report is a listing of the top three percent of feeders with the most feeder outage events. Figure 3-31 shows the multiple occurrences of feeders using a three-year and five-year basis. The five-year multiple occurrences analysis showed a marked decrease from the prior trend, which implies improving performance. The supporting data shows that the three-year multiple occurrences have dropped from 11 percent to 6 percent from 2008 to 2009. Gulf addressed the trend of poor feeder performance in the 2008 reliability report, with corrective efforts in 2009. The illustration in the chart below depicts the success of those efforts.

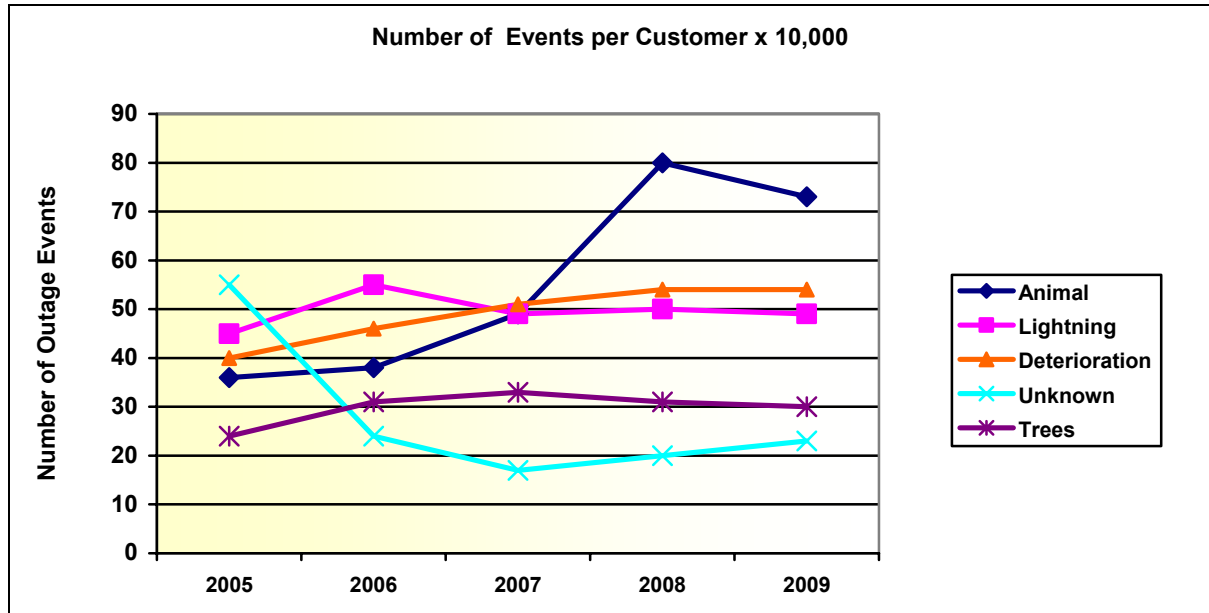
**Figure 3-32. Gulf’s Top Five Outage Causes (Adjusted)**

Figure 3-32 is a graph of the top five causes of outage events on Gulf’s distribution system normalized to a 10,000 customer base. The figure is based on Gulf’s adjusted data of the top ten causes of outage events and represents 87 percent of the total adjusted outage events that occurred during 2009. The top five causes of outage events were: animals (28 percent), deterioration (21 percent), lightning (18 percent), trees (12 percent), and unknown causes (9 percent). The percentage of cause of outages due to animal has decreased by 9 percent from 2008 to 2009, but still remains the highest cause of outages.

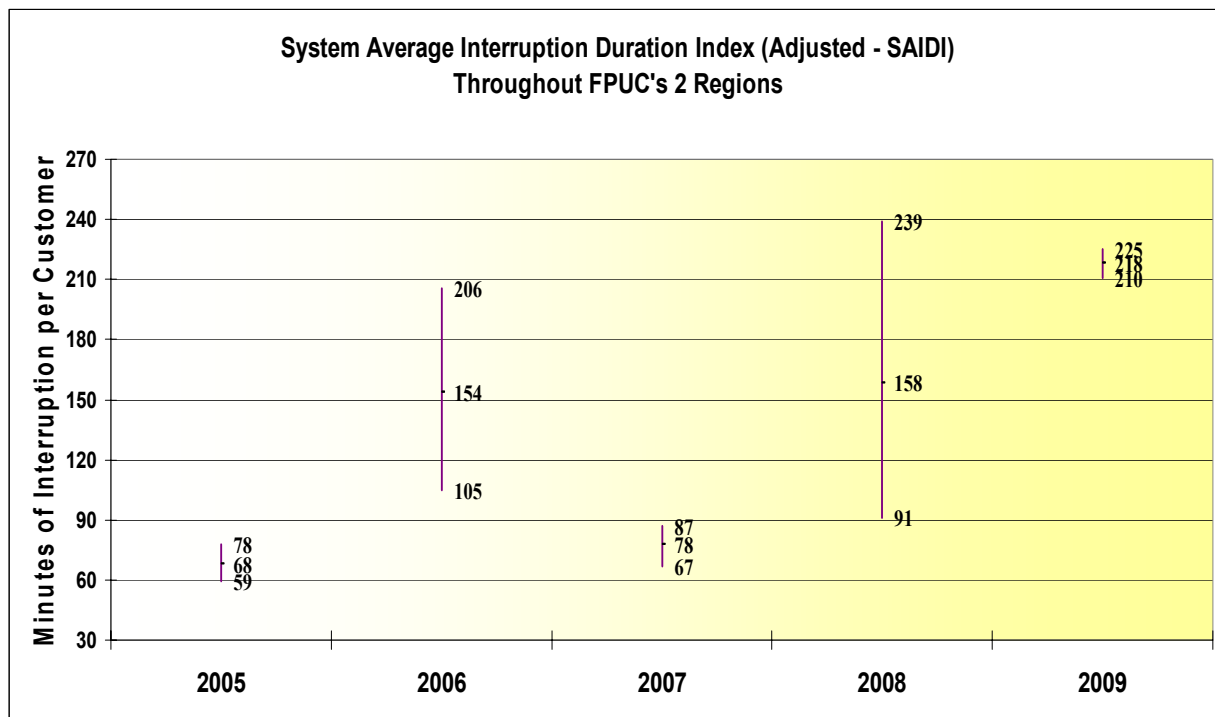
**Figure 3-33. SAIDI across FPUC's Two Regions (Adjusted)**

Figure 3-33 shows the highest, average, and lowest adjusted SAIDI values recorded across FPUC's system. The data shows a continued increase in SAIDI from 2005 to 2009. FPUC's 2009 Reliability Report notes the installation of an Outage Management System (OMS) in both divisions. FPUC stated this resulted in significant improvement in data collection and retrieval capability for analyzing and reporting reliability indices. The improved data collection resulted in higher reliability numbers, as expected by FPUC, and it attributed the higher numbers to better data, not necessarily a decline in system or personnel performance.

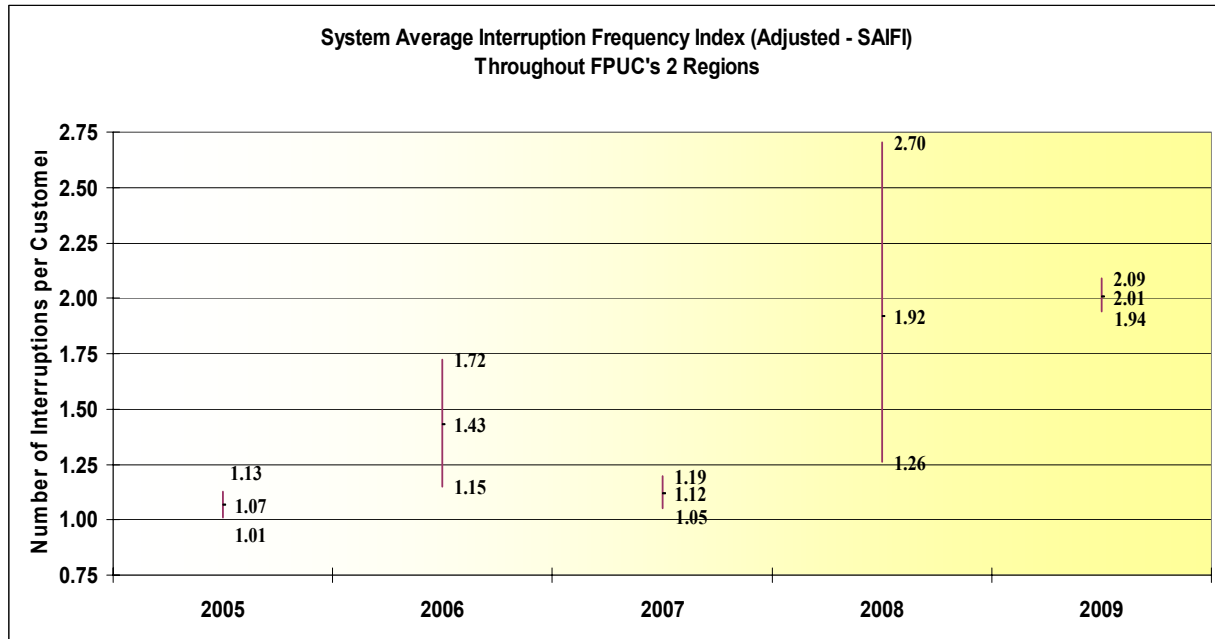
**Figure 3-34. SAIFI across FPUC's Two Regions (Adjusted)**

Figure 3-34 shows the adjusted SAIFI (number of interruptions per customer) across FPUC's two divisions. The data depicts a five percent increase in the 2009 average SAIFI reliability index from 2008. Staff notes that following the installation of the OMS for the Northeast Division in January 2009, the spread between the highest and lowest frequency of interruptions being reported appears to have narrowed.

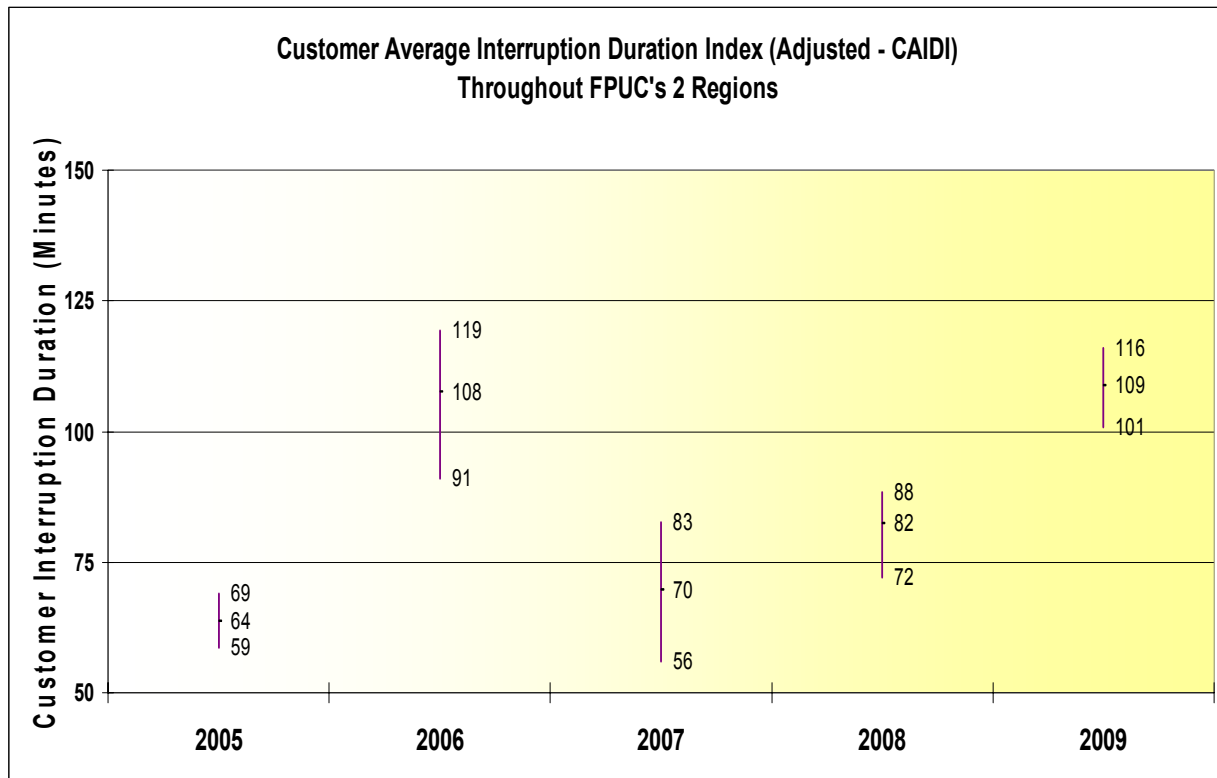
**Figure 3-35. CAIDI across FPUC's Two Regions (Adjusted)**

Figure 3-35 shows the highest, average, and lowest adjusted CAIDI values across FPUC's system. FPUC's data shows a 31 percent increase in the 2009 reliability indices relative to 2008 values, and once again, this increase is attributed to the introduction of OMS in the divisions. FPUC has reported it is apparent that enhanced data collection for 2009 compared to prior year's information will not produce credible results for the NE Division. Additionally, this is the second year of data collection using the new OMS system in the NW Division, and FPUC reports that two years does not provide enough data to produce credible trend results. There is no specific pattern observed concerning the regional CAIDI values between the two divisions implying that FPUC's outage response process and location of service centers relative to affected customers are comparable in both divisions.

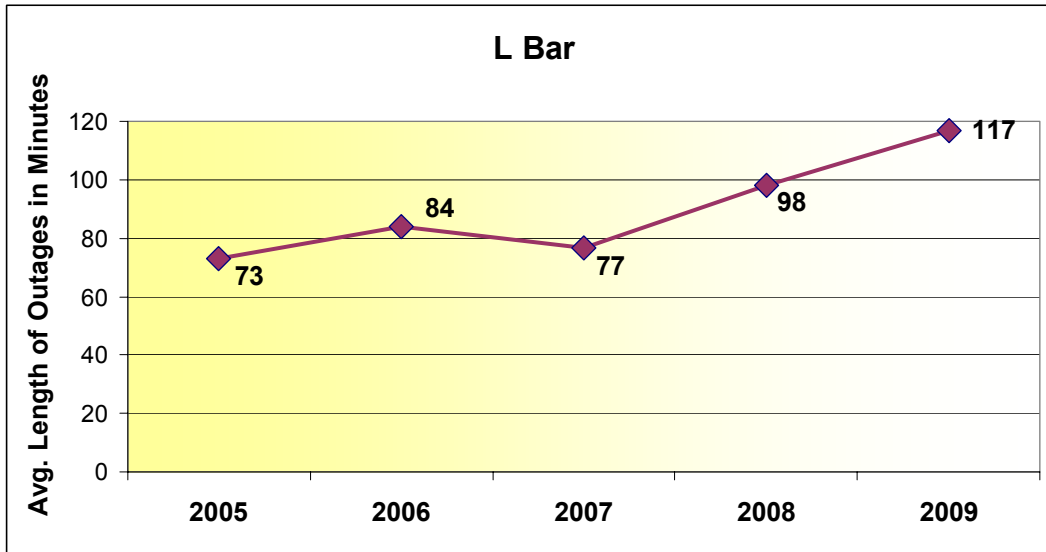
**Figure 3-36. FPUC's Average Duration of Outages (Adjusted)**

The average length of time FPUC spends recovering from outage events (adjusted L-Bar), is shown in Figure 3-36 on the following page. The data demonstrates variability and an increasing trend of longer outage recovery times. Many factors contribute to increases in L-Bar, including increased number of underground outages, the cause and location of the outage event, the number of distribution facilities needing replacement or repair, and the number of available trained and equipped personnel. The L-Bar for FPUC's Northwest Division had a 40 percent increase from 2007 to 2009, while the Northeast Division experienced a 10 percent increase in 2009.

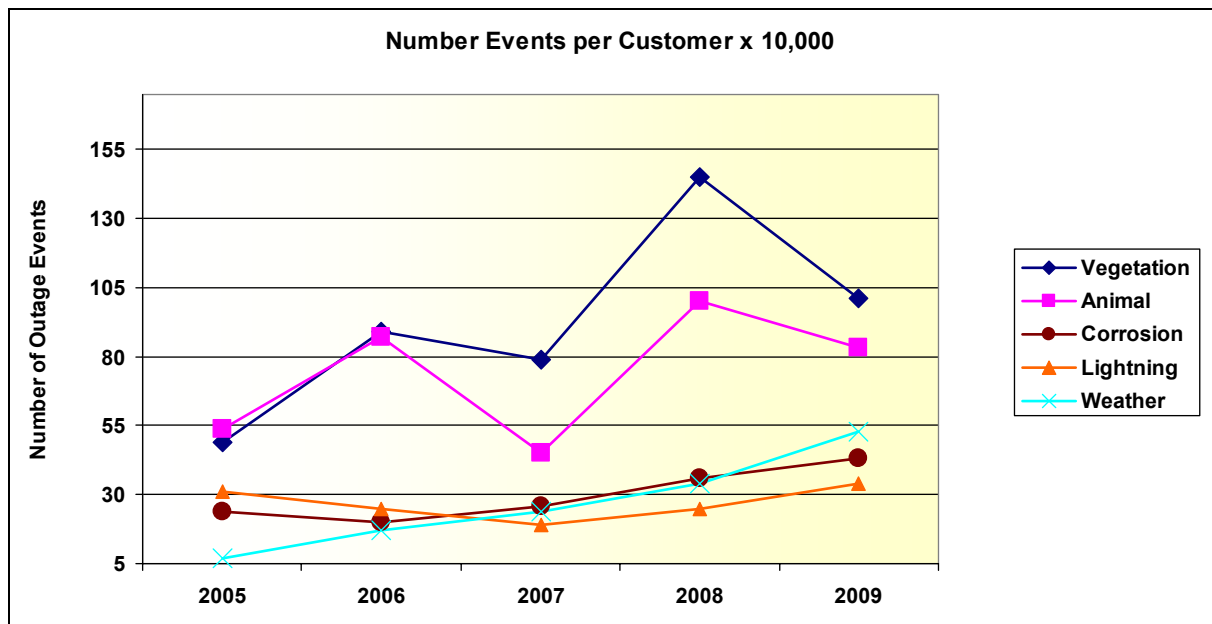
**Figure 3-37. FPUC's Top Five Outage Causes (Adjusted)**

Figure 3-37 shows the top five causes of outage events on FPUC’s distribution system normalized to a 10,000 customer base. The figure is based on FPUC’s adjusted data of the top ten causes of outage. For the five-year period, the top five causes of outage events were vegetation (27 percent), animal (22 percent), weather (14 percent), corrosion (11 percent), and lightning (9 percent). These five factors represent 65 percent of the total adjusted outage causes in 2009. A decrease in vegetation and animal caused outages can be attributed to FPUC’s commitment to better management of vegetation growth, continuance of FPUC’s program of installing animal guards and insulating the primary taps of service transformers where the majority of damages occur from small animals. FPUC has a long range plan to address the corrosion issue by replacing sections of outdated underground cable. The cause of outages related to corrosion increased approximately 65 percent from 2007 to 2009. In other words, there were 43 corrosion outages in 2009 compared to 26 corrosion outages in 2007 on an adjusted 10,000 customer basis.

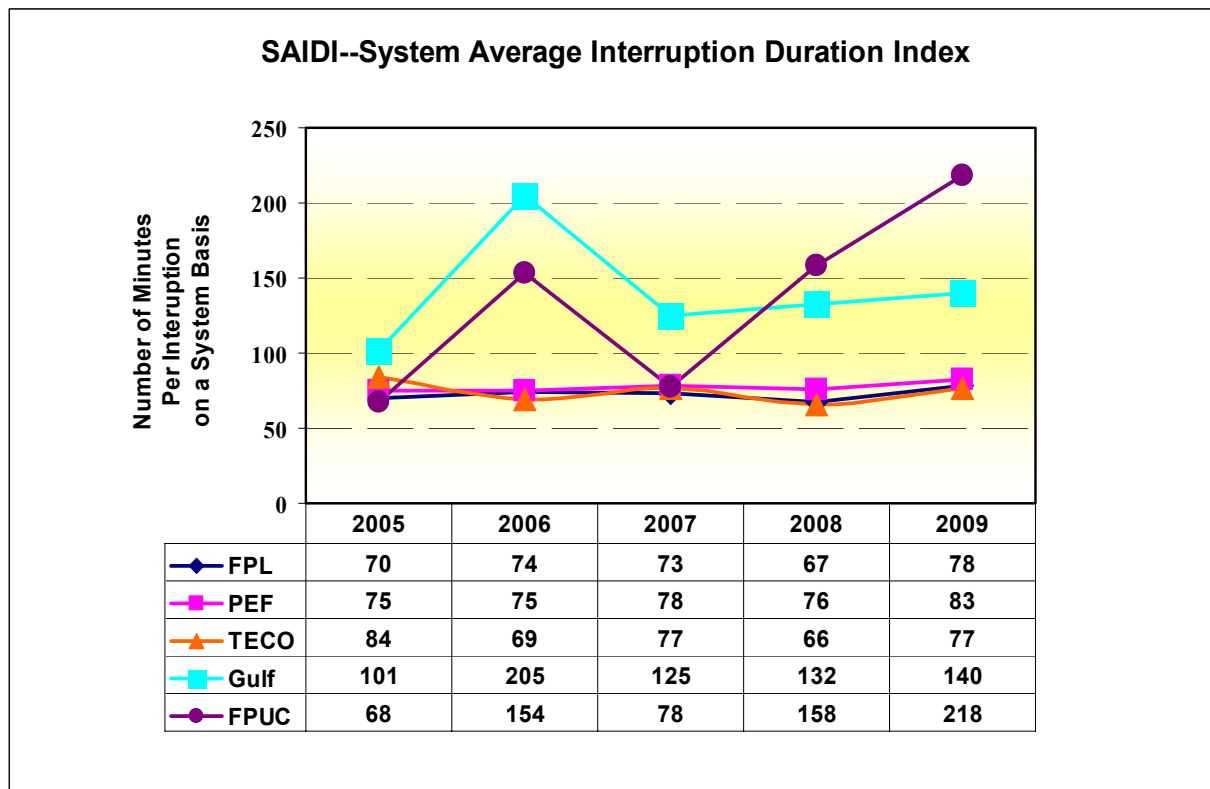
**Figure 4-1. Average Interruption Duration (Adjusted SAIDI)**

Figure 4-1 indicates that three IOUs, FPL, PEF, and TECO, have relatively flat SAIDI trends over the last five years. Gulf and FPUC have higher SAIDI values and more variability. FPUC's climb to 218 minutes in 2009 can be attributed to implementation of the Outage Management System (OMS) within its two divisions. FPUC stated the OMS resulted in significant improvement in data collection and retrieval capability for analyzing and reporting reliability indices. The improved data collection resulted in higher reliability numbers.

The inter-utility trend comparison focuses on a graphical presentation that combines all of the IOUs' distribution reliability indices for the years 2005 through 2009. Figures 4-1 through 4-3 apply to all five utilities while Figures 4-4 and 4-5 do not apply to FPUC because it is not required to report MAIFIE and CEMI5 due to the size of its customer base. The adjusted data that is used in generating the indices in the report is based on the exclusion of certain events allowed by Rule 25-6.0455(4), F.A.C. Generalizations can be drawn from the side by side comparisons; however, any generalizations should be used with caution due to the differing sizes of the distribution systems, the degree of automation, and the number of customers. The indices are unique to each IOU.

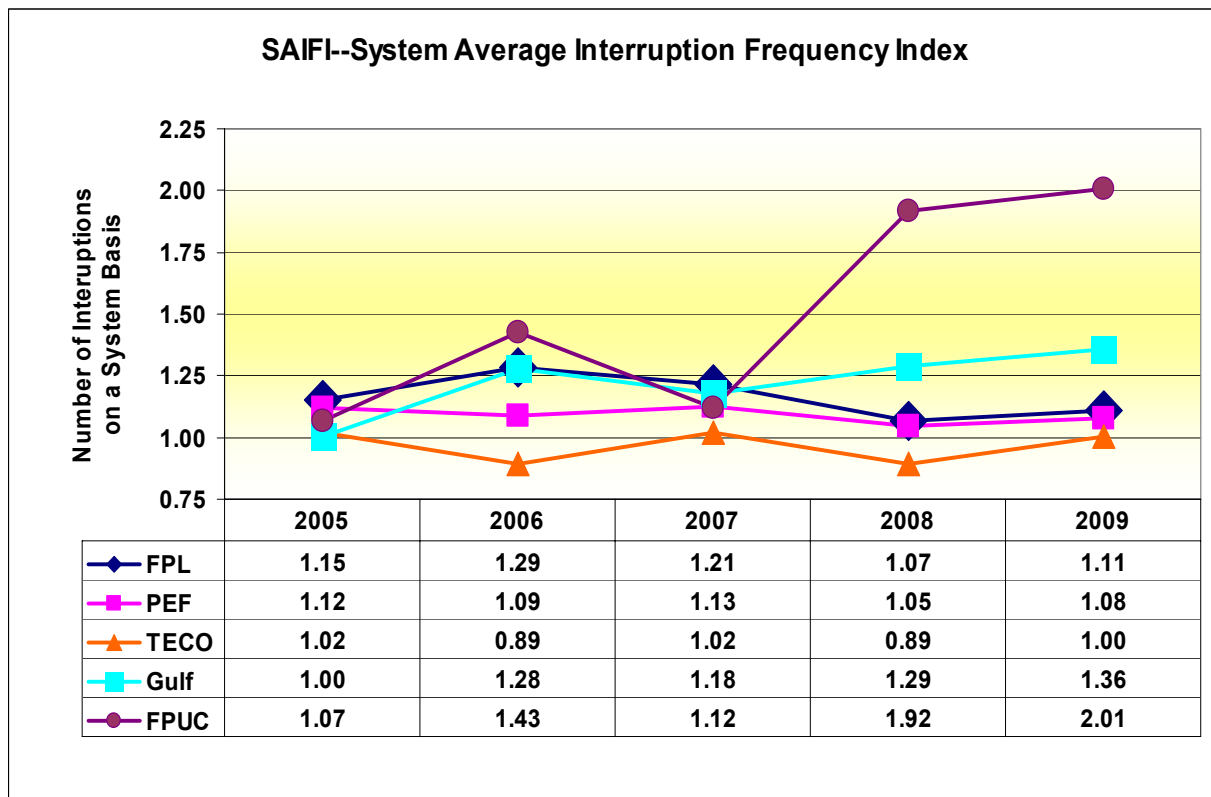
**Figure 4-2. Average Number of Service Interruptions (Adjusted SAIFI)**

Figure 4-2 is a five-year graph of the adjusted SAIFI (system average frequency of interruptions per customer) for each IOU. In 2009, Gulf and FPUC recorded significantly higher values compared to the other IOU's.

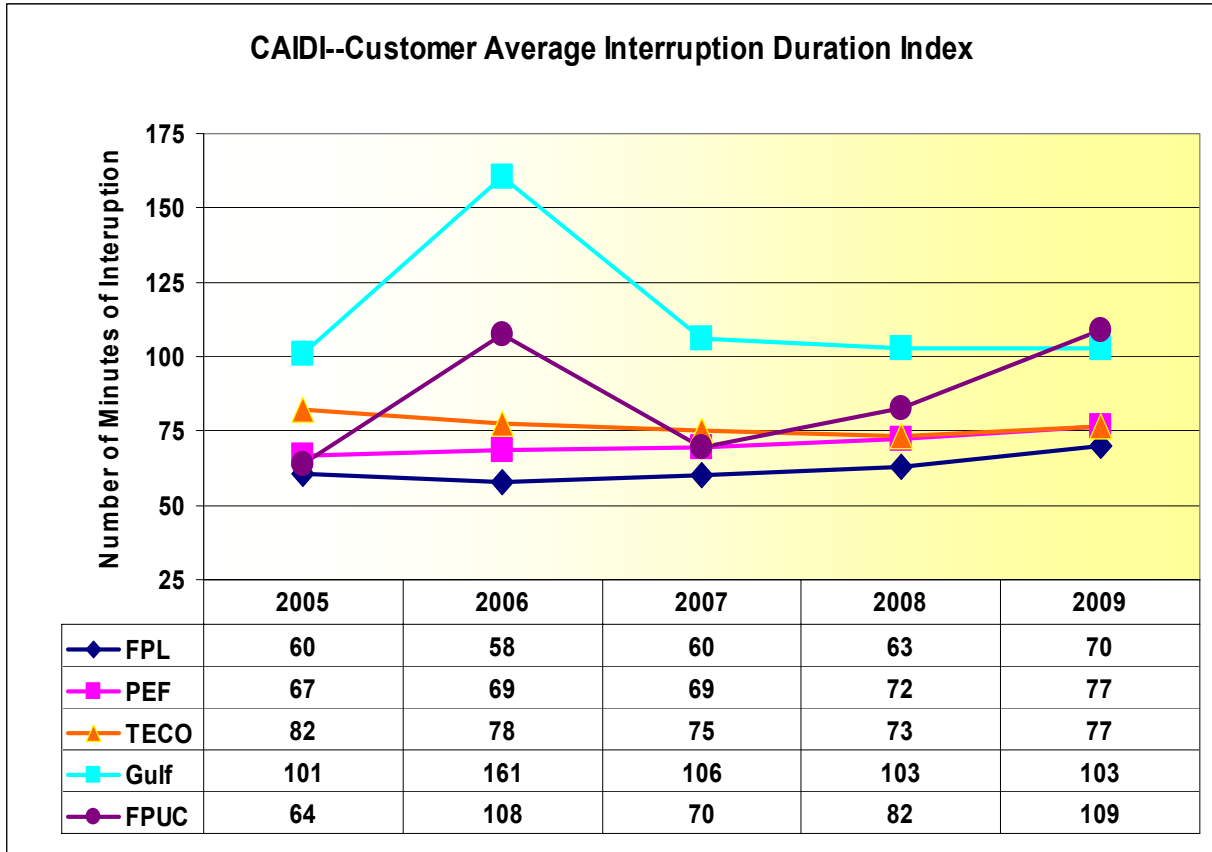
**Figure 4-3. Average Service Restoration Time (Adjusted CAIDI)**

Figure 4-3 is a five-year graph of the adjusted CAIDI (customer average interruption duration) for each IOU. FPUC attributes the rise in the CAIDI values to uncontrollable events which were not excluded from the adjusted values.

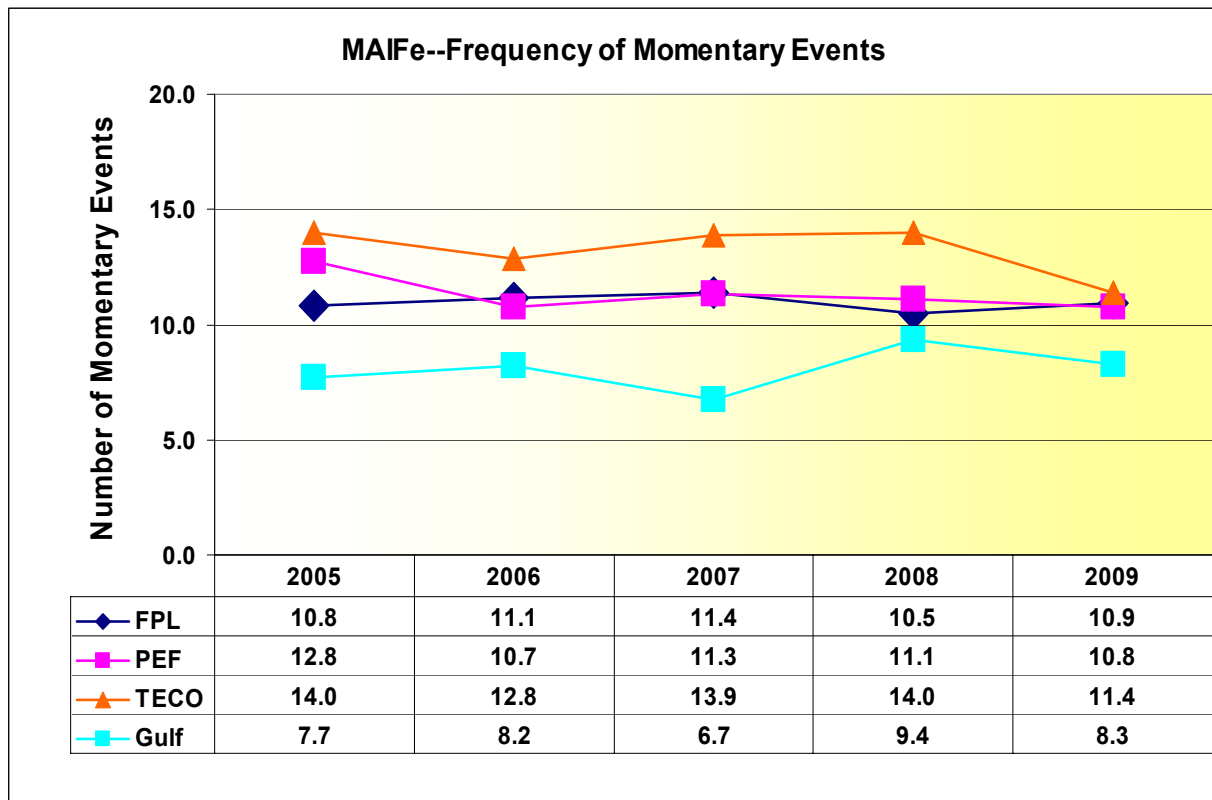
**Figure 4-4. Average Number of Feeder Momentary Events (Adjusted MAIFe)**

Figure 4-4 is a five-year graph of the adjusted MAIFe (system average frequency of momentary events on primary circuits per customer) for FPL, PEF, TECO and Gulf. Improvements were indicated by FPL, PEF and TECO in 2009 from their 2007 results and continued improvement throughout the five-year period. However, Gulf show decreased performance as compared to 2007. Throughout the following comparative discussion it is important to remember that FPUC is exempt from reporting certain indices (MAIFe and CEMI5) because FPUC has fewer than 50,000 customers.

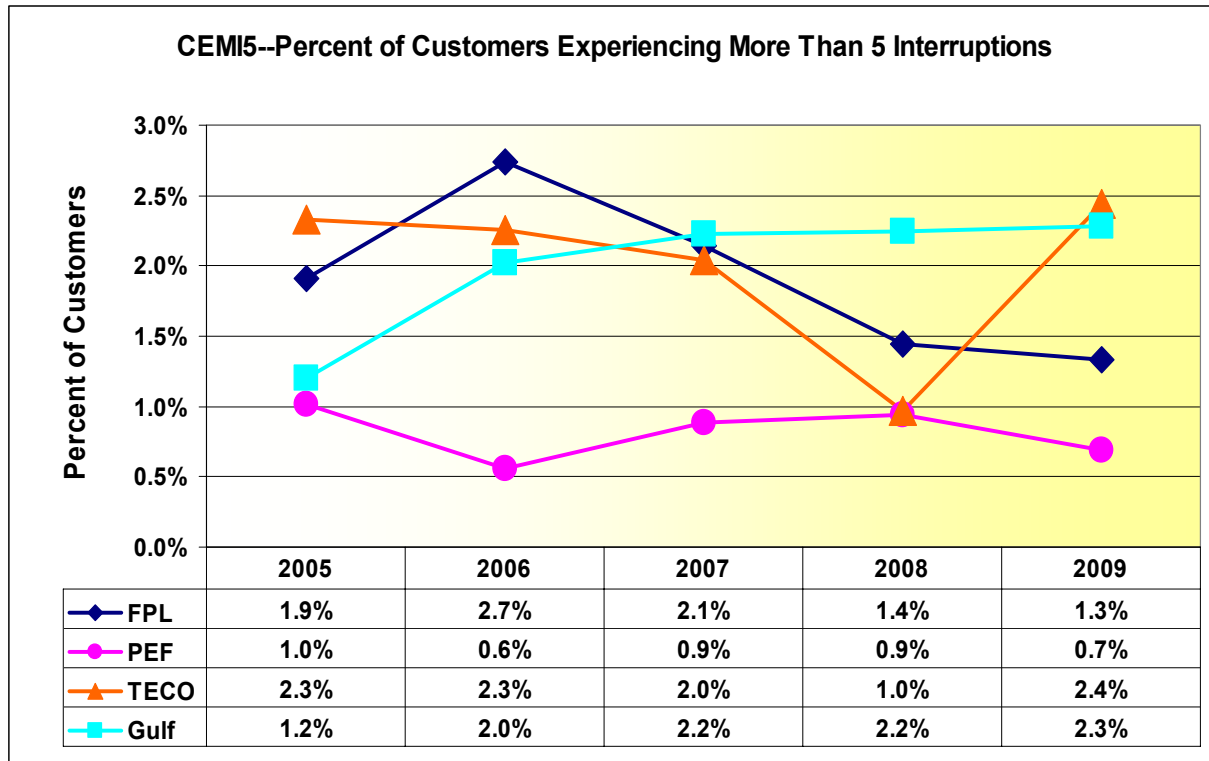
**Figure 4-5. Percent of Customers with More Than Five Interruptions (Adjusted CEMI5)**

Figure 4-5 is a five-year graph of the adjusted CEMI5 (percentage of customers experiencing more than five service interruptions) for FPL, PEF, TECO and Gulf. The adjusted CEMI5 decreased in 2009 for Gulf relative to 2008 suggesting more customers were excluded from the category of experiencing more than five service interruptions. PEF, for the fourth consecutive year, reported the lowest adjusted CEMI5 and TECO had an increase from 1.0 percent in 2008 to 2.4 percent in 2009 indicating that more customers experienced five or more momentary events.

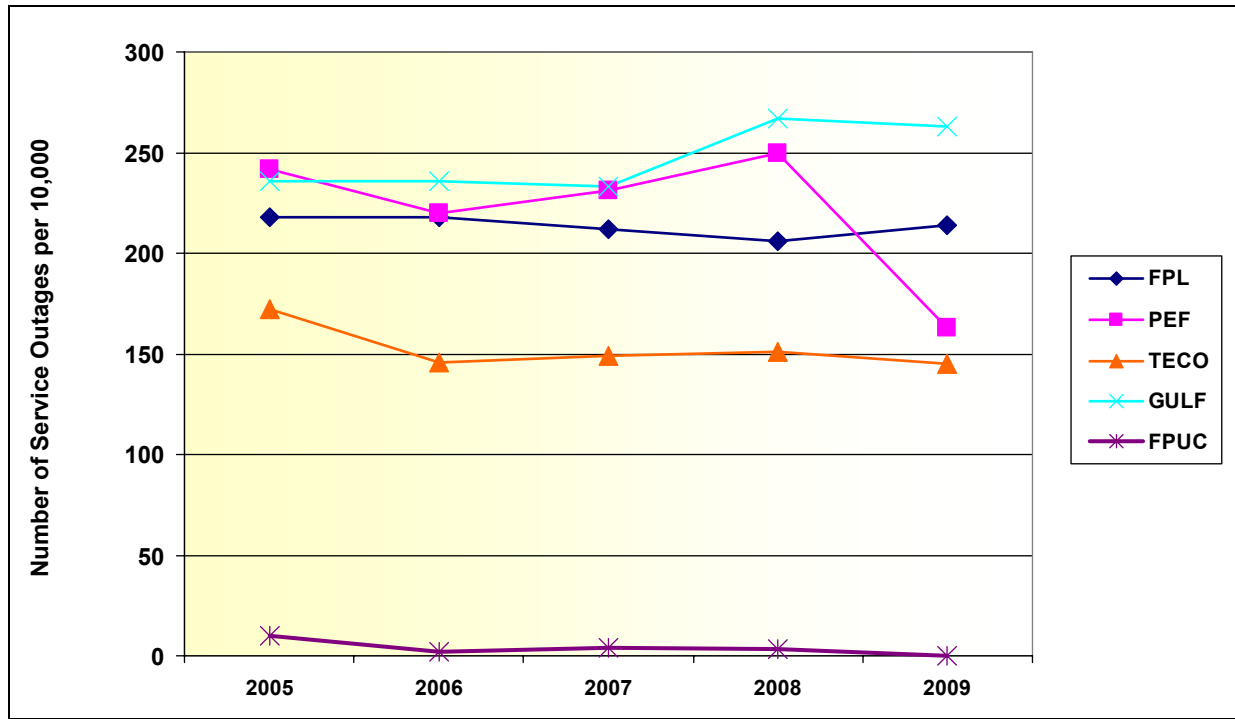
**Figure 4-6. Number of Outages per 10,000 Customers (Adjusted N)**

Figure 4-6 shows the number of outages per 10,000 customers on an adjusted basis for the five IOUs. The graph is developed from each utility's adjusted data concerning the number of outage events and the total number of customers on an annual basis. For example, FPL reported 91,647 outage events for 4,447,244 customers in 2009. Dividing the outage events by the number of customers and multiplying by 10,000 results in 206 outage events in 2009 per 10,000 customers. TECO has a declining number of outages since 2005, while Gulf, PEF, and FPL continue to demonstrate variability. FPUC's results appear to be relatively flat and are trending downward with 10 outage events per 10,000 customers in 2005, and less than one outage event per 10,000 customers in 2009.

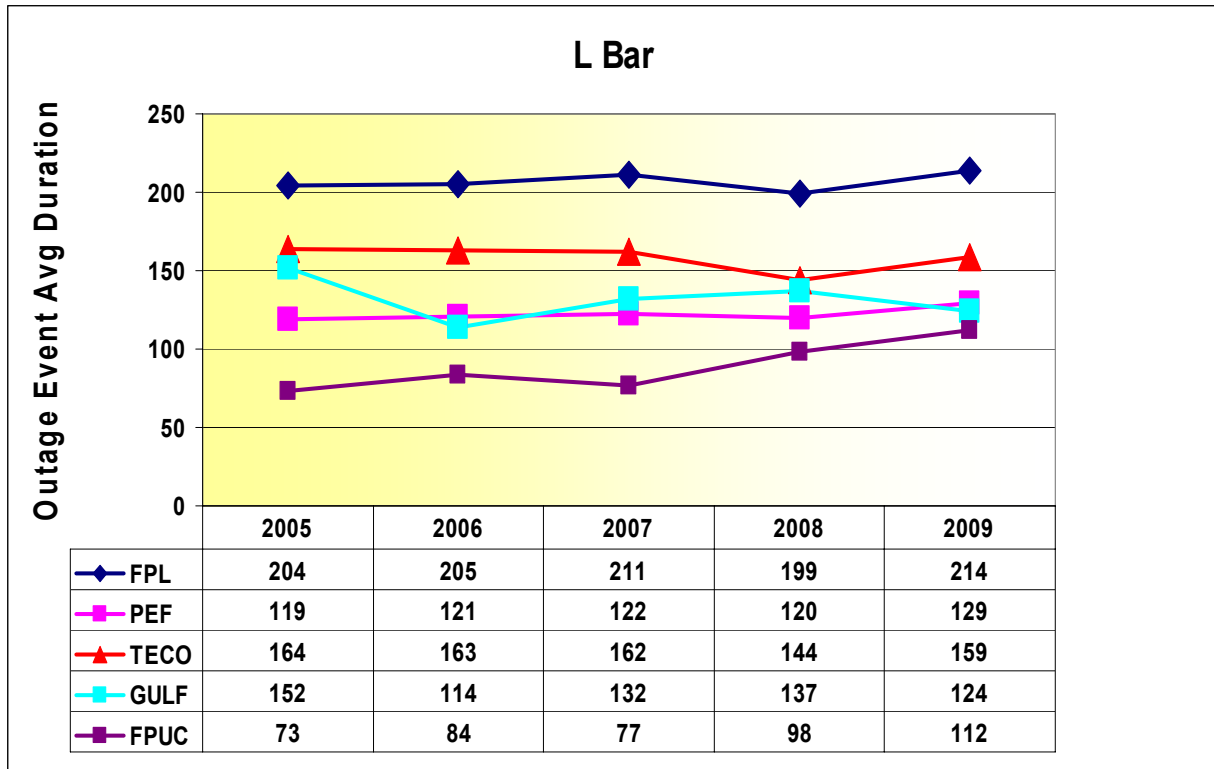
**Figure 4-7. Average Duration of Outage Events (Adjusted L-Bar)**

The average duration of outage events (Adjusted L-Bar) for each IOU is graphed in Figure 4-7. Gulf had a decrease in the L-Bar value, demonstrating improvements in recovery time from outage events. FPUC attributes their higher readings to the recent installation of an Outage Management System (OMS) in the Northwest Division. This resulted in significant improvement in data collection and retrieval capability for analyzing and reporting reliability indices, not necessarily a decline in service reliability.
