*Review of Florida's  
Investor-Owned Electric Utilities' Service Reliability  
In 2009*

*Florida Public Service Commission  
Division of Service Quality, Safety, and Consumer Assistance  
December 21, 2010*

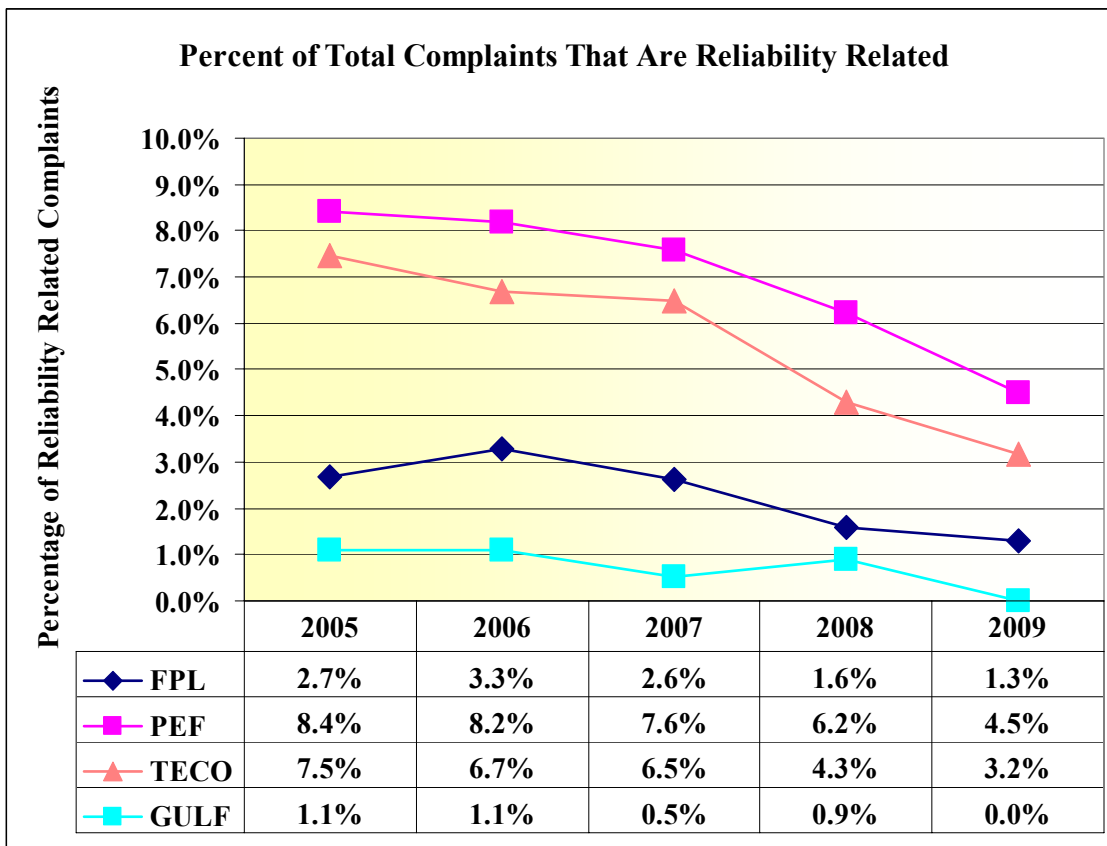
**Figure 4-8. Percent of Complaints That Are Reliability Related**

Each customer complaint received by the Commission is assigned an alphanumeric category after the complaint is resolved. Reliability related complaints have ten specific category types. The reliability complainants pertain to trees, safety, repairs, quality of service, and momentary service interruptions. The “quality of service” category was established in July 2003, resulting in a shift of some complaints that previously would have been coded in another complaint category. For the years 2005 through 2009 and Figures 4-8 and 4-9, the consumer complaint data was extracted from the Commission’s Consumer Activity Tracking System (CATS).<sup>18</sup>

As shown in Figure 4-8, the percentage of reliability related customer complaints in relation to the total number of complaints for each IOU appears to be trending downward. FPUC was excluded from the comparison because FPUC has relatively few customer reliability complaints and a much smaller customer base in comparison to the other utilities.

FPL's reliability related complaints for its customers decreased by 0.3 percent from 2008 to 2009 as shown in Figure 4-8..

TECO's reliability related complaints for its customers decreased by 1.1 percent from 2008 to 2009 as illustrated in Figure 4-8.

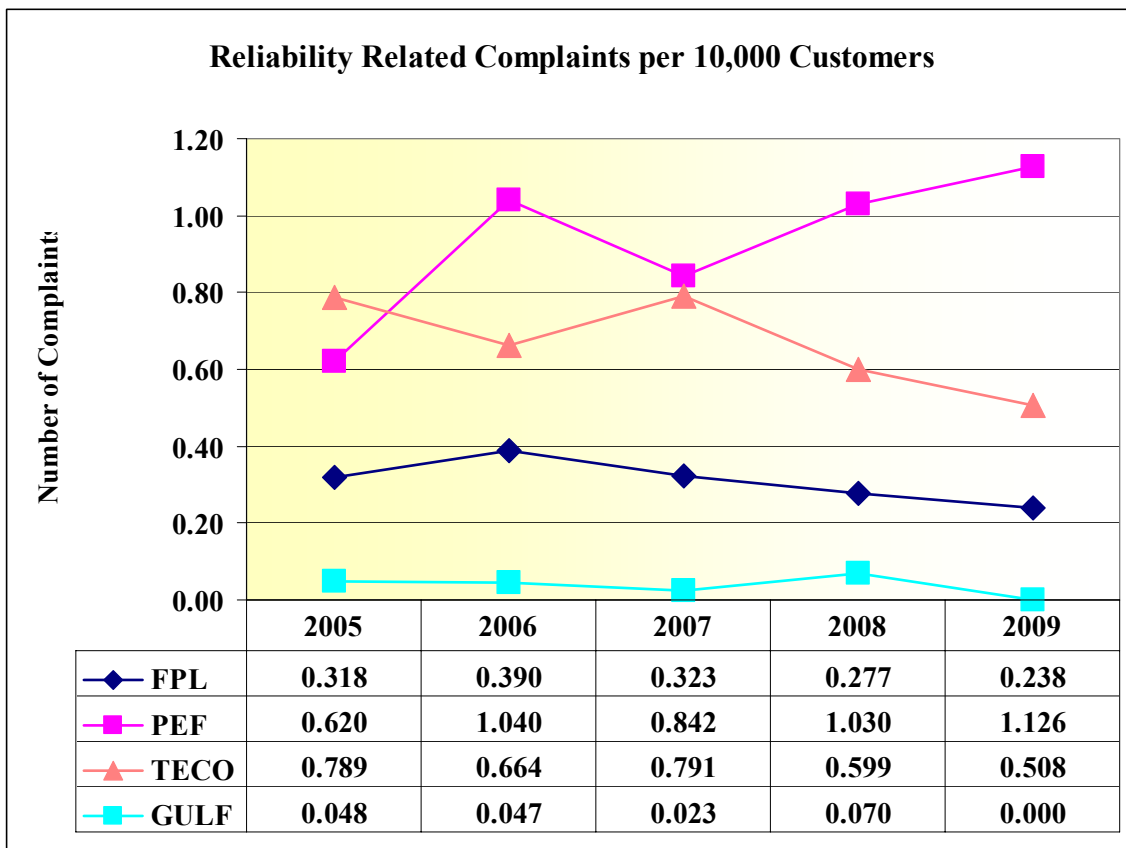
**Figure 4-9. Service Reliability Related Complaints per 10,000 Customers**

The volume of service reliability related complaints is normalized to a 10,000 customer base for comparative purposes. This is calculated for each IOU by dividing the total number of reliability complaints reported to the Commission by the total number of the utility’s customers. This fraction is then multiplied by 10,000 for graphing purposes. As shown in Figure 4-9, FPL, TECO, and PEF have between 0.238 and 1.126 reliability complaints for ten thousand customers. For 2009, Gulf’s results were zero complaints per ten thousand customers.

FPUC was also examined and for 2009, the utility had 38 total complaints of which five were reliability related. Normalizing to a 10,000 customer basis results in 1.787 reliability related complaints. The results for the previous years varied from zero in 2005 to a high of 4.256 in 2008. The volatility of FPUC’s results can be attributed to its small customer base which typically averages 28,000 or fewer customers.
