Review of
Electric Service Quality of Florida
Investor-Owned Utilities
Tampa Electric Company

June 2005

By Authority of
The State of Florida for
The Public Service Commission
Division of Competitive Markets and Enforcement
Bureau of Regulatory Review

RR-04-07-001

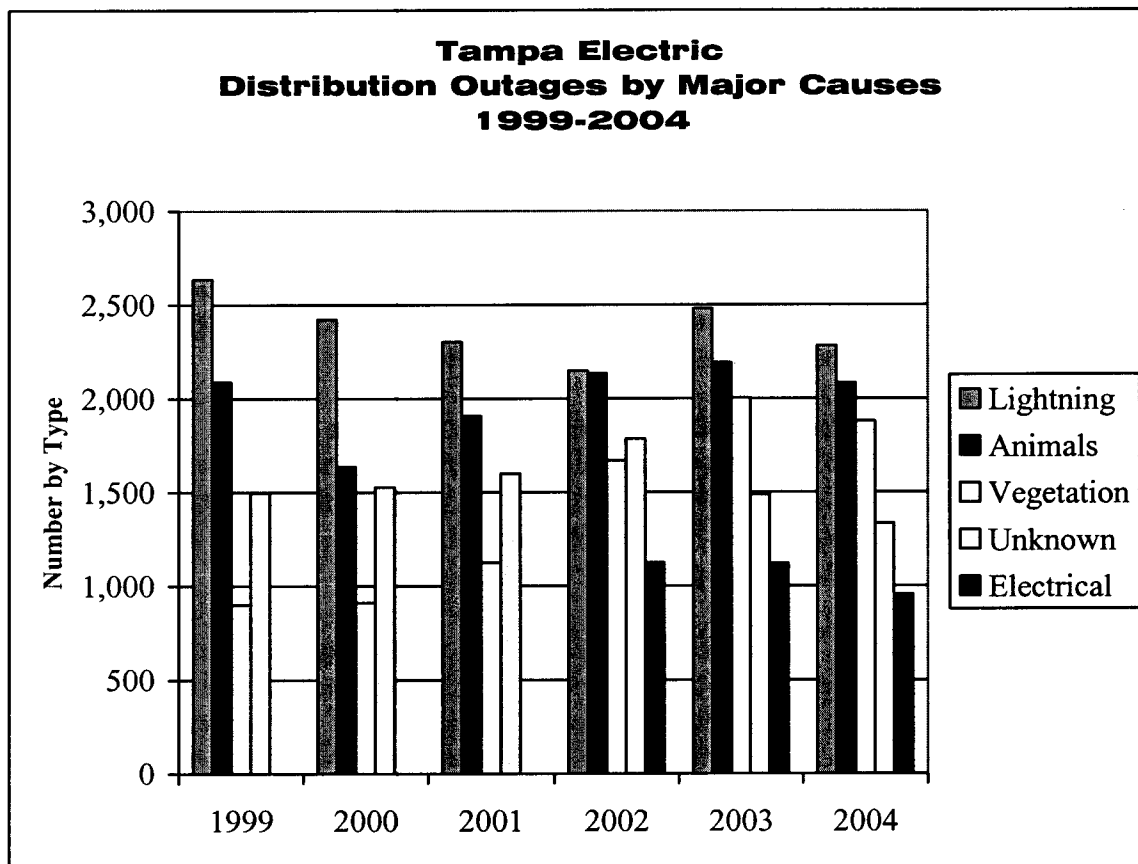
EXHIBIT 16

In 1997, Tampa Electric began reporting outages separately by overhead lines and underground. The totals reflected in **Exhibit 16** report the leading cause codes for the period 1999 through 2004.

*Electrical category not reported for 1999-2001

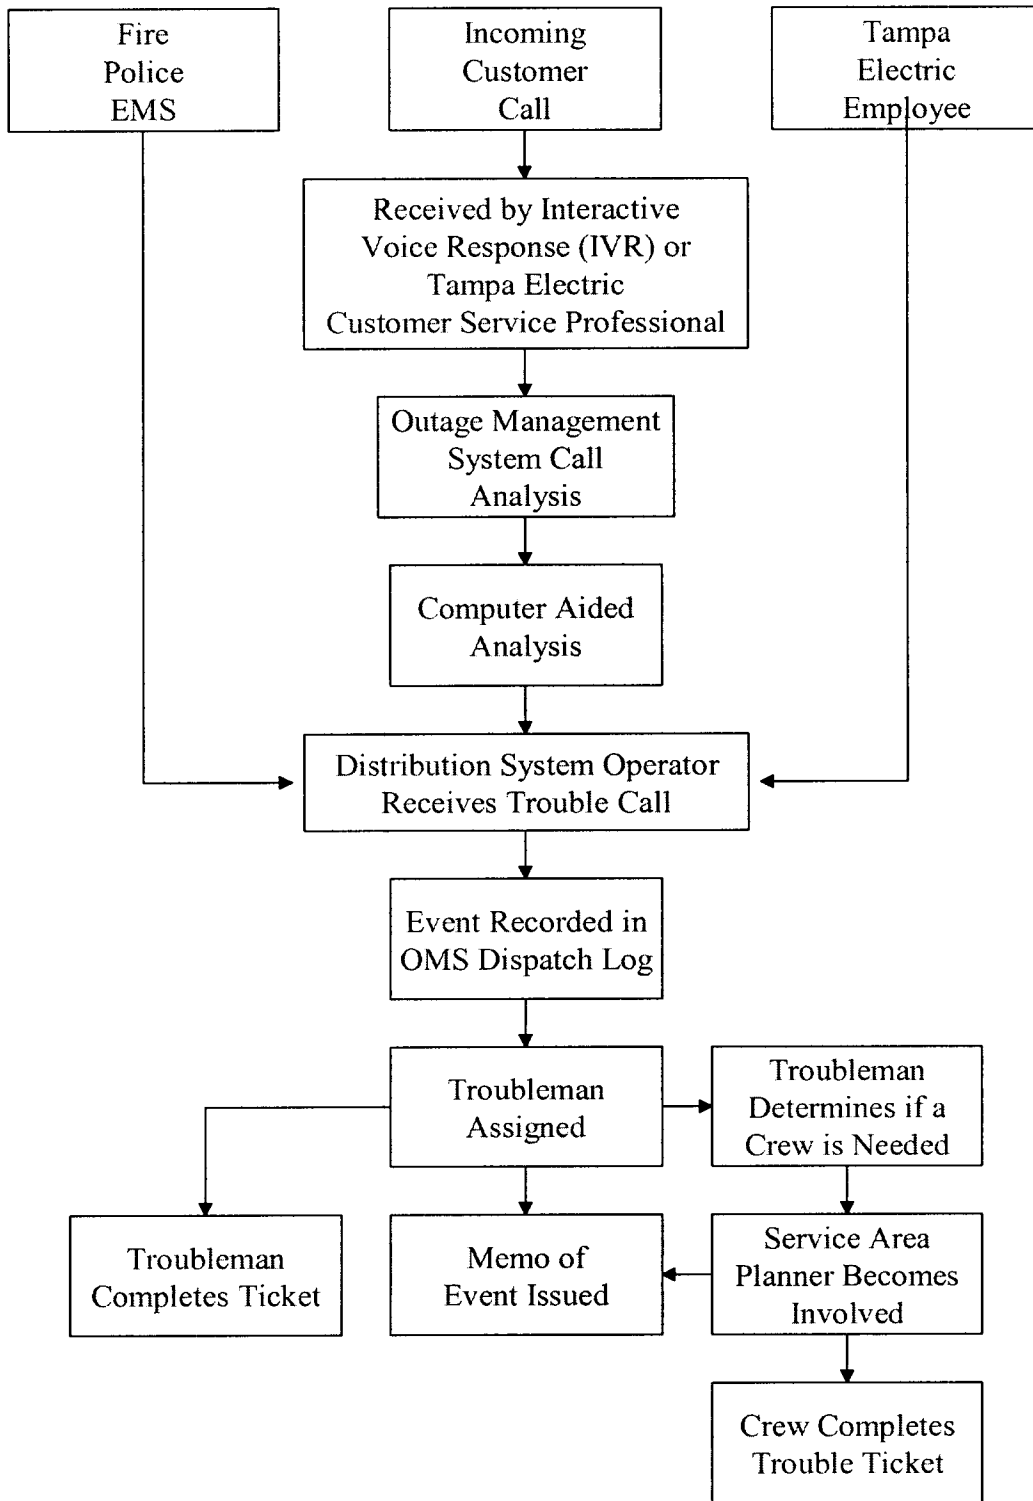
EXHIBIT 19

For example, a troubleman may have three trouble tickets assigned to him, each being displayed on his mobile data terminal. One ticket may be coded to indicate the customer is experiencing a "partial outage" and the second may be coded to indicate "all power out". A third ticket, also coded as "all out," is upgraded to indicate multiple calls from the same area - an indication that the outage is widespread. In this example, the troubleman would probably take the "all out" upgraded call first, next would be the "all out" single residence, and third would be the "partial outage".

**Tampa Electric
Trouble Reporting Process
As of 12/31/04**

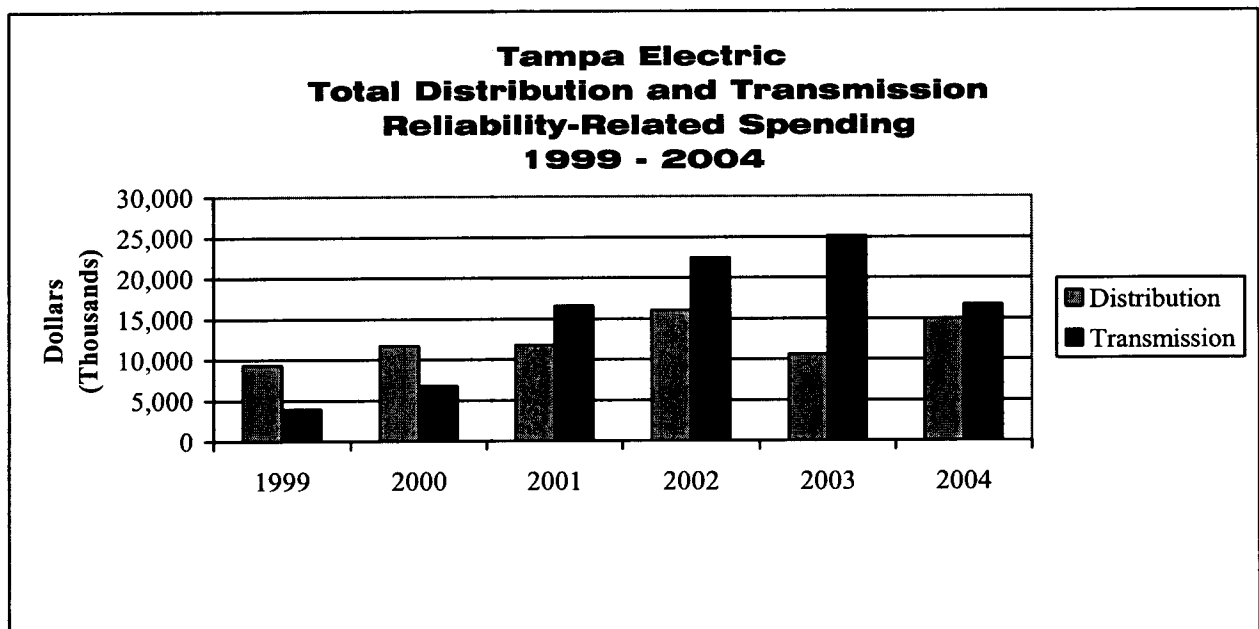
EXHIBIT 27

Exhibit 27 shows Tampa Electric’s total expenses for distribution and transmission reliability-related spending during 1999-2004. These amounts include both preventive and corrective maintenance and upkeep of the company’s distribution and transmission facilities.

*2004 transmission actual expenses are as of the end of September

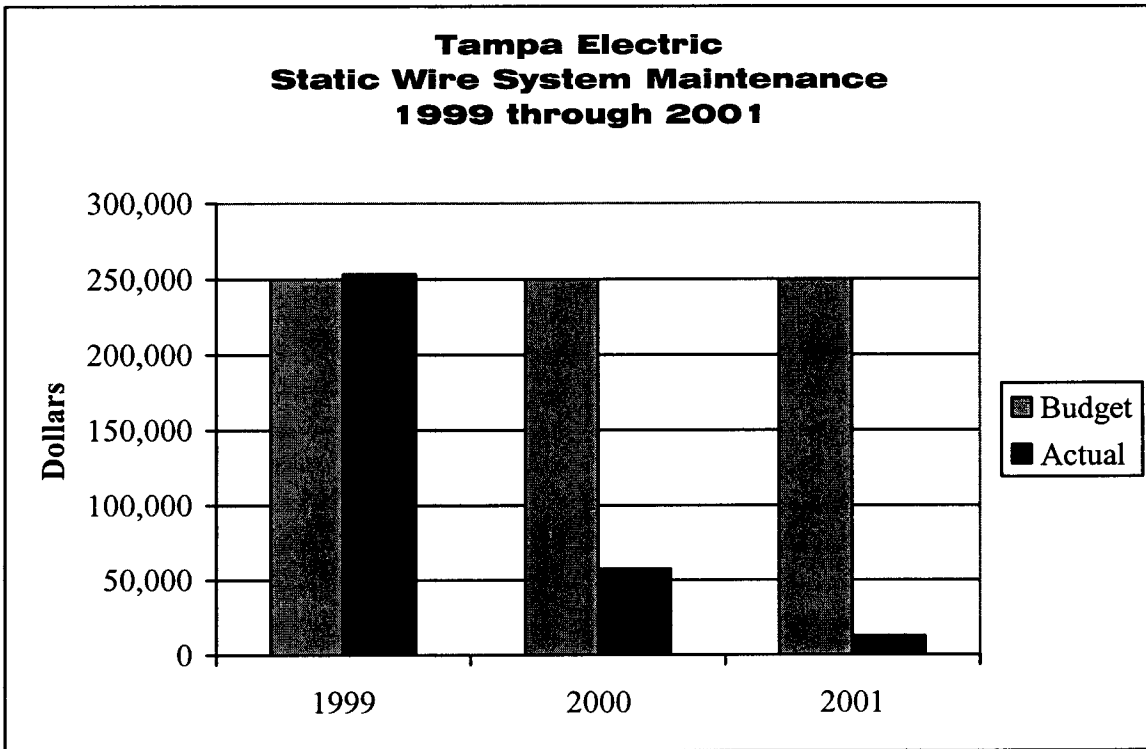
EXHIBIT 32

In 2002, Tampa Electric ceased tracking efforts for transmission static wire maintenance as a separate item. Beginning in 2000, Tampa Electric states that it began to move away from a program of performing both preventive and corrective static wire maintenance to a modified process focused on making repairs on a corrective basis. The company states that shifting maintenance practices to making corrective repairs was directed at maximizing the benefit to the system for each dollar spent. Funds that were budgeted for static wire maintenance but not spent could have been made available for other maintenance or construction.

Tampa Electric states that it intends to focus on more preventive static wire replacements in 2005. As a result of recent inspections, Tampa Electric has identified preventive maintenance work that can be done on static wire splices that will greatly reduce or eliminate corrosion at the joint. The company believes that these inspections and corrective actions should prevent a reduction in service life for the splices and wires and are an integral part of the company's increased focus on maintenance in 2005.

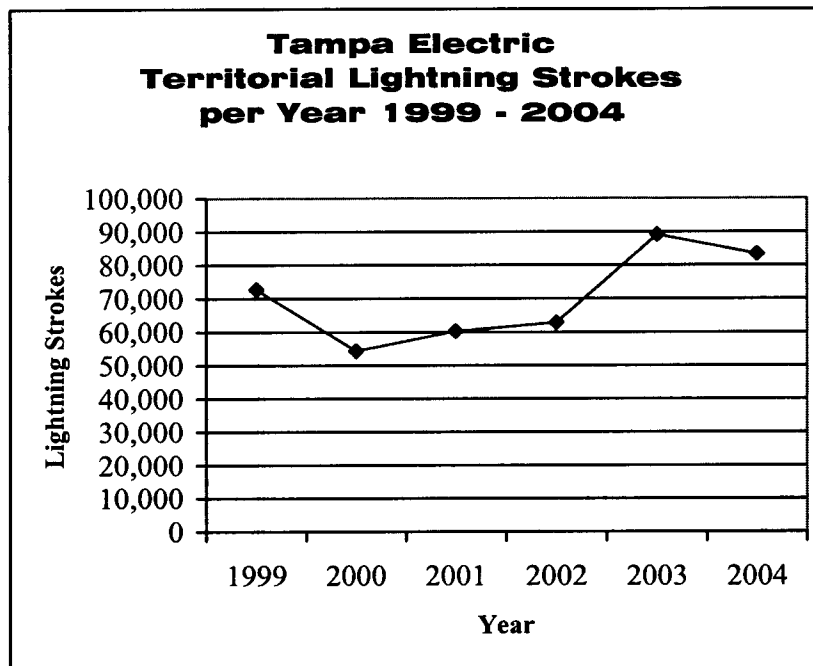
EXHIBIT 33

There are two basic lightning protection components for distribution facilities, the shield wire design and the arrester design. Tampa Electric utilizes the arrester design and arresters with ground wires. Tampa Electric's lightning protection design includes the following:

- Arresters located at least every one-quarter mile on wood poles and every one-eighth mile on concrete poles and on all equipment poles.
- Circuit breaker reclosing sequenced to decrease potential for equipment damage.
- Surge arresters installed in auto-switch gear.
- Program developed to install meter-based surge arresters.

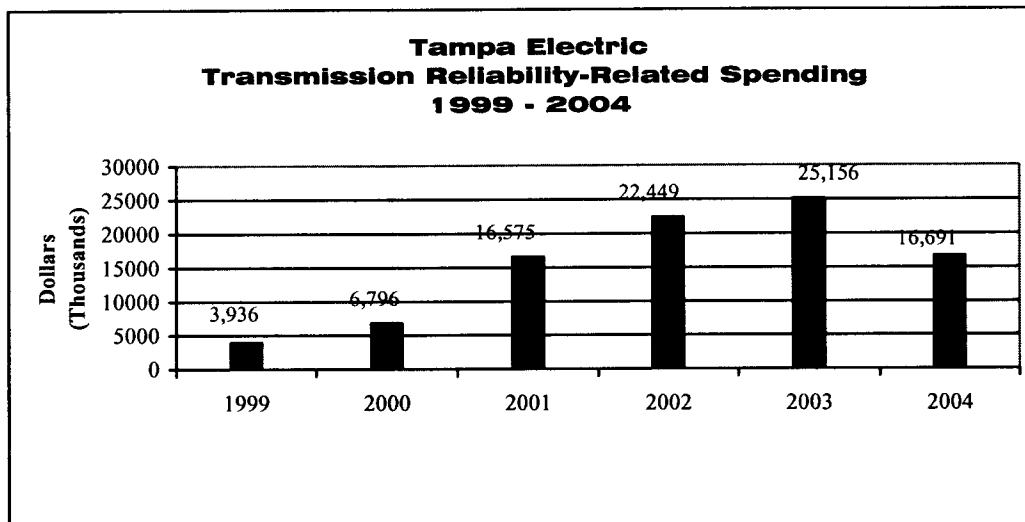
EXHIBIT 36

As indicated in Exhibit 36, transmission reliability spending rose sharply from \$3.9 million dollars in 1999 to approximately \$25.2 million dollars in 2003. However, in 2004 total transmission reliability spending dropped to \$16.7 million, and for 2005 the company has budgeted just \$12.3 million.

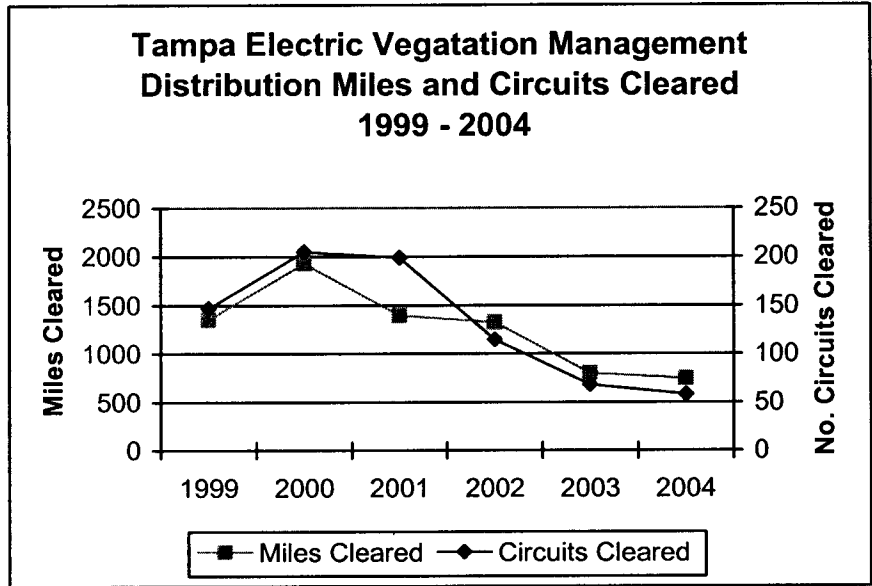
EXHIBIT 43

Vegetation control encompasses the removal and clearing of all plant matter from transmission and distribution lines. Although tree-trimming is the largest component of this process, removal of vines and other vegetative material is also included here. **Exhibits 43 and 44** depict the total miles and number of circuits cleared of vegetation annually from 1999 through 2004 for both distribution and transmission.

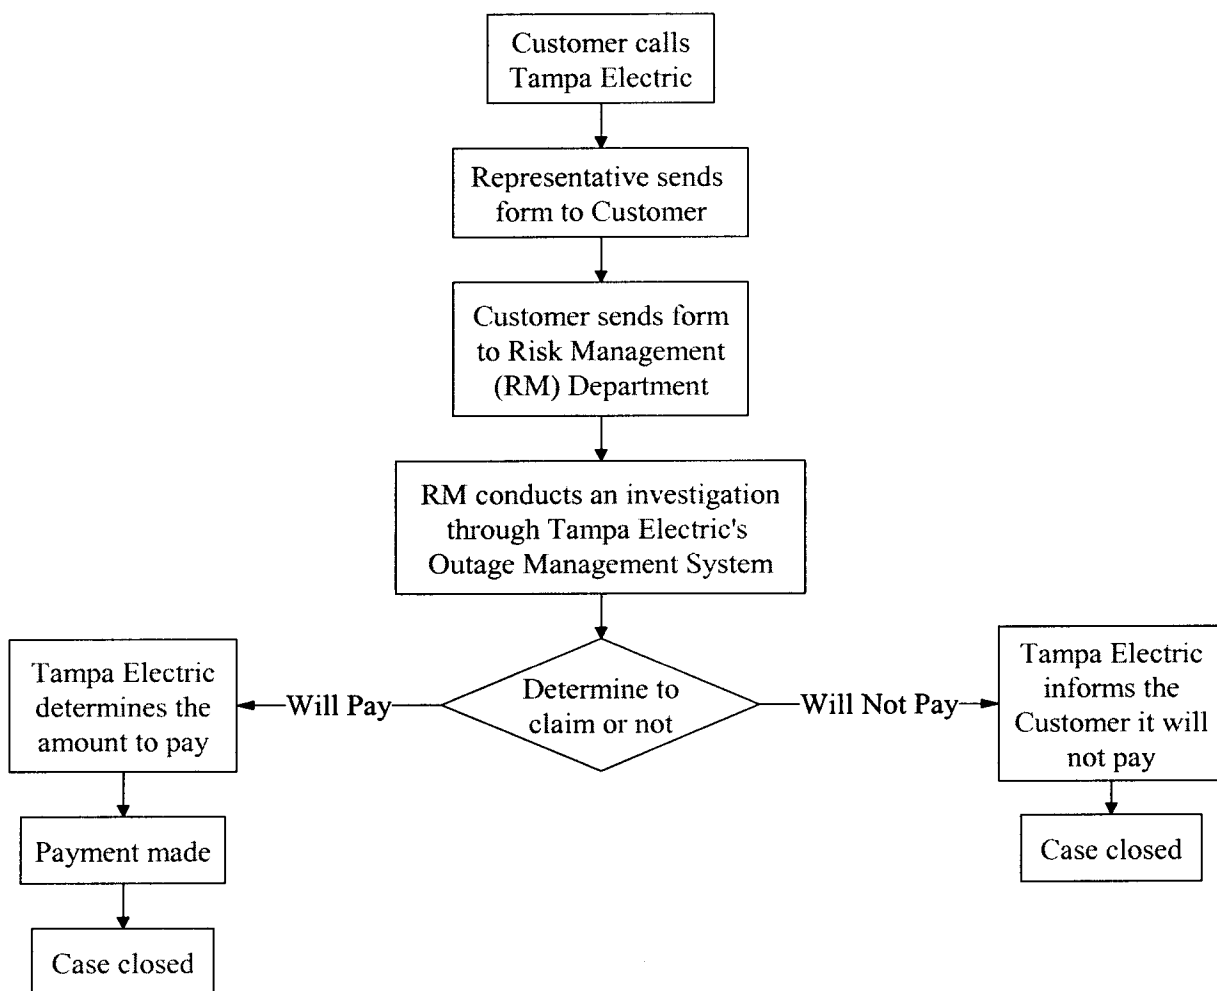
EXHIBIT 47

As depicted in Exhibit 47, the process for resolving a damage claim begins with the customer contacting Tampa Electric to make a complaint. As described in the process for handling customer inquiries, a customer service representative will take down the address from the customer and mail a Customer Claim form.

Once completed, the Customer Claim form is sent to Tampa Electric's Risk Management Department. Risk Management conducts an investigation to verify that there was some type of trouble reported or indicated at the location and time where the damage was claimed to have

occurred. If the investigation determines the location did experience trouble during the time in question, the claim is further investigated. Tampa Electric determines whether the trouble reported have caused the damage claimed and ultimately whether the company is liable for the cause of the damage. Once all elements of the claim have been looked at, the company will decide whether to pay the claim or not. If the decision is that the company should pay, the appropriate amount is determined, payment is made, and the case is closed. If the decision is that the company should not pay, the customer is informed of that decision. If a customer disagrees or has additional information, the customer may contact Tampa Electric to re-open the file.

Tampa Electric Company Damage Claims Process As of 12/31/2004
