Flooding Hazard Reevaluation
Turkey Point Nuclear Generating Station Units 3&4 (PTN)

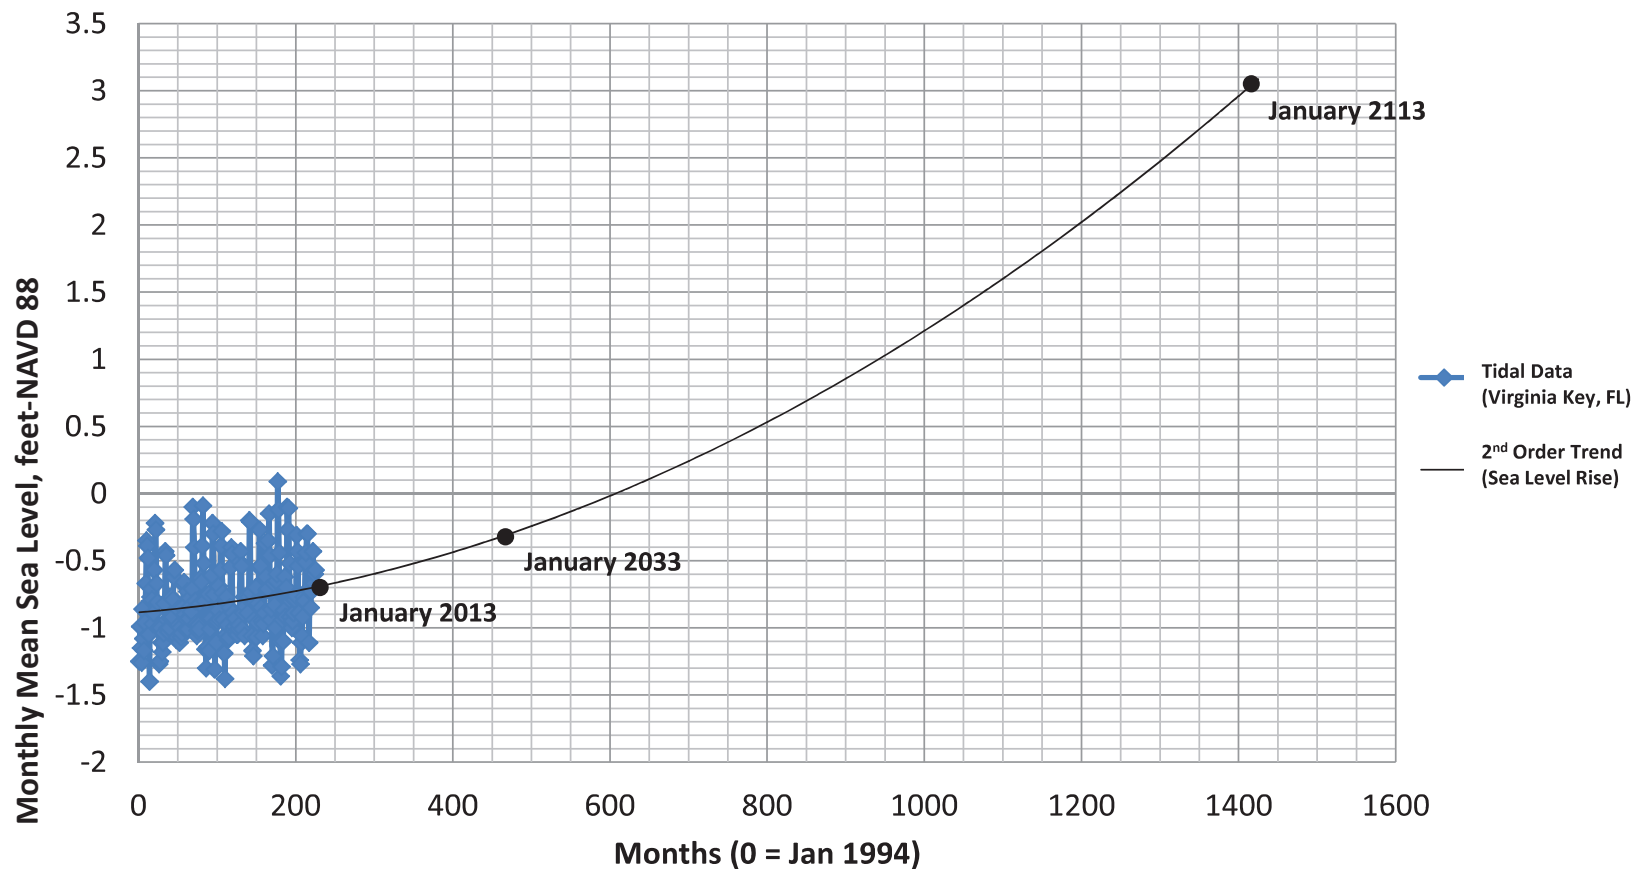
Figure 4-13

References: NOAA, 2012e.

Sea Level Rise – 2nd Order Trend
