FPL's Response to OPC's First
Production of Documents Nos. 4-5

Power Delivery Performance

Hurricane Irma

Report Date: April 19, 2018

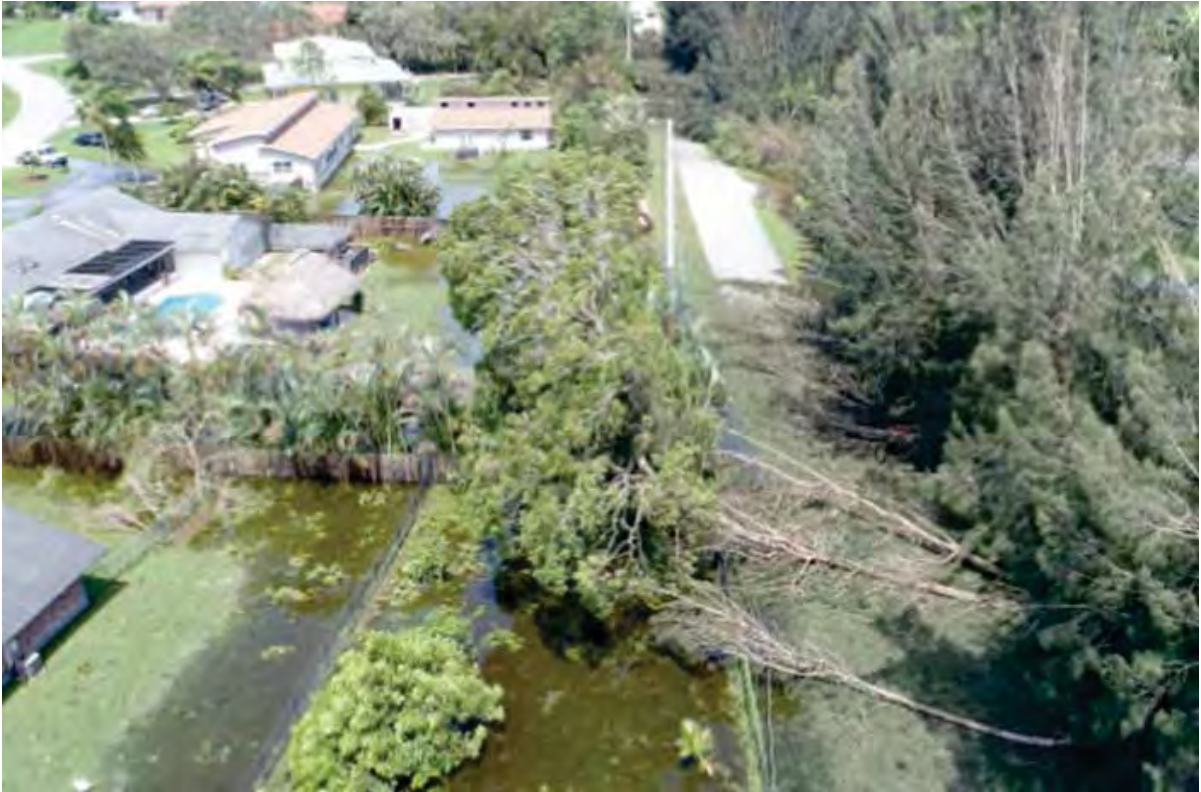
Vegetation outside of ROW toppling into Overhead Circuits was common.

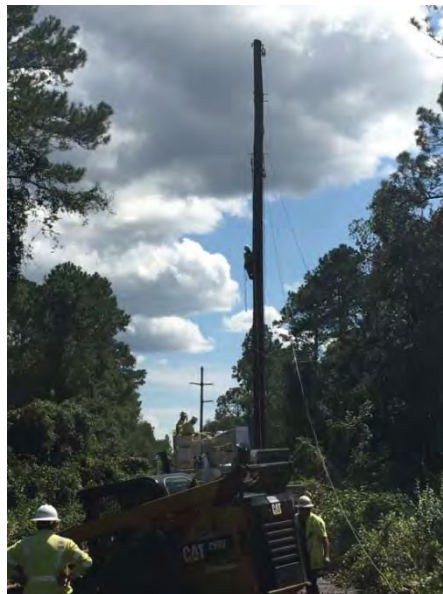
Pole Replacement of Structure 75G3 (115KV line in North area)

- One single pole wood structure (75G3) was replaced on the Deland-Putnam 115kV [0091] Line, Satsuma Tap-Putnam Tap Section.
 - The poles were inspected in 2017. The pole was reported as Level 4 condition (replacement not required).
- Winds in the area were reported to be 61-80 mph gusts or higher
- An approximately 80 foot tall slash pine tree was reported to have fallen on the transmission line; the impact caused this pole to fail.

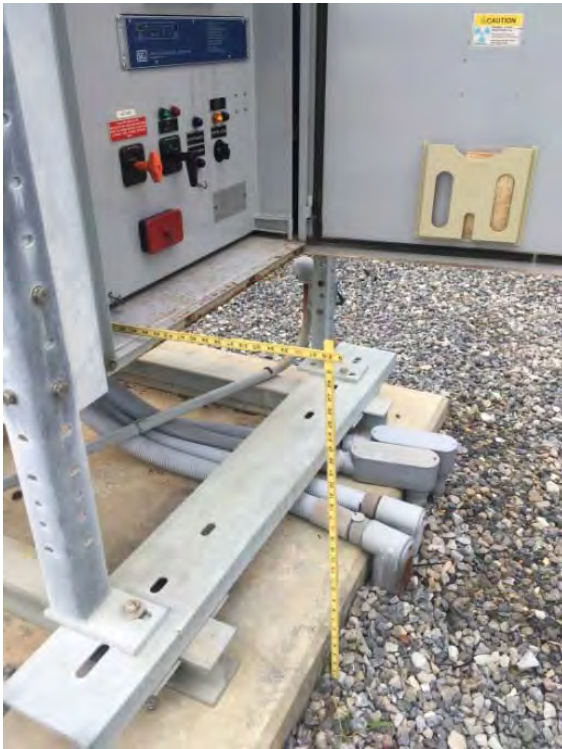
Only St. Augustine substation had damaged equipment related to flooding.

Feeder Breakers with water intrusion

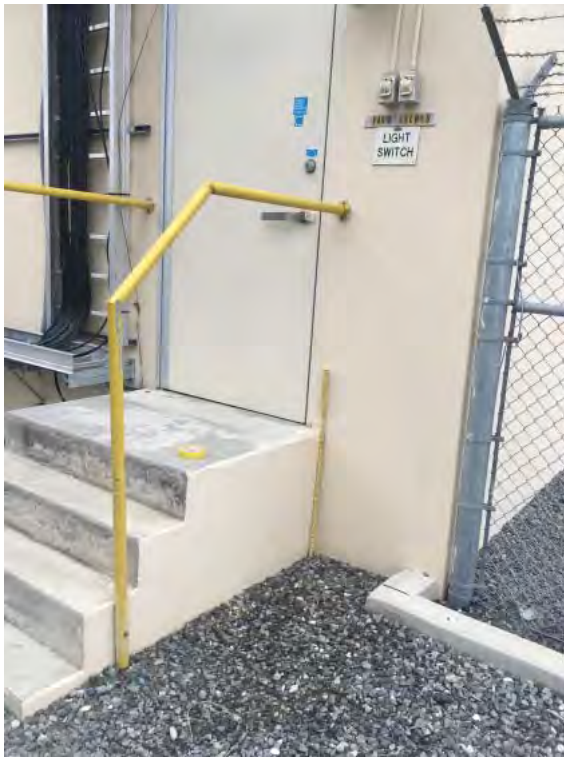
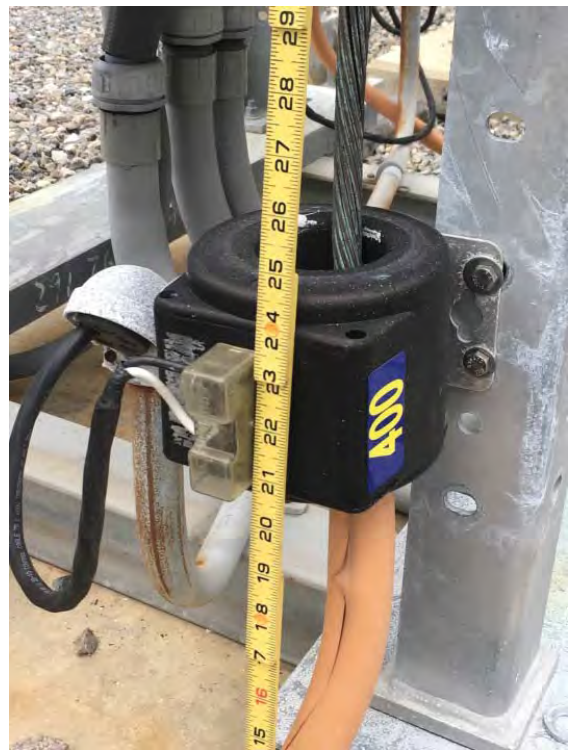
Fault bus CT's were submerged throughout entire substation

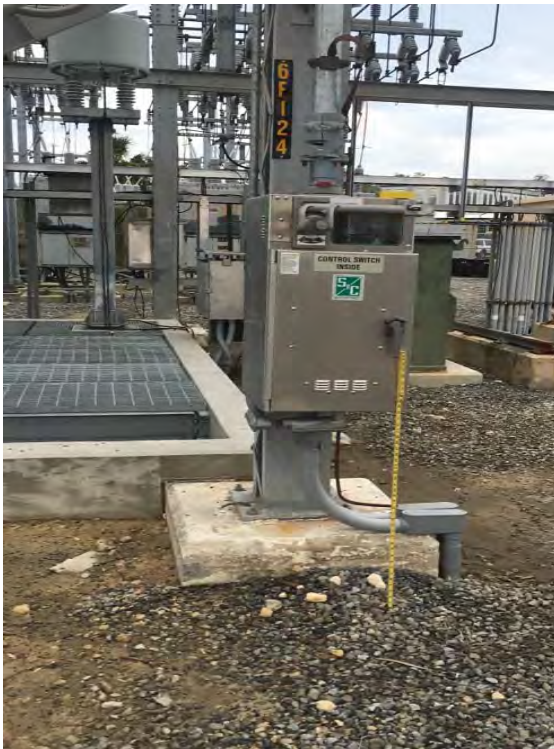
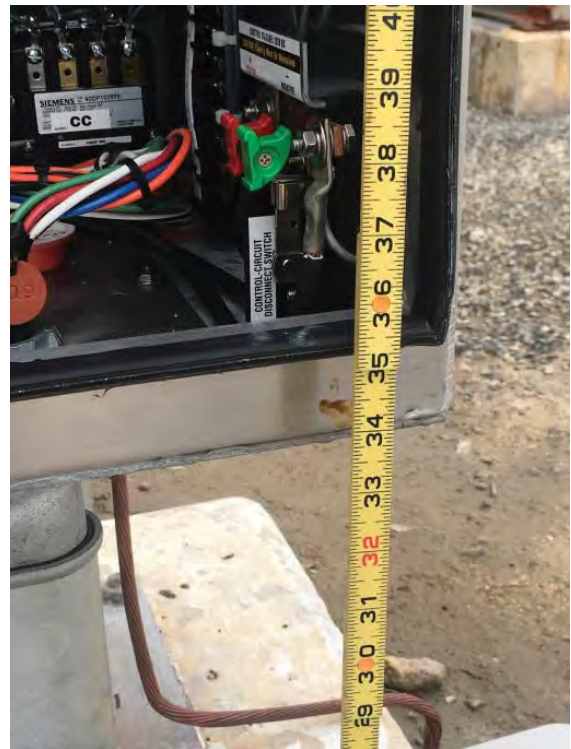
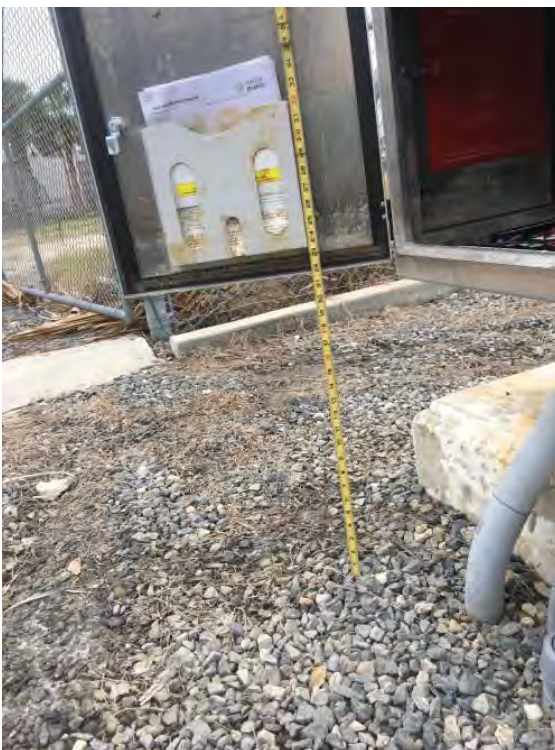
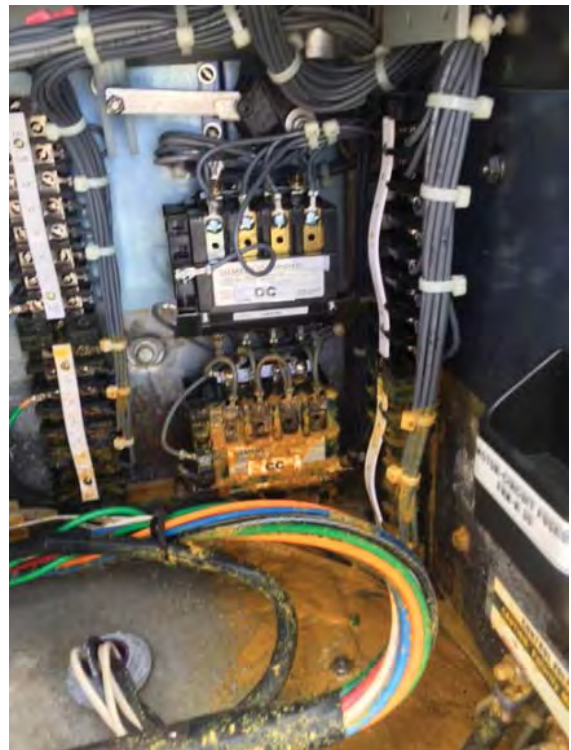
Examples of St. Augustine Substation motor operator impacted by storm surge

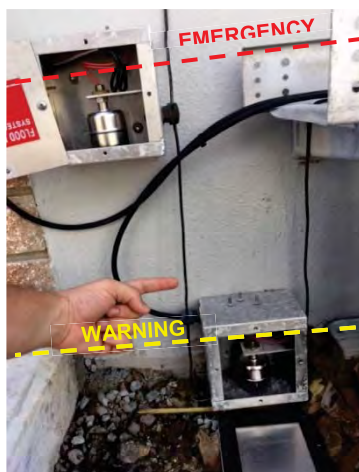
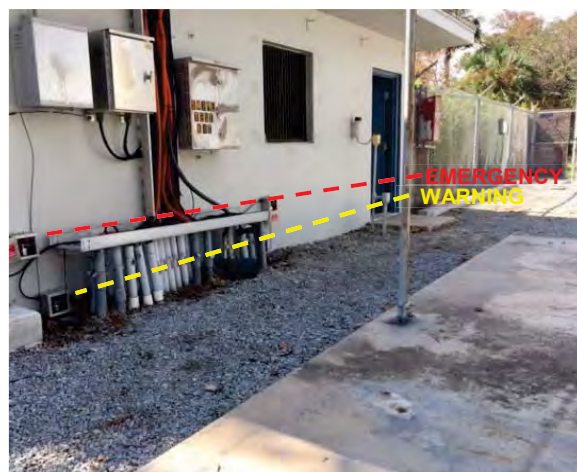
South Daytona Substation and Flood Warning Monitors

Station flood monitor warning alarm set off at 1:21 am on 9/11

Station flood monitor emergency alarm set off at 2:27 am

Both outdoor flood monitor alarms cleared at 6:57 pm

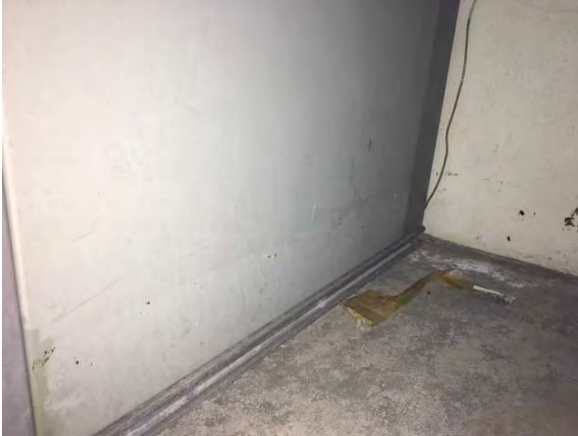
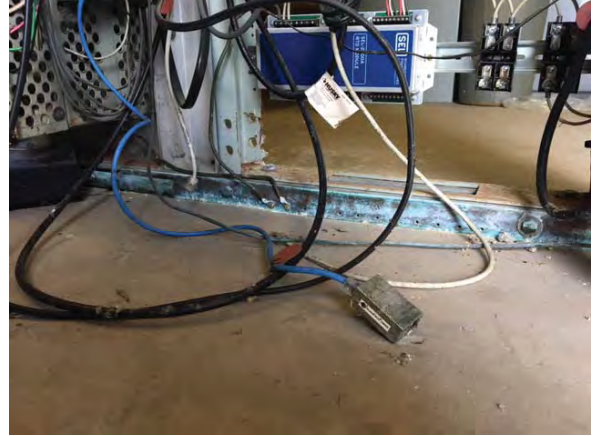
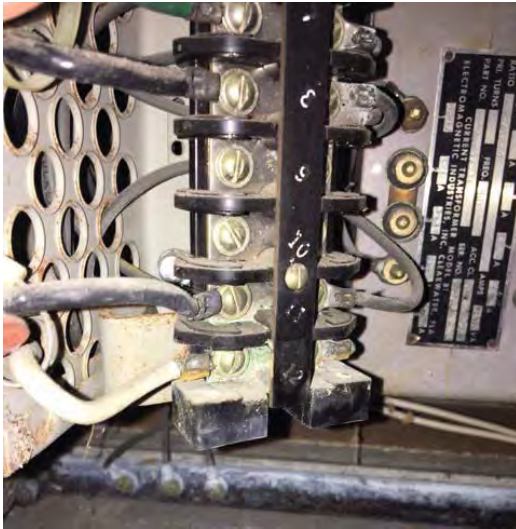
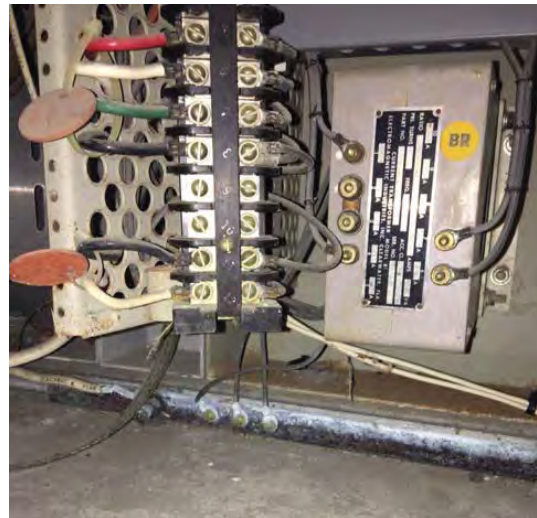
Examples of South Daytona Substation Damage inside the vault

Flood waters reached 5 1/2" on the inside of the relay vault and affected ground bus and some connections

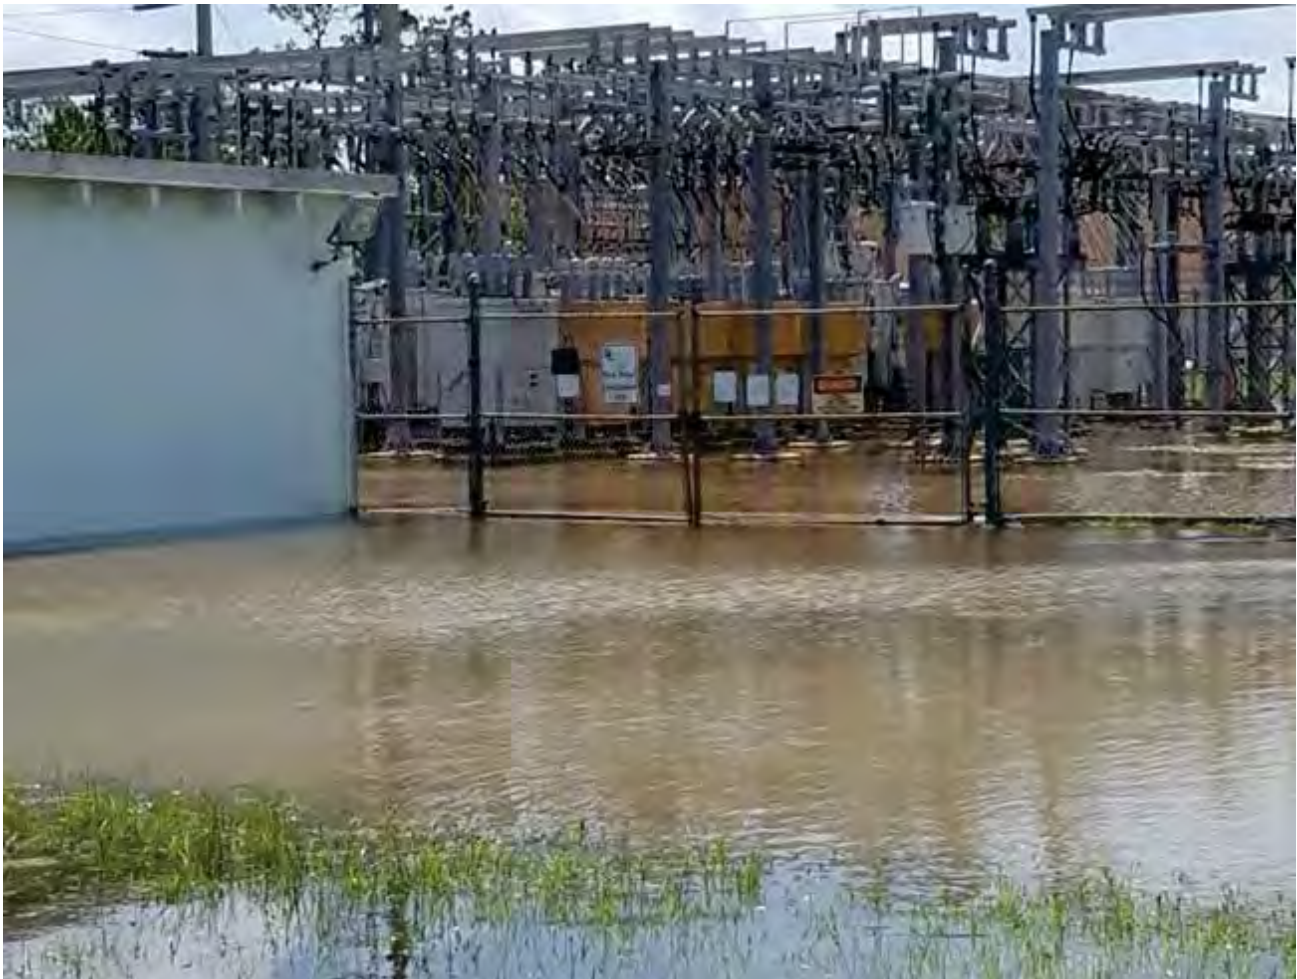
Pine Ridge Substation rain event flooding

Relay vault does not have flood doors, which allowed flooding to occur inside vault

- Rain Flooding .01 Ft. above Relay Vault small puddle on floor.

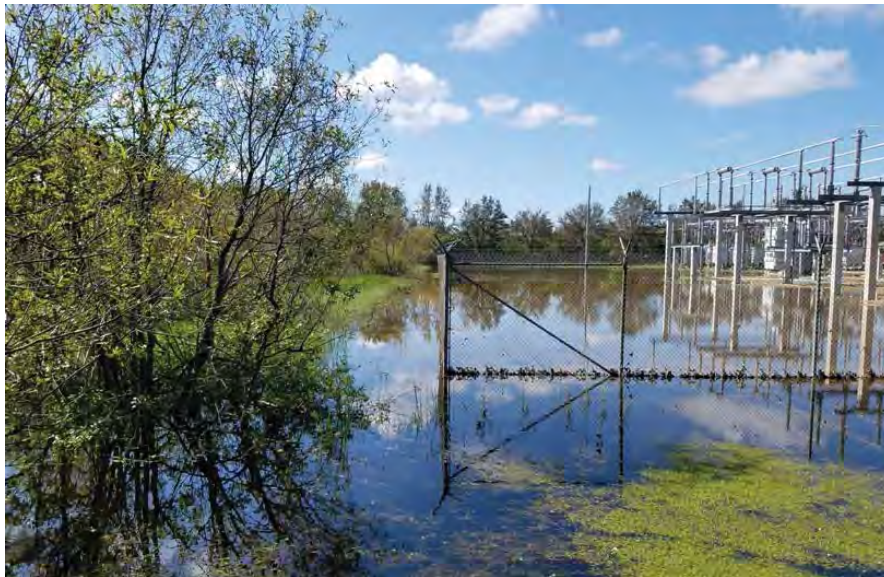
Corkscrew Substation Rain Event Flooding

Corkscrew Sub and Corkscrew Access drive (patrol road) flooded, including surrounding area and adjacent subdivision, however homes seems to be above flood levels.

- Flood waters from adjacent property impacted FPL property
- P&C van became stuck on Access drive attempting to access the substation
- Substation was only accessible by off road vehicles
- Rain flooding reported to be 1.5 Ft. to 2 Ft. above access drive.
- Rain flooding inside substation is 0.65 Ft. above average yard grade
- Relay vault does not have flood doors
- Rain flooding did not enter Relay Vault

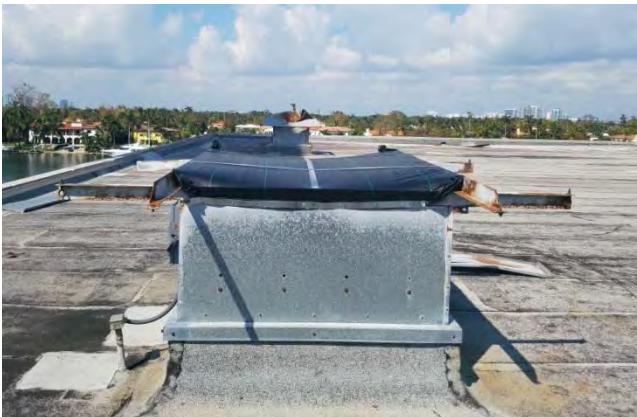
Indian Creek Substation – Roof Exhaust Fan

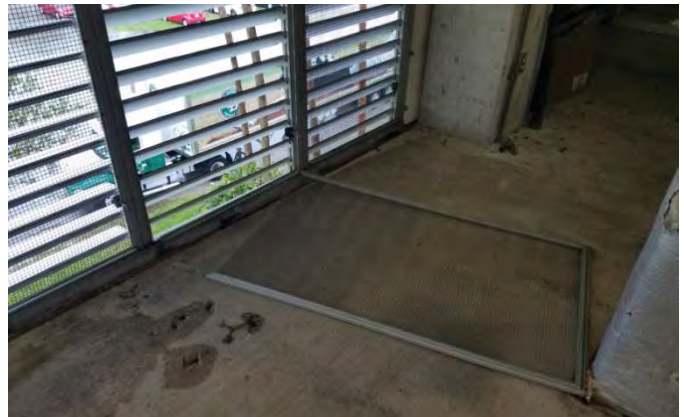
Watkins Substation – Louver Screen

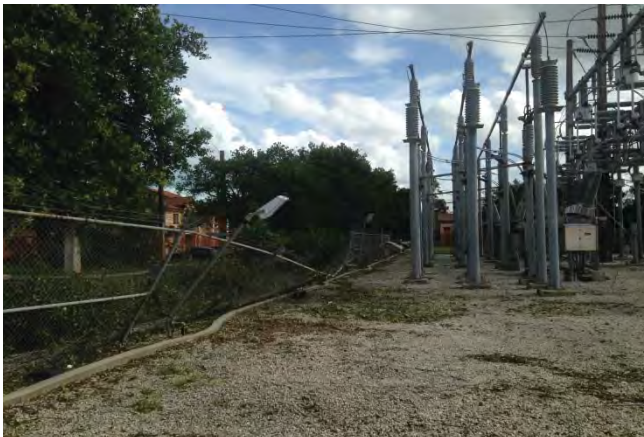
Crystal River Substation – Fence

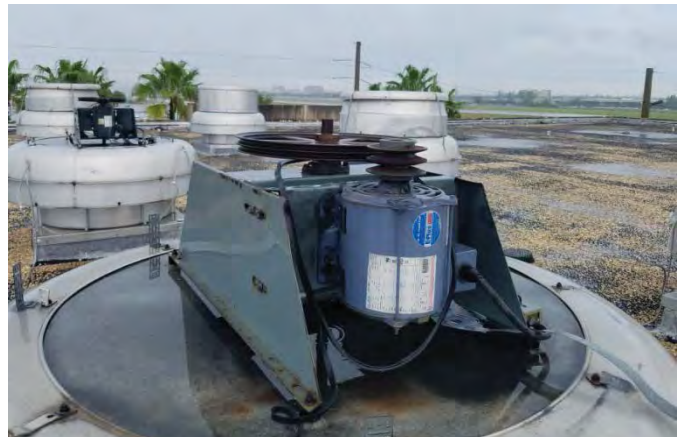
Watkins Substation – Roof Exhaust Fan

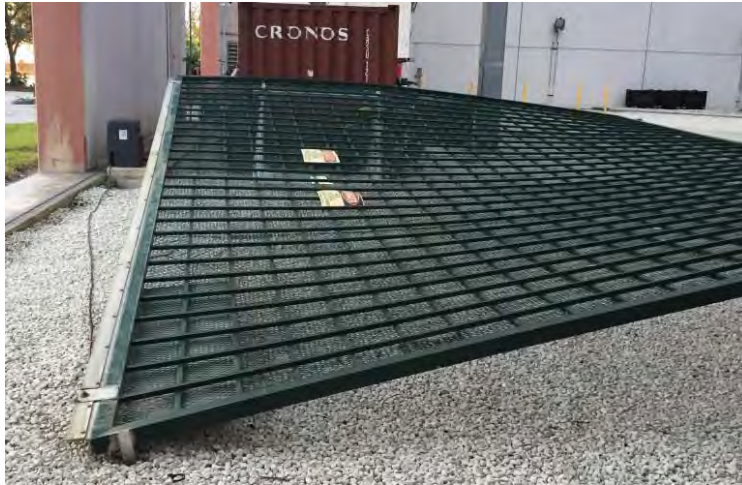
Natural Bridge Substation – Gate

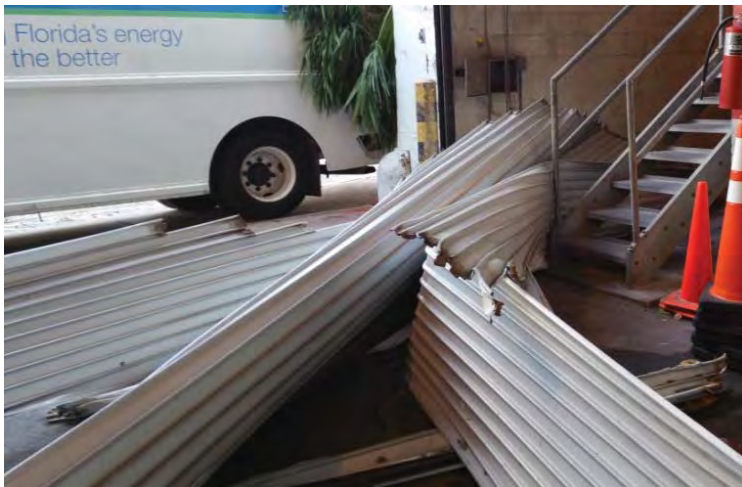
Watkins Substation – Overhead Door

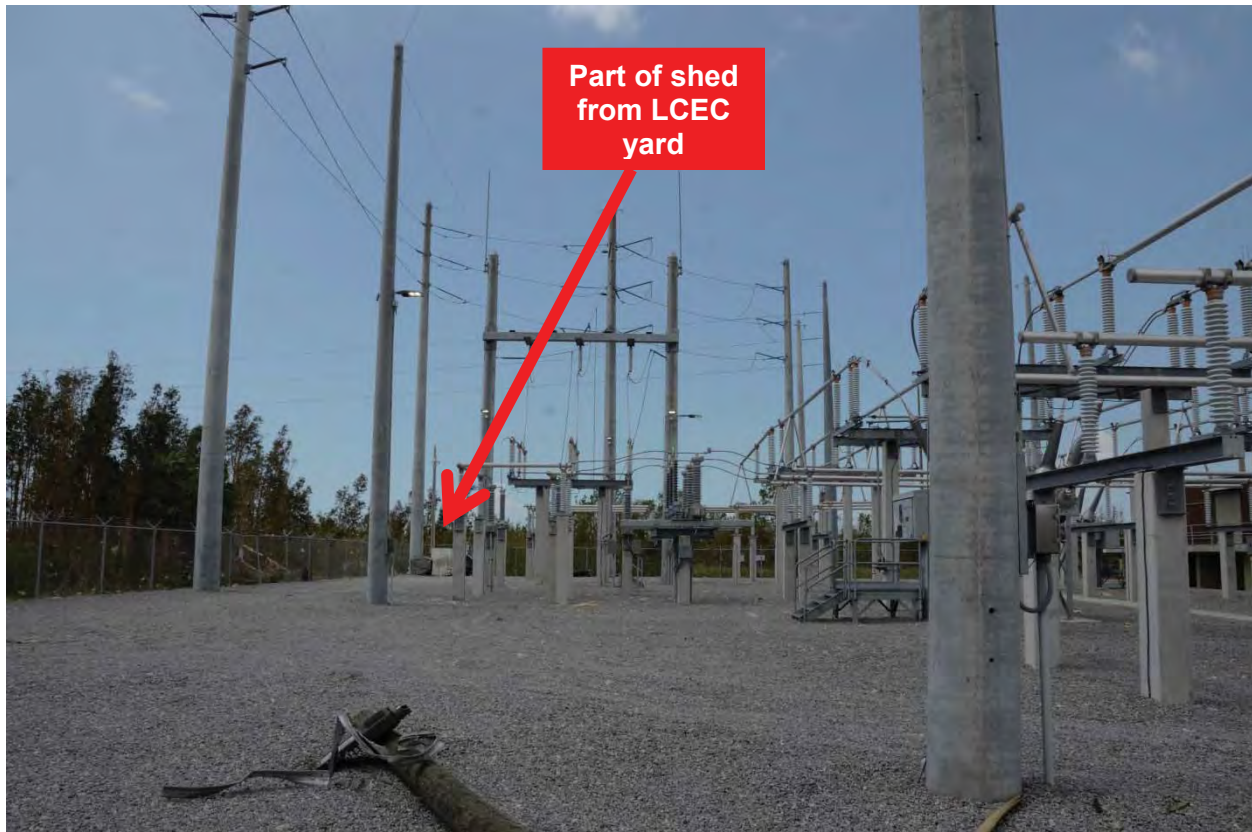
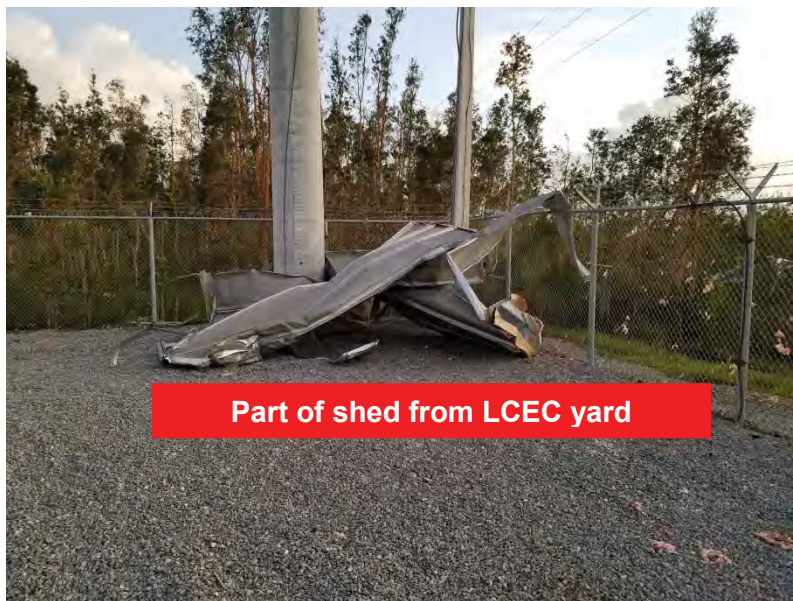
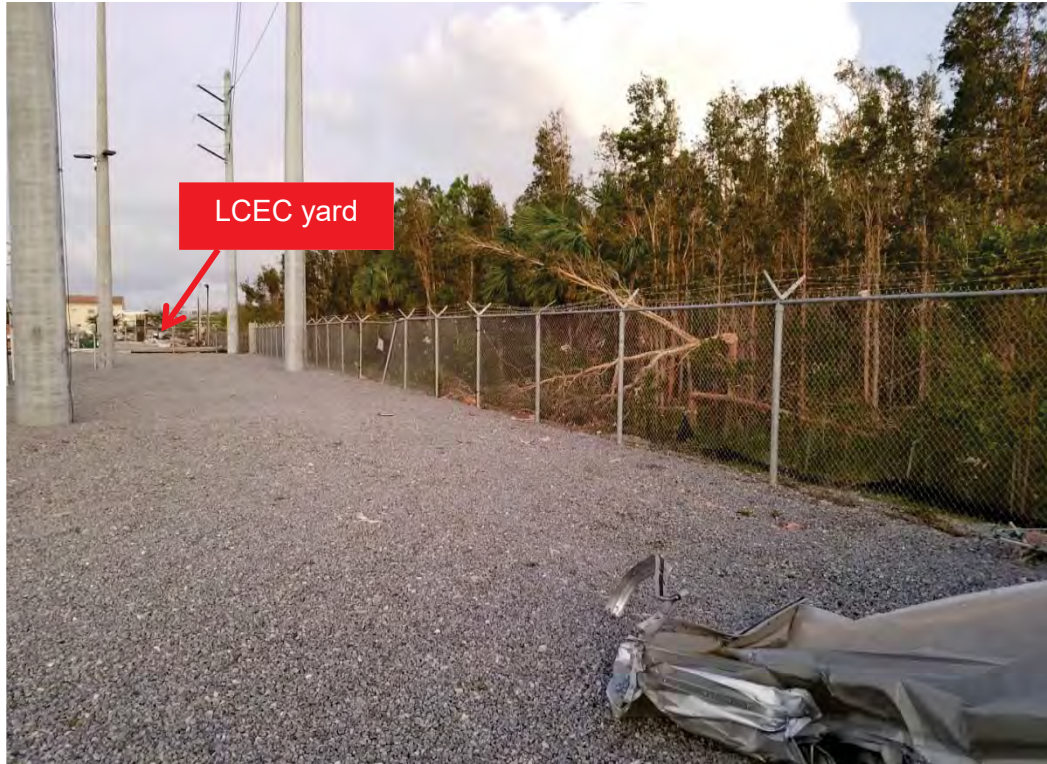
No evidence of flooding in station and no flood monitor alarm. Capri Sub did have evidence of flooding, so there may have been flooding in Belle Meade with no evidence found.

Large debris found in substation (part of shed and wood light pole from LCEC yard).

Current design, 150mph-gust-wind-designed fence partially damaged in areas due to flying debris and failing LCEC wood light pole.

Switch jumper was damaged/disconnected due to debris from LCEC.

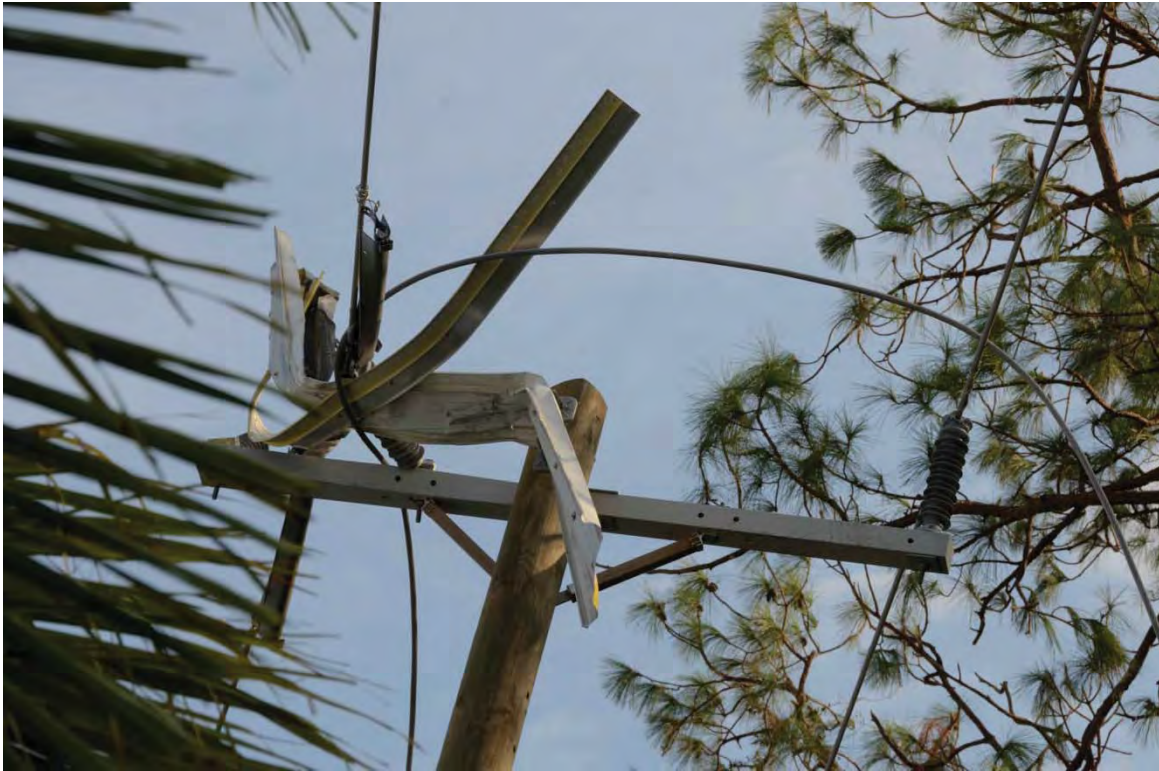
Debris wrapped around pole in line.

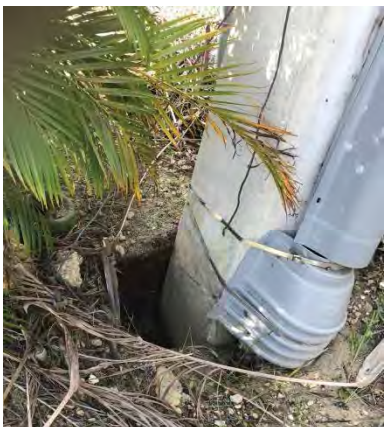
Base of leaning concrete pole

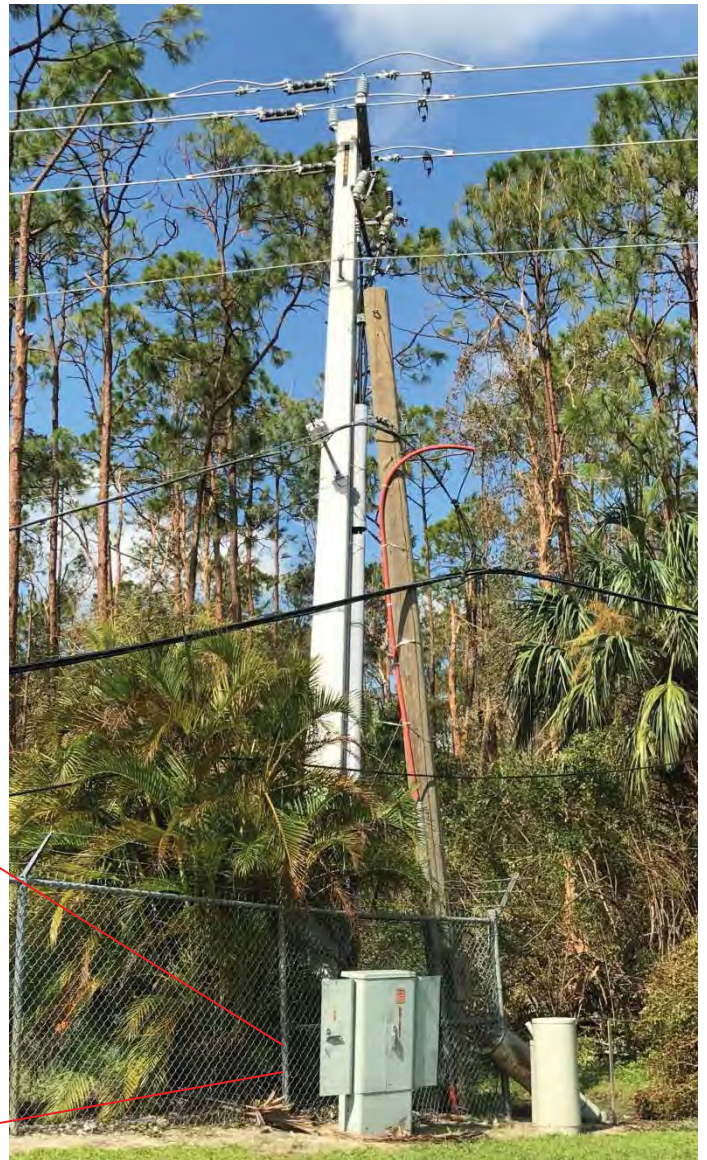
Leaning concrete pole

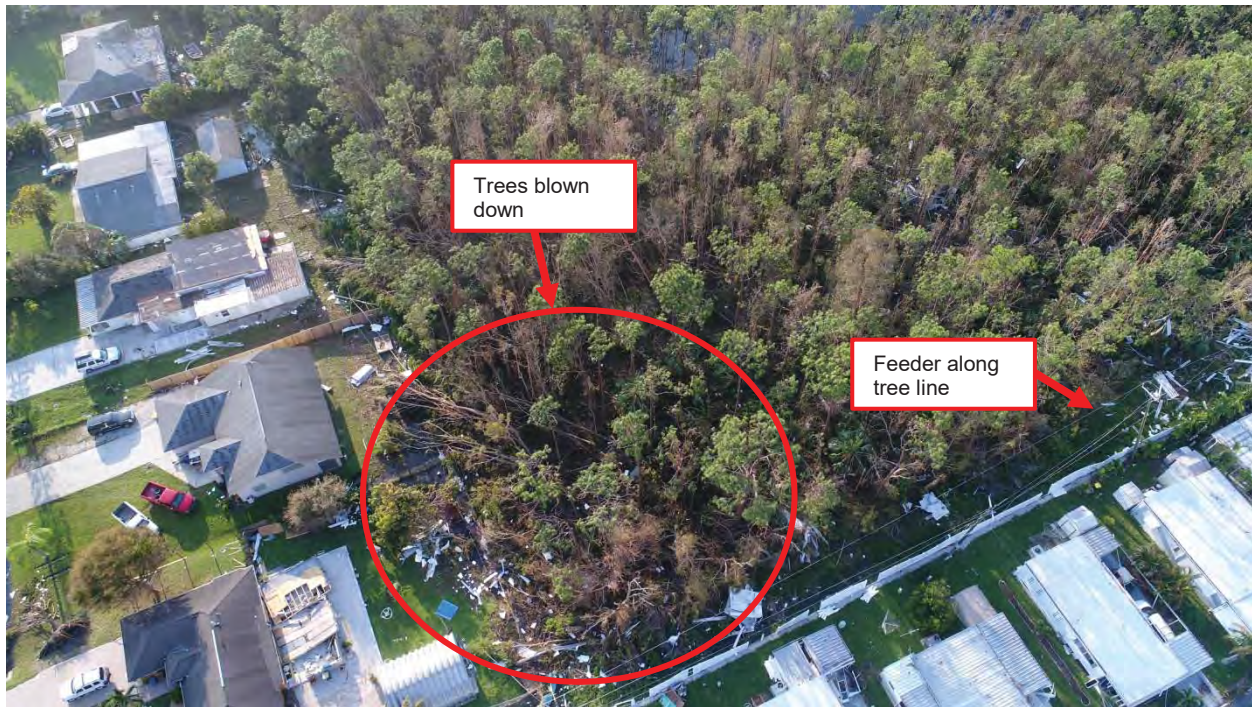
Indications of enhanced wind activity

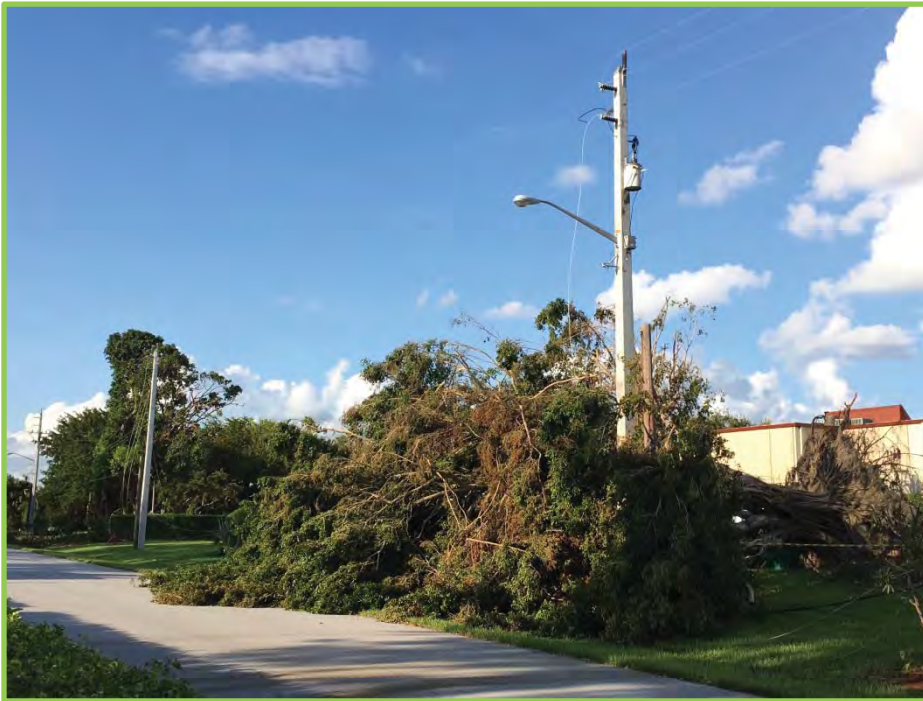
Hardened Feeder

- Wires down, but not the poles will result in quicker restoration.
- Boca Raton Area

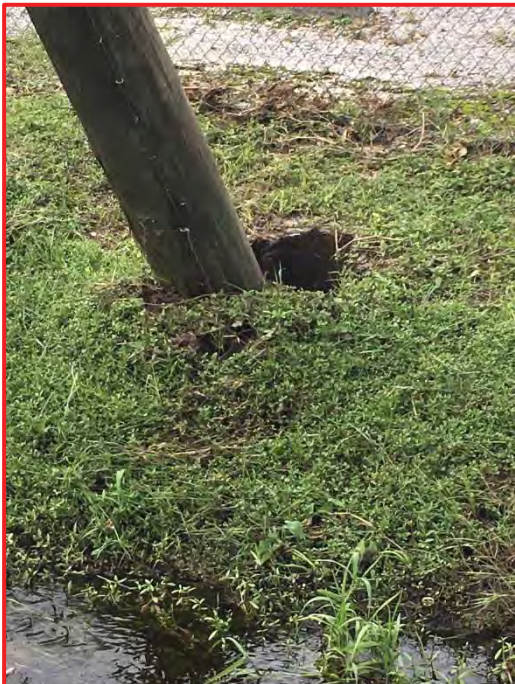
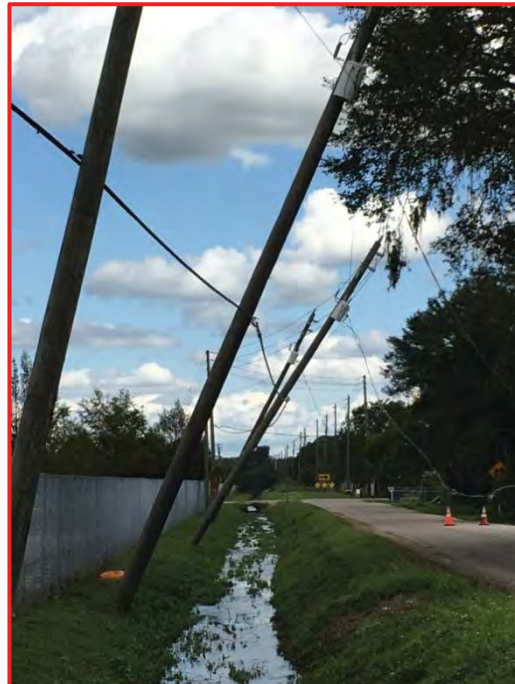
Non-Hardened Feeder (independent of the above Hardened Feeder)

- Leaning poles due to soft / saturated ground
- Carlstrom 5961 (Ft. Myers / Arcadia Area)

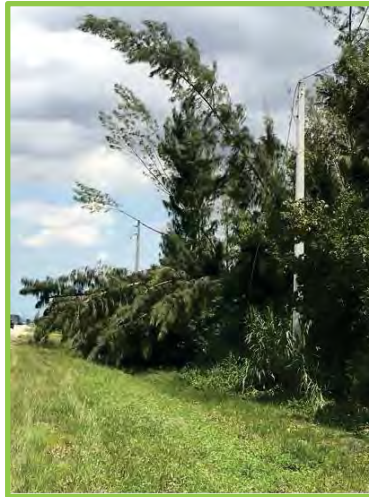
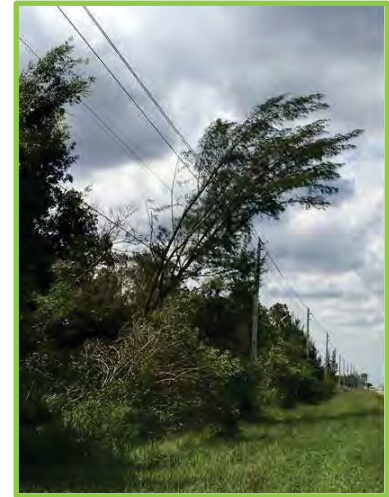
Hardened:

- No poles down.
- The only wires down were due to a massive tree
- However, this leaning tree did not bring down poles

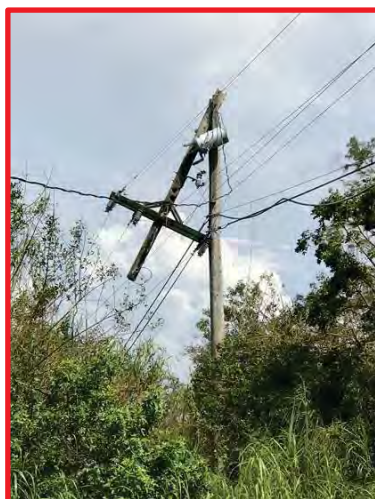
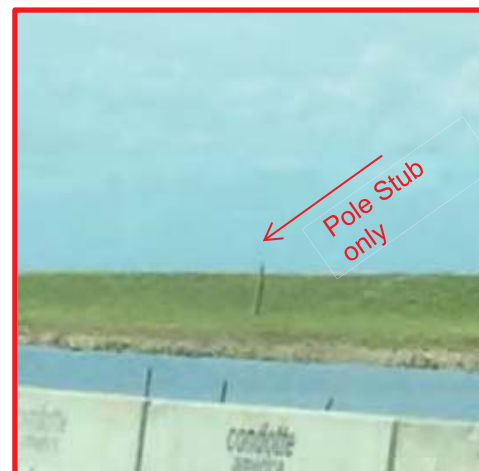
Non-Hardened:

- Feeder behind the OCR had three broken poles shown below due to wind
- Two stub poles are all that remain and the rest of the poles and wires were behind the berm across the canal

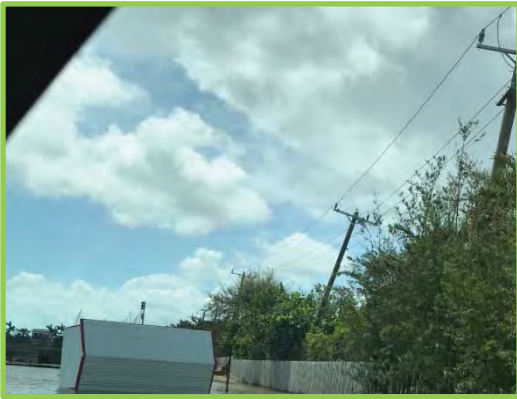
Hardened (Holy Cross 701937):

- Slightly leaning in rear of due to wind

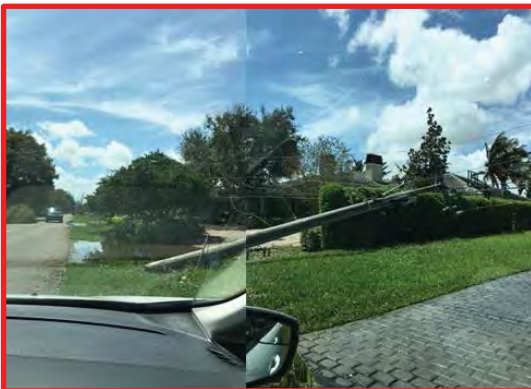
Non-Hardened (Sample 701932):

- Broken pole

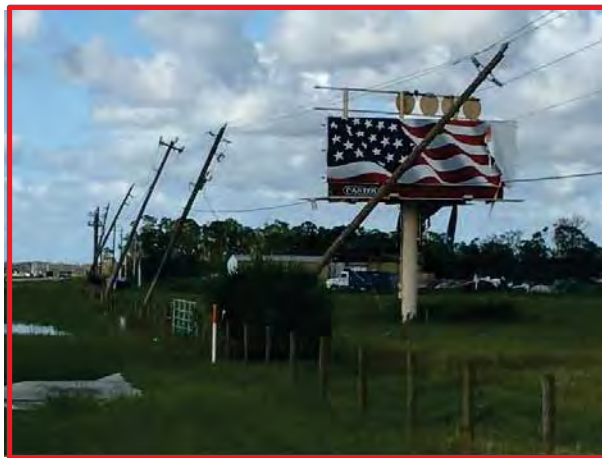
Leaning →

- Pole line leaning significantly as well as another section that had 2 broken poles. This section of Feeder was not Hardened
- Poles appeared to be 45'5 or 45'4 poles, but could not identify pole brand

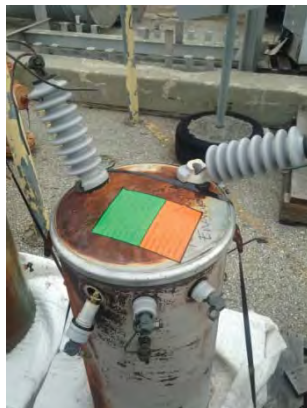
- The observed aerial transformers mainly fall in two categories:
 - Broken insulator/bushings due to trees and flying objects
 - Extensive physical deformation due to impact or fall due to broken pole

Broken bushings

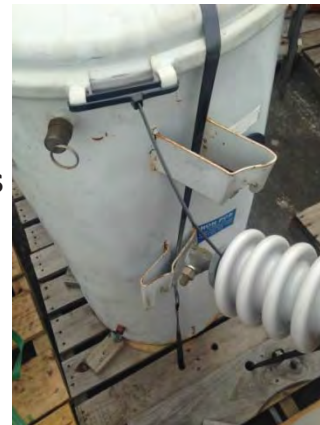
Bent frames

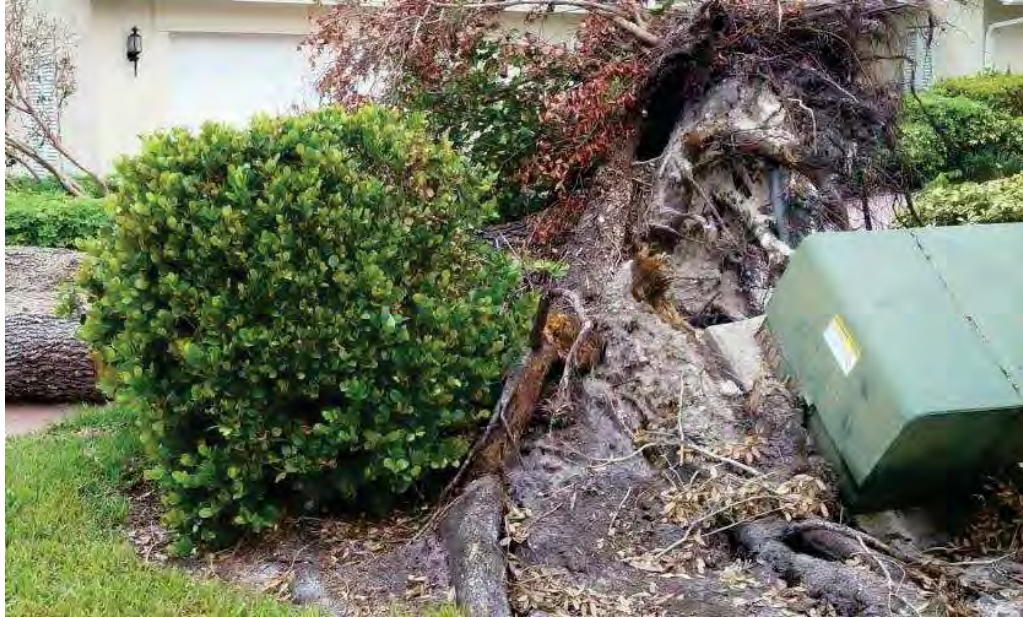
Before Restoration

Underground facilities were also impacted by vegetation

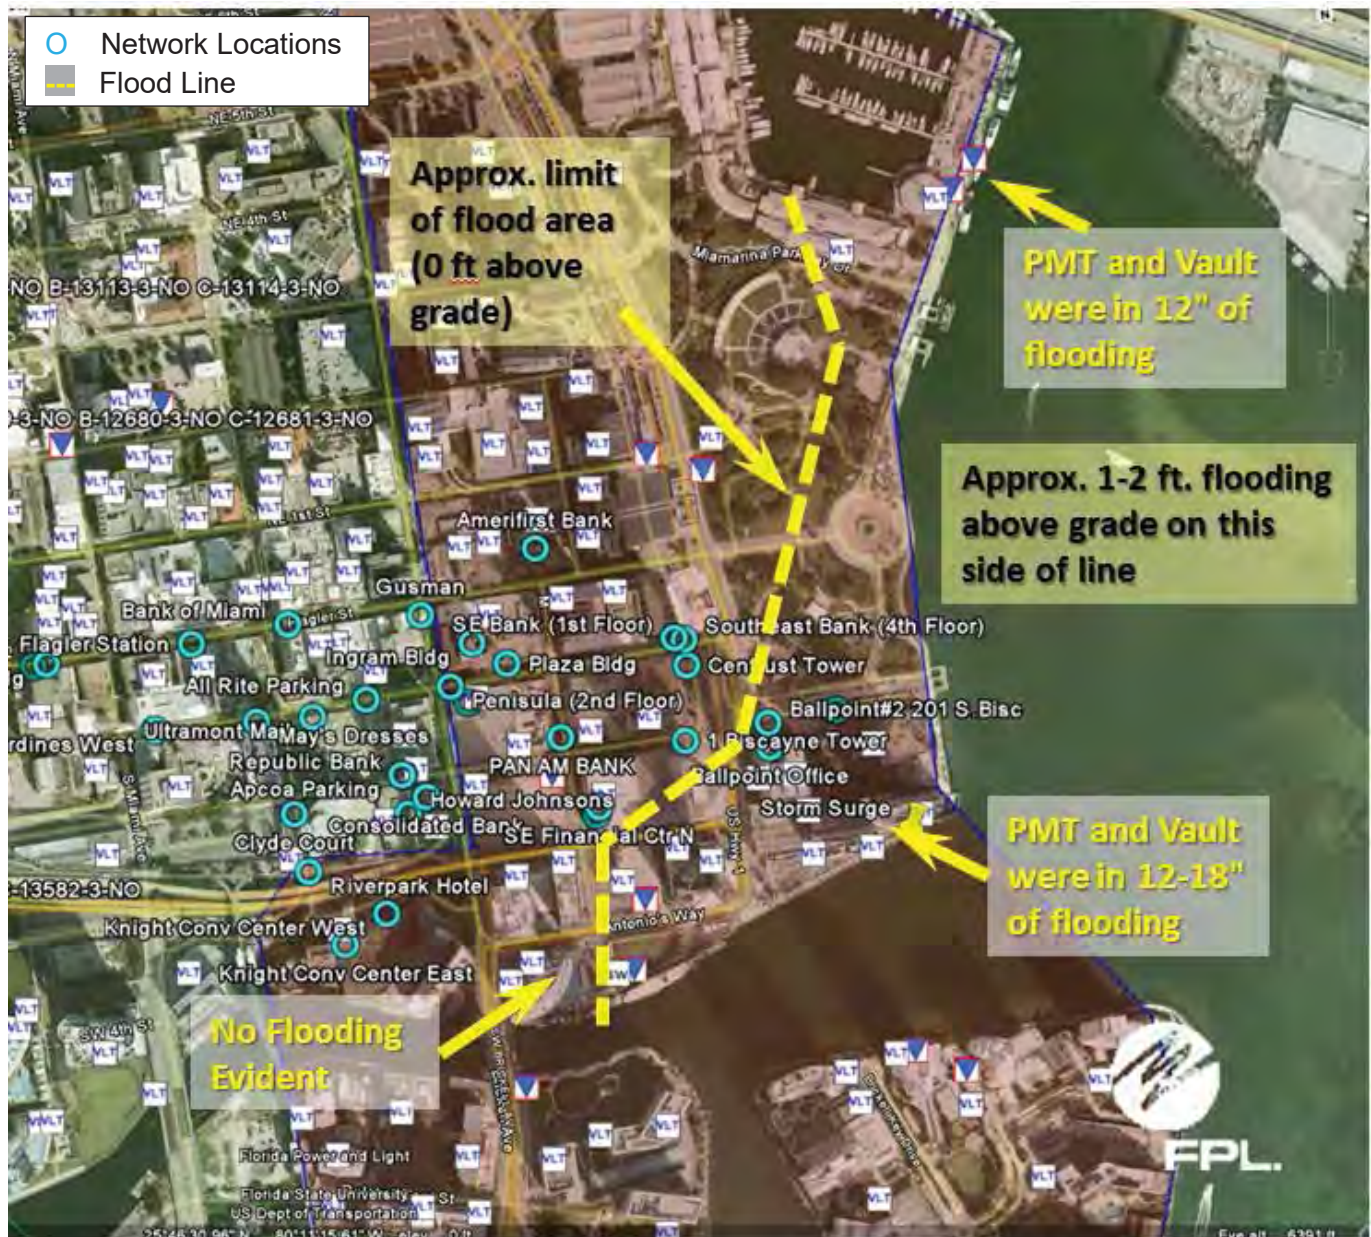
Exhibit 1: Flood intrusion into the Distribution Equipment in Miami

Of the above-ground Distribution equipment locations observed in select areas north of the Miami River, three of these locations are assumed to have experienced flooding ranging from 12" to 18" of depth. These locations are shown in **Exhibit 1**. South of the Miami River, vault locations in buildings were inaccessible, but flooding estimations were made.

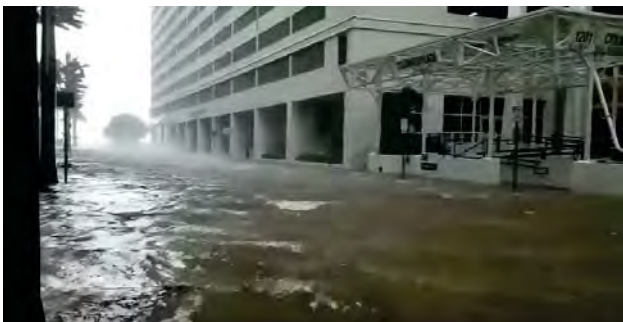
2' deep at SE 12th St & Brickell Ave (Mike Seidel Twitter Feed)

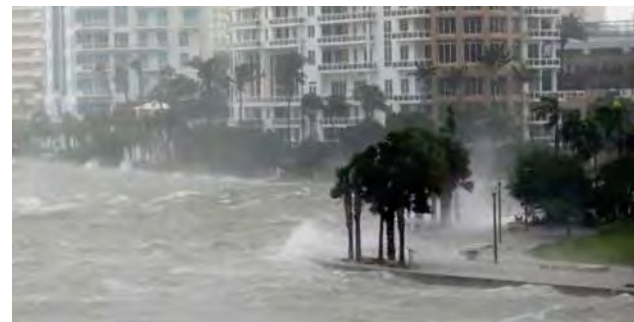
Waves crash at mouth of Miami River at Biscayne Bay (AP)
