FPL's Response to OPC's First
Production of Documents Nos. 4-5

Power Delivery Performance

Hurricane Irma

Report Date: April 19, 2018

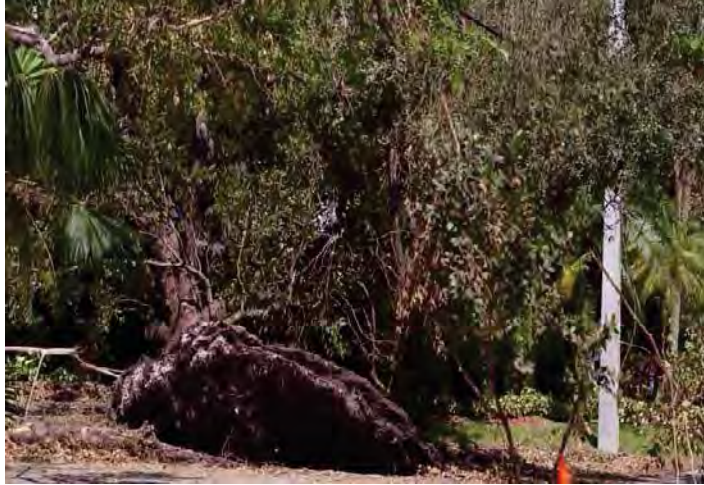
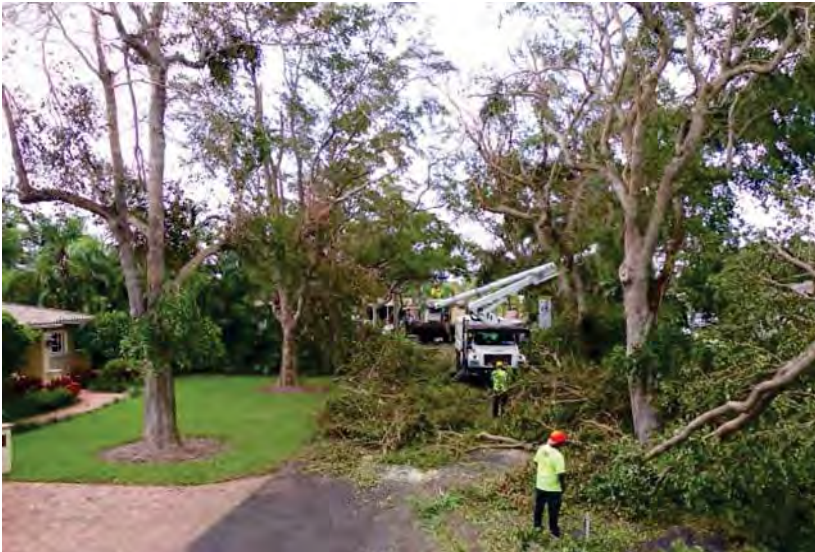
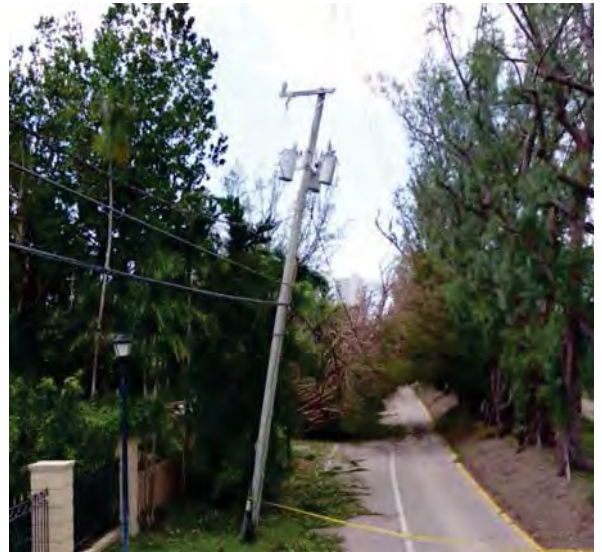
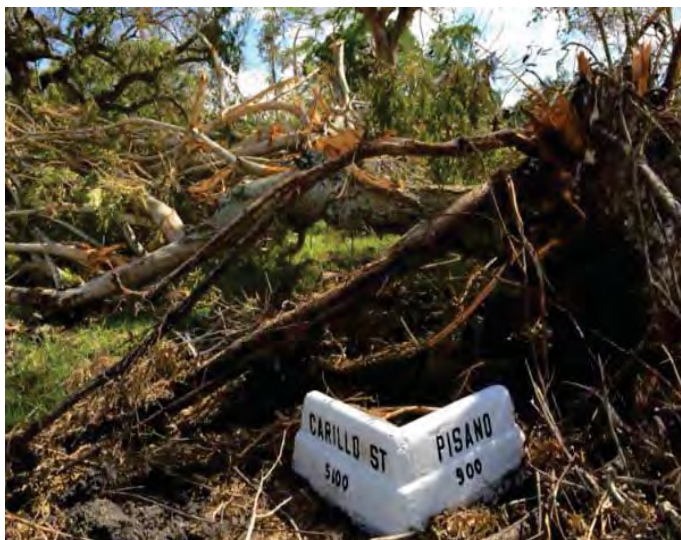
Examples of Vegetation Damage in Dade Area

Observation	Dade	East	North	West
% of tree damage For Native and non-Native trees	Native 20% Non-Native 80%	Native 30% Non-Native 70%	Native 70% Non-Native 30%	Native 55% Non-Native 45%
% of tree damage by tree type	Ficus 23% Palm 10% Aust. Pine 9% Black Olive 7% Oak 6% Avocado 5% Mango 5% Bischofia 4% Royal Poin. 3% Bean Tree 3% H.K. Orchid 3% Vine 3% Other 20%	Ficus 24% Aust. Pine 13% Oak 11% Palm 7% Melaleuca 6% Pine 6% Back Olive 4% Brazi. Pepper 4% Acacia 2% Java Plum 2% Vine 2% Other 18%	Oak 43% Pine 21% Palm 8% Hardwood 5% Aust. Pine 5% Other 19%	Pine 30% Oak 16% Ficus 9% Palm 7% Melaleuca 6% Acacia 5% Aust. Pine 5% Carrotwood 4% Other 19%
Primary damage	Up-rooted trees and broken trunks	Broken Limbs	Broken Limbs	Up-rooted trees and broken trunks
% of primary damage	59%	57%	56%	70%
Secondary damage	Broken Limbs	Up-rooted trees and broken trunks	Up-rooted trees and broken trunks	Broken Limbs

% of secondary damage	41%	43%	44%	30%
Ground Condition	Saturated			Saturated
General Comments	Access was an issue due to large number of exotics which are less storm resilient	Higher percentage of non-native and exotics are less storm resilient	Larger and older trees which are typically less storm resilient	Larger and older trees which are typically less storm resilient, High winds and saturated soil caused storm resilient trees to fail such as palms

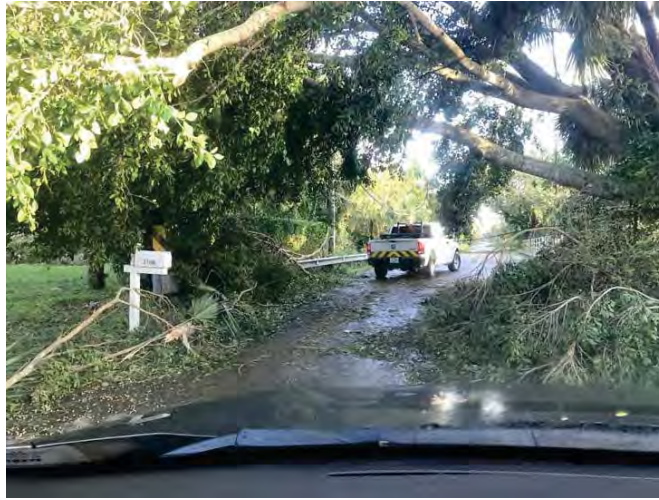
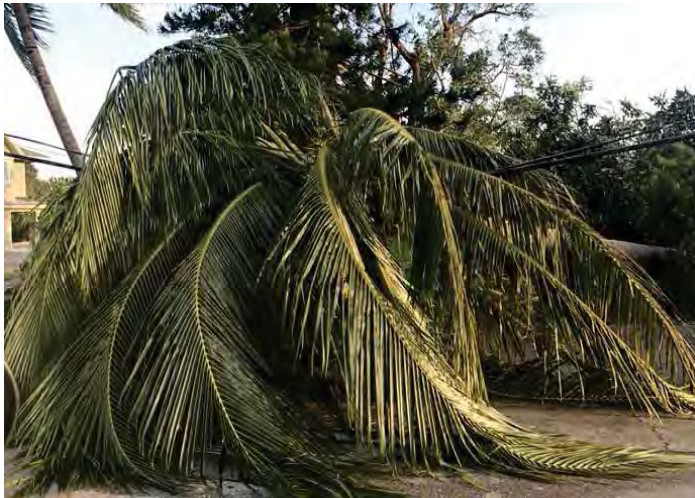
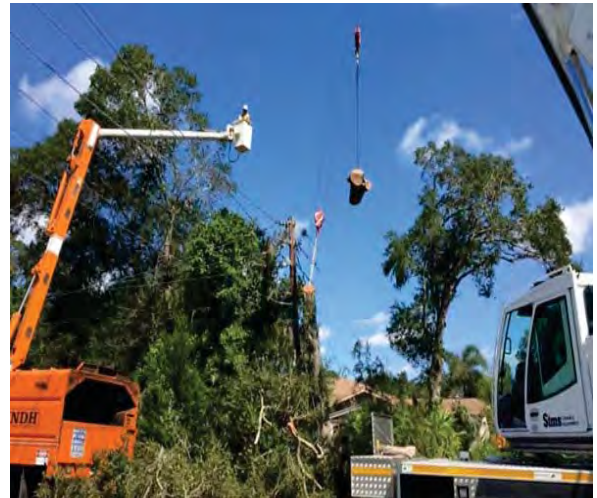
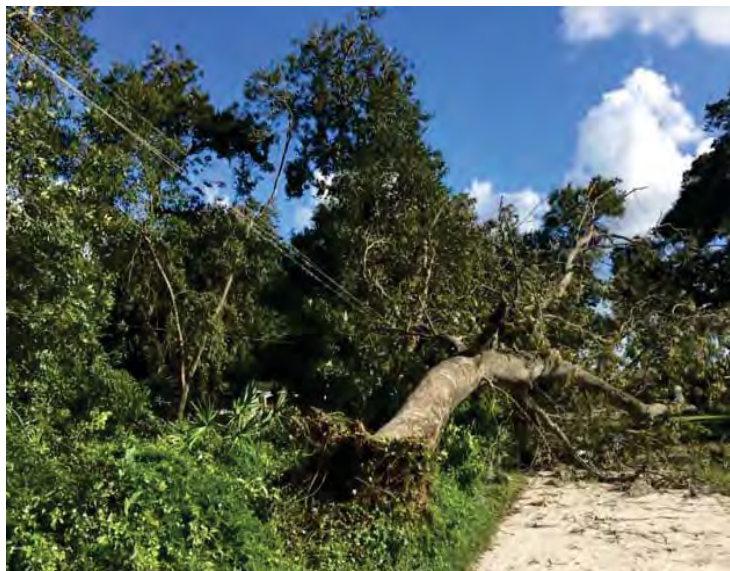
Examples of Vegetation Damage in West Area

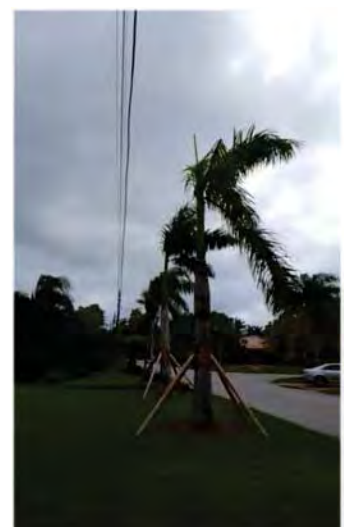
Pictures above:
Large, mature ficus trees topple over due to massive tree canopy with shallow root systems

Pictures to the right:
Young canopy trees (i.e. oak) and palms planted in the wrong place and will impact facilities in the future

Recommendations:

- Prior Lessons Learned from the 2004 and 2005 storm seasons, older trees are more likely to fail in hurricanes and over-mature trees should be removed and replaced by new trees. Source: "Wind and Trees: Lessons Learned from Hurricanes" published by UF Institute of Food and Agriculture Sciences (IFSA).
- Follow Right Tree Right place guidelines and stop actively planting large canopy trees adjacent to power lines.
- Adopt ordinances that support keeping vegetation away from utilities

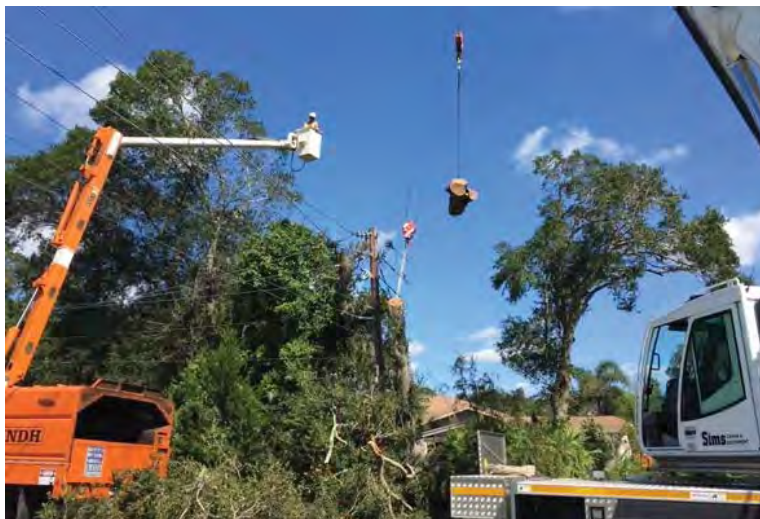
Trimming crews use a crane to remove large tree from utility lines

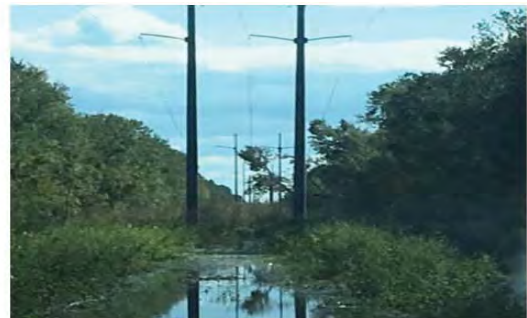
2 OHGW down

1 pole base eroded by wave action

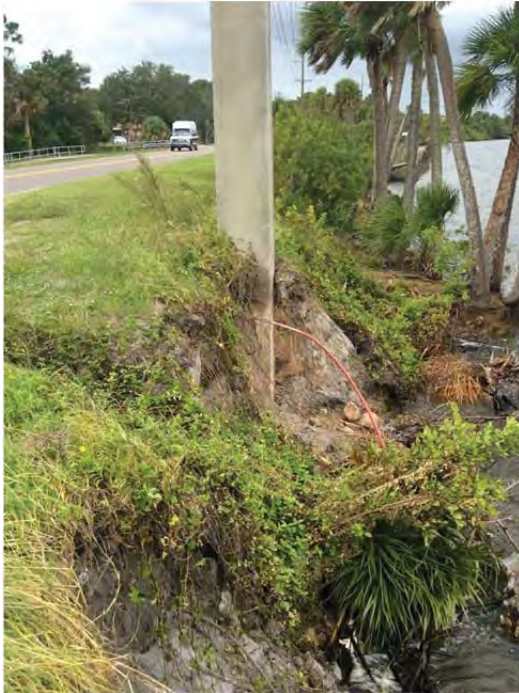
One transmission pole was replaced due to wave action washing out the foundation

This event did not cause an interruption

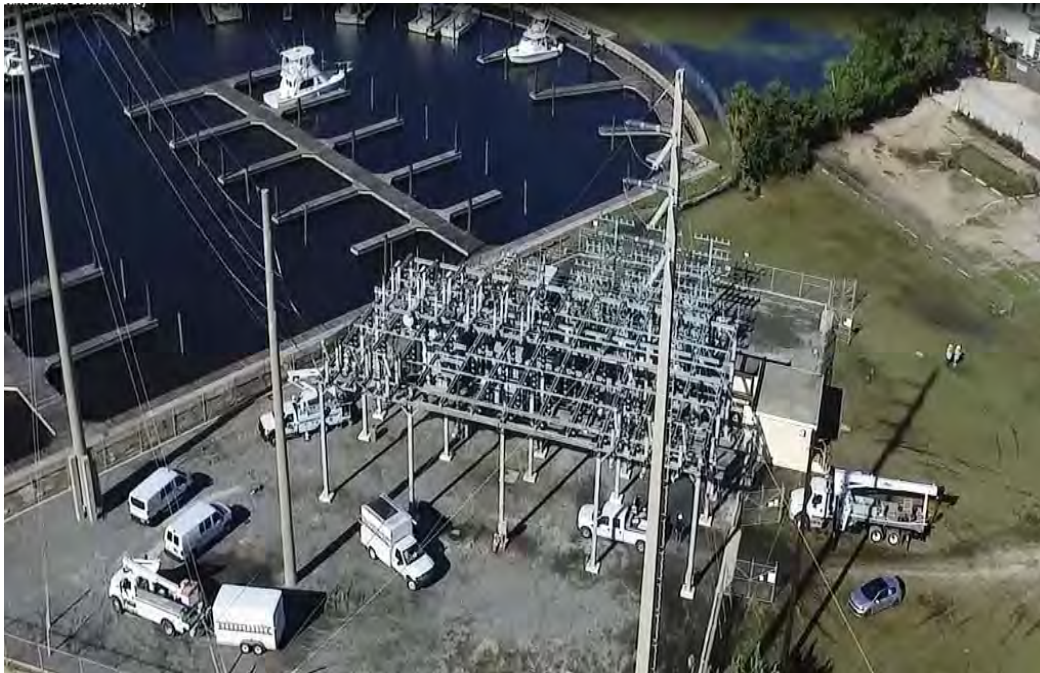
2 line switches were impacted

2 transformer circuit switcher were impacted

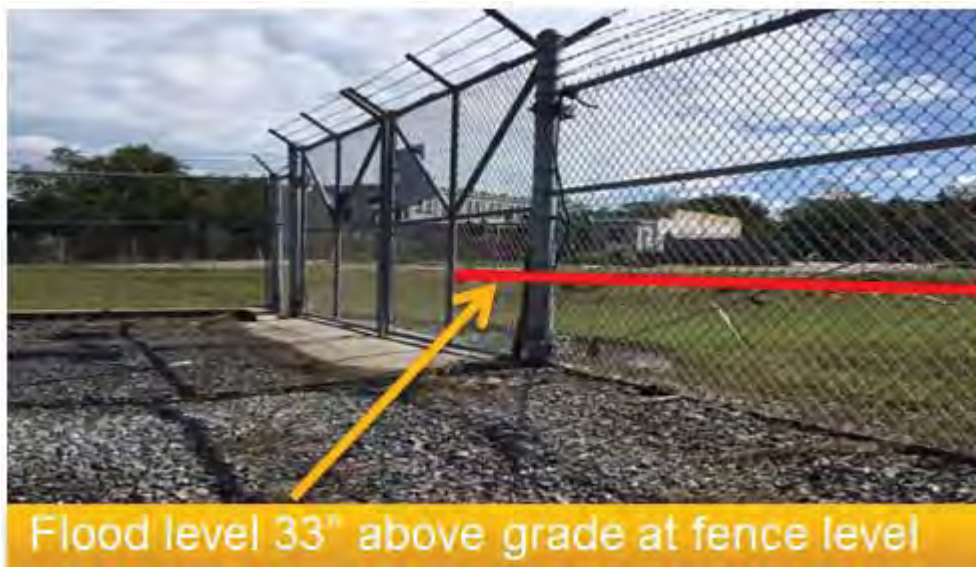
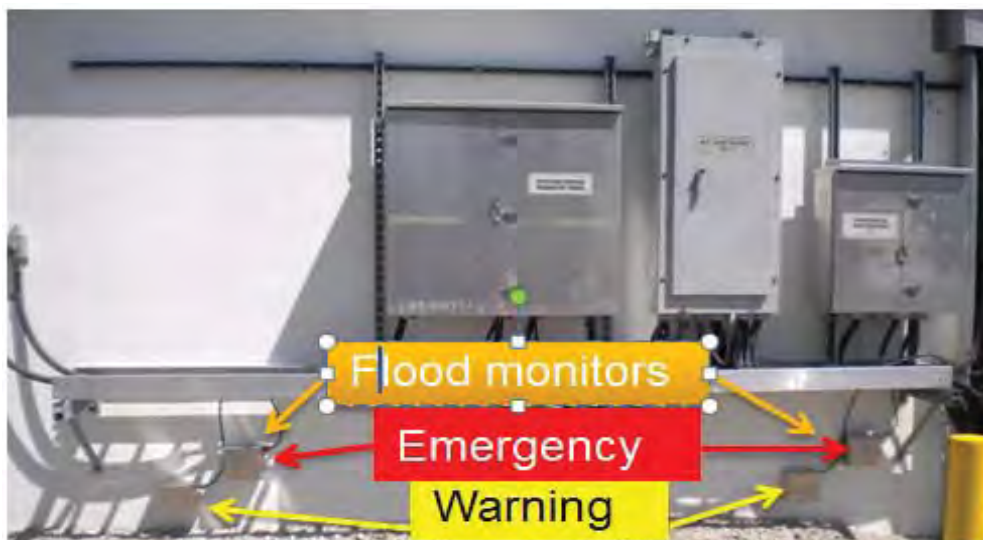
St. Augustine Case Study

Flooding level was significant

2 transformer circuit switches were impacted

Fault bus current transformer schemes (Transformer, Feeders, Regulators)

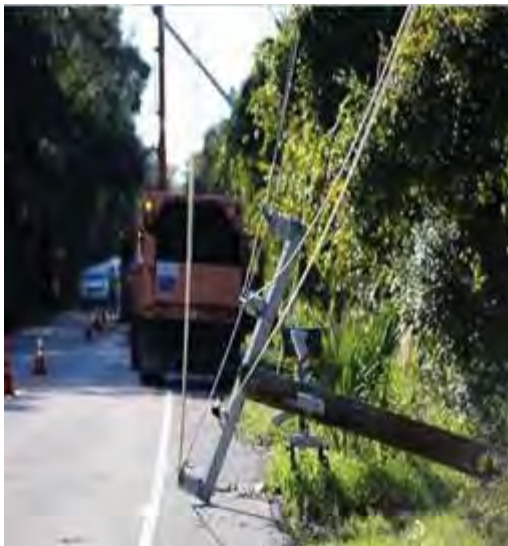
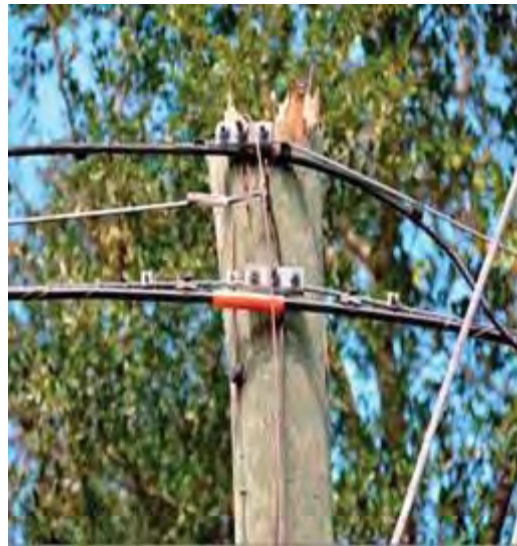
Poles down on Wildwood Drive

There were 13 broken poles on Wildwood Drive (3.7mi). The majority of the poles were 40ft Class 3 wood poles in good condition that broke approximately 1/3 to 1/2 from the top of the pole; they were last inspected in 2015 with no strength or other rejects found. The poles broke due to large trees falling into the line. Distribution poles are naturally tapered, so it is not uncommon to have the point of maximum stress (and failure) 5ft or more above ground line for overloaded conditions (such as trees or debris in the lines), these poles broke even higher due to several factors. When a tree falls on a line, the wire experiences a sudden and very large increase in tension force in that span of wire. With the steel cross arm and triangular framing that we have on this line, these forces are transferred to the very tip of the pole. The foreign utility and guy wire attachments lower down on the pole can both restrain the pole and, like the ground, transfer some of the load from the pole. This restraint can move up the point of maximum stress (and thus failure) higher up the pole. The majority of these poles failed just above the foreign utility or guy wire. Internal defects in the pole (knots, etc.) can also cause the maximum stress location to change.

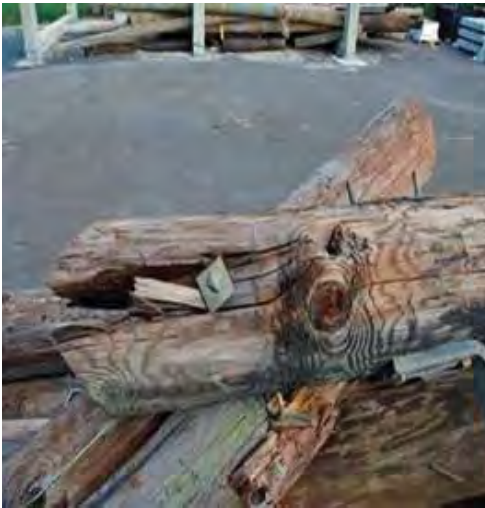
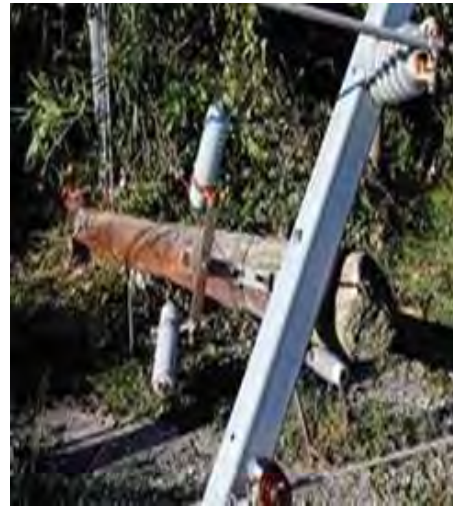
IntelliRupter Pole

One square concrete pole supported an IntelliRupter AFS switch. The IntelliRupter was damaged as a result of a pine tree falling into the feeder line and will be replaced. The concrete pole itself was not damaged and will remain in service. When the pine tree fell on the feeder lines, several of the line insulators and dead end insulators broke apart, and fell to the ground. The IntelliRupter support hardware was bent by the force, damaging the components shown. The switch will need to be replaced.

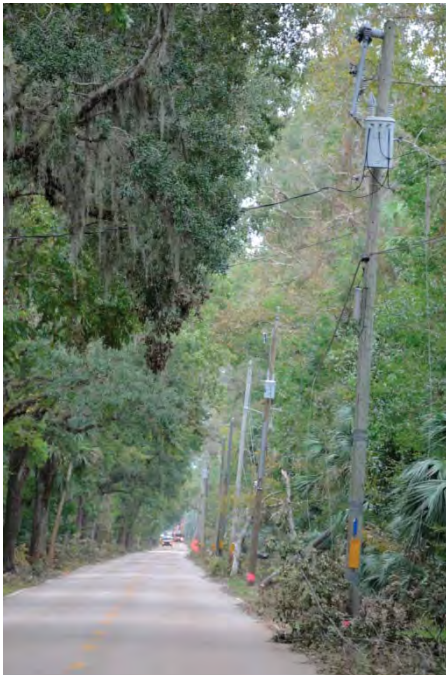
Maytown Road Lateral Case Study

The failed poles were 40ft Class 4 or 5 wood poles. Two were owned by AT&T and one was owned by FPL. The line was last inspected in 2011.

The poles that were leaning the most had soft soil foundations. The rain from Hurricane Matthew saturated the soils so that the foundations failed before the poles did when the trees came down and broke the wire.

The poles that failed had varying factors that caused the failure. All failed at or just above ground line. The root cause of the pole failures were the tree failures.

The AT&T pole with a pull-off to a home failed due to trees coming down on the lateral and on the pull-off to the home.

One AT&T pole that failed was in process of being replaced. The new pole had been installed and some but not all utilities had transferred their attachments to the new pole. The new pole did not fail. The old pole failed; it had significant ground line corrosion and had been reinforced

The FPL pole failed in-line due to being pulled along the line when wire broke due to tree failures. This pole was in good condition and broke just above ground line as would be expected.

Numerous sections of wire were down, 3 poles were broken, and 24 poles had severe leaning along the three mile section of Maytown Road. The restoration effort required five poles which were replaced with stronger poles set deeper, FPL wire down and other damage was repaired and restored. Pull-offs and services to homes were restored as quickly as possible. The line section was re-energized at approximately 6:30am on October 12, 2016.
