Condition Analysis

Block: 01 Northwest Unit of the plant. Includes Gasification Unit, Brine Unit, Acid Unit, Coal Slurry Building, and pipe lines to flares.

Subblock: A On West side of Block 1. Contains Flare, pipe racks to flare, and conveyor belt.

Section: 01 Flare and associated structure.

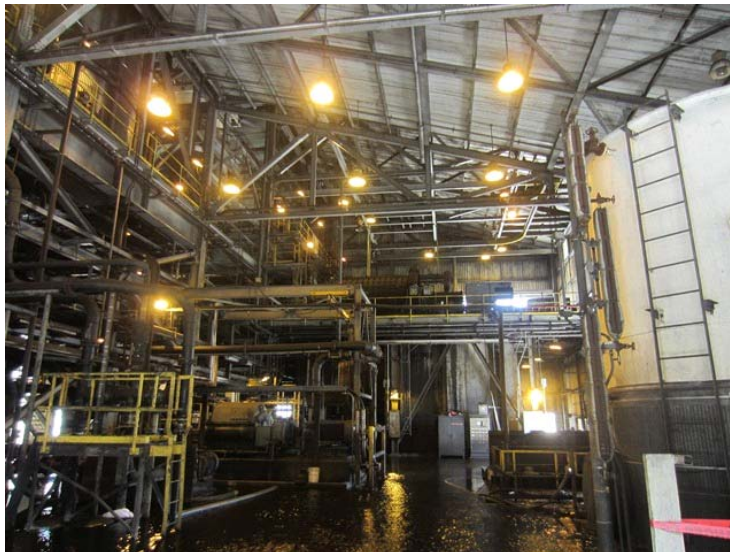
Comments: Couldn't walk in building- Flooded with water.

General view of section

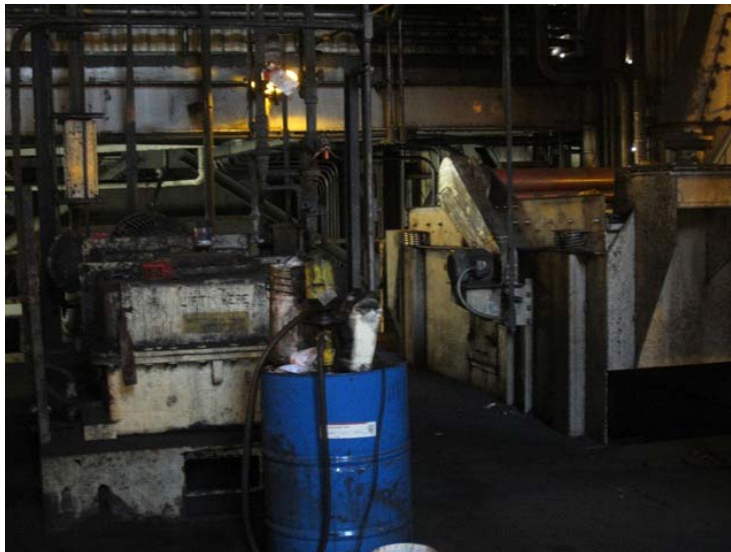
Environment Rating 3 - Moderate
Visibility: 6 - Low Traffic or Visibility
Corrosion Rating: 6.5 - 0.7% rust
Corrosion Type: B - Surface Rust
Priority: 3 - Wearout

Comments: Hard to view due to product contamination.

General view of section

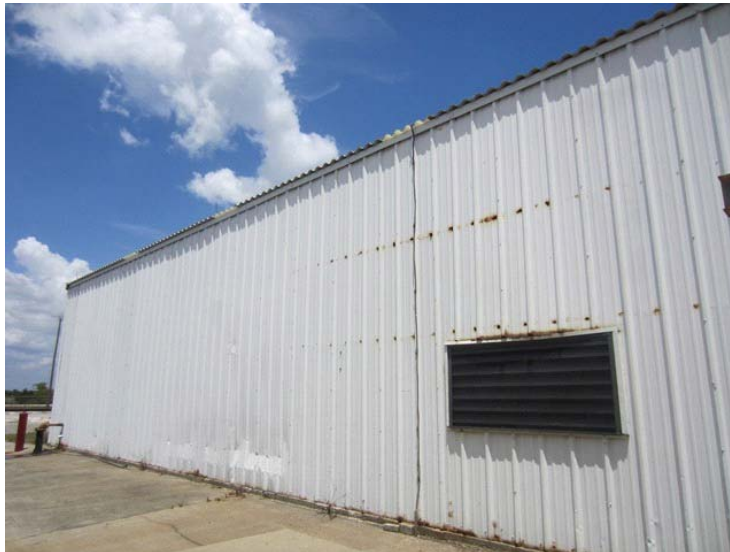
Comments: Corrosion on bottom edge of siding.

General view of section

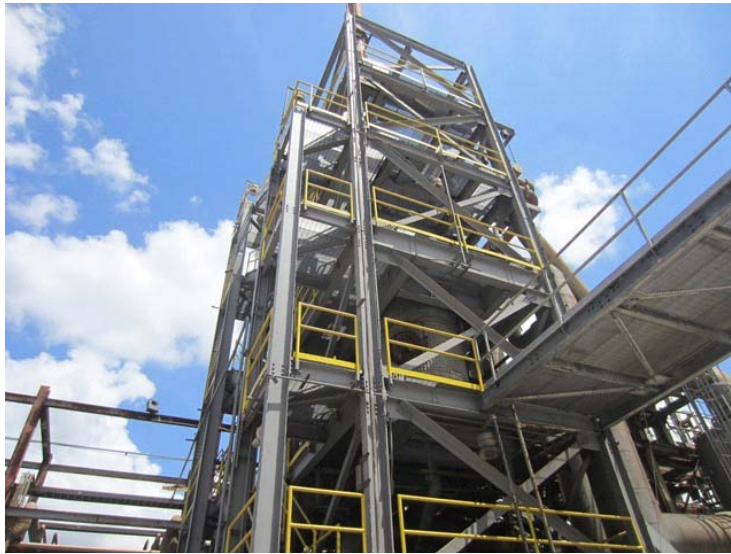
Comments: Localized- Miscellaneous Piping, Valves, Flanges. (Thin wall thickness.)

General view of section

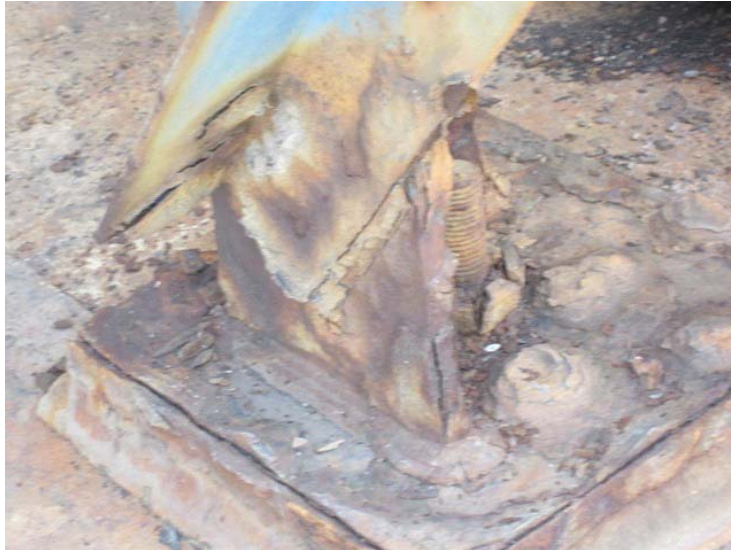
Priority: 1 - Advanced Corrosion

Metal loss occurring

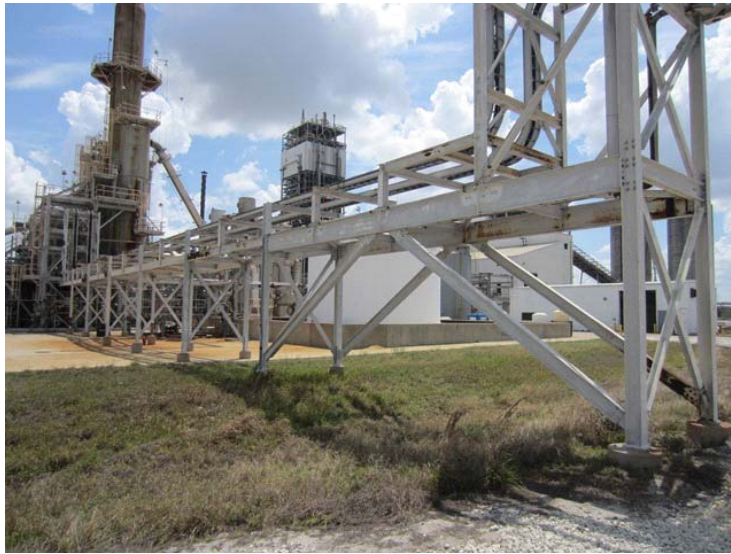
Corrosion Rating: 5.0 - 3% rust

Corrosion Type: D - Undercutting or Mill Scale

General view of section

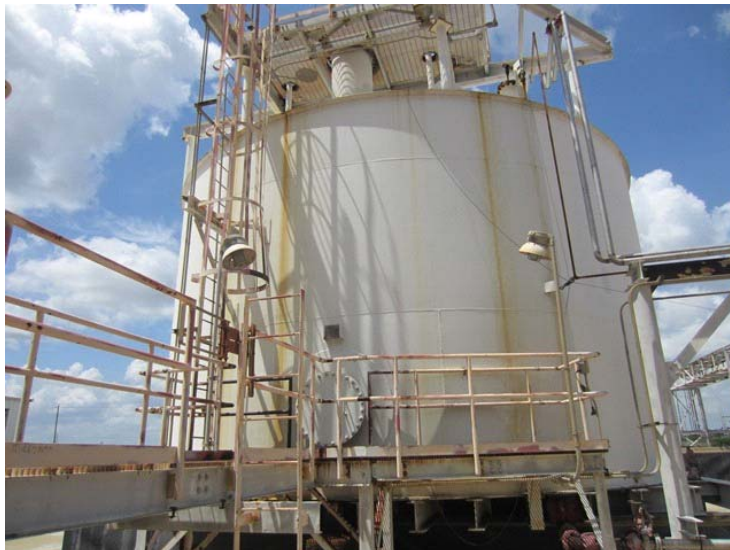
Comments: Tank Fair, Handrails, Ladder, Platform Southside needs repair.

General view of section

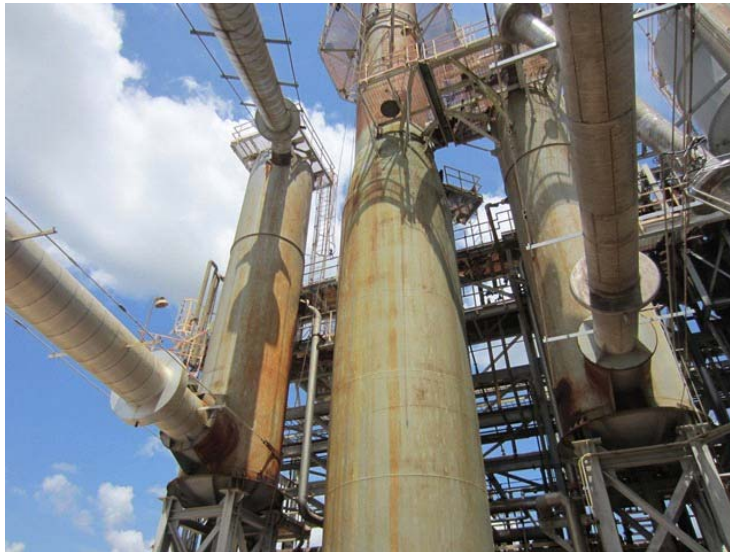
Corrosion Rating: 6.0 - 1% rust

Corrosion Type: B - Surface Rust

General view of section

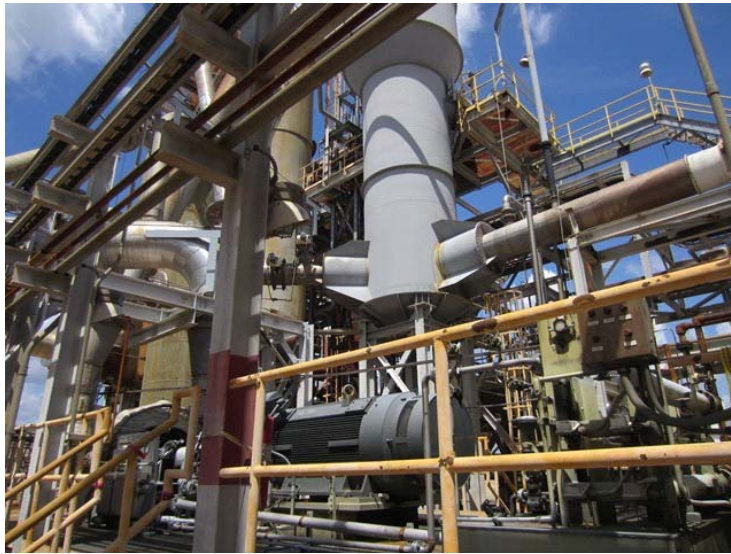
Comments: Localized, Undercutting on Structure Southeast side of Section.

General view of section

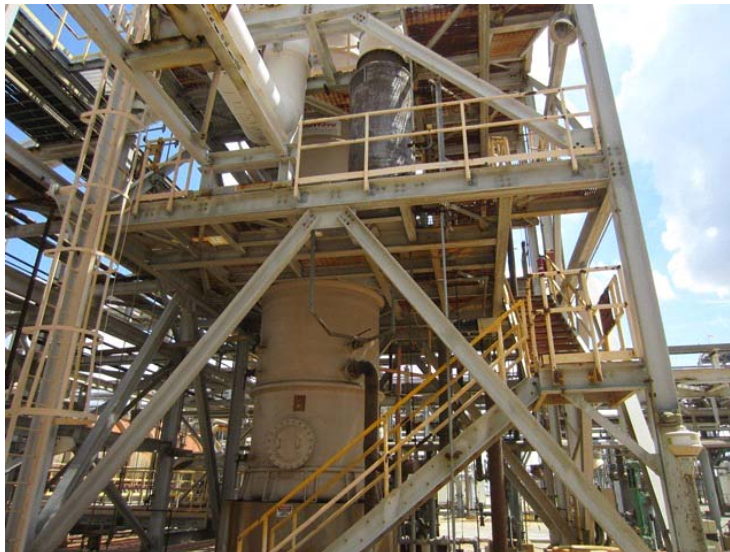
Comments: Edge of Corrosion on Structure. Some Undercutting on West side.

General view of section

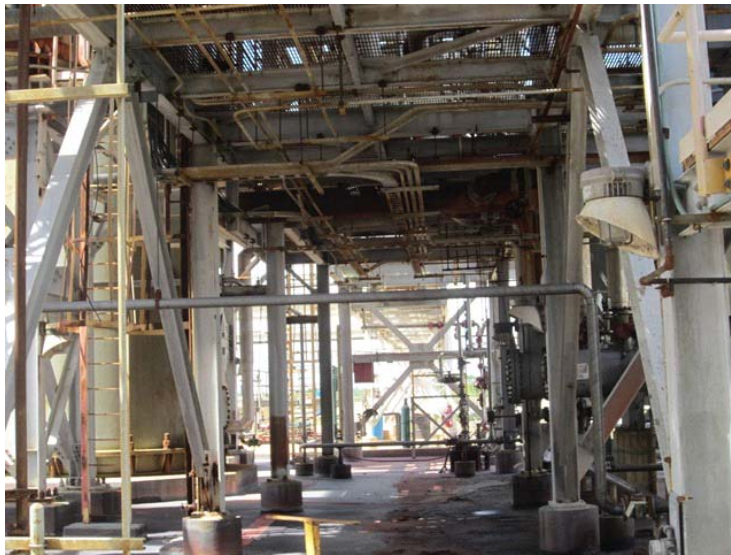
Corrosion Rating: 6.0 - 1% rust

Corrosion Type: D - Undercutting or Mill Scale

General view of section

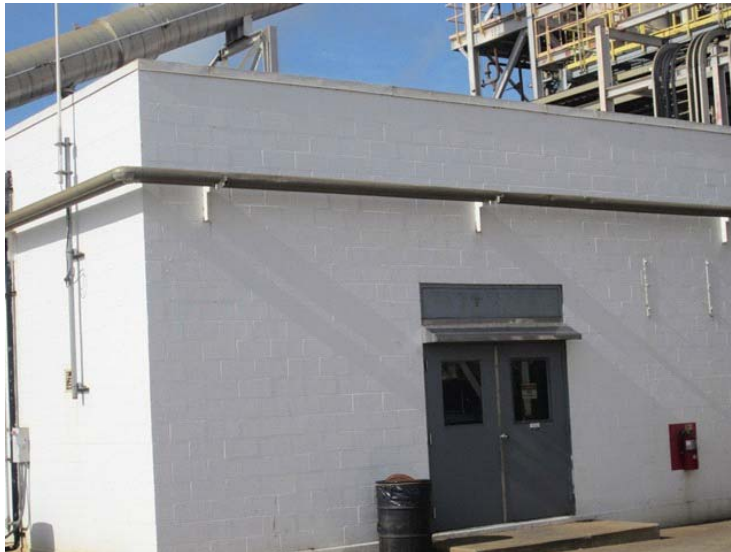
Corrosion Rating: 8.5 - <0.1% rust

Corrosion Type: A - No or Minimal Corrosion

General view of section

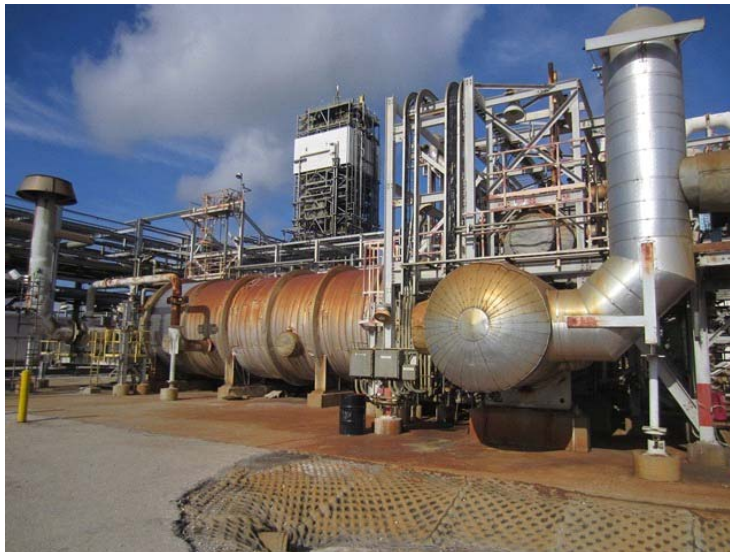
Corrosion Rating: 6.5 - 0.7% rust

Corrosion Type: D - Undercutting or Mill Scale

General view of section

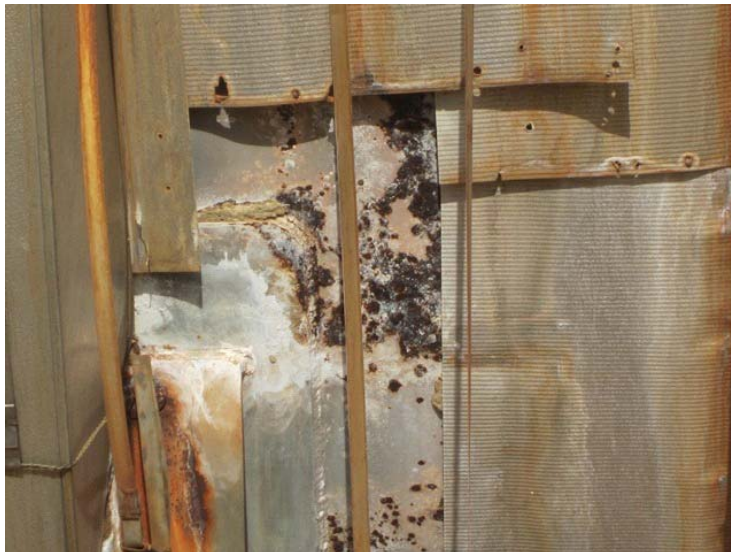
Corrosion Rating: 6.5 - 0.7% rust

Corrosion Type: D - Undercutting or Mill Scale

Corrosion visible

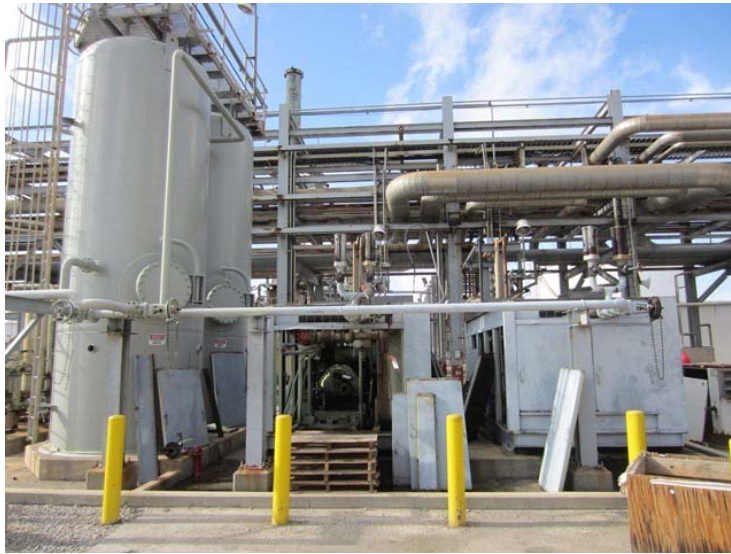
Comments: Localized- Miscellaneous structure and pipe in Section and Pumps on West side.

General view of section

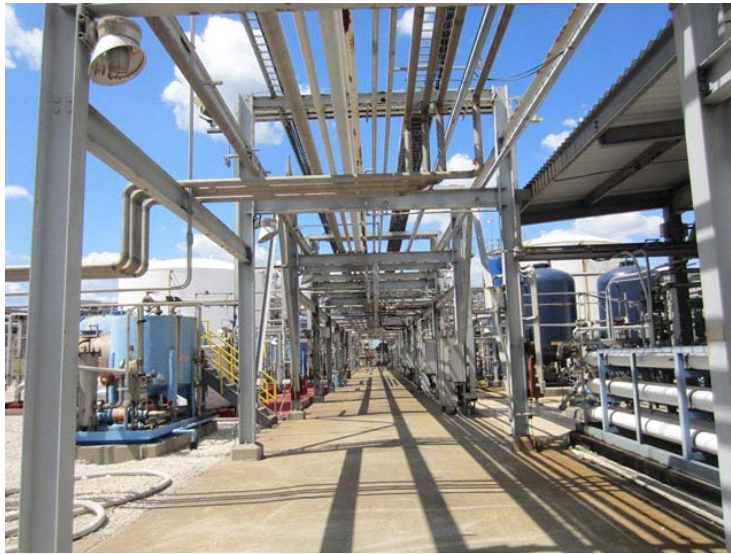
Environment Rating 3 - Moderate
Visibility: 5 - Moderate Traffic or Visibility
Corrosion Rating: 6.0 - 1% rust
Corrosion Type: D - Undercutting or Mill Scale
Priority: 3 - Wearout

General view of section

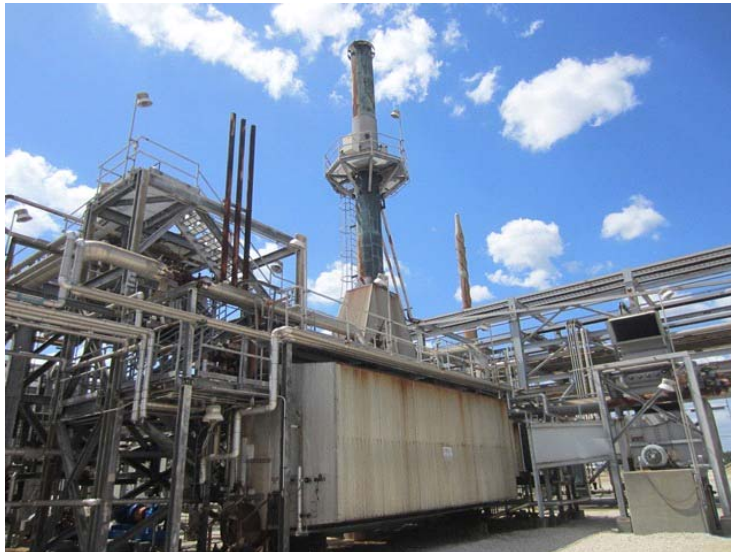
Environment Rating 3 - Moderate
Visibility: 3 - Tank Area
Corrosion Rating: 6.0 - 1% rust
Corrosion Type: B - Surface Rust
Priority: 3 - Wearout

General view of section

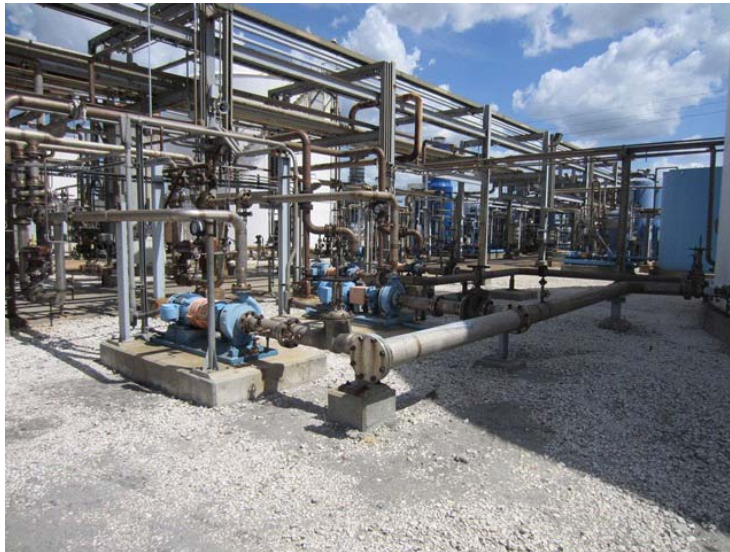
Corrosion Rating: 7.0 - 0.3% rust

Corrosion Type: D - Undercutting or Mill Scale

General view of section

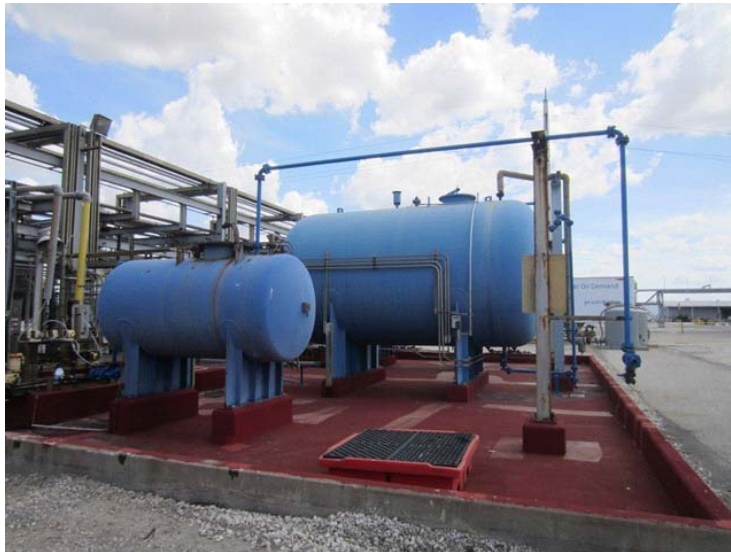
Tanks in section

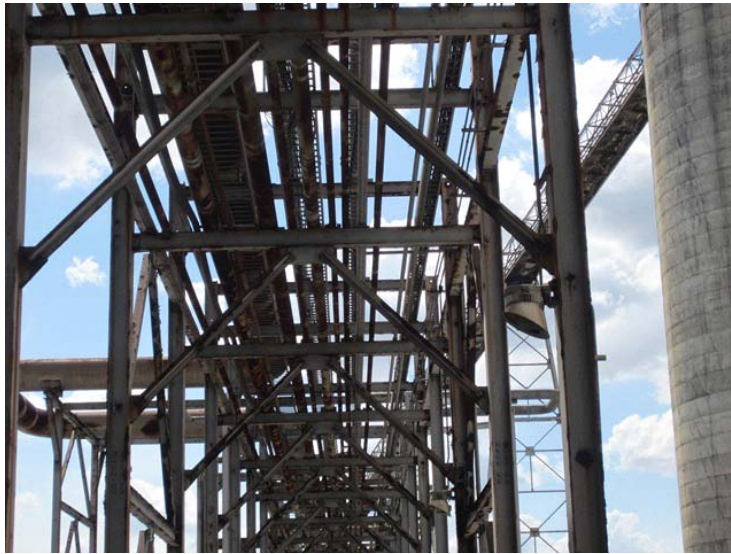
General view of section

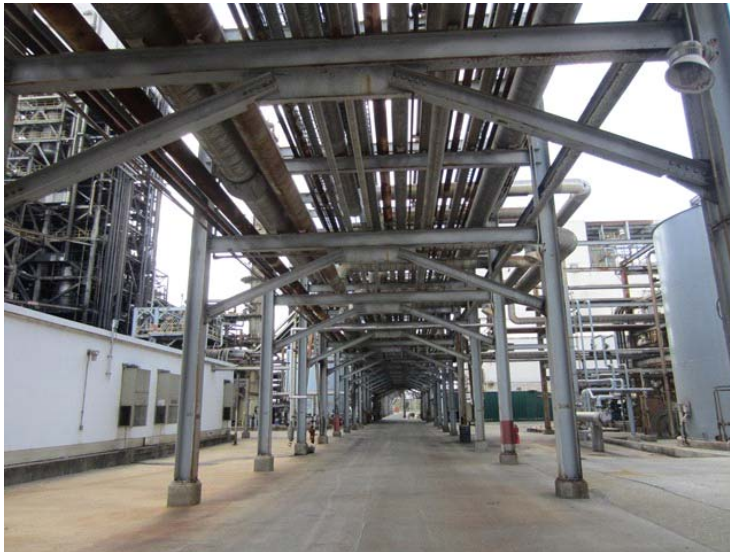
General view of section

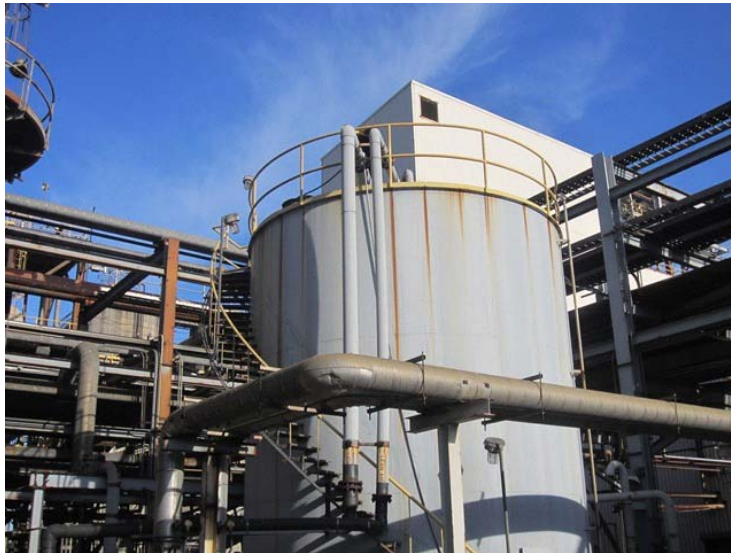
Comments: Metal lose on Structure on Southwest side of tank.

Corrosion Rating: 5.0 - 3% rust

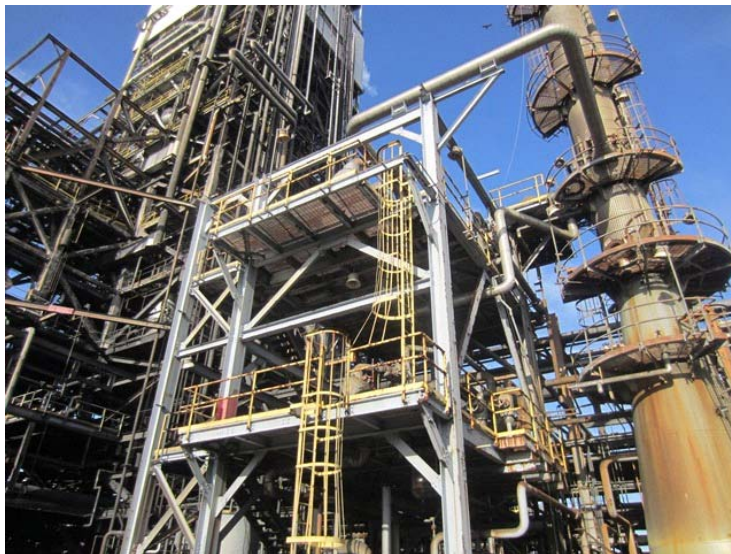
Comments: Metal Loss Throughout.

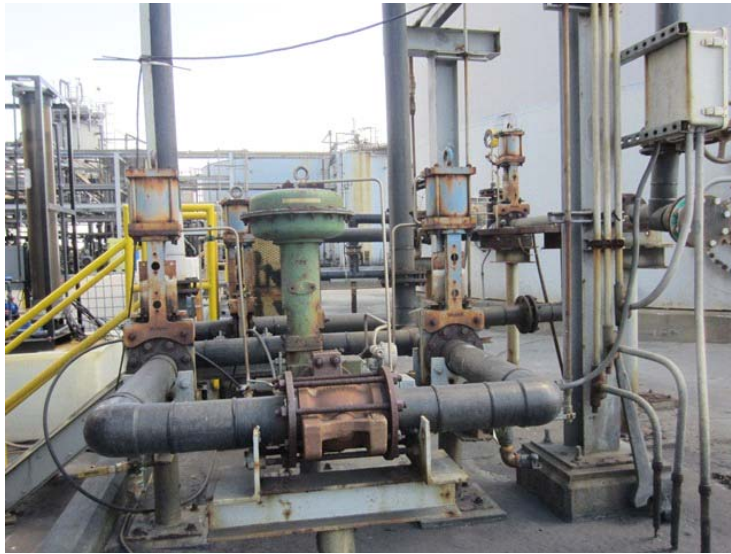
Comments: Optimum- Pinhole Corrosion Northwest side.

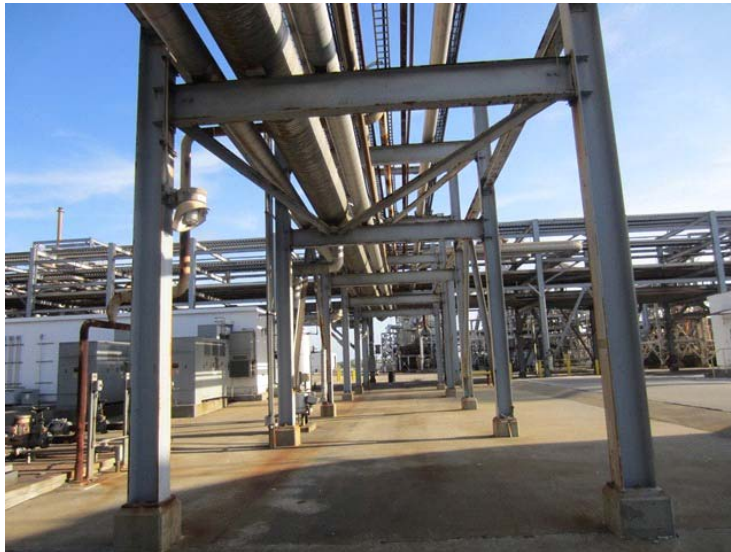
Comments: Heavy Corrosion Visible- Undercutting Throughout

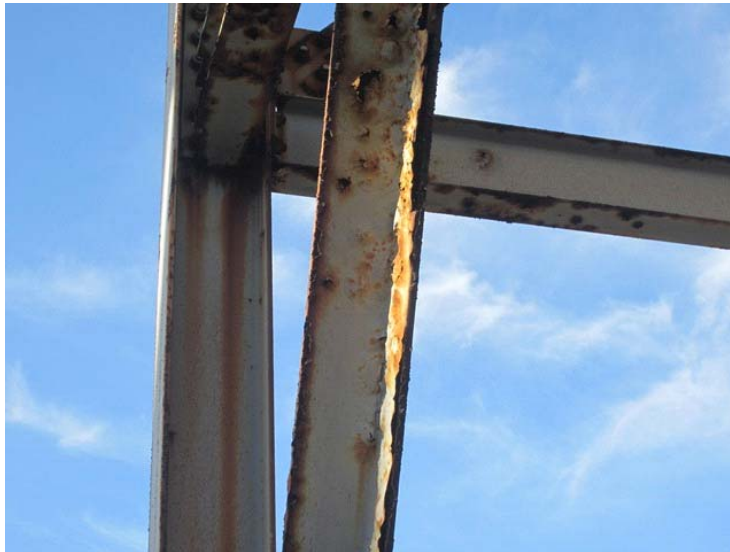
Comments: Heavy Corrosion Visible- Undercutting Throughout

Heavy corrosion occurring

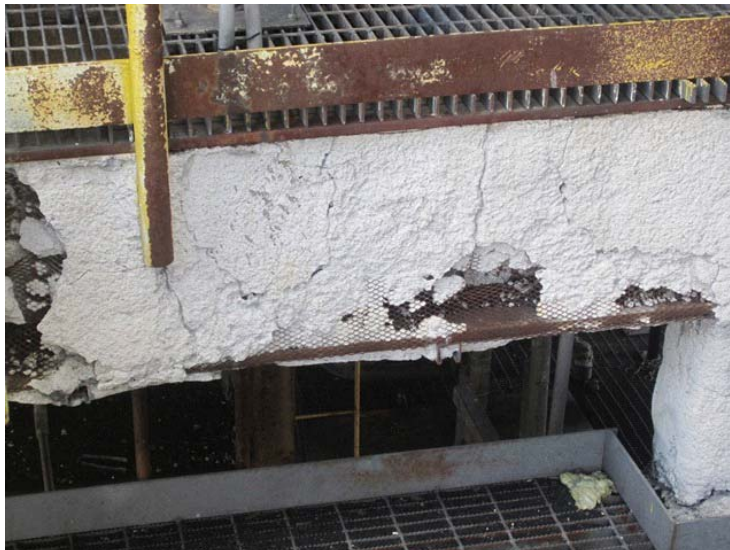
Corrosion occurring

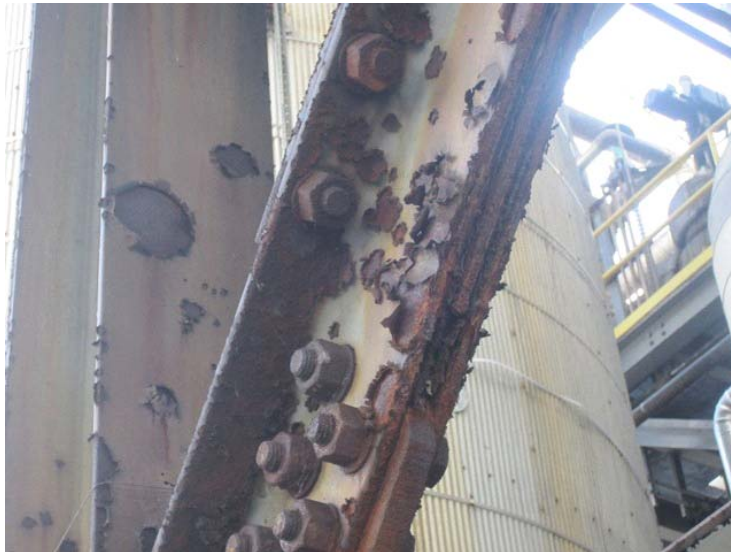
Heavy corrosion

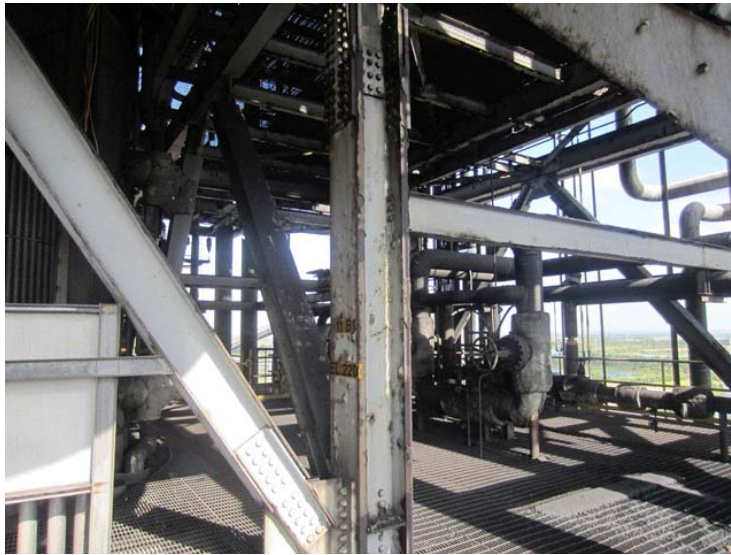
Comments: Pitting Apparent- Heavy Undercoating

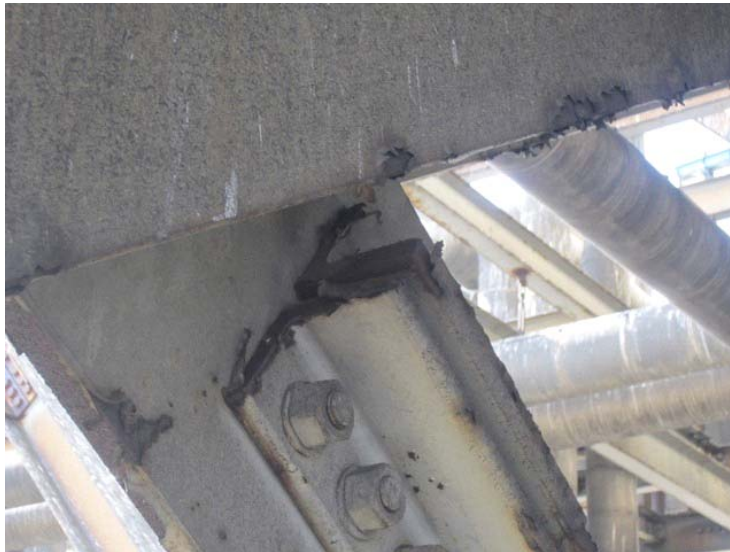
Undercutting visible

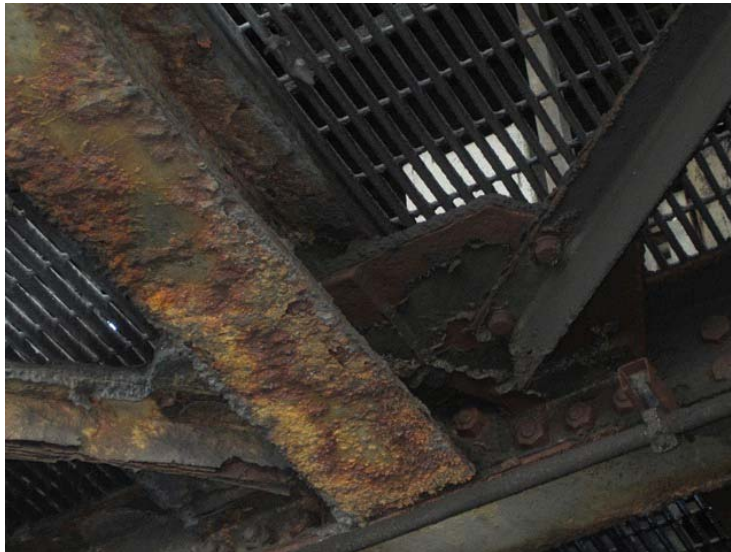
Comments: Heavy Undercoating, Pitting Visible and Metal Loss

Severe corrosion and metal loss occurring

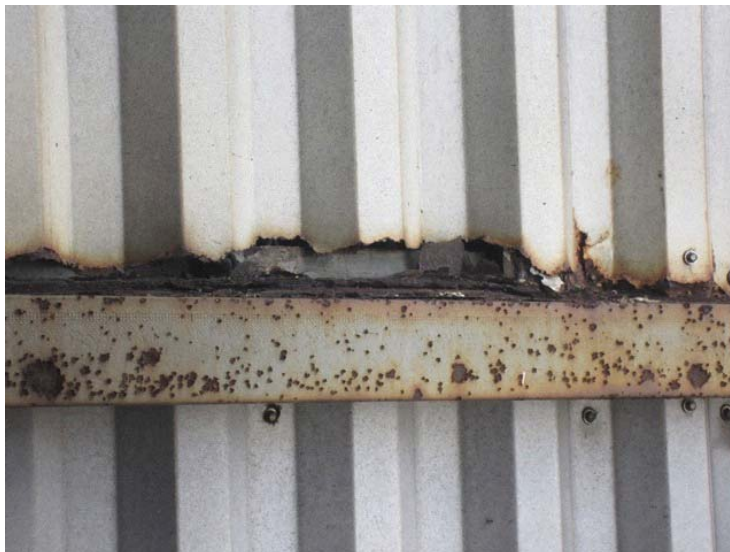
Comments: Heavy Undercoating, Pitting Visible and Metal Loss

Corrosion and metal loss occurring

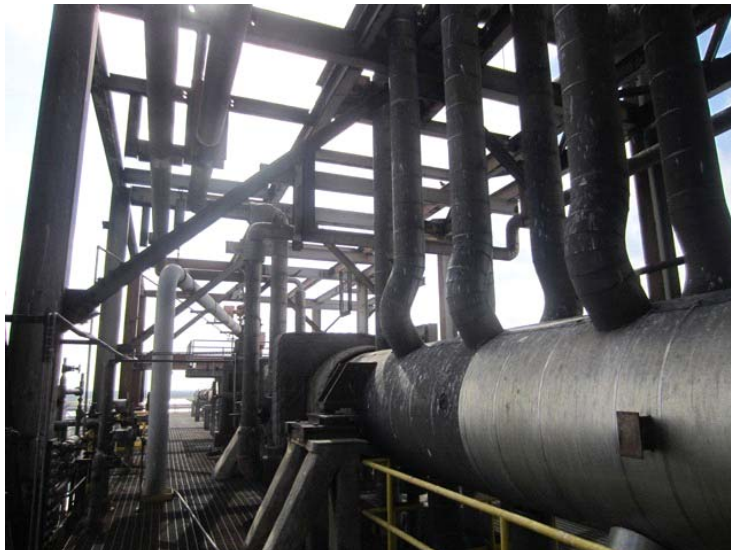
General view of section

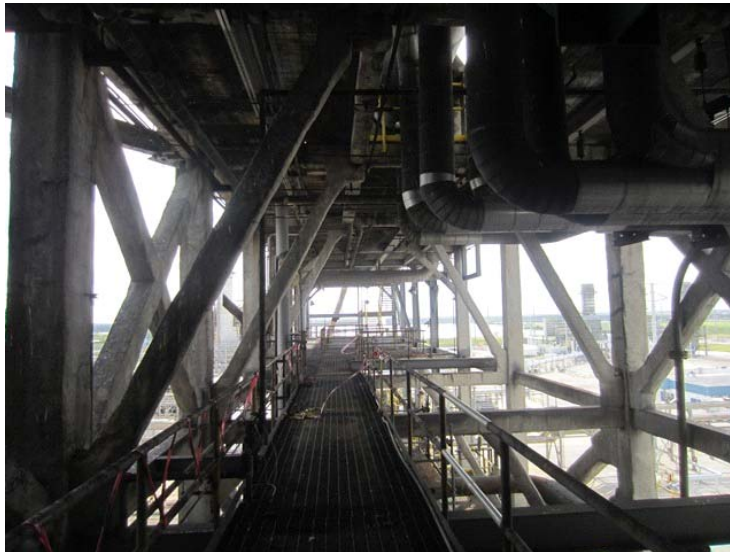
Corrosion Rating: 7.5 - 0.2% rust

Corrosion Type: D - Undercutting or Mill Scale

General view of section

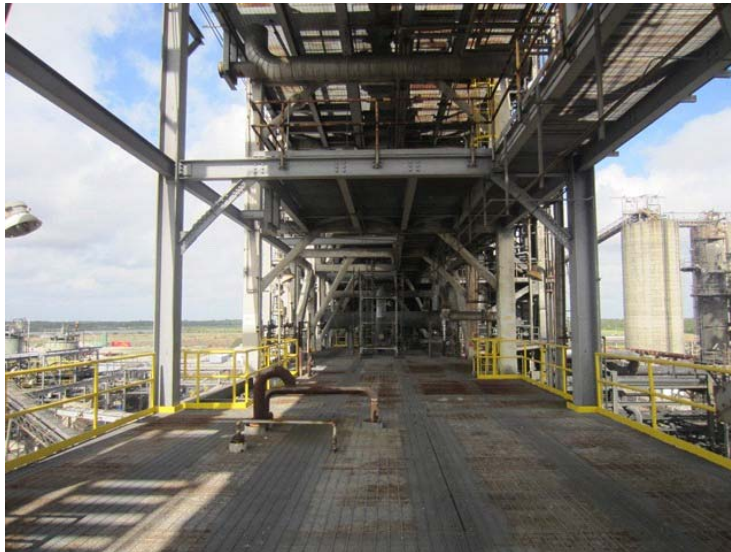
Comments: Localized- Miscellaneous Pipe and Handrails- Structure Good.

General view of section

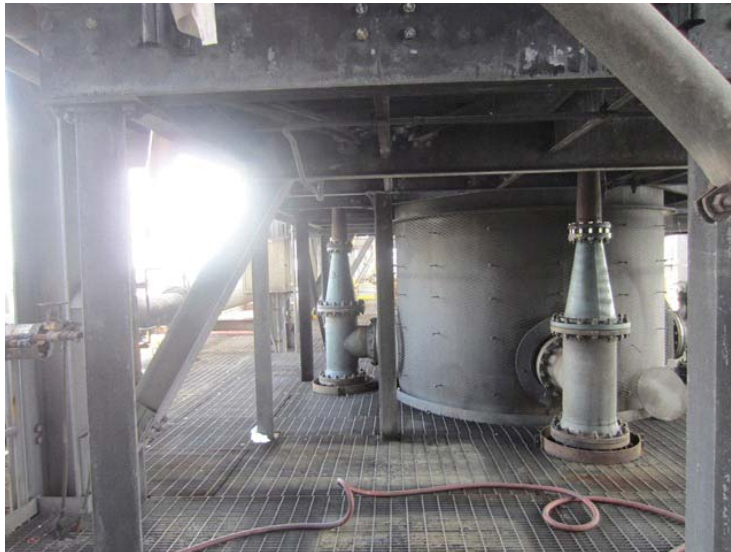
Corrosion Rating: 7.5 - 0.2% rust

Corrosion Type: D - Undercutting or Mill Scale

General view of section

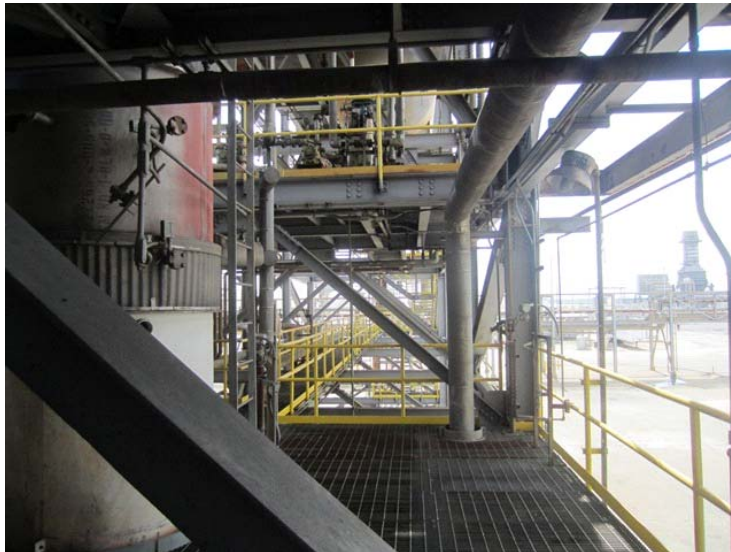
Comments: Localized- Metal Loss on Structure area North side of section above Pipe Rack.

General view of section

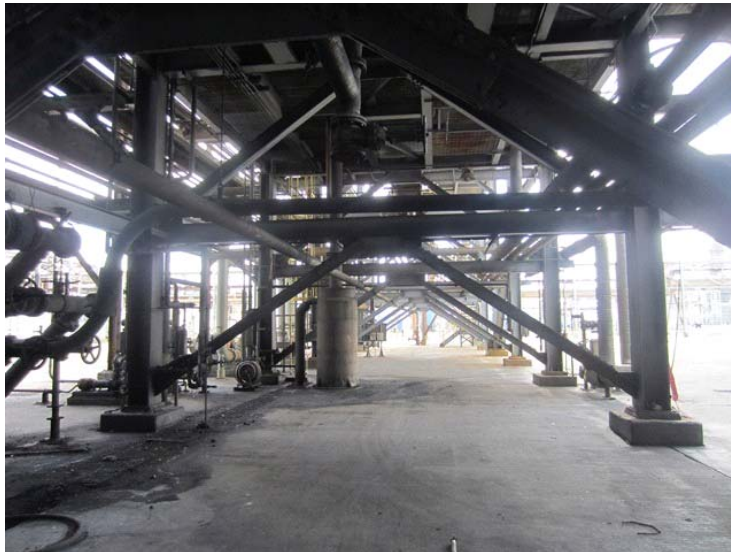
Corrosion Rating: 7.0 - 0.3% rust

Corrosion Type: C - Edge or Pinhole Corrosion

General view of section

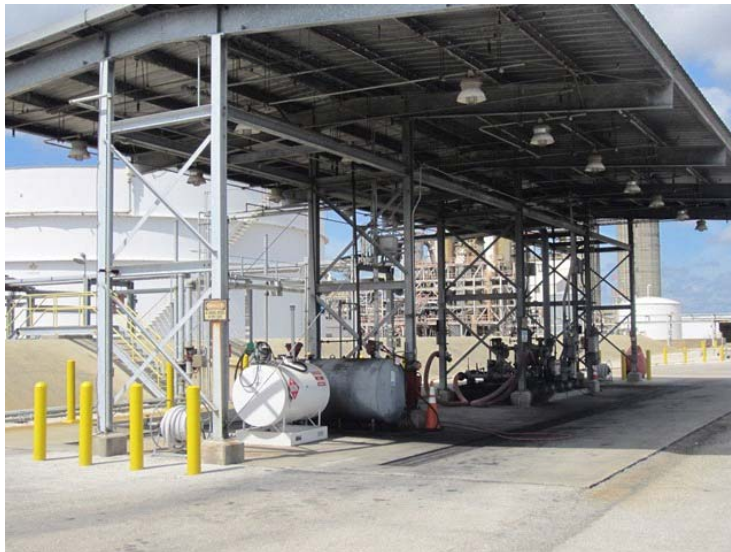
Environment Rating 3 - Moderate
Visibility: 6 - Low Traffic or Visibility
Corrosion Rating: 8.0 - 0.1% rust
Corrosion Type: A - No or Minimal Corrosion
Priority: 7 - Fair

General view of section

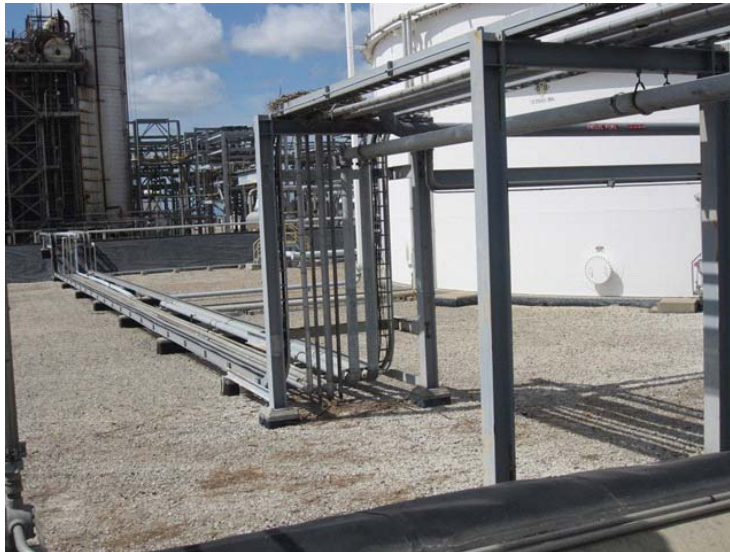
Environment Rating 3 - Moderate
Visibility: 5 - Moderate Traffic or Visibility
Corrosion Rating: 5.5 - 2% rust
Corrosion Type: D - Undercutting or Mill Scale
Priority: 3 - Wearout

Comments: Structure South End.

General view of section

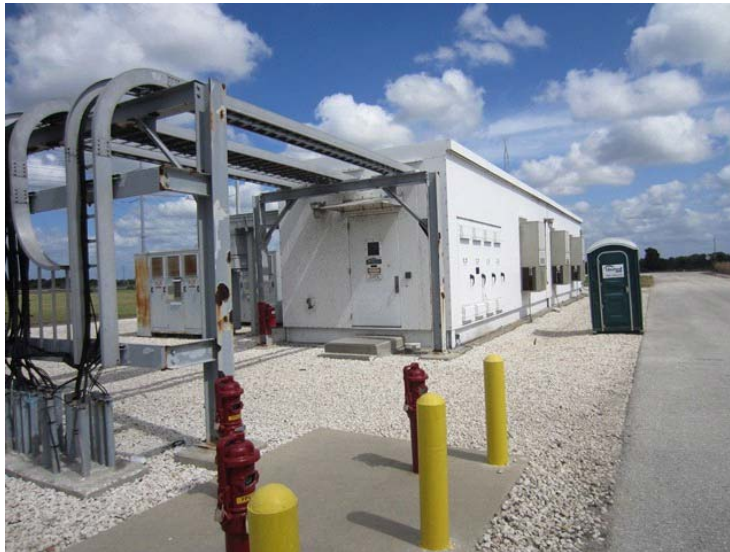
Comments: Electrical Boxes on West side and South Structure needs paint.

General view of section

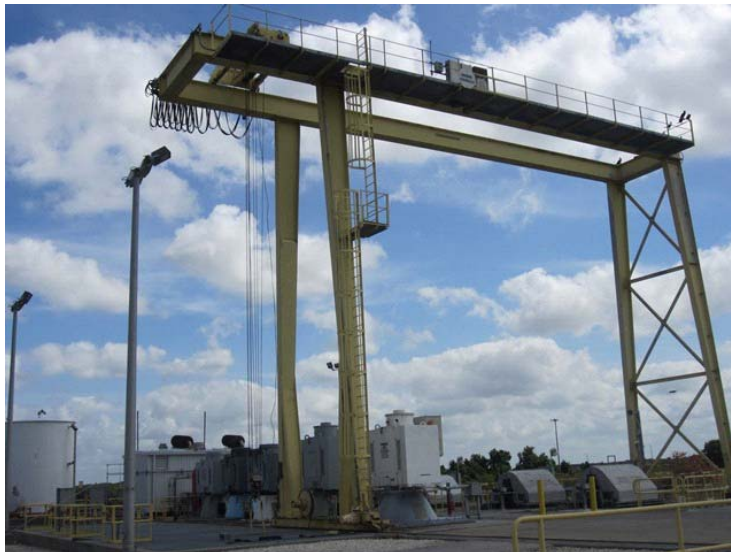
Environment Rating 3 - Moderate
Visibility: 6 - Low Traffic or Visibility
Corrosion Rating: 7.0 - 0.3% rust
Corrosion Type: C - Edge or Pinhole Corrosion
Priority: 2 - Optimum

Comments: Needs Pressure Washed.

General view of section

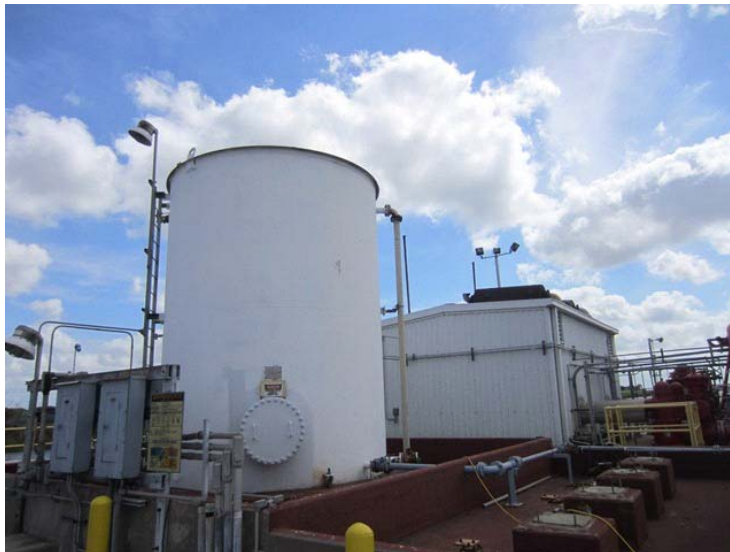
Comments: Needs Pressure Washed.

General view of section

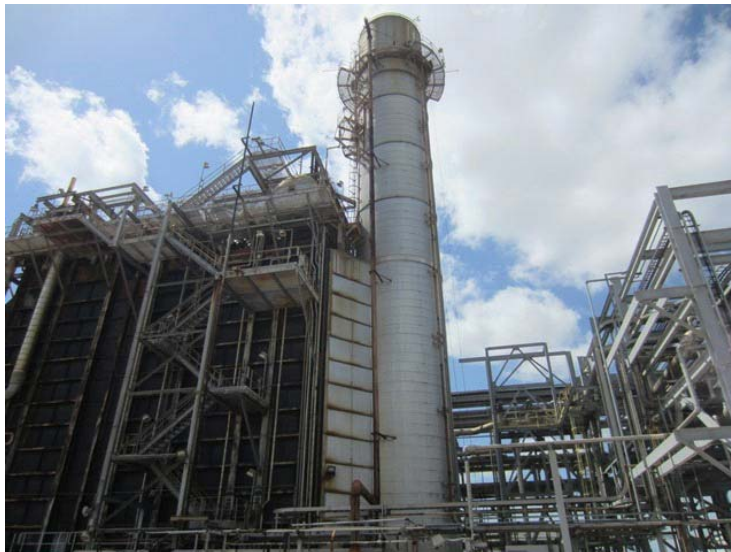
Comments: Stack is Insulated. Supporting Structure Only

General view of section

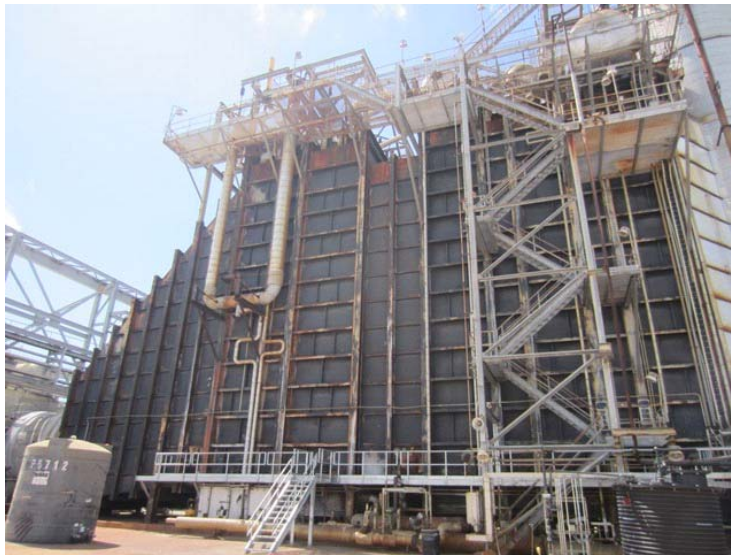
Corrosion Rating: 4.0 - 10% rust

General view of section

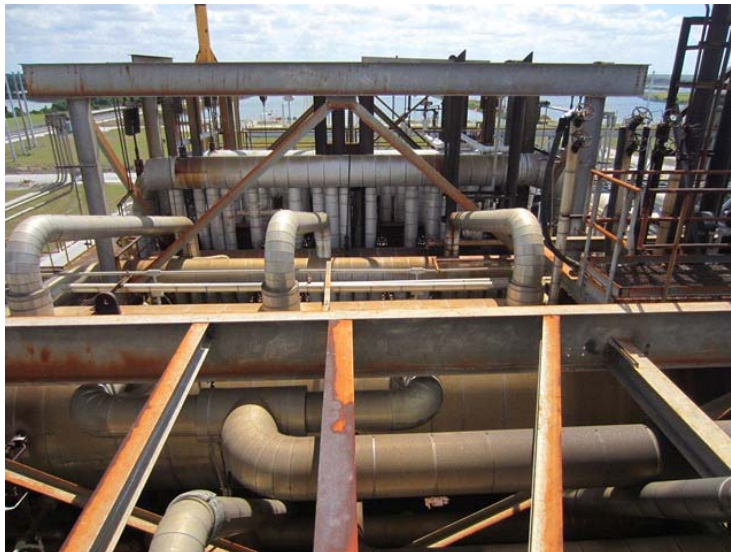
Corrosion Rating: 4.0 - 10% rust

Corrosion Type: E - Pitting or Rust Nodules

General view of section

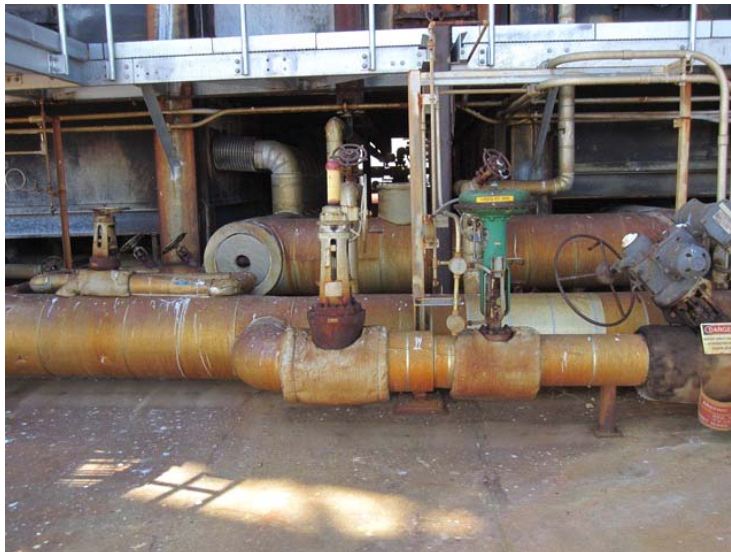
Priority: 3 - Wearout

General view of section

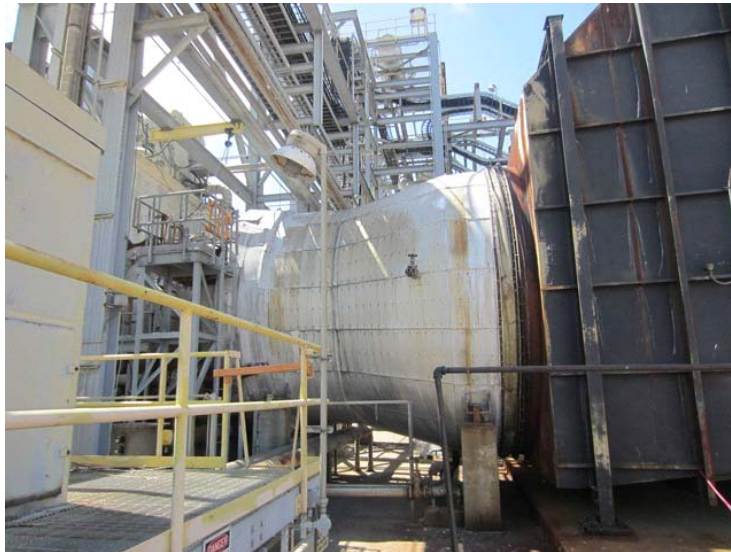
Corrosion Rating: 6.0 - 1% rust

Corrosion Type: B - Surface Rust

General view of section

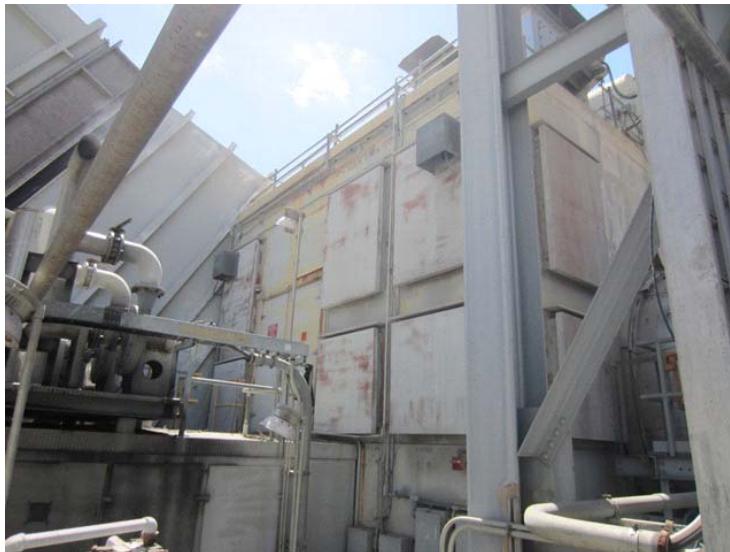
Environment Rating 3 - Moderate
Visibility: 5 - Moderate Traffic or Visibility
Corrosion Rating: 6.0 - 1% rust
Corrosion Type: B - Surface Rust
Priority: 3 - Wearout

General view of section

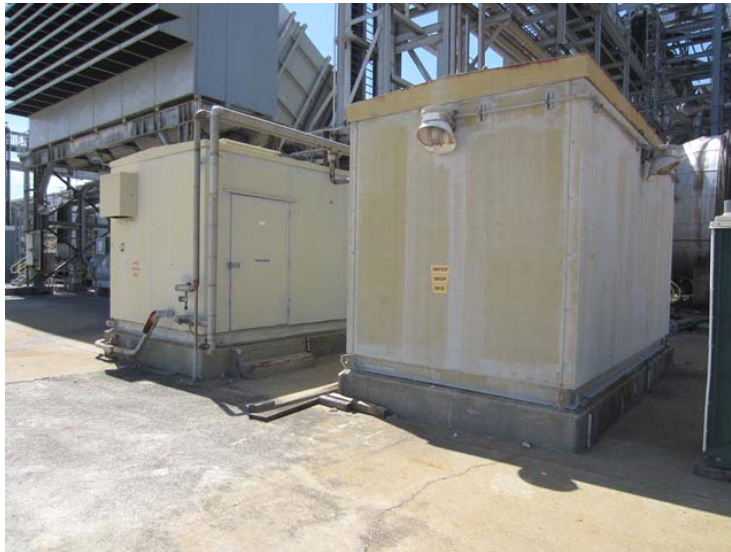
Environment Rating 3 - Moderate
Visibility: 5 - Moderate Traffic or Visibility
Corrosion Rating: 7.0 - 0.3% rust
Corrosion Type: D - Undercutting or Mill Scale
Priority: 2 - Optimum

General view of section

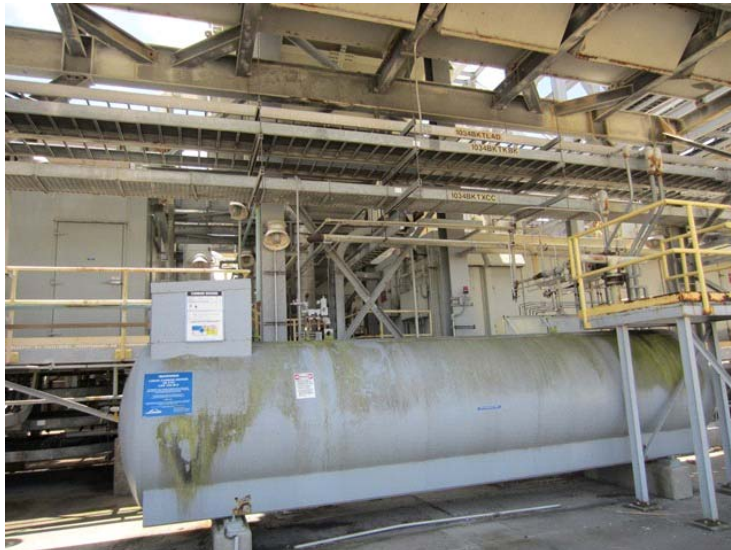
Environment Rating 3 - Moderate
Visibility: 5 - Moderate Traffic or Visibility
Corrosion Rating: 6.5 - 0.7% rust
Corrosion Type: D - Undercutting or Mill Scale
Priority: 7 - Fair

General view of section

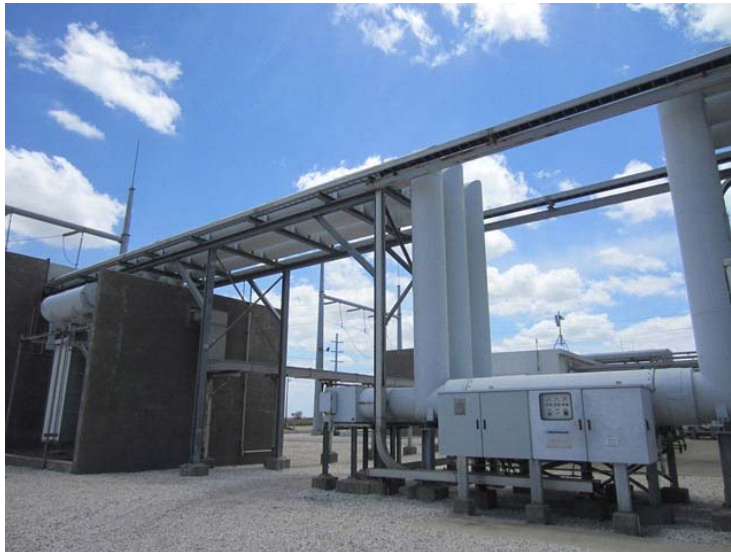
Environment Rating 3 - Moderate
Visibility: 3 - Tank Area
Corrosion Rating: 8.0 - 0.1% rust
Corrosion Type: B - Surface Rust
Priority: 7 - Fair

General view of section

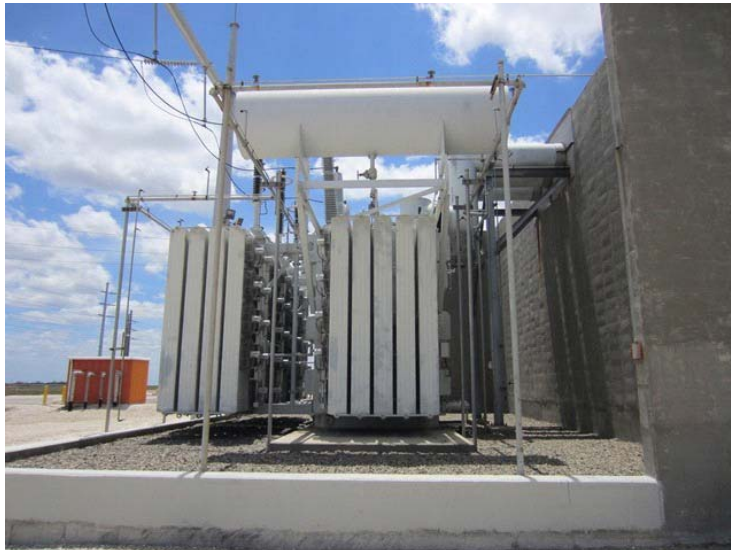
Environment Rating 3 - Moderate
Visibility: 6 - Low Traffic or Visibility
Corrosion Rating: 8.5 - <0.1% rust
Corrosion Type: A - No or Minimal Corrosion
Priority: 7 - Fair

General view of section
