Condition Analysis

Block: 01 Northwest Unit of the plant. Includes Gasification Unit, Brine Unit, Acid Unit, Coal Slurry Building, and pipe lines to flares.

Subblock: A On West side of Block 1. Contains Flare, pipe racks to flare, and conveyor belt.

Section: 01 Flare and associated structure.

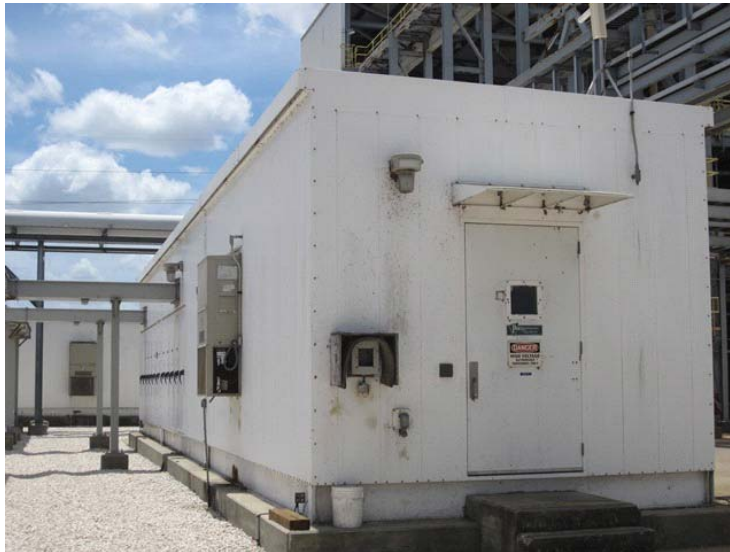
Environment Rating 3 - Moderate
Visibility: 5 - Moderate Traffic or Visibility
Corrosion Rating: 8.0 - 0.1% rust
Corrosion Type: E - Pitting or Rust Nodules
Priority: 7 - Fair

General view of section

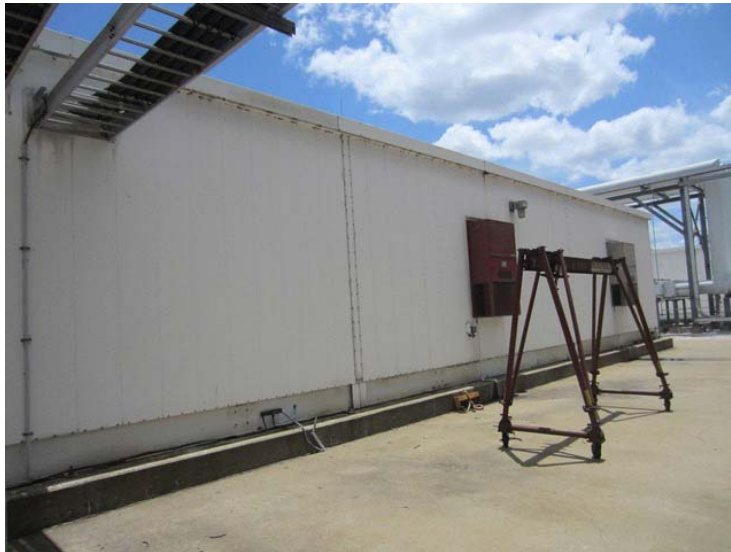
Environment Rating 3 - Moderate
Visibility: 5 - Moderate Traffic or Visibility
Corrosion Rating: 8.0 - 0.1% rust
Corrosion Type: E - Pitting or Rust Nodules
Priority: 7 - Fair

General view of section

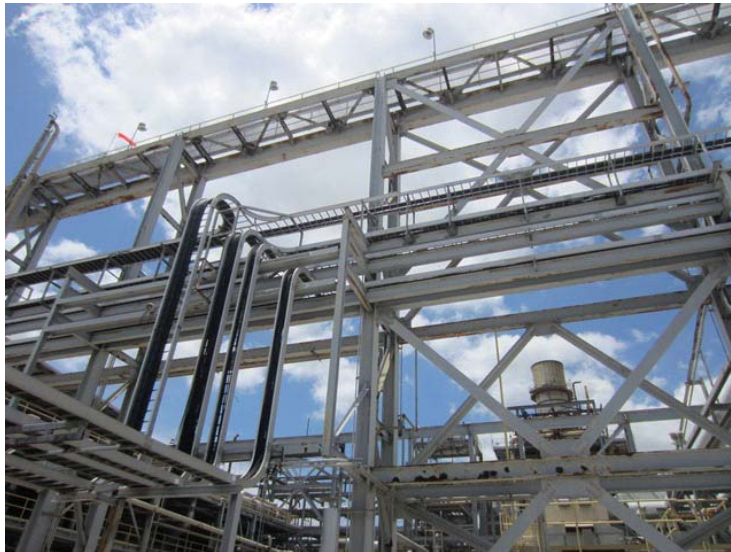
Environment Rating 3 - Moderate
Visibility: 4 - Hi Employee Traffic or Visibility
Corrosion Rating: 5.5 - 2% rust
Corrosion Type: E - Pitting or Rust Nodules
Priority: 3 - Wearout

General view of section

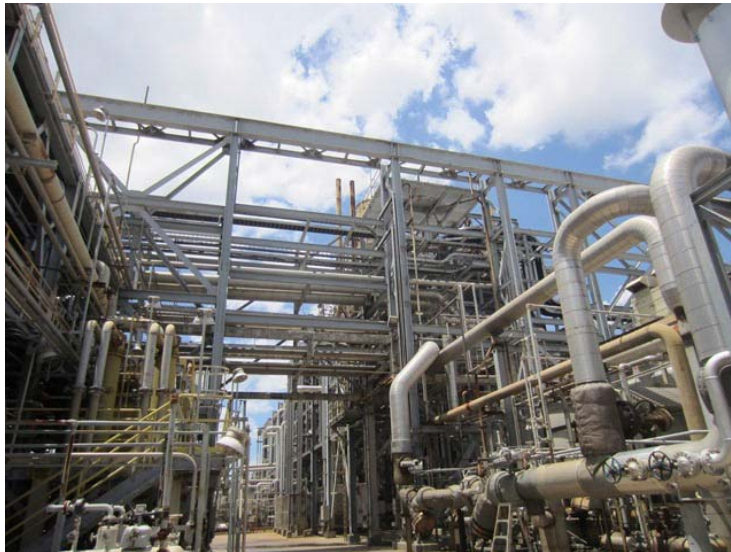
Environment Rating 3 - Moderate
Visibility: 5 - Moderate Traffic or Visibility
Corrosion Rating: 7.0 - 0.3% rust
Corrosion Type: E - Pitting or Rust Nodules
Priority: 3 - Wearout

General view of section

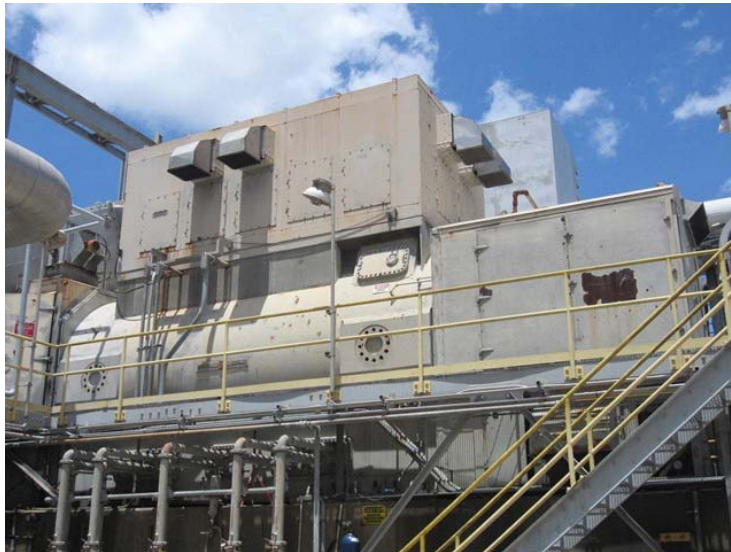
Environment Rating 3 - Moderate
Visibility: 5 - Moderate Traffic or Visibility
Corrosion Rating: 6.0 - 1% rust
Corrosion Type: D - Undercutting or Mill Scale
Priority: 3 - Wearout

General view of section

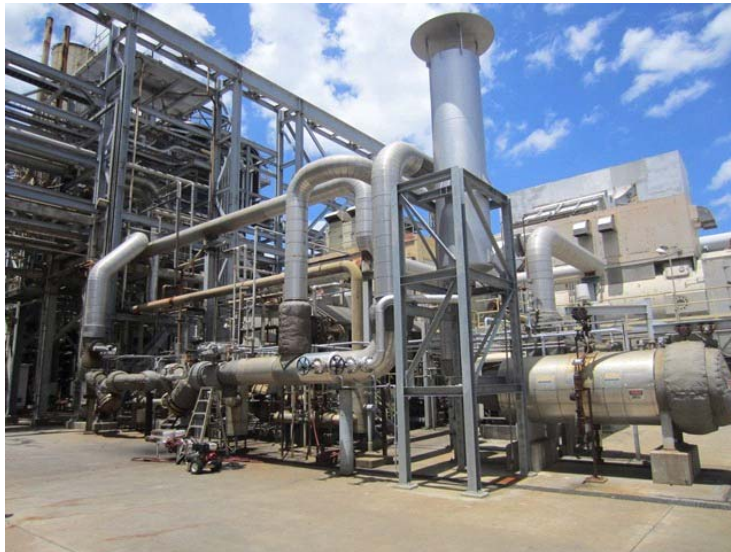
Environment Rating 3 - Moderate
Visibility: 5 - Moderate Traffic or Visibility
Corrosion Rating: 6.0 - 1% rust
Corrosion Type: C - Edge or Pinhole Corrosion
Priority: 3 - Wearout

General view of section

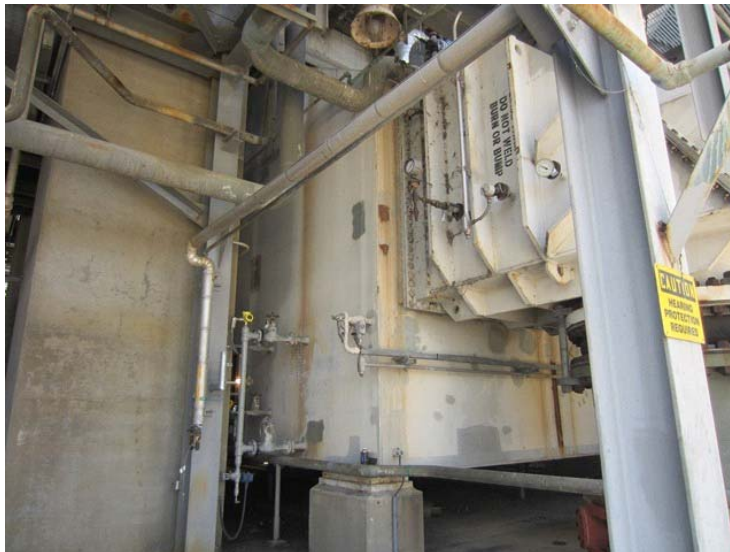
Corrosion Rating: 6.5 - 0.7% rust

Corrosion Type: C - Edge or Pinhole Corrosion

General view of section

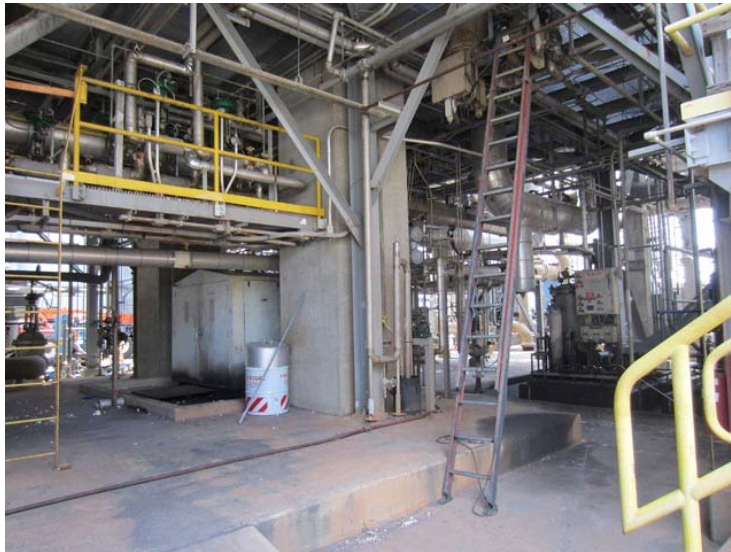
General view of section

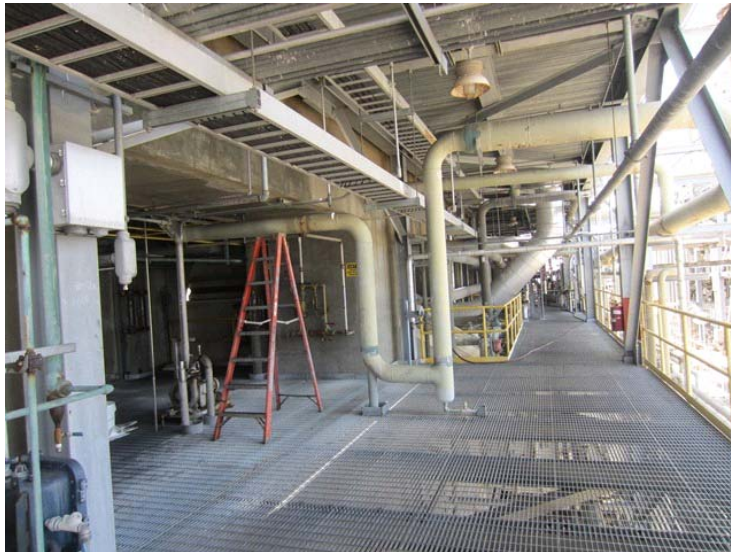
General view of section

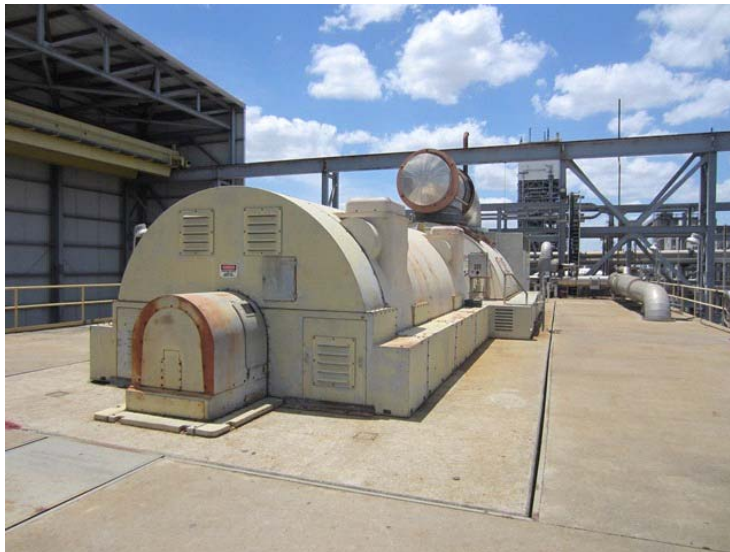
General view of section

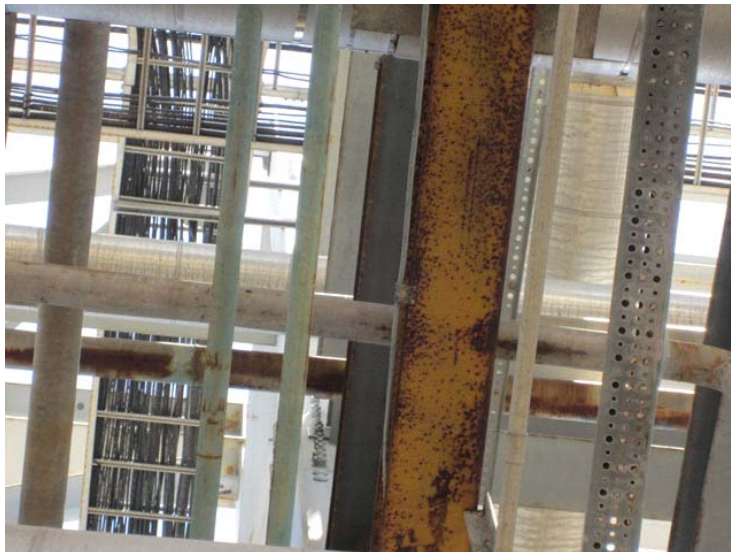
Environment Rating 3 - Moderate
Visibility: 4 - Hi Employee Traffic or Visibility
Corrosion Rating: 6.5 - 0.7% rust
Corrosion Type: E - Pitting or Rust Nodules
Priority: 2 - Optimum

View of corrosion on structure

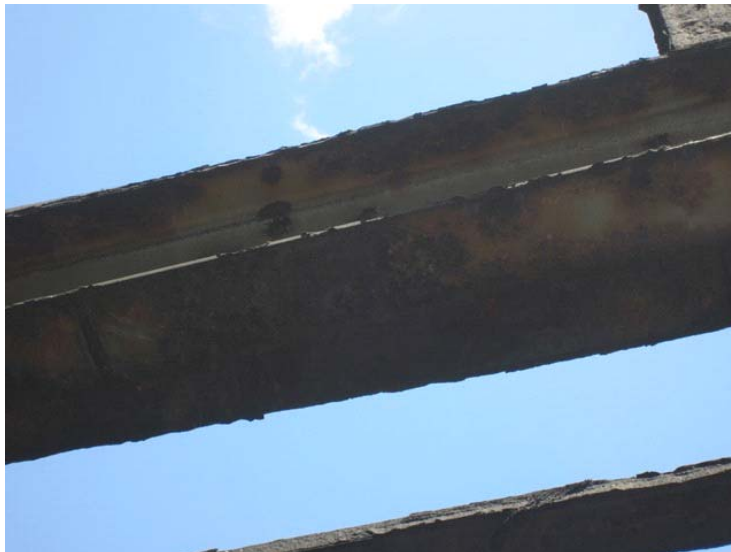
Priority: 1 - Advanced Corrosion

Severe corrosion

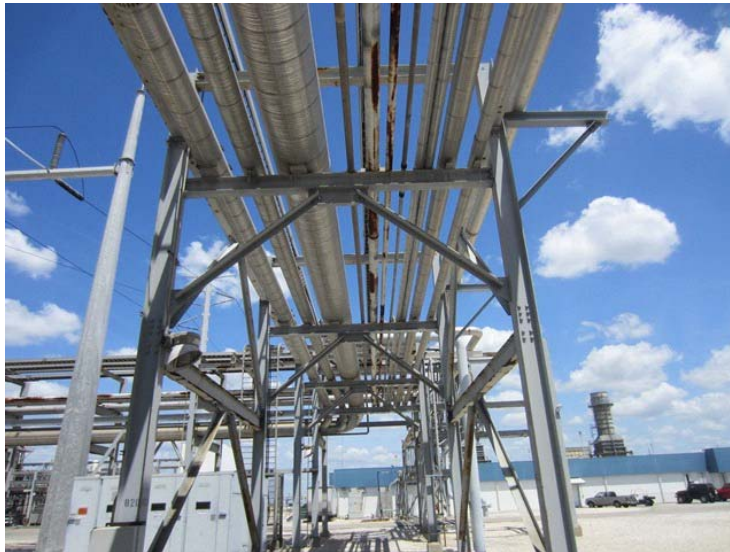
Environment Codes:
GF - General Plant Fallout

General view of section

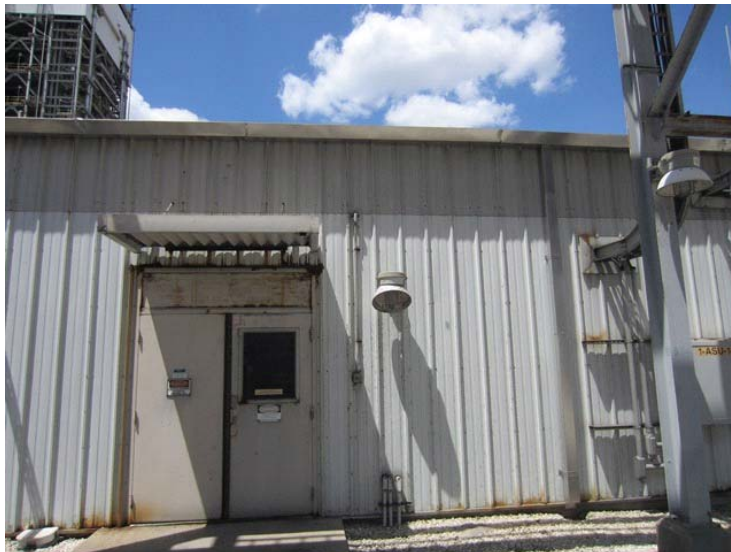
Environment Rating 3 - Moderate
Visibility: 4 - Hi Employee Traffic or Visibility
Corrosion Rating: 8.0 - 0.1% rust
Corrosion Type: C - Edge or Pinhole Corrosion
Priority: 7 - Fair

General view of section

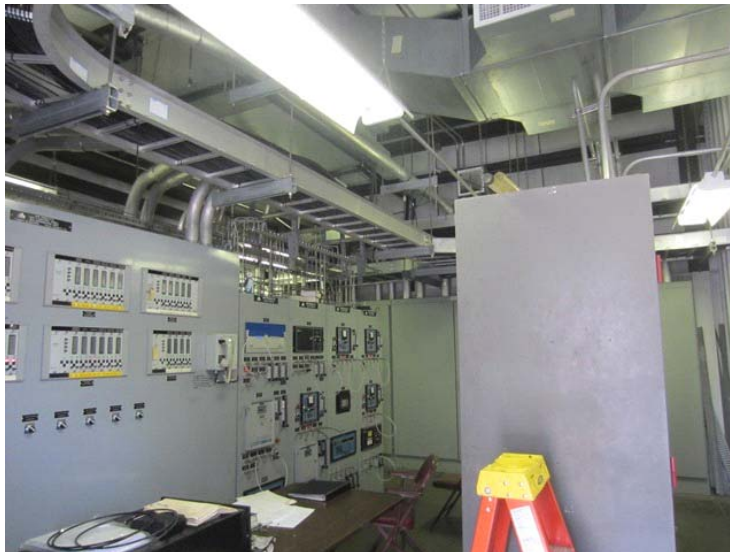
Corrosion Rating: 8.5 - <0.1% rust

Corrosion Type: A - No or Minimal Corrosion

General view of section

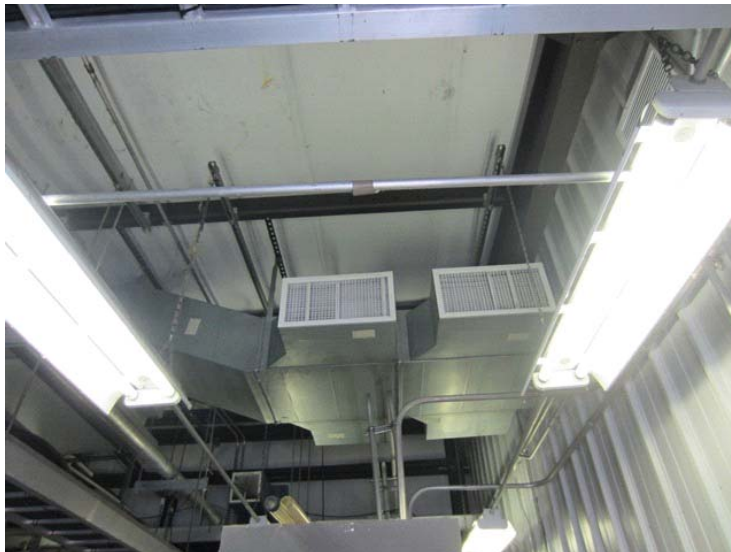
Corrosion Rating: 8.5 - <0.1% rust

Very minor corrosion

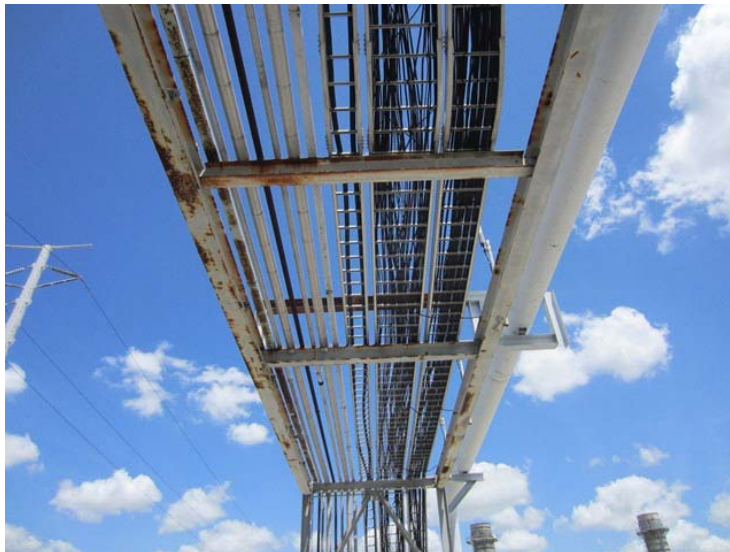
Environment Rating 3 - Moderate
Visibility: 4 - Hi Employee Traffic or Visibility
Corrosion Rating: 4.5 - 7% rust
Corrosion Type: E - Pitting or Rust Nodules
Priority: 4 - Substandard

General view of section

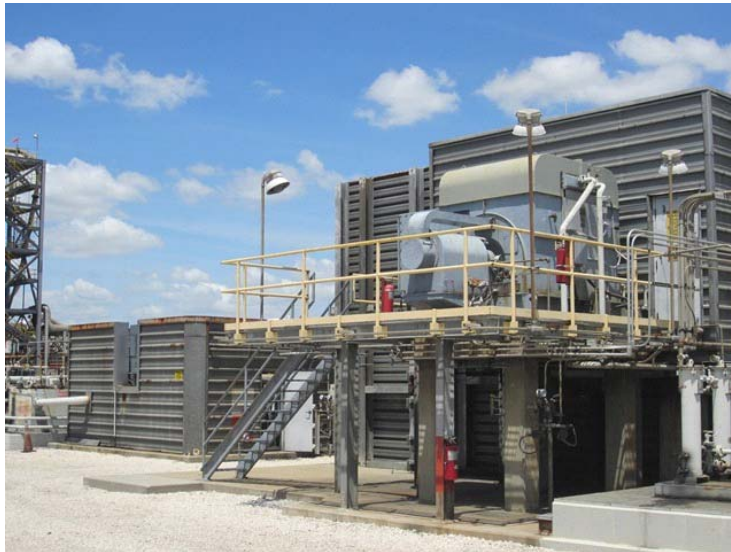
Environment Rating 3 - Moderate
Visibility: 6 - Low Traffic or Visibility
Corrosion Rating: 6.0 - 1% rust
Corrosion Type: E - Pitting or Rust Nodules
Priority: 3 - Wearout

General view of section

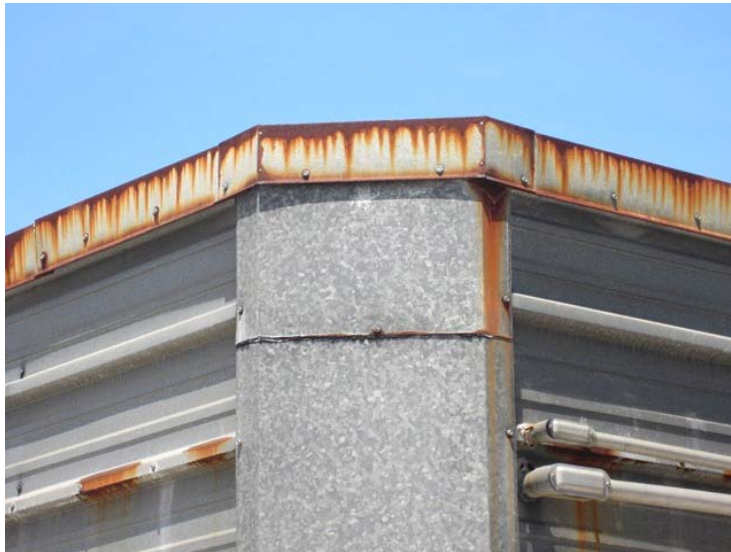
Environment Rating 3 - Moderate
Visibility: 6 - Low Traffic or Visibility
Corrosion Rating: 6.0 - 1% rust
Corrosion Type: E - Pitting or Rust Nodules
Priority: 3 - Wearout

Edge corrosion

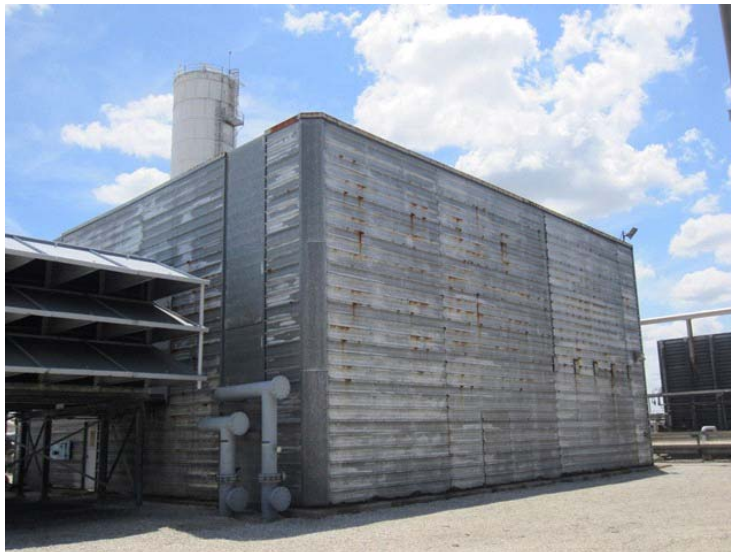
Environment Rating 3 - Moderate
Visibility: 6 - Low Traffic or Visibility
Corrosion Rating: 7.0 - 0.3% rust
Corrosion Type: E - Pitting or Rust Nodules
Priority: 7 - Fair

General view of section

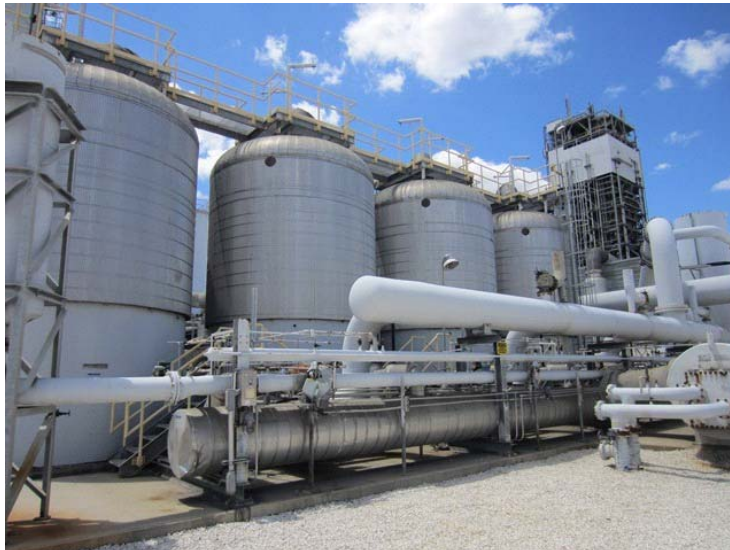
Environment Rating 3 - Moderate
Visibility: 4 - Hi Employee Traffic or Visibility
Corrosion Rating: 6.5 - 0.7% rust
Corrosion Type: D - Undercutting or Mill Scale
Priority: 3 - Wearout

General view of section

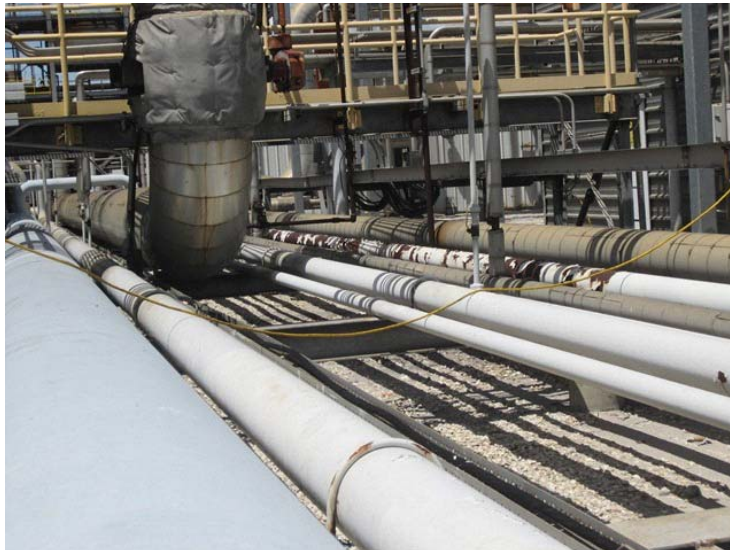
Environment Rating 3 - Moderate
Visibility: 6 - Low Traffic or Visibility
Corrosion Rating: 5.5 - 2% rust
Corrosion Type: D - Undercutting or Mill Scale
Priority: 3 - Wearout

General view of section

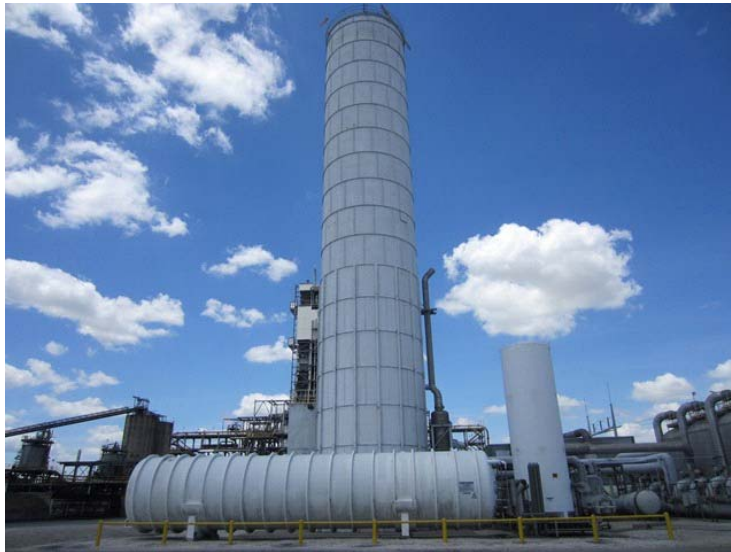
Environment Rating 3 - Moderate
Visibility: 6 - Low Traffic or Visibility
Corrosion Rating: 5.5 - 2% rust
Corrosion Type: D - Undercutting or Mill Scale
Priority: 3 - Wearout

General view of section

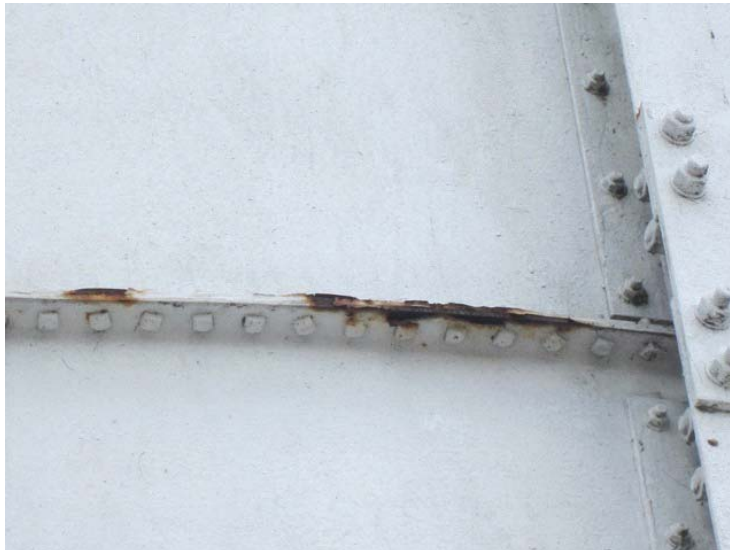
Environment Rating 3 - Moderate
Visibility: 6 - Low Traffic or Visibility
Corrosion Rating: 5.5 - 2% rust
Corrosion Type: D - Undercutting or Mill Scale
Priority: 3 - Wearout

Edge corrosion

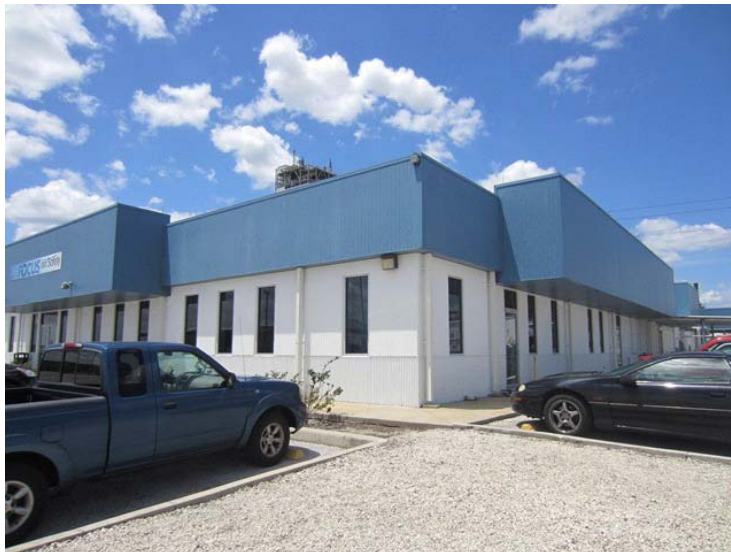
Environment Rating 3 - Moderate
Visibility: 2 - High Public Visibility or Parade Route
Corrosion Rating: 9.0 - <0.1% rust
Corrosion Type: A - No or Minimal Corrosion
Priority: 8 - Design

General view of section

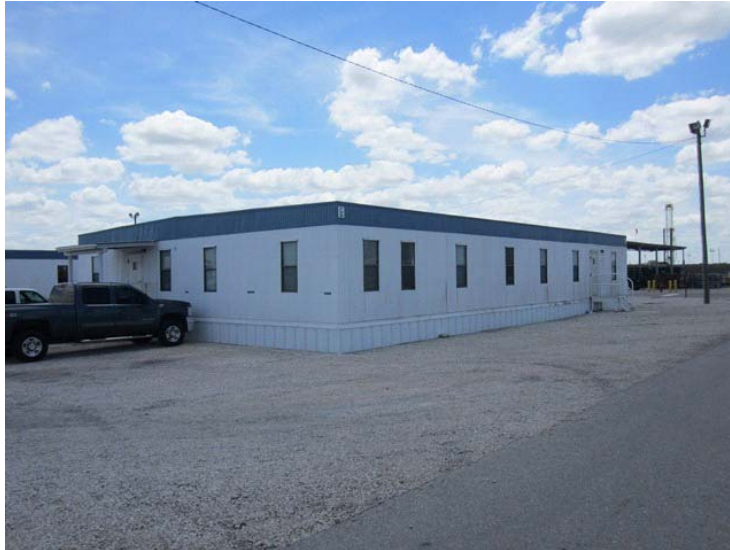
Comments: Pressure wash- Mold Delaminationon Air Conditioner Vents

General view of section

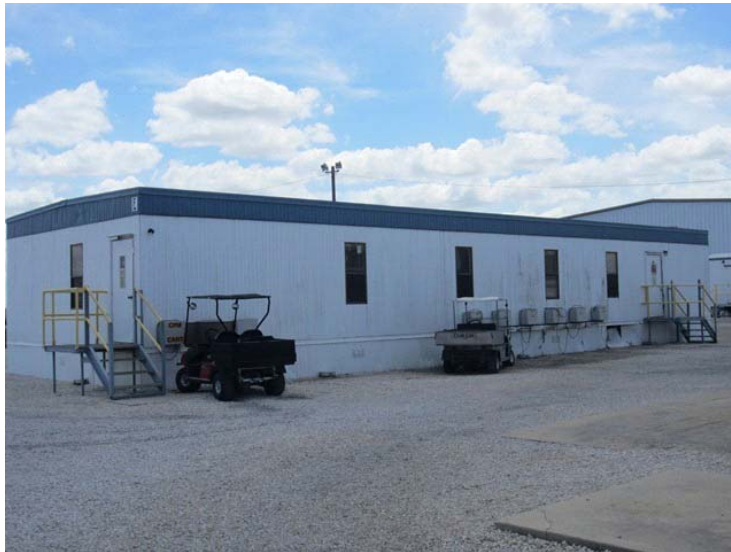
Comments: Pressure wash- Mold Delaminationon Air Conditioner Vents

General view of section

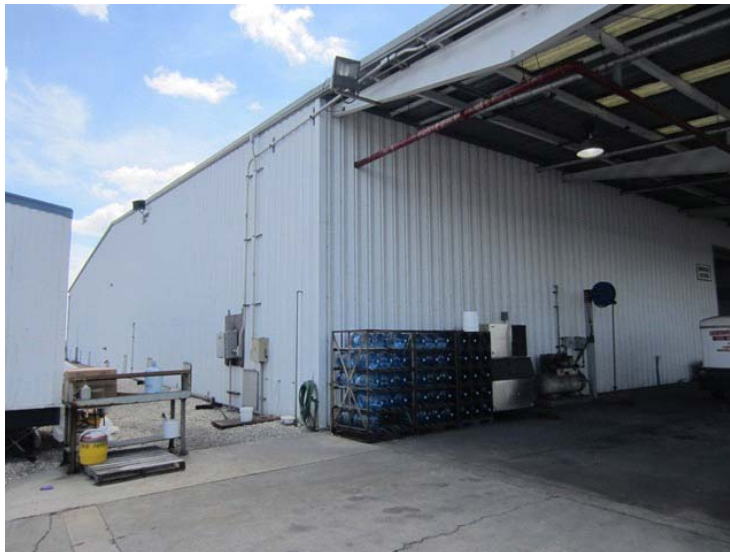
Environment Rating 3 - Moderate
Visibility: 4 - Hi Employee Traffic or Visibility
Corrosion Rating: 4.5 - 7% rust
Corrosion Type: E - Pitting or Rust Nodules
Priority: 5 - Localized Corrosion

Comments: Localized corrosion on South side cover and structure.

General view of section

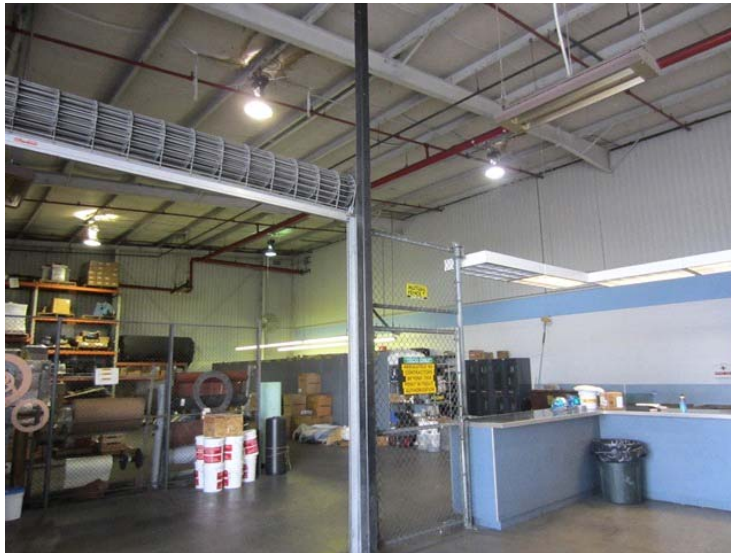
Corrosion Rating: 8.5 - <0.1% rust

General view of section

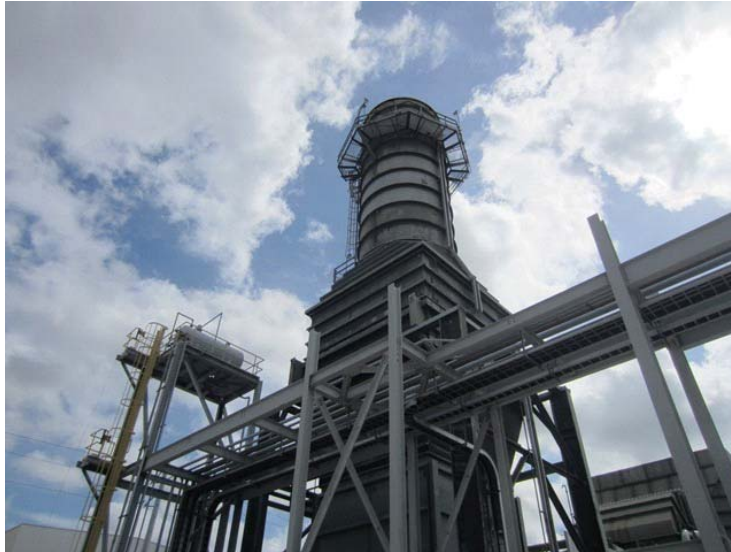
Environment Rating 3 - Moderate
Visibility: 3 - Tank Area
Corrosion Rating: 7.0 - 0.3% rust
Corrosion Type: C - Edge or Pinhole Corrosion
Priority: 2 - Optimum

General view of section

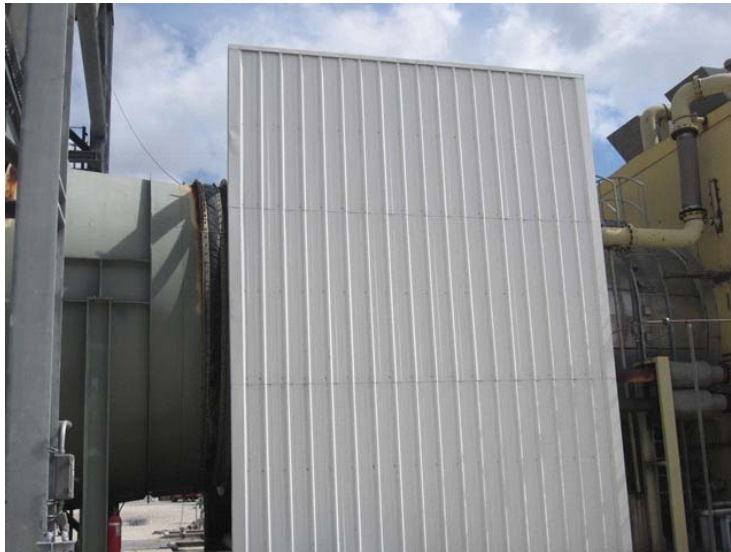
Environment Rating 3 - Moderate
Visibility: 4 - Hi Employee Traffic or Visibility
Corrosion Rating: 3.5 - 13% rust
Corrosion Type: E - Pitting or Rust Nodules
Priority: 5 - Localized Corrosion

Comments: Corroding pipe on South Side of section.

General view of section

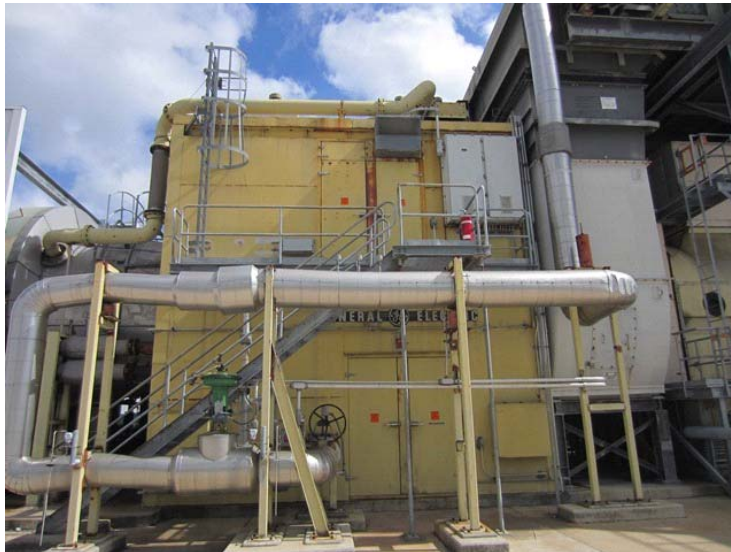
General view of section

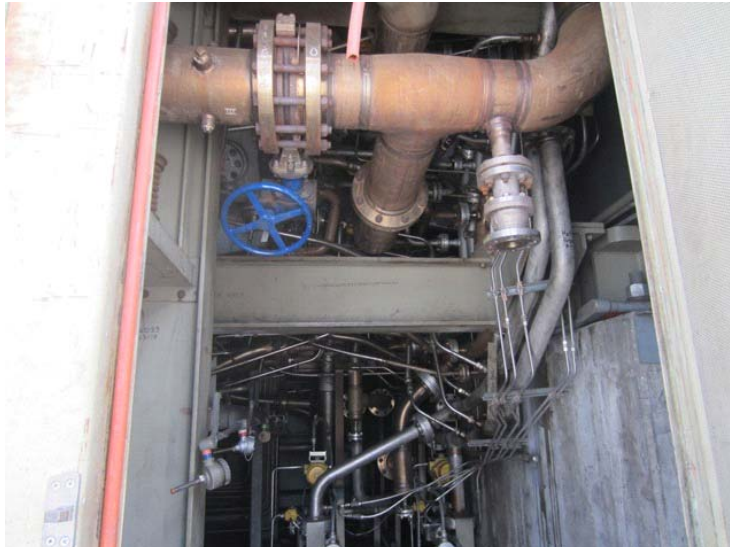
General view of section

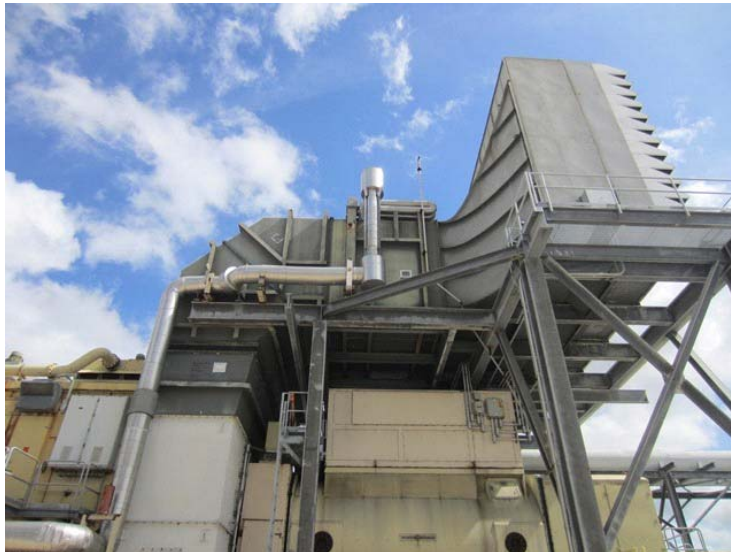
General view of section

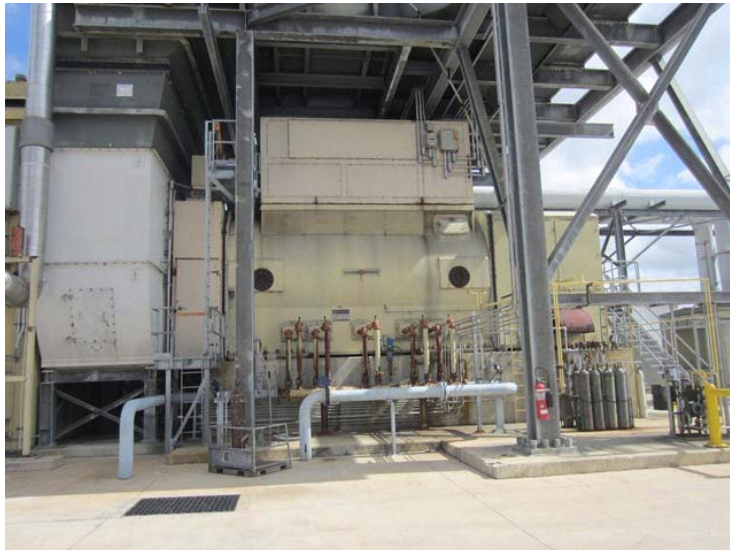
General view of section

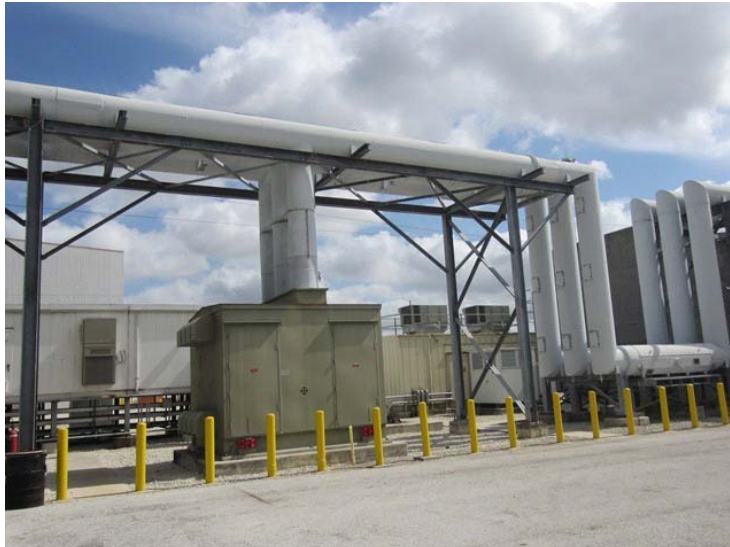
General view of section

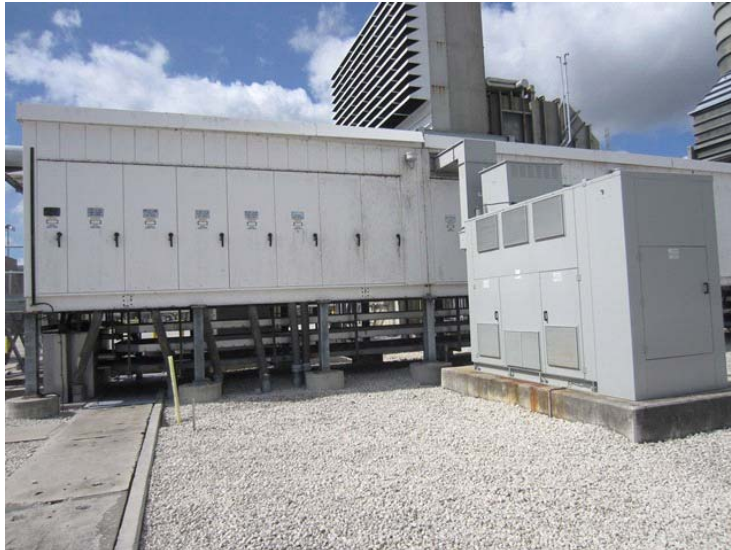
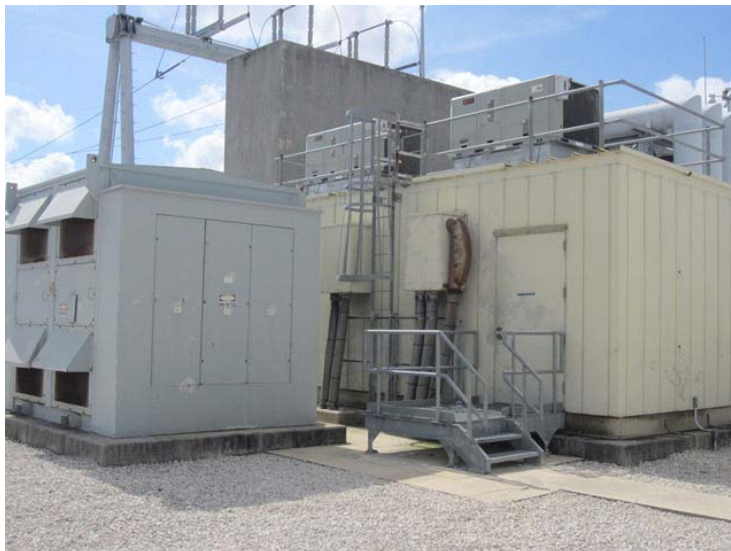
Comments: Building has corrosion on south side.

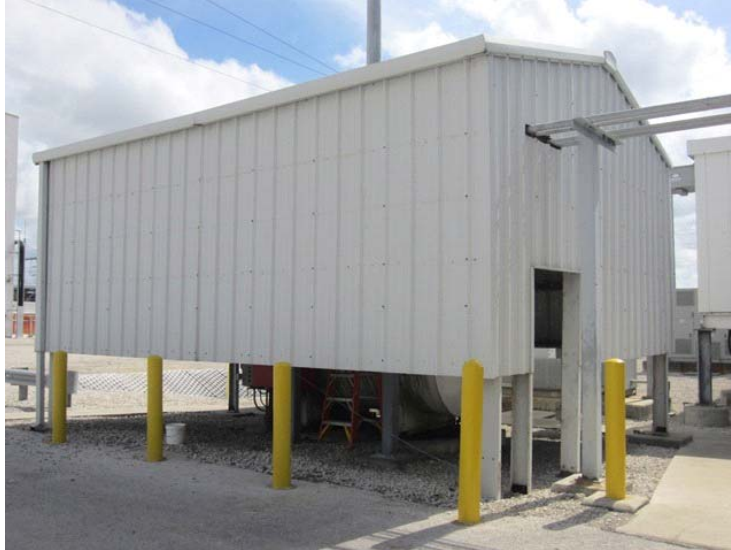
Comments: Mold

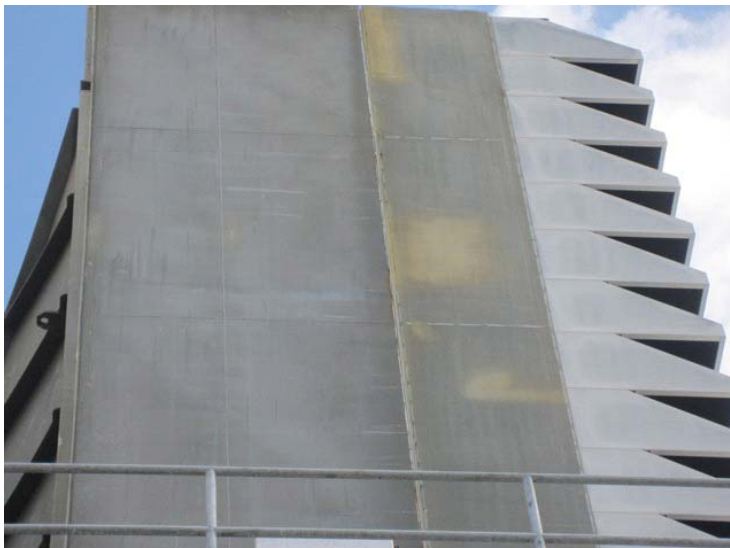
Environment Rating 3 - Moderate
Visibility: 3 - Tank Area
Corrosion Rating: 7.0 - 0.3% rust
Corrosion Type: E - Pitting or Rust Nodules
Priority: 2 - Optimum

Coating wear

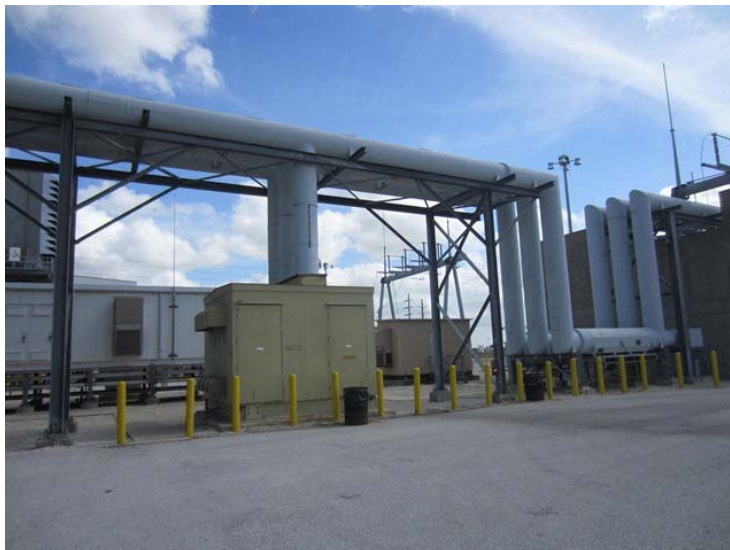
Comments: Mold

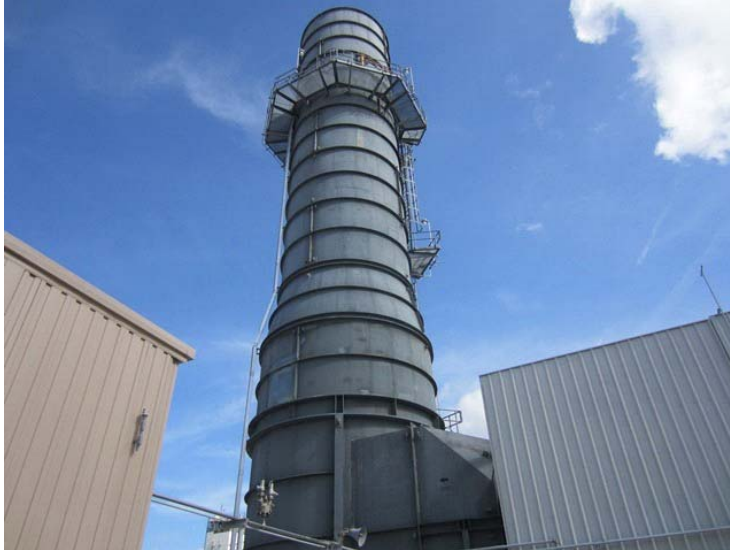
Environment Rating 3 - Moderate
Visibility: 3 - Tank Area
Corrosion Rating: 7.5 - 0.2% rust
Corrosion Type: C - Edge or Pinhole Corrosion
Priority: 7 - Fair

Edge corrosion on stack

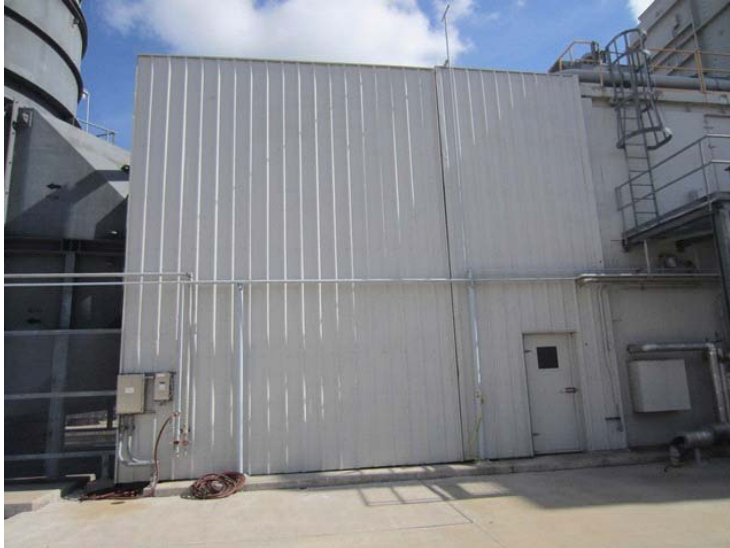
Environment Rating 3 - Moderate
Visibility: 4 - Hi Employee Traffic or Visibility
Corrosion Rating: 3.5 - 13% rust
Corrosion Type: E - Pitting or Rust Nodules
Priority: 5 - Localized Corrosion

Comments: Highly Corroded pipe- Inside Door on South Side
